**Aquatic specialist inputs to proposed erosion control measures for road OP06914 on Swartvlei Lake, Sedgefield.**

**Prepared by: Dr. Jackie Dabrowski of Confluent Environmental (Pty) Ltd**

**For: Garden Route District Municipality**

**April 2021, updated June 2021**

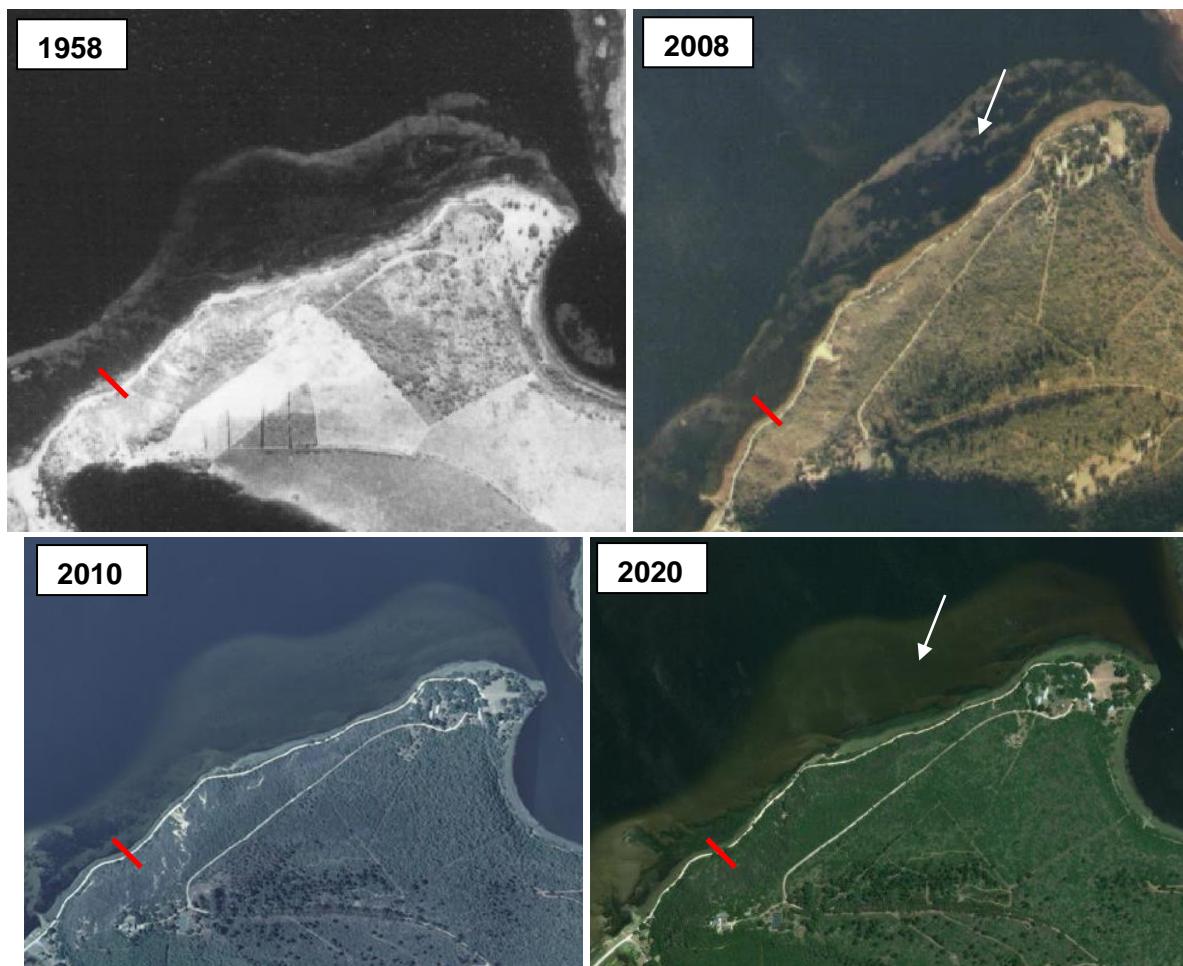
Historical imagery of the eroding section is not of sufficient resolution to identify specific locations of erosion along the road if it occurred in the past. Photos do indicate that the road has been at this location for many decades and can be seen on images as long ago as 1958. The sandy shelf indicated off the lake shore has been present at its approximate location and has not changed significantly in dimensions over several decades (Figure 9).

An important aspect which has changed over time has been well documented (Russell and Randall, 2017) and can be easily observed when comparing images between 2008 and 2010 (Figure 9). Salinity levels in Swartvlei Lake rose considerably following extended open conditions post-2007 flooding coupled with reduced freshwater inflows due to the following drought. As a result, submerged macrophytes with low tolerance to high salinity levels died off on the near-shore sand banks all around Swartvlei Lake. The macrophytes in the 2008 image can be observed as dark 'shadows' on the sand bank, while plain sand with no plants is evident in the image from 2010 and the present images. The dominant plant species was *Stuckenia pectinata* syn., *Potamogeton pectinatus*. This plant formed thick areas of growth which effectively dampened wave action along the shore. The loss of this submerged vegetation is likely the cause of more recent erosion due to higher energy wave action when water levels in the lake are high. This explains why erosion has not been an ongoing problem for the many decades the road has been present. It can also be seen in the image from 1958 (Figure 9).

Figure 9. Historical images of the road section showing the approximate start of erosion (red line) and offshore sandbank where vegetation was historically abundant and is now absent (white arrow).

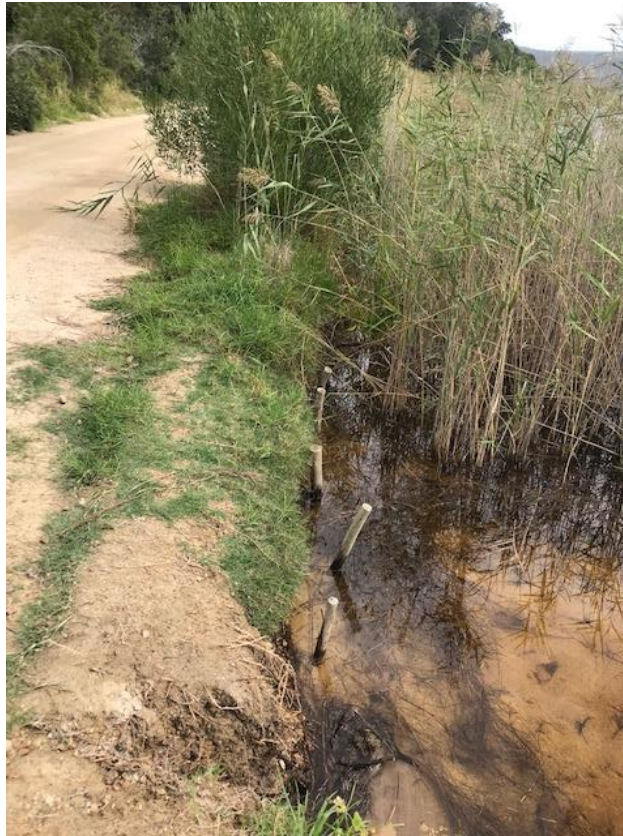
Erosion at the site was previously controlled by packing sandbags adjacent to the road edge. During the site visit broken bags were observed and they were not providing any level of protection from wave action. The eroding road edge has resulted in the road narrowing, and in some places, vehicles need to travel dangerously close to the eroded edge.

Figure 10. Section of the road where sandbags were historically placed but have now disintegrated allowing erosion to recur.

One of the simplest options is to use sandbags against affected areas of shoreline, in a similar way to what has been done in the past. However, biodegradable bags made of a product such as jute would be recommended over woven plastic bags. Their lifespan before biodegrading would be 2-3 years. In this time, they could provide cost-effective short- to medium-term protection of the shoreline until the offshore vegetation has established. If a second application is required, it is not a costly or technical exercise to repeat. Sand for the sandbags would also need to be sourced from a suitable location nearby to ensure no foreign material (e.g. building sand) is introduced to the lake (as described in Section 1.2). A biodegradable mat should be staked into the sand below the sandbags to provide a more stable surface, and the sandbags should be staked in place using wooden stakes as support.

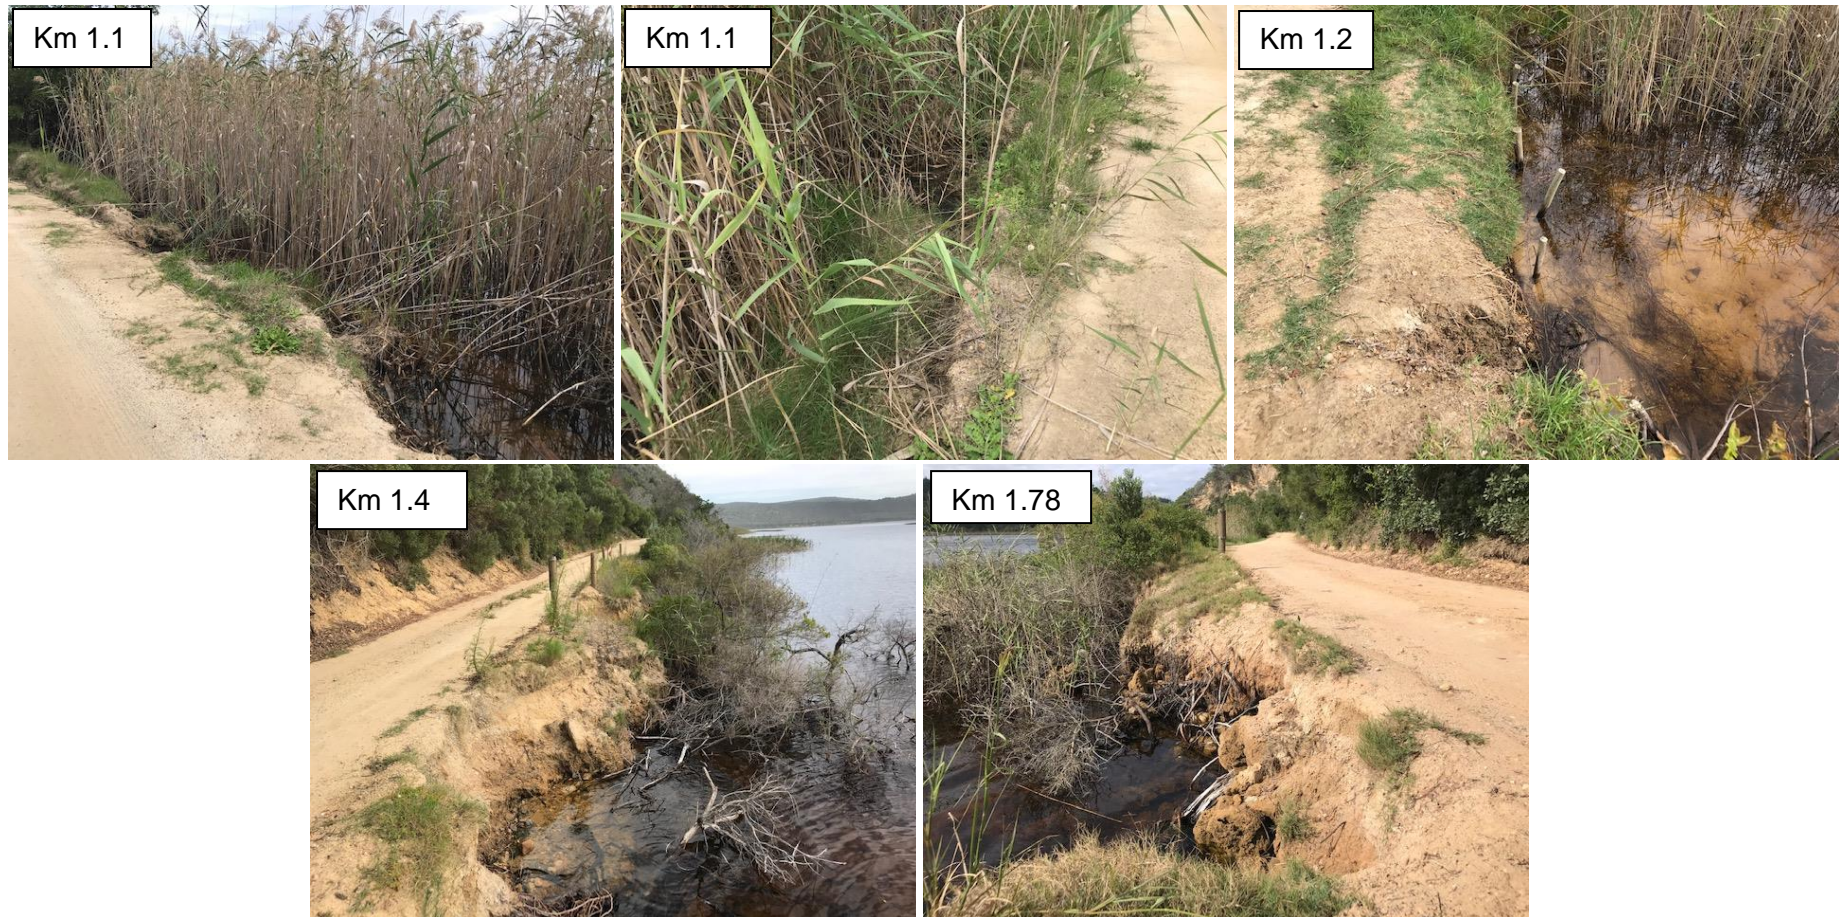
The road was in a driveable condition at the time of the site visit, but much of it was suitable for a single vehicle only. The first observable point of erosion was at 33°59'56.49"S, 22°46'37.02"E, or approximately Km 1.1 measured from the N2 highway (Figure 11). Erosion was discontinuous along the road with some parts more eroded than others. At Km 1.2 sandbags have historically been placed but have sunk or moved and only wooden stakes and a few broken bags are remaining. The bags historically used were made of woven plastic which, when broken, causes pollution of the area. Several broken bags were removed from the site during the site visit. The worst affected section was at Km 1.4 where the road had eroded close to where vehicles needed to drive, leaving a vertical, undercut edge highly susceptible to further erosion (Figure 11). This section subsequently eroded more severely following strong westerly winds (> 40 knots) on 25 May 2021 (Figure 12).

Figure 11. Photos showing various sections of the road OP06914 where erosion is occurring taken 24 March 2021. Kms measured from the N2 highway.

The necessity of interventions must be carefully considered. Not all points where the road is eroding may need to be addressed. The sections indicated at km 1.1 for instance are still some way off from eroding badly, and simply placing rocks spaced strategically to prevent cars from driving over the vegetation could be sufficient for re-stabilising the edge. Planting of additional grass and spiny plant species such as *Carissa bispinosa* along this edge may also help in protecting it from unrestricted access and the roots will help stabilise soil.

As described in Option 2 of Section 1.2, the installation of a gabion retaining wall is recommended in the vicinity of Kms 1.4 and 1.78. Gabions should be constructed using suitably sized rock from the area so as to look as natural as possible (ie. Not from a granite quarry, and not small enough to fall out of the mesh). A geofabric such as bidim must be laid beneath, behind, and above the gabions to prevent sand from moving through the gabions which results in undermining of the structure with subsequent slumping. The fabric can be secured with cable ties. Soil pockets must be created in the structure to enable vegetation of the wall face (see below).

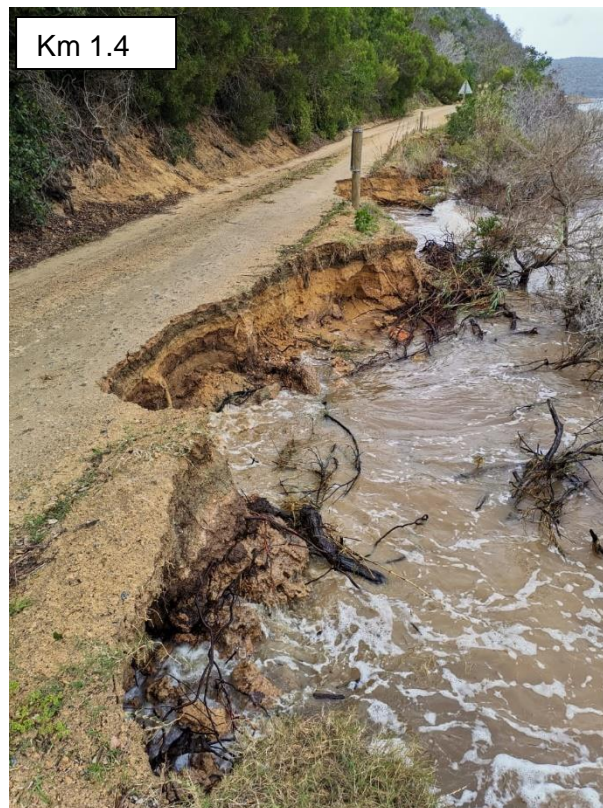
Figure 12. Updated image of the road at Km 1.4 taken on 25 May 2021 (Photo J. Britton, SANParks).
