Section A

Koo river bridge

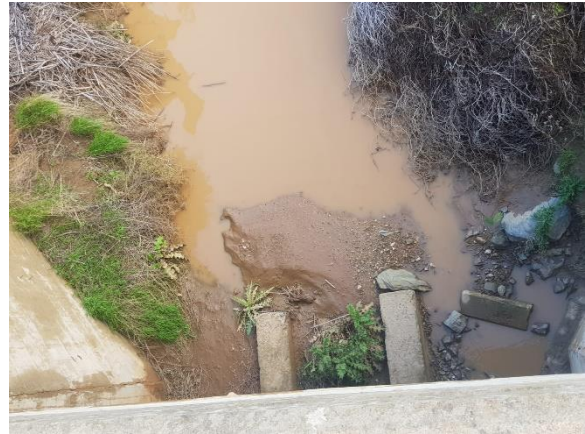
Image 12: Watercourse bed and adjacent vegetation.

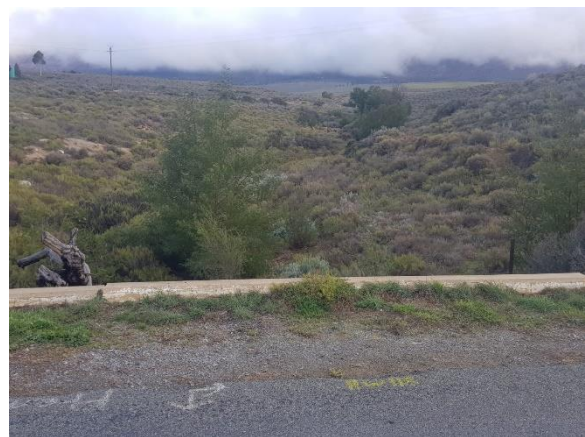
Image 14: Fence line near to Major Culvert C10507.

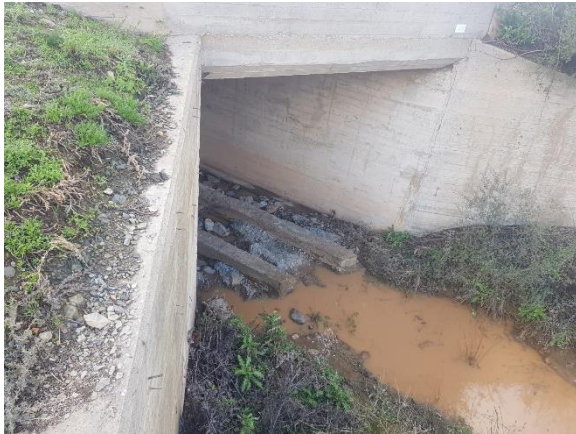
Image 21: Damaged infrastructure on Major Culvert C10508.

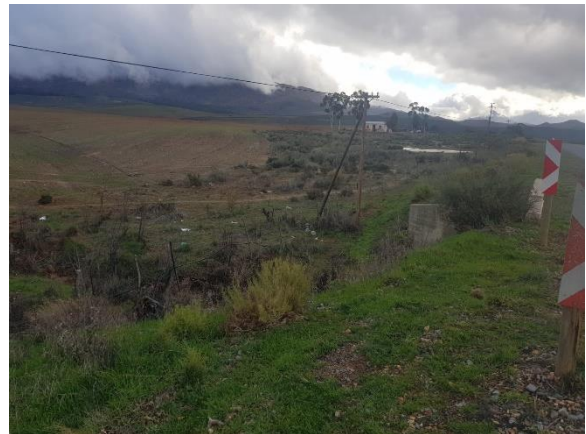
Image 26: Disturbed area adjacent to Major Culvert C10508.

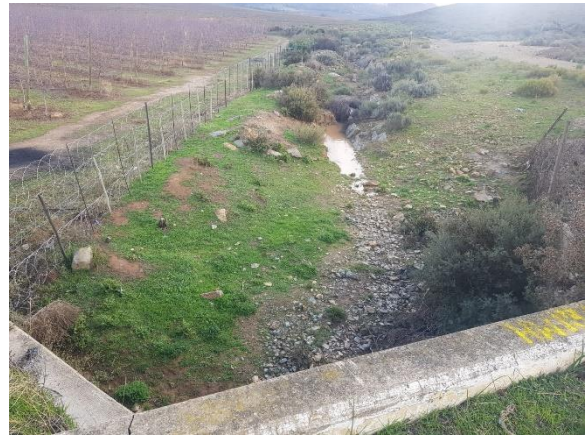
Image 30: Poorly sorted natural material within the riverbed.

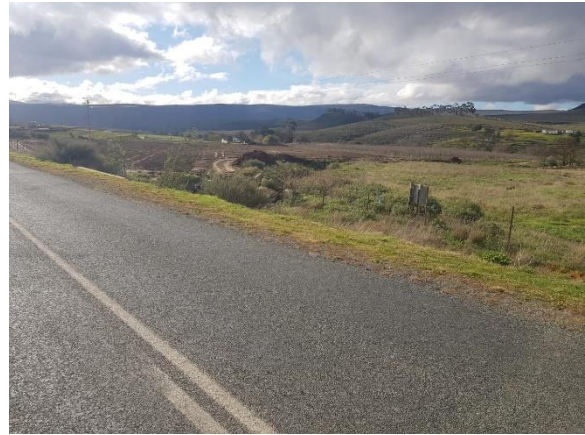
Image 34: Alien vegetation adjacent to the watercourse.

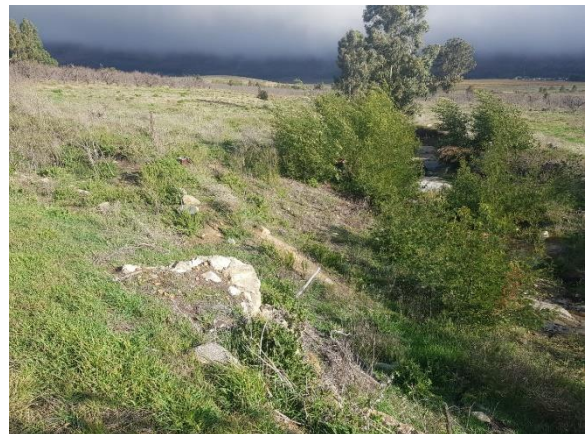
Image 38: Watercourse with alien vegetation.

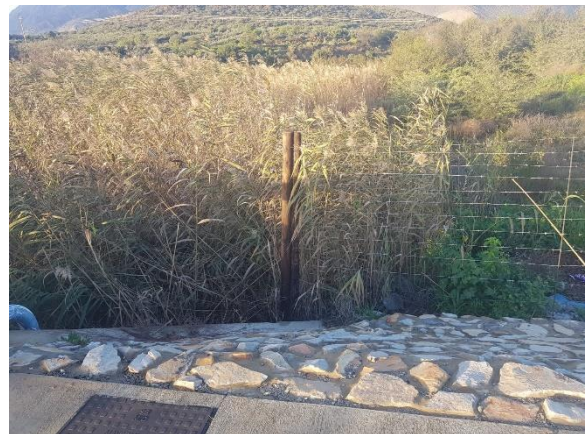
Image 64: Disturbed area adjacent to the bridge.

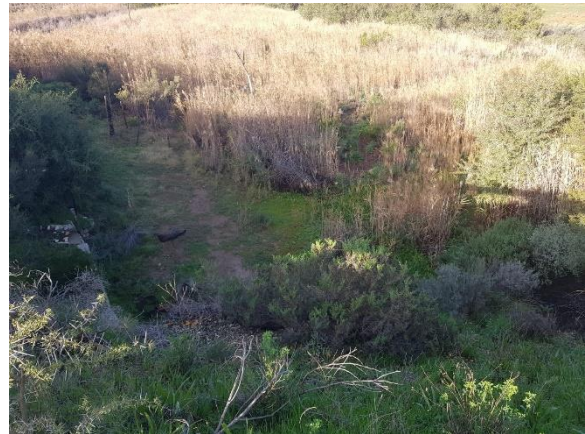
Image 99: Disturbed area adjacent to the watercourse.

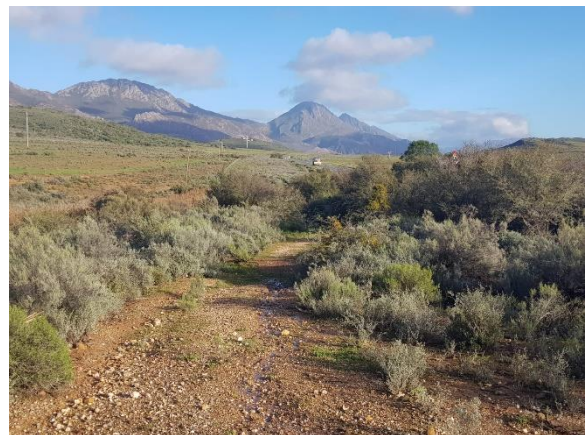
Image 101: Disturbed path to be utilized as a working corridor.
