STRUCTURAL & CIVIL ENGINEER'S REPORT

**BASIC DUE DILIGENCE REPORT ON STRUCTURAL AND CIVIL ENGINEERING
ASPECTS OF PREMISES & BUILDINGS ON ERF 19134, PAARL**

Prepared for NEXUS^{AG}, Paarl

21 November 2016

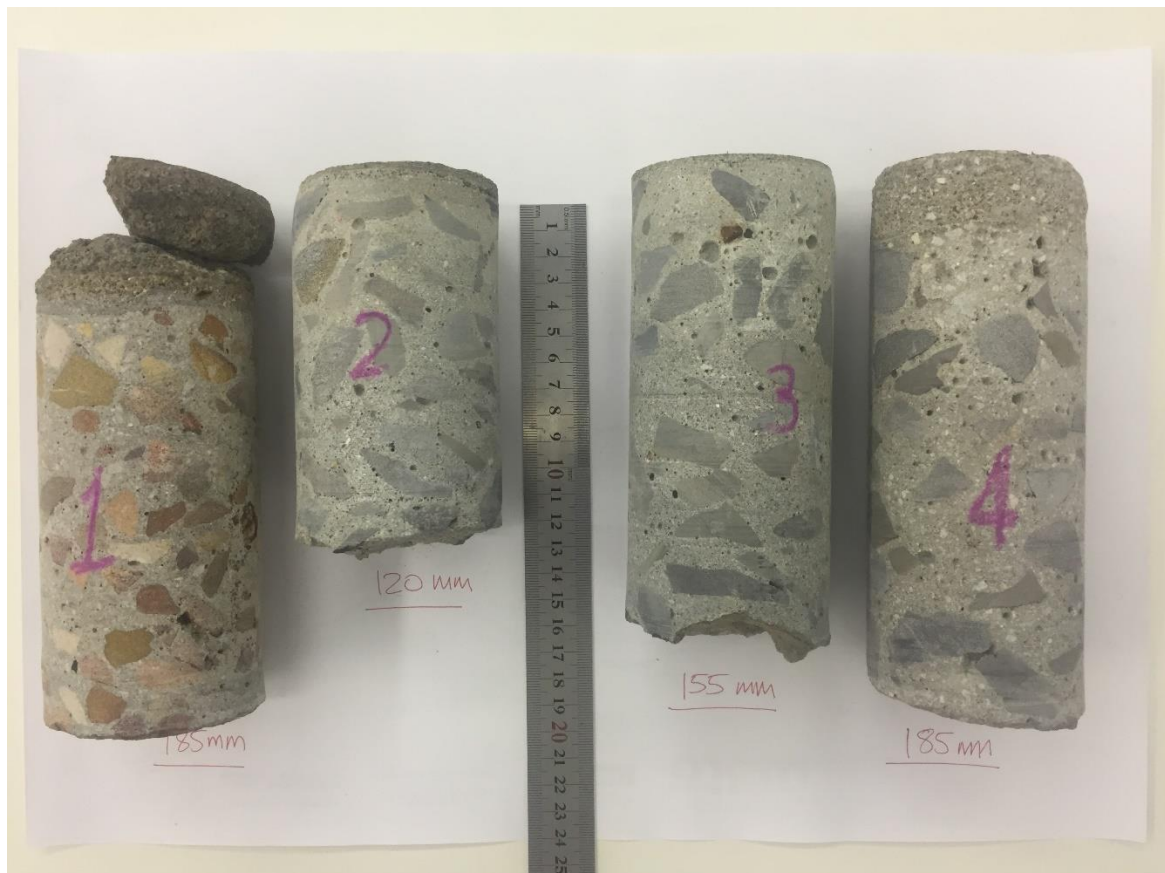
Concrete cores (75mm \varnothing) have been taken in all the buildings (except the dwelling house) and indicate an average thickness of 161mm. Only one core has evidence of reinforcing mesh (8mm) in the bottom of the floor.

The 120mm thick core was found in the large warehouse, but since the cores are on average above 150mm, it can be assumed that this is an outlier.

Photo 1: Concrete cores from floor slabs on the ground.

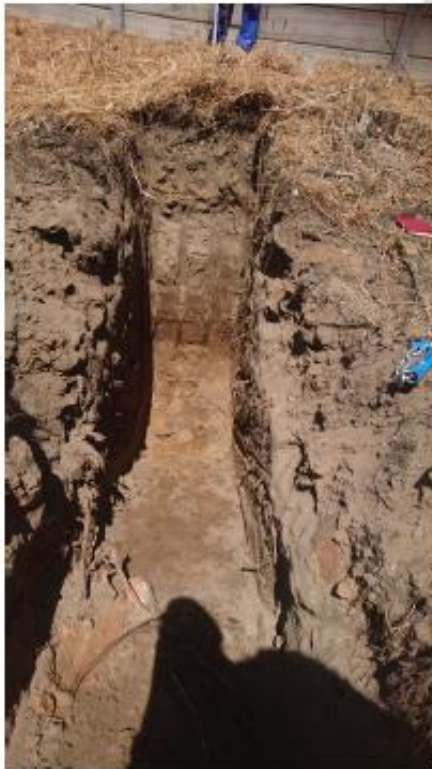
0.45m: Slightly moist, brown with orange mottles, dense, Fill material consisting of mostly building rubble.

0.6m: Slightly moist light grey, loose, intact, silty Sand. Alluvium (elluviated layer)

0.9m: Slightly moist, dark brown, medium dense-stiff, sandy Clay with silt. Alluvium.

2.0m: Slightly moist to moist, brown grading to orange, medium dense to loose, silty Sand with clay. Alluvium.

Figure 2: NX3 soil profile

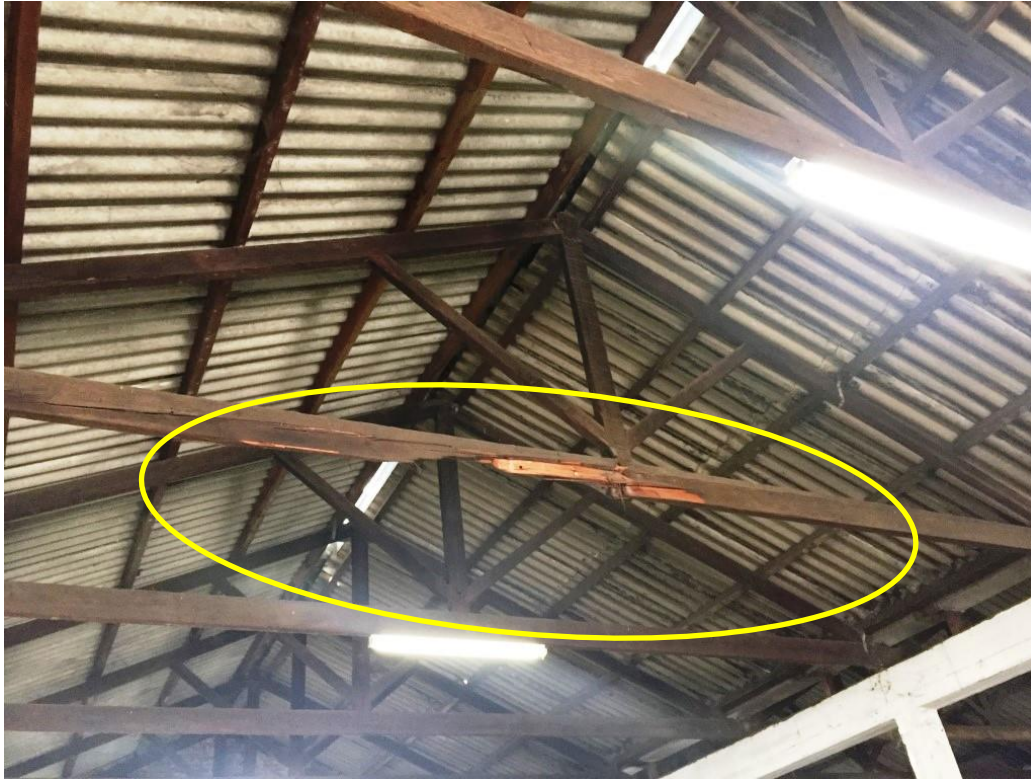
Photo 1: Damaged timber truss in Warehouse B

- The damaged timber roof truss in Building B need to be repaired in-situ, with replacement of missing and/or damaged members. (See photo attached)
- We would also recommend as a general and ongoing maintenance issue the overall cleaning, waterproofing, repair and painting of the buildings prior to occupation.

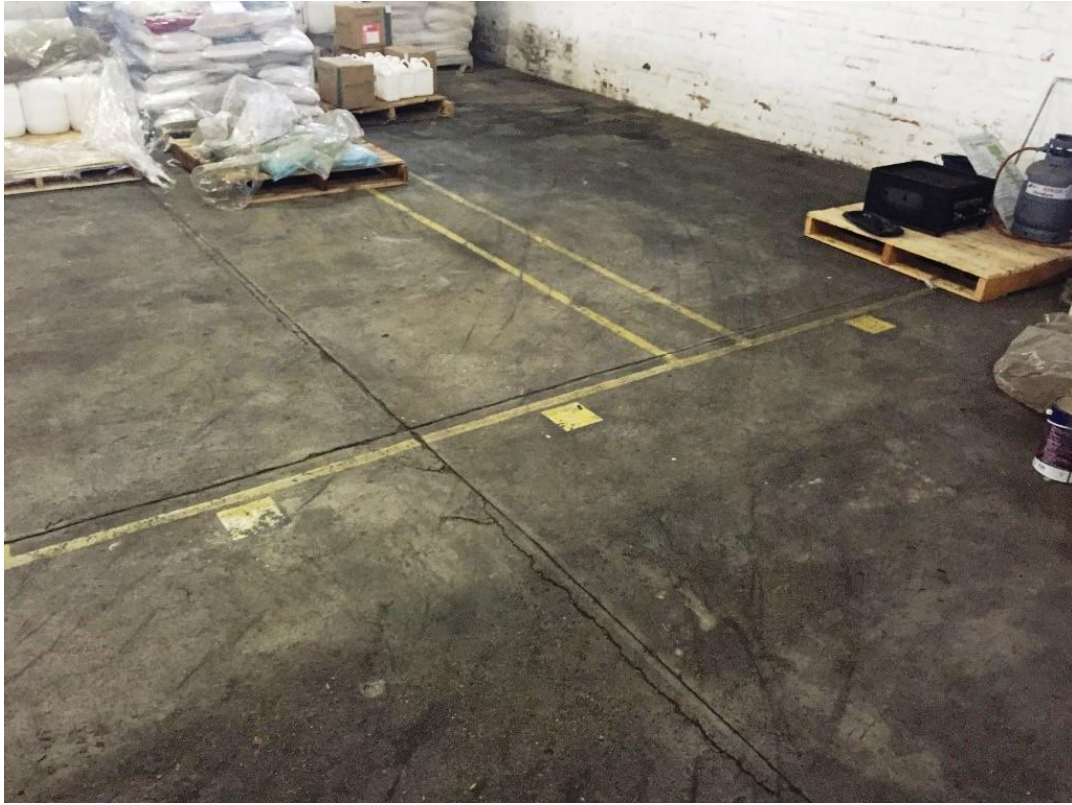
Photo 5: Warehouse Floor B - notice edge breaks

- The concrete floors in all the buildings are in a fair condition and can be used without restrictions.
- Edge breaks and corner breaks are visible in some locations and should be repaired to avoid further deterioration due to small, hard wheel loads and forklifts.
- A full assessment of the floor and the true extent of all the defects can only be fully assessed once the storage areas have been cleared.
- The Ground Floor in the small workshop is at different and varying levels. This should be addressed with a 150mm thick, 30 MPa concrete overlay, should the building be used for warehousing and storage with forklift traffic. Approx. 600m². The unit cost of an overlay is approx. R 380/m², including joint cutting and sealing.
