01 August 2024

Our Reference: AFP240047-PR-MILKWOOD-R00

**MILKWOOD MANOR REVETMENT: COASTAL ENGINEERING ASSESSMENT****1. INTRODUCTION**

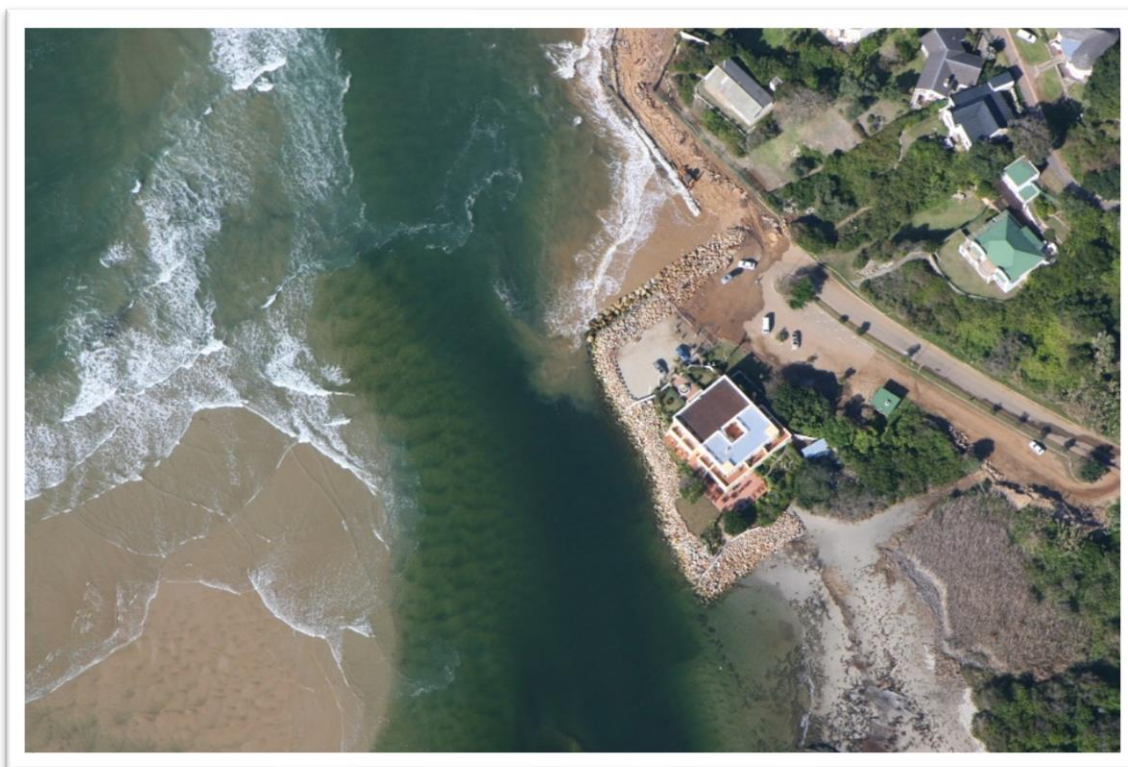
*Figure 3.2.2 after construction of revetment (circa 2008)*

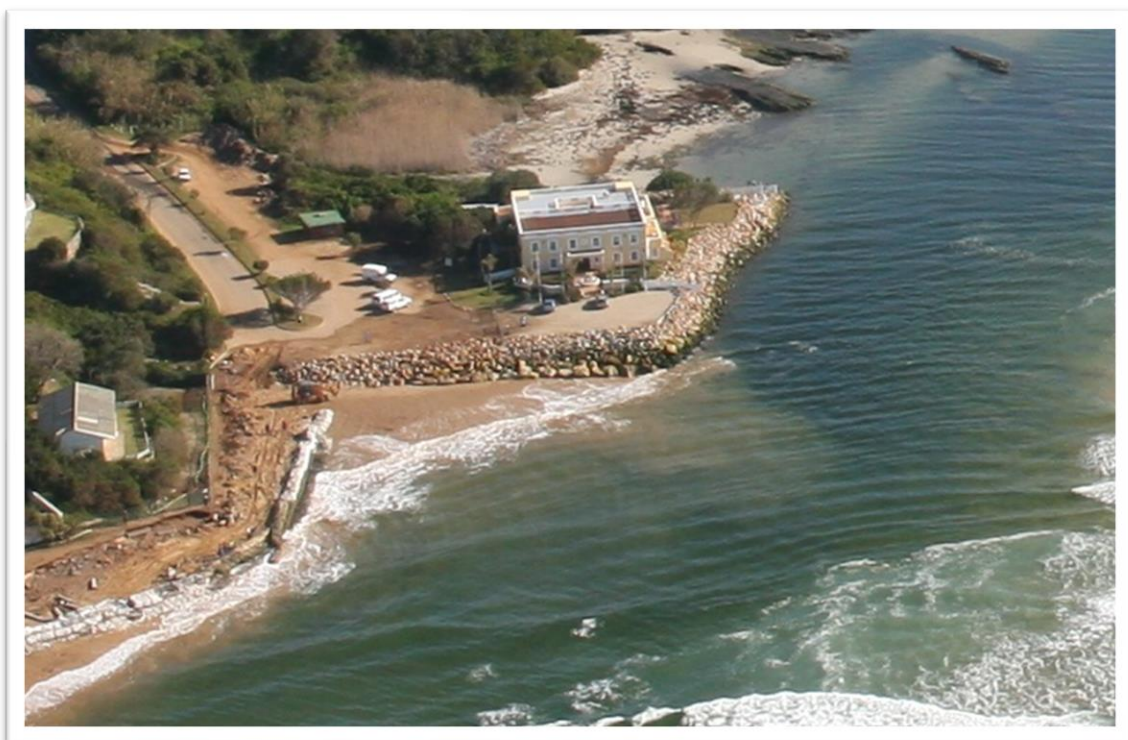
*Figure 3.2.3 Revetment post construction (circa 2008)*
