RE: Milkwood Updated SDP

Our Reference: AFP240047-PR-MILKWOOD-R00

**MILKWOOD MANOR REVETMENT: COASTAL ENGINEERING ASSESSMENT****1. INTRODUCTION**

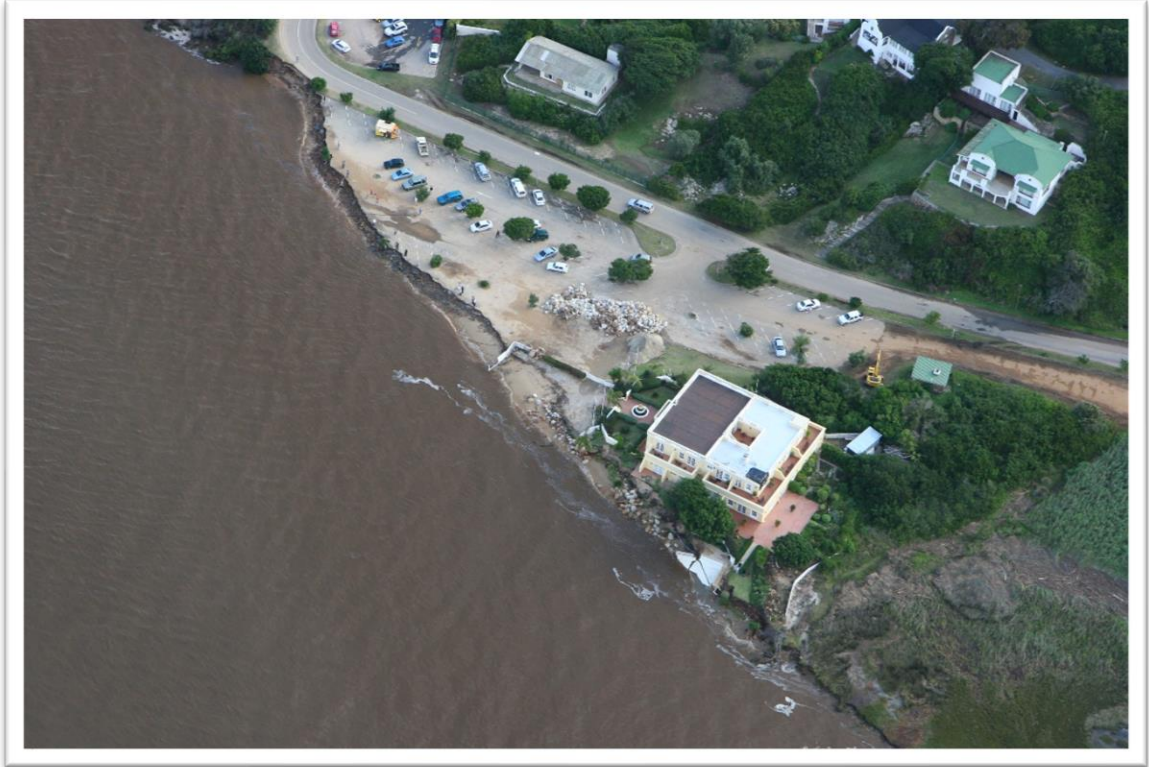
***Figure 3.2.1: November 2007 during flood***

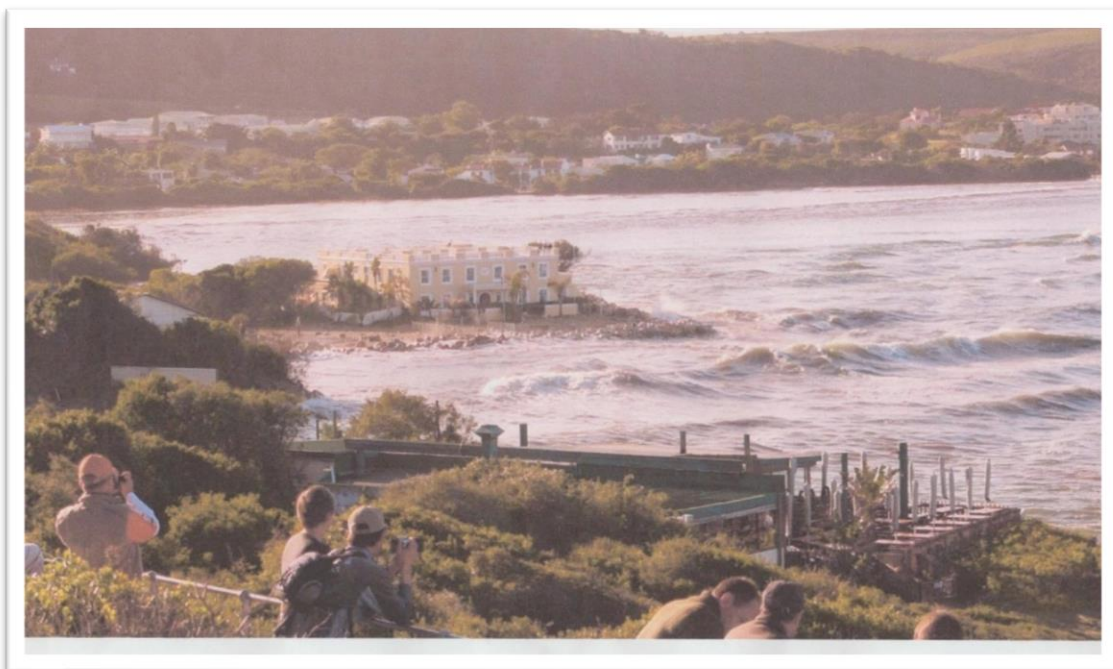
***Figure 3.2.4 Typical high water and wave action***

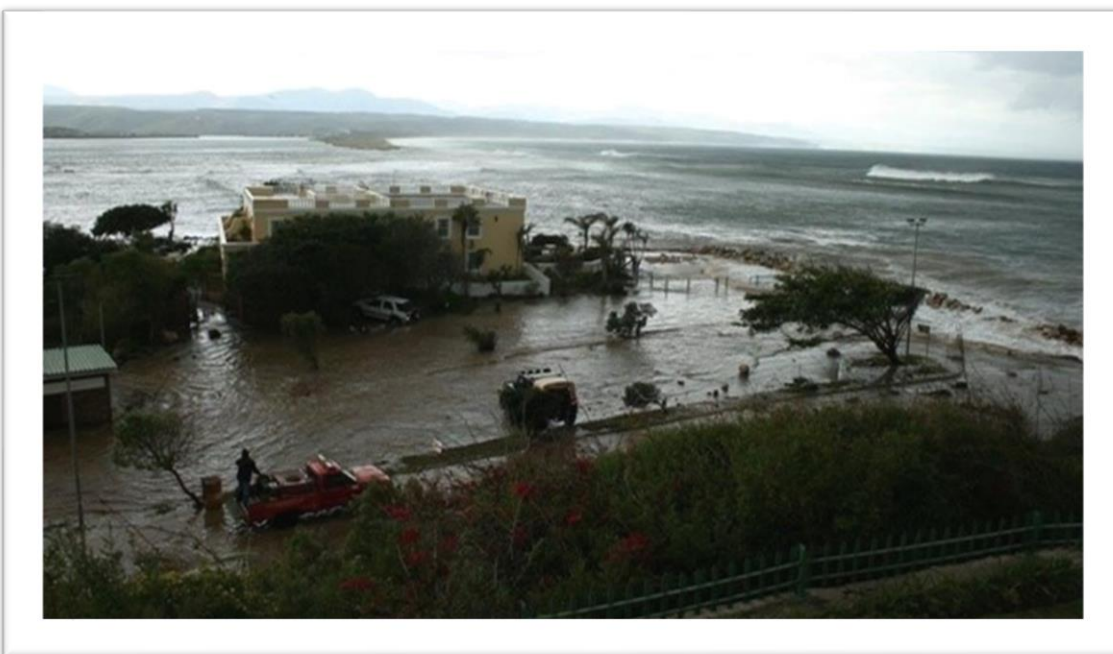
***Figure 3.2.5 Flooding of the car park (post 2008 construction)***

The conditions illustrated in these photographs are considered extreme events but are nevertheless likely to recur again in future and should therefore be considered in any new development or ongoing maintenance plans.

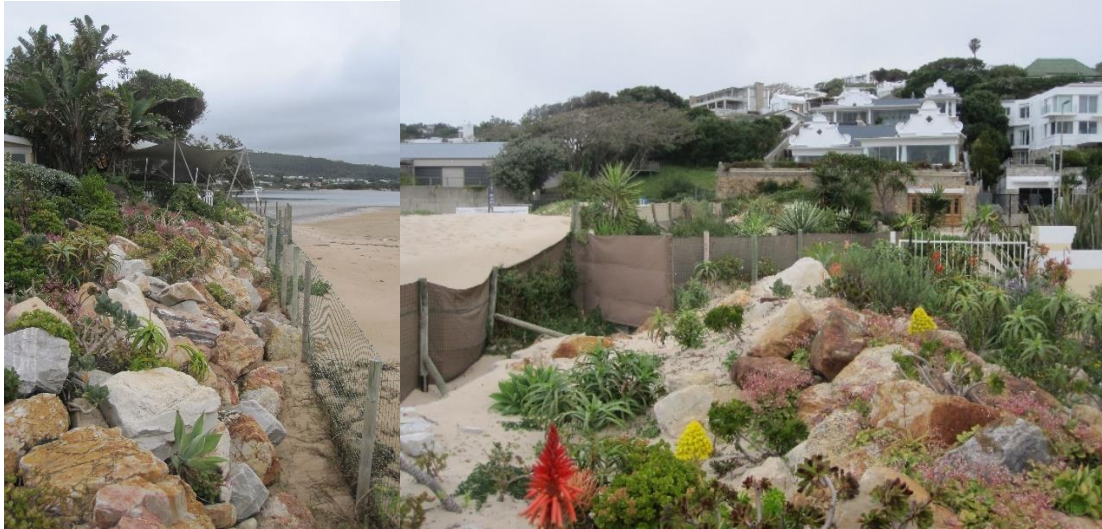
**Figure 3.2.6 Revetment taken July 2024**

The state of the revetment inspected during the site visit in July 2024 is good. The Table Mountain Sandstone (TMS) rock shows little sign of weathering with only minor settlement over its length. Most of the structure is currently below the accreted beach sand level. The long-term stability of the revetment is dependent on the toe of the structure not being undermined, the units on the slope remaining in position and the crest not being damaged. Jet probe information received at the site meeting indicates that bedrock levels vary between 4 and 9 m below NGL over the length of the revetment. The construction of the revetment could not build the toe of the structure on bedrock and relies on additional rock in front of the main slope to form a falling apron in the event of future erosion. The stability of the structure is therefore a function of the amount of rock placed. Records (bills of quantities delivered) obtained from the owner indicate that a total of 5300 tonnes of rock was placed in the revetment over a period of approximately 7 months. If it is assumed that this was distributed over the 160 m of the revetment this equates to around 18 m<sup>3</sup> of rock per metre. This would appear to be adequate for the maintenance of the integrity most of the structure.

No units appear to have been displaced on the slope of the revetment. The apparent minor settlement of parts of the structure is not of concern but indicates that additional rock should be added to the structure in future to ensure that the crest level is maintained.
