## Cape Environmental Assessment Practitioners (Pty) Ltd

### **MOLEN CLOSE RIVER REHABILITATION** **Environmental Control (ECO) Report – May / June 2023**

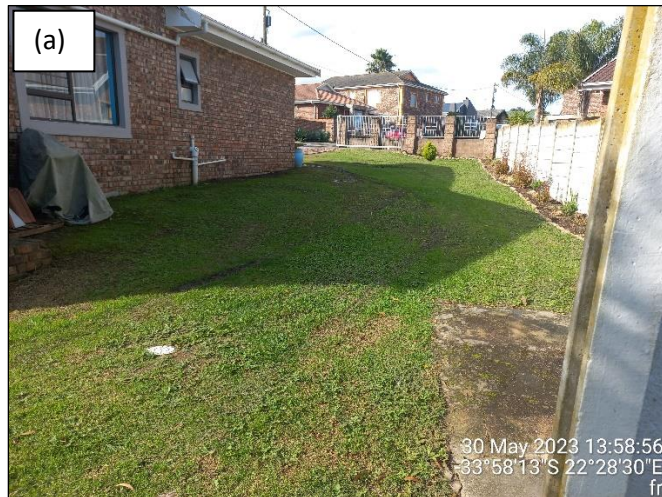
- Site access via Molen Close Street through erven 21150 & 21151. Main access will be through erf 21151 by breaking a portion of the wall near the entrance gate (*photograph a*).
- Further access to the eastern embankment as well as the stockpile area would require breaking another portion of the wall between erven 21150 & 21151.
- Permission was obtained from both landowners (erven 21150 & 21151).
- A temporary access route will be constructed with G7 material which will be rehabilitated to its original state.
- Certain alien trees will have to be removed to access the eastern river embankment. All tree biomass and spoil material will be transported to the municipal dump. Indigenous trees with the access route will be rescued and transplanted on the open lawn area north of the site. Landowner consent has been received.

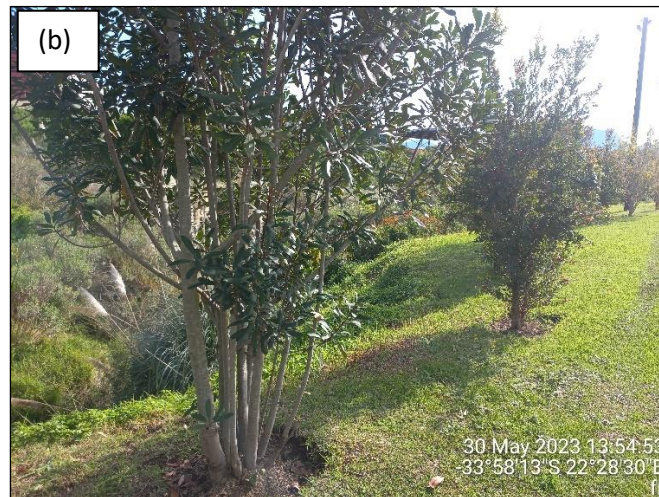
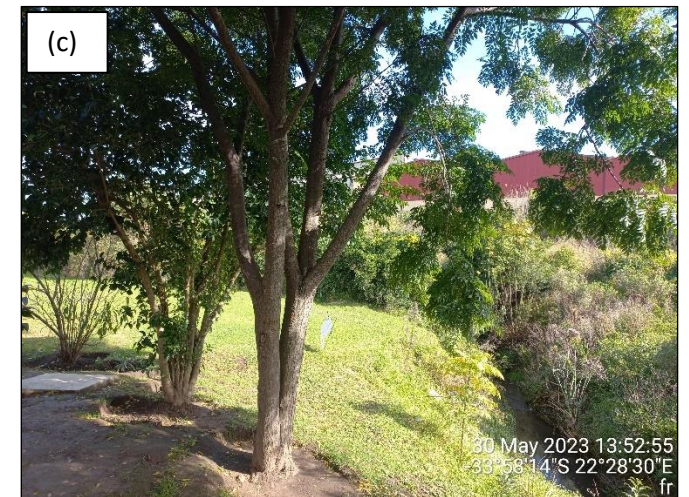
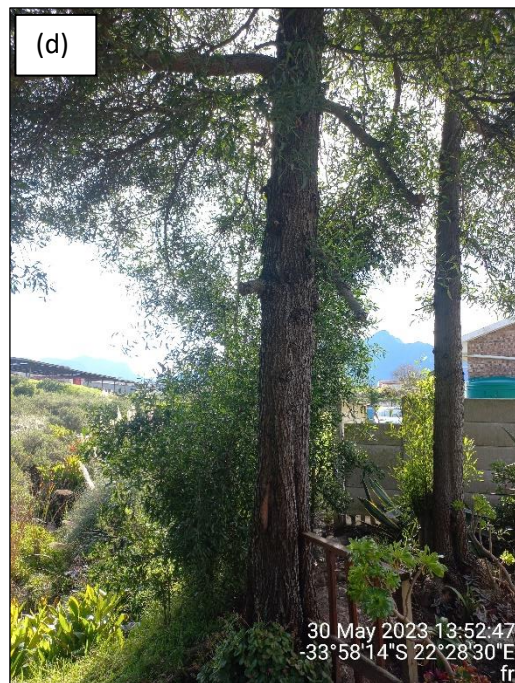
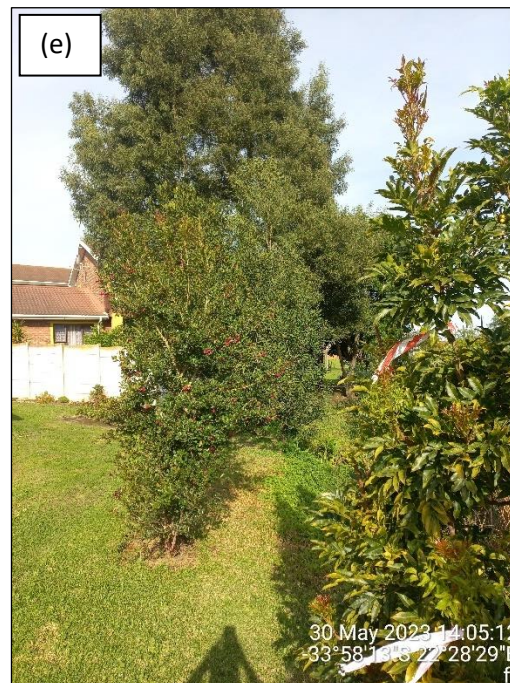
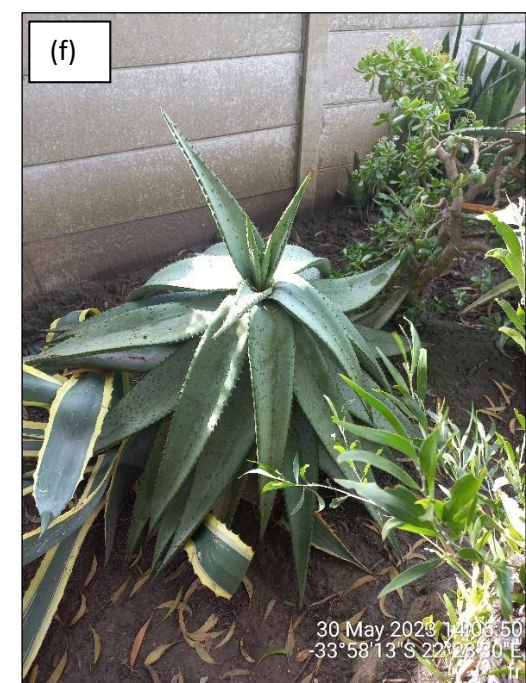
- Marked the trees that they should try to keep (indigenous trees) (*photograph e*). The rest of the trees on/next to erven 21151 & 21150 can be removed if the landowners give consent (alien trees) (*photographs b – f*).
- Site observation: There is also a lot of water coming down Meul River, especially when it rains. Requested that the contractor provide another method statement explaining how they intent to divert the stream during construction.

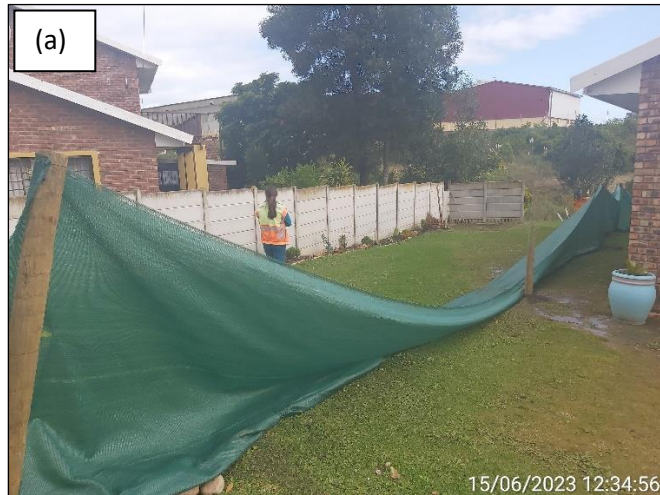
- Demarcation of access road (*photograph a*).
- Cutting vegetation along a portion of the eastern embankment (*photograph b*).
- Noted a lot of storm water running into Erf 21151, making the access road very muddy (*photograph c*). Recommended that sandbags be placed on walkway outside the erf to divert the stormwater on the road and into the existing municipal road stormwater system.

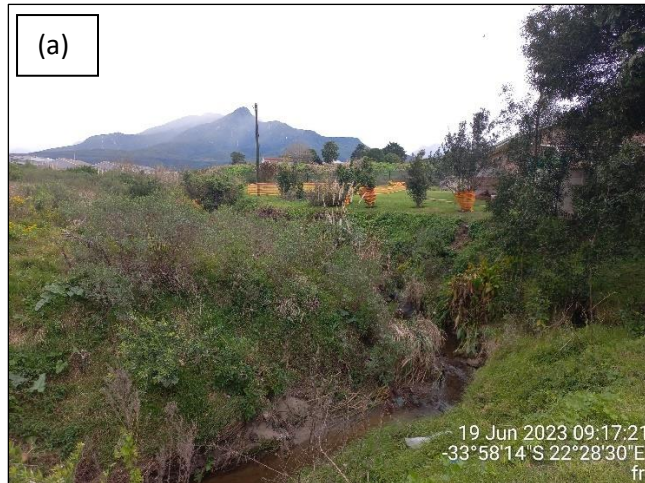
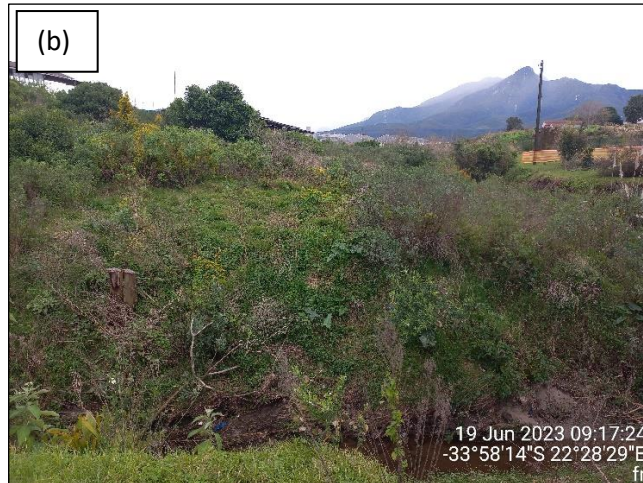
- Downstream silt control measures (silt fences) will be installed within the watercourse (*photographs a & b*).
- The construction area will be divided into three sections.
- Each section will be channelled through the stormwater pipes and flow diverted with sandbags. The first-row gabion baskets will be packed separately before moving on to the next section.

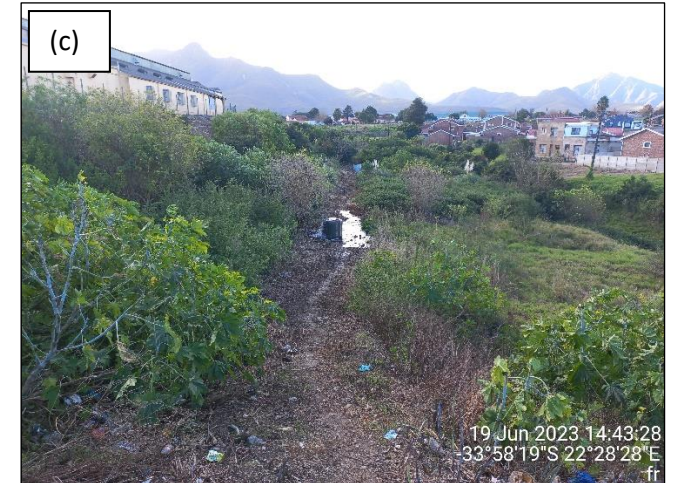
- Considerable plastic litter noted flowing down river and becoming trapped by vegetation on the western & eastern embankments. Told the contractor that while it is their site, it is their responsibility to remove any waste noted in the site (river).
- An overflowing sewer manhole was noted downstream of the site adjacent to Grens Street (opposite Margo Swiss). This was reported to both the Environmental & Civil Department of the George Municipality for remediation (*photograph c*).

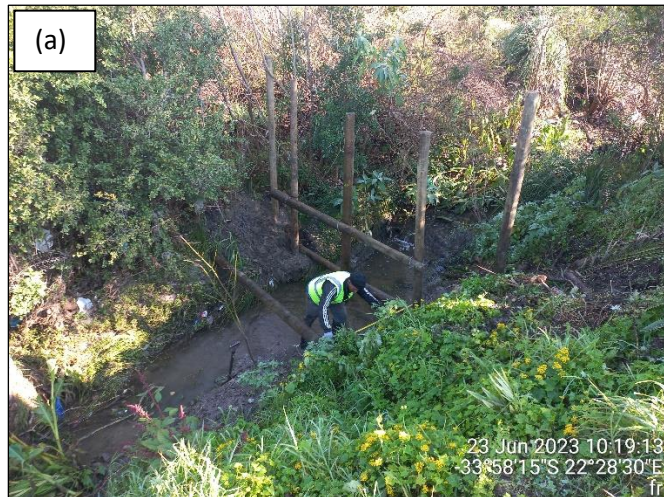
- The contractors' team were busy installing silt fences within the watercourse (*photograph a*).
- The alien trees are cut down (*photograph b & d*).
- The temporary site access has been established (*photograph c*).
- The excavator & truck is on-site to deliver material (*photograph e*).
- The site is demarcated (*photograph f*).
- The garden plants of Erf 21150 are rescued and planted elsewhere.

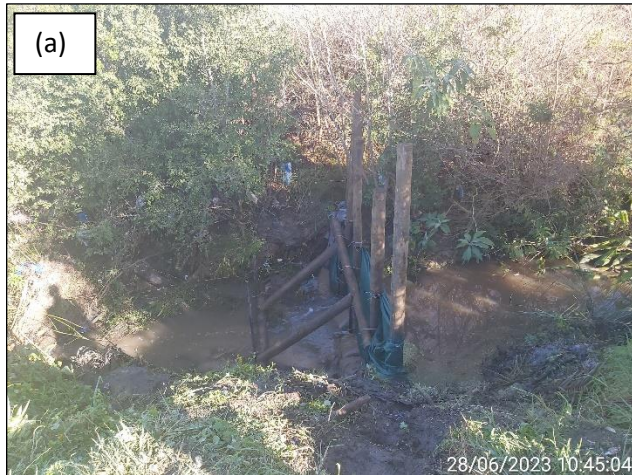
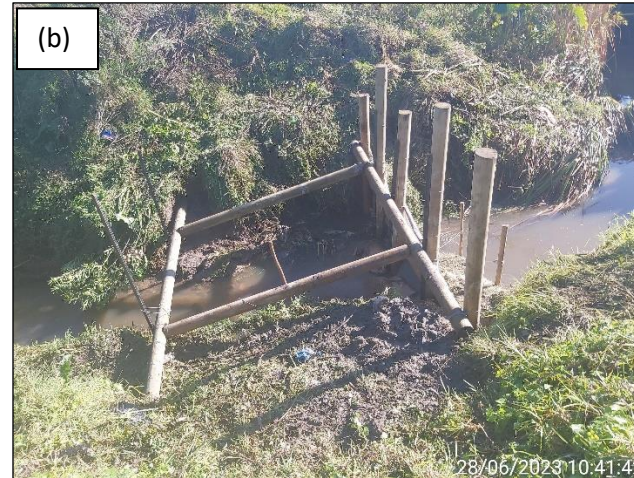
- Silt fences are in place (*photographs a & b*).
- One toilet & bin are on-site (*photograph c*).
- The contractor has commenced with Section 1 (*photograph d - g*).
- A lot of storm water still enters Erf 21151. Reminded the contractor to place sandbags on the sidewalk to direct storm water into the municipal system (*photograph h*).
- A portion of the demarcation is not closed properly (*photograph i*). Asked the contractor to close the demarcation.
- First induction with the contractor's team working within the watercourse. The contractor told the ECO that a few local workers from rosemoor will also help with the gabions. He will inform the ECO once they are on-site so that the ECO can do an induction with them as well.
