AFR240103 WILDERNESS ERF 90 ROCK REVETMENT

Coastal Protection Assessment

Specialist Report

AFR240103-RP-GA-001

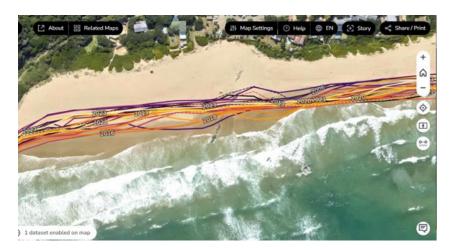
Figure 2-4 DE Africa mean sea level analysis (2023)

The coastal morphology associated with the site under consideration is defined by the natural processes affecting the greater coastal zone from the Kaaimans river estuary to several kilometres of beach to the east. Developments on the foredune system over the last 80 years has reduced the amount of sand in storage which in turn has resulted in a more vulnerable shoreline to large episodic storm events. Under normal conditions it remains in a dynamic equilibrium between sand availability, wave energy distribution and prevailing sea levels. An analysis of the coastal erosion since the year 2000 (DE Africa (2023)) shows no net erosion. (see Figure 2.4)

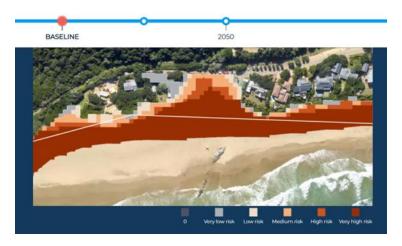
Figure 2-5 CSIR (2023) Greenbook coastal vulnerability assessment

An assessment of coastline vulnerability undertaken by CSIR (2023) indicates a high risk of erosion to the east of the site. This is associated with the low lying car park, stormwater outfalls and the presence of a vertical seawall. (see Figure 2.5)

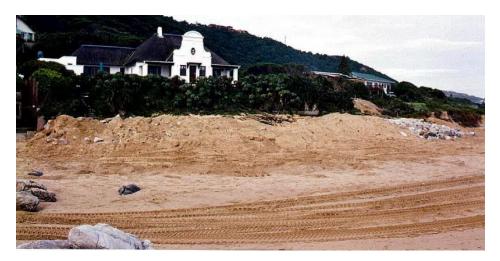
Figure 3-2 Post construction of the revetment in 2003

The revetment design as proposed by the contractor is expected to have a capacity to protect the slope at high water spring tide subject to breaking waves up to 2 m wave height, which would typify an extreme event. The design includes a geotextile filter which is required to ensure that sand is not removed from inside the revetment, however the vegetation above the +3 m MSL level would be available to feed the beach during a major storm. Post construction in October 2003, the revetment was buried underneath beach sand. (see Figure 3.2)

The photograph above illustrates the as built condition of the revetment. Attention is drawn to the large boulders in the foreground. These rocks indicate the level of sand depletion in the back beach area and represents the foundation level of the revetment as indicated on the cross section above.

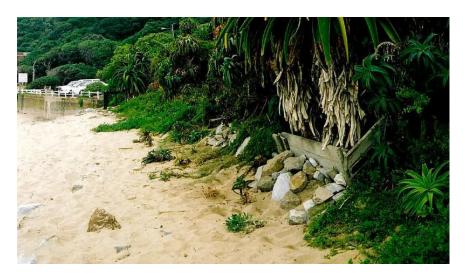
Figure 3-3 The toe of the foredune slope above the rock revetment (October 2004)

The photograph above shows the top of the revetment in October 2004 still covered in sand. An inspection of the revetment on site in January 2025 shows the revetment revealed, after the largest recorded storm event to date, in September 2023. An assessment, based on what is visible on the surface, indicates that good quality rock has been used for the construction and that the revetment is largely intact. Generally, the rock size appears to be larger than the 0.4–0.7 t rock indicated on the drawing. Our estimate would be closer to 0.5 t–2.0 t, on average. Although it was not possible to see the geotextile layer, we have no reason to believe that this is not still intact. A year after the last major storm event the beach has largely recovered on the bottom and mid sections. Our overall assessment is that the revetment is in good condition and will continue to function as an effective protective barrier during the next storm event.

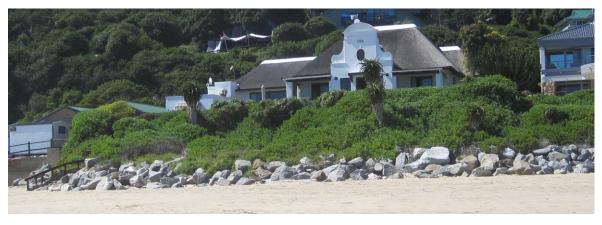
Figure 3-4 The rock revetment (January 2025)

When considering any sandy beach dune stabilization system, it is important to evaluate its potential impact on the overall beach stability. Whilst the revetment is designed to protect the toe of the foredune under extreme storm conditions it should not prevent the build-up of sand on the middle and back beach areas and should allow for the natural vegetation to re-establish itself post the event. Both these conditions appear to have been met by the structure. Apart from protecting Erf 90, this revetment forms a hard point (similar Leentjiesklip) which protects the car park seawall and adjacent properties to the east, without any detrimental effects of the overall beach system.

A soft engineering option would be to re-establish the foredune in front and over the top of the existing revetment. This would entail rebuilding the foredune using suitable beach sand and establishing appropriate vegetation. The revetment would maintain its protective function during storm events but would also fulfil the sand storage function of the foredune which could supply the beach during extreme event. Maintenance would be required after large storm events but the overall resilience of the beach to storm events would be improved. It is recommended that the same approach be implemented in front of the car park vertical wall.

- It is recommended that the structure be retained as it represents a net positive benefit to erven 90 and
 91 and the public car park without causing any detrimental impact on the beach.
- In the light of projected climate change effects on the overall beach area in future, it is recommended that the structure be covered with sand and revegetated with dune building plantings with a view to improving the resilience of the beach to large storm events. This action should, if possible, be extended to the car park seawall as well.
