## **ANNEXURE 1: PHOTOGRAPHIC EVIDENCE**

**The development of the Herolds Bay Country Estate on a portion of Portion 7 of the farm Buffelsfontein no. 204 in Herold's Bay, George Municipality, Western Cape.**

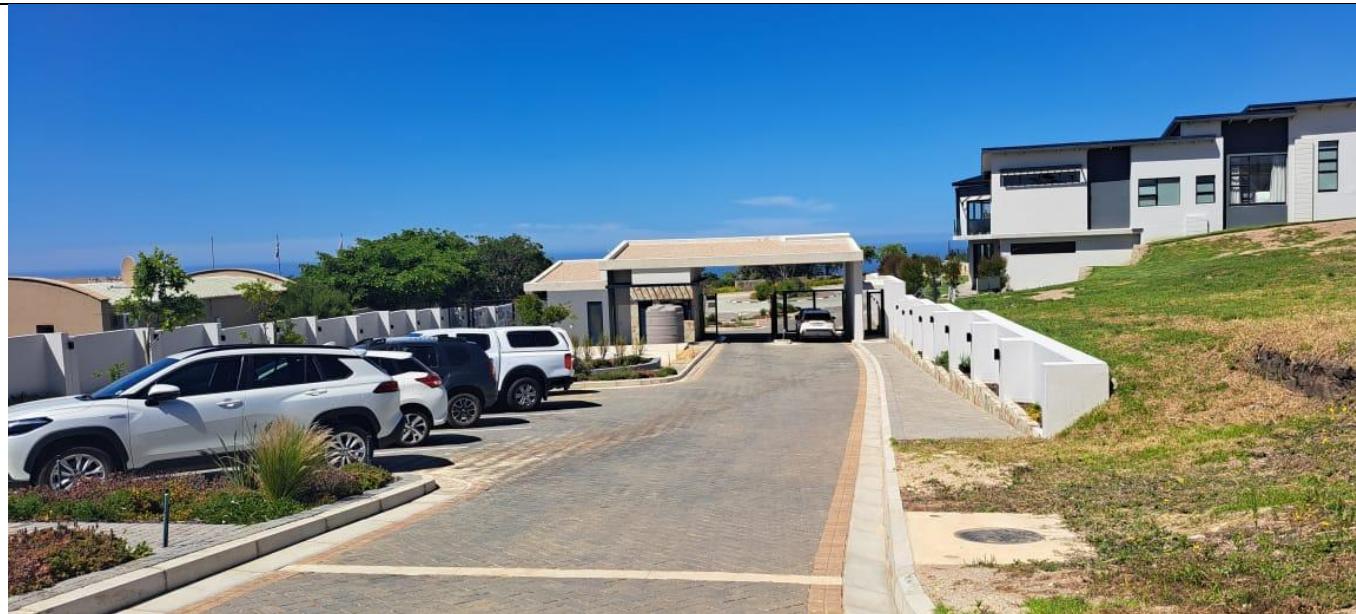
**Image 1:**

Entrance to Herolds Bay Country Estate with controlled access to site.

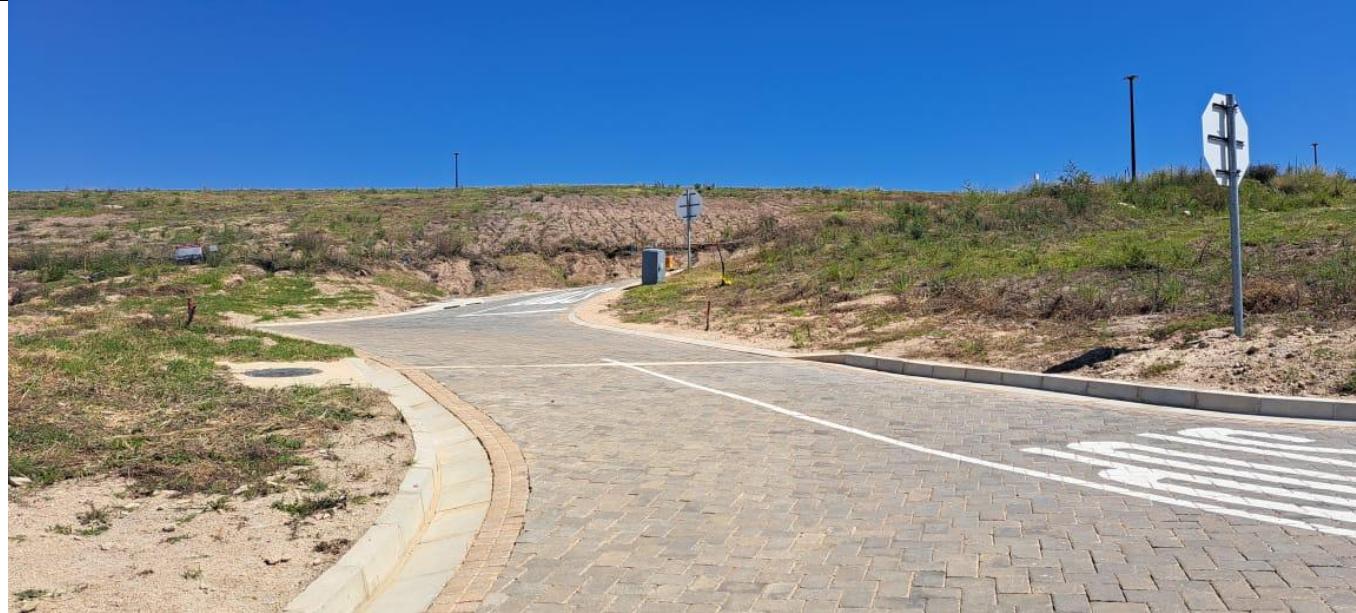
**Image 2:**

Bulk internal service infrastructure (internal roads; water, sewer, electricity, reticulation and bulk storm water) have been installed.

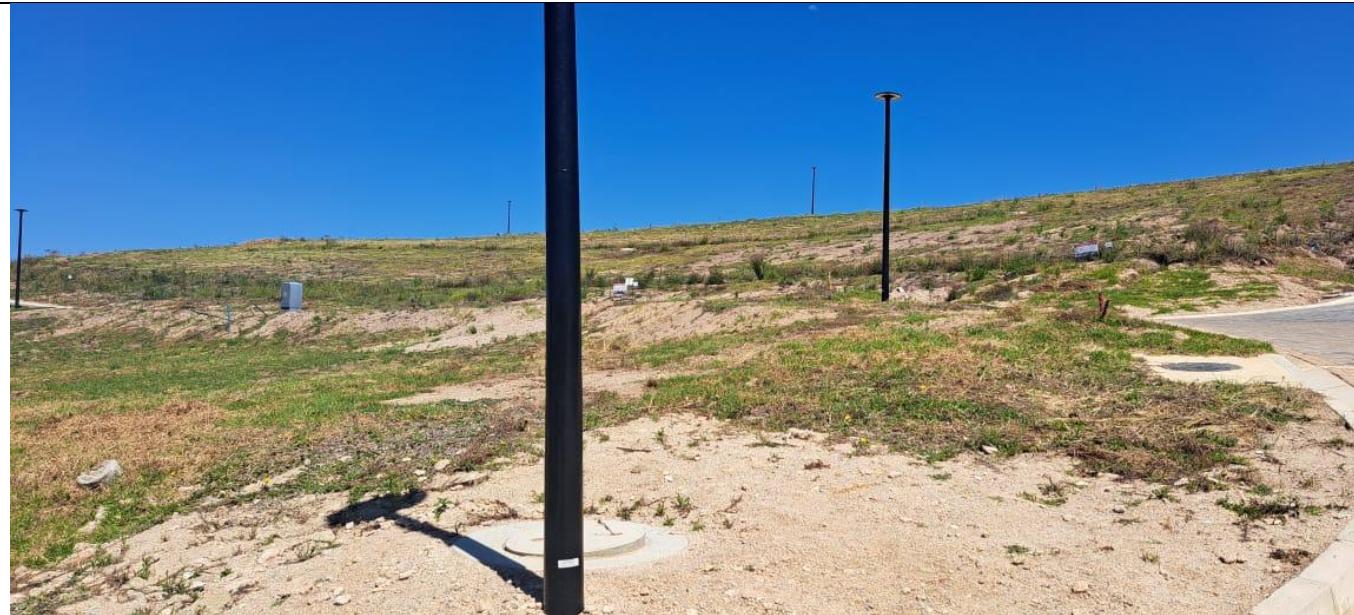
**Image 3:**

Outdoor lighting has been installed.

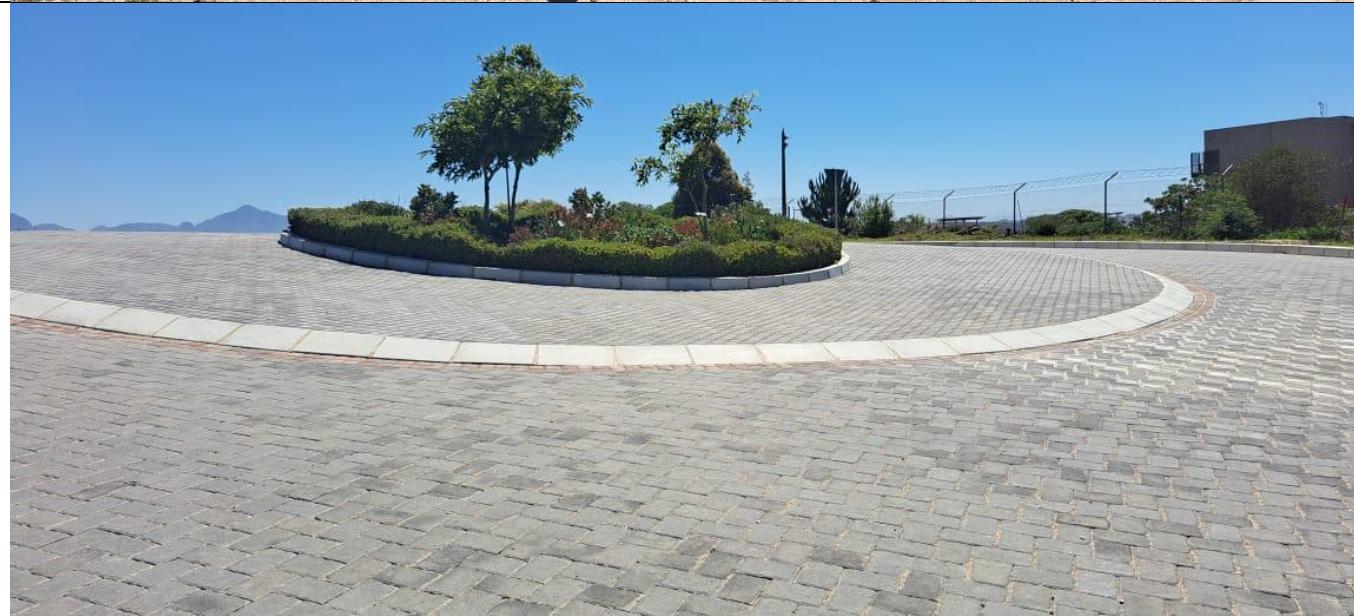
**Image 4:**

Paved roads have been constructed.

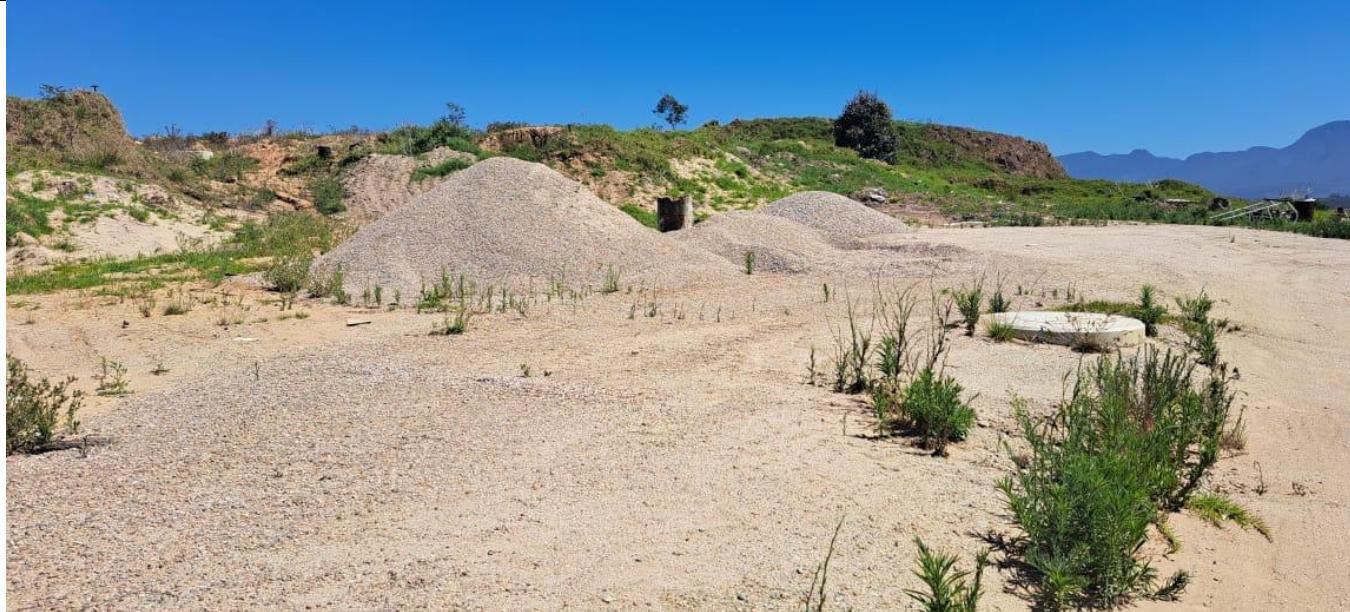
**Image 5:**

Area for stockpiling.

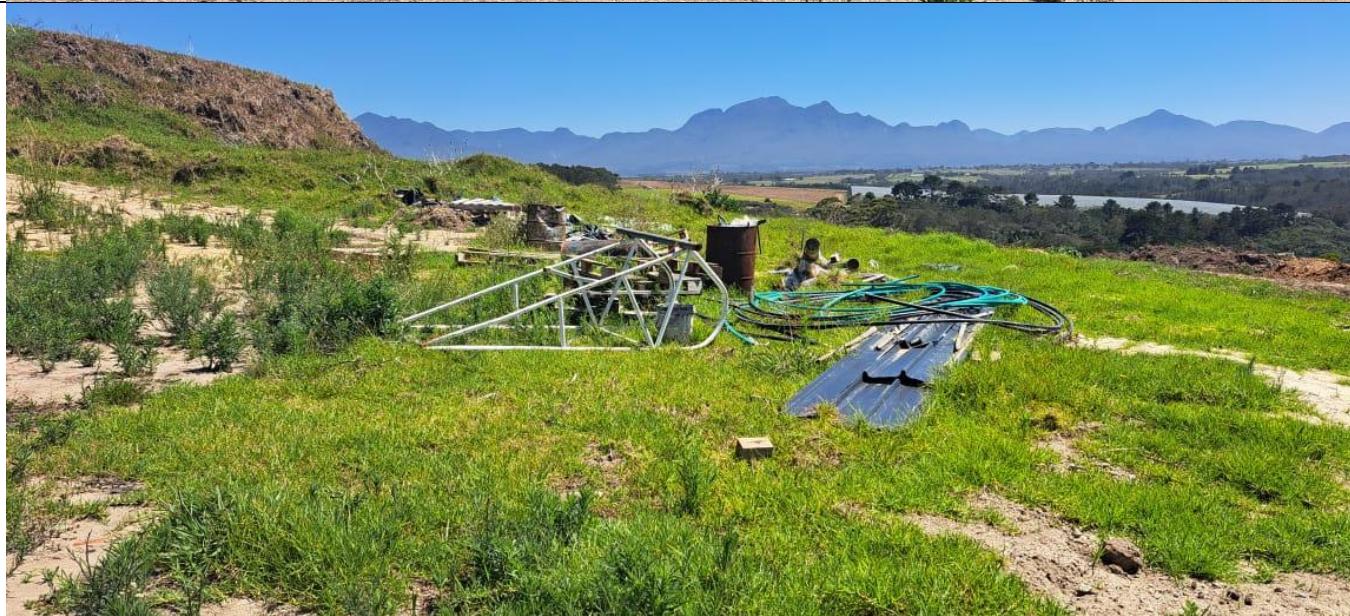
**Image 6:**

Materials stored on site at stockpiling area.

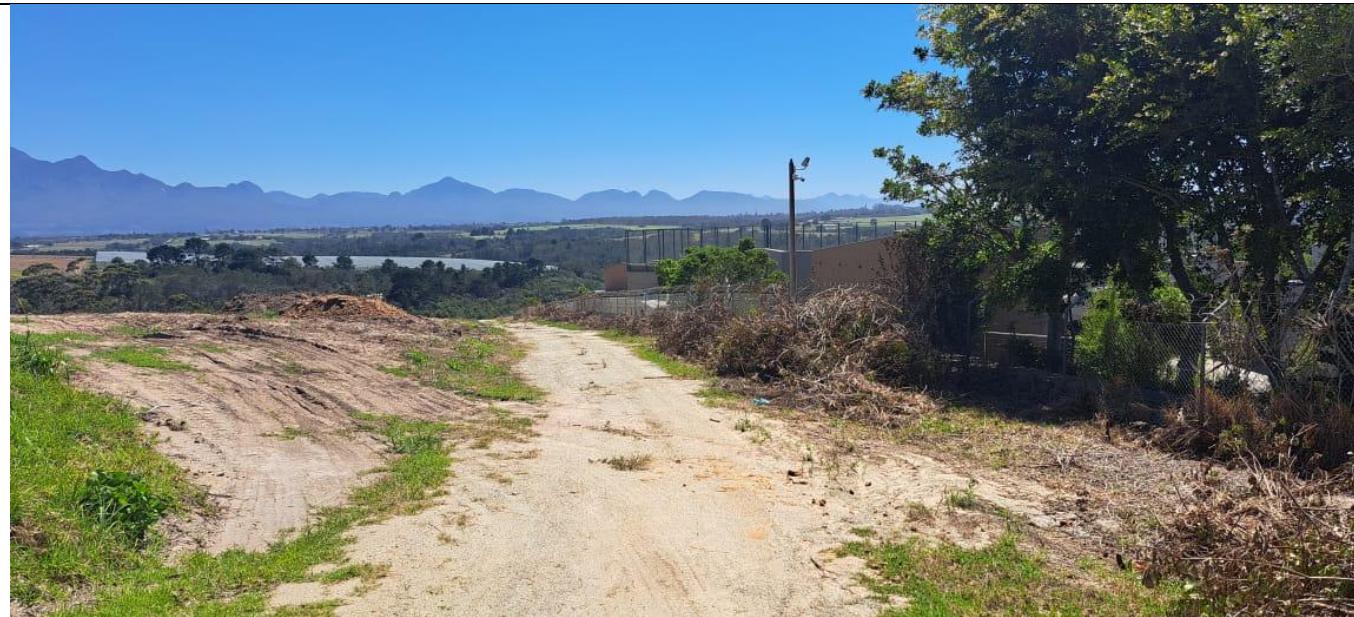
**Image 7:**

Removal of vegetation on the boundary of the development.

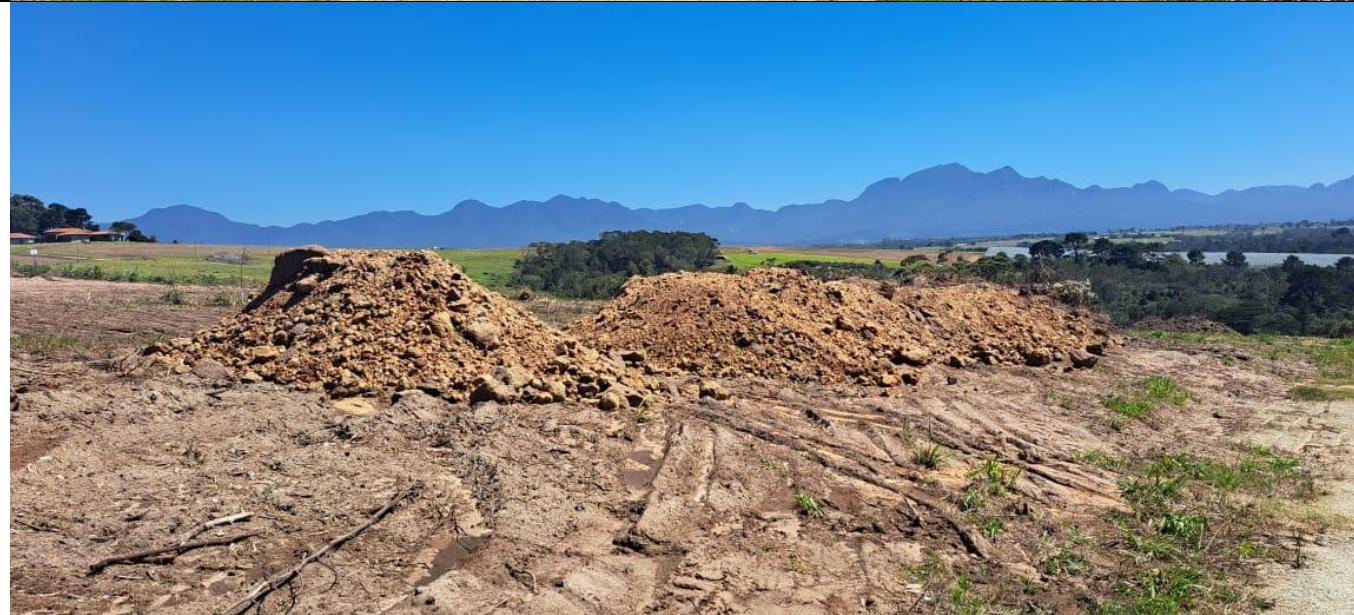
**Image 8:**

Stockpiling of excavated materials.

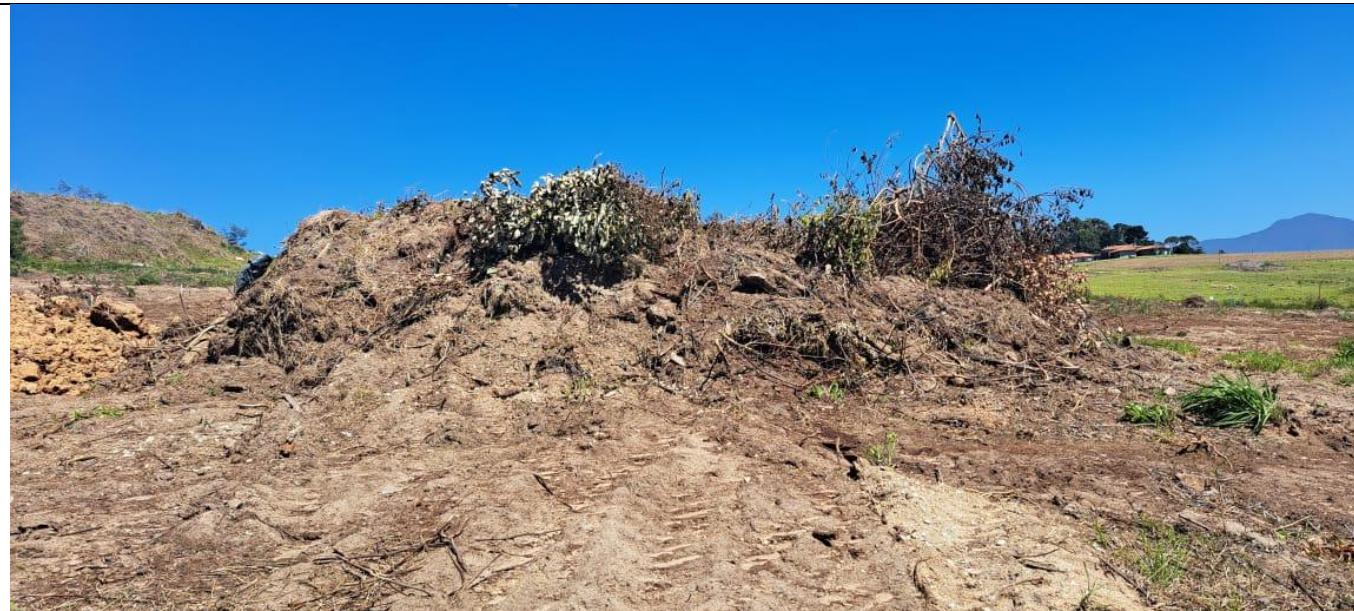
**Image 9:**

Stockpiled excavated materials and recently cut vegetation.

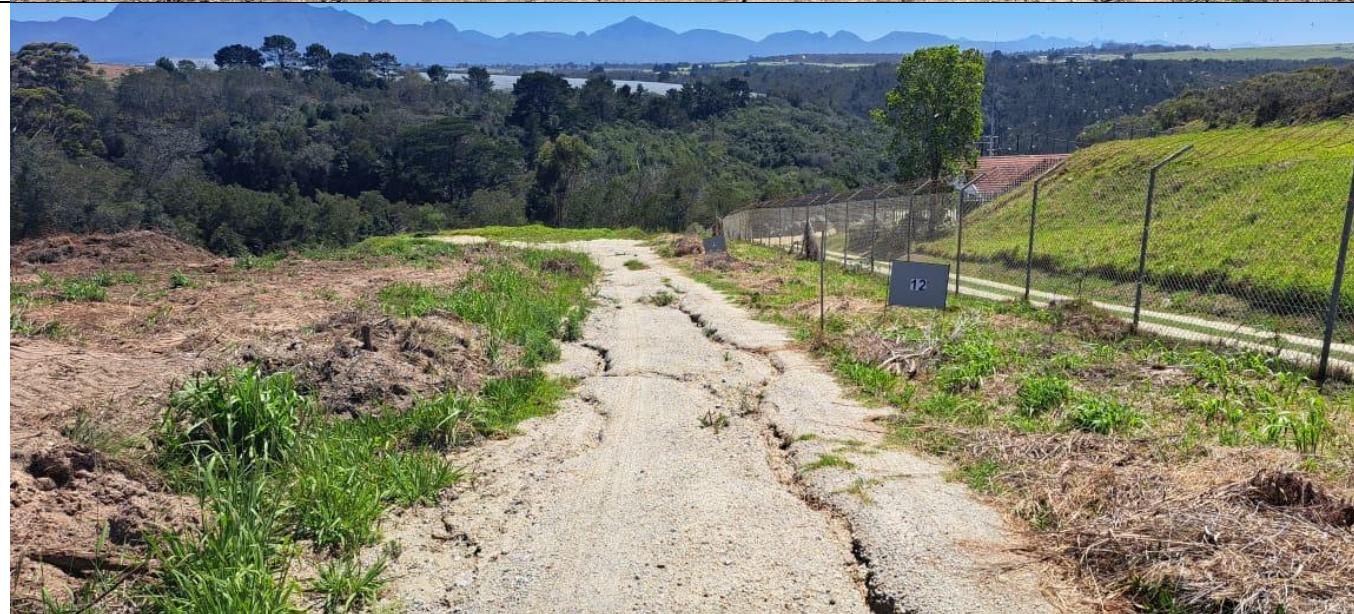
**Image 10:**

Erosion observed on sloping single track road.

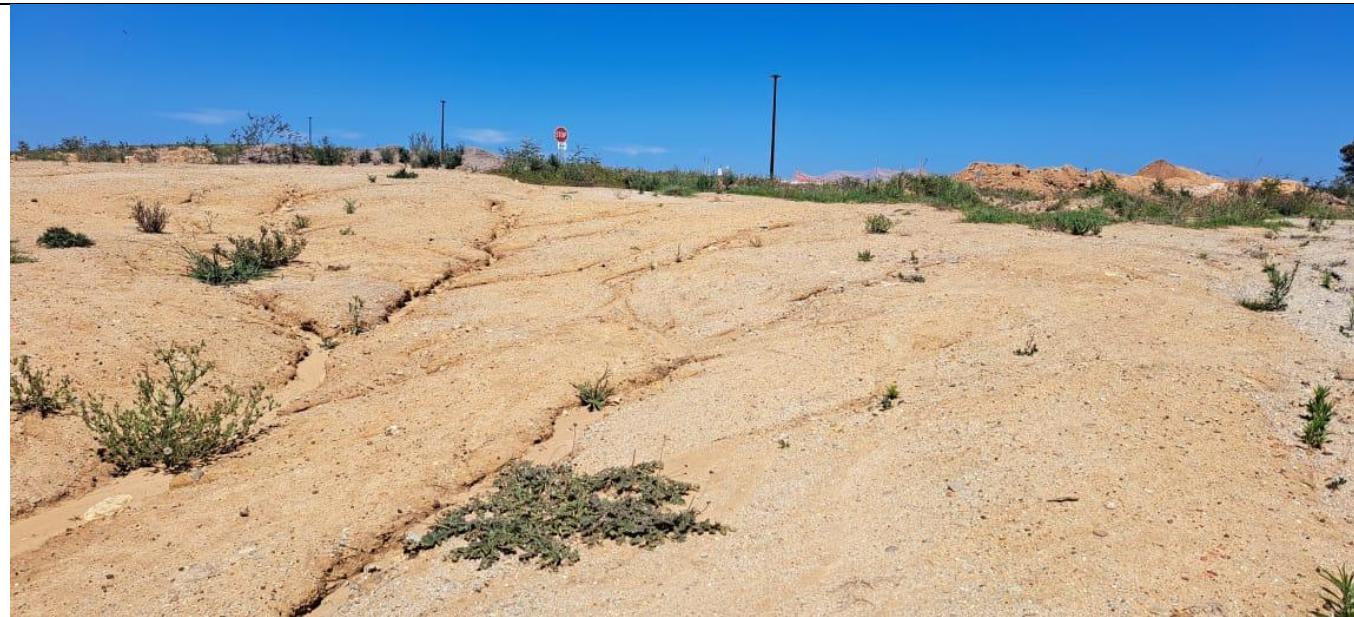
**Image 11:**

Erosion observed on exposed slopes and roads.

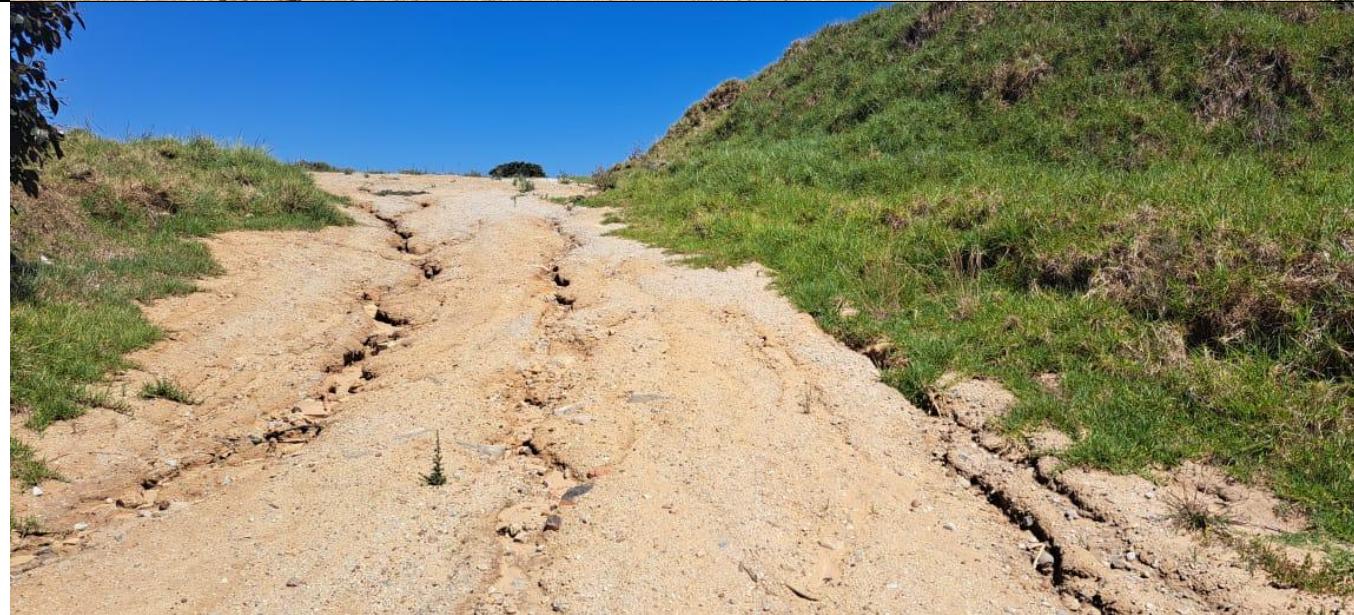
**Image 12:**

Erosion observed on exposed slopes and roads.

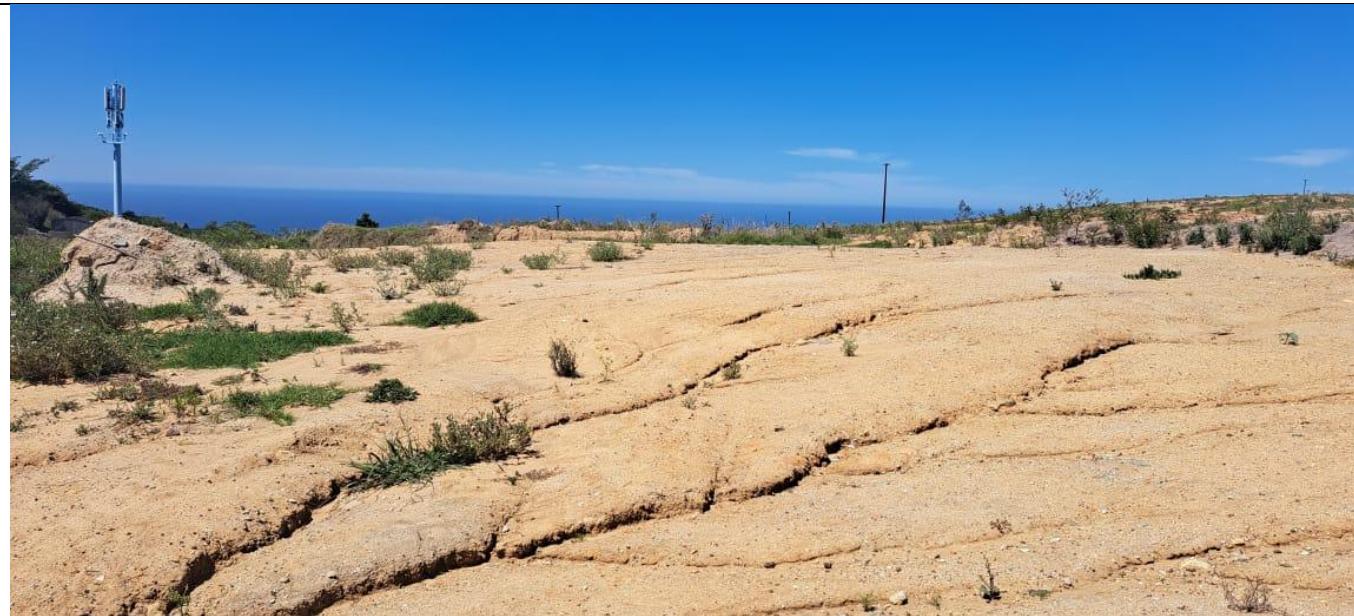
**Image 13:**

Erosion observed on exposed slopes and roads. Runoff causing rills and formation of gullies (potential gully erosion).

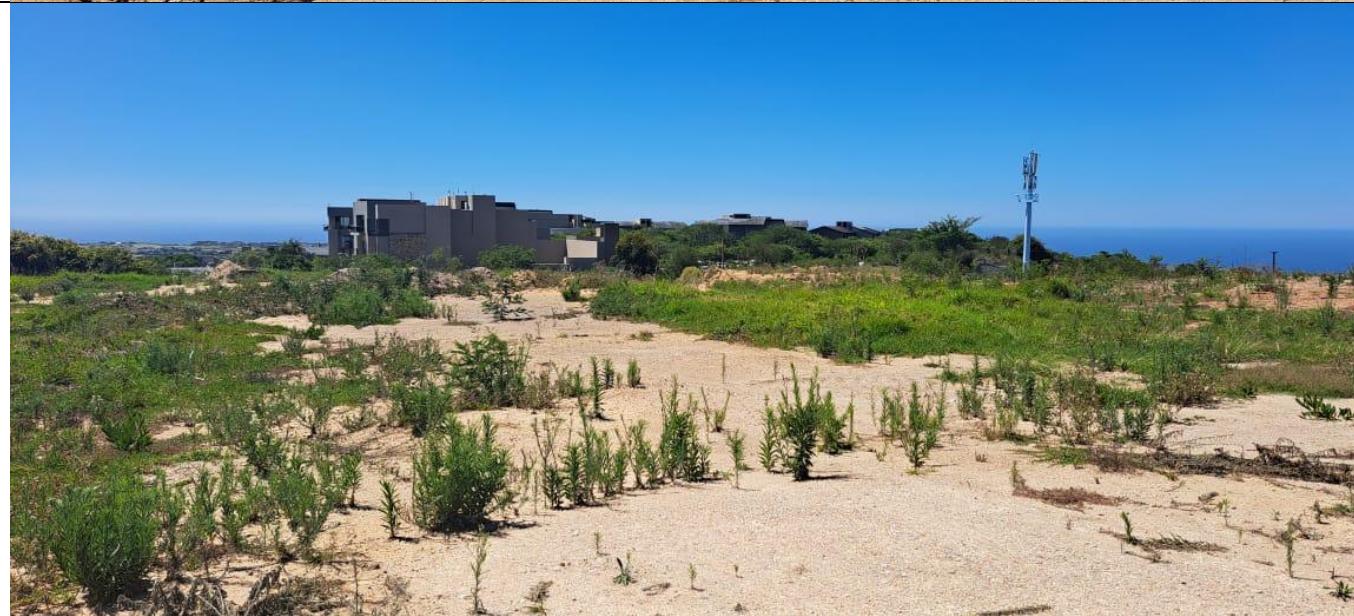
**Image 14:**

Some vegetation regrowth on flat areas.

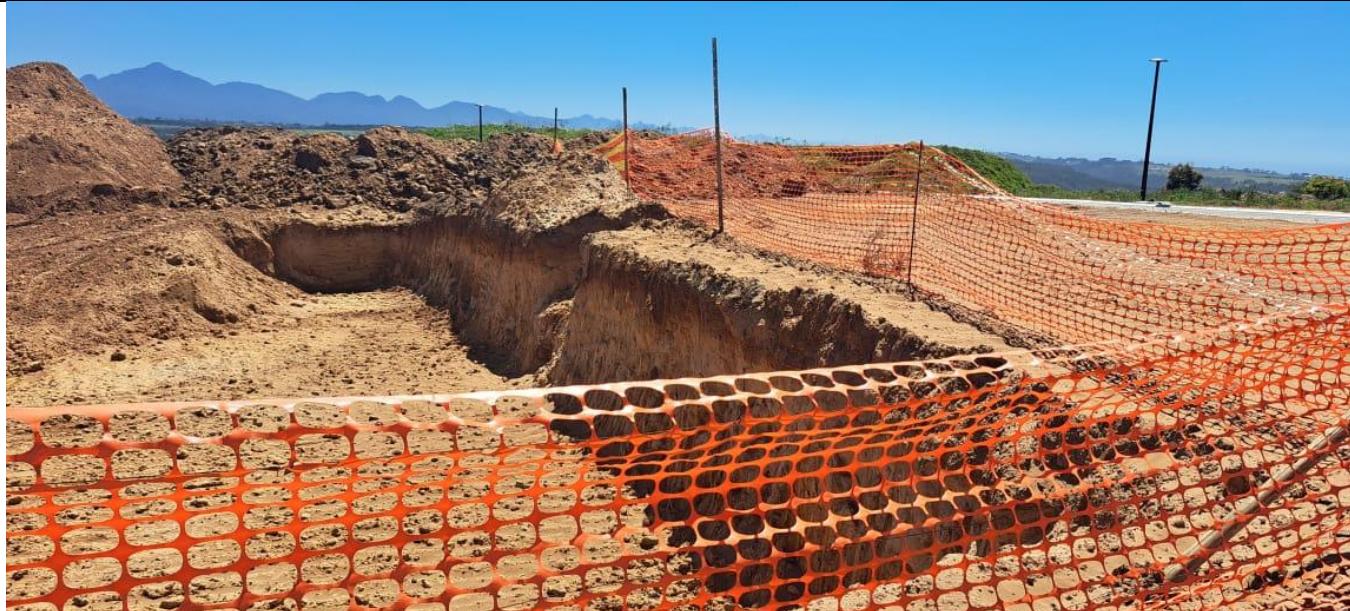
**Image 15:**

Recent excavation observed for house foundations. Site is demarcated.

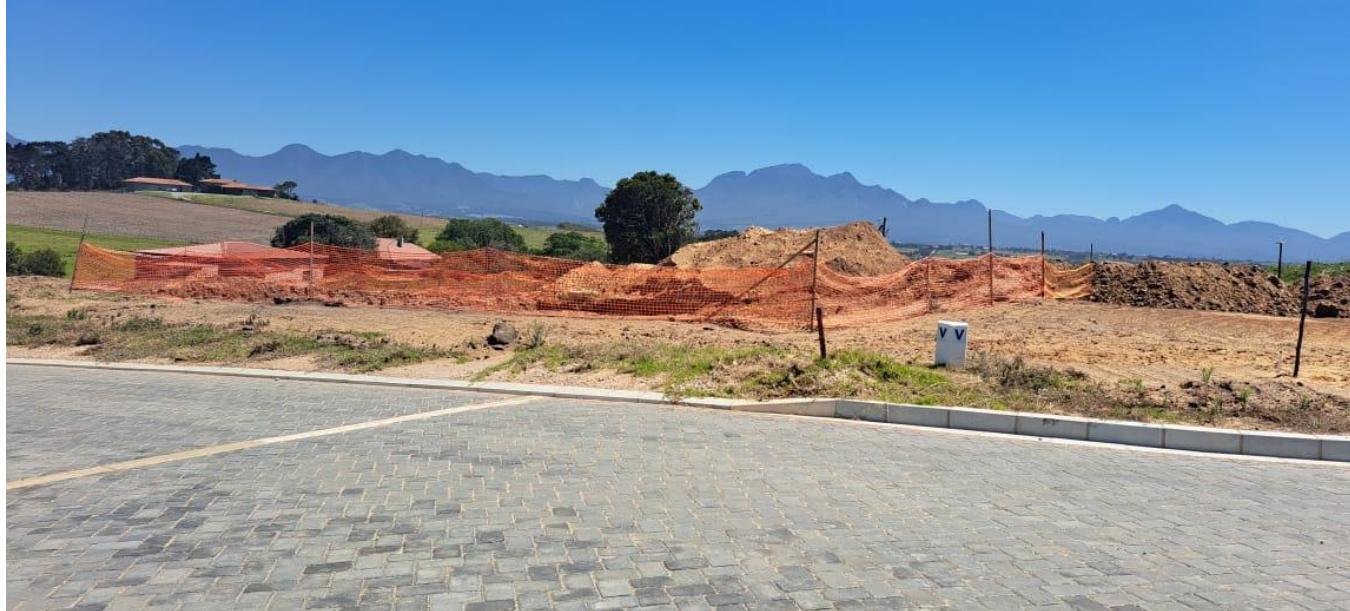
**Image 16:**

Recent excavation observed for house foundations. Site is demarcated.

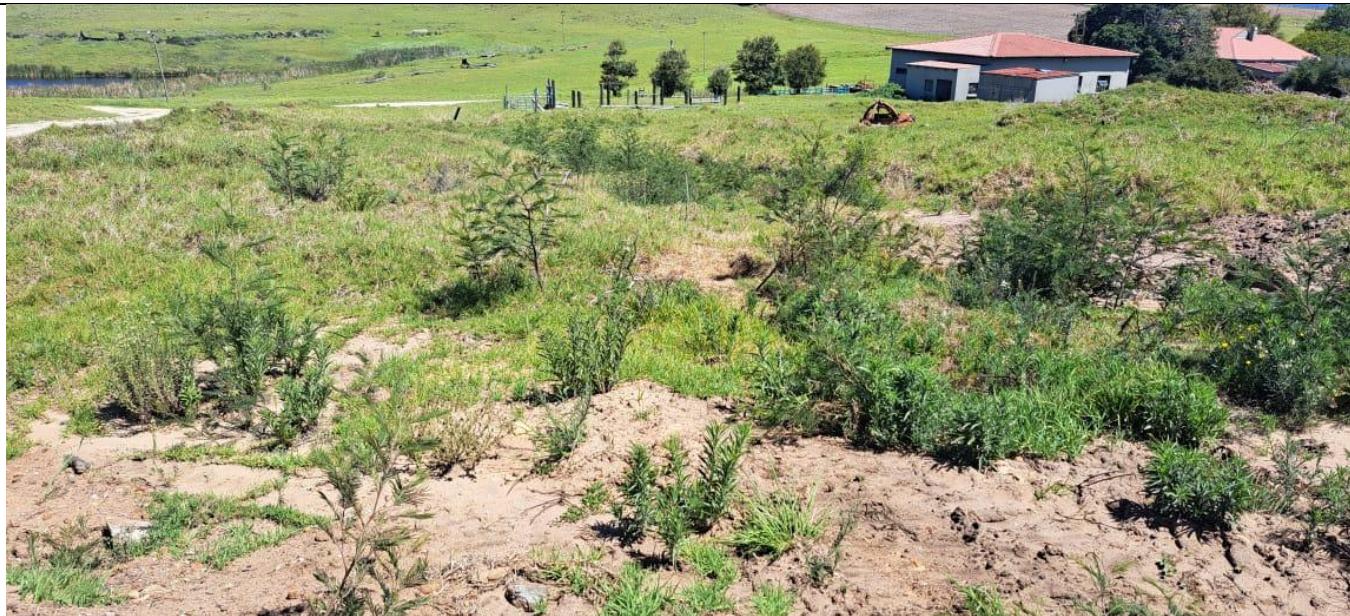
**Image 17:**

Emerging black wattle and other invasive alien plants near wetland area.

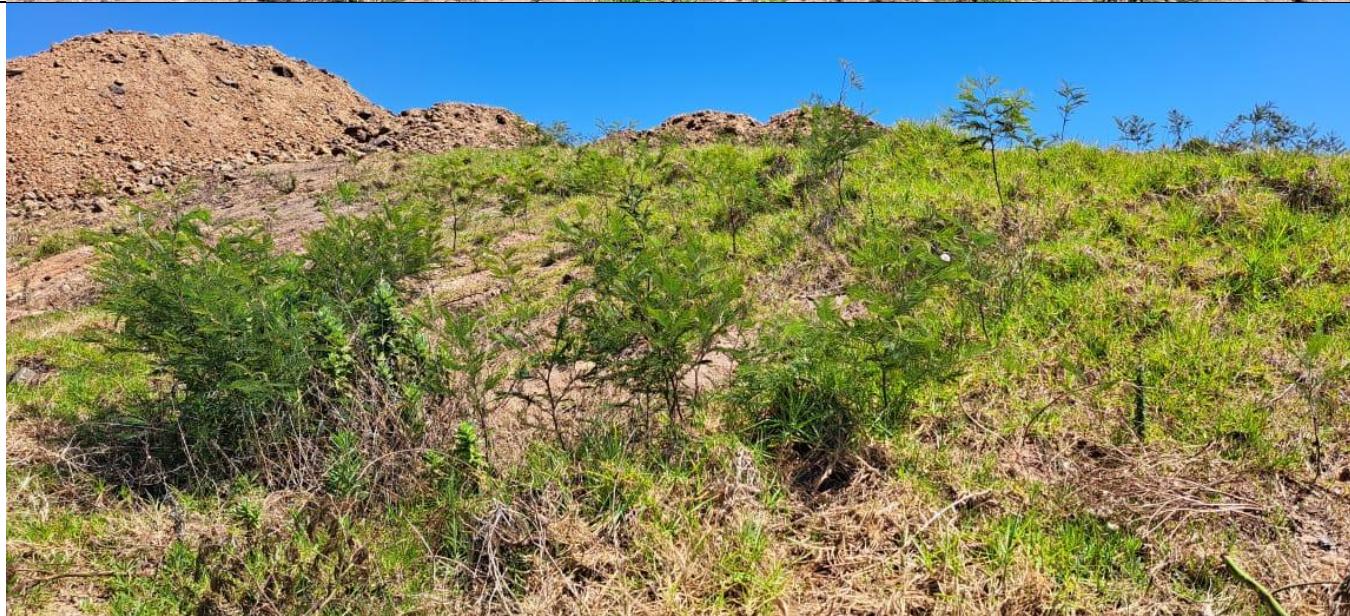
**Image 18:**

Emerging alien invasive species observed across areas of the development site.

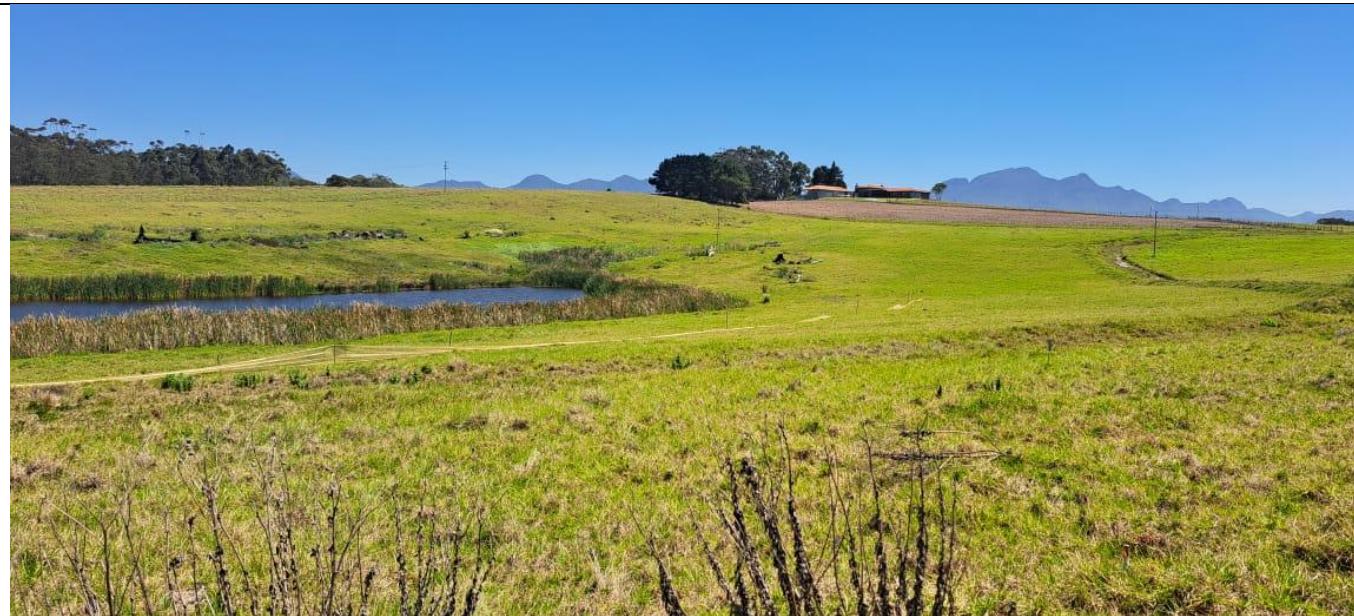
**Image 19:**

Wetland area demarcated with netting. The netting will need to be maintained once construction commences again.

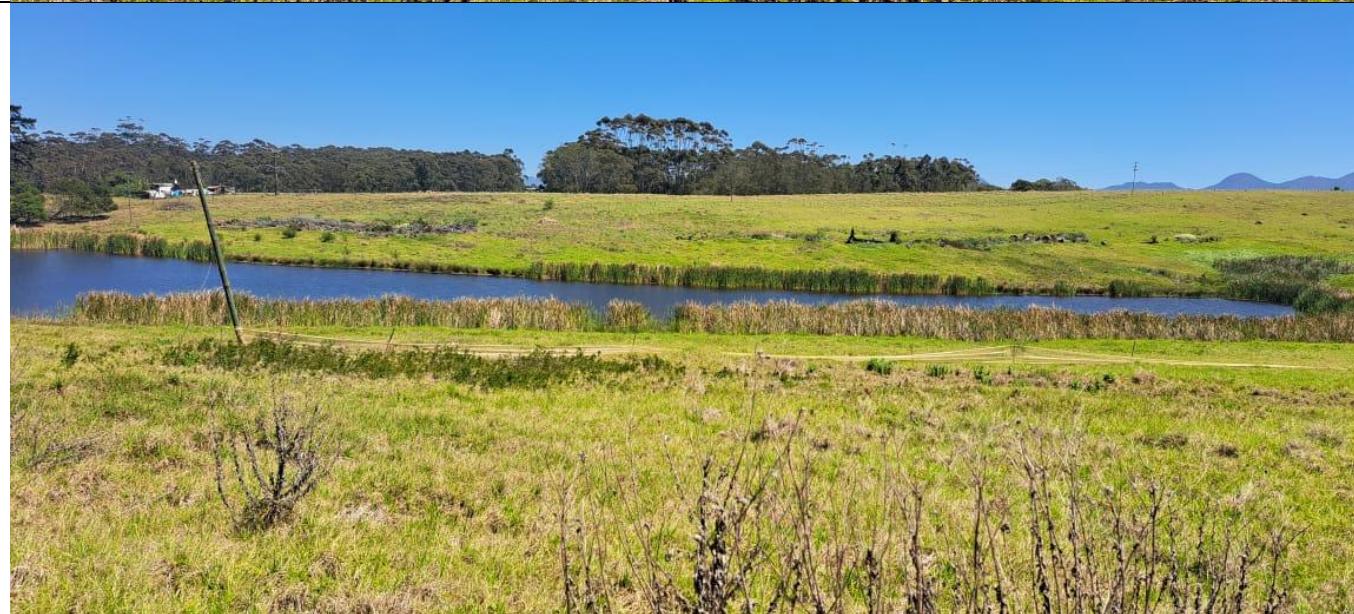
**Image 20:**

Wetland area demarcated with netting. The netting will need to be maintained once construction commences again.

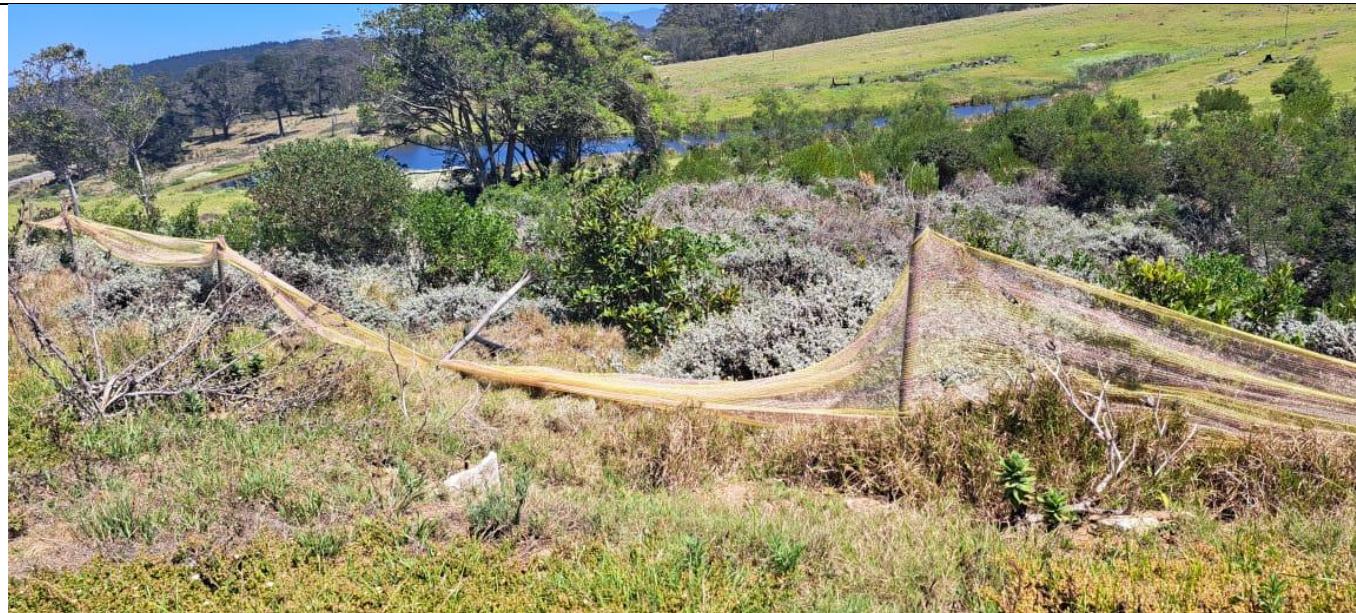
**Image 21:**

Wetland tributary demarcated (proposed pond and stream). Netting needs maintenance when construction commences.

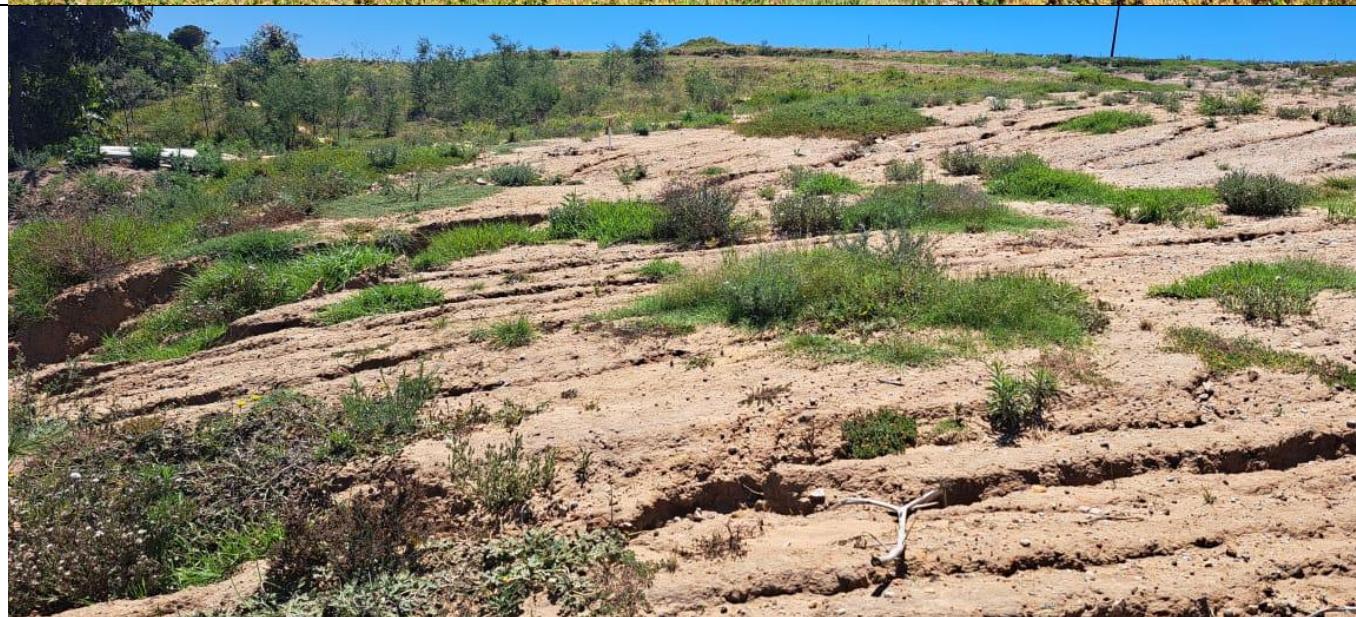
**Image 22:**

Erosion observed near the tributary (proposed pond and stream), which may contribute to siltation in the wetland if not addressed.

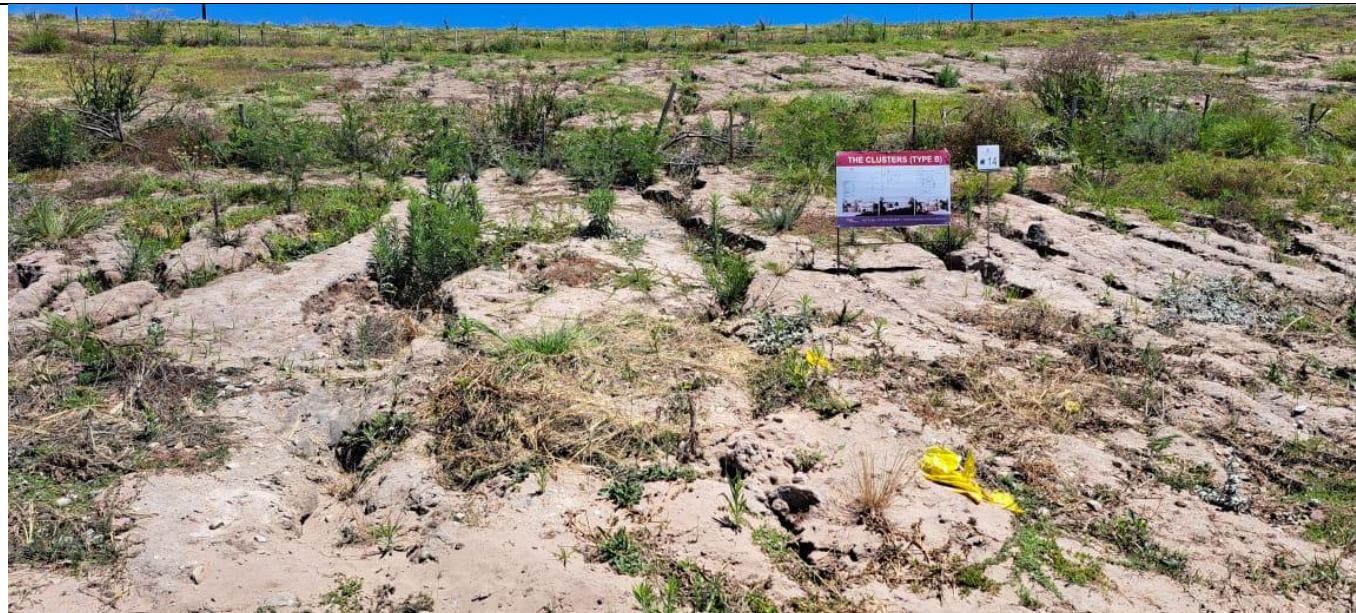
**Image 23:**

Runoff causing rills on exposed slopes.

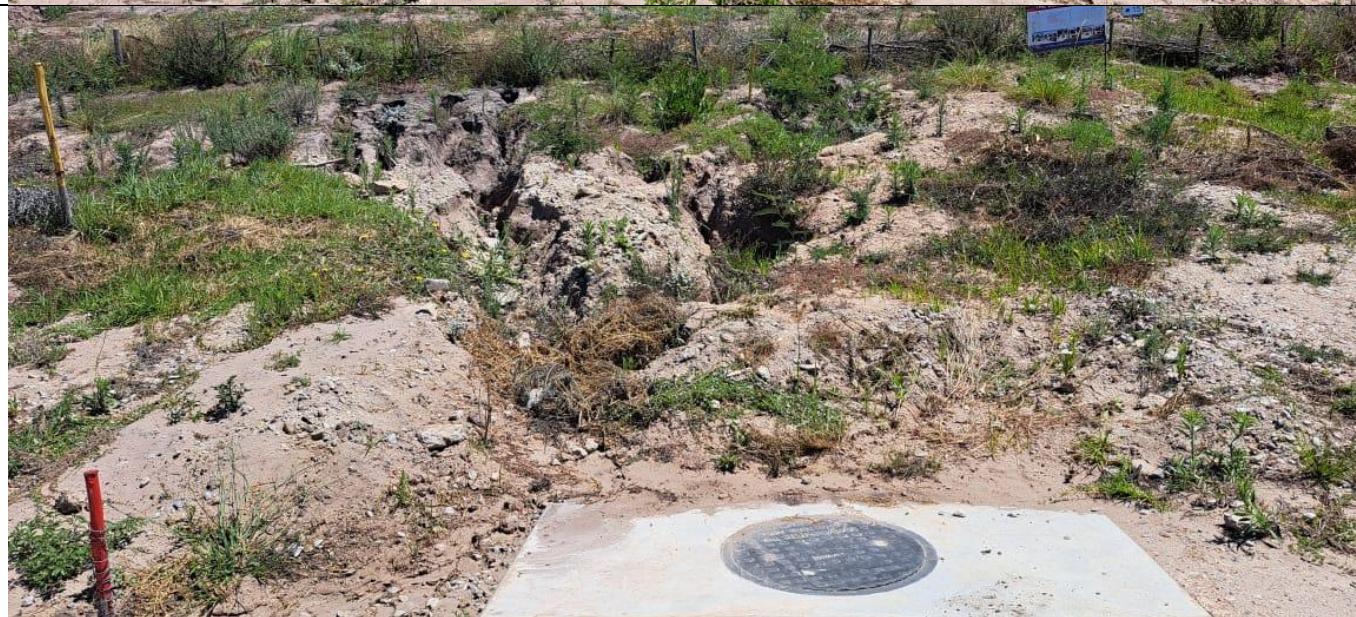
**Image 24:**

Runoff causing rills on exposed slopes.

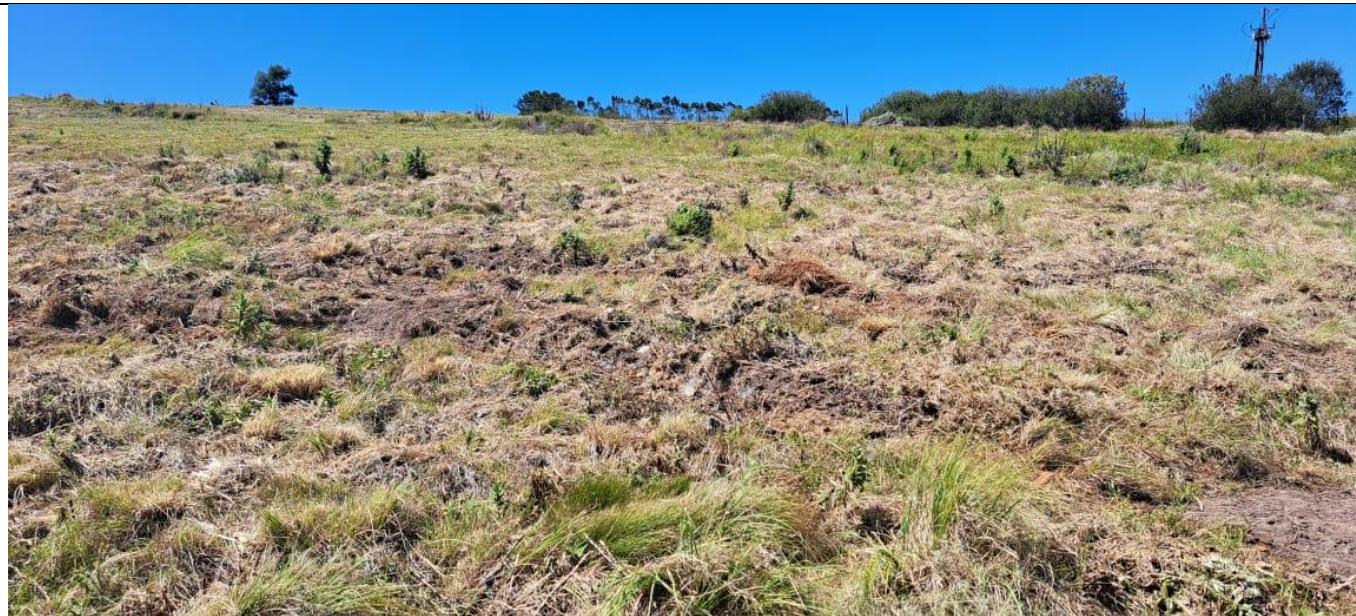
**Image 25:**

Vegetation has been mowed in development footprint.

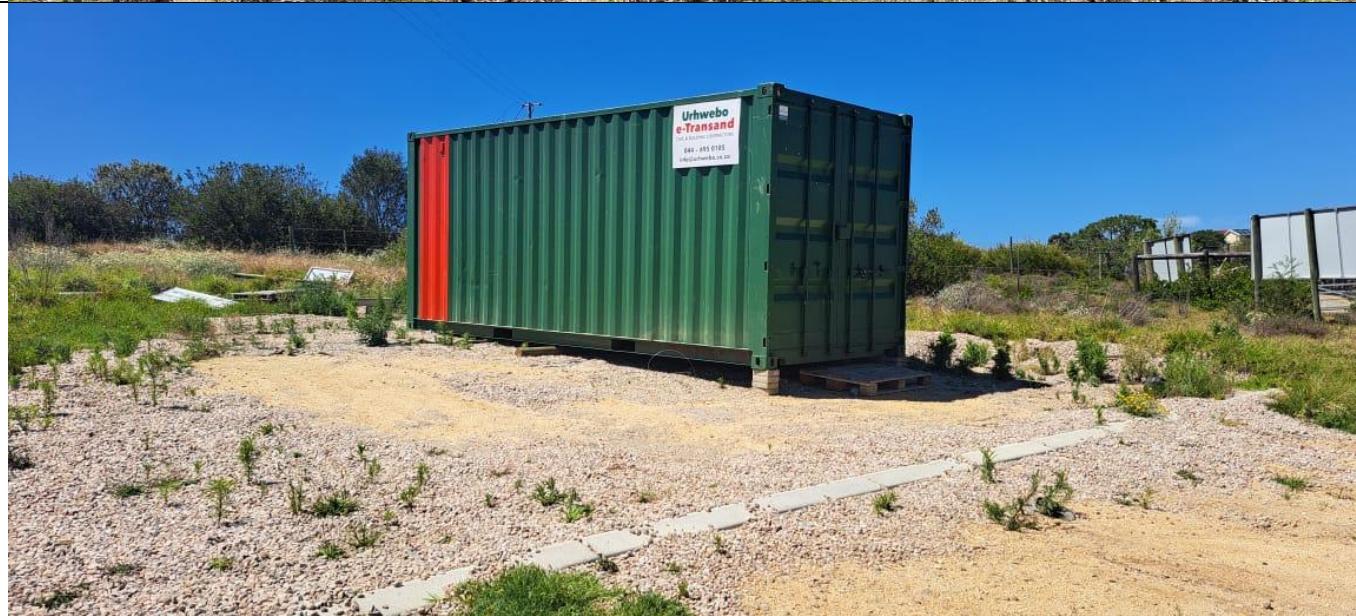
**Image 26:**

Storage container on site.

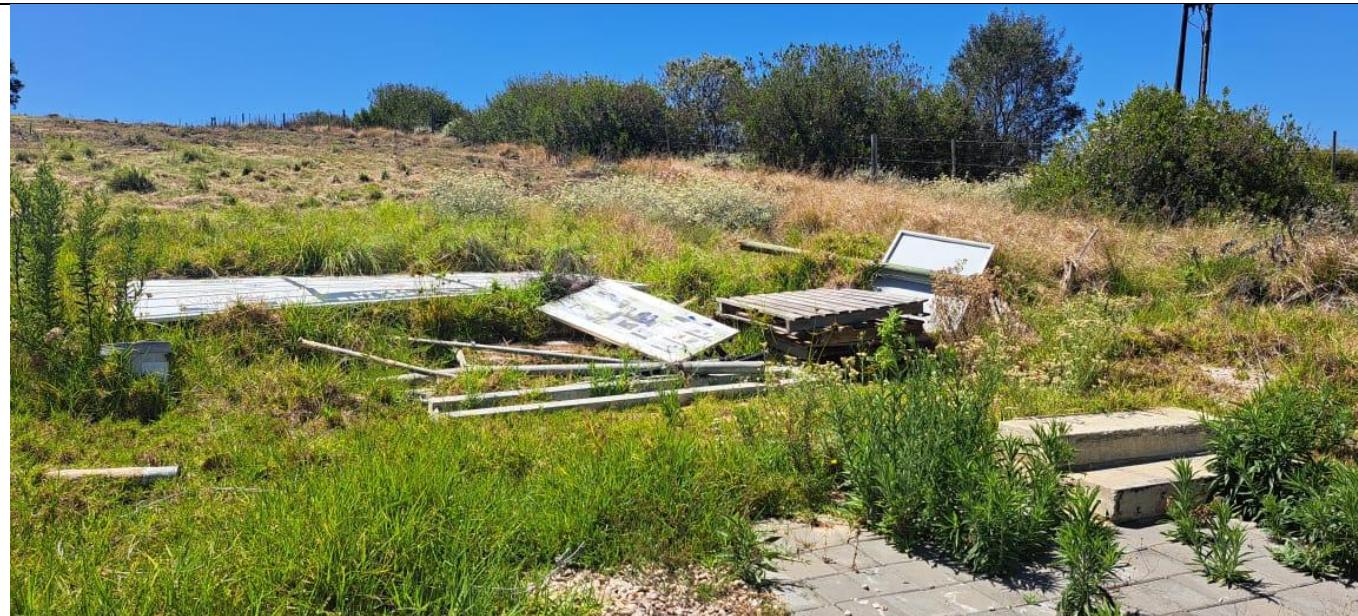
**Image 27:**

Various items disposed of around the container.
