## **ANNEXURE 1: PHOTOGRAPHIC EVIDENCE**

**The development of the Herolds Bay Country Estate on a portion of Portion 7 of the farm Buffelsfontein no. 204 in Herold's Bay, George Municipality, Western Cape.**

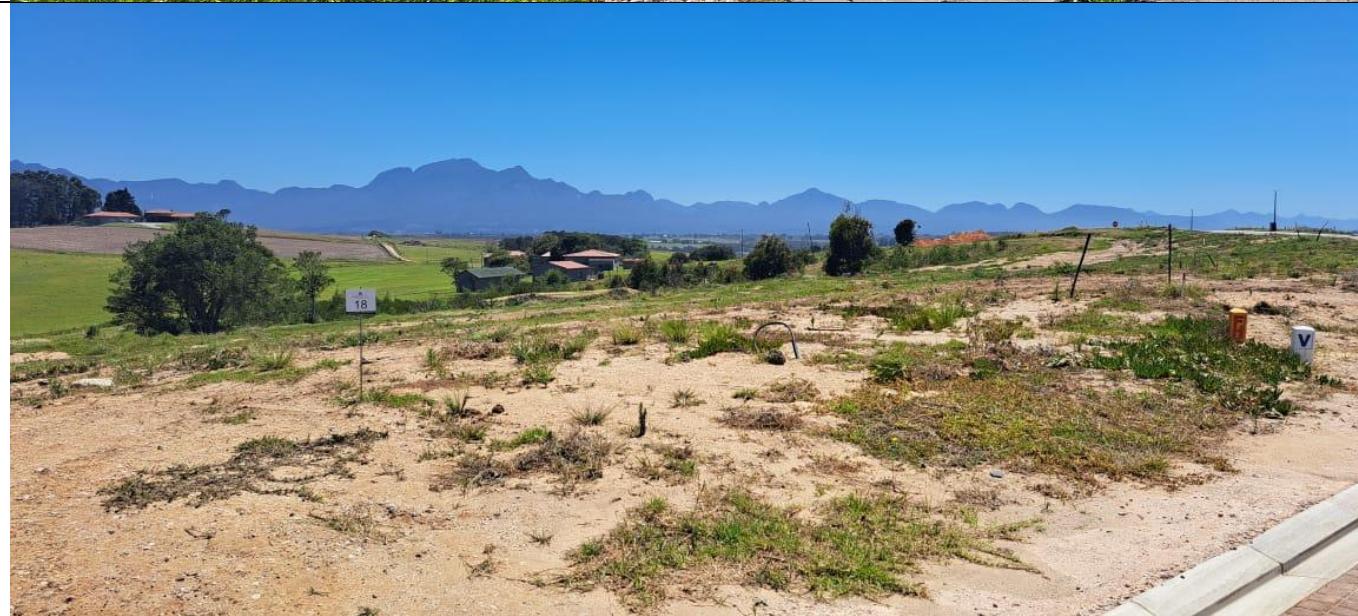
**Image 28:**

Exposed surface with little vegetation cover.

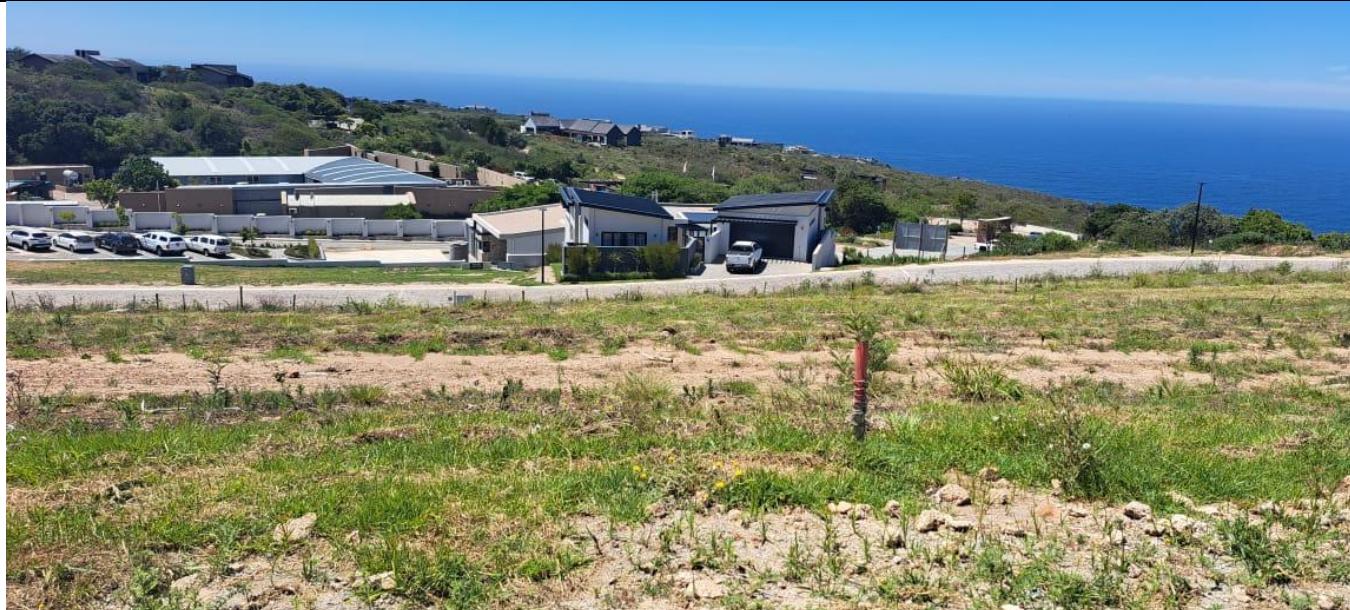
**Image 29:**

Exposed surface with some vegetation cover.

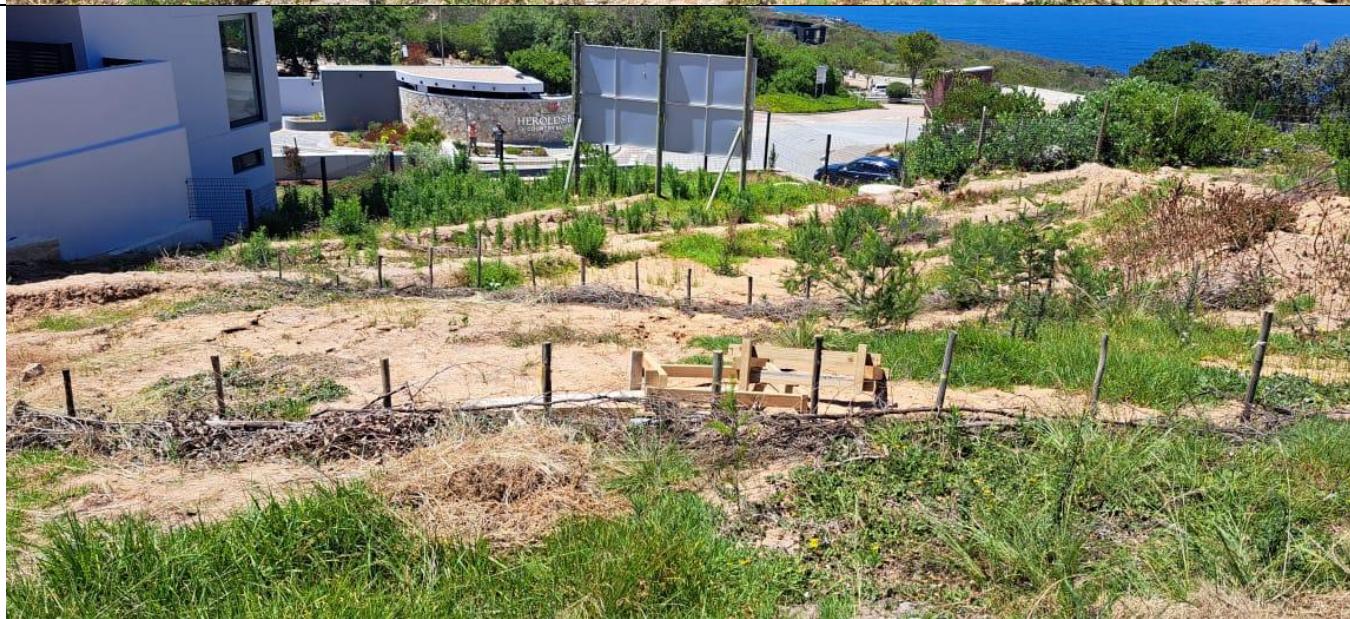
**Image 30:**

Some measures put in place to address erosion.

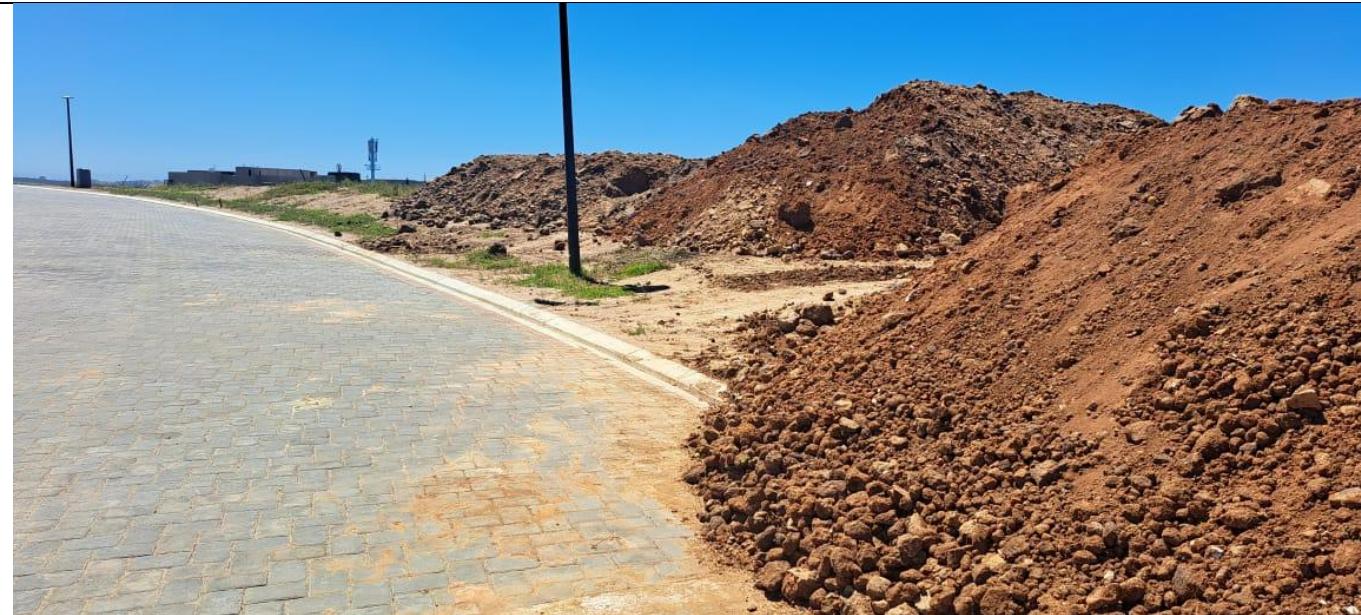
**Image 31:**

Recent excavation observed for house foundations. Site is demarcated.

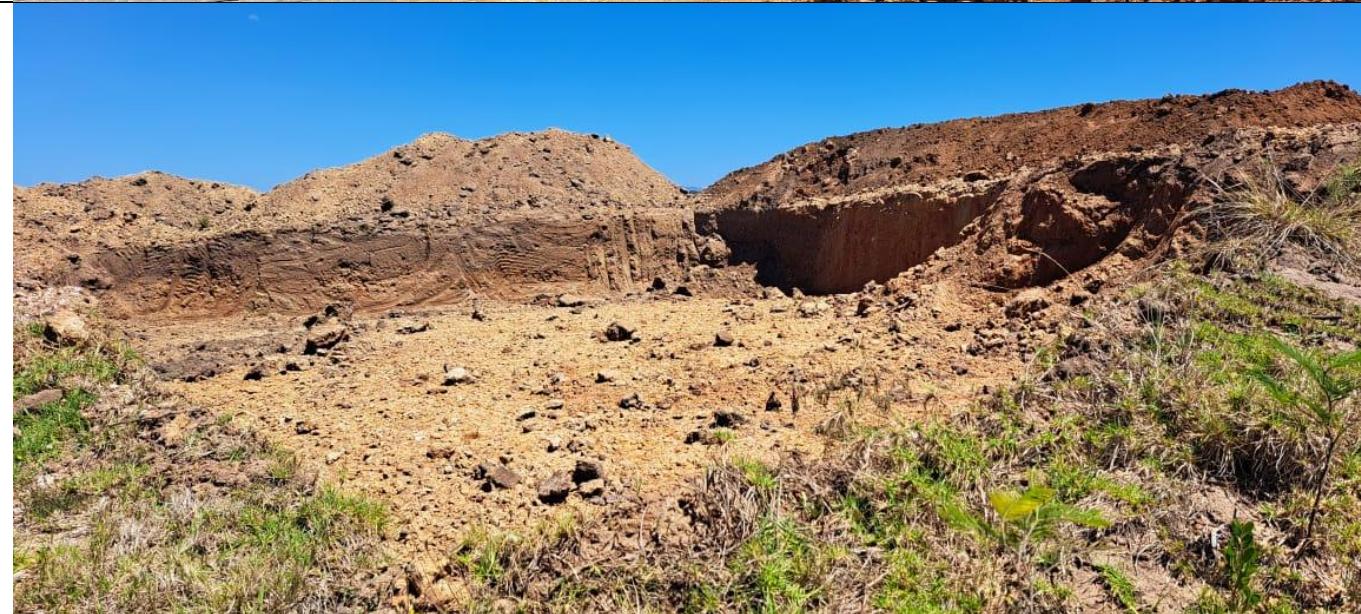
**Image 32:**

Recent excavation observed for house foundations. Site is not demarcated.

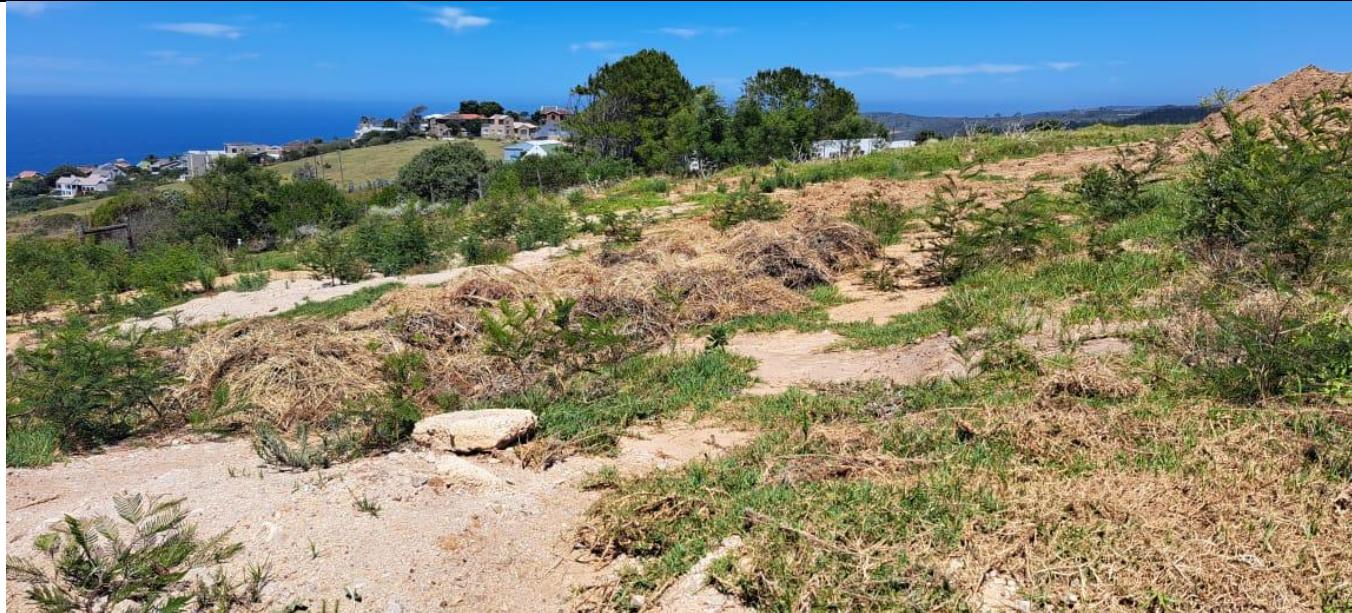
**Image 33:**

Emerging alien invasive species observed across areas of the development site.

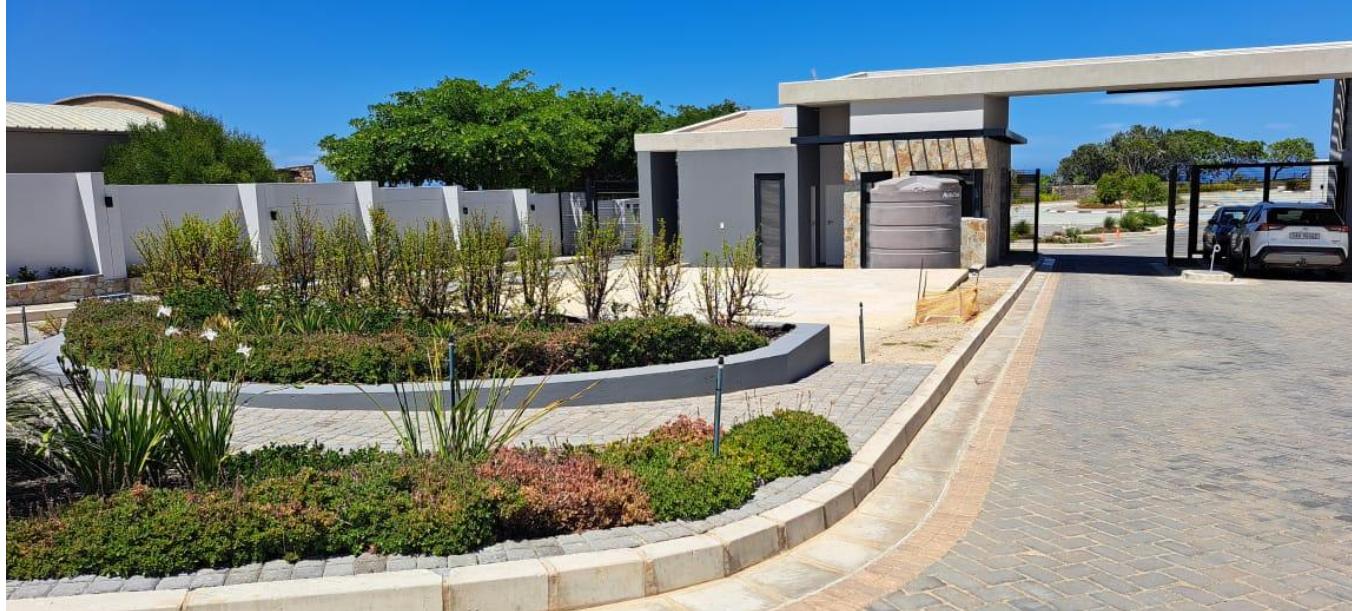
**Image 34:**

Constructed guard house.

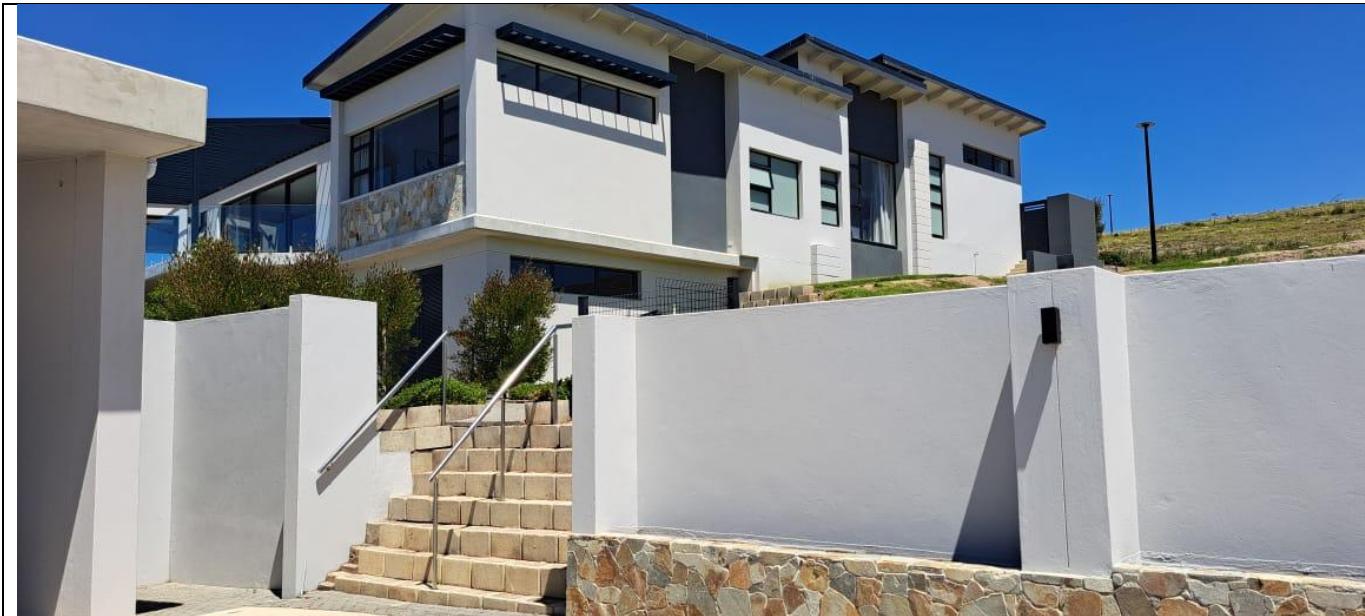
**Image 35:**

Constructed show house.

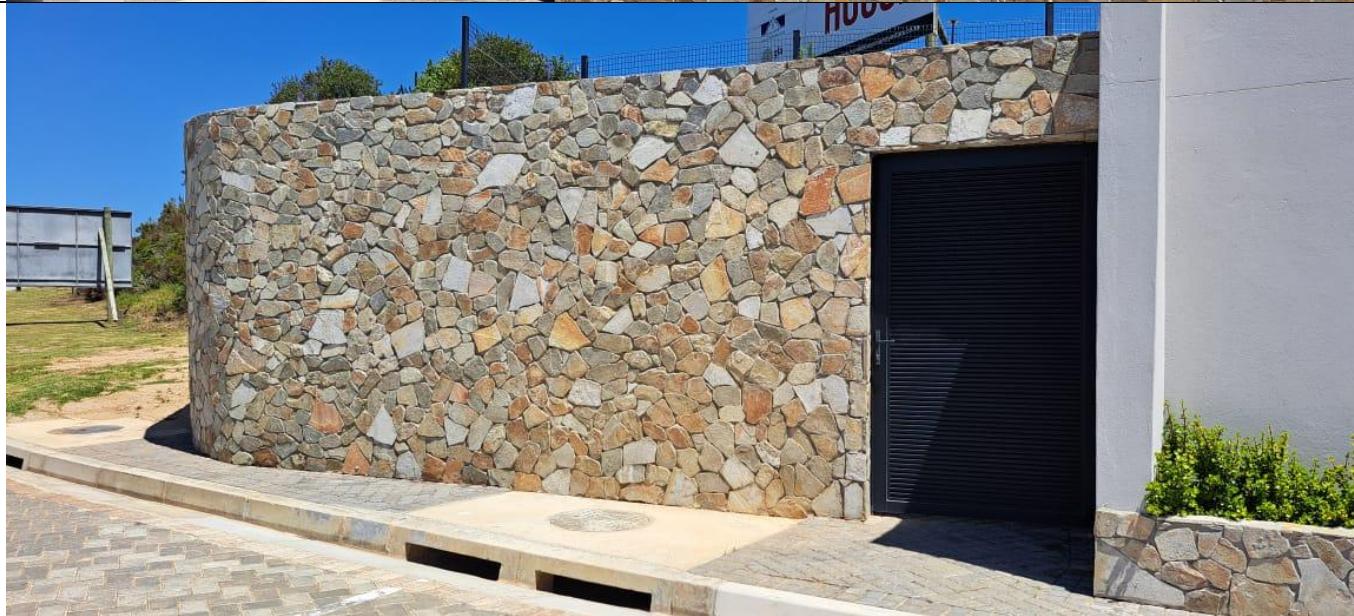
**Image 36:**

Housing for the package plant, pointed out by the ECO.
