**Western Cape Government: DTPW Road Programme Management
Contract C1157.02: Flood Damage Repairs to Structures in the
Garden Route Area**

Incident Report

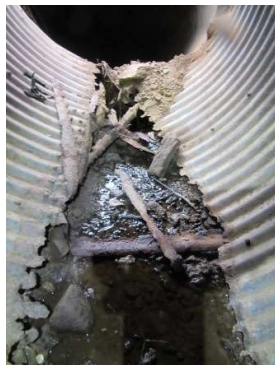
The culvert is corroded badly, especially the invert where there are not steel in most sections, thus the culvert has lost its structural integrity. The upstream side of the inlet works is in a good condition, but the last section of the Armco culvert washed away and collapsed due to erosion. There is no outlet structure visible. It appears as if the outlet side of the pipe is considerably higher than the riverbed into which it exits.

Severe corrosion to invert of Armco culvert

Replace the Armco culvert by jacking a concrete pipe over the existing Armco and subsequently remove the Armco culvert.

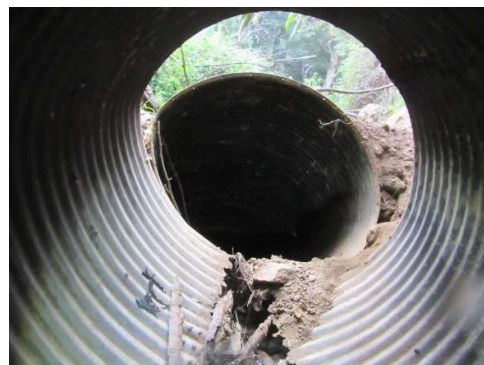
Downstream section of the Armco culvert washed away and collapsed due to erosion

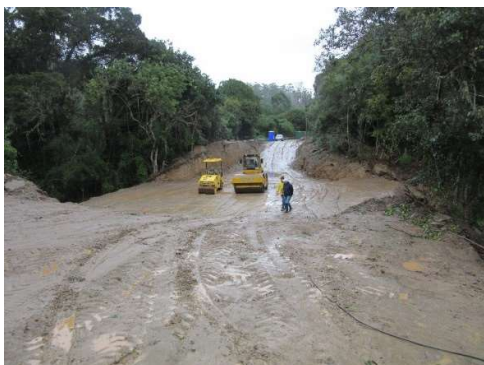
Road MR00355 at km 3.77; upstream on RHS.
Backfilling in progress.

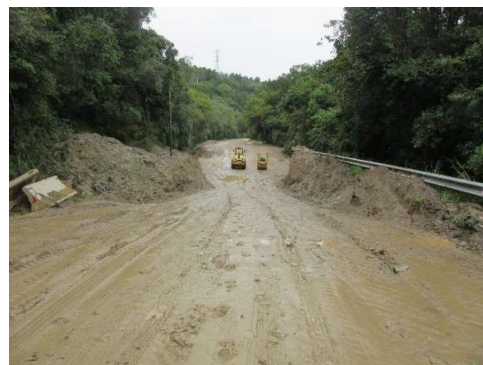
Road MR00355 at km 3.77; upstream on LHS.
Backfilling in progress.

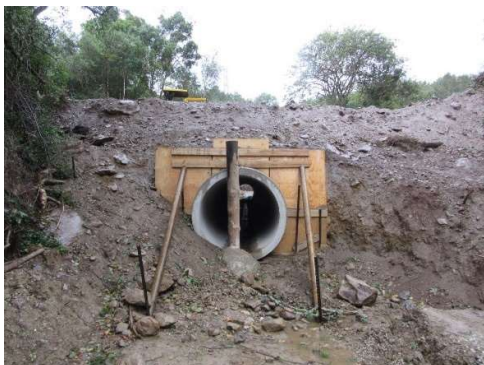
Downstream – looking towards culvert. Headwall construction in progress.

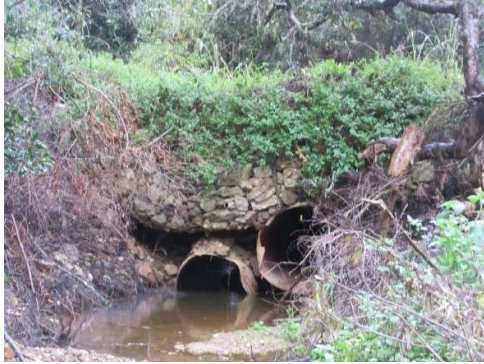
The road just upstream of the repaired culvert is in a bad condition and may collapse during a high rainfall event, causing the debris to block the opening of the new culvert. Refer to the last photo in the Appendix for this structure. This structure does not belong to the WCG, but its collapse poses a risk to the integrity of the road fill.

Existing Armco culvert on private road upstream of MR00355 at risk of collapse. May cause damage to MR00355 if this happens.

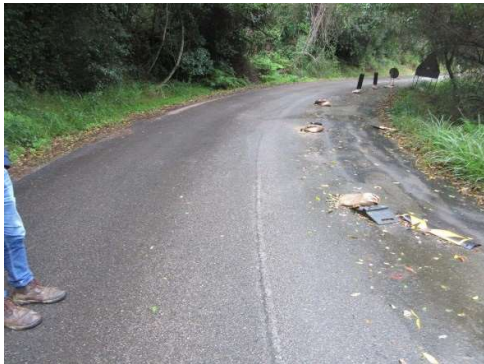
Road slip on RHS at MR00355 at km 7.95

We recommend that the affected area is excavated and re-built in layers of 500mm thick reinforced earth. Once the road has been reinstated, either re-use the existing rocks to re-build the wall along the face of the fill material, or alternatively use gabions, to protect the road edge from erosion.

Repair slip with reinforced earth complete with a screen wall, consisting of stone, to protect the reinforcement fabric.

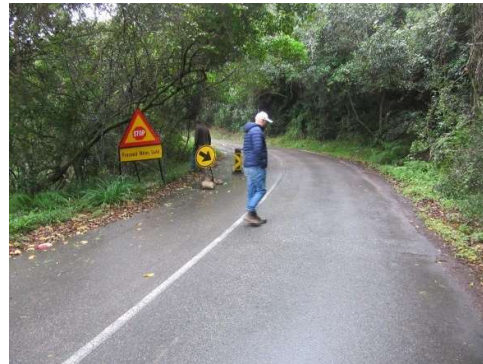
Road slip on RHS at MR00355 at km 7.95

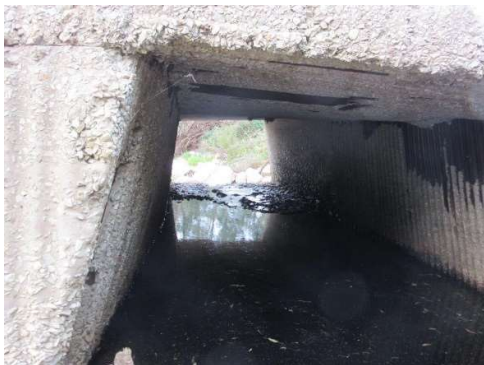
The existing concrete causeway structure is 30m long and 8m wide and includes one drainage opening of 1600mm wide x 1200mm high. The structure has return walls which are underscoured. Due to the undersized drainage opening the structure acts as a weir during larger rainfall events causing wide erosion on the downstream side.

Corrosion visible to inside of causeway structure

It is recommended to replace this structure with a causeway with adequate drainage openings so that the design flood can pass under the structure with limited overtopping so that it will still be safely trafficable. A visual estimate is that an in situ reinforced concrete structure with two 6m wide x 1.5m high openings will be required. A 6.2m road width between guide blocks is recommended.

Construct a new causeway with adequate drainage openings (visual estimate of 2 cells 6m wide x 1.5m high). A 6.2m road width between guide blocks is recommended.

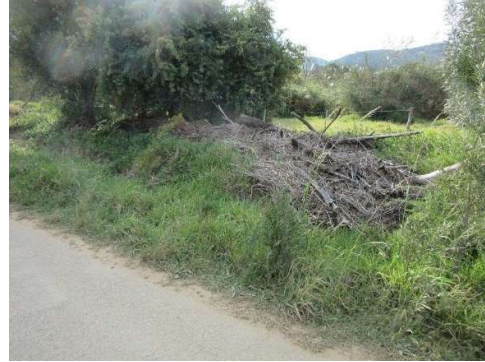
Debris from previous flood trapped against fence on downstream side of road.

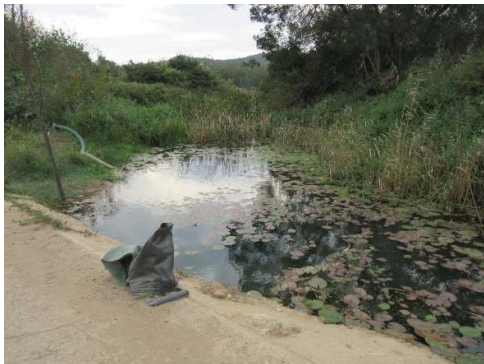
The existing concrete causeway is 20m long x 6.1m wide with three Ø600mm pipes which is submerged permanently thus it does not contribute to hydraulic capacity. This is in essence a drift structure. During the floods of November 2021, a part of the unreinforced concrete deck slab was lifted by the flood action. The structure has water pools on both sides of the road and this appears to be a permanent feature with water lilies growing in the pond on the downstream side.

Water ponding downstream of drift

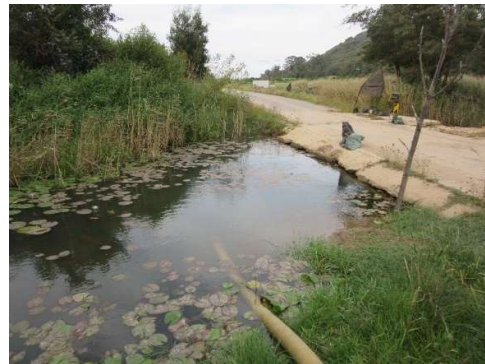
Water ponding downstream of drift

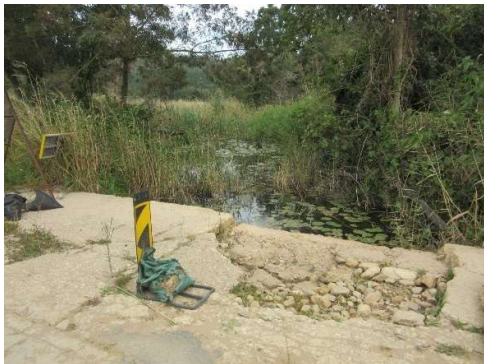
Water ponding upstream of drift. Damage to deck caused during previous flood.

1. Repair the causeway slab by reinstating the missing top slab to prevent vehicle damage.
2. Replace the structure with a causeway with larger openings and lift the top deck level marginally to increase the hydraulic capacity marginally.

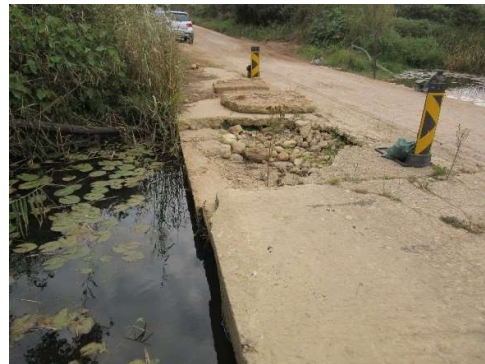
Water ponding upstream of drift. Damage to deck caused during previous flood.

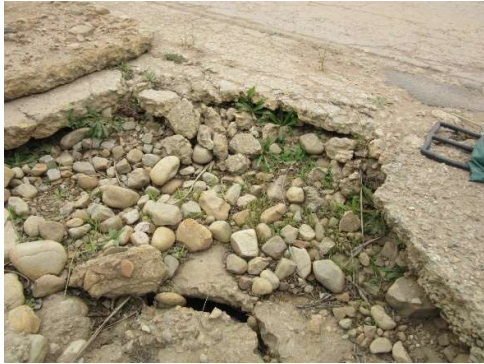
Damage to deck and pipe culvert caused during previous flood.

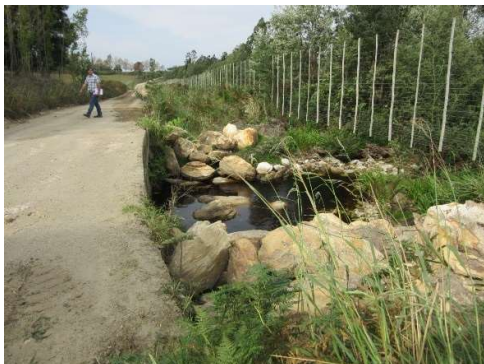
Rip rap has recently been placed on the downstream side to reduce scour

The rip rap which was recently placed on the downstream side will reduce scour and this can be improved by placing more rip rap. The basic problem, i.e., the drainage openings are too small for the catchment area and small debris would easily block these small drainage openings, will remain. These problems will not persist if a structure with adequate large draining openings is provided. Should option no. 1 be implemented, and the causeway must ever be replaced due to collapsing pipes, the new works will make it very difficult to carry out these repair works and the road width will remain at 4.6m unless the inlet and outlet structures are demolished.

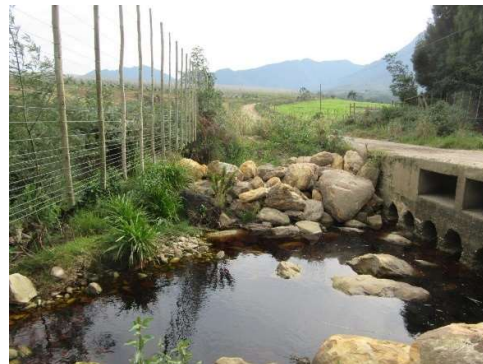
Rip rap has recently been placed on the downstream side to reduce scour

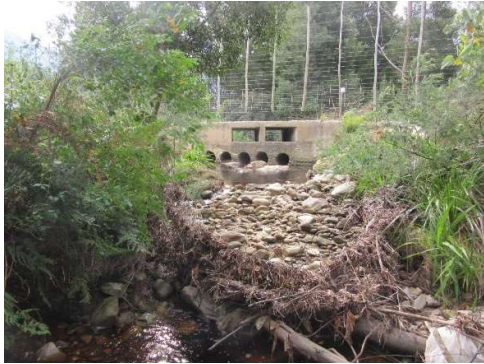
Downstream – looking towards culvert. Flood fence missing.

The flood fence on the downstream side is missing and needs to be replaced.

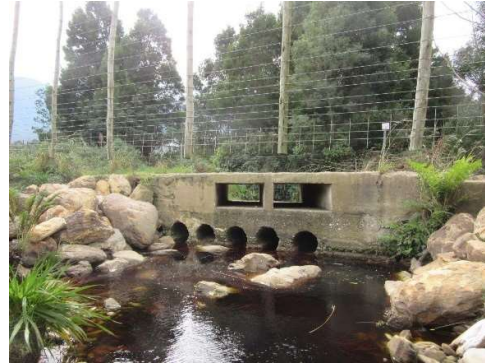
Downstream – looking towards culvert. Flood fence missing.

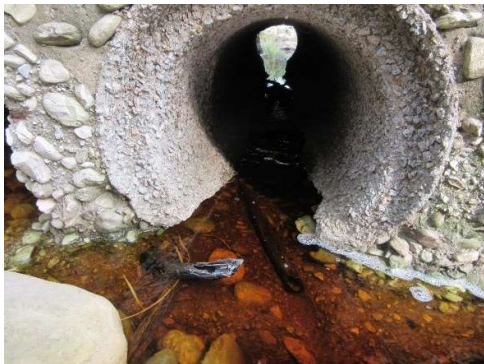
Severe corrosion to invert of pipe culvert

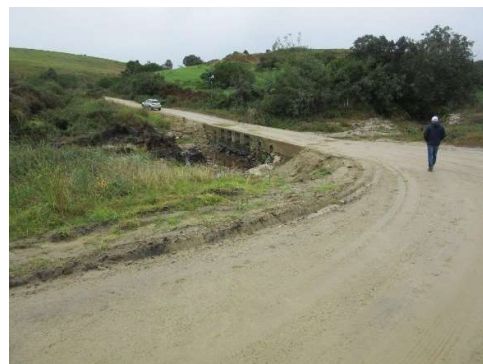
During the November 2021 flood the George side approach road was washed away for a length of 15m. This portion of road has been repaired and widened

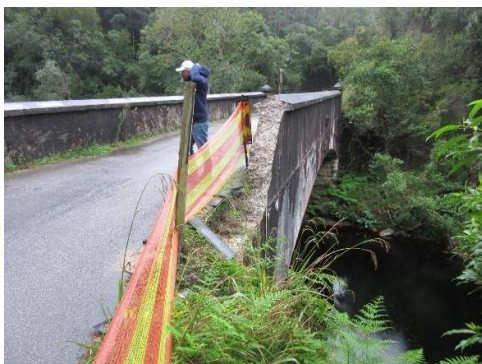
One of the end-blocks and part of the balustrade to the Salt River bridge on road MR00355 at km 8.67 was knocked down by vehicle impact. This is on the RHS when approaching the bridge from Saasveld side.

The only repair option available is to replace the end-block with the same geometric dimensions but to use reinforced concrete to make it more robust.

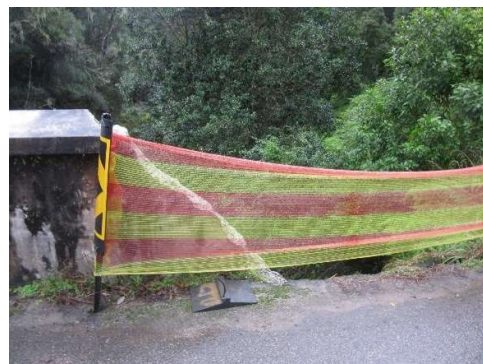
One of the end-blocks and part of the balustrade to the Salt River bridge on road MR00355 at km 8.67 was knocked down by vehicle impact. This is on the RHS when approaching the bridge from Saasveld side.

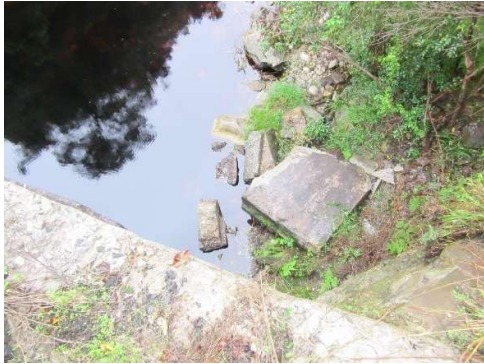
Remains of the damaged end-block and balustrade

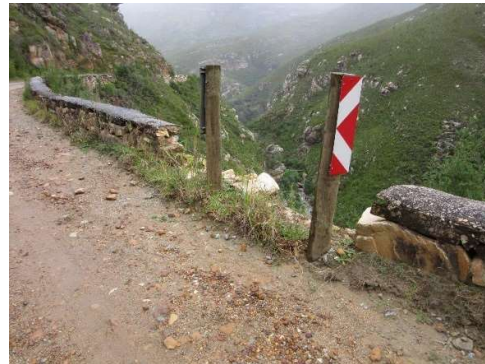
There are five sections where the dry-stack wall is missing with the following section lengths: 4m, 12m, 14m, 6m and 4m. The wall is 600mm wide and 700mm high with a thin layer of mortar on the top surface. The pass is dangerous to road users where the balustrade wall is missing.

Damage to dry-stack balustrade wall on DR1640 at km 7.55

A combined length of 40m of dry-stack wall needs to be reinstated using existing rocks in the vicinity. We recommend that mass concrete is used to bind these rocks together whilst ensuring that the mass concrete is not visible on the external faces of the wall.

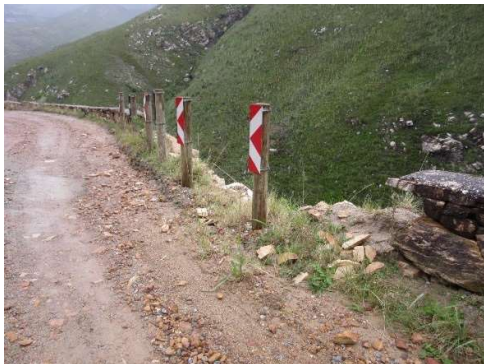
Damage to dry-stack balustrade wall on DR1640 at km 7.63

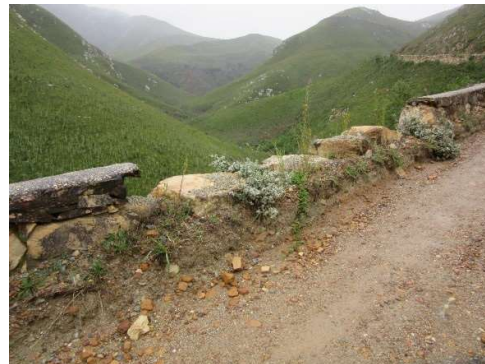
Damage to dry-stack balustrade wall on DR1640 at km 7.87

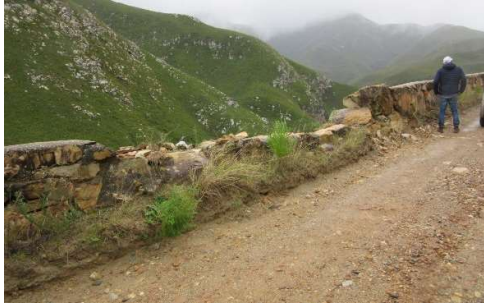
Damage to dry-stack balustrade wall on DR1640
at km 7.87

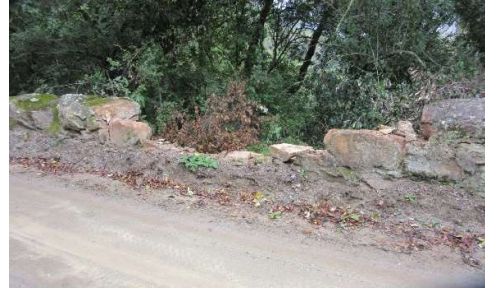
Damage to dry-stack balustrade wall on DR1640 at
km 9.84
