## METHOD STATEMENT

For the works already undertaken as part of the erosion repairs, works to be completed and rehabilitation at the stormwater outlet at the Outeniqua Waste Water Treatment Works (WWTW),  
George

| Date | 17 January 2024 |
| Client | George Municipality |

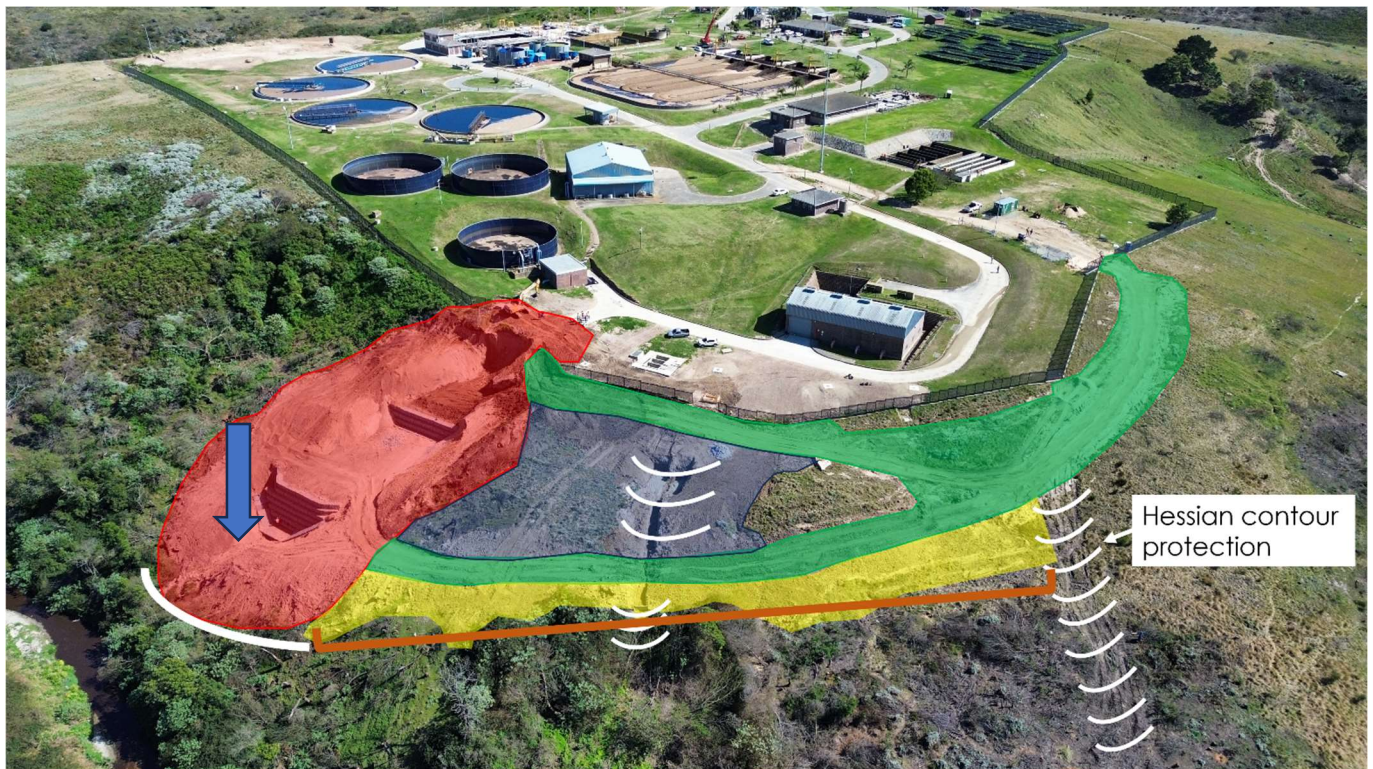
**Figure highlighting the various areas where work is required on site**

- **RED: Blue arrow** - installation of the final stormwater headwall and dissipator to be completed as per the engineering design – below the current gabion wall closest to the river. This is the highest priority as rehabilitation of the surrounding area cannot be completed until this work is completed.

- **RED:** general area – areas not already backfilled, reshaped, covered with topsoil and seeded need to be shaped, topsoiled and seeded immediately as the work is completed. Geojute/sausage bags to be installed across slopes to protect the slopes while the seed germinates. Silt fence to be installed as indicated along the white line between the works (not yet complete) and the river before commencement of the construction of stormwater outlet. Work within the 32m of the watercourse

- **BLUE:** areas not already backfilled, shaped and topsoiled need to be backfilled, reshaped, covered with topsoil seeded and silt fences to be installed as indicated by the white lines

- **YELLOW:** excess material to be pulled back up the slope away from the river using an excavator (as part of the rehabilitation of the green zone) and removed to stockpile. Area to be reshaped, covered with topsoil and seeded. Silt fencing to be installed as indicated. Hessian sausages to be installed at the base of the slope which will remain for the long-term (will biodegrade over time) – as indicated in brown. This will protect the entire length of the river bank from silt movement.

- **GREEN:** storm water pipeline to be installed and temporary access road to be ripped, reshaped to the natural slope as soon as the work at the final outlet structure is complete and access no longer required. The area is then to be covered with topsoil and seeded. Additional hessian contour protection to be installed at eroded area south of the road. Area first to be reshaped, covered with topsoil, seeded and contour protection to be installed

- The entire affected site must be **reshaped** to form natural slopes. It is important to ensure that the excavator teeth marks do not lead down the slope (as this will result in erosion between the subsoil and the topsoil in future). Preferably have any ridges running in contours across the slope.
- **Topsoil** must be spread over the entire site.
- Include shallow topsoil **contour berms** **across the whole slope** to slow water down and encourage infiltration and reduce runoff.
