## ENVIRONMENTAL MANAGEMENT & MAINTENANCE MANAGEMENT PLAN including REHABILITATION

**For the works already undertaken as part of the erosion repairs, works to be completed and rehabilitation at the stormwater outlet at the Outeniqua Waste Water Treatment Works (WWTW),  
George**

| <b>Hilland reference</b> | GEO23/1251/07 |
| <b>Date</b> | December 2023 |

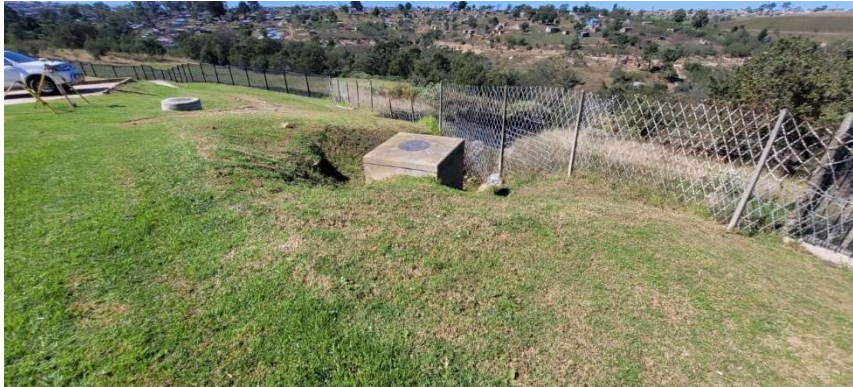
**Stormwater outlet that started eroding (photograph taken April 2020)**

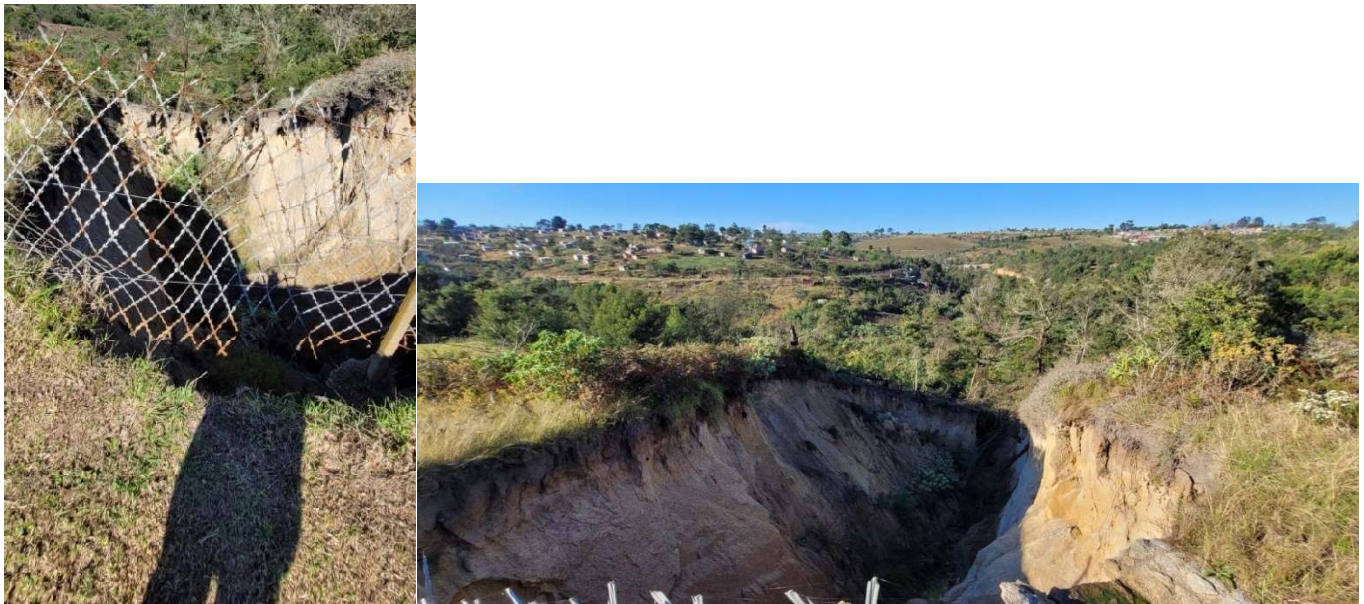
**Donga that formed through headward erosion below the stormwater outlet (photographs taken April 2020)**

The released stormwater from the structure then ran in a southerly direction towards the Schaapkop River (overland). The stormwater discharge resulted in the formation of a large erosion gully over the course of 6 or more years (signs of erosion are evident on the 2017 aerial imagery).

As with typical headward erosion, the erosion donga has migrated upslope to the point where it crossed the boundary fence of the WWTW facility and posed an immediate threat to the WWTW infrastructure. The excessively large erosion gully/donga beyond the fence lead all the way into the Schaapkop River – an elevation difference of 28m (approximately 182m to 154m at the river). The gully was 15-20m wide and extended 80m down slope towards the river.

The erosion led to the deposition of noticeable quantities of sediment into the river and as such the erosion has negatively impacted the river and it also posed a risk to the infrastructure within the WWTW.

The proposal was to rehabilitate the erosion gully and construct a formal stormwater structure for the controlled release of stormwater from the facility.

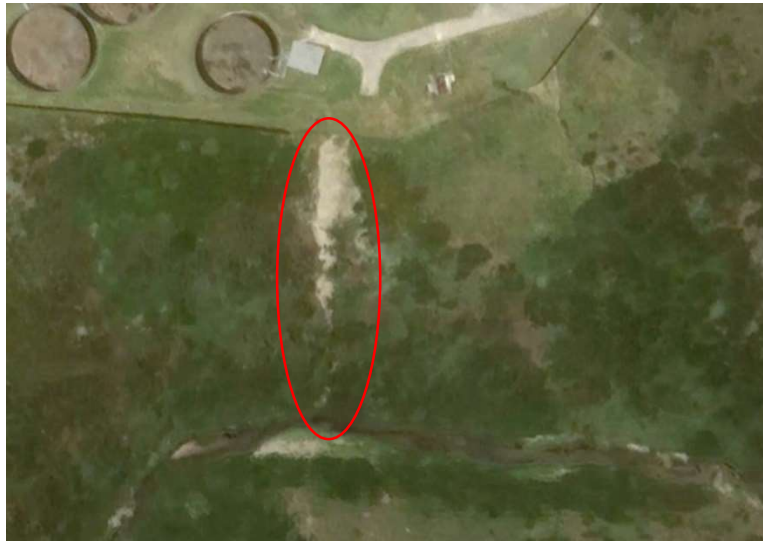
**2022 Google Earth image showing the erosion gully/donga from the WWTW**

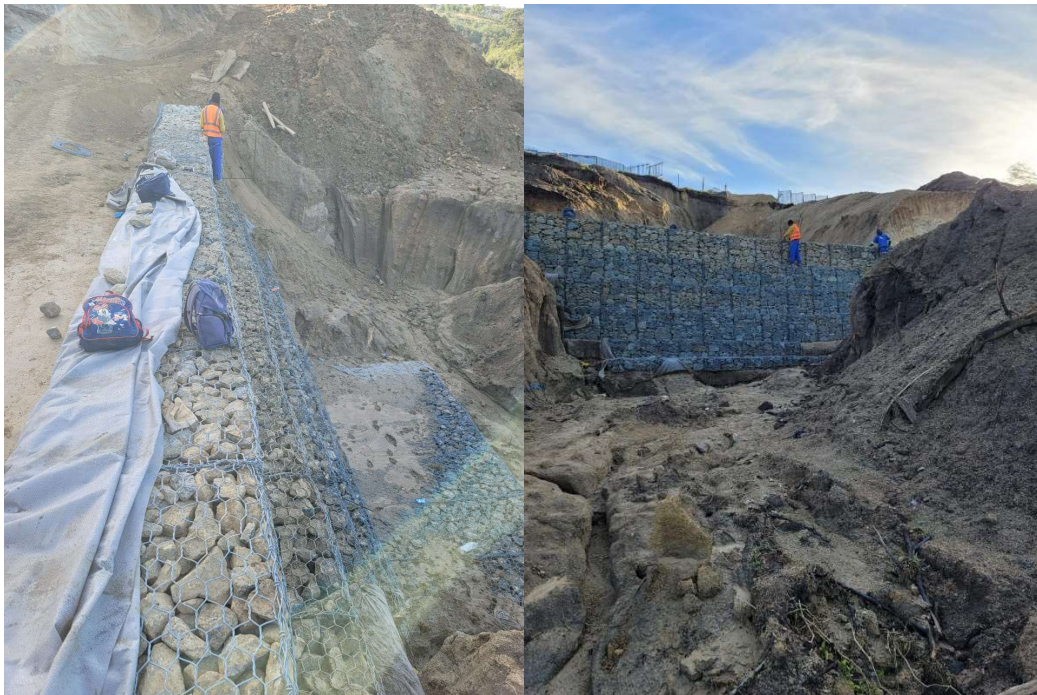
**Retaining walls being installed to repair the existing donga (photograph taken July 2023)**

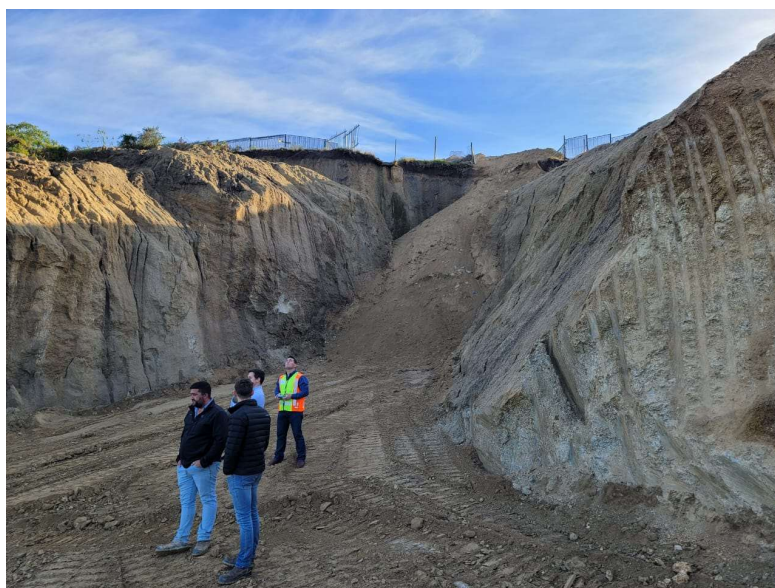
**Donga/gully being filled and sloped to natural ground level (photograph taken July 2023)**

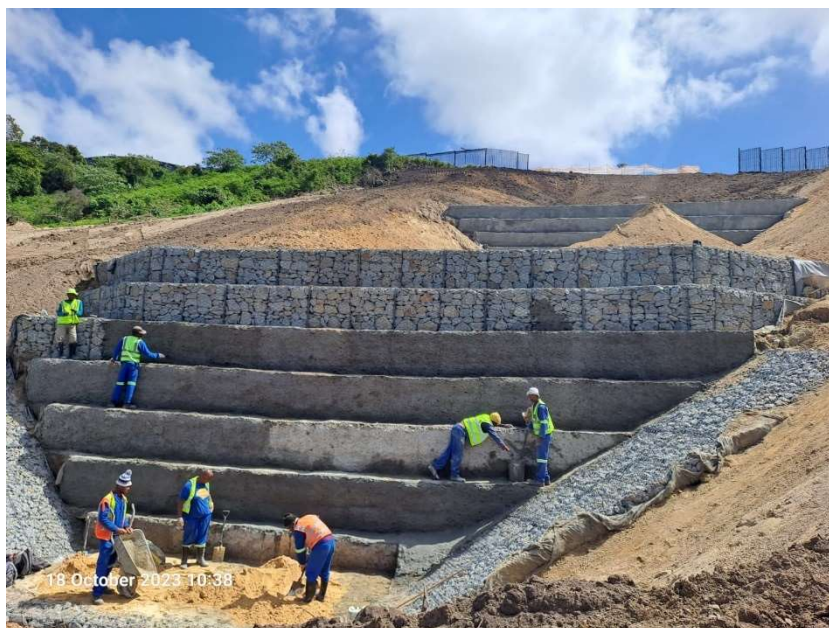
**Gabions installed and donga being backfilled (photograph taken 18 October 2023) - works all beyond the 32m buffer from the edge of the watercourse.**

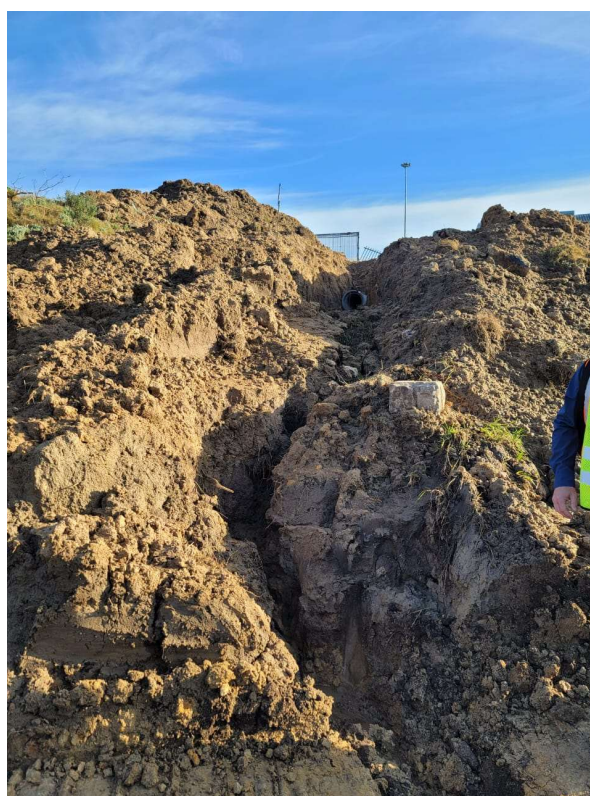
The temporary storm water discharge point already shows signs of erosion which poses an environmental risk as it cannot be connected to a formal system until the pipeline and outlet structure have been installed.

**Point at which the diverted stormwater is currently released and that is eroding (photograph taken July 2023)**

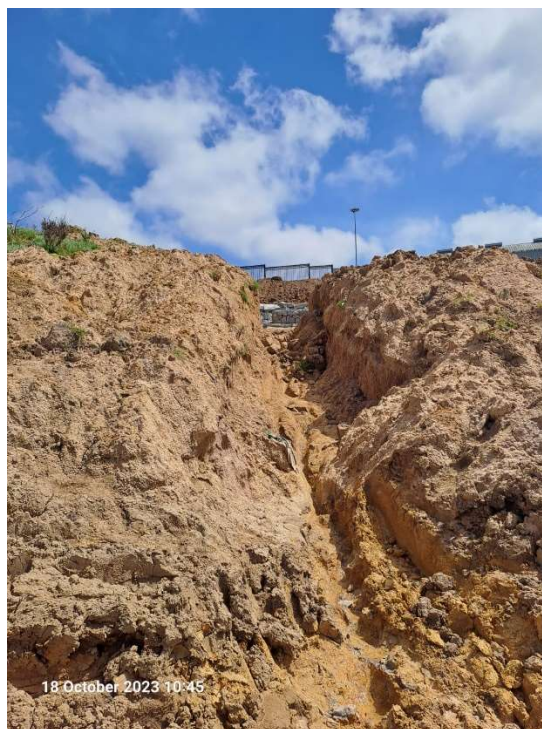
**State of the erosion at the current outlet (photograph taken 18 October 2023)**

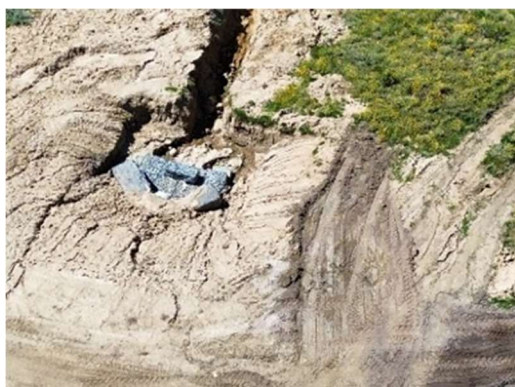
**Temporary headwall and dissipator constructed at the stormwater outlet. Note there is still significant erosion below this structure and headward erosion will eventually result in the formation of a similar gully to the one that has just been the target of the rehabilitation effort (photo Zutari, November 2023)**

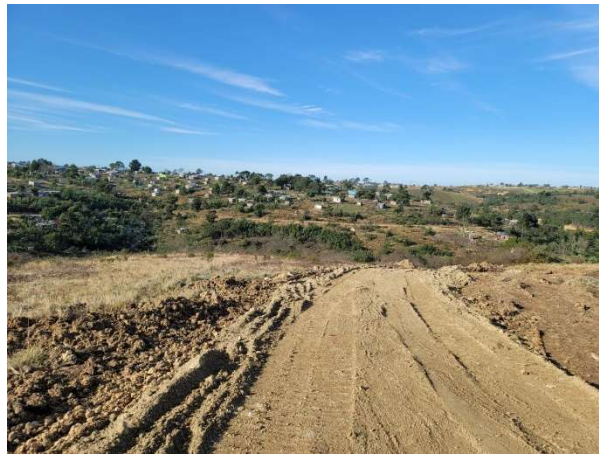
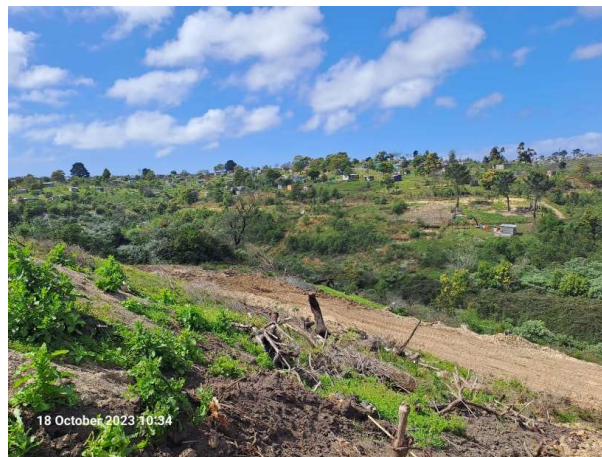
A temporary road (wider than 4m) was created along the future pipeline route to access the site for the installation of the gabions and rehabilitation of the donga. This road will not remain and will be fully rehabilitated. It has no road reserve.

**Temporary access road and route for the installation of the new stormwater pipeline**

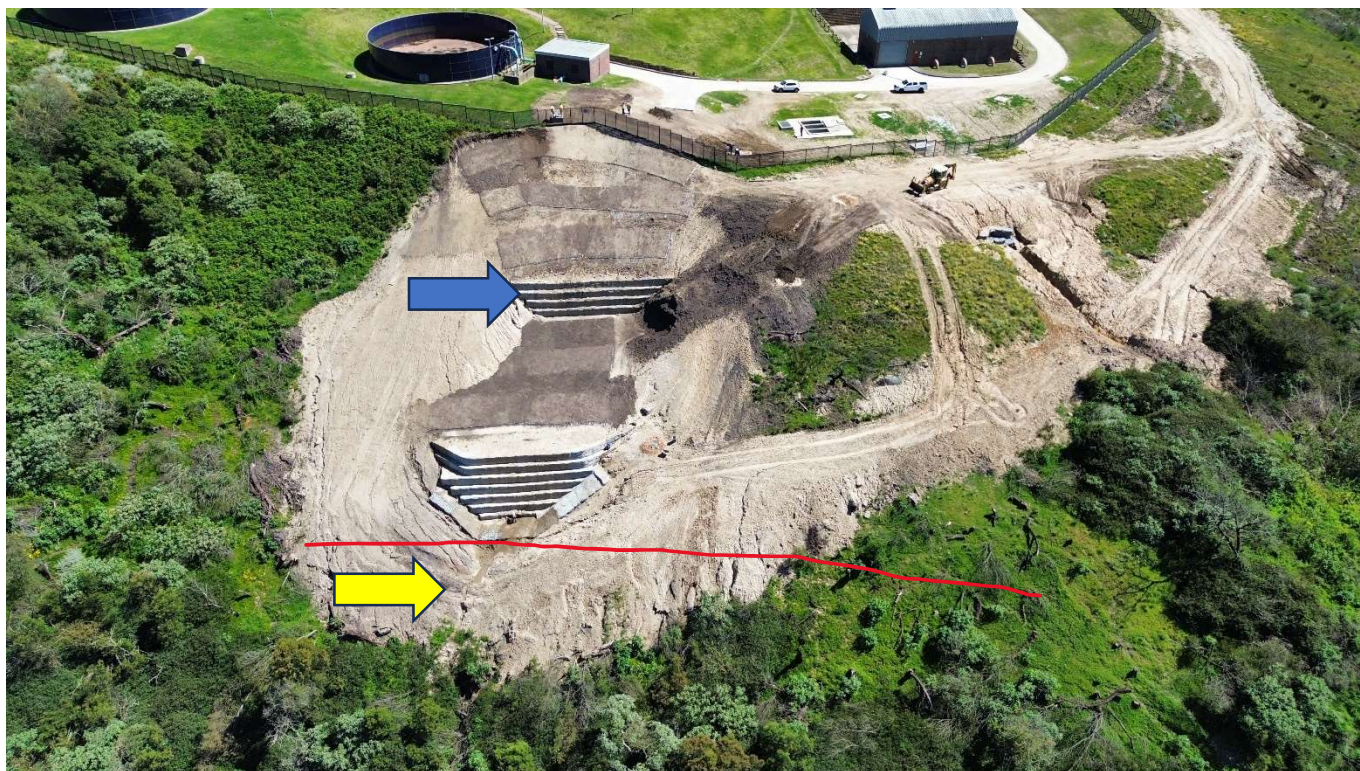
Current status following installation of structures outside the 32m riparian buffer (Photos taken by Zutari, 15 November 2023)

**Blue arrow** - Secondary 4m gabion section installed within the donga based on on-site engineering design requirements for slope stability

**Yellow arrow** - over spill of material into the 32m riparian zone which will all need to be removed as part of the rehabilitation plan.

**Red line** - Approximate position of the 32m riparian buffer line

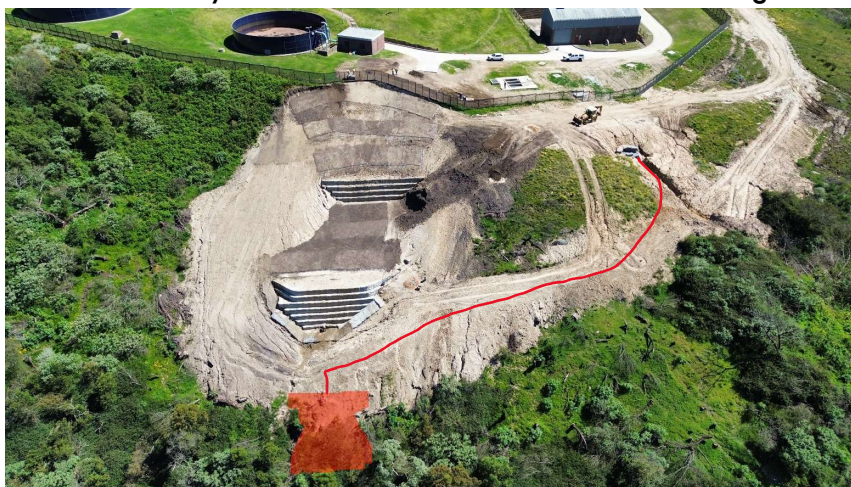
**Drone photo showing the existing gabions installed (4m and 7m structures) and the approximate route of the new pipeline and outlet structure. Note that there has been no construction within the 32m buffer zone of the river, but that there has been overspill of material into this zone which needs to be rehabilitated.**

The area around the donga has been reshaped as part of the rehabilitation, the material from the temporary access road and work close to the watercourse will be pulled back over the rehabilitated donga-area once construction is completed.

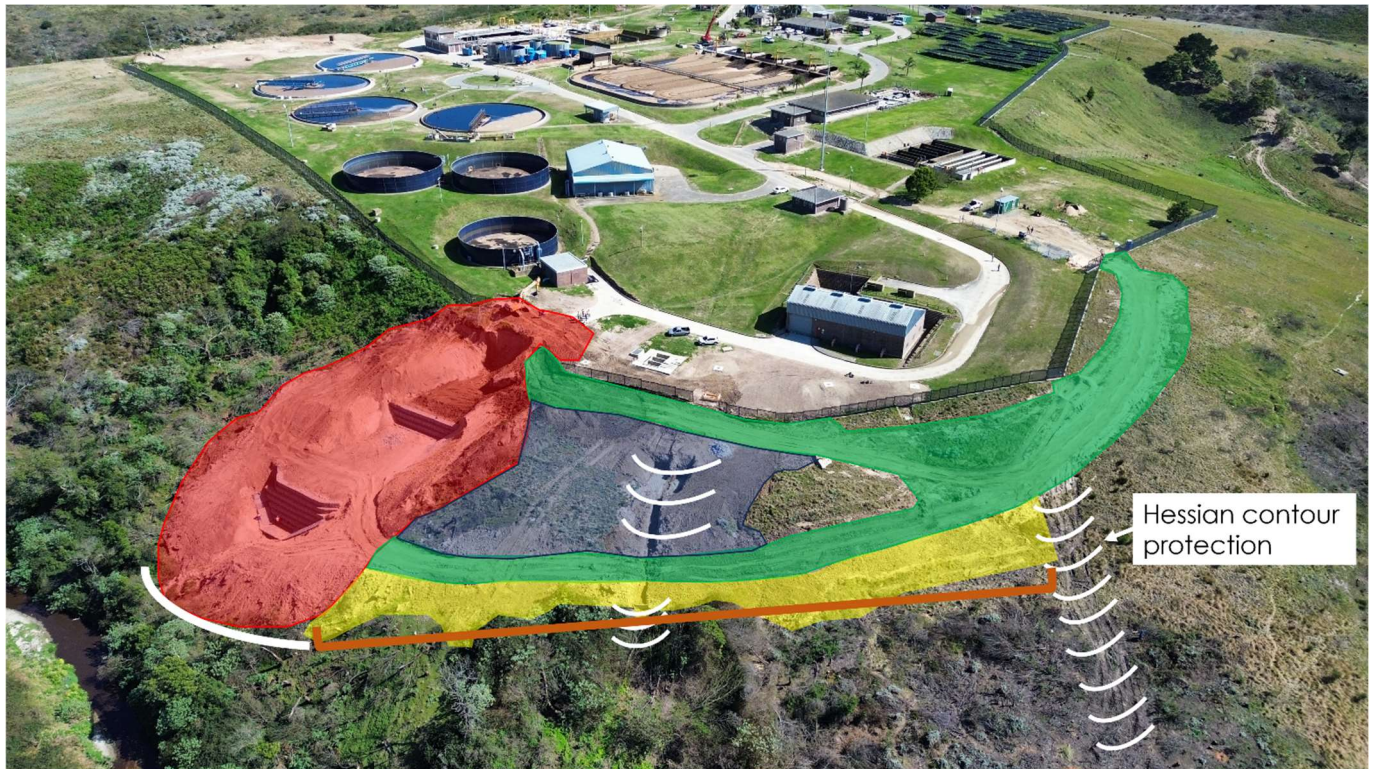
Figure highlighting the rehabilitation to be done at various sections of the site

**RED:** installation of the final stormwater headwall and dissipator to be completed, area to be backfilled, reshaped, covered with topsoil, seeded and geojute/sausage bags to be installed. Silt fence to be installed between the works and the river before commencement of the construction of stormwater outlet

Additional hessian contour protection to be installed at eroded area south of the road. Area first to be reshaped, covered with topsoil, seeded and contour protection to be installed
