## ENVIRONMENTAL MONITORING REPORT 1

## THE OUTENIQUA WASTEWATER TREATMENT WORKS, GEORGE

**GEO24/1251/10**

**July to 21 August 2024**

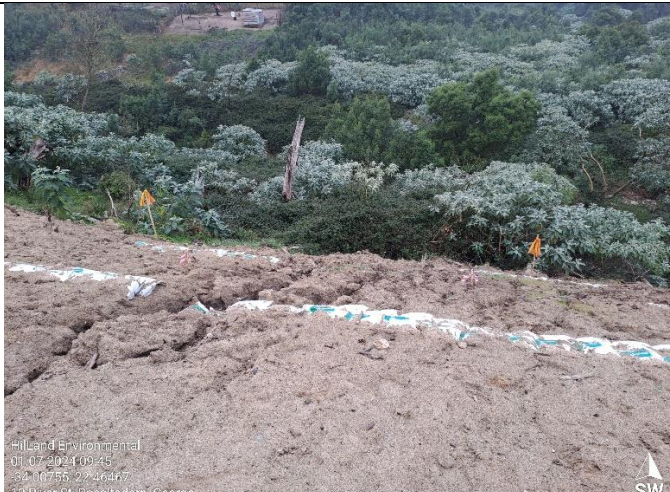
| Photo | Comment/ Finding |
|---|---|
| <p>HilLand Environmental<br/>011 07 2024 69 45<br/>08 10 55 29 46am<br/>10 River St. Paarltdorp, George</p> <p>SW</p> | <p>Wooden droppers and danger tape used to demarcate the working area. Sandbags along high-risk erosion areas.</p> |

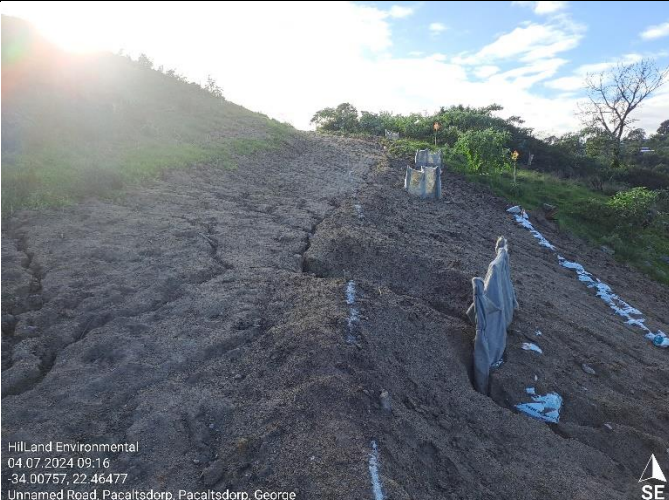
| <p>Hill and Environmental<br/>04.07.2024 09:16<br/>-34.00757, 22.46477<br/>Unnamed Road, Pacaltsdorp, Pacaltsdorp, George</p> <p>SE</p> | <p>Silt fences in place to reduce silt wash.</p> |

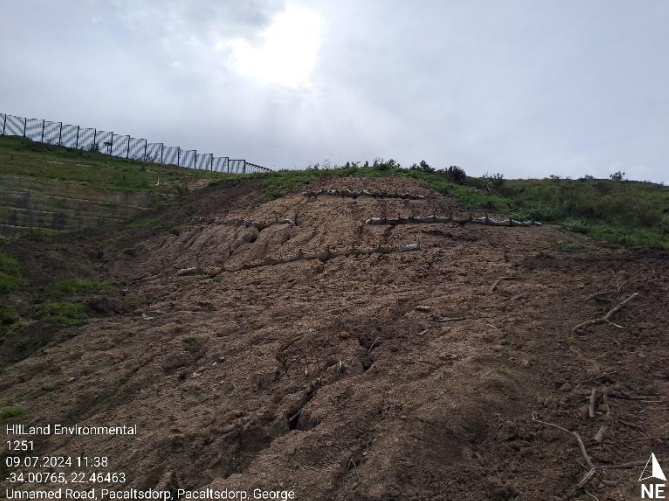
| <p>Hill and Environmental<br/>1251<br/>09.07.2024 11:38<br/>-34.00766, 22.46463<br/>Unnamed Road, Pacaltsdorp, Pacaltsdorp, George</p> <p>NE</p> | <p>Mulch filled sausages pegged along the steepest slopes to reduce erosion as part of the rehabilitation phase.</p> |

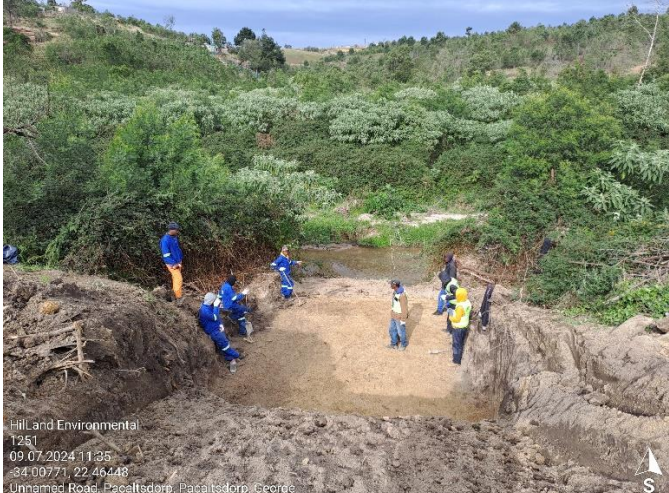
| <p>Hill and Environmental<br/>1251<br/>09.07.2024 11:25<br/>-34.00771, 22.46448<br/>Unnamed Road, Pacaltsdorp, Pacaltsdorp, George</p> <p>S</p> | <p>Excavation for the new stormwater outlet headwall and energy dissipating structure (gabion and reno mattress).</p> |

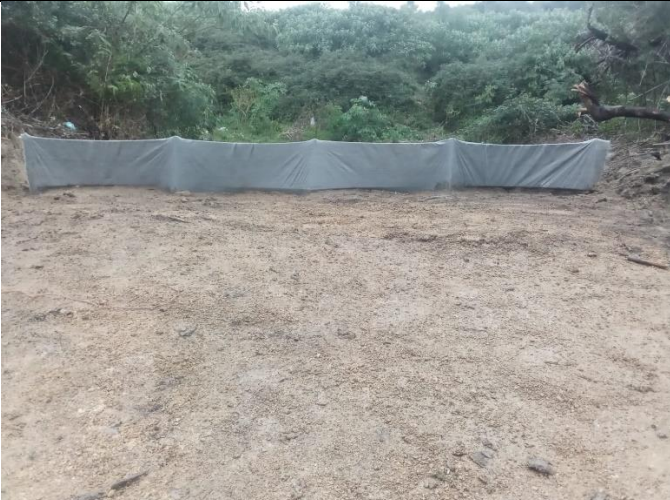
| | <p>Silt fences in place to reduce silt washing into the river below the working area for the excavations and installation of the energy dissipating structure.</p> |

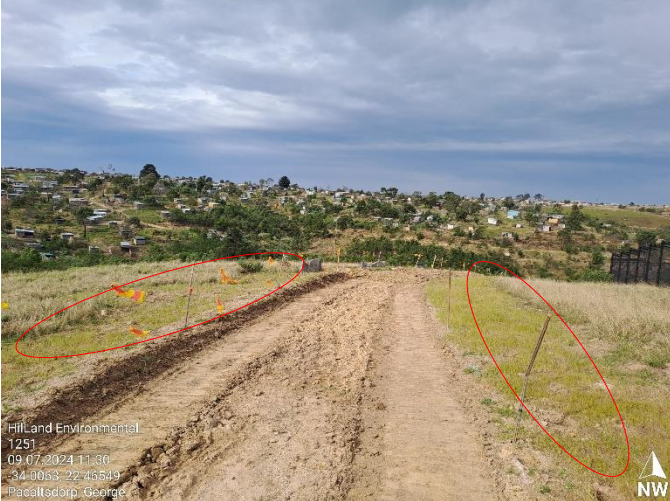
| <p>HillLand Environmental<br/>1251<br/>09.07.2024 11:36<br/>34.0083, 22.45549<br/>Pacaltsdorp, George</p> <p>NW</p> | <p>Wooden droppers and danger tape used to demarcate the working zone and haul road. The sides of the road have been rehabilitated (note the grass starting to grow).</p> |

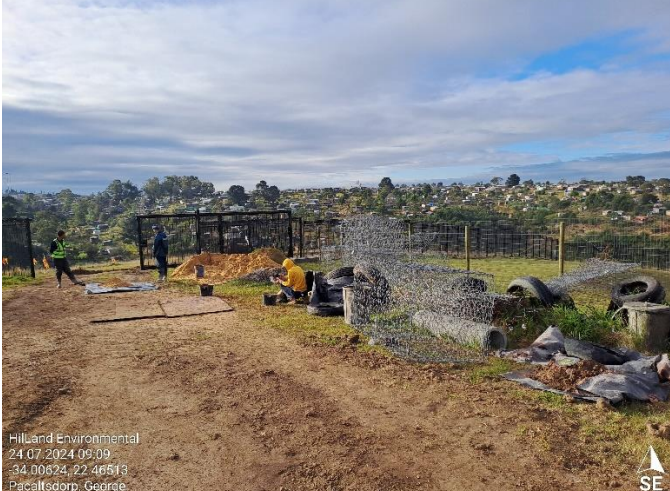
| <p>HillLand Environmental<br/>24.07.2024 09:09<br/>34.0083, 22.46513<br/>Pacaltsdorp, George</p> <p>SE</p> | <p>Construction materials stored in the site camp.</p> |

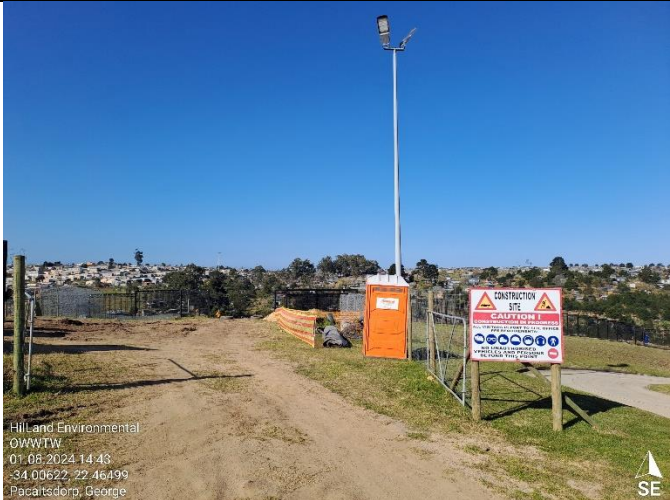
| <p>Hill and Environmental<br/>O/W/T/W<br/>01.08.2024 14:43<br/>34 00622 22 46499<br/>Pacaltsdorp, George</p> | <p>Ablution facilities available in the site camp. Construction and safety signage is up.</p> |

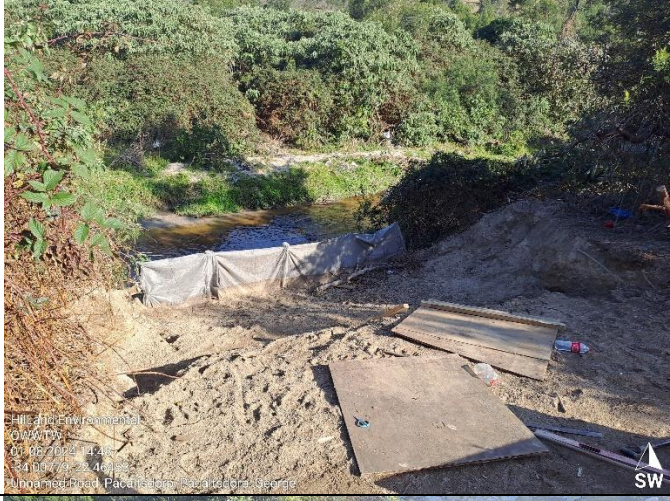
| <p>Hill and Environmental<br/>O/W/T/W<br/>01.08.2024 14:43<br/>34 00622 22 46499<br/>Pacaltsdorp, George</p> | <p>Silt fence in place to prevent silt movement and indicating the no-go area.</p> |

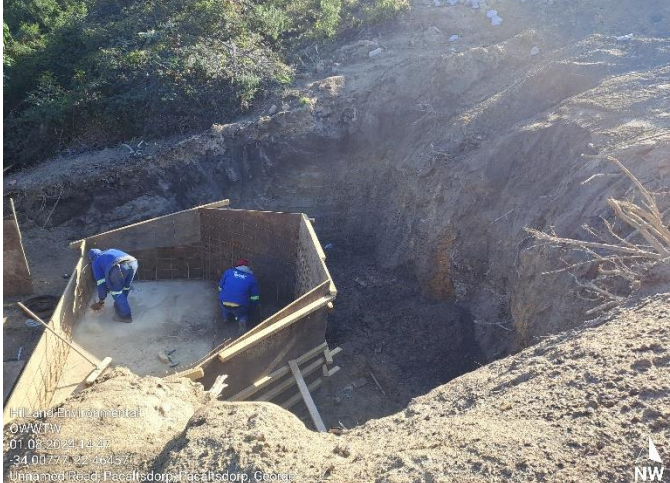
| <p>Hill and Environmental<br/>O/W/T/W<br/>01.08.2024 14:43<br/>34 00622 22 46499<br/>Pacaltsdorp, George</p> | <p>Construction of the stormwater outlet head wall.</p> |

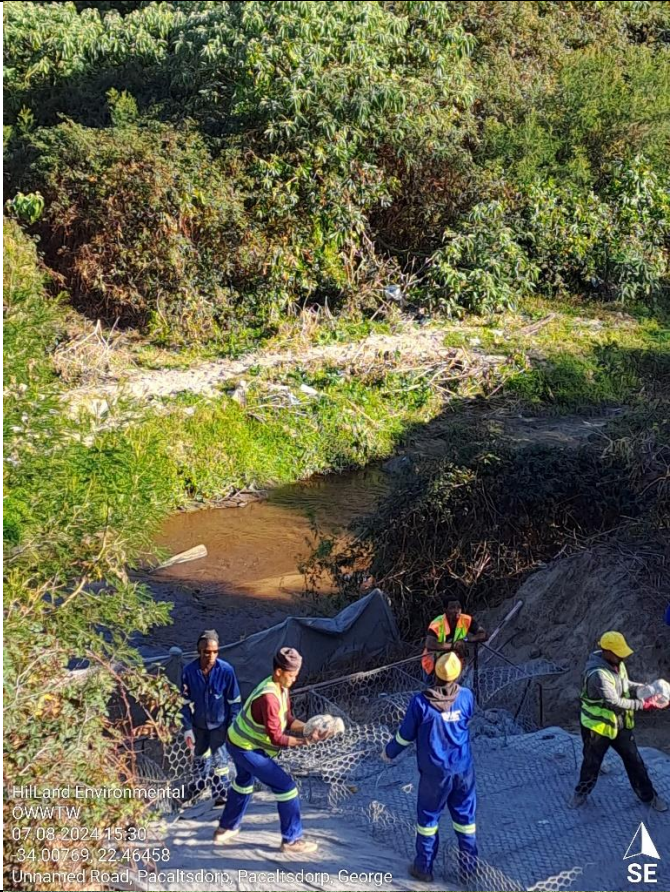
Construction of the gabions. Silt fence maintained between the river and the construction activity.

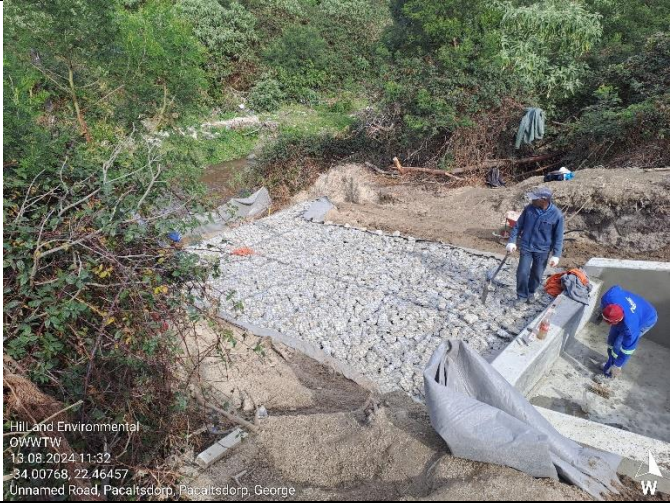
Construction progress.
