## ENVIRONMENTAL MONITORING REPORT 2

### THE OUTENIQUA WASTEWATER TREATMENT WORKS (WWTW), GEORGE EROSION REPAIR

**GEO24/1251/16**

**ENVIRONMENTAL MONITORING REPORT NO 2**

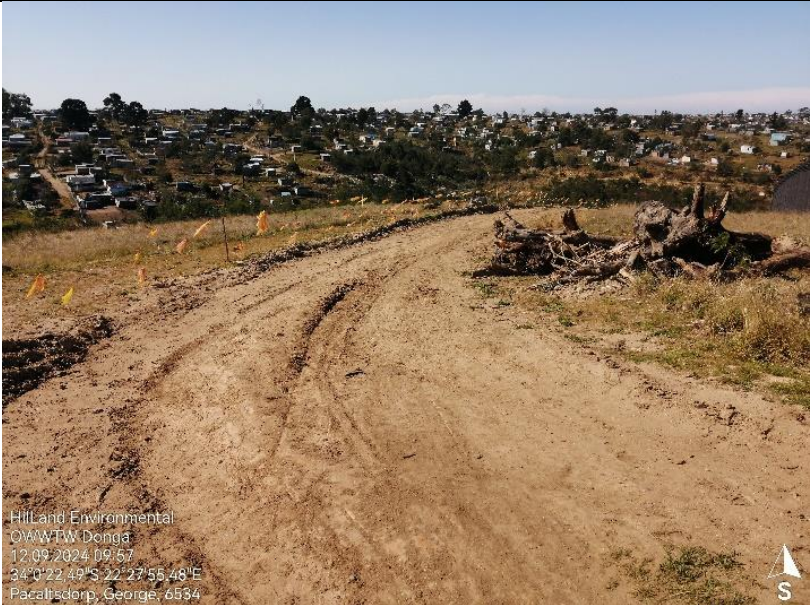
| Photo | Comment/ Finding |
|---|---|
| <p data-bbox="342 732 541 829"> Hilland Environmental<br/> OW/WTW Donga<br/> 12/09/2024 09:57<br/> 34°0'22.49"S 22°27'55.48"E<br/> Pacatiindorp, George, 6534 </p> | <p data-bbox="1306 228 1829 326"> Wooden droppers and danger tape used to demarcate the working area. Sandbags along high-risk erosion areas. </p> |

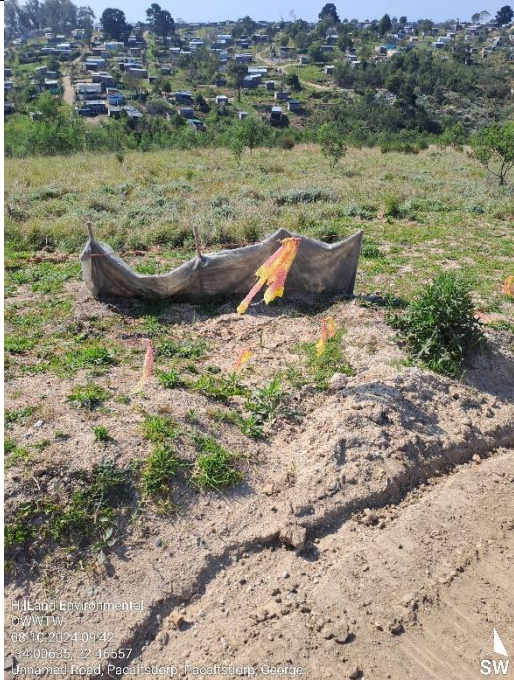
| | <p>HilLand Environmental<br/>O/W WTW<br/>08-10-2024 09:42<br/>32.00635, -82.16557<br/>Unnamed Road, Ponglishup, Accra Region, Ghana</p> <p>SW</p> | <p>Silt fences in place to reduce silt wash.</p> |

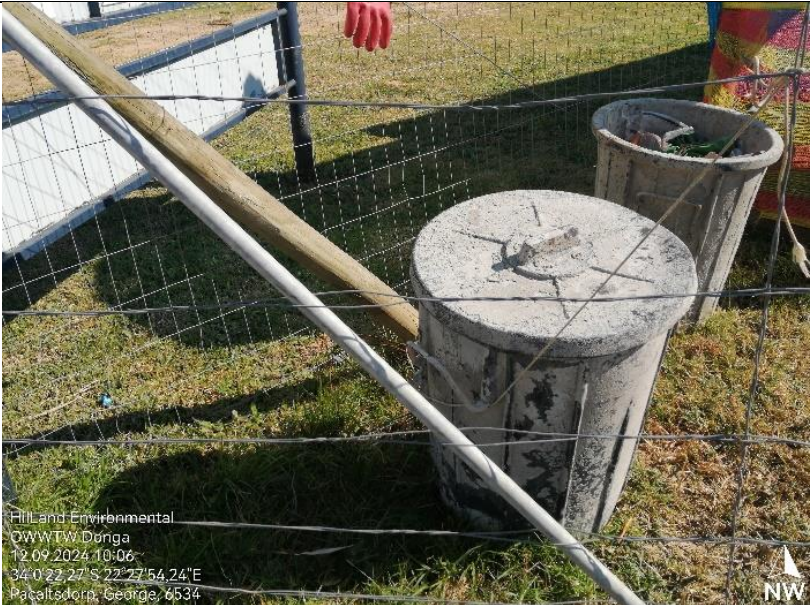
| <p>HillLand Environmental<br/>QWWTW Donga<br/>12.09.2024 10:06<br/>34°02'27"S 27°27'54.24"E<br/>Pacaltsdorp, George, 6534</p> <p>NW</p> | <p>Bins in the site camp.</p> |

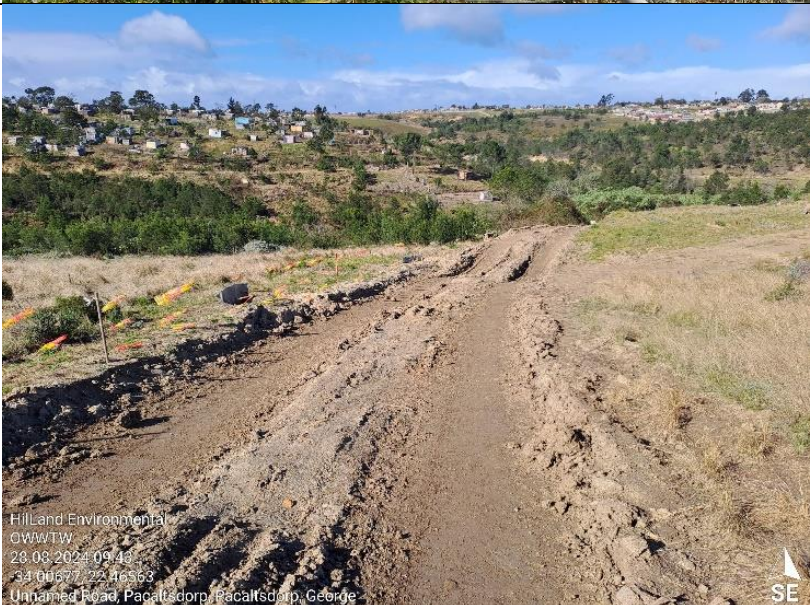
| <p>HillLand Environmental<br/>QWWTW<br/>28.08.2024 09:40<br/>34°04'57.72"S 27°46'59.33"E<br/>Unnamed Road, Pacaltsdorp, Pacaltsdorp, George</p> <p>SE</p> | <p>Wooden droppers and danger tape used to demarcate the working zone and haul road. The sides of the road have been rehabilitated and have successfully revegetated.</p> |

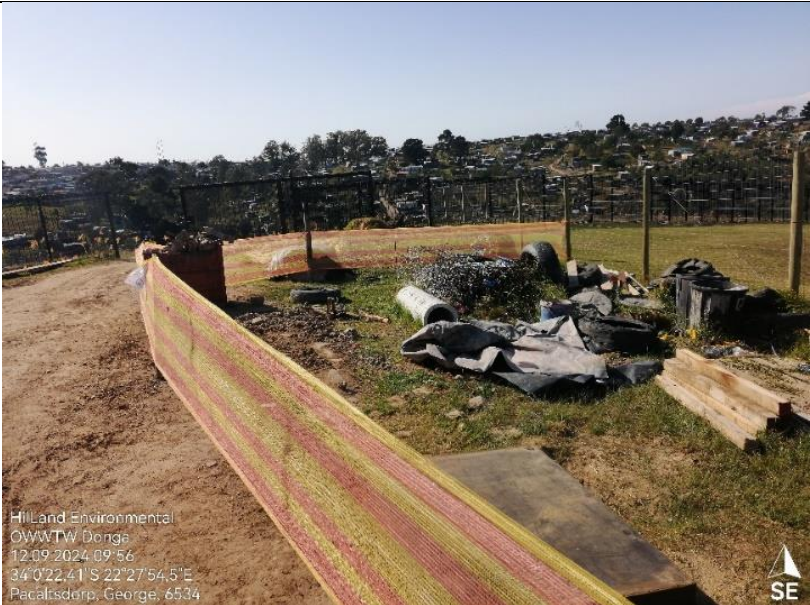
| | <p>HillLand Environmental<br/>OWWTW Donga<br/>12.09.2024 09:56<br/>34°0'22.41"S 22°27'54.5"E<br/>Pacaltsdorp, George, 6534</p> <p>SE</p> | <p>Construction materials stored in the site camp.</p> |

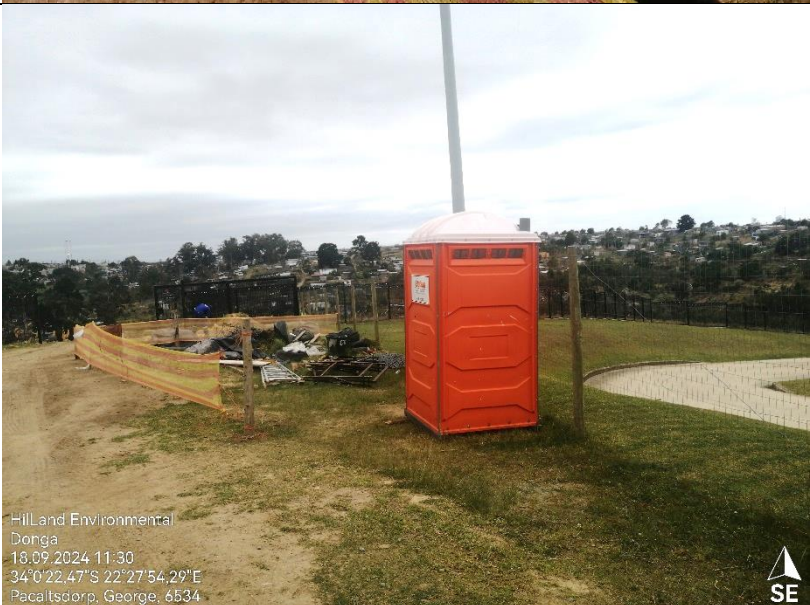
| | <p>HillLand Environmental<br/>Donga<br/>18.09.2024 11:30<br/>34°0'22.47"S 22°27'54.29"E<br/>Pacaltsdorp, George, 6534</p> <p>SE</p> | <p>Ablution facilities available in the site camp. Construction and safety signage is up.</p> |

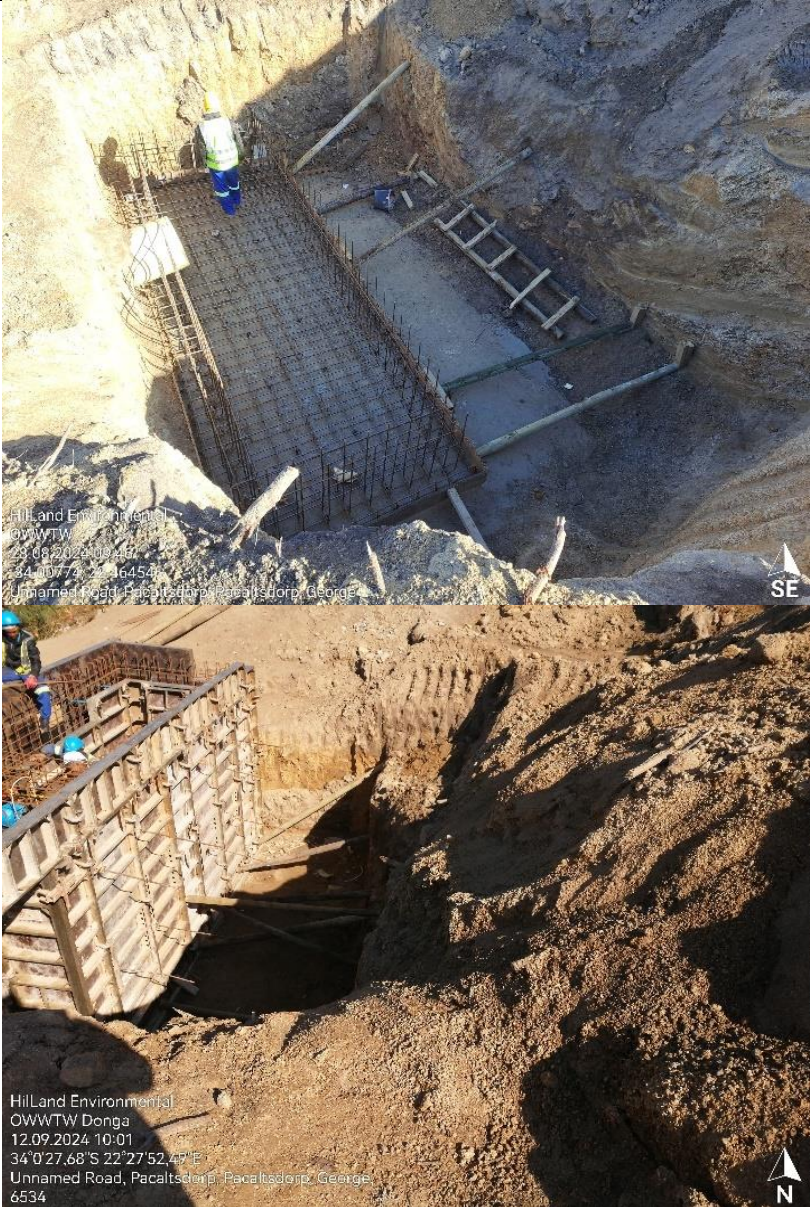
| <p>HillLand Environmental<br/>OWWTW Donga<br/>12.09.2024 10:01<br/>34°0'27.68"S 22°27'52.47"E<br/>Unnamed Road, Pacaltsdorp, Paarl, South Africa<br/>6534</p> <p>SE</p> <p>N</p> | <p>Construction of the outlet manhole.</p> |

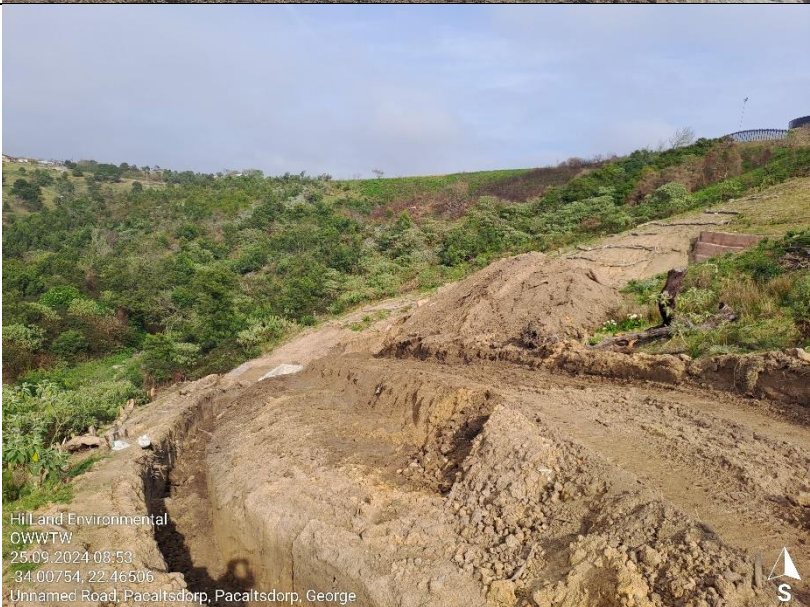
| | <p>Hill and Environmental<br/>OWWTW<br/>28.09.2024 08:53<br/>34.00754, 22.46506<br/>Unnamed Road, Pacaltsdorp, Pacaltsdorp, George</p> | | <p>Excavation of the pipeline. Excavator track on the right and pipeline excavation on the left. Material on the excavator track was re-used for backfilling.</p> |

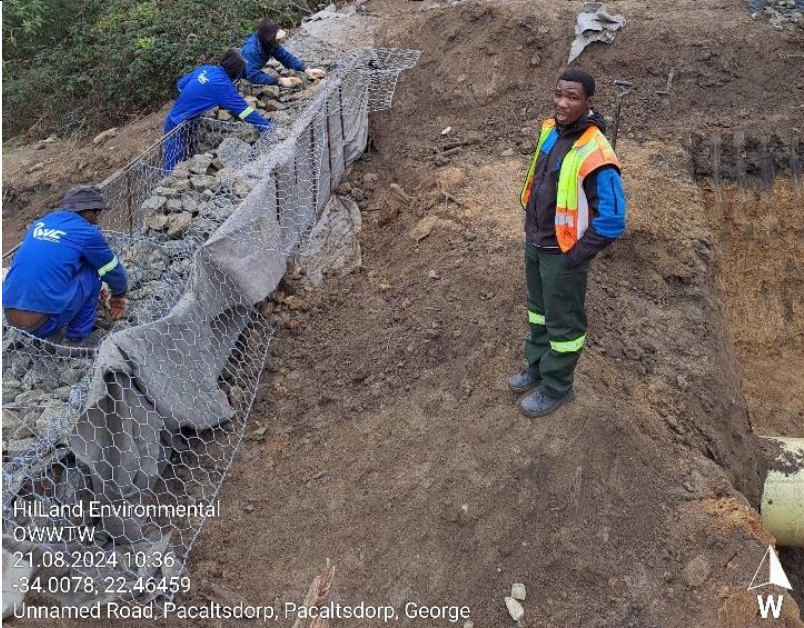
| <p>HillLand Environmental<br/>OWWTW<br/>21.08.2024 10:36<br/>-34.0078; 22.46459<br/>Unnamed Road, Pacaltsdorp, George</p> <p>W</p> | <p>Construction of the gabion retaining wall behind the stormwater headwall.</p> |

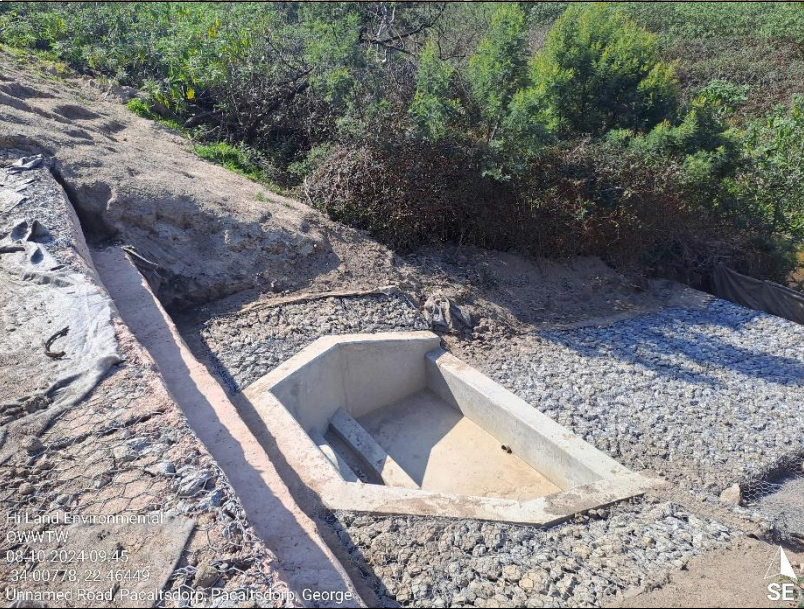
| <p>HillLand Environmental<br/>OWWTW<br/>08.10.2024 09:47<br/>-34.00778; 22.46279<br/>Unnamed Road, Pacaltsdorp, George</p> <p>SE</p> | <p>Energy dissipating headwall</p> |

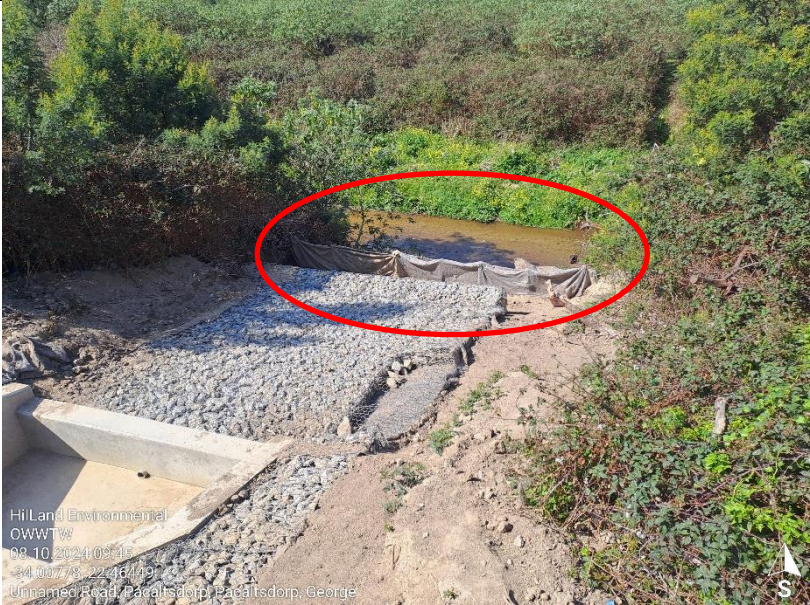
| | <p>Silt fence along the river is maintained.</p> |

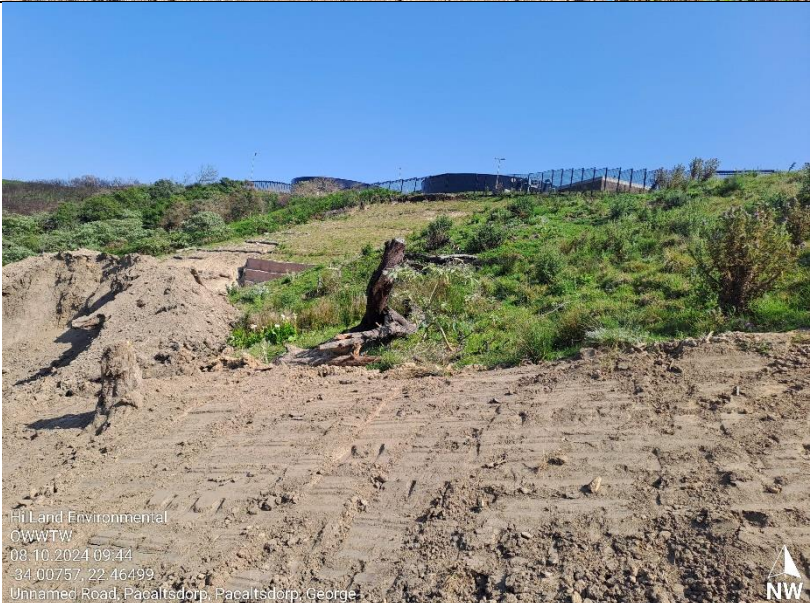
| | <p>Rehabilitation of top section shows no erosion</p> |

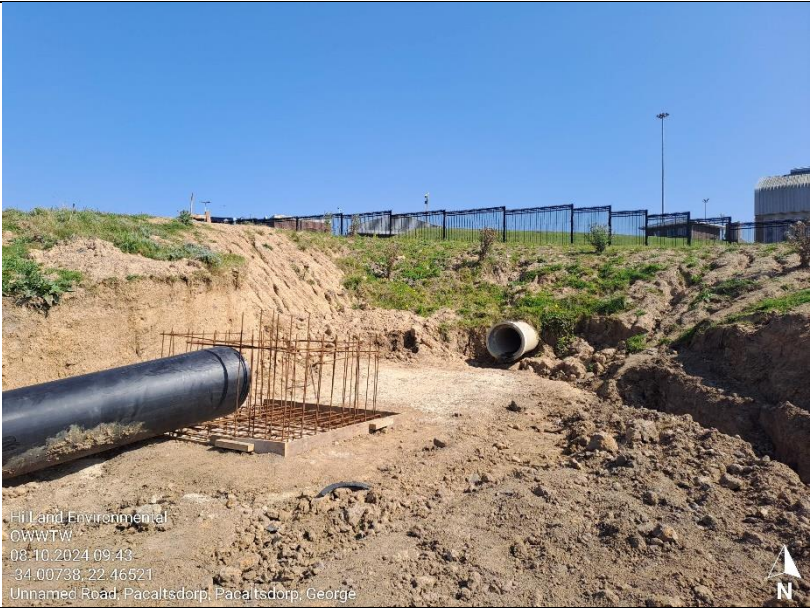
| <p>Hill and Environmental<br/>OWWTW<br/>08-10-2024 09:43<br/>34.00738; 22.46521<br/>Unnamed Road, Pacaltsdorp, Pacaltsdorp, George</p> | <p>Commencement of the replacement of the temporary stormwater infrastructure</p> |

The replacement of the temporary stormwater infrastructure commenced. The pipeline is installed and backfilled. Final tie ins to be completed.
