# FINAL ENVIRONMENTAL AUDIT REPORT

THE UNLAWFUL DEVELOPMENT OF STORMWATER  
INFRASTRUCTURE WITHIN 32M OF A WATERCOURSE,  
OUTENIQUA WASTEWATER TREATMENT WORKS ON  
THE REMAINDER OF ERF 325, GEORGE (MORIAH  
STREET)

**PREPARED FOR:** George Municipality**DATE:** 19 October 2026**SES REPORT NR:** EAR/OWWTW/GEOR/WC/06/26**DEADP REF NO:** 14/2/4/2/3/D2/20/0009/24**COPY TO:** Mr Danie Swanepoel – DEADP  
Admin – DEADP EIA Admin  
Armand Scheepers- GEORGE MUNICIPALITY  
Marilise van Wyk- Zutari  
Stefan Delpont- HillLand Environmental (ECO)

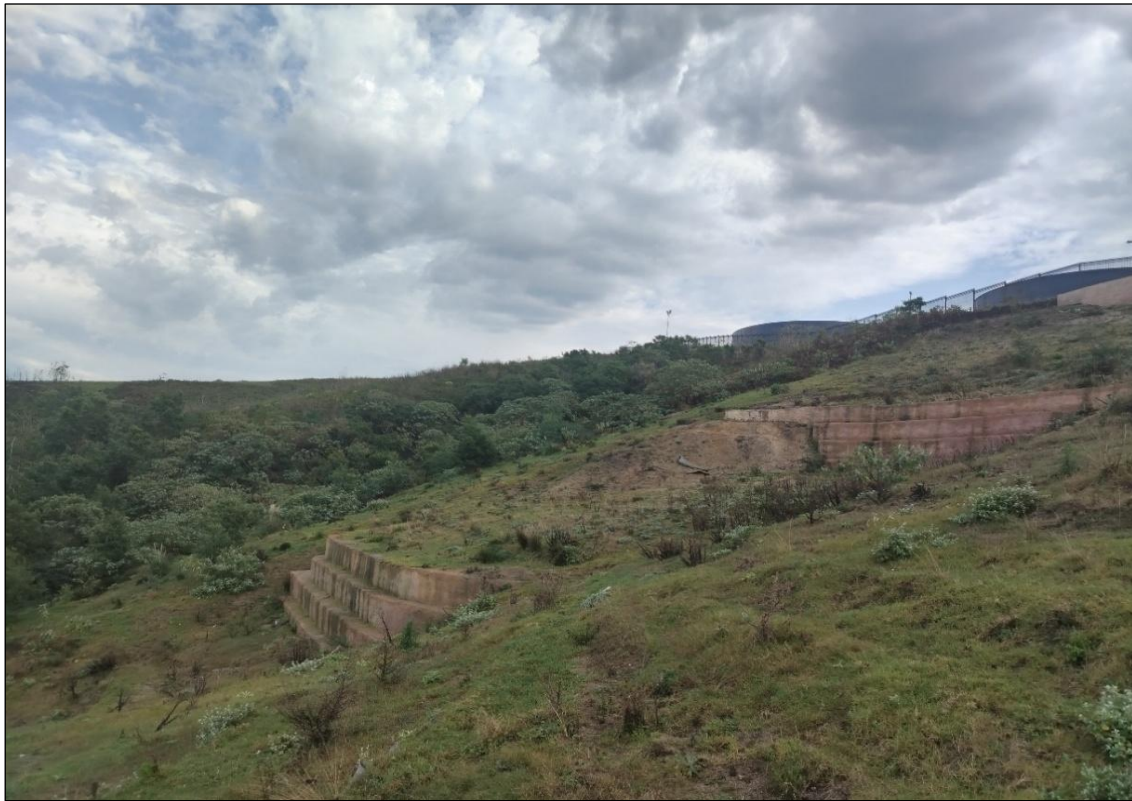
**Image 1: Left Side angle of Rehabilitation work.**

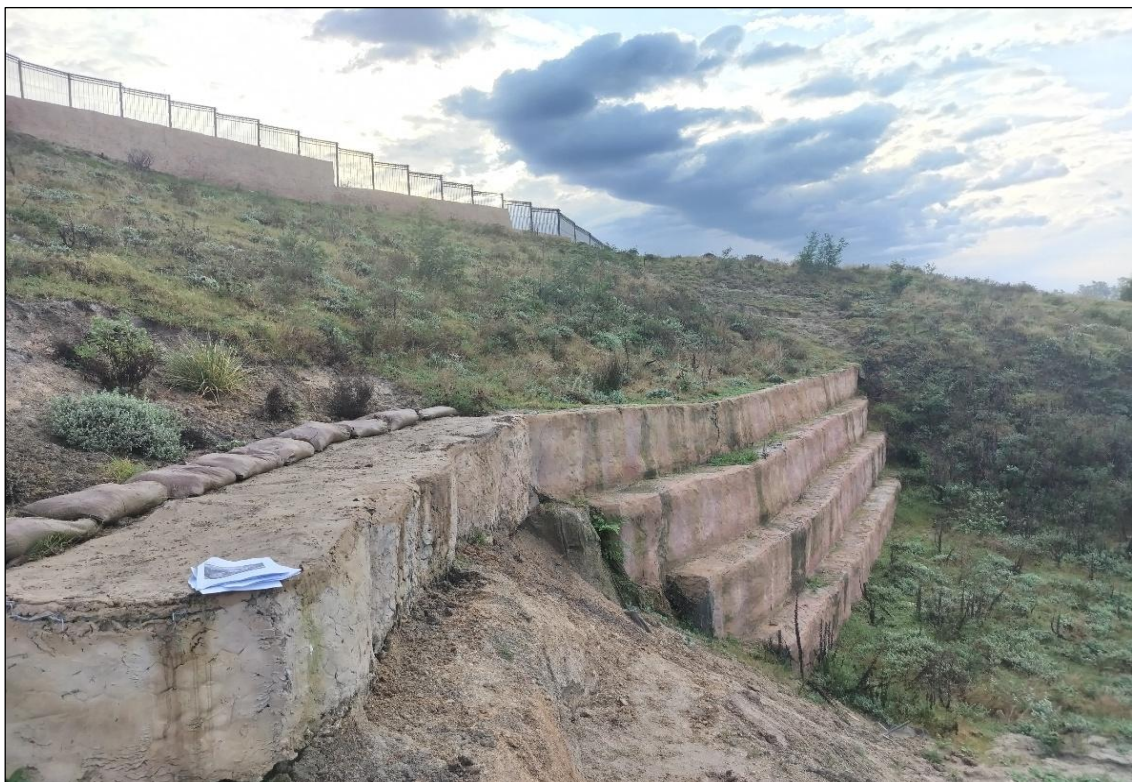
**Image 2: Right Side angle of Rehabilitation work.**

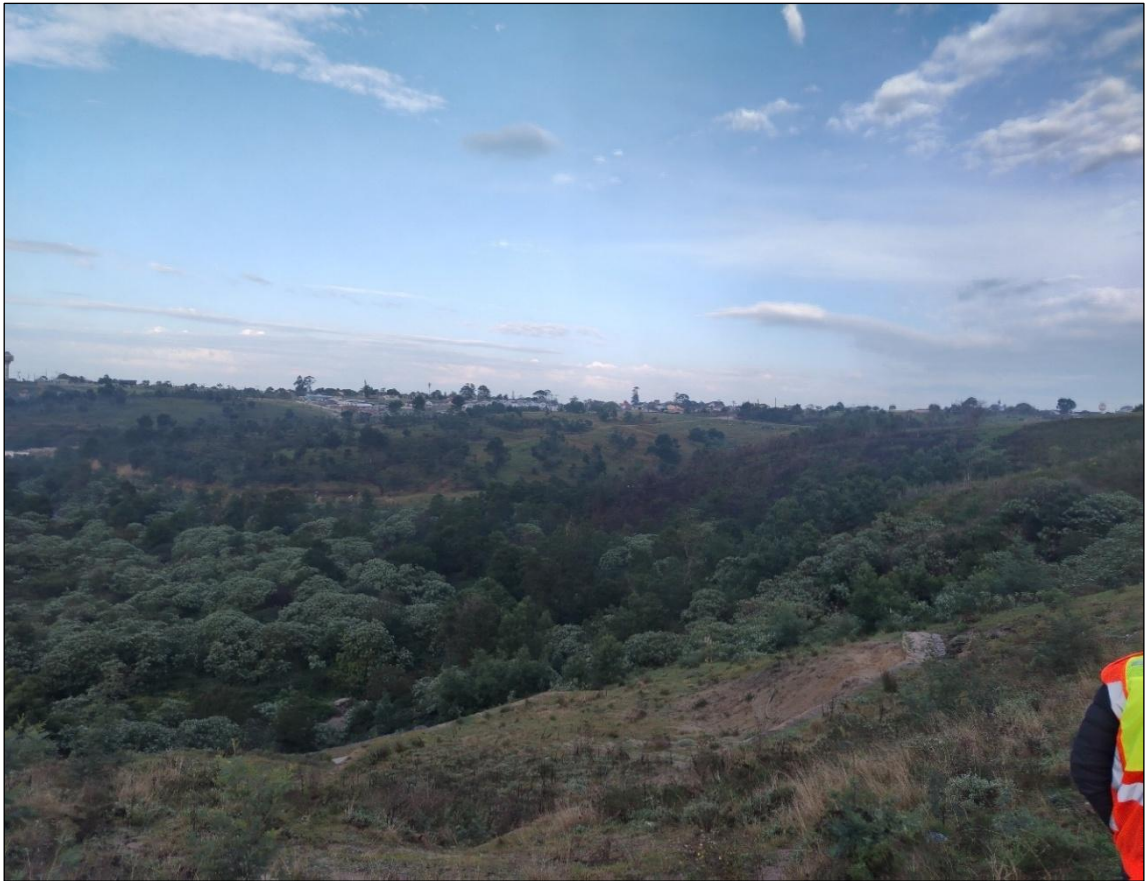
**Image 3: Top angle of Rehabilitation work.**

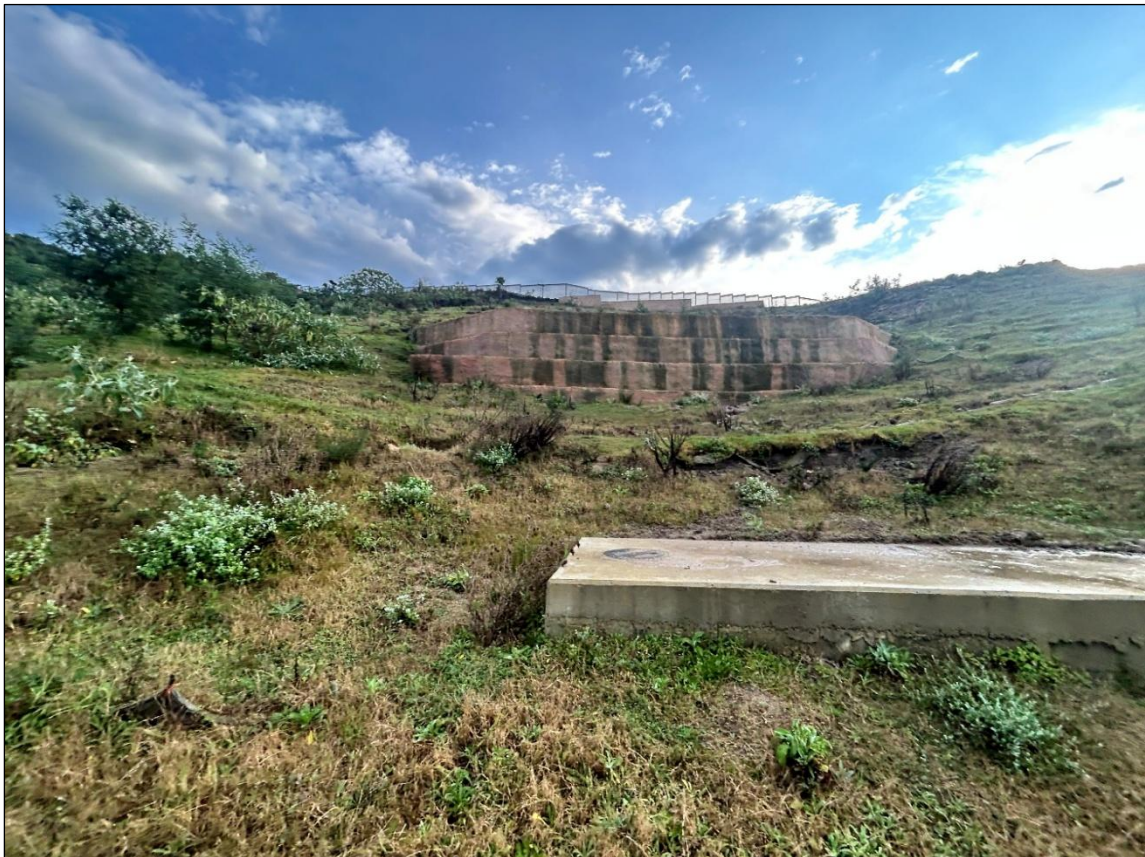
**Image 4: Bottom angle of Rehabilitation work.**

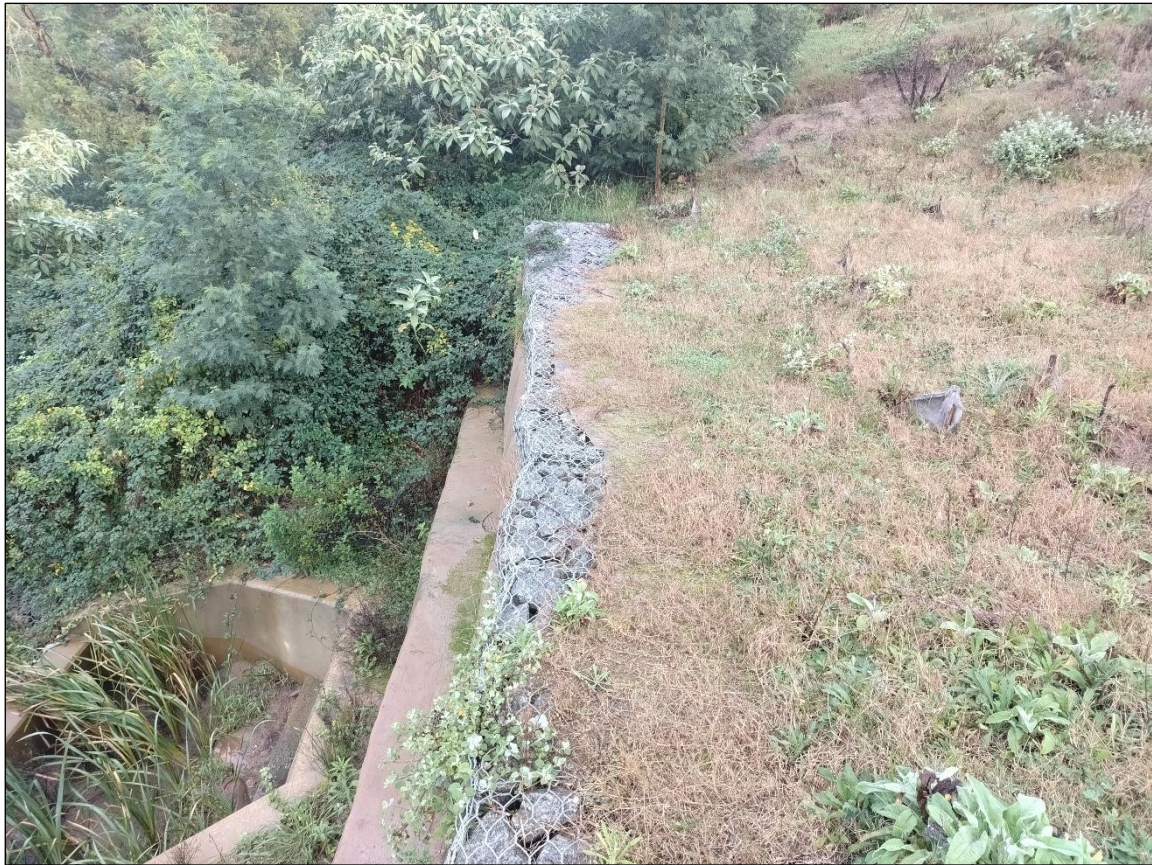
**Image 5: Energy dissipating headwall.**

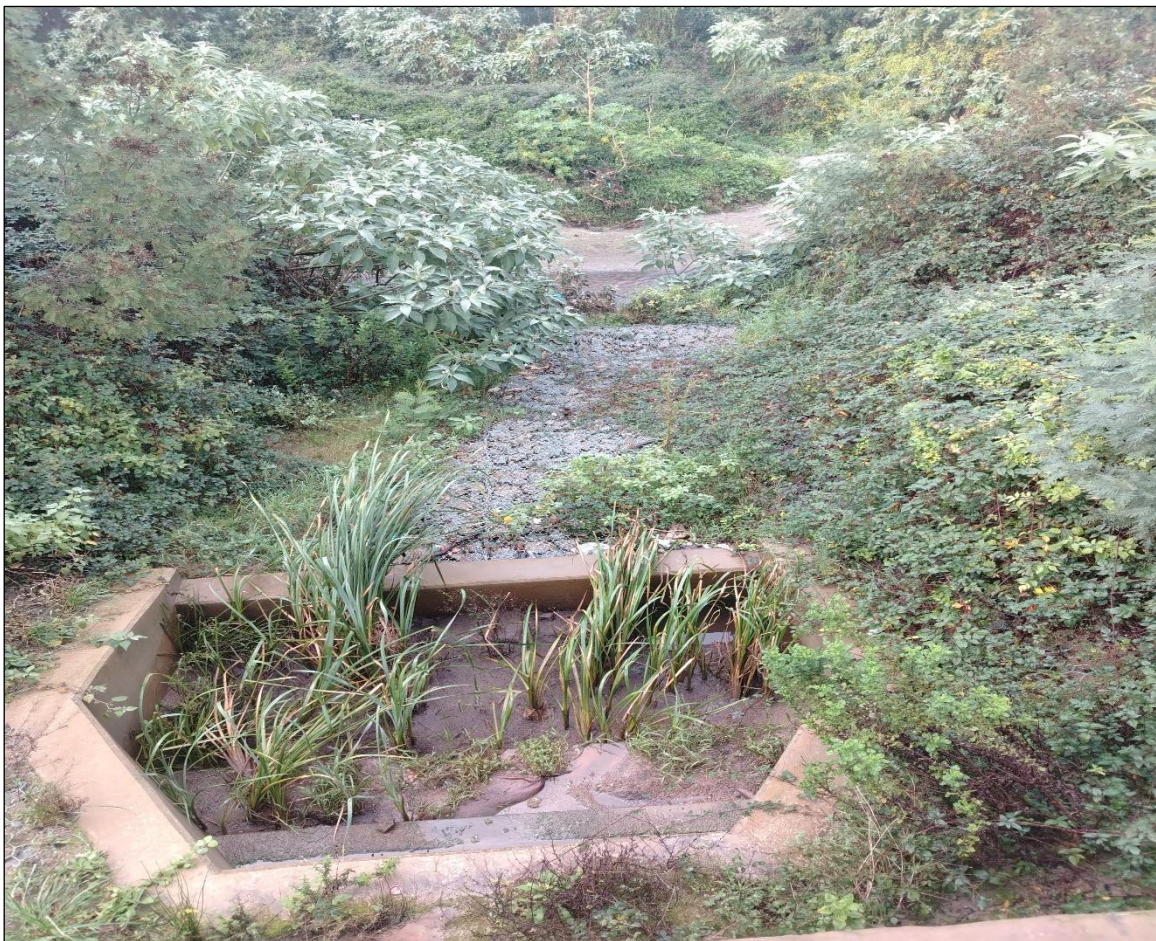
**Image 6: Retention pond.**

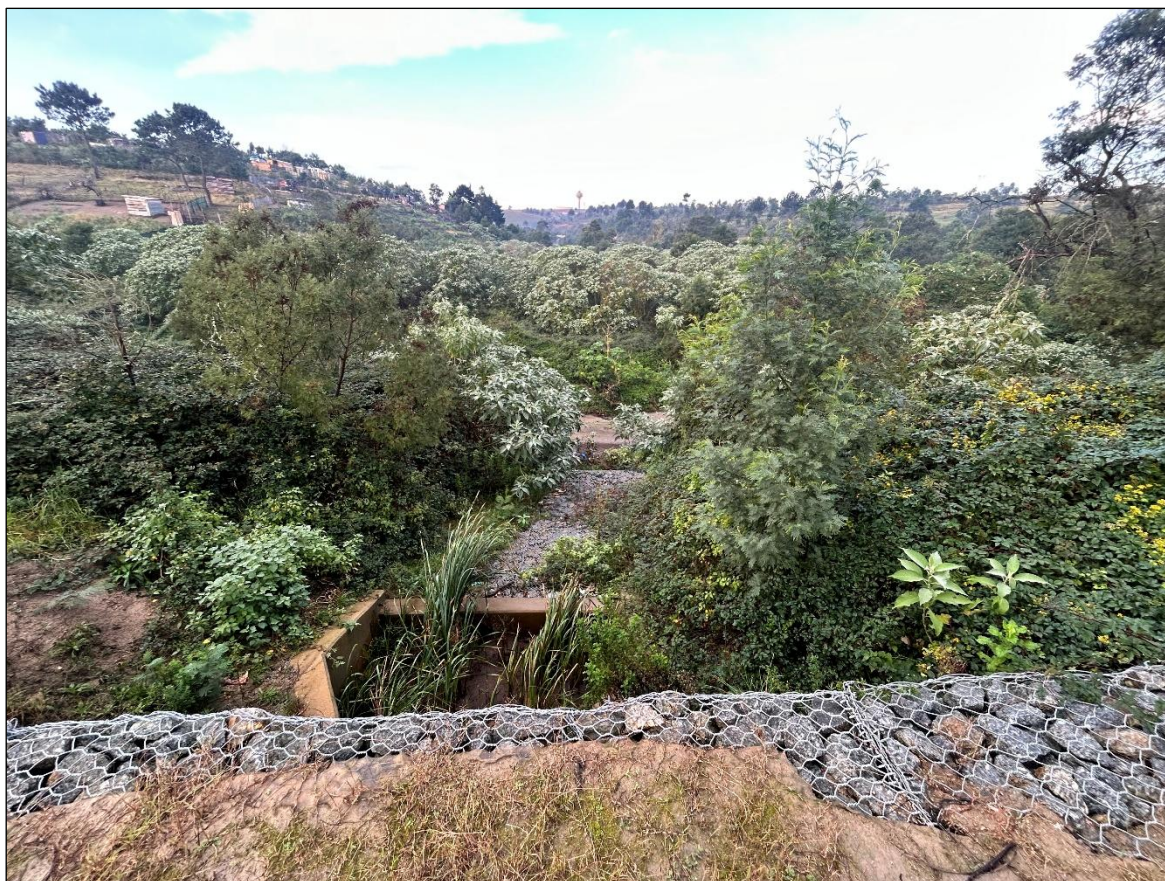
**Image 7: Downstream view of the retention pond and associated gabion protection work.**

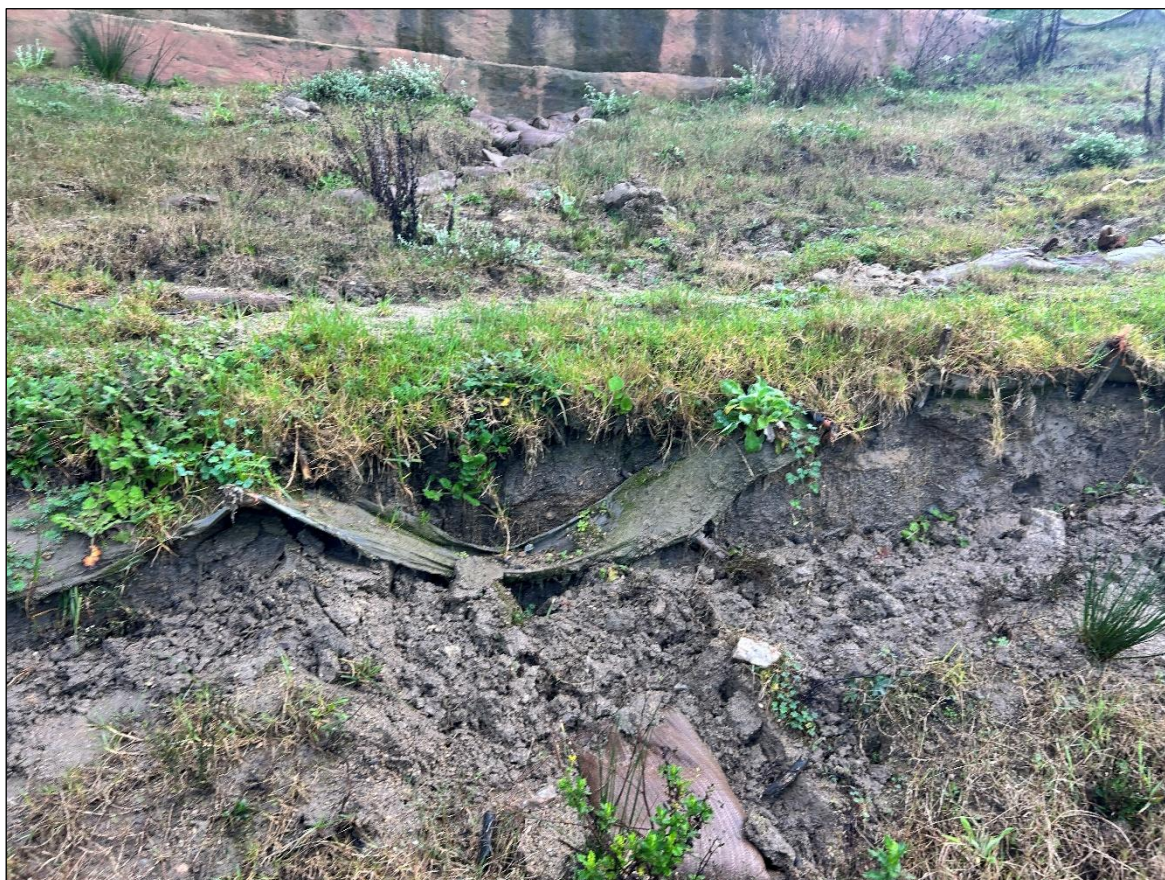
**Image 8: Condition of the embankment stabilization measures (Geotextile Liner).**

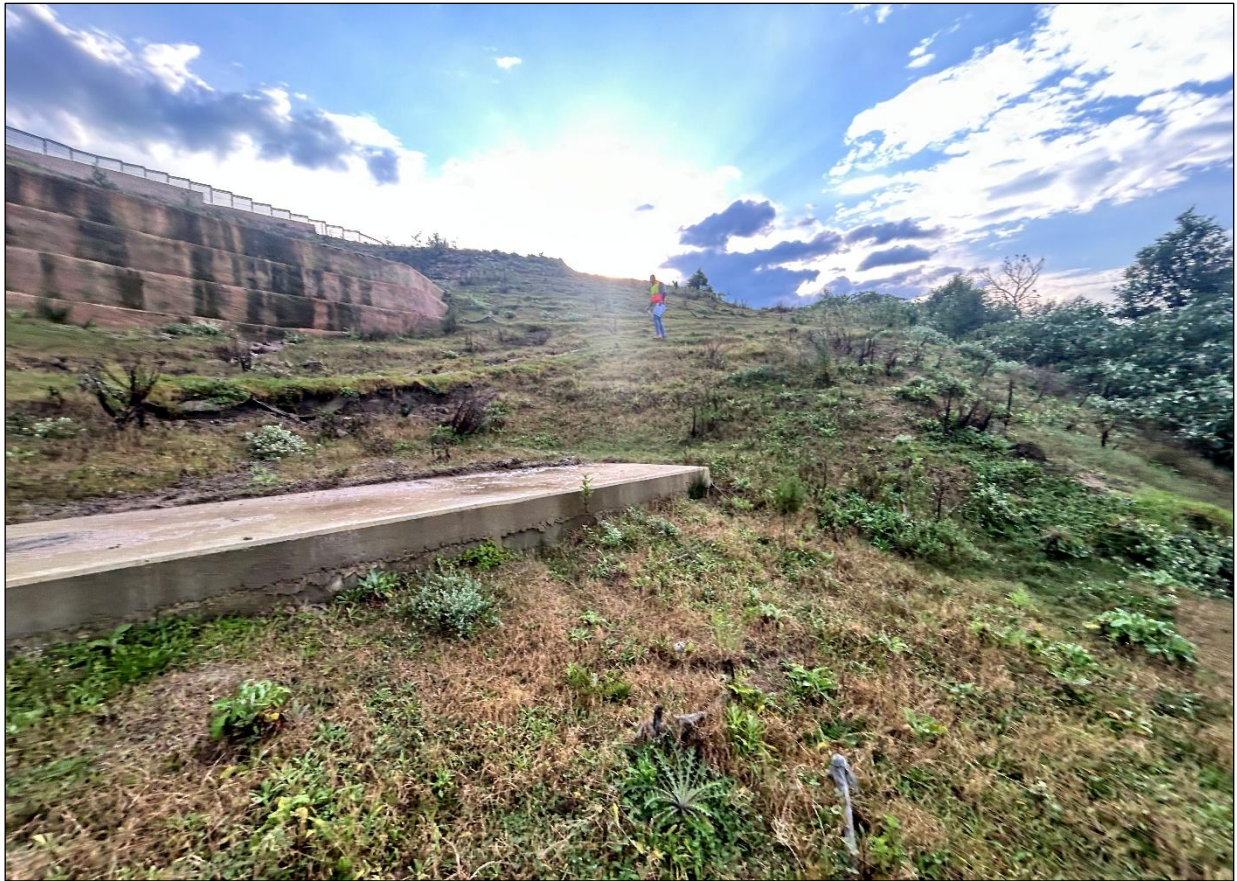
**Image 9: Wide view of the terraced slope Rehabilitation area.**

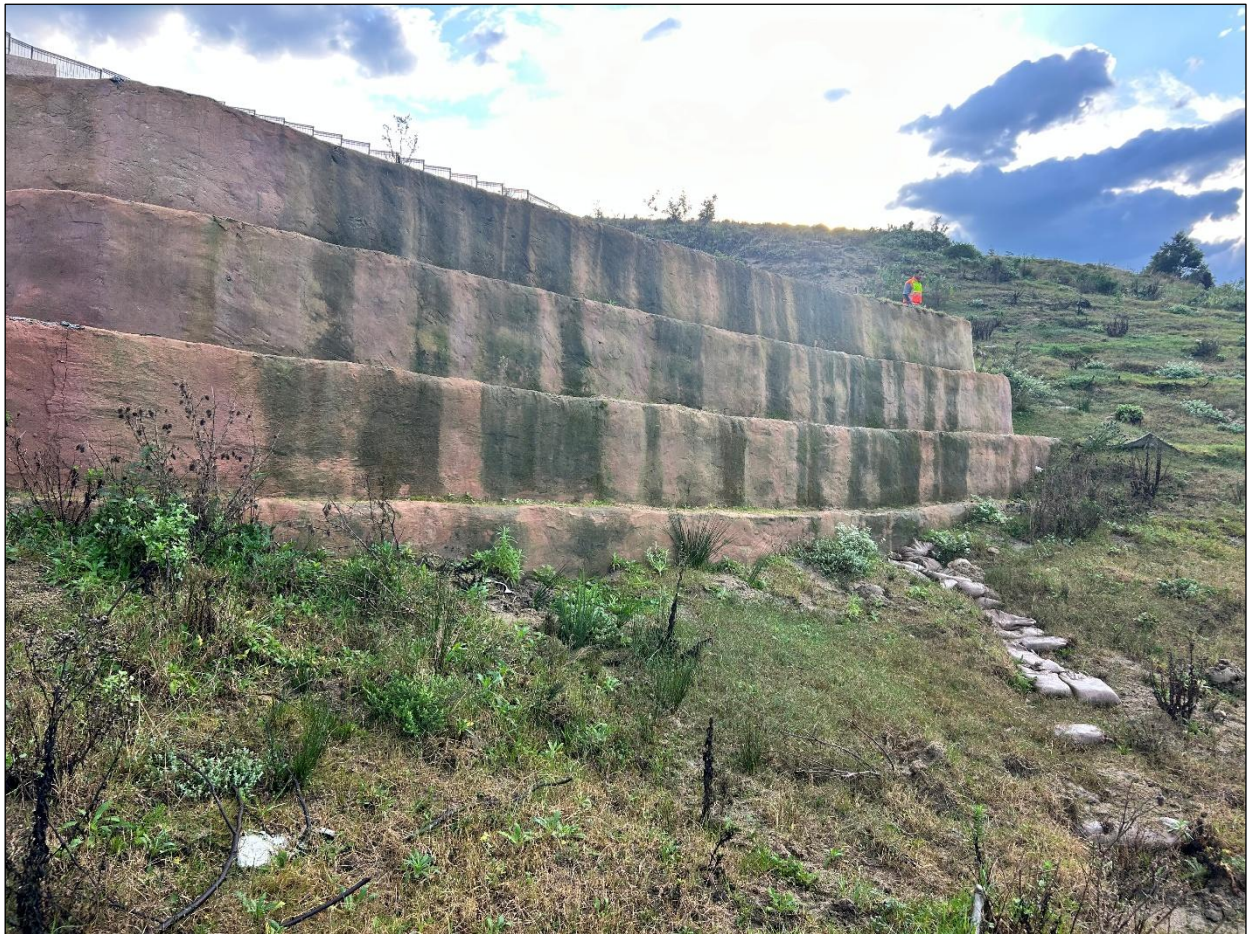
**Image 10: View of the stepped retaining wall.**

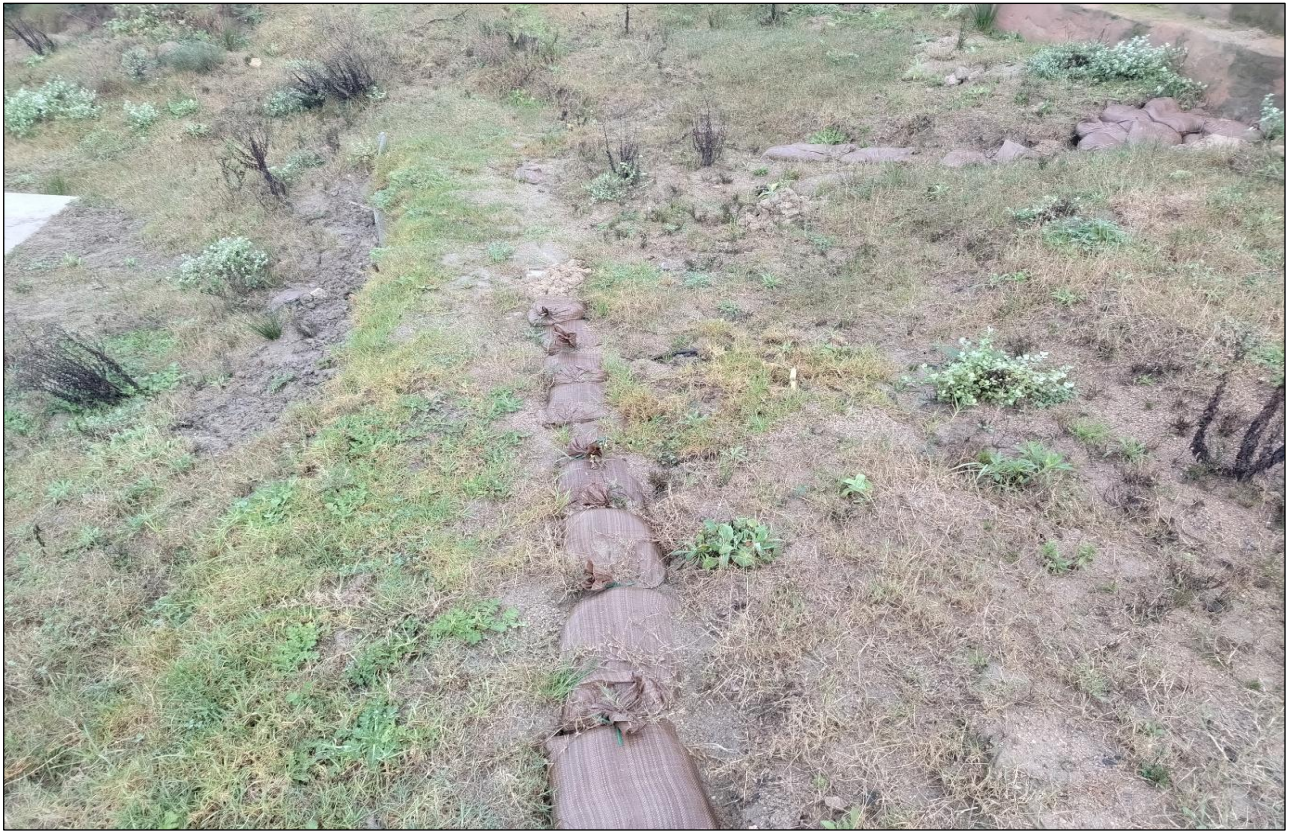
**Image 11: Erosion control measures(Geotextile sandbags) implemented on the slope footprint**

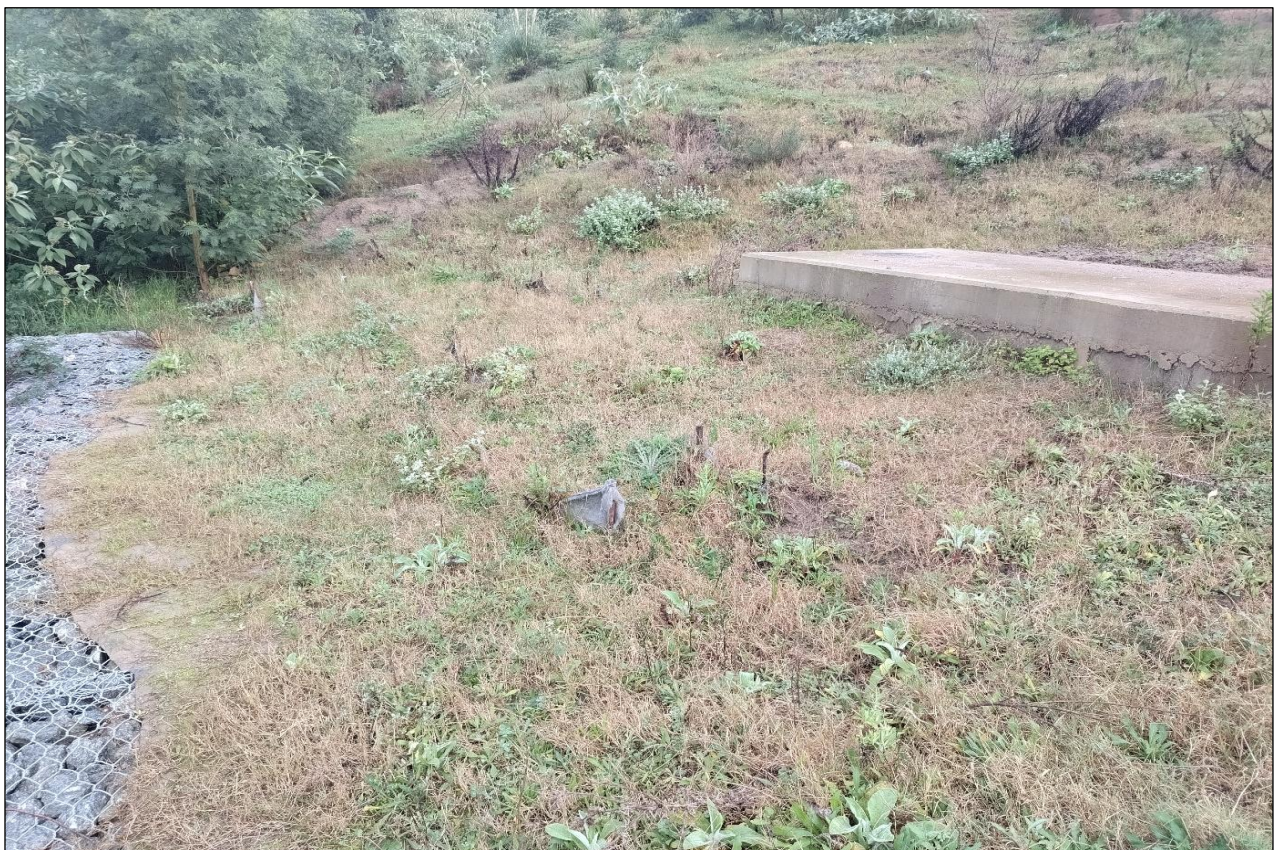
**Image 12: Photographic evidence of alien plant recruitment on the rehabilitated embankment.**

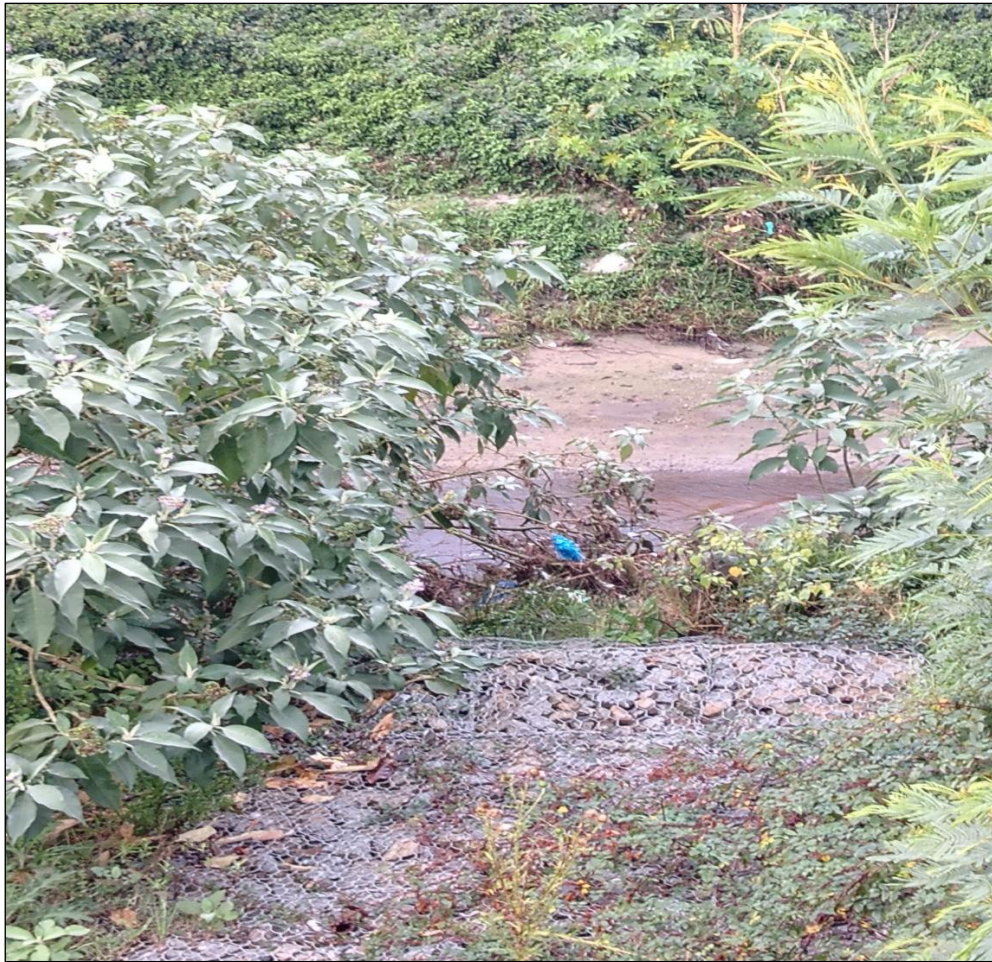
**Image 13: Close-up view of the gabion discharge point (Dense stands of mature *Solanum mauritianum* (Bugweed)).**
