*Geohydrological and geotechnical  
assessment for the proposed expansion of  
the Goue Akker Cemetery in Beaufort West.*

GEOSS Report No: 2020/03-29

*30 March 2020*

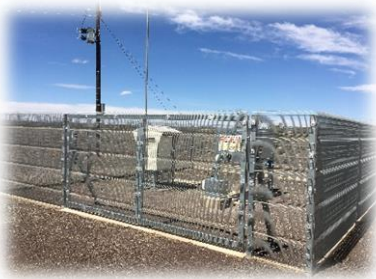
Site Label	Latitude (DD, WGS84)	Longitude (DD, WGS84)	Dec 2019 WL (mbgl)	Yield (L/s)	EC (mS/m)	TDS (mg/L)	pH	Comments	Photo
SR_10	-32.396904	22.566017	26.735	4.5	176	1124.5	7.31	Borehole working and in use.

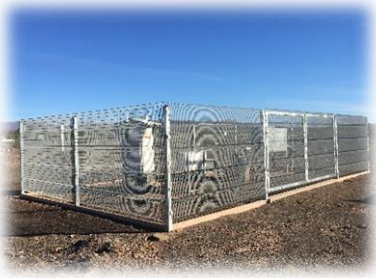
HK_NDA (Hoenderplaas)	-32.362841	22.597848	46.35	1.1	245.7	703	7.75	Borehole working and in use.

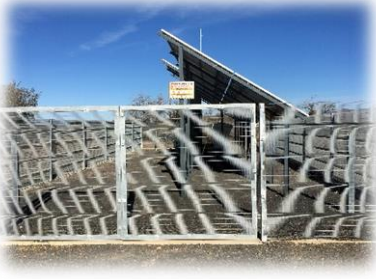
HR_18	-32.391491	22.605513	14.46	2	-	-	-	Borehole working and in use. Solar pump.

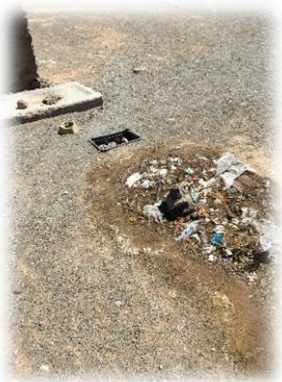
Site Label	Latitude (DD, WGS84)	Longitude (DD, WGS84)	Dec 2019 WL (mbgl)	Yield (L/s)	EC (mS/m)	TDS (mg/L)	pH	Comments	Photo
Nieuveld swembad	-32.372314	22.570565	-	-	-	-	-	Borehole buried. Not in use currently.

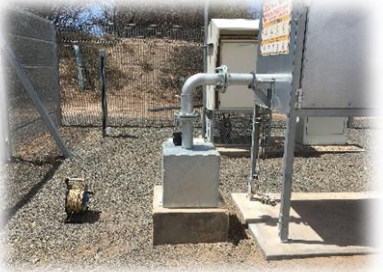
KH1	-32.3876	22.585417	-	-	-	-	-	Borehole not in use.	No photo possible
KH2	-32.388567	22.582383	-	-	-	-	-	Borehole not in use.	No photo possible
KH3	-32.395322	22.572818	28.515	5.3	200.7	1326	7.4	Borehole working and in use.

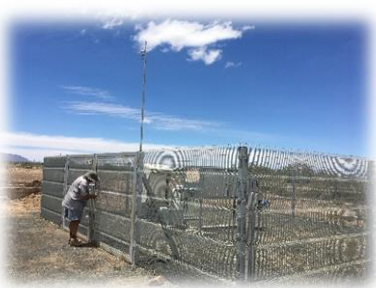
Site Label	Latitude (DD, WGS84)	Longitude (DD, WGS84)	Dec 2019 WL (mbgl)	Yield (L/s)	EC (mS/m)	TDS (mg/L)	pH	Comments	Photo
KH5	-32.387615	22.585355	14.035	5.1	303.9	1969.6	7.18	Borehole working and in use.

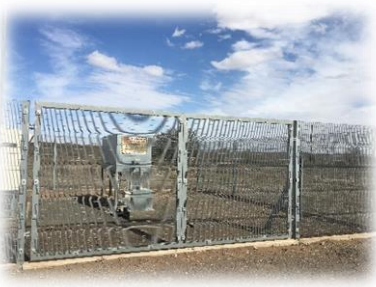
Flagship	-32.37455	22.591727	37.905	2.9	284.4	1846	7.31	Borehole working and in use.

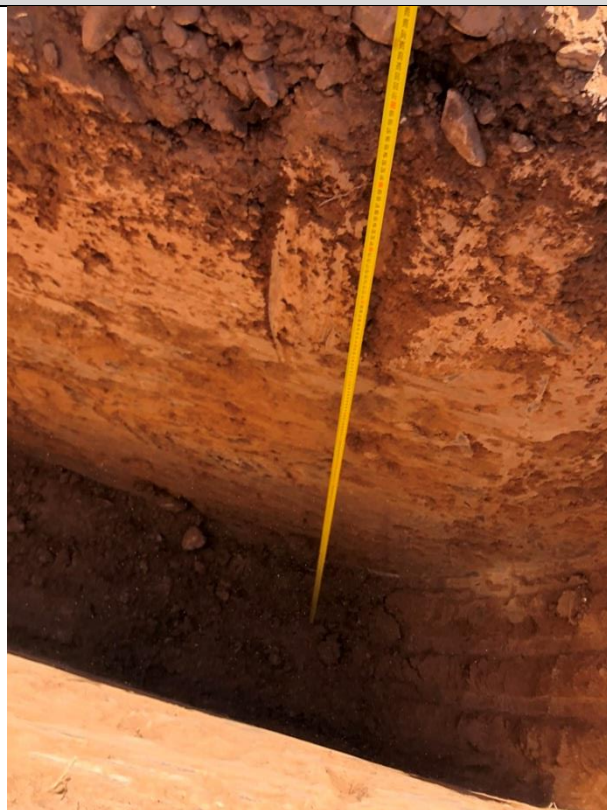
*TP\_9*

Log of Trial Pit No.:		TP09	
<b>Location:</b>	Beaufort West Cemetary	<b>Latitude:</b>	-32.38077228
<b>Date:</b>	11-Mar-20	<b>Longitude:</b>	22.58900383
<b>Client:</b>	Sharples Environmental Services	<b>Ground Elevation:</b>	830
Lithological Description	Lithology (mbgl)	Construction	Comments
<b>Unit 1:</b> 0.00 - 0.20  Very slightly moist, pale brown, clast supported, very dense, coarse GRAVEL with sandy silty matrix. Transported, alluvial-lacustrine.			TLB Refusal on boulders
<b>Unit 2:</b> 0.20 - 1.90  Very slightly moist, orangish pale brown, very dense, weakly cemented, pinholed, clayey sandy SILT with some pebbles. Transported, alluvial-lacustrine.			
<b>Unit 3:</b> 1.90 to 2.25  Very slightly moist, light brown, very dense, matrix supported, cobbles and BOULDERS with sandy silty matrix. Transported, alluvium			
			End of Hole = 2.25 mbgl
<b>Excavated By:</b> GEOSS <b>Drill Method:</b> TLB Excavator <b>Logged By:</b> CM/ MB	<b>Remarks:</b> No groundwater

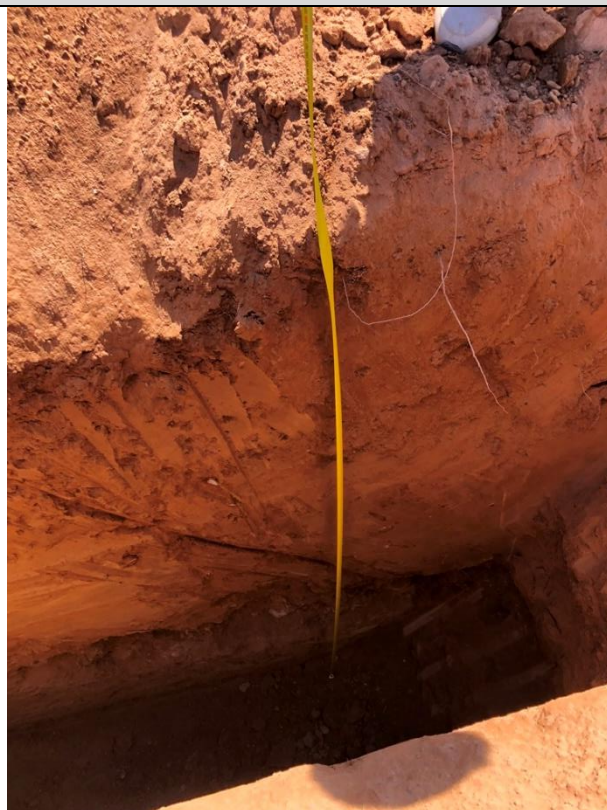
*TP\_10*

Log of Trial Pit No.:		TP10	
<b>Location:</b>	Beaufort West Cemetary	<b>Latitude:</b>	-32.38077228
<b>Date:</b>	11-Mar-20	<b>Longitude:</b>	22.58900383
<b>Client:</b>	Sharples Environmental Services	<b>Ground Elevation:</b>	830
Lithological Description	Lithology (mbgl)	Construction	Comments
<b>Unit 1:</b> 0.00 - 1.60 Very slightly moist, orangish pale brown, very dense, weakly cemented, pinholed, clayey sandy SILT with some pebbles. Transported, alluvial-lacustrine.			TLB Refusal on boulders
<b>Unit 2:</b> 1.60 - 2.10 Very slightly moist, light brown, very dense, matrix supported, cobbles and BOULDERS with sandy silty matrix. Transported, alluvium		End of Hole = 2.10 mbgl	
<b>Excavated By:</b> GEOSS <b>Drill Method:</b> TLB Excavator <b>Logged By:</b> CM/ MB	<b>Remarks:</b> No groundwater
