*Groundwater impact assessment for a
proposed development near Herolds Bay,
Western Cape.*

GEOSS Report No: 2020/07-14

22 July 2020

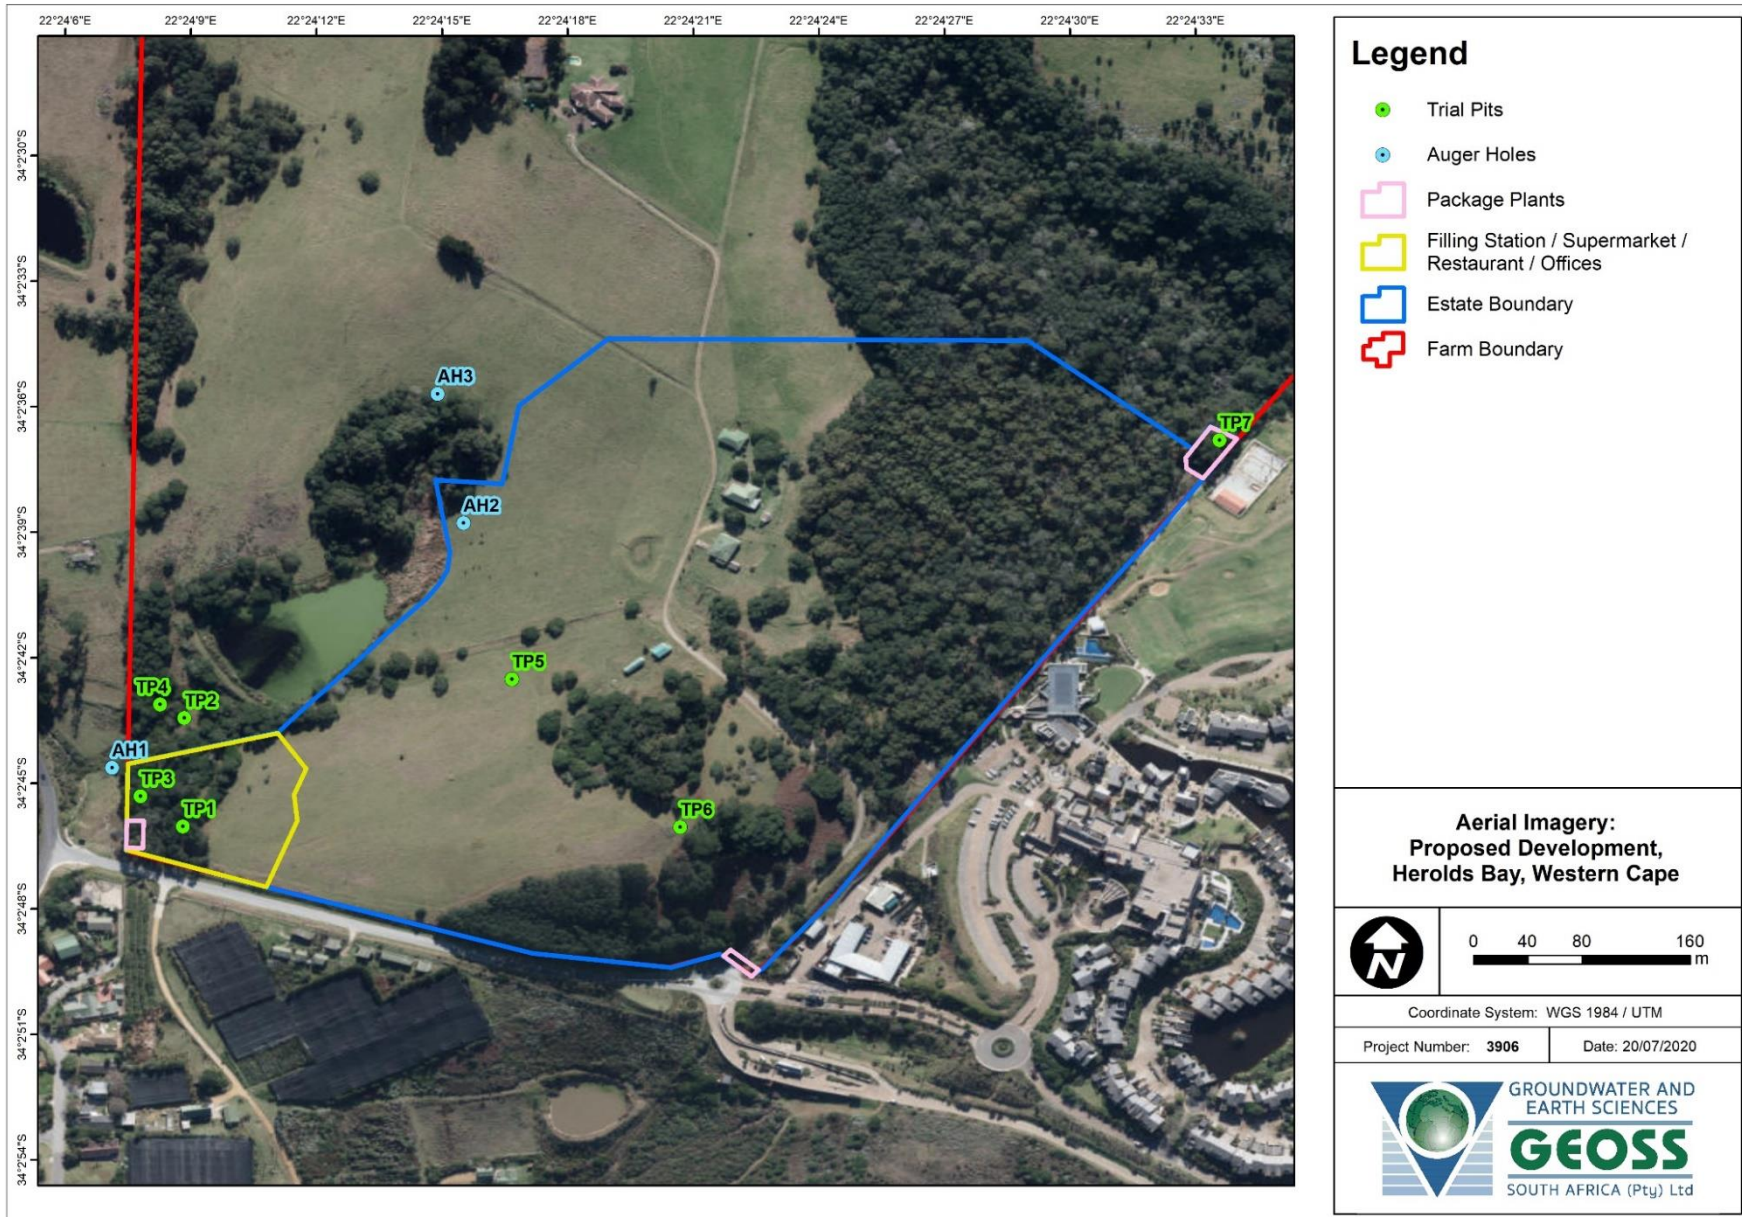
Map 7: Aerial map showing trial pit and piezometer locations.

The site visit involved the installation of a piezometer into an auger holes. The holes were excavated using a hand auger to a maximum depth of 3.3 m or until refusal (which ever comes first). One piezometer was installed at AH1 where the soil had the highest degree of moisture. The details of this piezometer are presented in **Table 4**. As no groundwater was intersected in any of the remaining two auger holes and seven trial pits, no further piezometers were installed. The location of the installed piezometer and trial pits are shown in **Map 7**

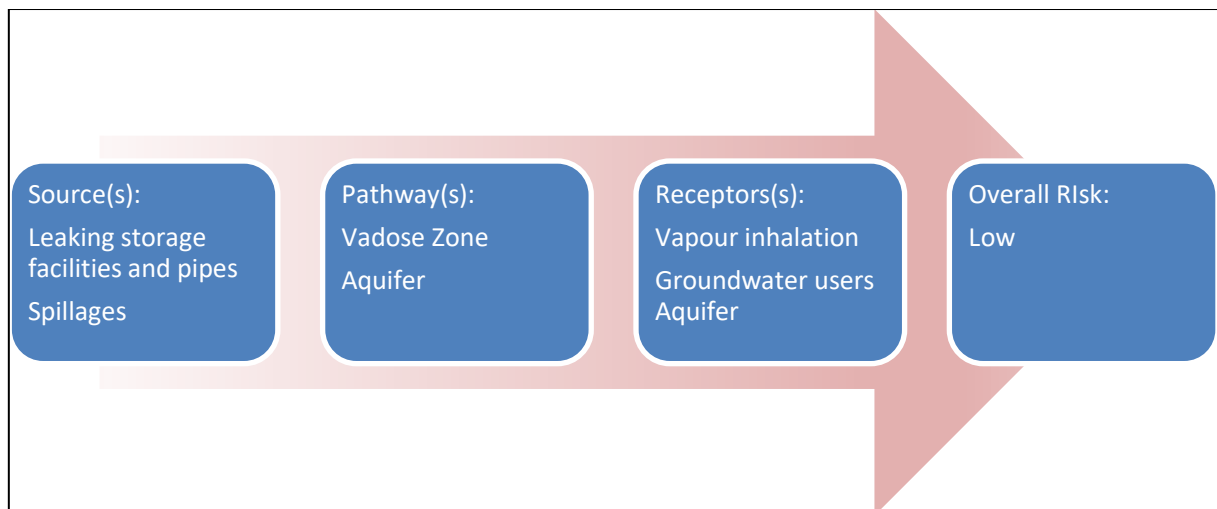
Figure 4: Source, Pathway and Receptor assessment.

For a risk to exist there must be a source (s), pathway(s) and receptor(s), these are presented in **Figure 4**. All three are present in this case. The proposed filling station, accompanying infrastructure and on-site activities, irrigation with treated effluent represent potential sources of contamination. The underlying aquifer and drainage channels represents both a potential pathway and receptor. The surrounding environment represent receptors of potential contamination.

Given the vulnerability of the aquifer and clay rich soil, the risk assigned to potential impacts of contamination is considered to be **low**. However, good practise dictate that no activities should be allowed that are likely to result in contaminants to enter into the subsurface. Mitigation is necessary to prevent any potential contamination. Regular groundwater monitoring is recommended to detect potential contamination proximal to the filling station and inspection of the integrity of package plants and sampling of treated water.

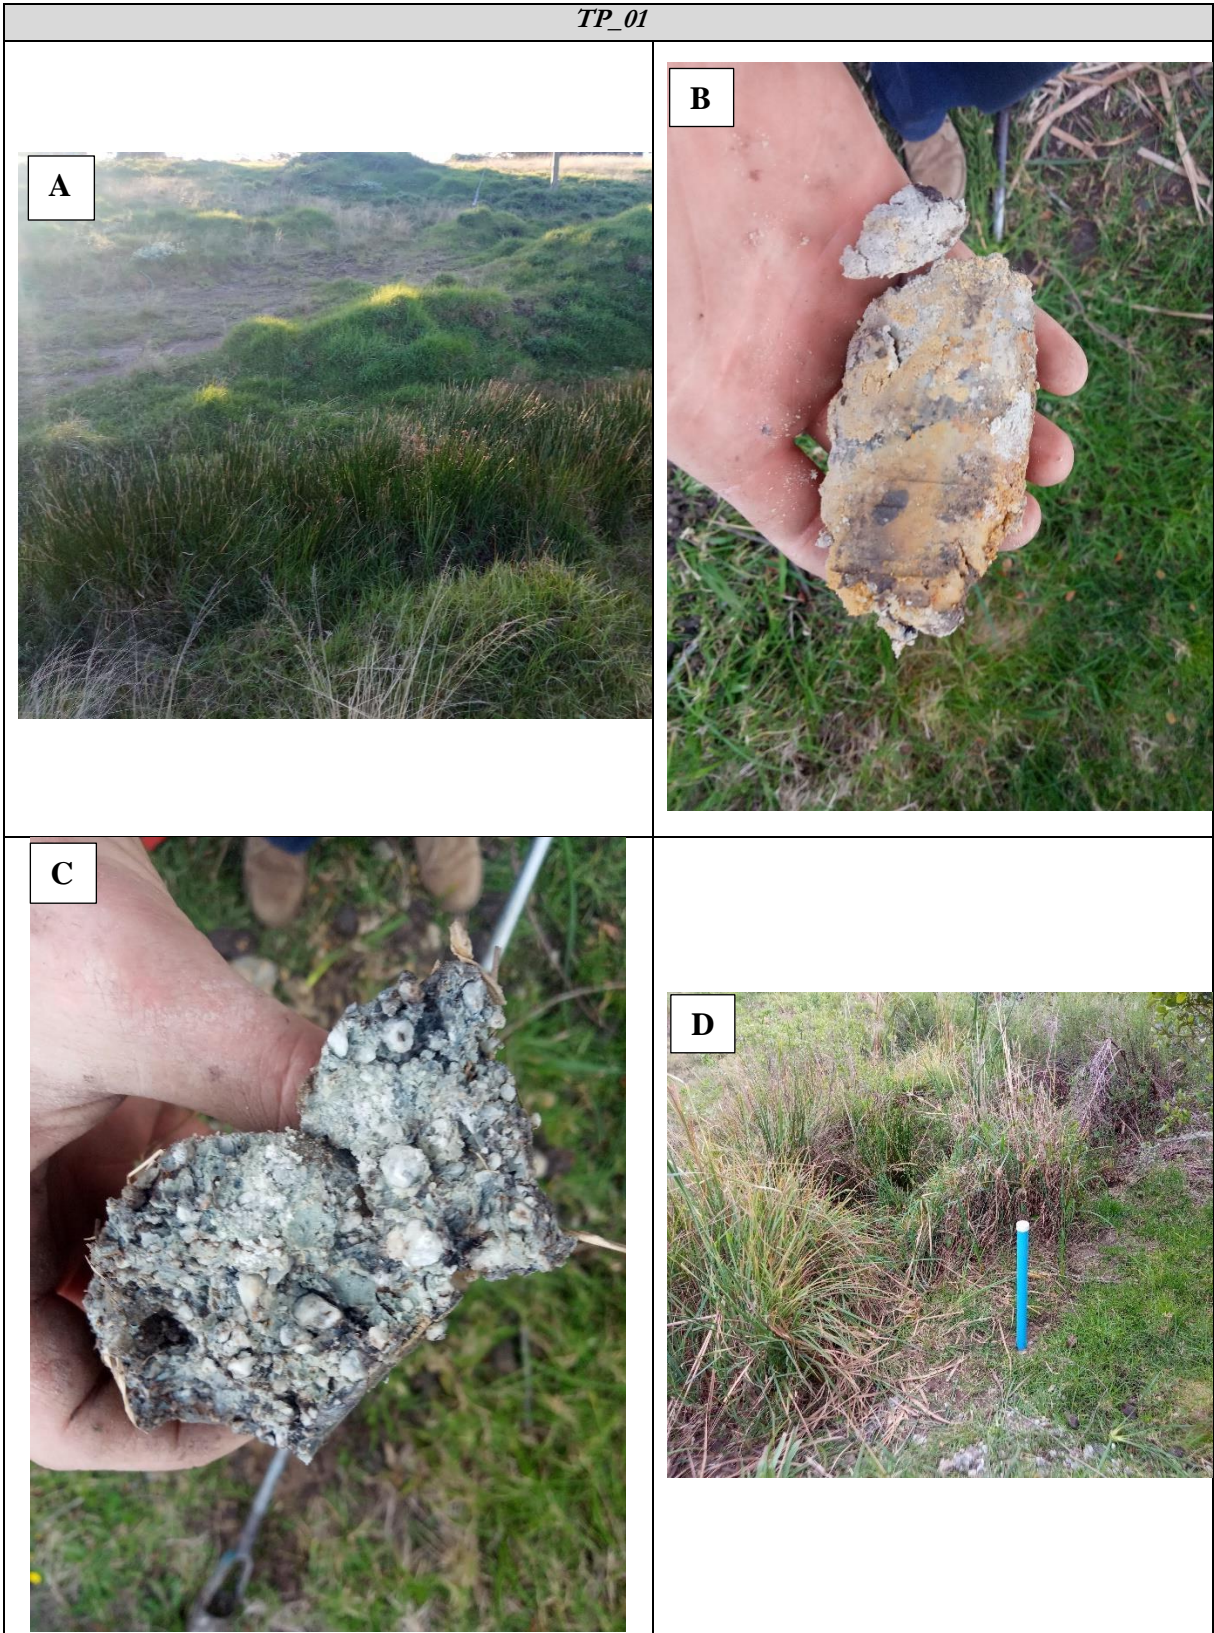
TP_01

Figure 6: A shows the thick vegetation where surface water concentrates. AH1 was positioned in the foreground of this photo in an attempt to intersect groundwater.
B shows the grey-red-brown weathered clay found across the site, typical of the weathered granite.
C shows angular quartz crystals and micaceous minerals just before hole refusal when going from weathered zone to less weathered granites.
D shows piezometer installation – no groundwater was measurable here even though soil had greatest moisture content for the site.

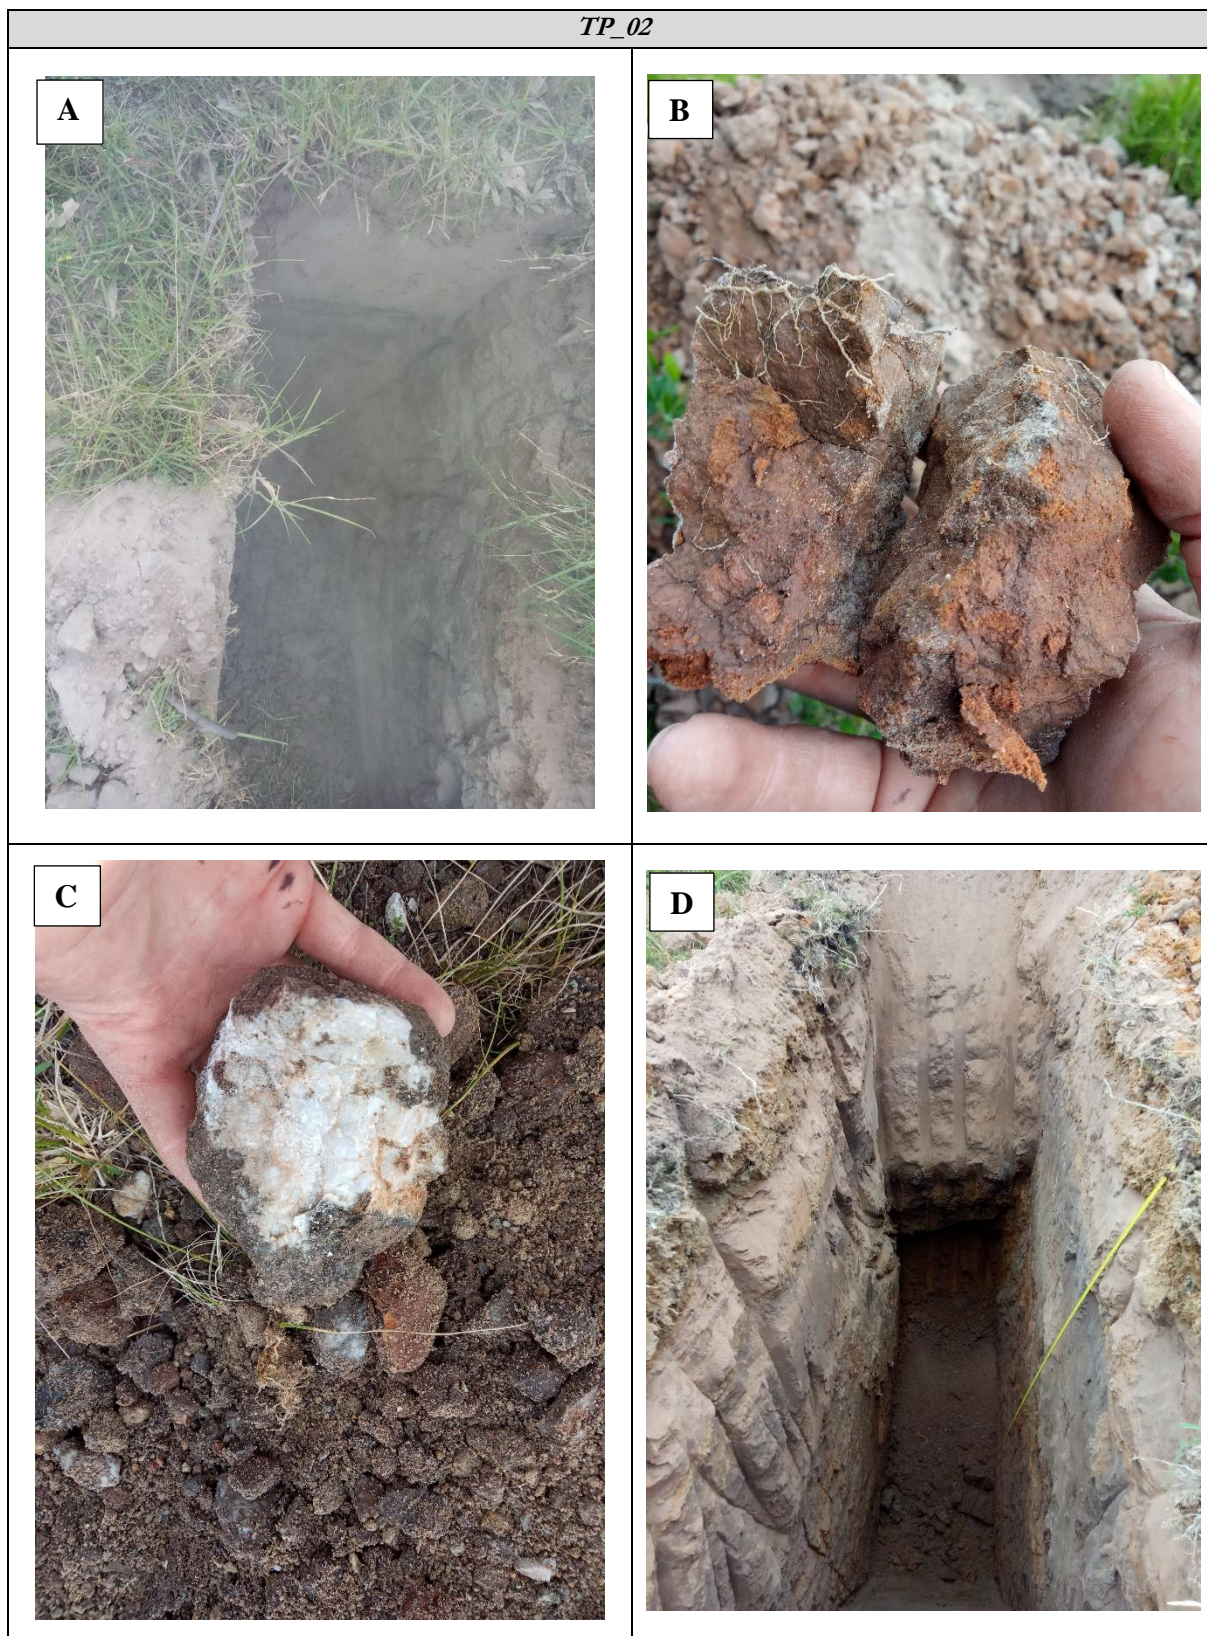
*Figure 7: A shows excavation of TP1.
B shows dry, red, firm, sandy CLAY from TP1.
C presents a large quartz crystal just before refusal of shows final trial pit depth.
D shows Trial Pit 3 (TP3) with final depth of 2.8 m.*

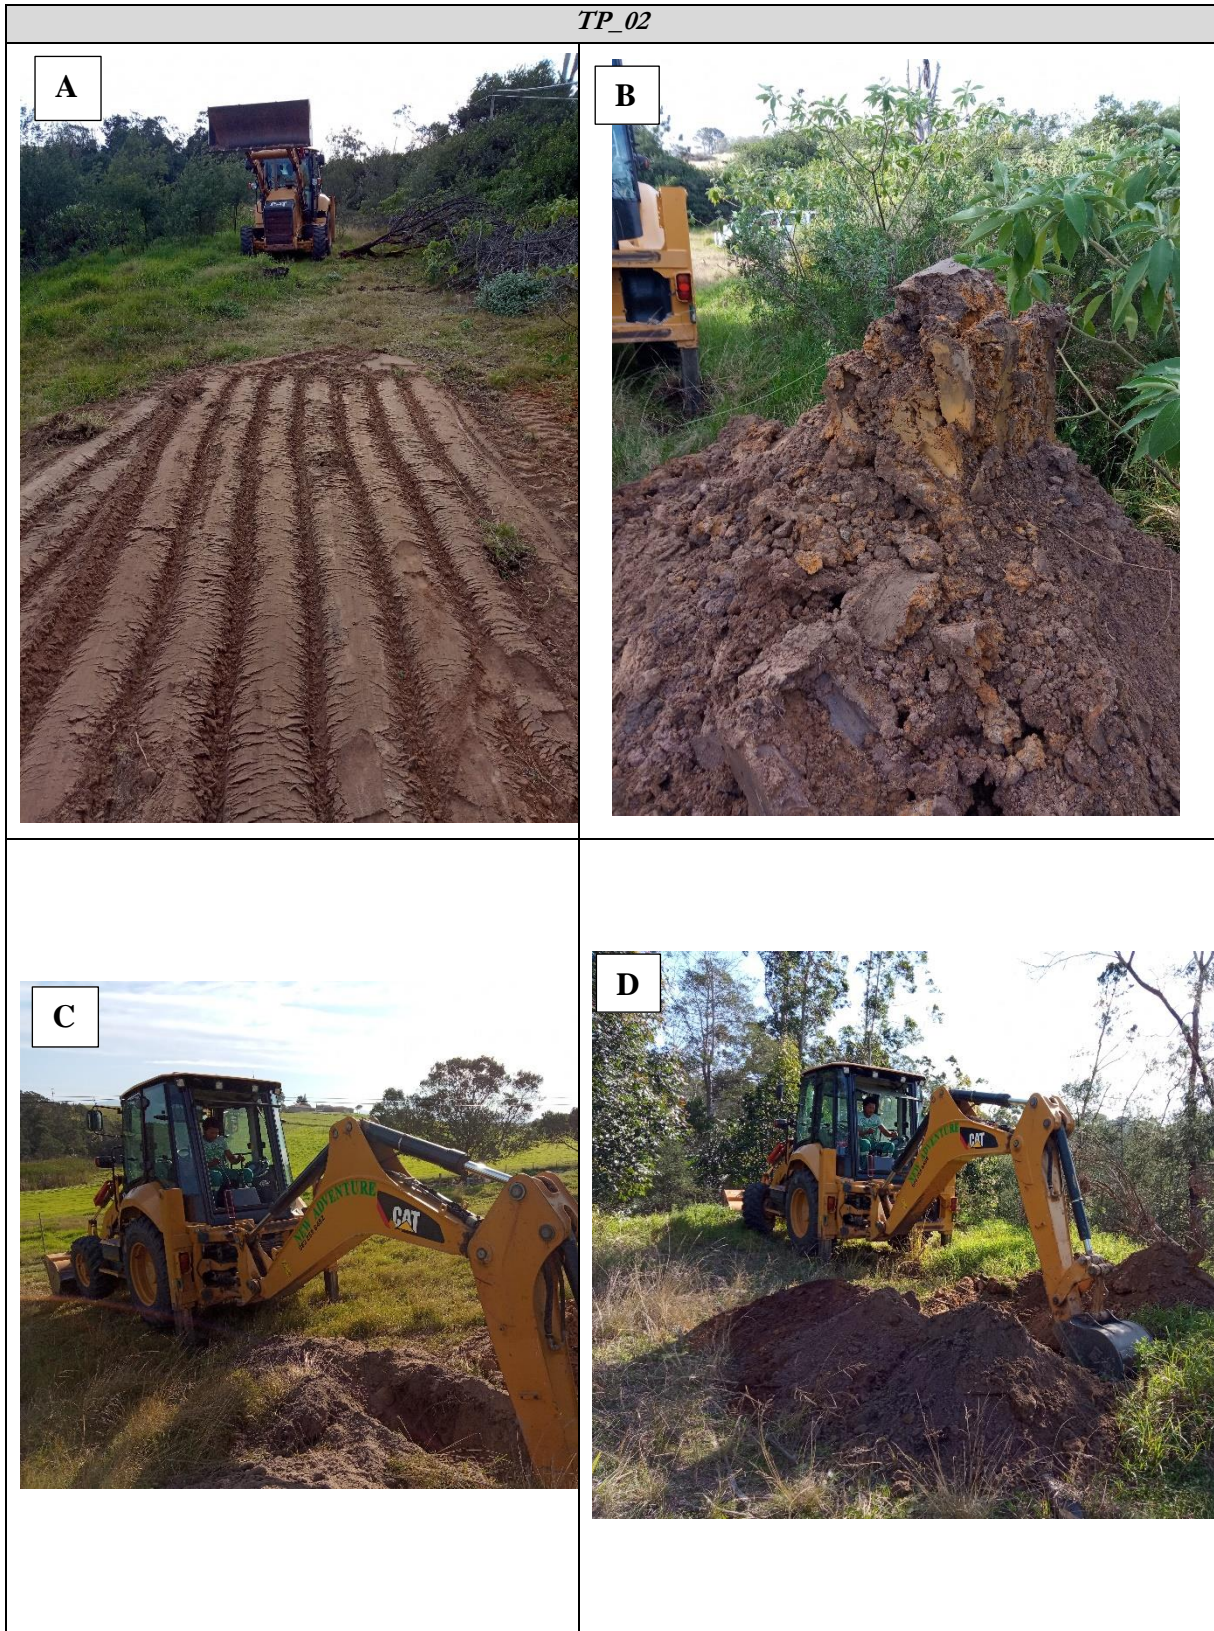
Figure 8: A shows TP3 backfilled and levelled, no sign of collapsing soils, B shows mounding of the stiff clay in TP4, keeping the shape of the TLB bucket, C shows the excavation of TP5 and D shows excavation of TP7 where a package plant is to be constructed.
