APPENDIX C: PHOTOGRAPHS

EXTERIOR OF SITE AND EXISTING WAREHOUSE

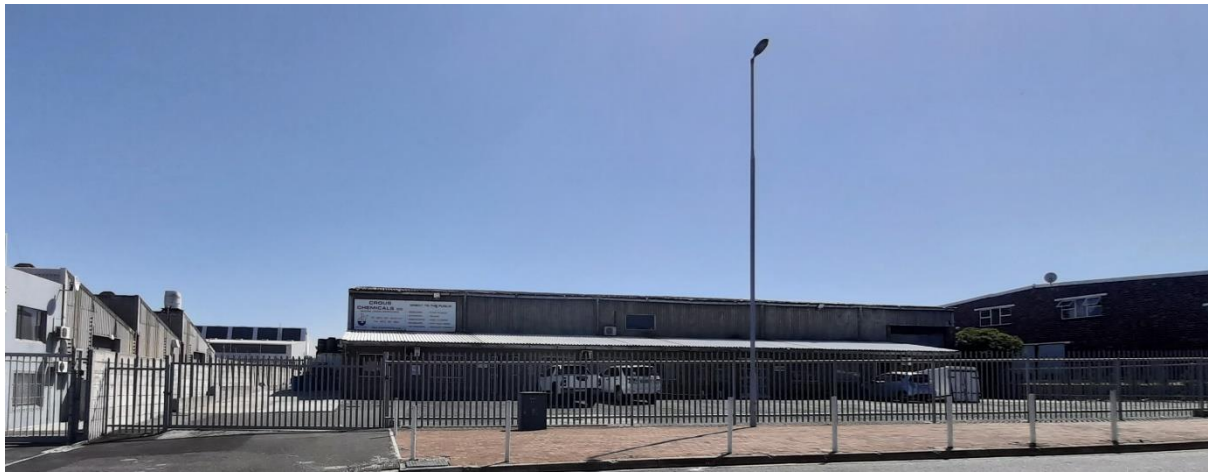
Figure 1: Photograph of the southern boundary of the site with main entry, off of Stella Road, indicating the western entrance. Southern portion of site completely transformed to hardened surface. Access to the northern portion of site, is obtained along the access corridor on the west of the warehouse.

- Its key to note that there are no changes planned to the driveway area, or outside tarred surface, or fence, at present.
- Exterior of the warehouse will be improved, and roof panels replaced, new paint, etc. The only indicators of a crematorium planned for the exterior, includes chimney stacks, which is not unlike the other properties located in and around the area.

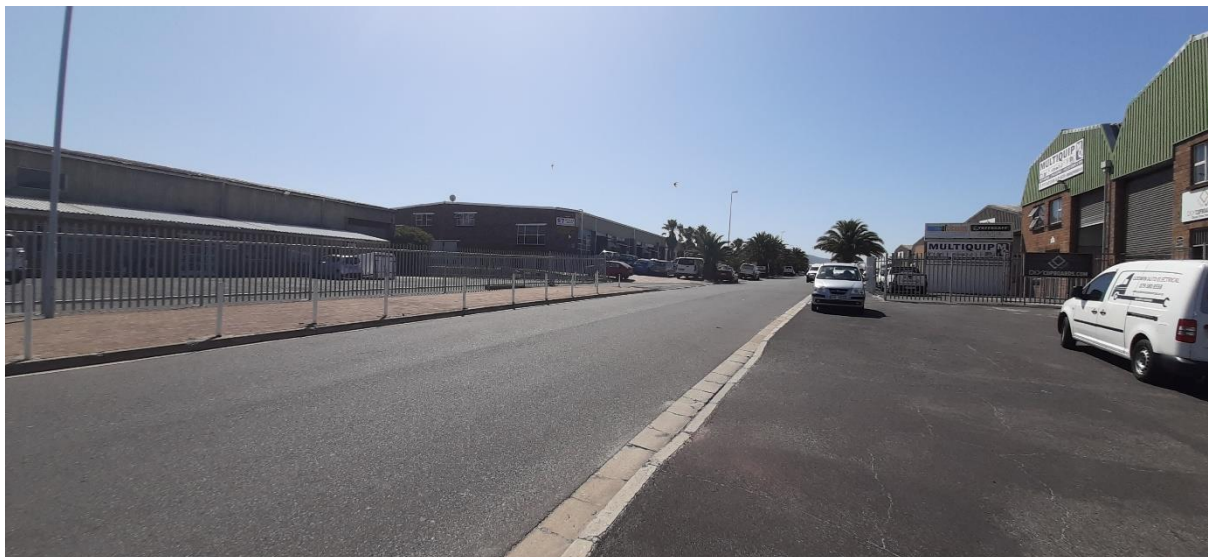
Figure 2: Stella Road towards the east, depicting the eastern entrance of the site.

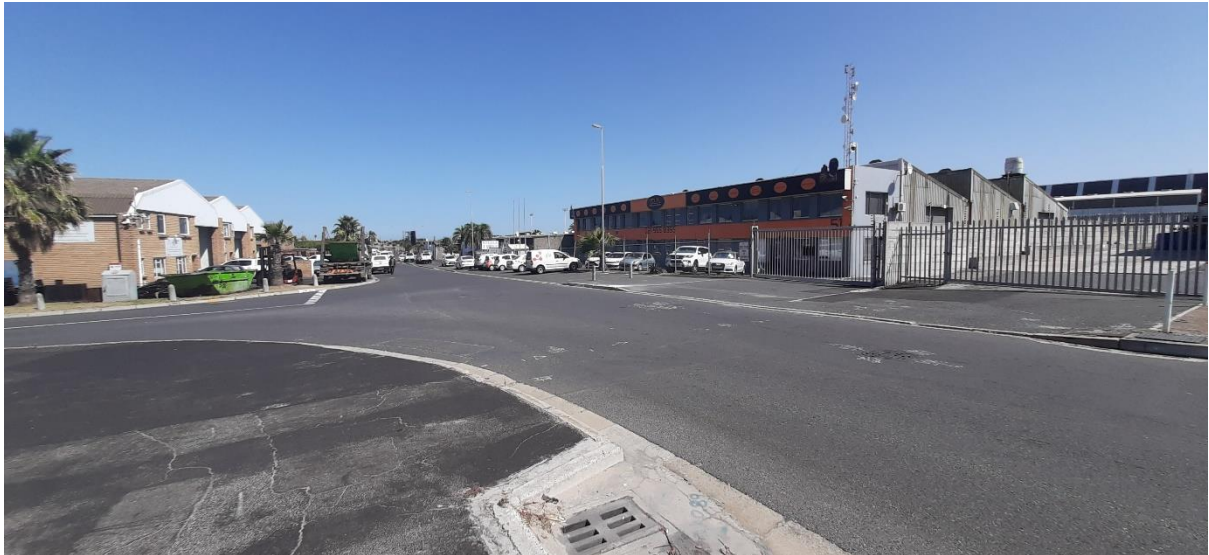
Figure 3: Intersection of Stella Road and Dawn Road towards the west, western entrance to site is depicted opposite Dawn Road.

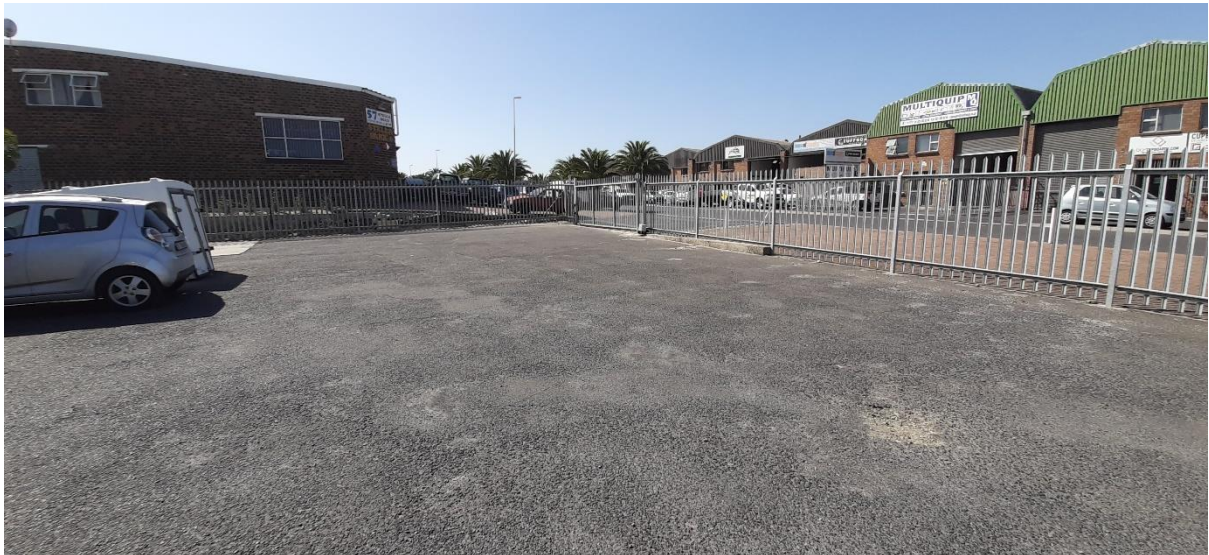
Figure 4: The south-eastern corner of the site and entrance on south-eastern boundary. South-east facing looking toward Stella Road.

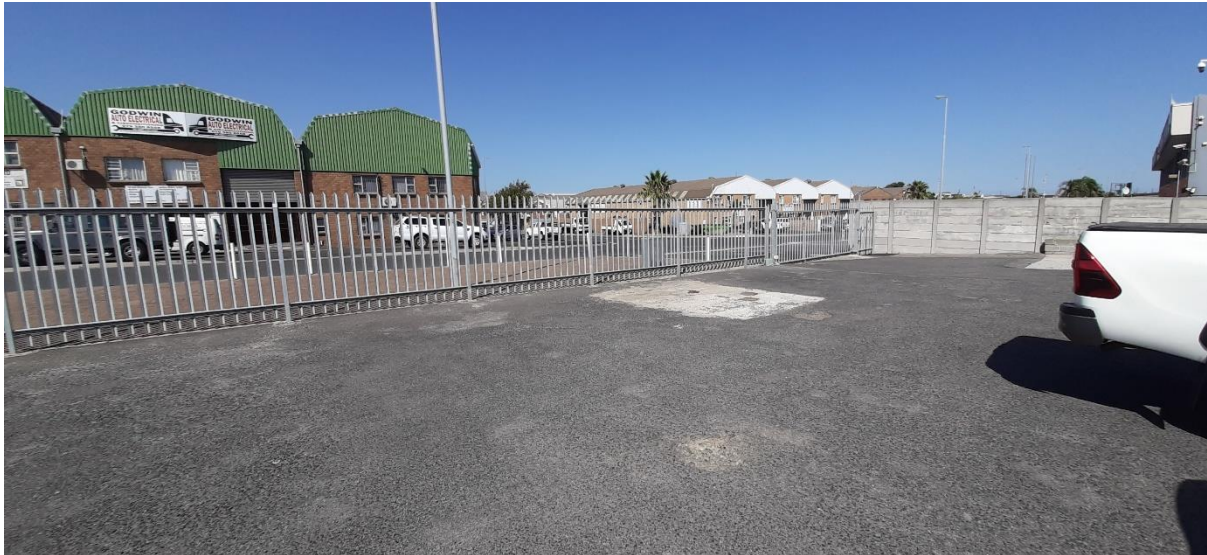
Figure 5: The south-western corner of the site and main entrance on south-western boundary.

- No changes planned to the hardened surfaces.

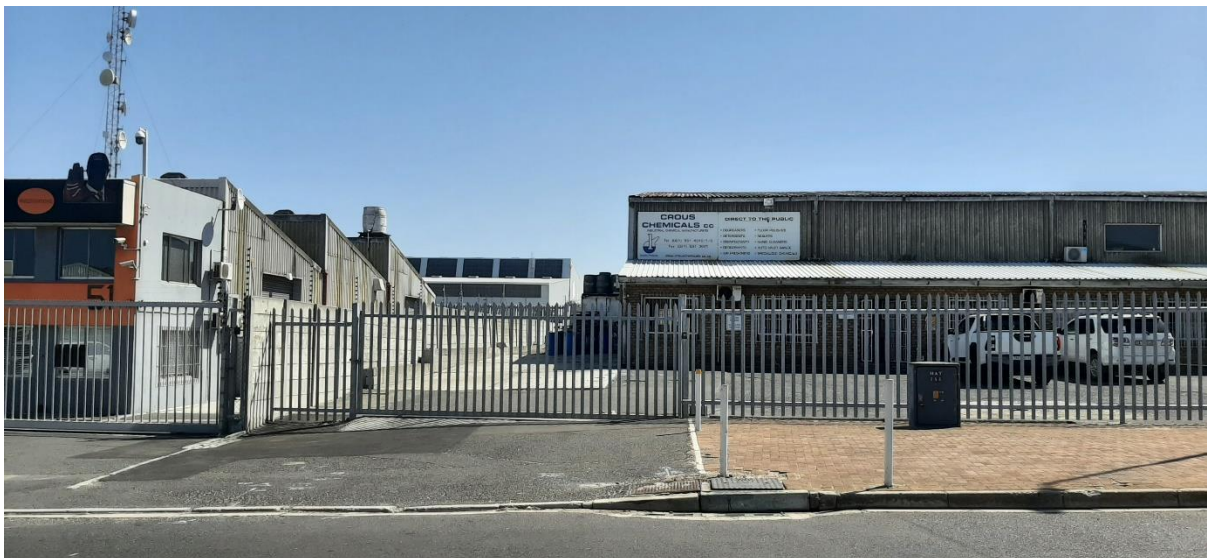
Figure 6: Photograph of the southern boundary of the site with main entry, off of Stella Road, indicating the western entrance. Southern portion of site completely transformed to hardened surface. Access to the northern portion of site, is obtained along the access corridor on the west of the warehouse.

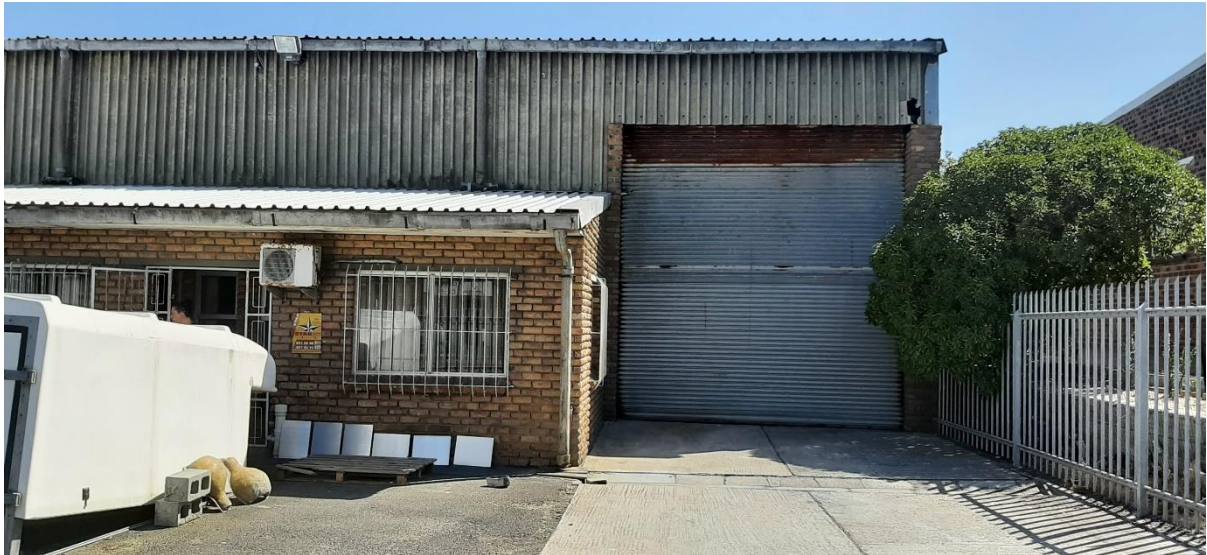
Figure 7: Western portion of warehouse, is built up toward the fence-line, shutter door entrance on the south-eastern corner of the warehouse easily accessed by the gated entrance on the south-eastern boundary (see Figure 4).

- Aged doors, metal walls and roofing will be replaced.

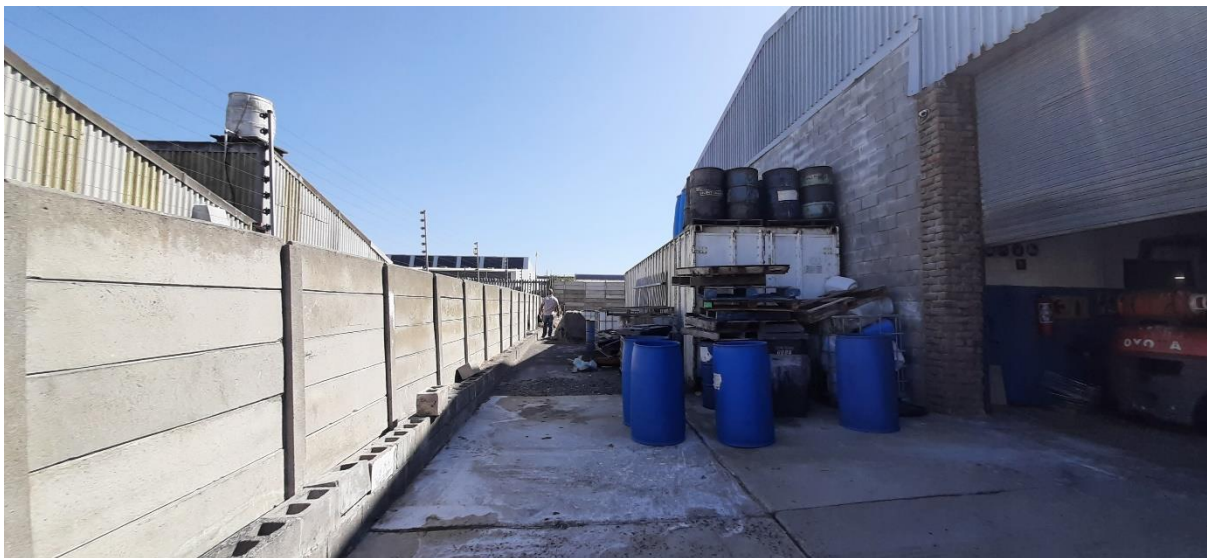
Figure 8: The western portion of the site, facing north, corridor to the northern portion of the site (backside of the warehouse). Entrance on the right indicates the shutter door entry on the south-western corner of the warehouse. Solid concrete fence is observed to along the western boundary in good condition, obscuring visuals onto the site.

- All stored material will be removed.
- Potential location for LPG storage area is along this are, beyond the roll-up doors.

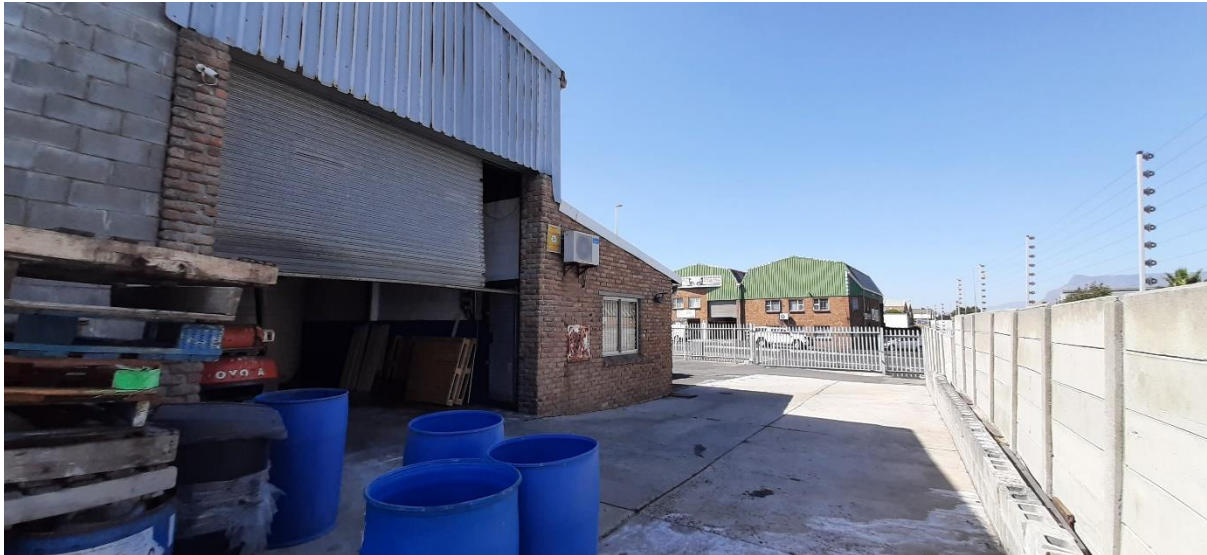
Figure 9: The entrance on the south-western corner of the warehouse accessed via the main entrance off Stella Road on the south-western corner of the site. This shutter door entrance to potentially be used as the off-loading zone for deliveries

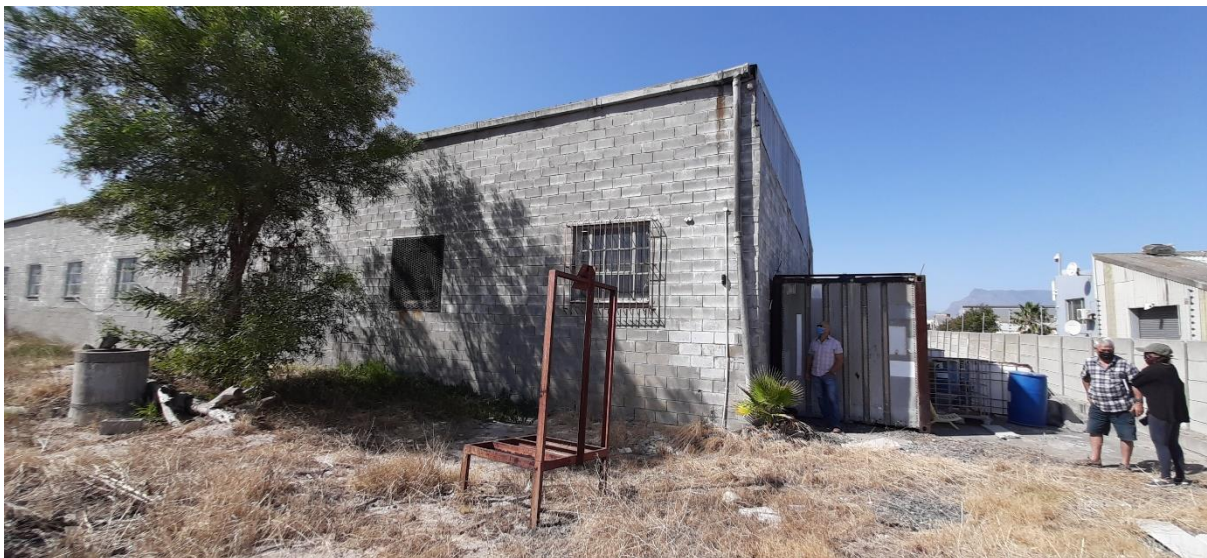
Figure 10: The north-western corner of the site, facing south-east, natural but significantly disturbed surface due to the storage of construction materials and alien invasive vegetation. Can potentially be used as LPG storage area.

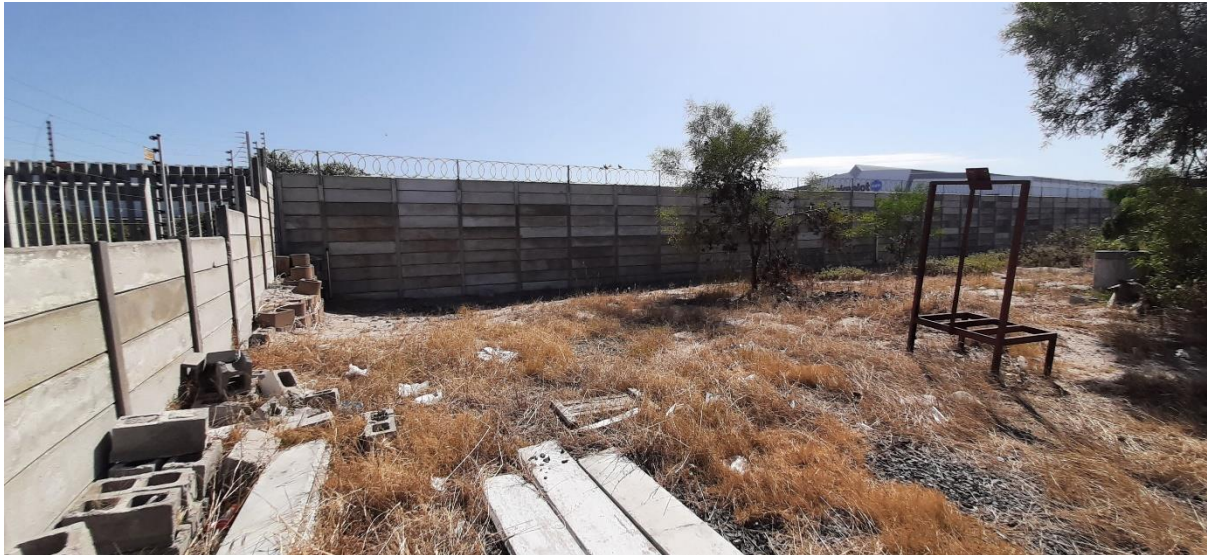
Figure 11: The north-western corner of the site, facing north, natural but significantly disturbed surface due to the storage of construction materials and alien invasive vegetation. Can potentially be used as LPG storage area.

- All waste will be removed from site. As well as alien invasives.

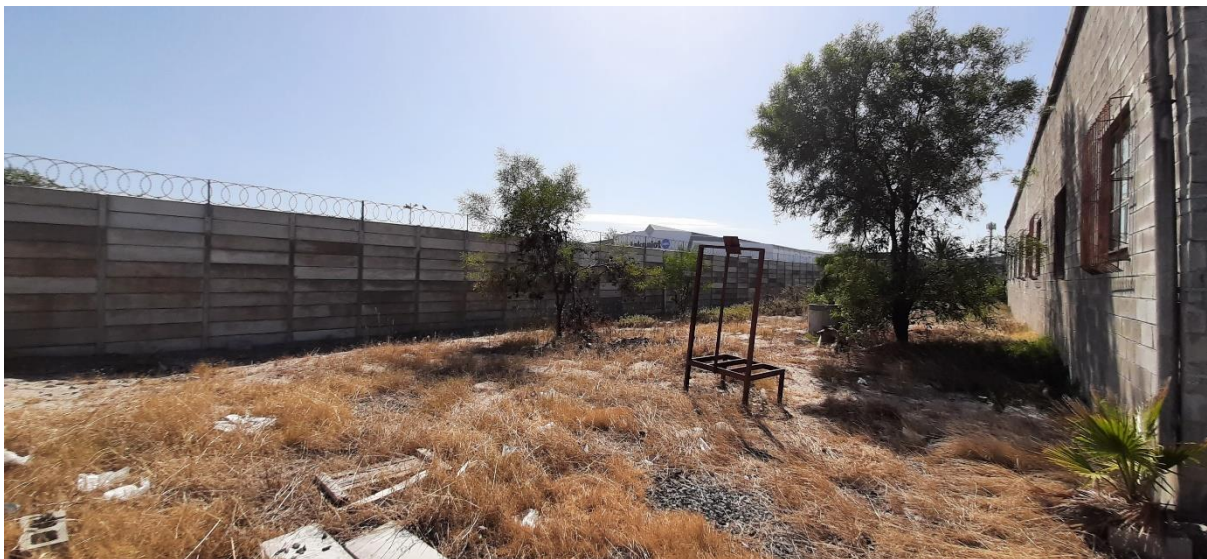
Figure 12: The northern portion of the site, facing north-east natural but significantly disturbed surface due to the storage of construction materials and alien invasive vegetation. Alien invasive clearance of this area has been included in the EMPr.

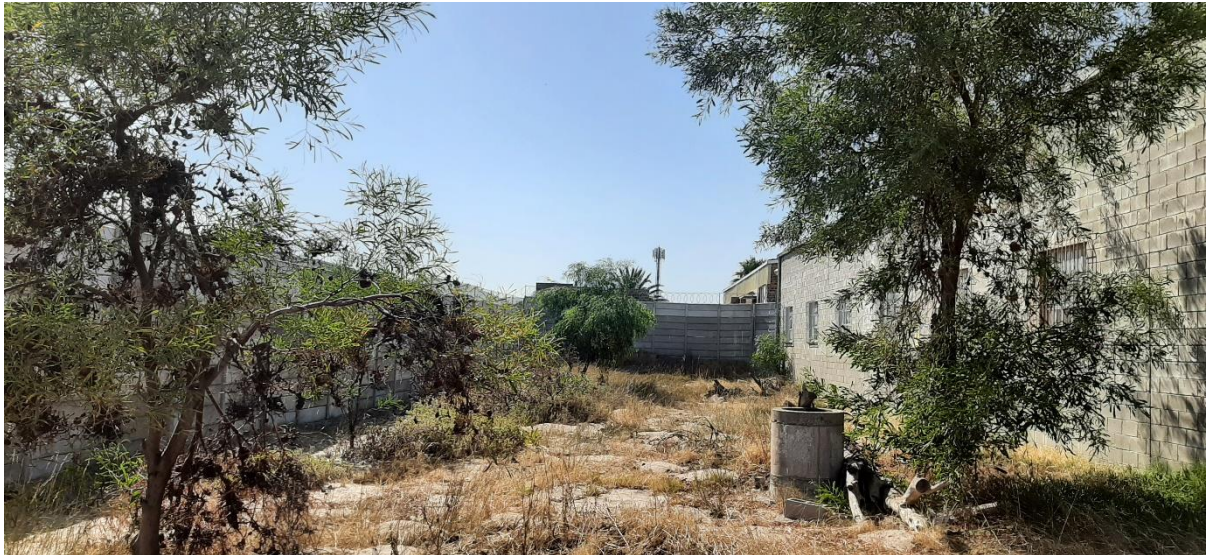
Figure 13: The northern portion of the site, facing east. Contains natural permeable surface but significantly disturbed due to the presence of alien invasive vegetation (*Acacia*) and extruding stormwater infrastructure (manhole). Contains patches of indigenous plant species (*Geraniaceae Pelargonium*), see Figure 14. Alien invasive clearance to be undertaken. No development is to encroach beyond the stormwater drain manhole, toward the eastern portion of the site.

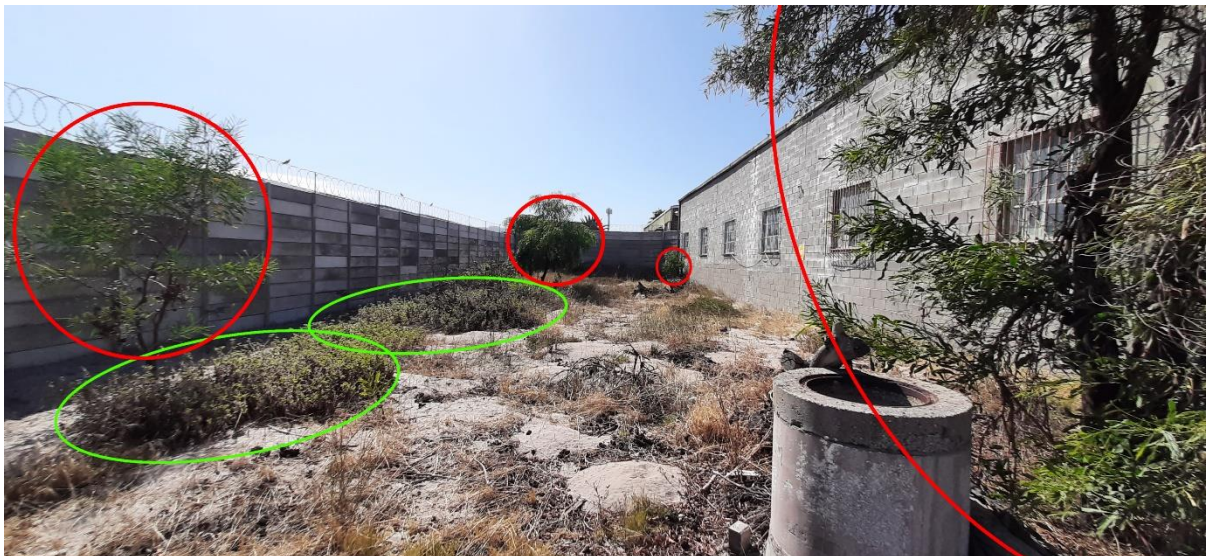
Figure 14: Northern portion of the site, with patches of indigenous species, *Geraniaceae Pelargonium* (circled in green) and alien invasive species, *Acacia* (circles in red).

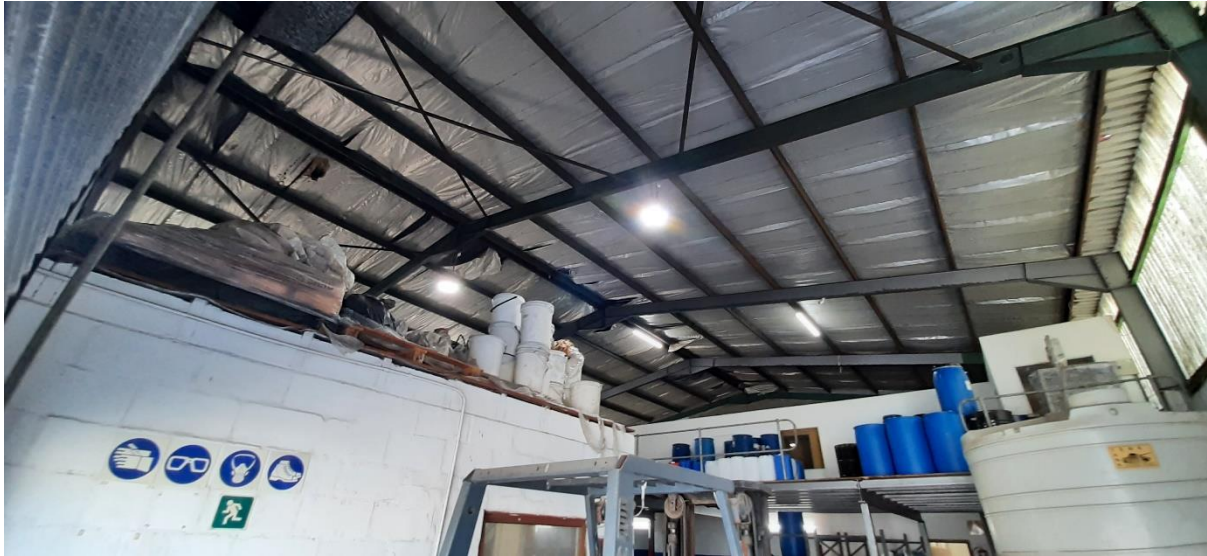
Figure 15: Inside of the warehouse from the shutter door entrance on the south-western side (see Figure 8 & Figure 9 for exterior).

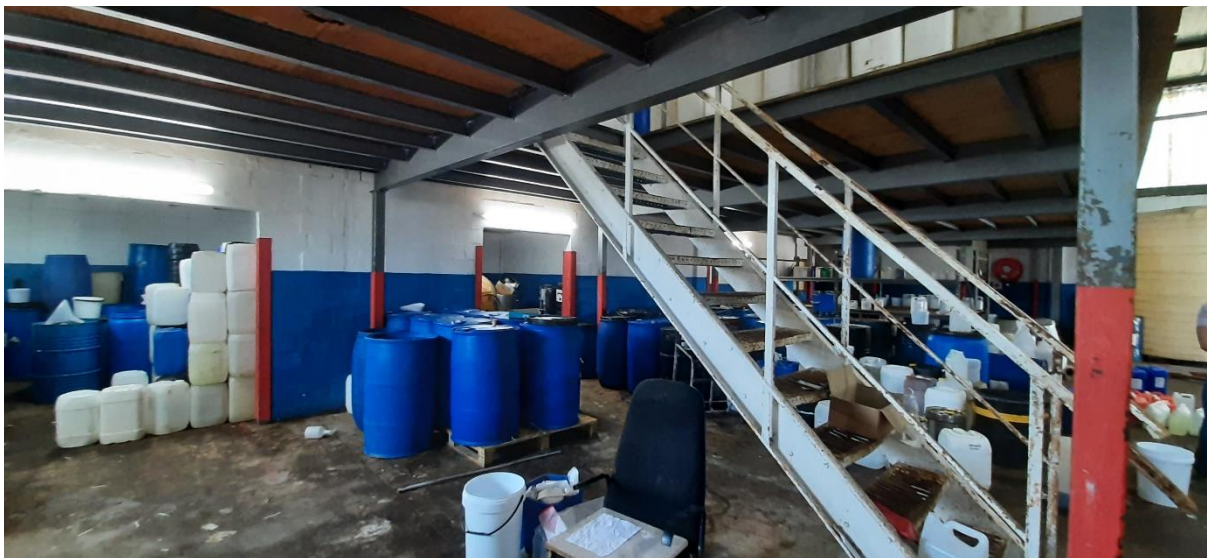
Figure 16: Interior of warehouse, planned refurbishment for flooring, etc.

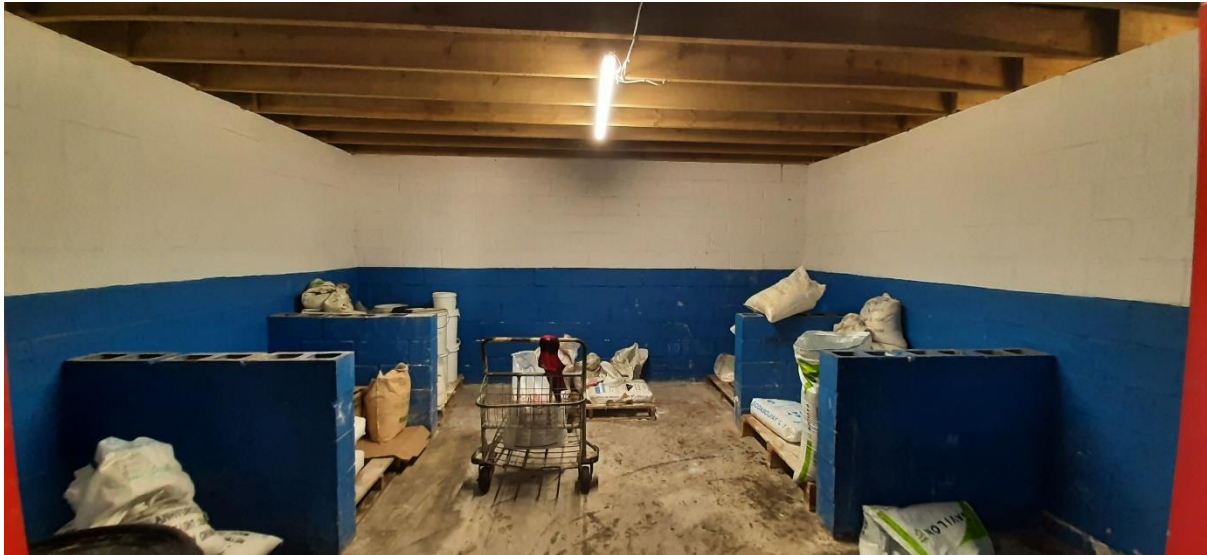
Figure 17: Interior rooms, to be refurbished and managed appropriately.

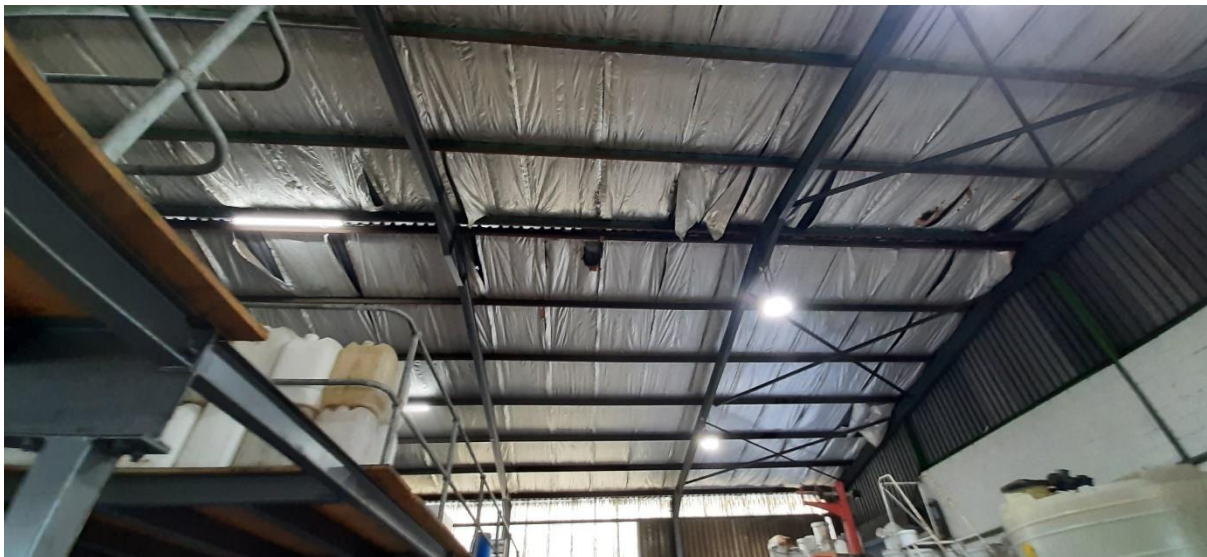
Figure 18: Interior roof of the western portion of the warehouse.

- Roofing interior will be refurbished, to ensure that the warehouse meets the relevant standards in compliance with such a facility.

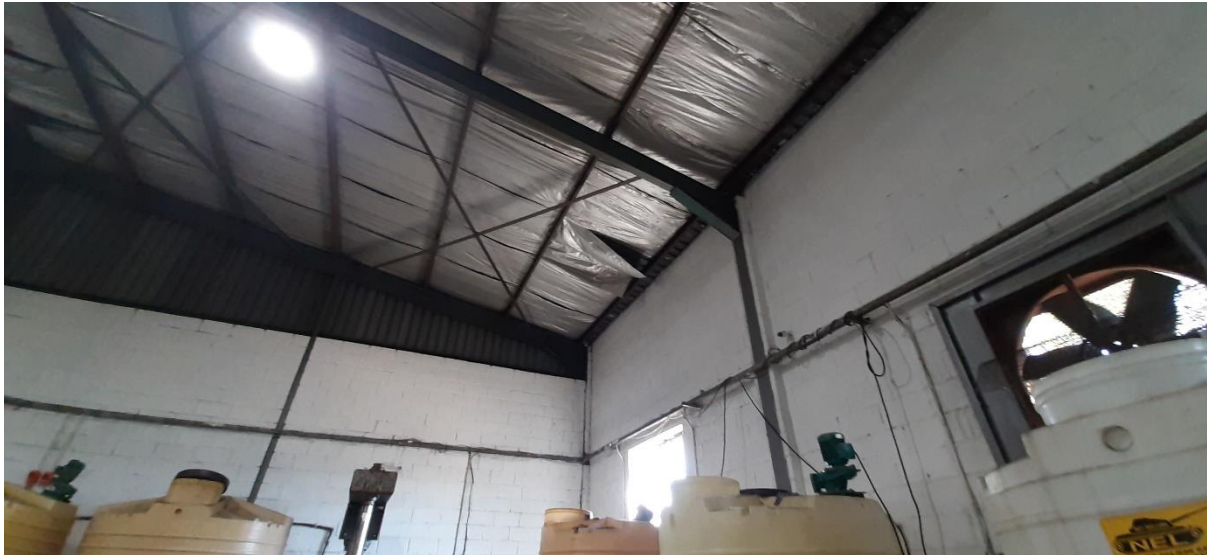
Figure 19: Photograph of the inside of the north-western corner of the warehouse.

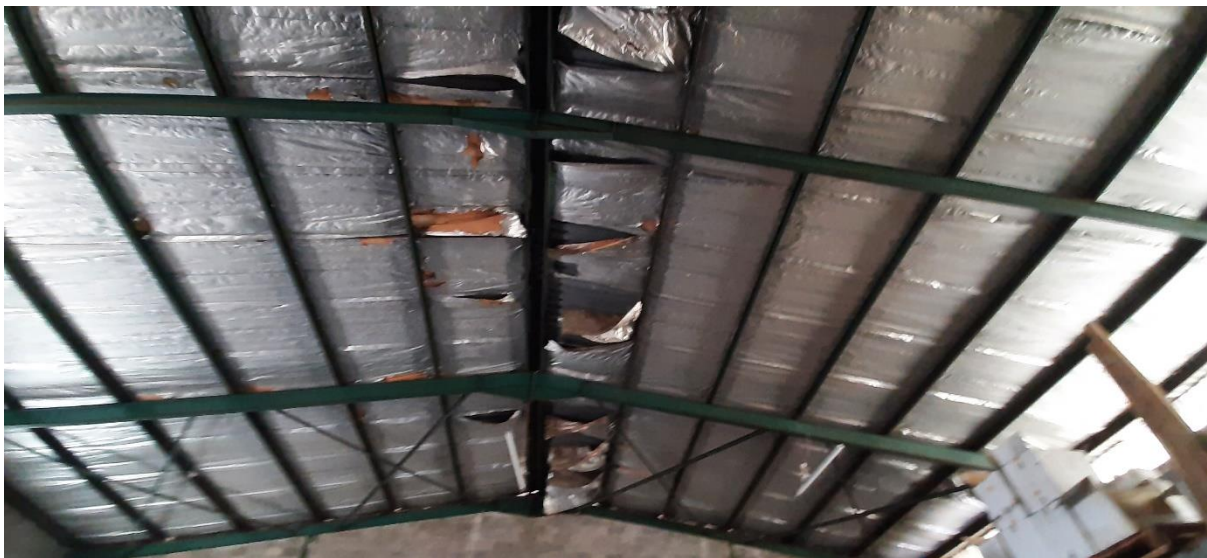
Figure 20: Disrepair of interior roof of the central portion of the warehouse.

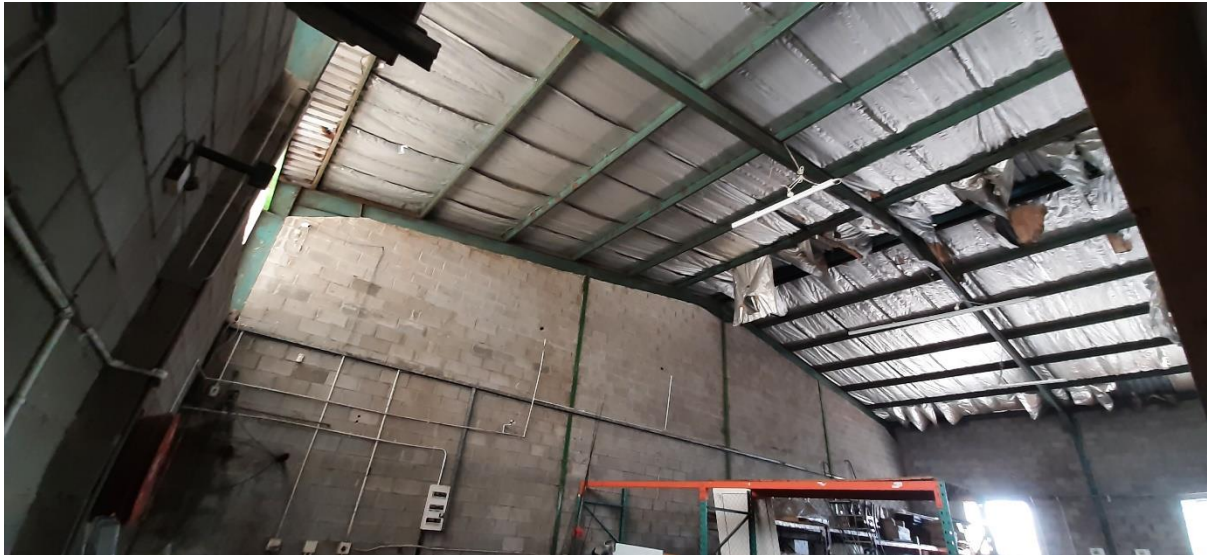
Figure 21: Disrepair of the interior roof on eastern side of warehouse.

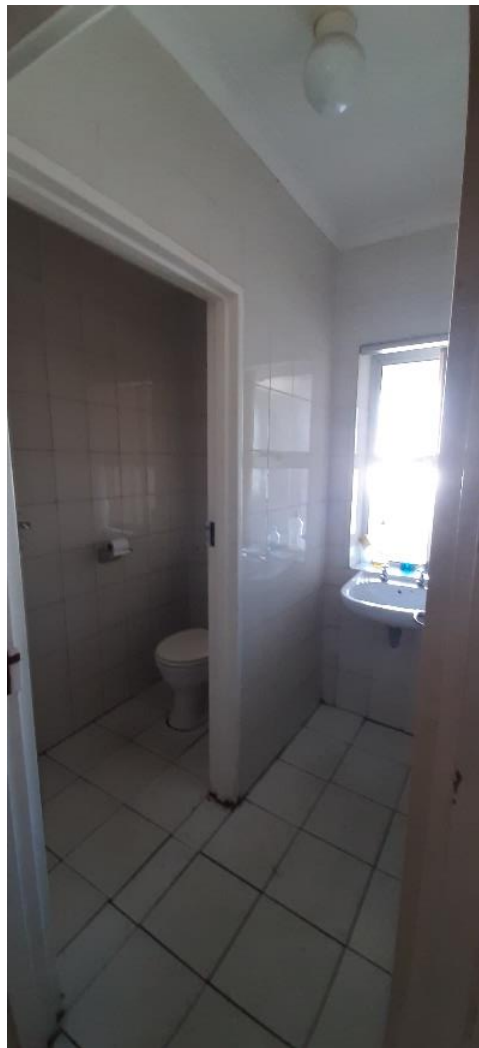
Figure 22: One of the existing ablution facilities inside the warehouse.

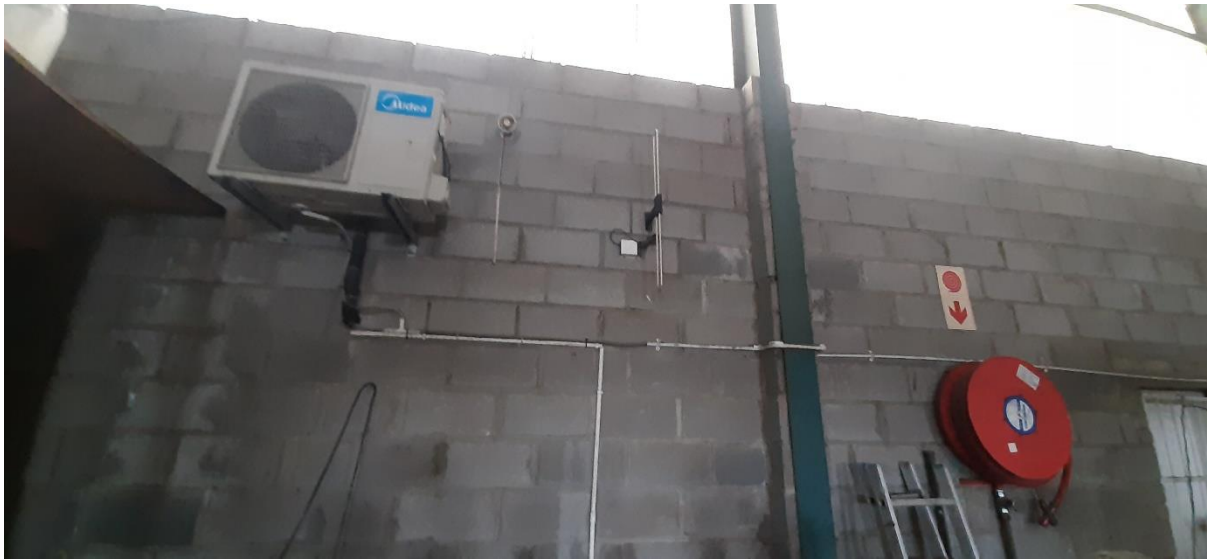
Figure 23: Existing fire hydrant and air conditioner in eastern portion of the warehouse.

- All fire fighting equipment will be checked for compliance and additional will be added on, based on the relevant requirements pertaining to fire safety for such a facility.
