APPENDIX C1: PHOTOGRAPHS

EXTERIOR OF SITE AND EXISTING WAREHOUSE

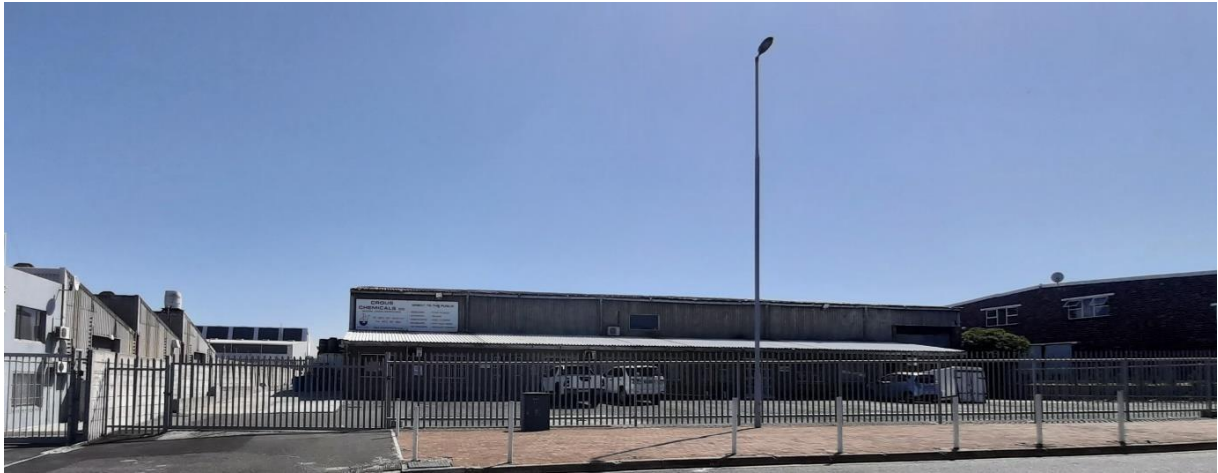
Figure 1: Photograph of the southern boundary of the site with main entry, off of Stella Road, indicating the western entrance. Southern portion of site completely transformed to hardened surface. Access to the northern portion of site, is obtained along the access corridor on the west of the warehouse.

- Its key to note that there are no changes planned to the driveway area, or outside tared surface, or fence, at present.
- Exterior of the warehouse will be improved, and roof panels replaced, new paint, etc. The only indicators of a crematorium planned for the exterior, includes chimney stacks, which is not unlike the other properties located in and around the area.

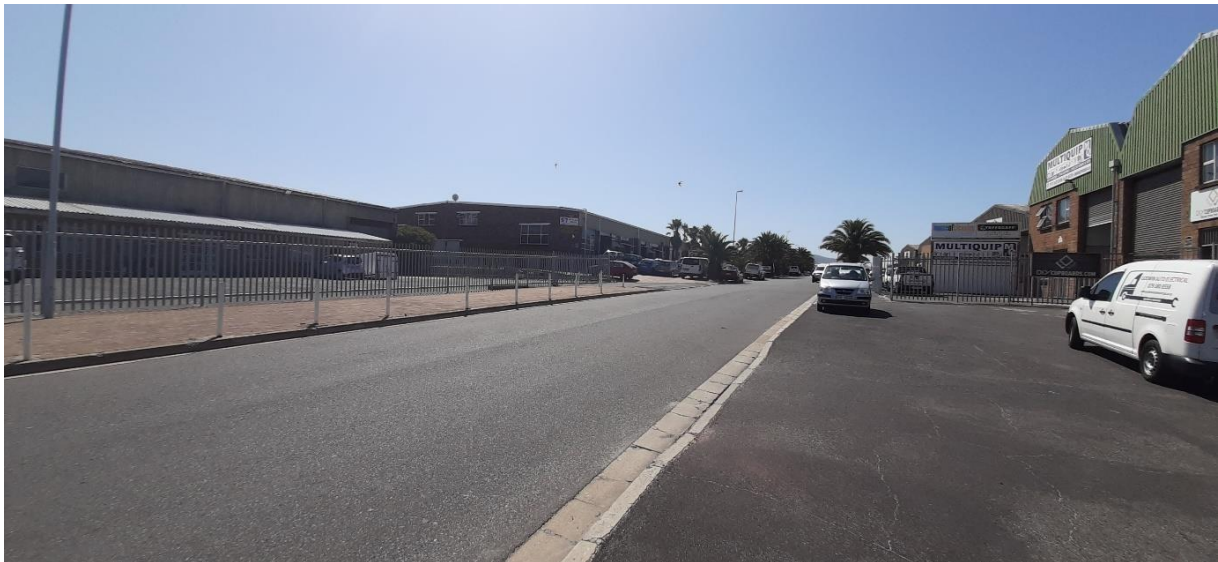
Figure 2: Stella Road towards the east, depicting the eastern entrance of the site.

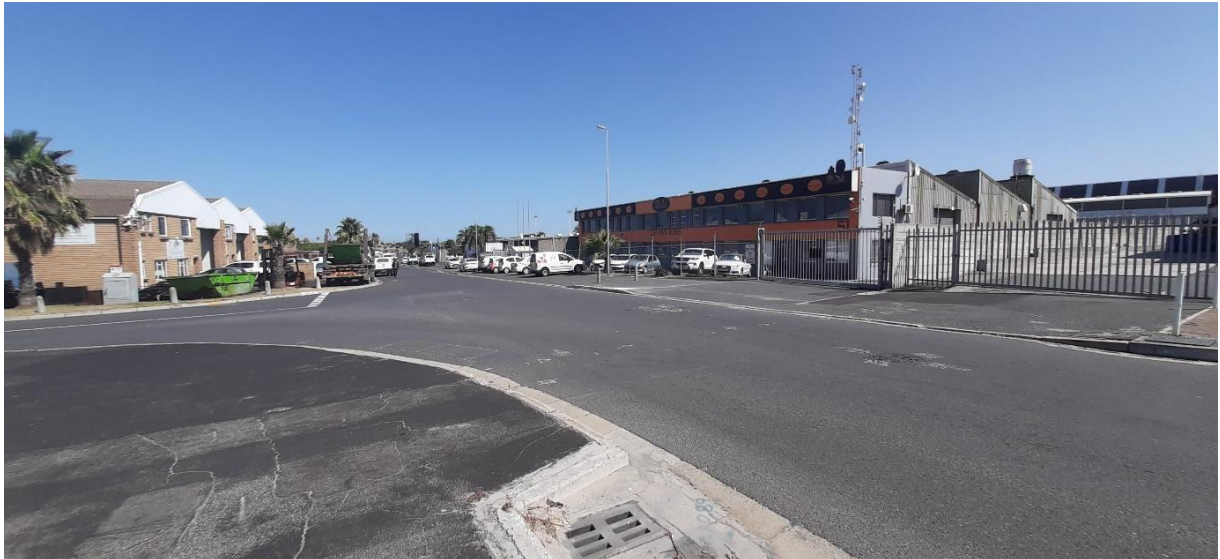
Figure 3: Intersection of Stella Road and Dawn Road towards the west, western entrance to site is depicted opposite Dawn Road.

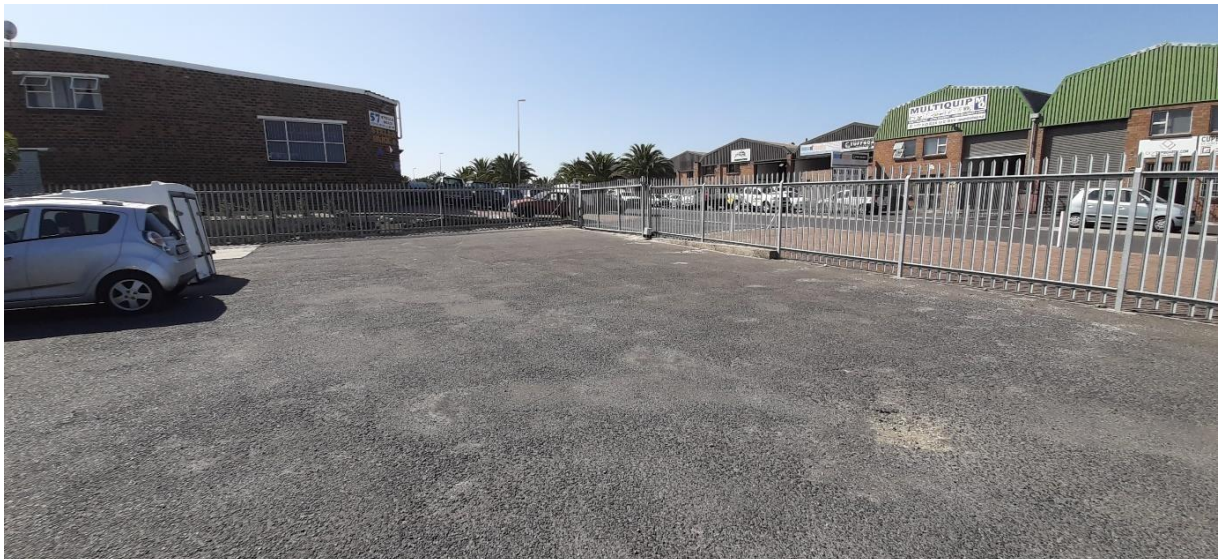
Figure 4: The south-east corner of the site and entrance on south-east boundary. South- east facing looking toward Stella Road.

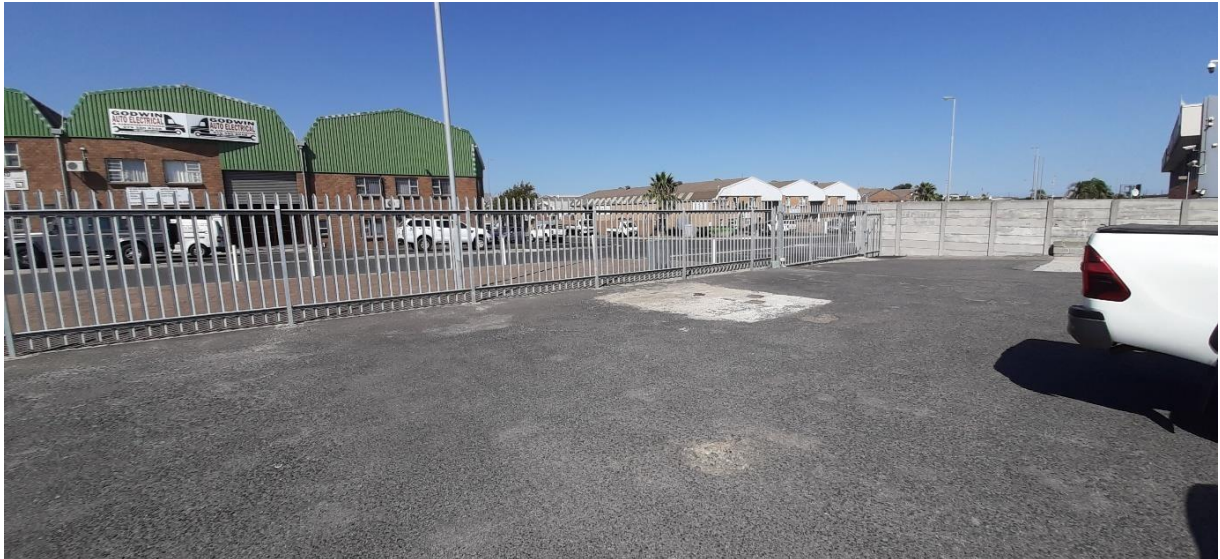
Figure 5: The south-western corner of the site and main entrance on south-western boundary.

- No changes planned to the hardened surfaces.

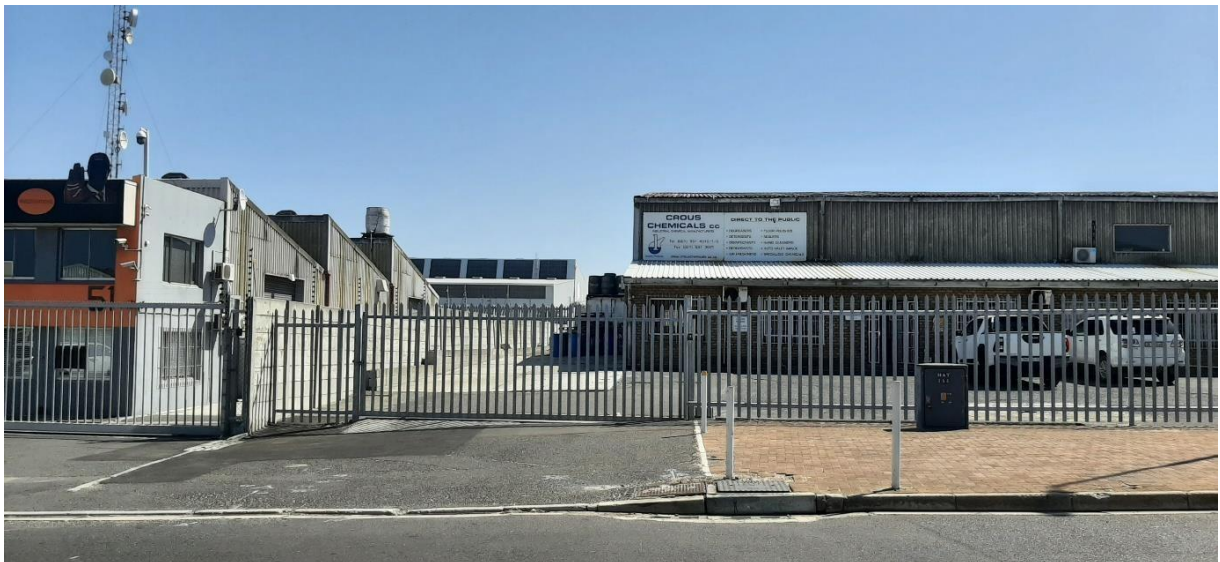
Figure 6: Photograph of the southern boundary of the site with main entry, off of Stella Road, indicating the western entrance. Southern portion of site completely transformed to hardened surface. Access to the northern portion of site, is obtained along the access corridor on the west of the warehouse.

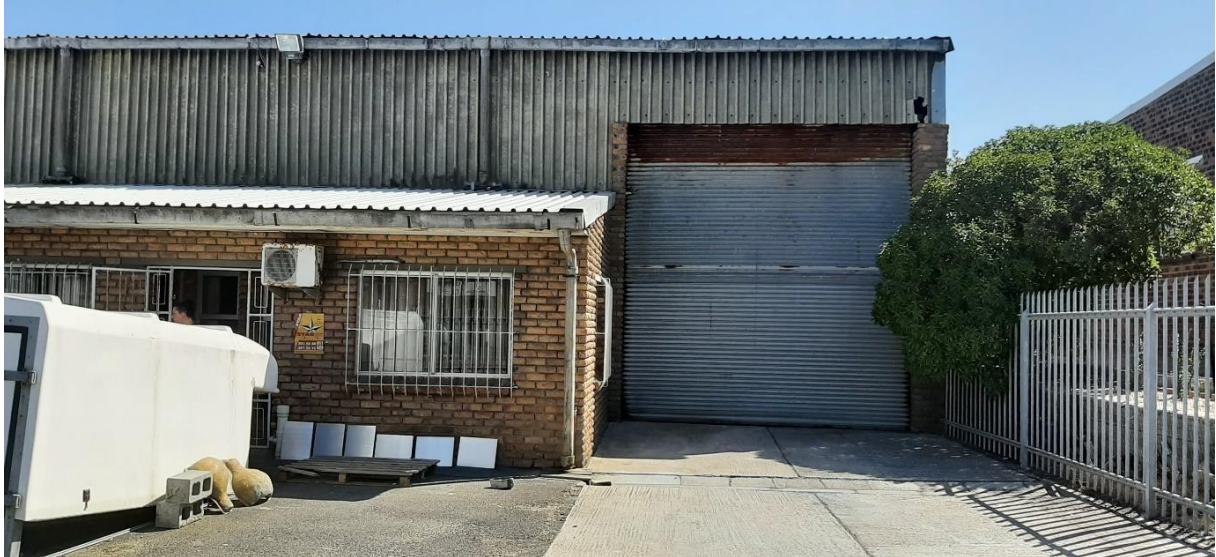
Figure 7: Western portion of warehouse, is built up toward the fence-line, shutter door entrance on the south-eastern corner of the warehouse easily accessed by the gated entrance on the south-eastern boundary (see Figure 4).

- Aged doors, metal walls and roofing will be replaced.

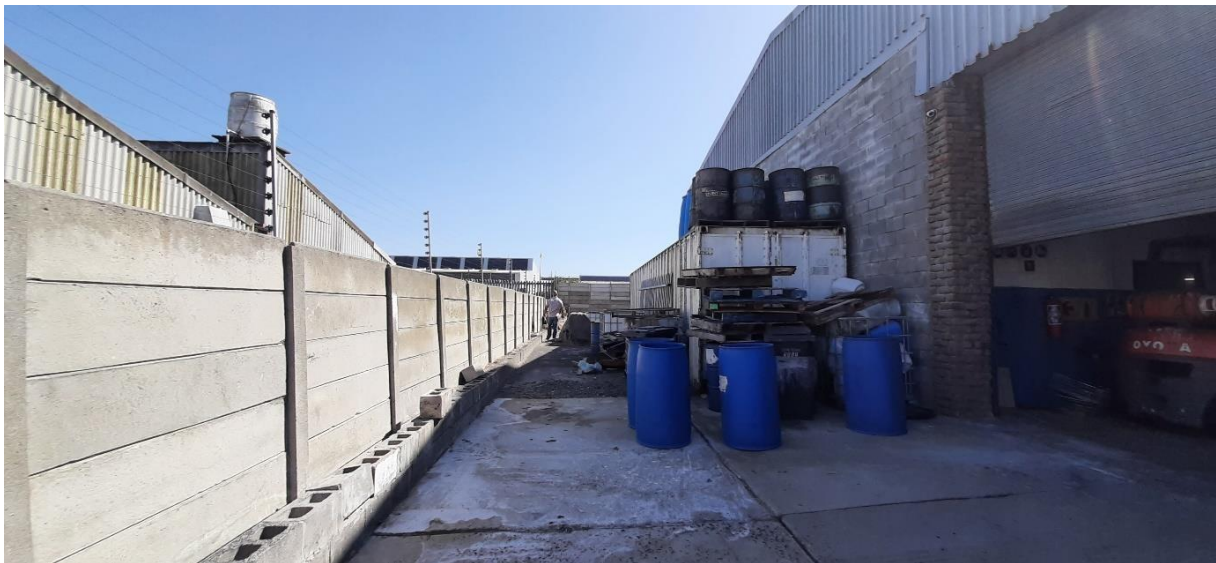
Figure 8: The western portion of the site, facing north, corridor to the northern portion of the site (backside of the warehouse). Entrance on the right indicates the shutter door entry on the south-western corner of the warehouse. Solid concrete fence is observed to along the western boundary in good condition, obscuring visuals onto the site.

- All stored material will be removed.
- Potential location for LPG storage area is along this are, beyond the roll-up doors.

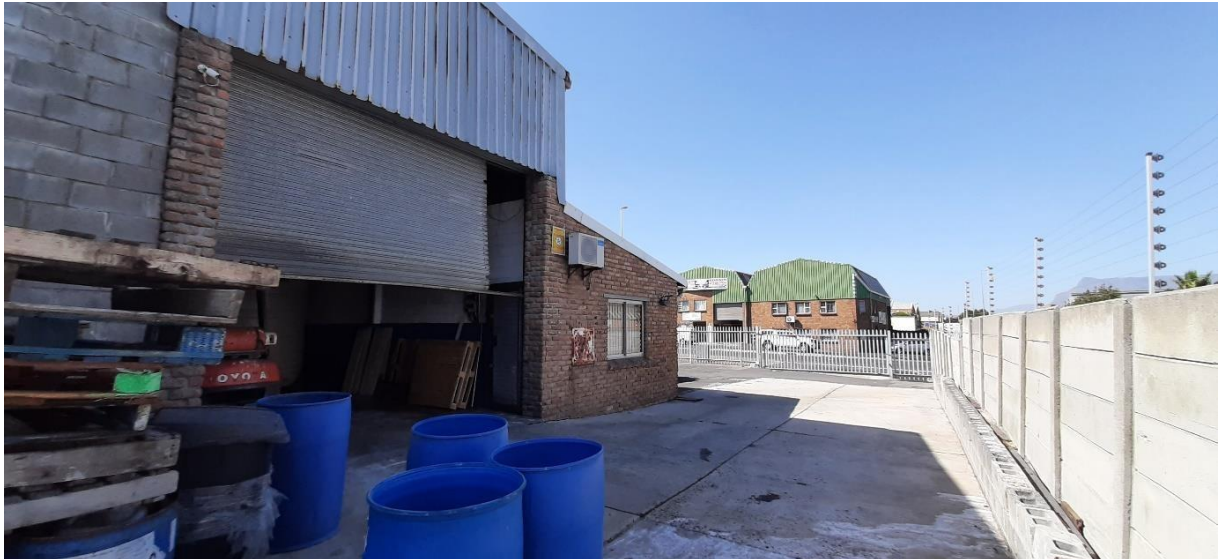
Figure 9: The entrance on the south-western corner of the warehouse accessed via the main entrance off Stella Road on the south-western corner of the site. This shutter door entrance to potentially be used as the off-loading zone for deliveries

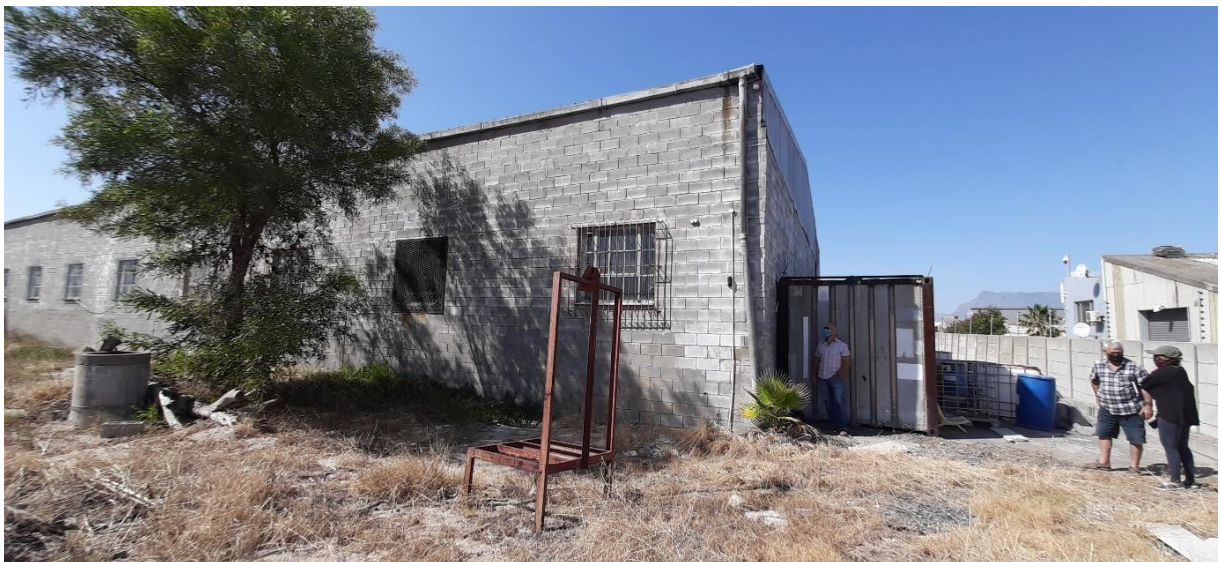
Figure 10: The north-western corner of the site, facing south-east, natural but significantly disturbed surface due to the storage of construction materials and alien invasive vegetation. Can potentially be used as LPG storage area.

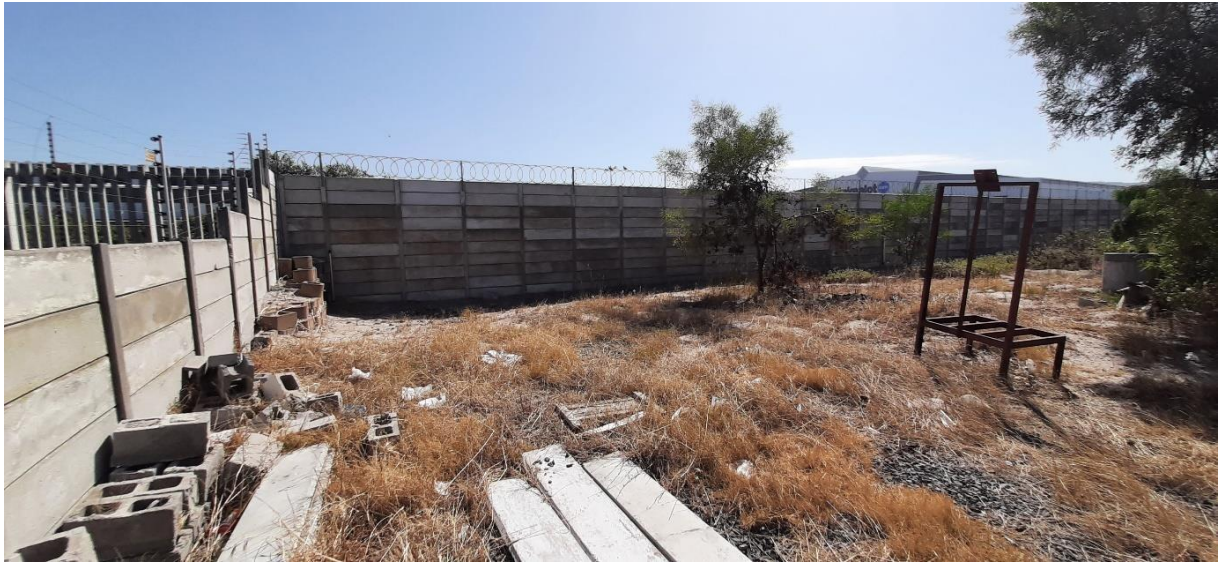
Figure 11: The north-western corner of the site, facing north, natural but significantly disturbed surface due to the storage of construction materials and alien invasive vegetation. Can potentially be used as LPG storage area.

- All waste will be removed from site. As well as alien invasives.

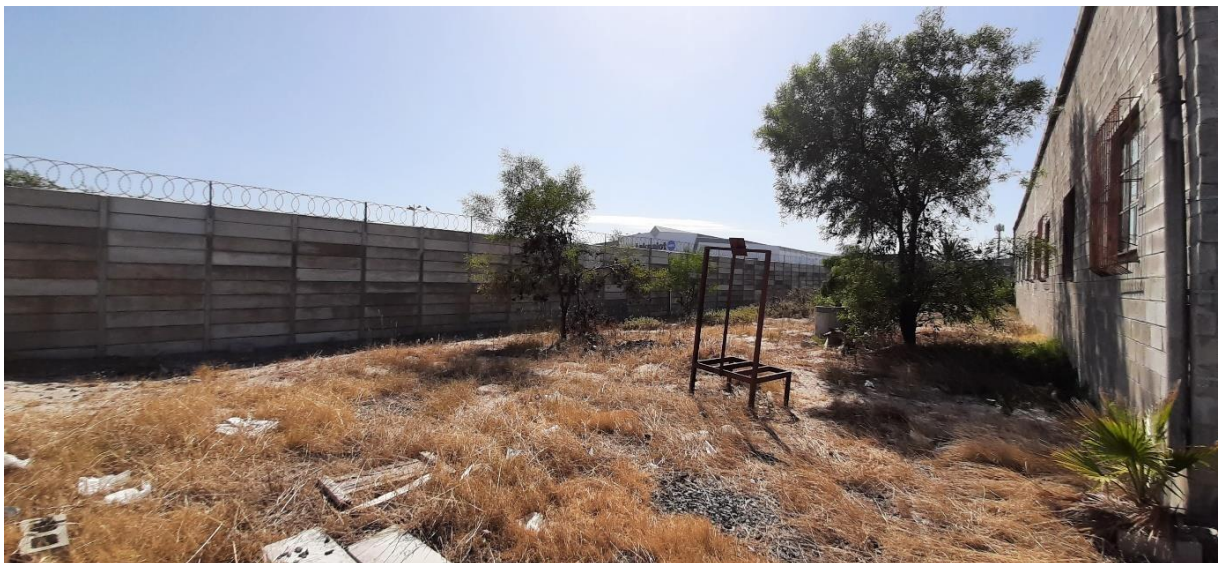
Figure 12: The northern portion of the site, facing north-east natural but significantly disturbed surface due to the storage of construction materials and alien invasive vegetation. Alien invasive clearance of this area has been included in the EMPr.

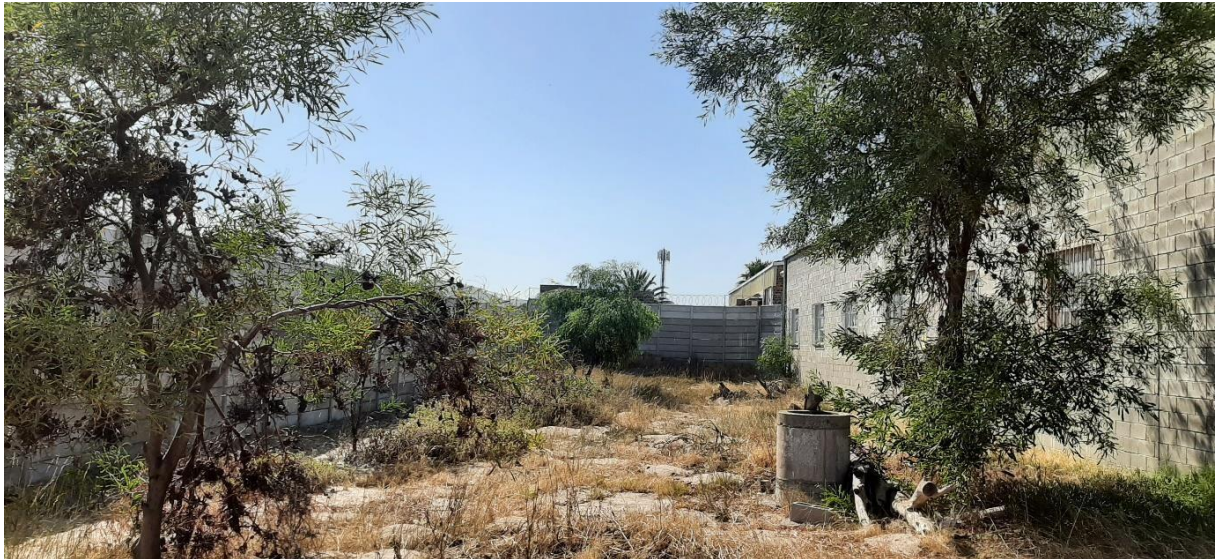
Figure 13: The northern portion of the site, facing east. Contains natural permeable surface but significantly disturbed due to the presence of alien invasive vegetation (*Acacia*) and extruding stormwater infrastructure (manhole). Contains patches of indigenous plant species (*Geraniaceae Pelargonium*), see Figure 14. Alien invasive clearance to be undertaken. No development is to encroach beyond the stormwater drain manhole, toward the eastern portion of the site.

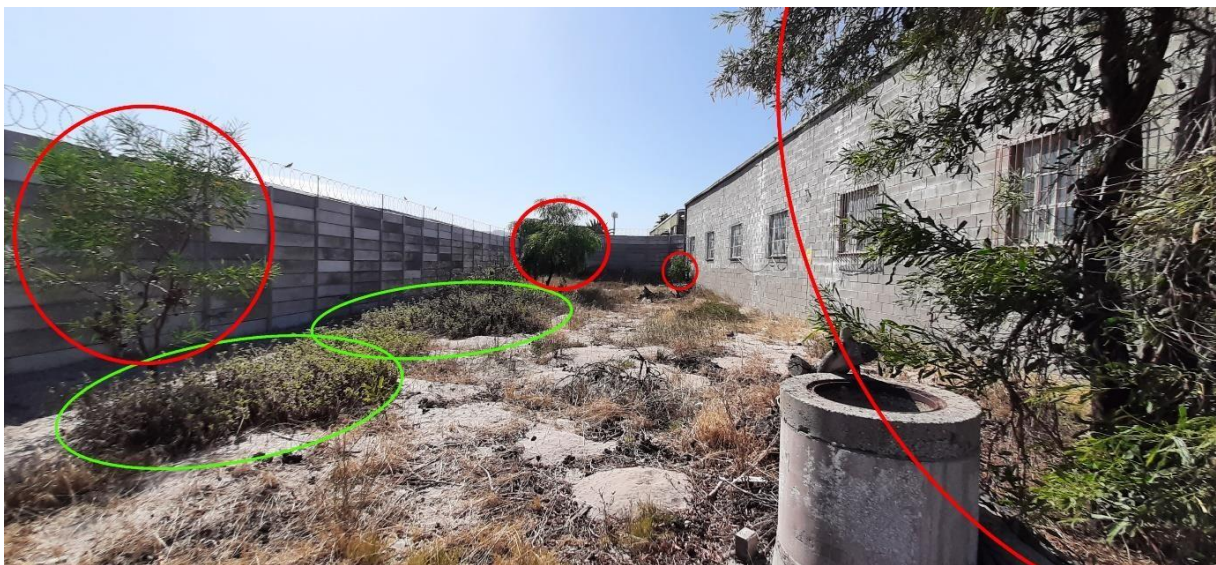
Figure 14: Northern portion of the site, with patches of indigenous species, *Geraniaceae Pelargonium* (circled in green) and alien invasive species, *Acacia* (circles in red).

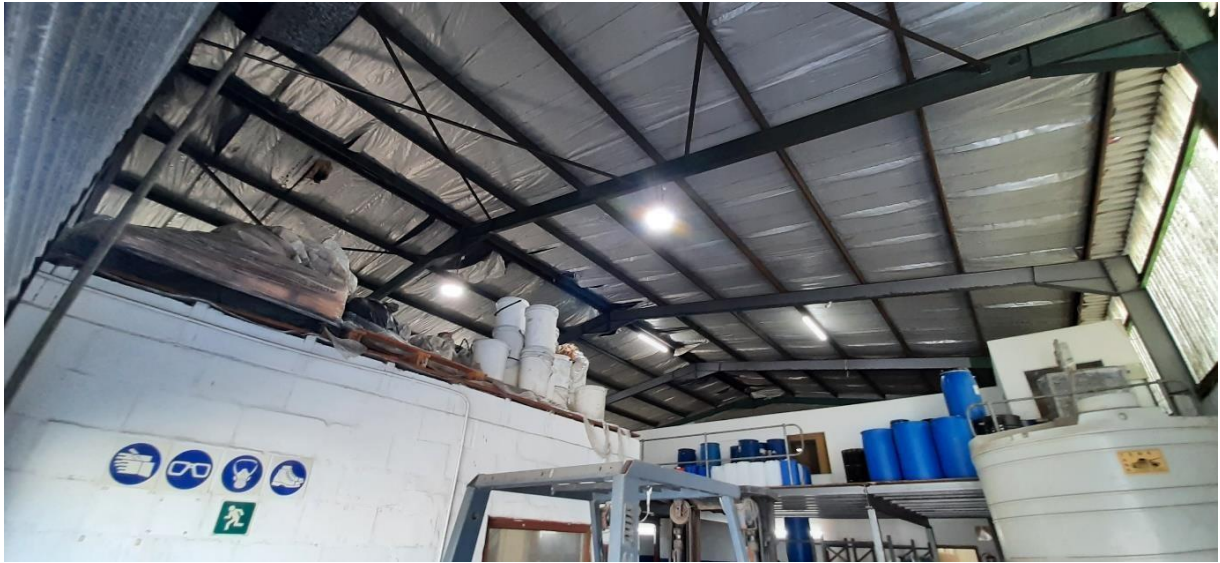
Figure 15: Inside of the warehouse from the shutter door entrance on the south-western side (see Figure 8 & Figure 9 for exterior).

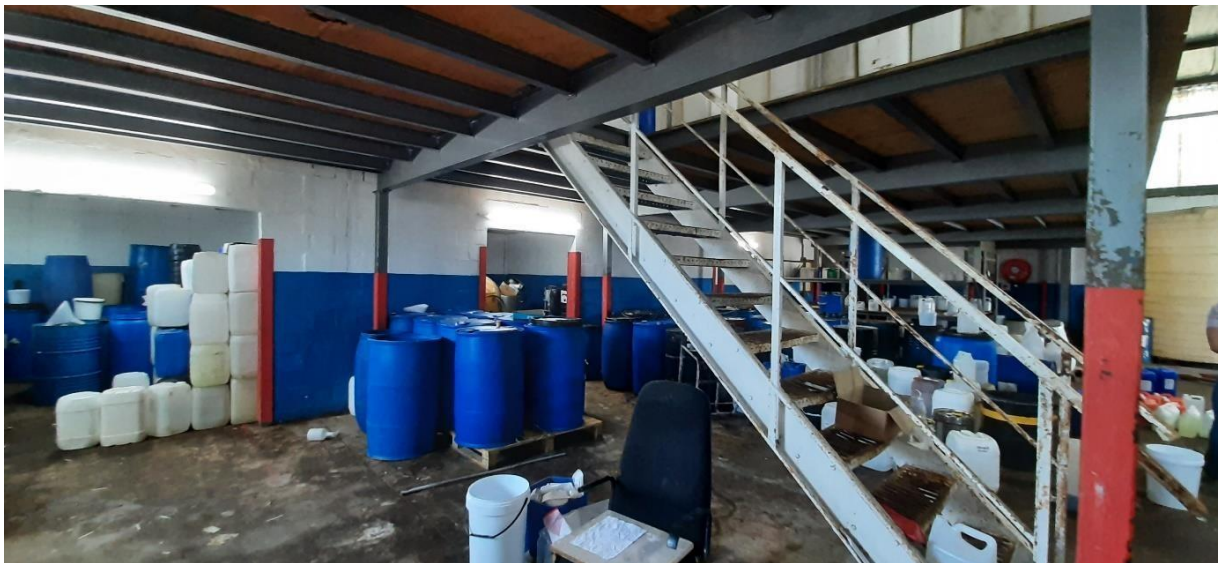
Figure 16: Interior of warehouse, planned refurbishment for flooring, etc.

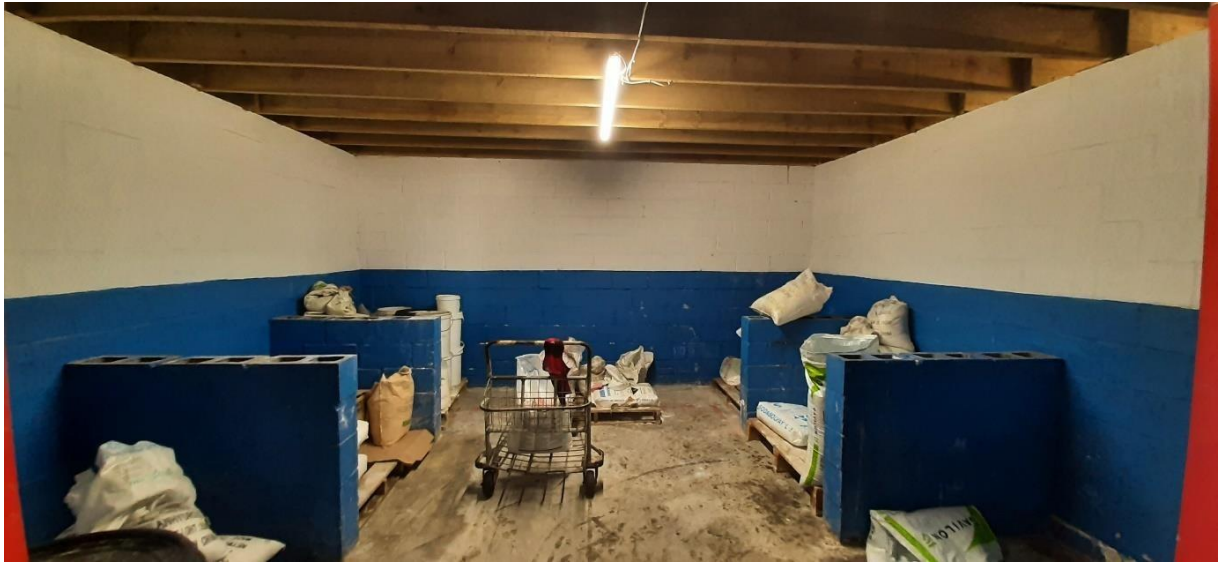
Figure 17: Interior rooms, to be refurbished and managed appropriately.

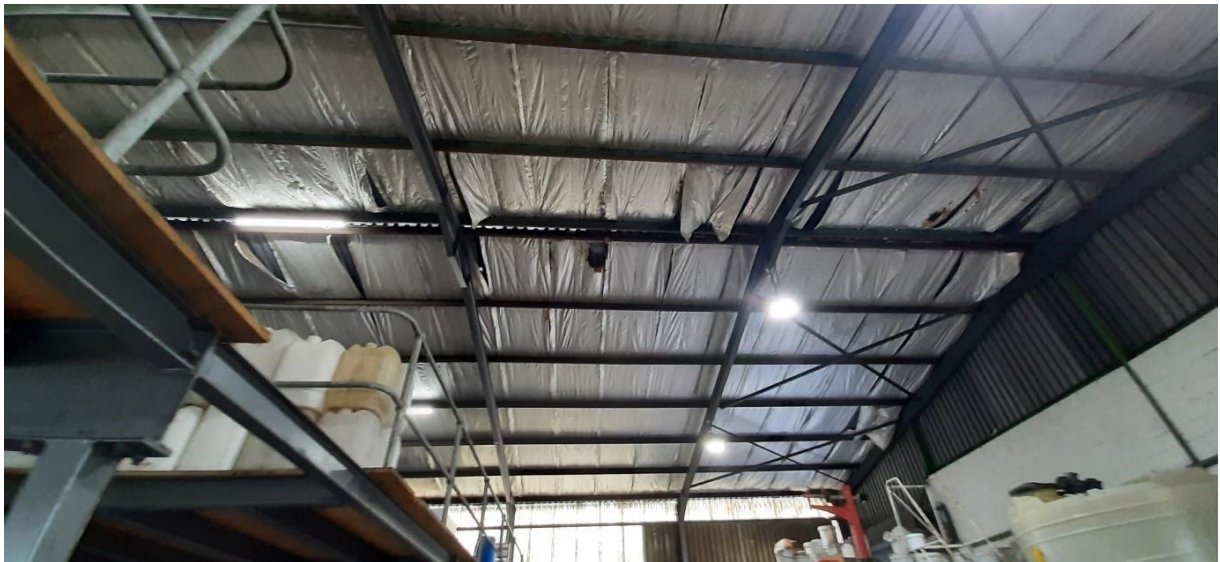
Figure 18: Interior roof of the western portion of the warehouse.

- Roofing interior will be refurbished, to ensure that the warehouse meets the relevant standards in compliance with such a facility.

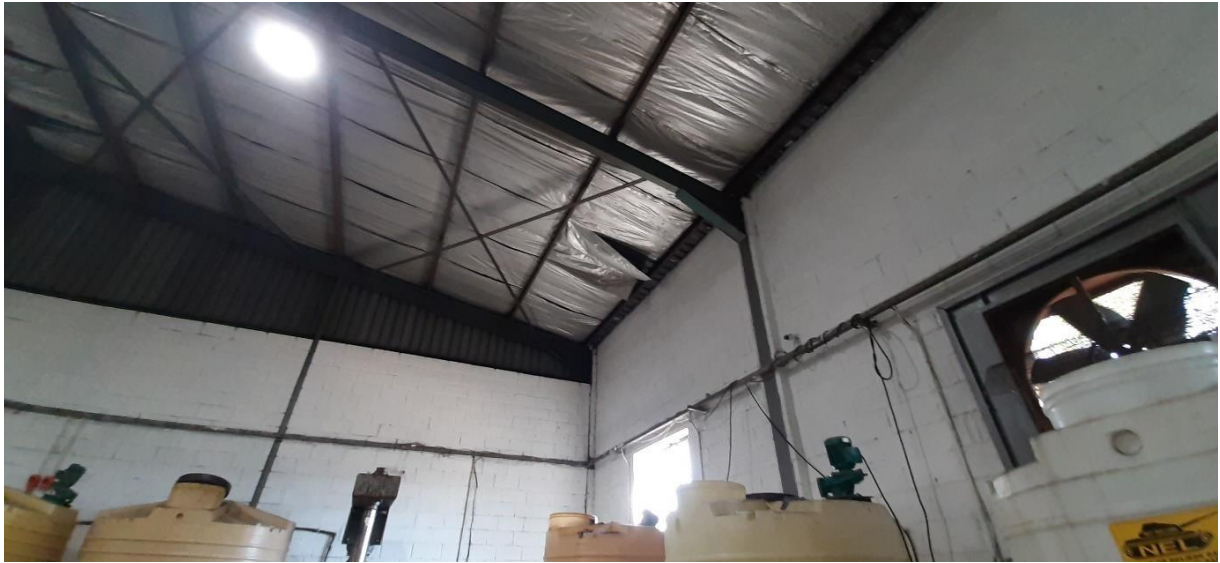
Figure 19: Photograph of the inside of the north-western corner of the warehouse.

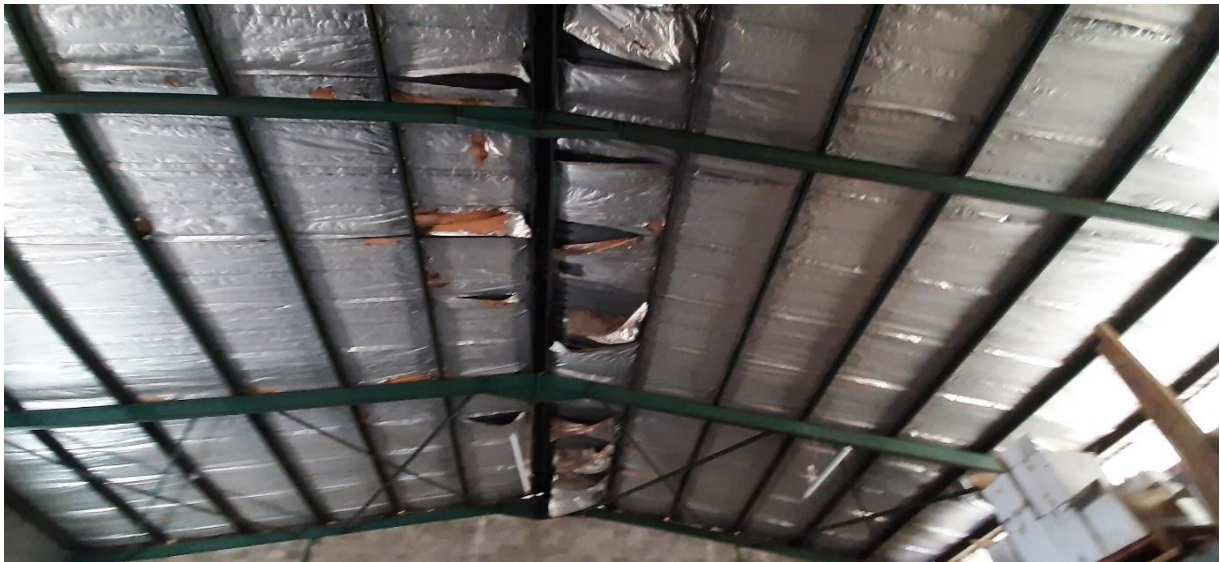
Figure 20: Disrepair of interior roof of the central portion of the warehouse.

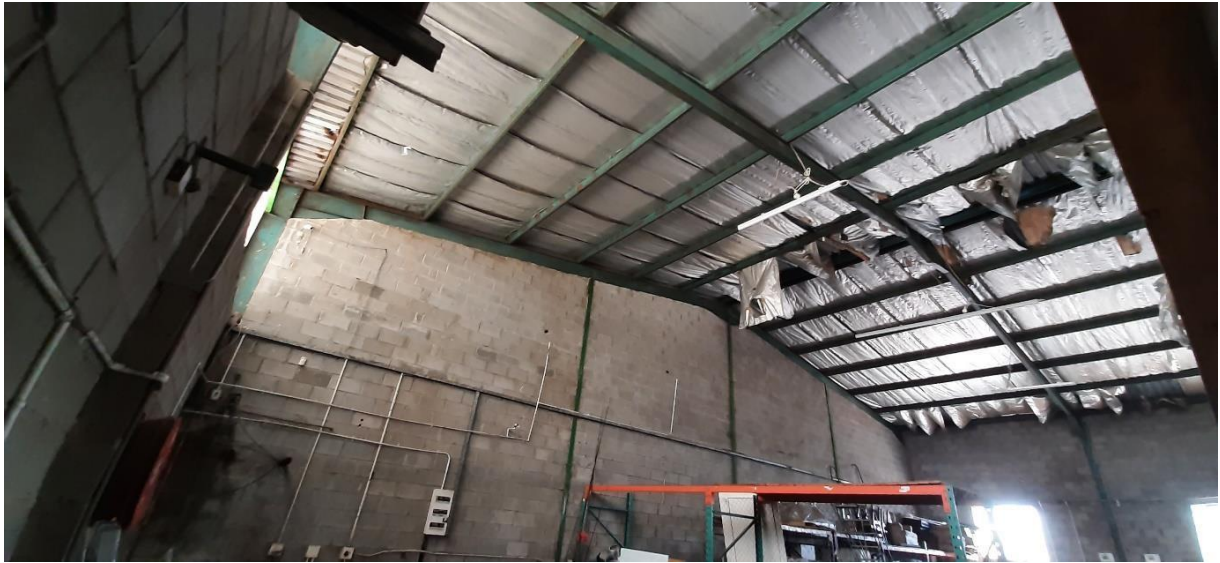
Figure 21: Disrepair of the interior roof on eastern side of warehouse.

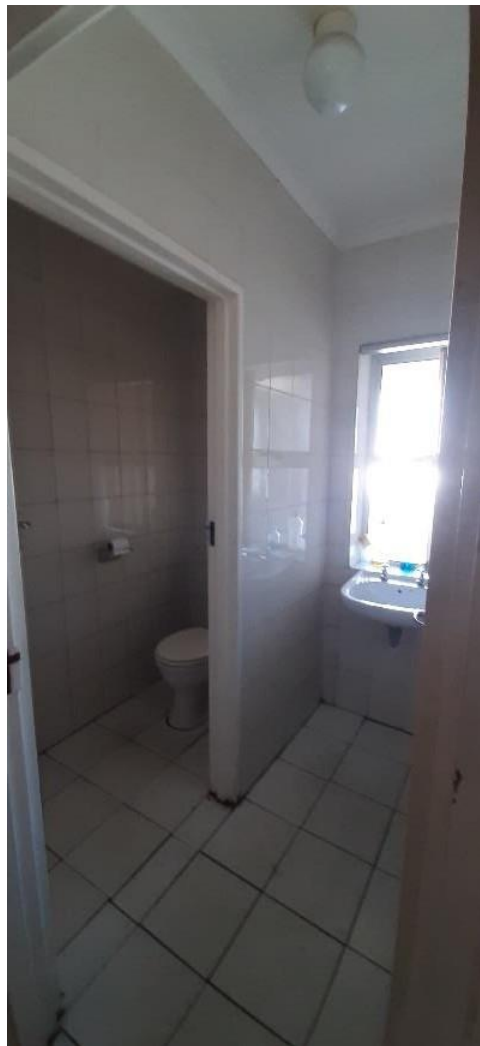
Figure 22: One of the existing ablution facilities inside the warehouse.

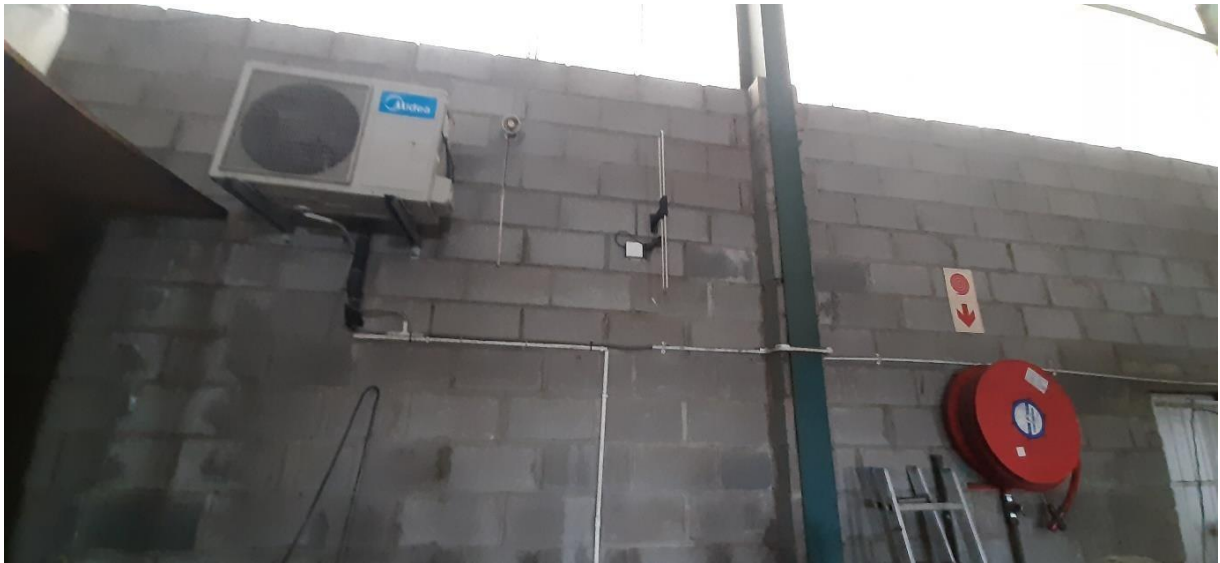
Figure 23: Existing fire hydrant and air conditioner in eastern portion of the warehouse.

- All firefighting equipment will be checked for compliance and additional will be added on, based on the relevant requirements pertaining to fire safety for such a facility.
