**Section 24G Application for the Unauthorised
Construction of a Road and Clearance of Vegetation at
Farms Portion 1, Platte Kloof 131 and Remainder Holle
Kloof 91 within the George Local Municipality,
Western Cape Province**

Botanical Compliance Statement

Prepared for Sharples Environmental Consultants

June 2022; October 2022

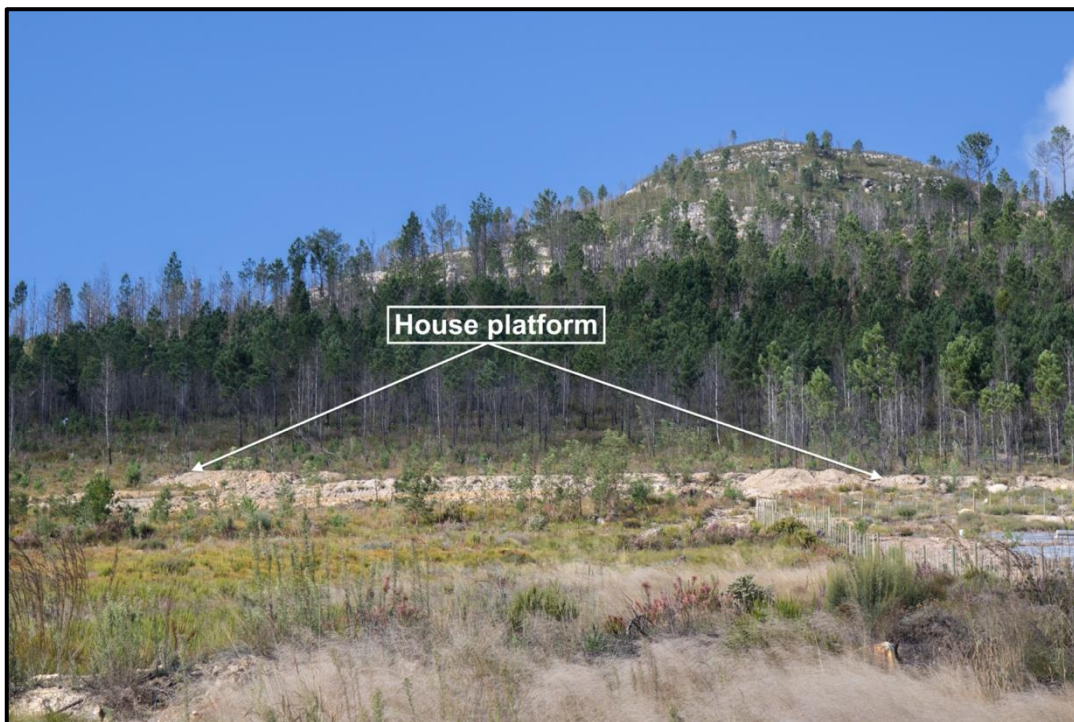
Figure 1. The cleared 'house platform' on the north-facing sandstone slopes of Geelhoutboomberg.

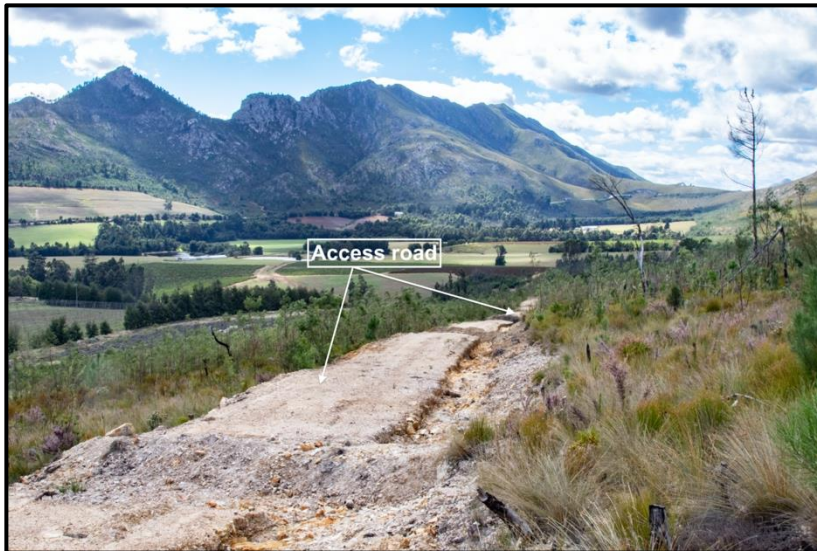
Figure 4. The access road that extends north-eastwards from the 'house platform'.

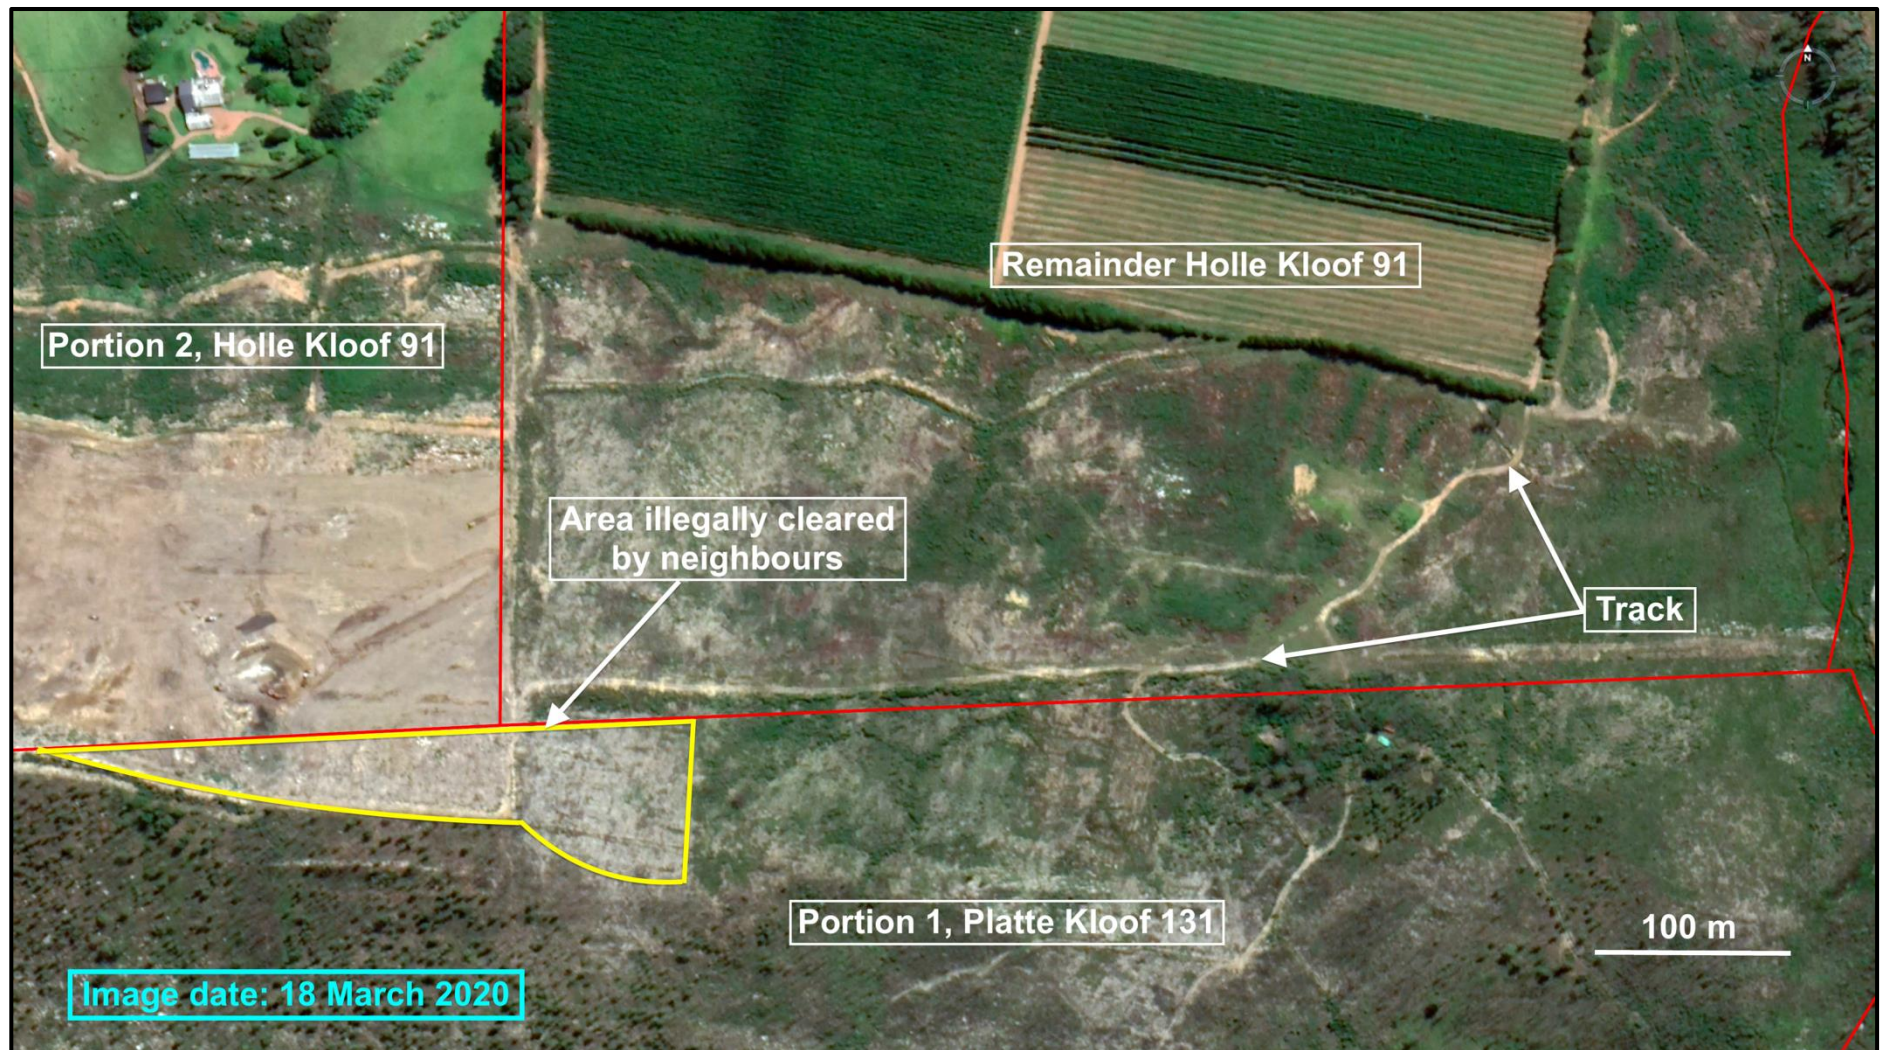
Figure 10. The disturbance regime in the area of interest, showing that Portion 1, Platte Kloof 131 was transgressed and cleared by the neighbours prior to March 2020.

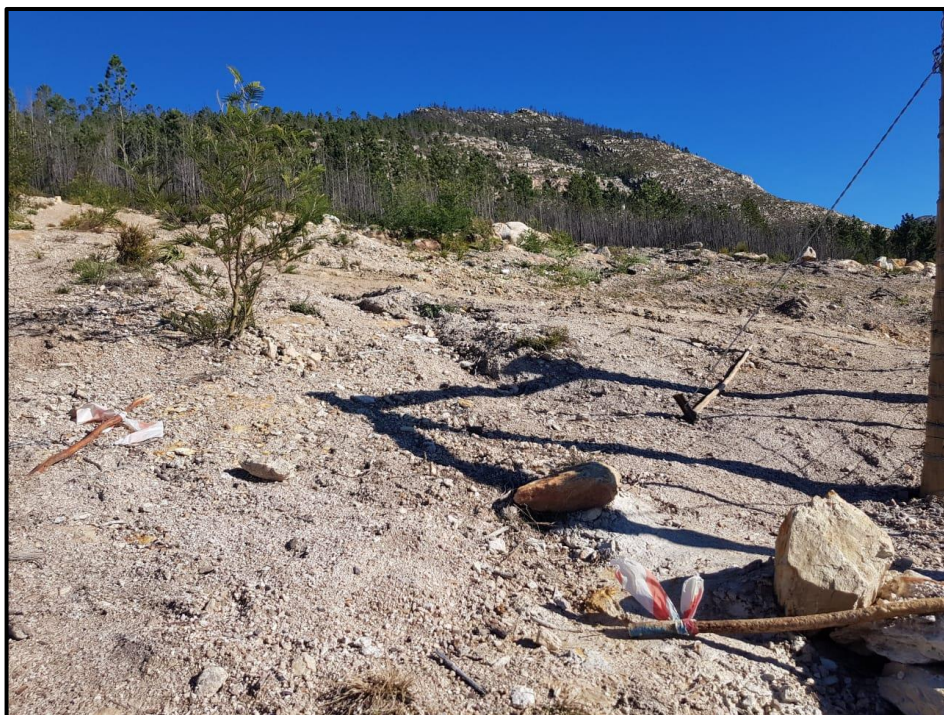
Figure 11. Unlawful clearing at Portion 1 Platte Kloof 131 prior to 2020

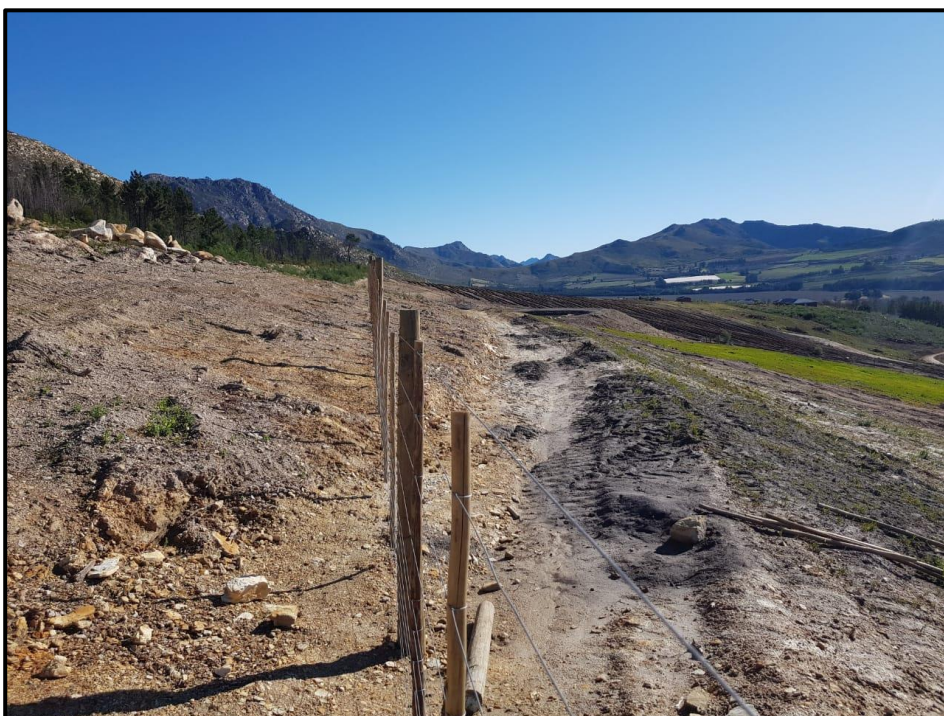
Figure 12. Unlawful clearing at Portion 1 Platte Kloof 131 prior to 2020

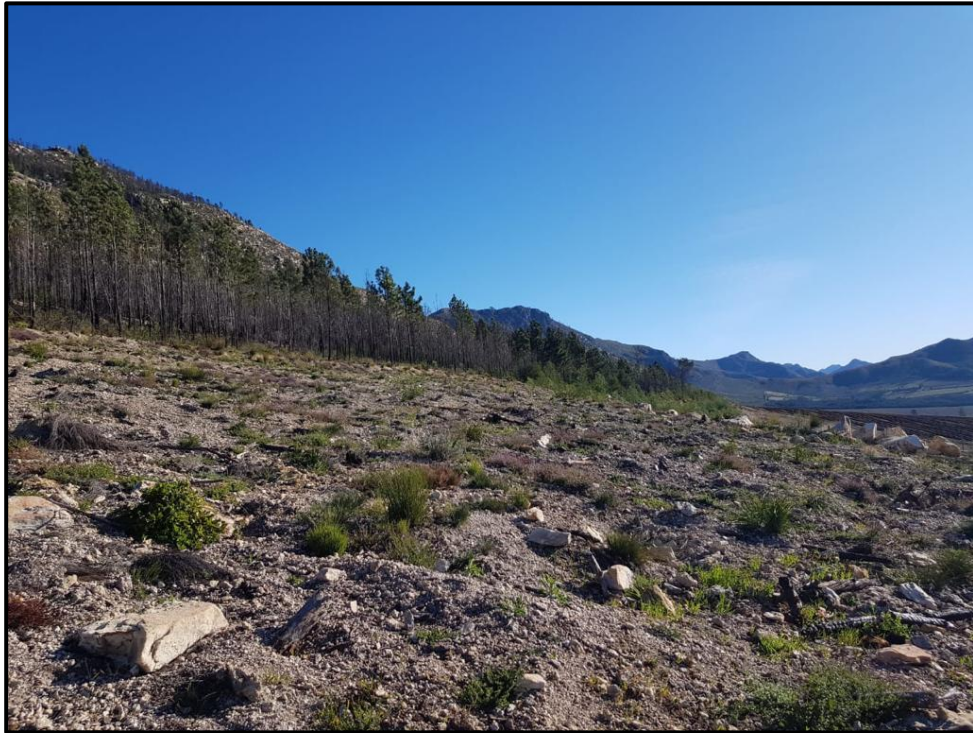
Figure 13. Vegetation regrowing on the cleared site prior to the earthworks to establish a house platform.

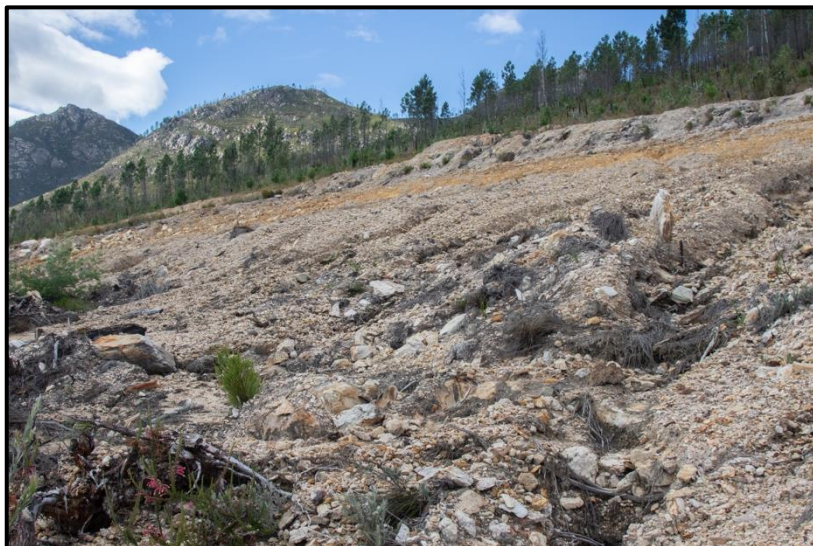
Figure 14. The cleared area where the house platform was established.

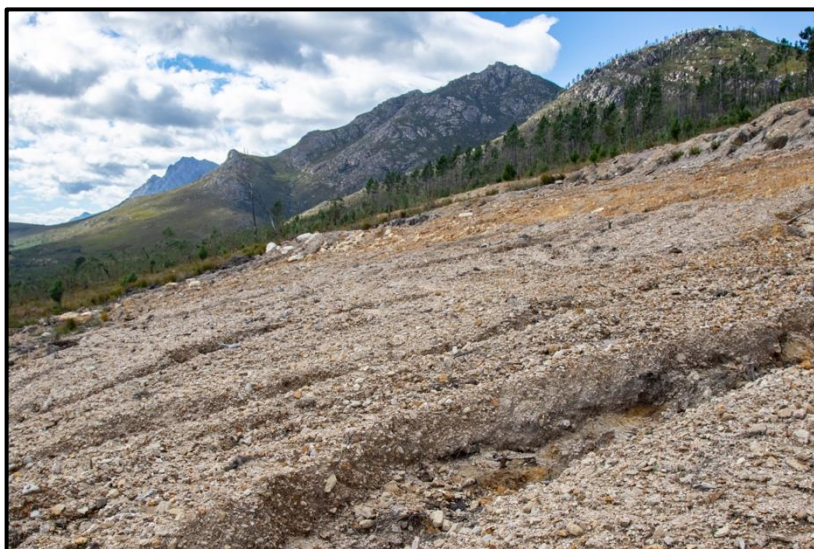
An unfortunate sequence of events followed since on 22 November 2021 an extreme rainfall event over the Garden Route of the Western Cape Province resulted in significant flooding in George and surrounding districts. The area of interest at Portion 1, Platte Kloof 131 was also strongly negatively impacted by the heavy rain, resulting in erosion of the 'house platform' (Figures 14 & 15) and severe erosion of the access road (Figures 17—22).

Figure 15. The cleared area was also severely eroded in November 2021.

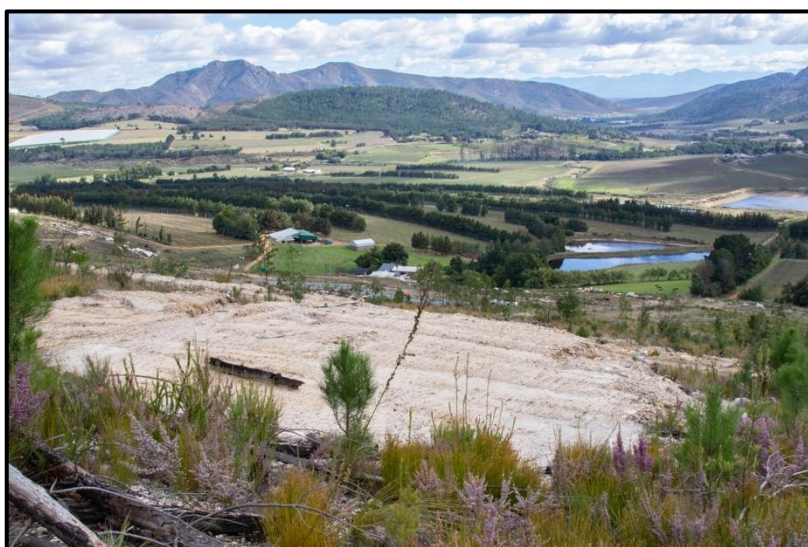
Figure 16. The small platform above the house platform.

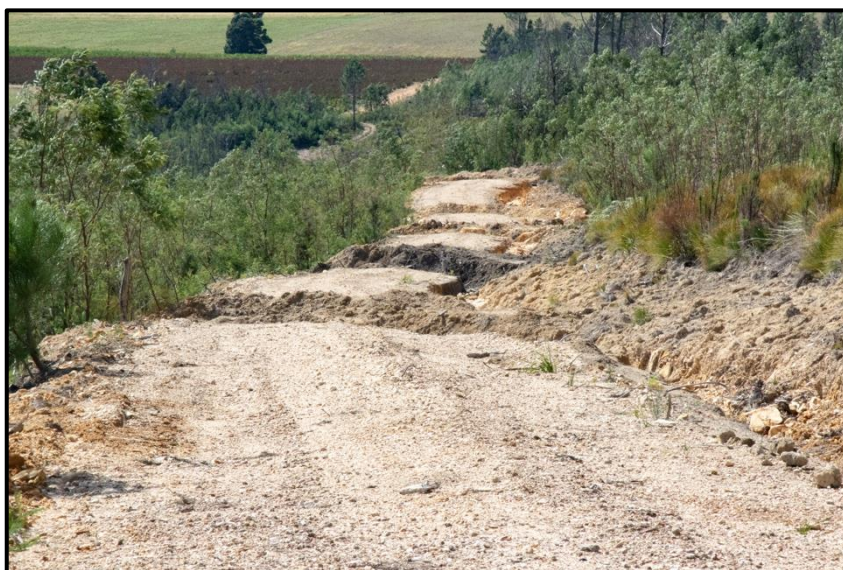
Figure 17. View northeast down the access road showing the severe erosion.

The greatest and unintended consequence of the unauthorized activities was that the road (and to a more limited extent the house platform) was not finished and thus not properly drained prior to the heavy rain of 22 November 2021, resulting in the high degree of erosion and formation of dongas as depicted in Figures 17—22.

- As much as it was necessary to stop the house platform and road construction in 2021, it is now imperative that the rehabilitation of the damage caused by the heavy rain should be permitted as soon as possible. The road must be carefully drained with pipes and humps (water bars) to divert the water from running directly down the road. Gabions may also be necessary in the dongas to slow the water velocity. At the point where the water cut through to disgorge into the catchment of the Kleinbos River, gabions must be installed to divert and prevent runoff water from running into the stream.

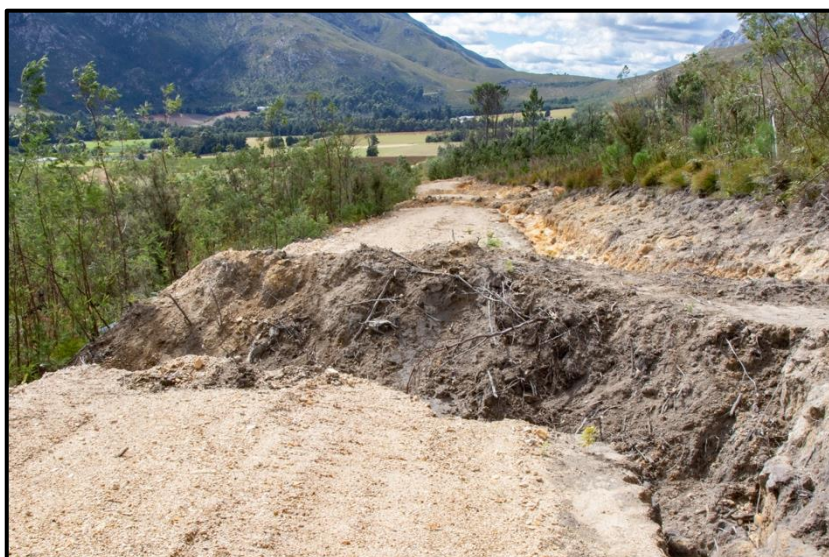
Figure 18. Dongas were formed across the access road by the stormwater runoff.

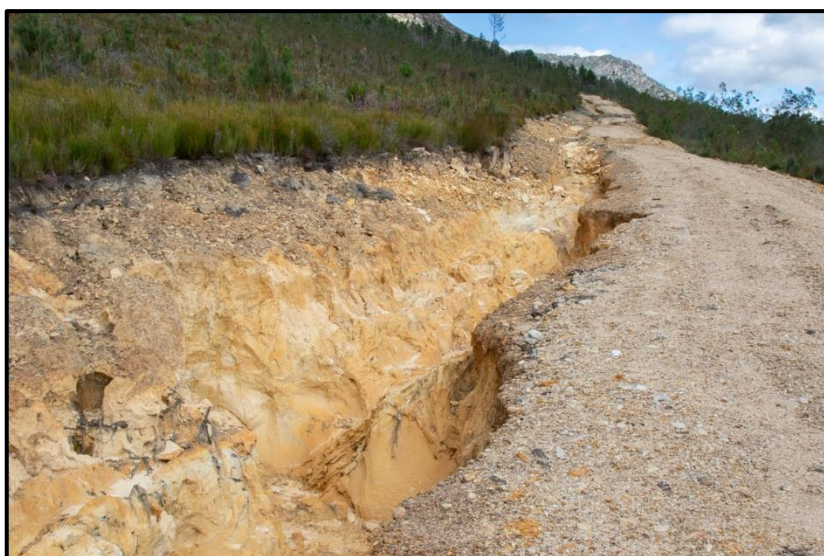
Figure 19. A deep donga down to bedrock formed on the upper side of the access road.

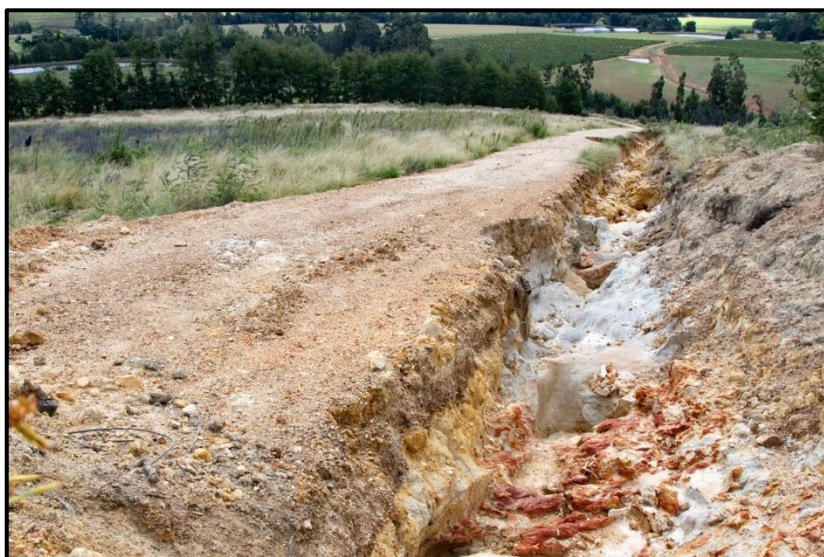
Figure 20. View northeast down the donga formed alongside the access road.

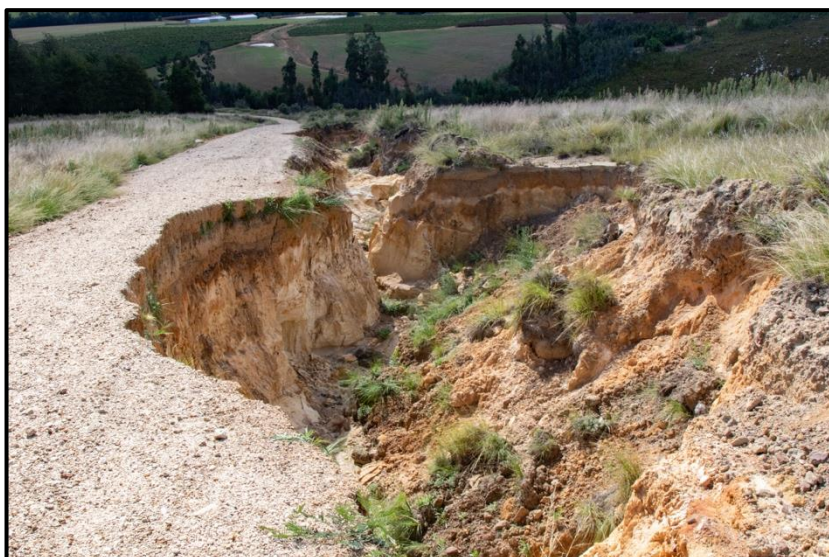
Figure 21. Sections of the access road were almost completely washed away.

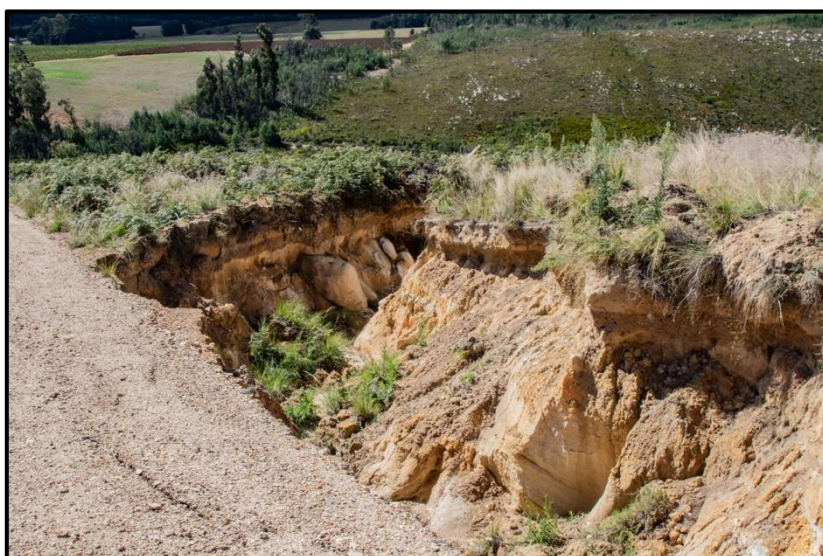
Figure 22. The point at which the donga broke through to the east and disgorge water into the catchment of the Kleinbos River.

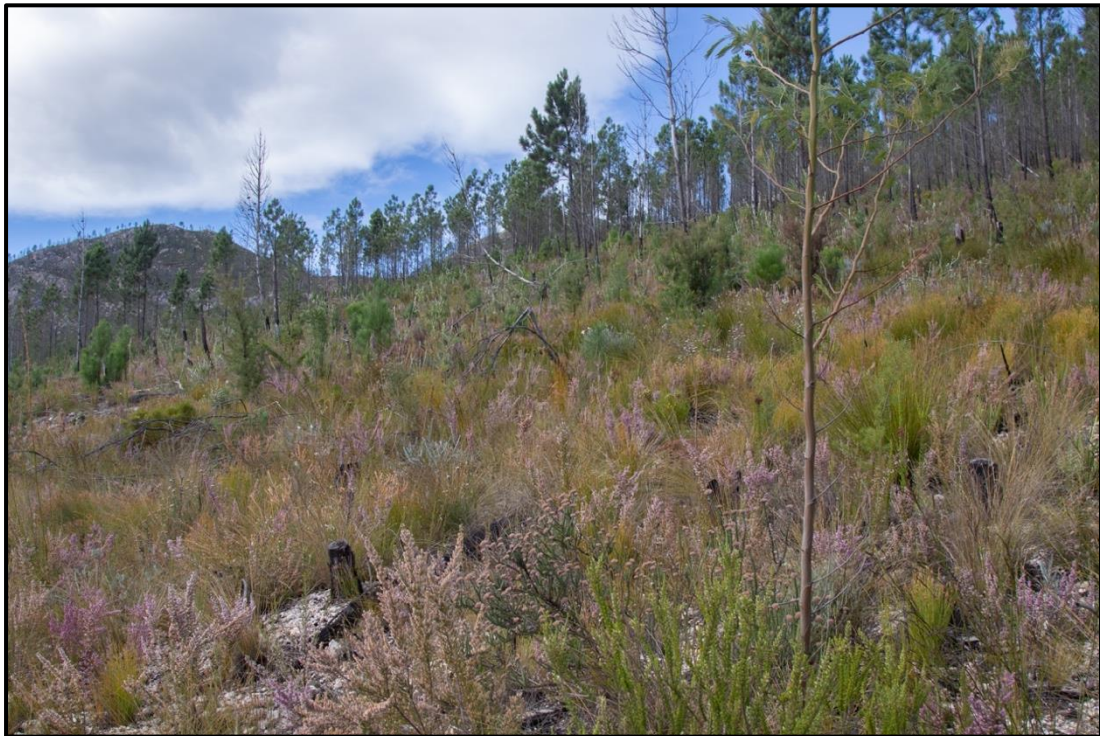
Figure 24. South Outeniqua Sandstone Fynbos on the slope above the house platform, strongly invaded by exotic pine trees and hakea shrubs.

Apart from the remediation that is the central issue of this investigation, every effort must be made to control the growth and spread of the above alien invasive plant species. In fact, it is a legal requirement for landowners to keep their property free of these aggressive invaders.

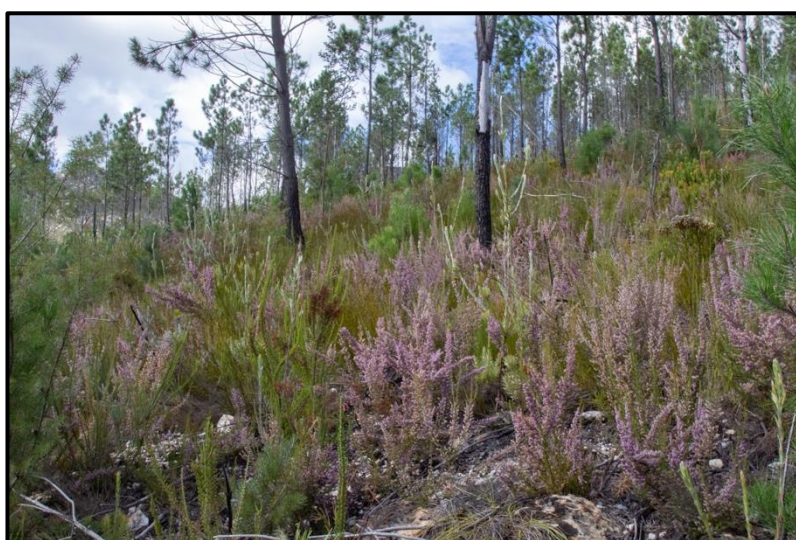
Figure 26. Low to mid-high
ericoid—restioid fynbos
representing South Outeniqua
Sandstone Fynbos on a north-
facing slope, invaded by alien
pine trees and hakea shrubs.

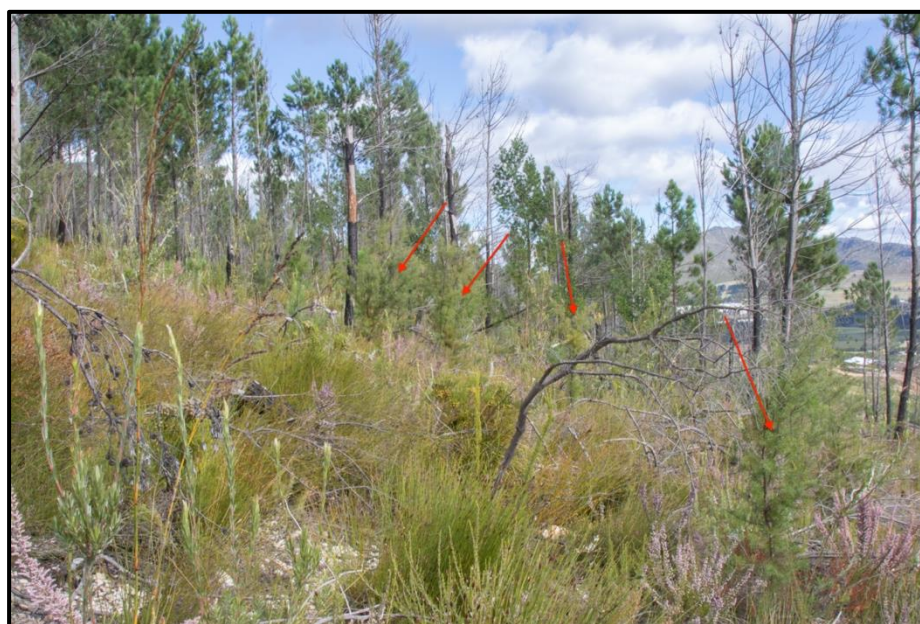
Figure 31. Unless cleared the *Pinus radiata* and *Hakea sericea* (red arrows) will suppress the growth of the indigenous fynbos.

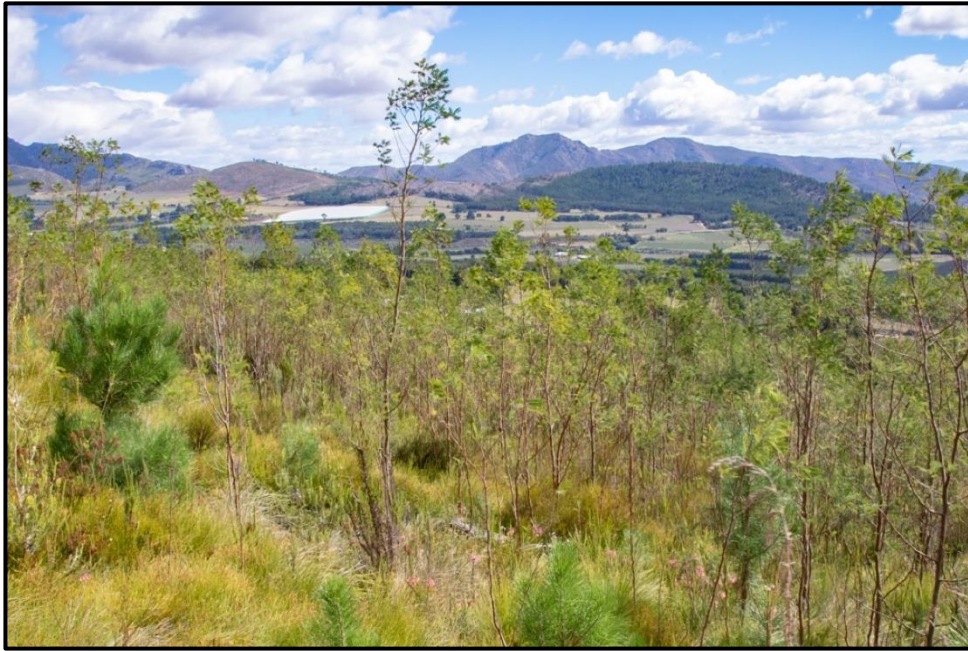
Figure 32. A strong stand of black wattle (*Acacia mearnsii*) stimulated to grow by the last fire. These saplings should be urgently cleared to curb their spread.

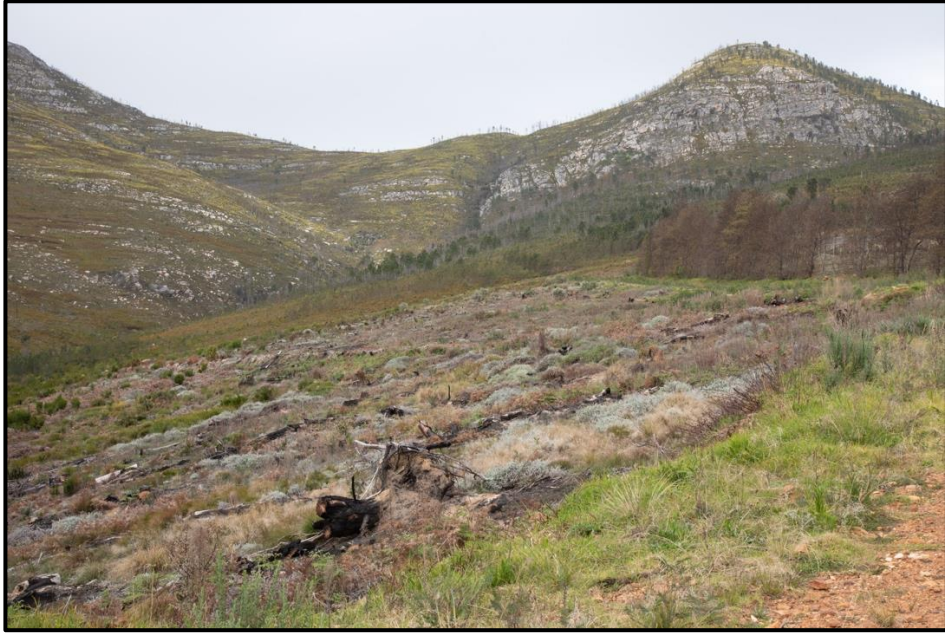
It is safe to say that there is no intact indigenous plant community anywhere adjacent to the section of road investigated. The environment is extremely disturbed and generally invaded by alien black wattle (*Acacia mearnsii*) and Kikuyu grass (*Pennisetum clandestinum*). A pine plantation was formerly present on the east side of the road, but it was burnt in the last severe fires in the area and the burnt trees have been felled. Opportunistic *Seriphium plumosum* (slangbos), grasses and other ruderal species have established in the burnt area (Figure A2).

Figure A2. The area of the burnt pine plantation, now invaded by opportunistic ‘weedy’ plant species.

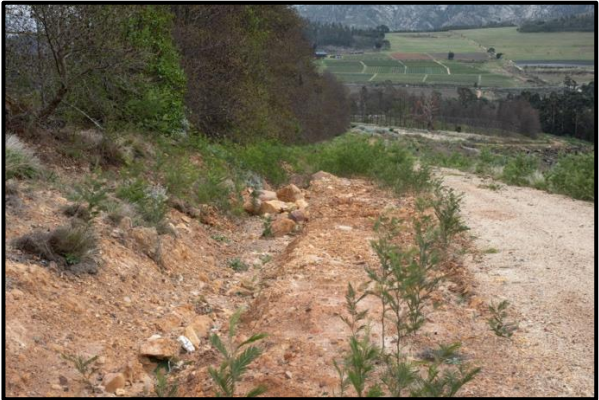
<p>The side drain alongside the upgraded track. This drain was partly washed out during the floods.</p>

<p>The side drain on the west side with invasive wattle saplings, with similar growth of wattle saplings on the east side of the upgraded track.</p>
 	<p>A view northwards showing the track where it has not been upgraded, with invasive wattles and Kikuyu grass on both sides. The trees on the west side (left side of image) are birch trees used as a windbreak for the hop orchard.</p>
 	<p>The track has been blocked at this point and runoff from the track is channelled into an area where less erosion would be caused.</p>
 	<p>Pipes intended for laying in the track / road side-drain to limit erosion.</p>

It is strongly recommended that the alien invasive black wattle saplings should be cleared as soon as possible before they become large, and the exercise becomes unwieldy and costly.

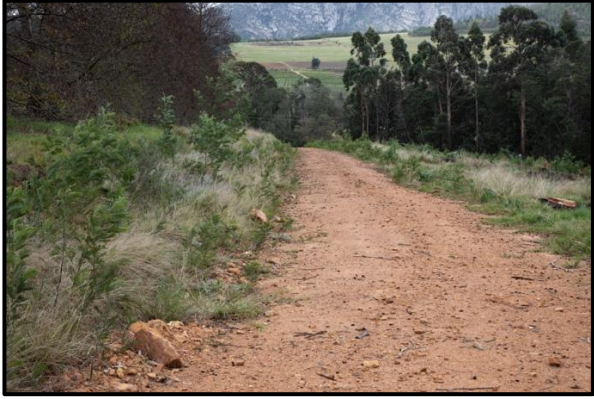
<p>Near the lower end of the road, the side drain is becoming blocked by wattle saplings and grass. (View northwards).</p>
 	<p>View southwards, up the track, with the side drain on the right side having been severely washed out by the heavy water flow.</p>
 	<p>Owing to current non-use of the track it is becoming overgrown by Kikuyu grass and other invasive plant species.</p>
