PREEKSTOEL BEACH LIFESTYLE ESTATE DEVELOPMENT ON ERF NO. 1028 AND PORTION 2 OF ERF NO. 599, STILL BAY EAST

REHABILITATION OF DUNES ON ERF 1028

METHOD STATEMENT

Date: November 2021

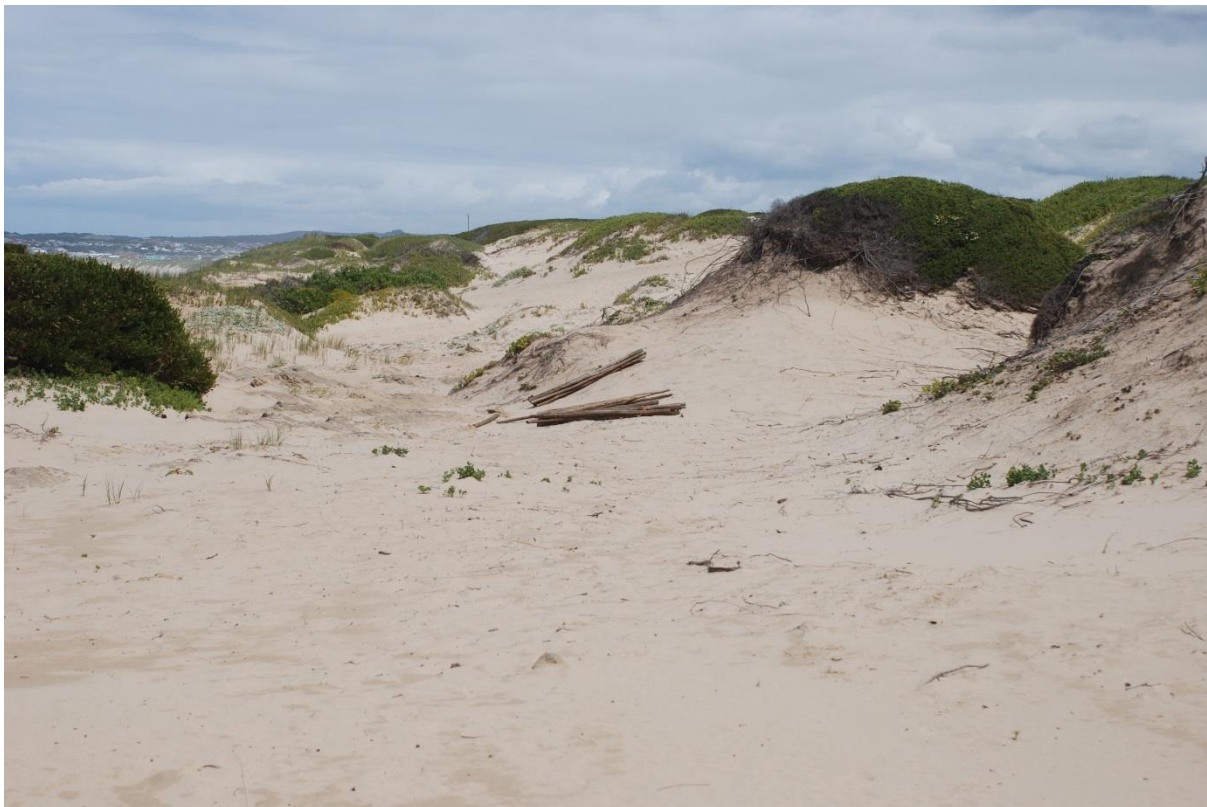
The public had uncontrolled access to the beach of Preekstoel from the 1960's onwards to today, where off-road vehicles were seen driving over the frontal dune system. Together with anthropogenic access to the frontal dune system of Preekstoel, these dunes suffered excessive erosion with the removal of dune vegetation, leading to large blowouts (**Photo 1**) and sand mobilisation into the interior (**Photo 2**).

Photo 1: Shows the large blow-outs on the frontal dune system on the Preekstoel Beach

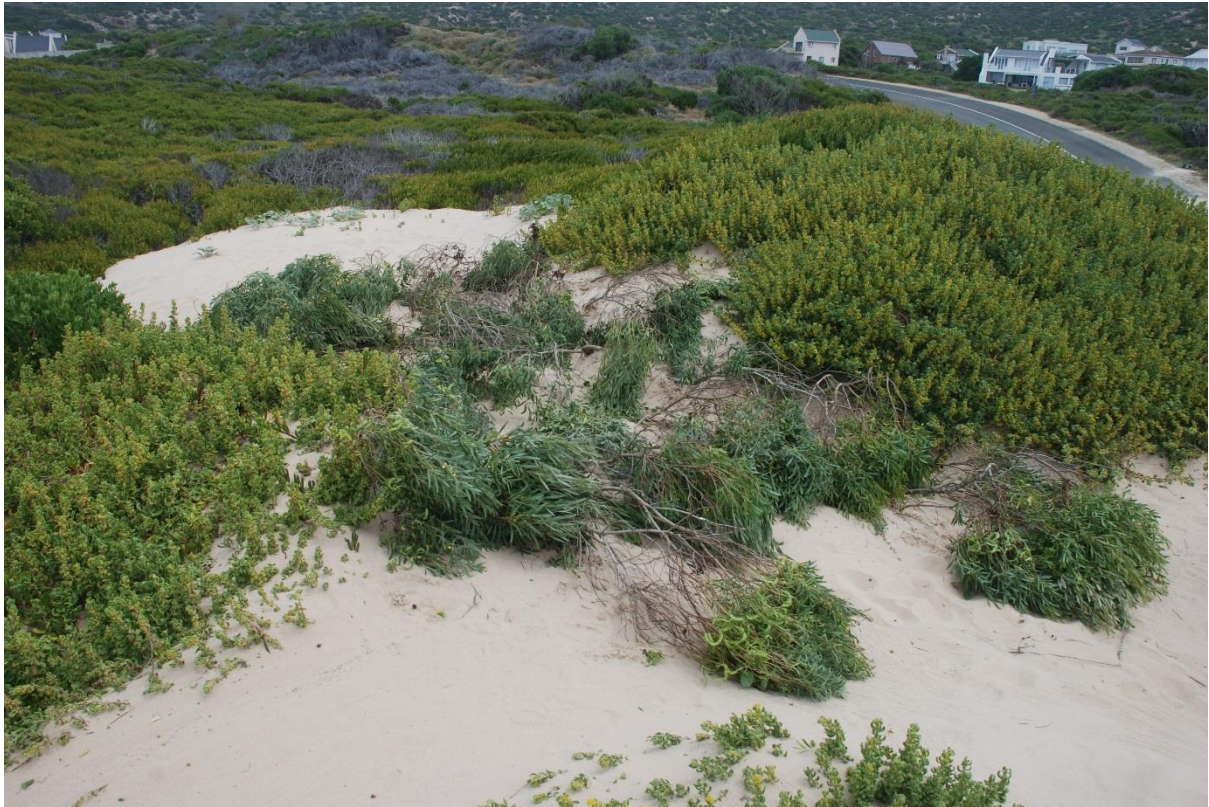
Photo 2: Brushwood has been packed on the open dune sand that has been blow into the backdune area.

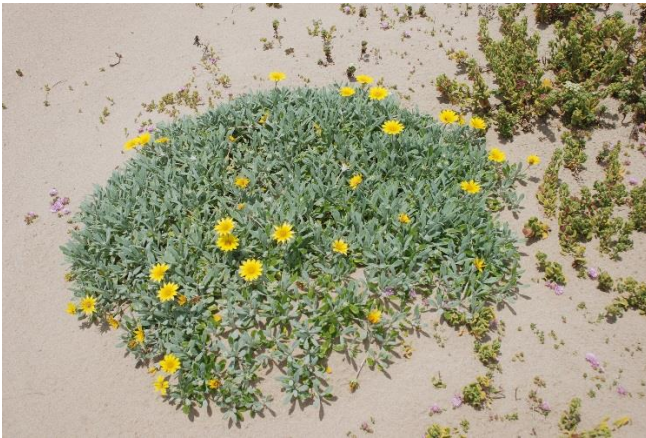
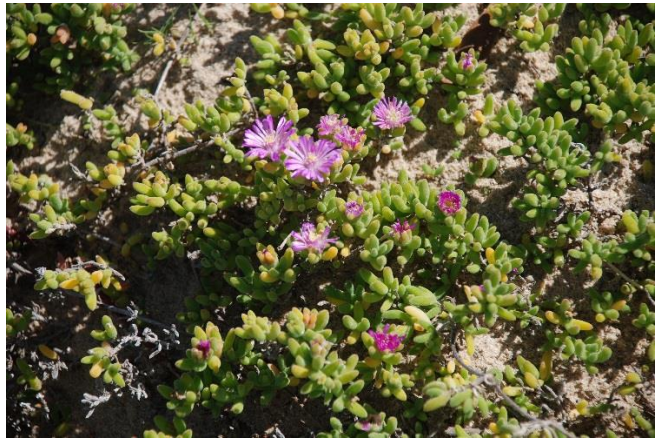
Photo 3: Indigenous Strandveld dune plants that will be used to stabilise the newly formed dunes.

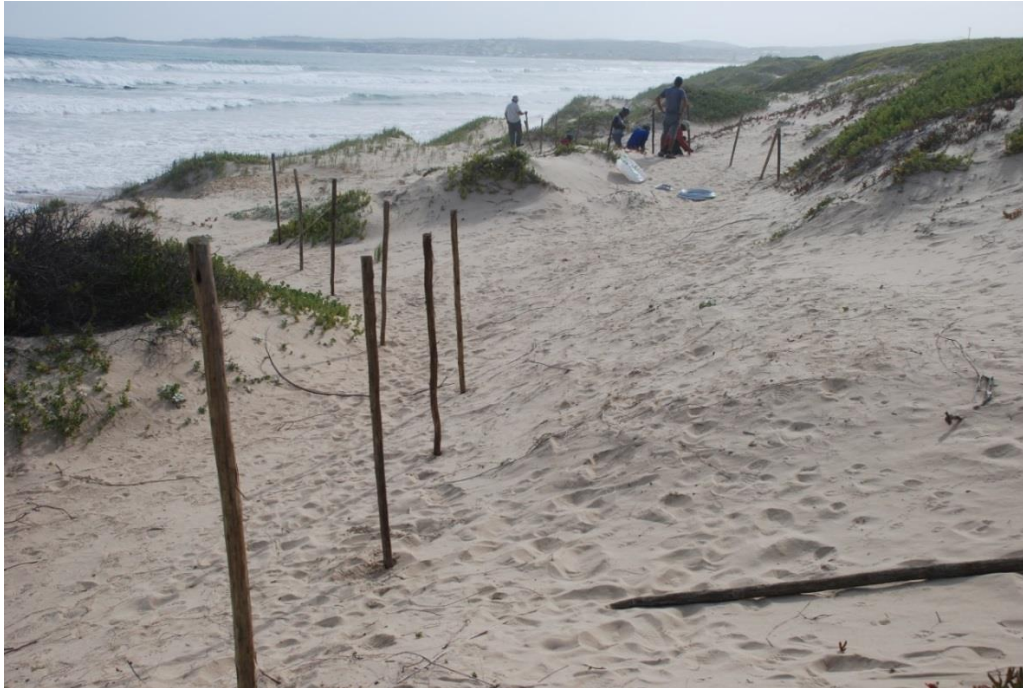
Photo 4: The layout of poles where sever wind erosion has taken place. Three strands of wire is attached to the poles about 1m off the sand.

A three-strand wire fence using 1.8m long, CCA treated gum poles between 32mm and 50mm in diameter was erected where sand trapping was necessary and where existing dunes needed protection from wind erosion (**Photo 4**).

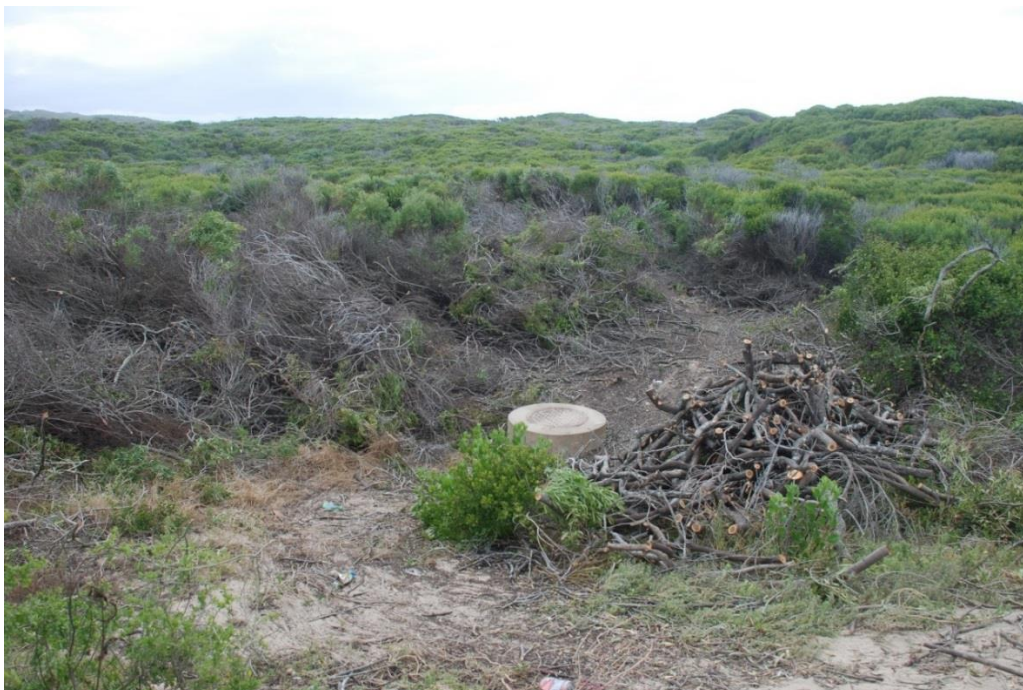
Photo 5: Brushwood was cut from the backdune area.

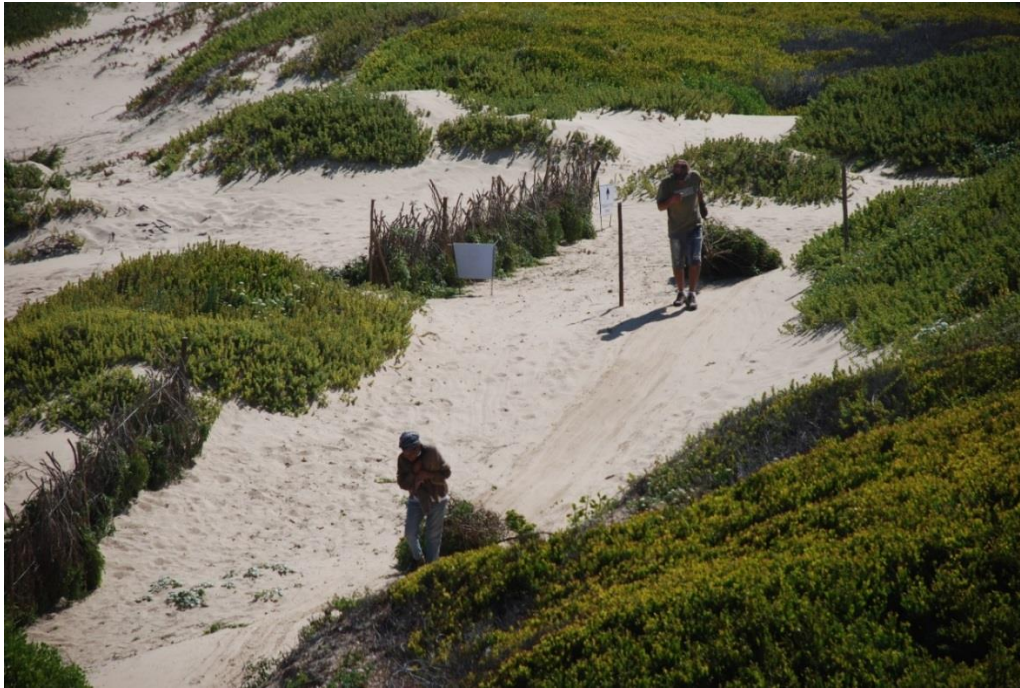
Photo 6: Brushwood was dragged to the areas where brushwood fences were erected. Note the brushwood fences to the left of photo.

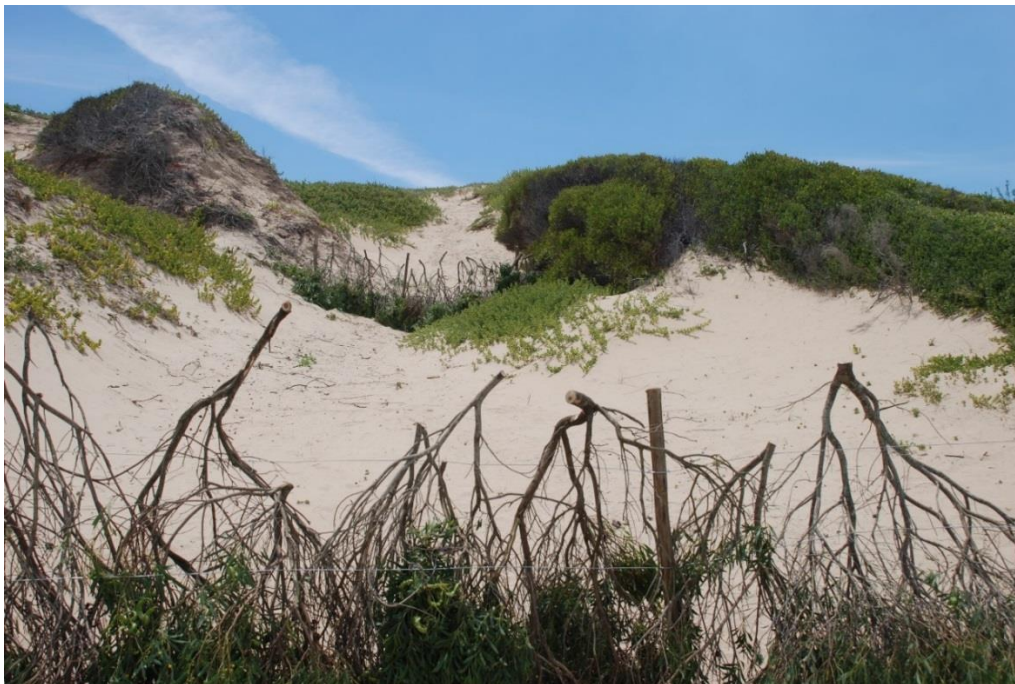
Photo 7: The brushwood was weaved between the wire strands and fixed to the wire with binding wire. Not the large blow-out towards the back of the dune. A brushwood fence has been placed in the blow-out to trap windblown sand.

Approximately 1m long brushwood fronds (rooikrans) were cut by chainsaw in the back-dune area where the development of the houses is to take place (**Photo 5**). The brushwood fronds were then dragged to the erected fences (**Photo 6**), where they were woven into the fence and fixed to the fence with binding wire (**Photo 7**).

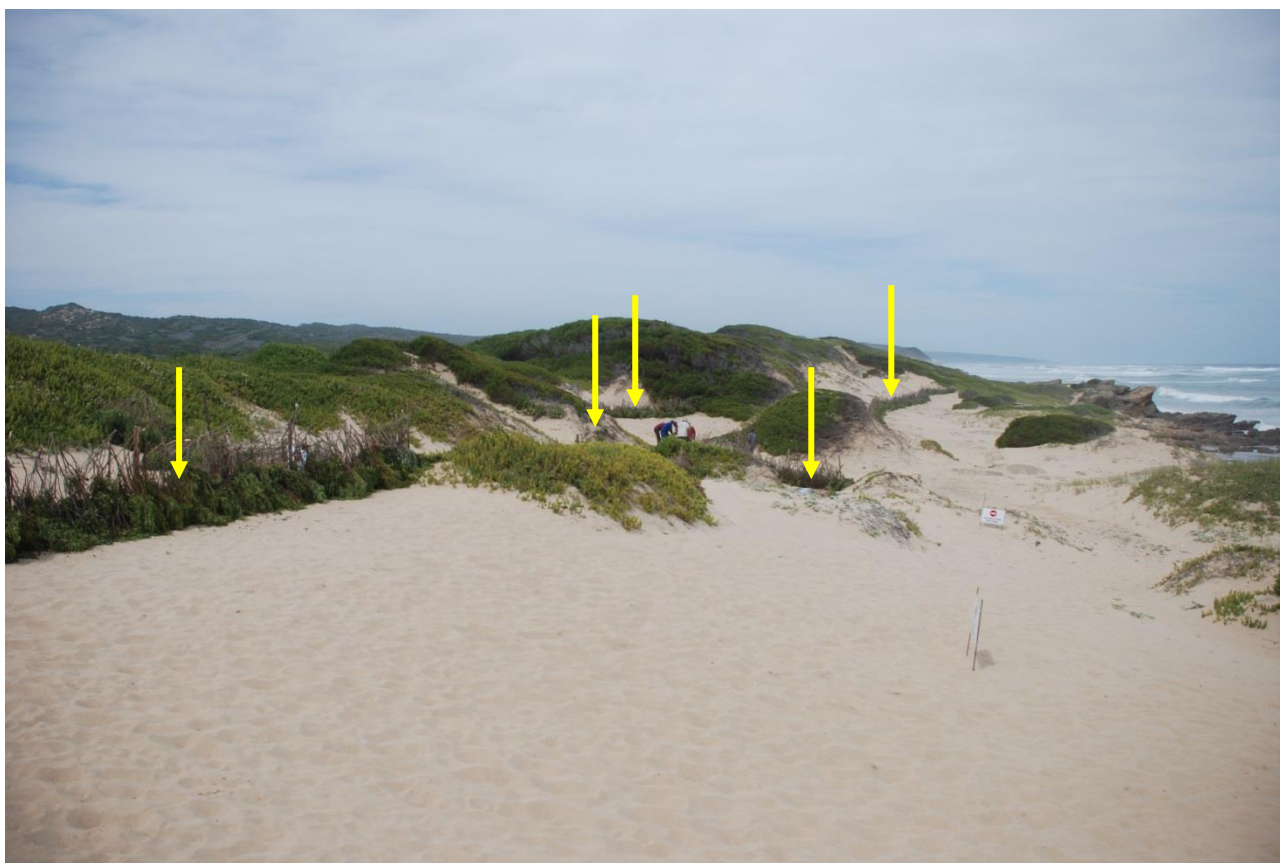
Photo 8: About 220m of brushwood fencing (arrows) has been erected on the highly eroded Preekstoel frontal dune system.

In all, about 220m of brushwood fences have been erected within the Preekstoel frontal dune system (**Photo 8**). Once sufficient sand has been trapped, a second phase of brushwood fencing will be constructed on the dunes (**Figure 1**). Further phases will be undertaken until a robust frontal dune system has developed.
