ENVIRONMENTAL CONTROL COMPLETION REPORT

MOLEN CLOSE RIVER REHABILITATION

Remainder of Farm 464, George

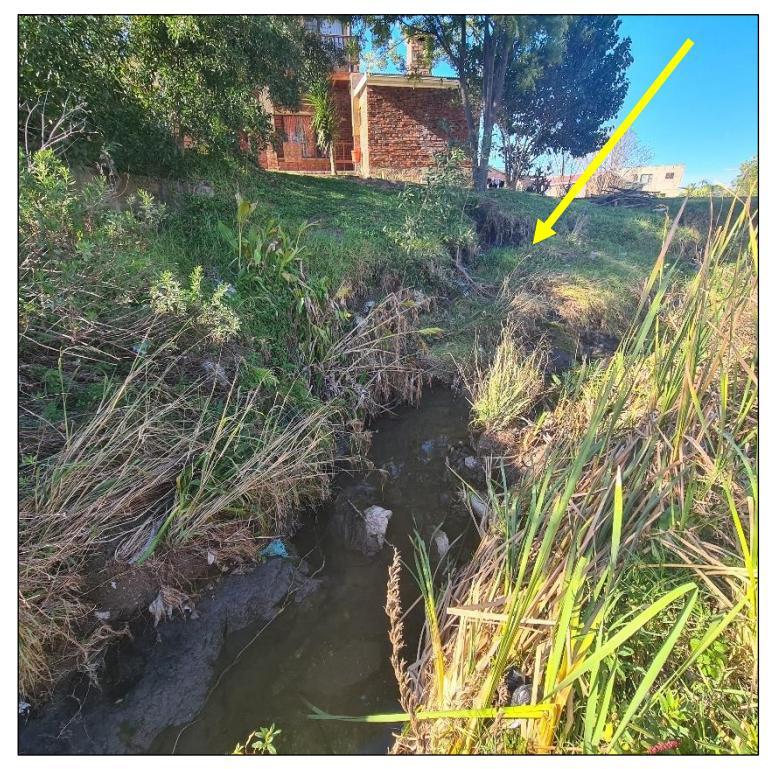
Figure 2: Eroded area next to erf 21150 in need of emergency rehabilitation.

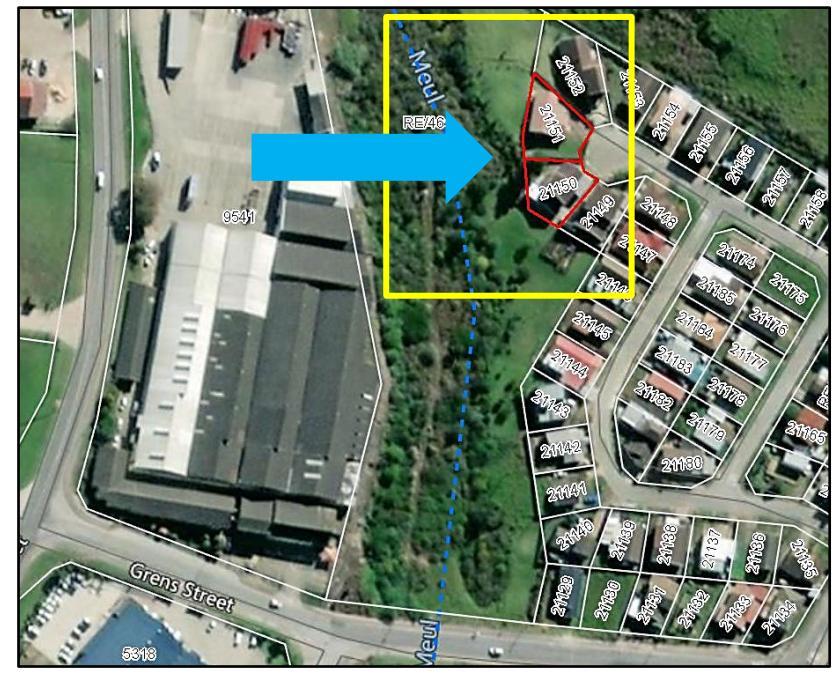
Figure 3: Locality of main area of concern which is along Erven 21150 & 21151 (red outlined properties) with the eroded area indicated with the BLUE arrow.

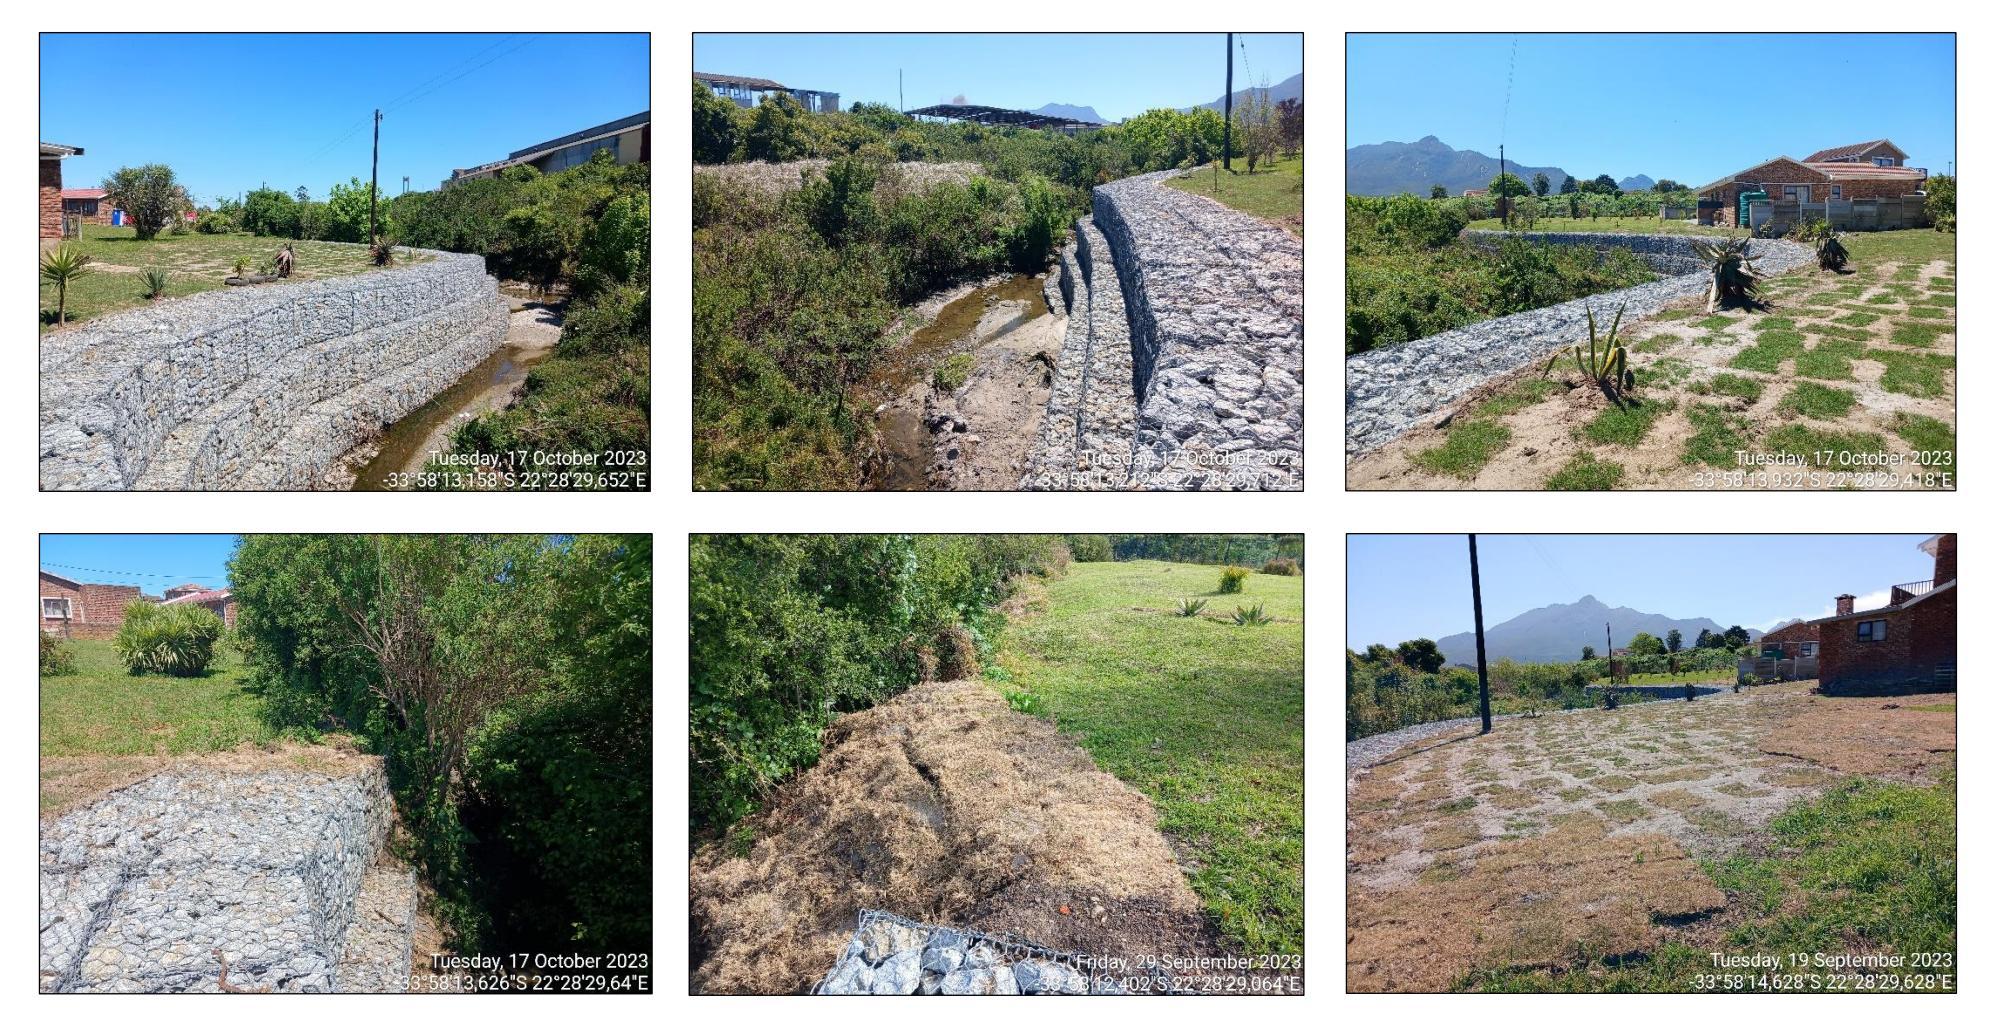
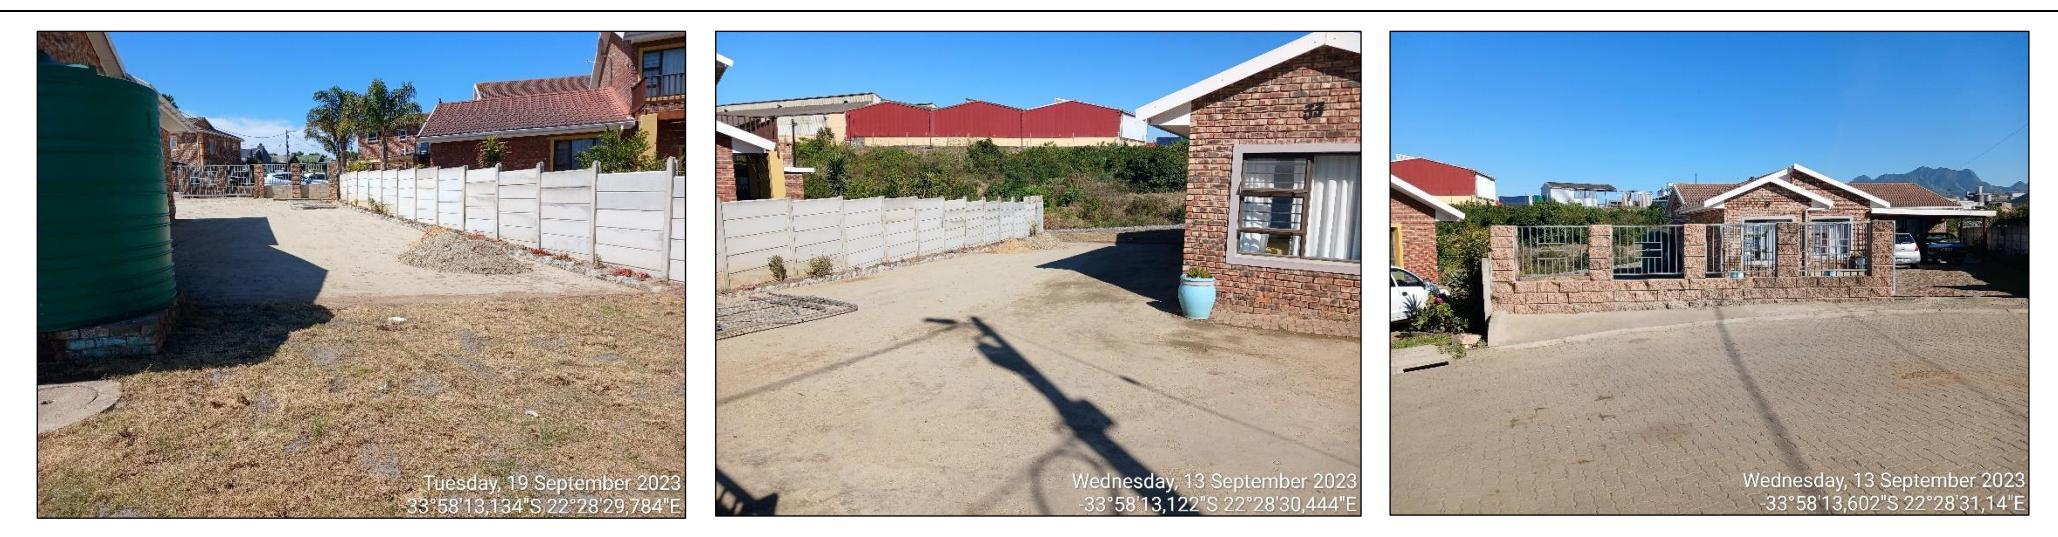
3. PHOTOGRAPHIC EVIDENCE OF FINAL SITE INSPECTION

Gabion baskets must be inspected for differential settlement caused by major storm events	Operational phase	To be inspected.		
Best Practise				
Construction work must take place during normal work hours.	✓	Compliant.		
Additional Actions				
Temporary access to the site changed from via Grens Street to via Molen Street through erf 21151 and a portion of erf 21150. Temporary access was approved on condition that (a) the landowners provide consent, (b) the temporary access must be rehabilitated, (c) the garden on erf 21150 must be re-instated and (d) the wall between erven 21151 and 21150 must be re-build.	~	Compliant. Note: The landowner of erf 21151 asked if the contractor could leave the gravel of the temporary access on his property and not to re- plant the grass that was initially there. This was approved on condition that all areas outside the private erven boundaries of 21150 and 21151 be rehabilitated (photograph i - k).

Upon final site inspection, the ECO noted that an alien plant was planted in a disturbed area adjacent to the gabion structure. According to the Contractor, the landowner of erf 21150 has planted the alien plant. The ECO asked the Contractor to remove the plant as it is on Municipal ground. This has not been done.
