KOEBERG CABLE INFRASTRUCTURE UPGRADE

THE PROPOSED INSTALLATION OF SERVICES ASSOCIATED WITH THE KOEBERG NUCLEAR POWER STATION ON FARM DUYNEFONTYN 1552, DUYNEFONTEIN, CITY OF CAPE TOWN METROPOLITAN MUNICIPALITY, WESTERN CAPE PROVINCE.

Site Photographs

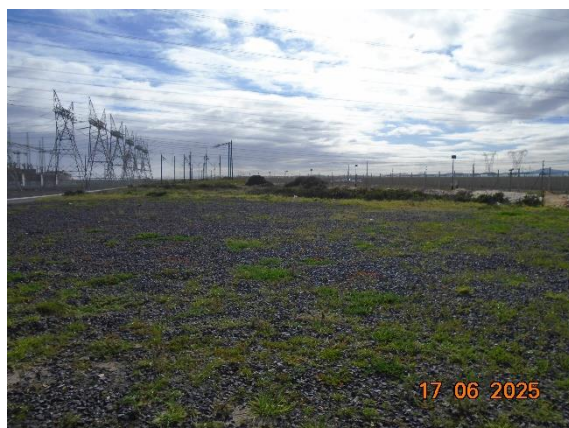
Figure 1. Gravel area (transformed) in the far eastern reaches of the proposed area of investigation. This image was taken facing north.

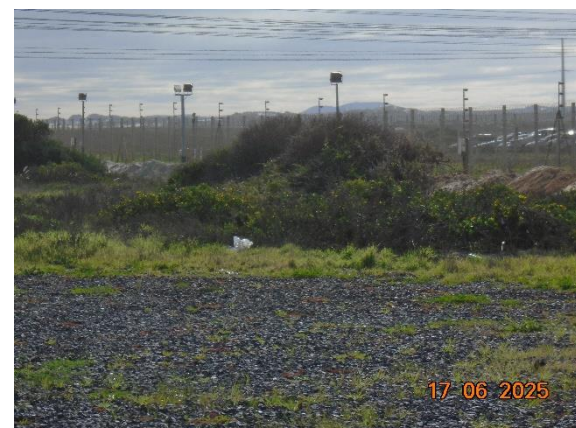
Figure 2. Vegetation adjacent to the Eastern fence line of the Koeberg Nuclear Power Station (KNPS). This image was taken facing north.

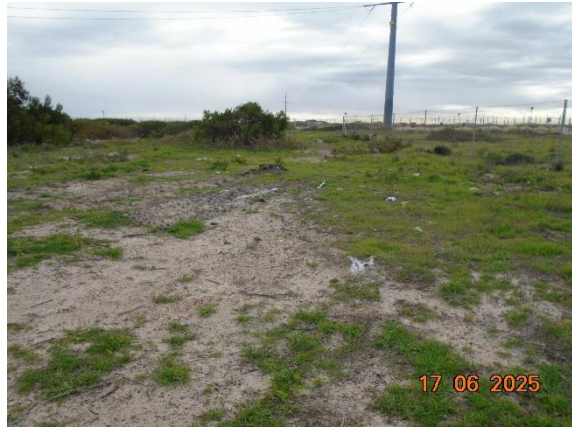
Figure 3. Vegetation within the KNPS showing bare patches of sand where vegetation growth did not persist. This image was taken along an access road facing south.

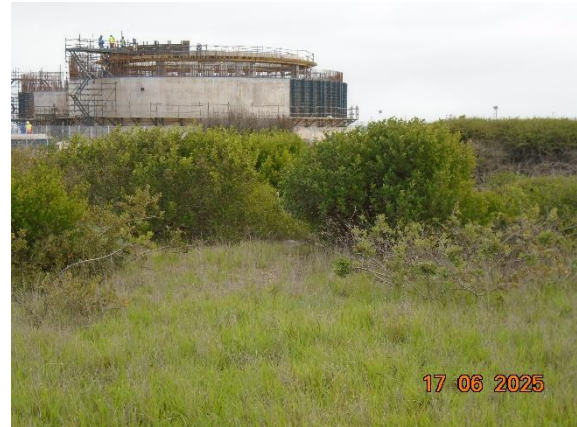
Figure 4. A visual representation of the vegetation cover within the proposed Area of Investigation. This image also indicates the hardened water reservoir currently under construction. This image was taken facing west.

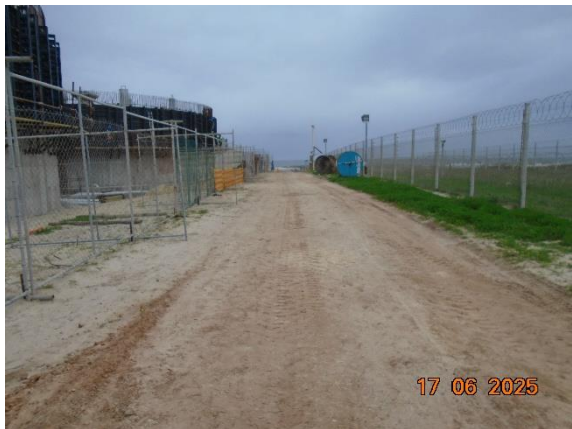
Figure 5. The Northern access road (Transformed area) leading past the current construction area of the approved hardened water infrastructure. This image was taken facing west.

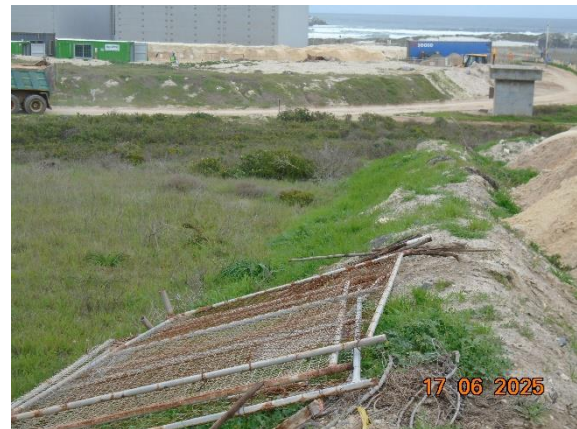
Figure 6. General site conditions within the proposed Area of Investigation indicating a vegetation pocket in between multiple transformed area. This image was taken facing west.

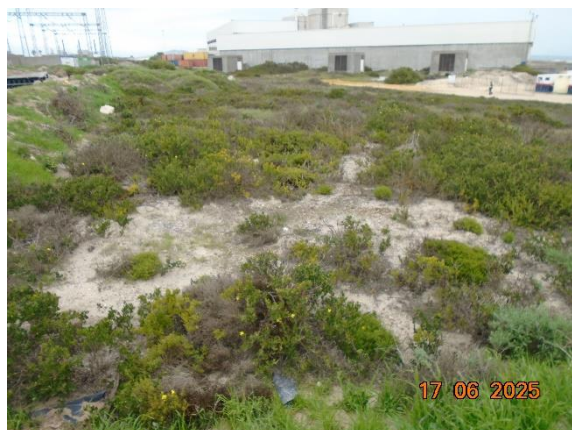
Figure 7. Vegetation within the KNPS showing bare patches of sand where vegetation growth did not persist. This image was taken facing south.

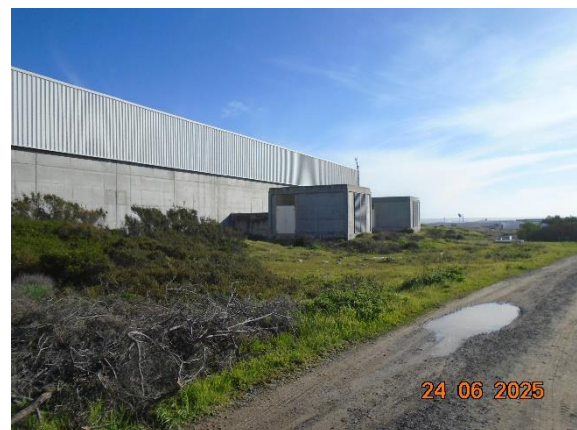
Figure 8. General site conditions within the proposed area of investigation. This image was taken facing north-west.

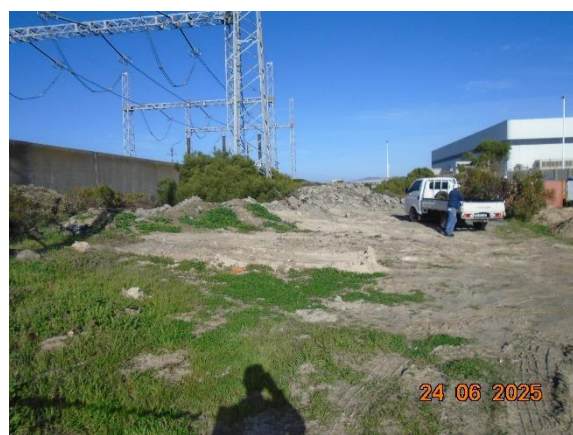
Figure 8. General site conditions within the proposed area of investigation. This image was taken facing south.

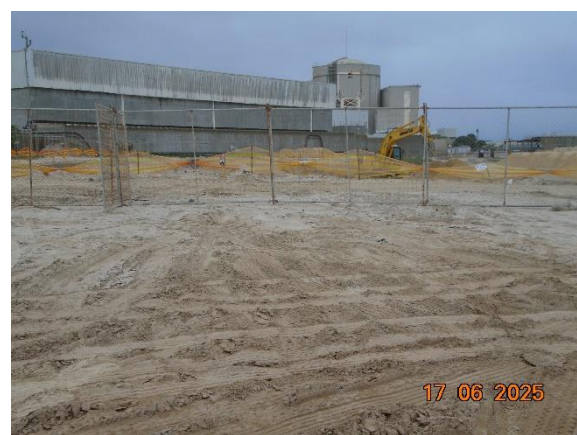
Figure 10. An area transformed within the proposed area of investigation. This area has been processed as part of the construction of the Temporary Infrastructure Storage Facility adjacent to the already constructed Original Steam Generator Interim Storage Facility. This image was taken facing west.

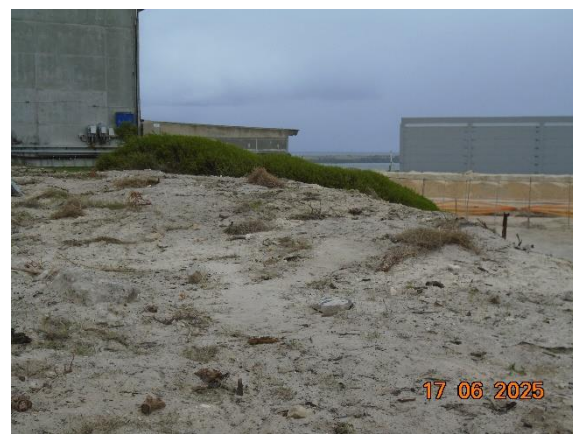
Figure 11. An area transformed within the proposed area of investigation. This area has been processed as part of the construction of the Temporary Infrastructure Storage Facility adjacent to the already constructed Original Steam Generator Interim Storage Facility. This image was taken facing south.

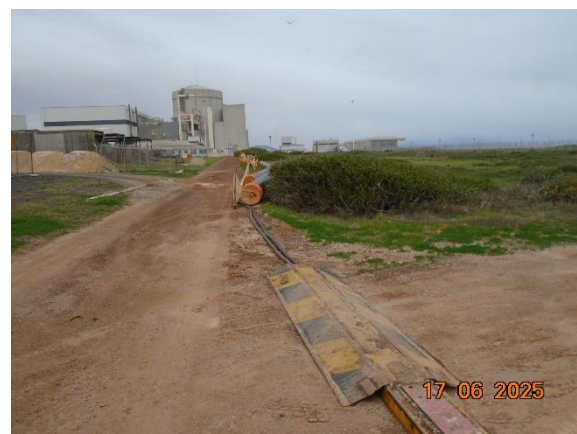
Figure 12. Areas transformed by the internal road network within the proposed area of investigation. This area is also located within 100 m of the highwater mark. This image was taken facing south.

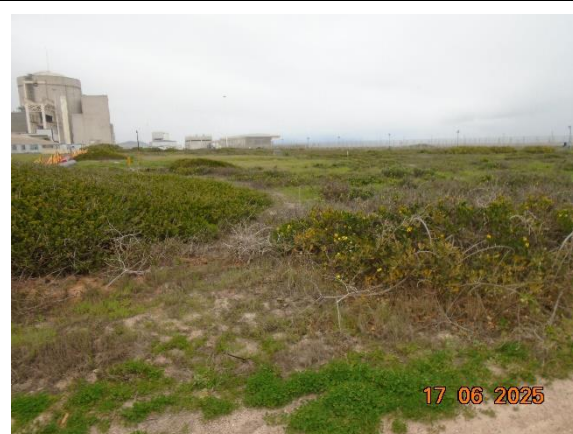
Figure 13. Vegetation located along the western portion of the proposed area of investigation. This area is also located within 100 m of the highwater mark. This image was taken facing south.

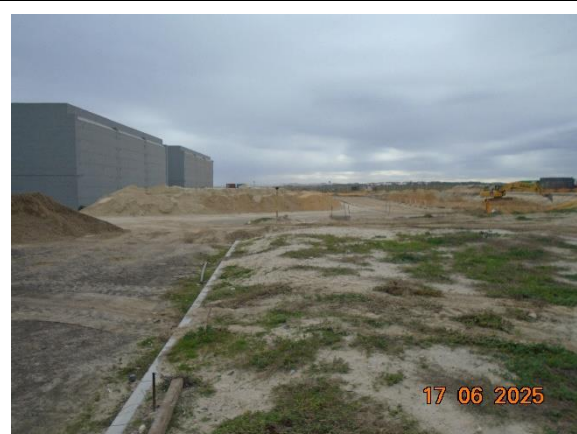
Figure 14. An area transformed within the proposed area of investigation. This area has been processed as part of the construction of the Temporary Infrastructure Storage Facility adjacent to the already constructed Original Steam Generator Interim Storage Facility. This image was taken facing north.
