# **PROPOSED PREEKSTOEL BEACH ESTATE**

## **ENVIRONMENTAL MAINTENANCE MANAGEMENT PLAN FOR THE REHABILITATION OF THE FRONTAL DUNE SYSTEM ON ERF 2341 STILL BAY EAST**

### **SHORT-TERM ENVIRONMENTAL MAINTENANCE MANAGEMENT PLAN**

**Date: May 2024**

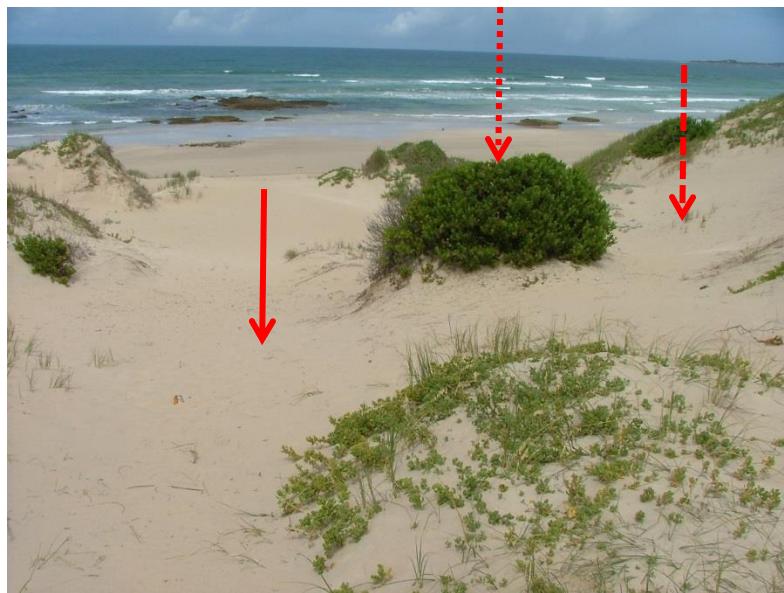
**Photo 1:** Shows the typical "U"-shaped blow-out on the frontal dune (red arrow). The blow-out is orientated in an approximate SW-NE direction. Note a second blow-out has occurred to the right of the first blow-out (hashed arrow) leaving the remnants of the dune as a "stack" (generally because of the presence of hardy vegetation, in this case bitou (*Crysanthemoides monilifera*) (dotted arrow)

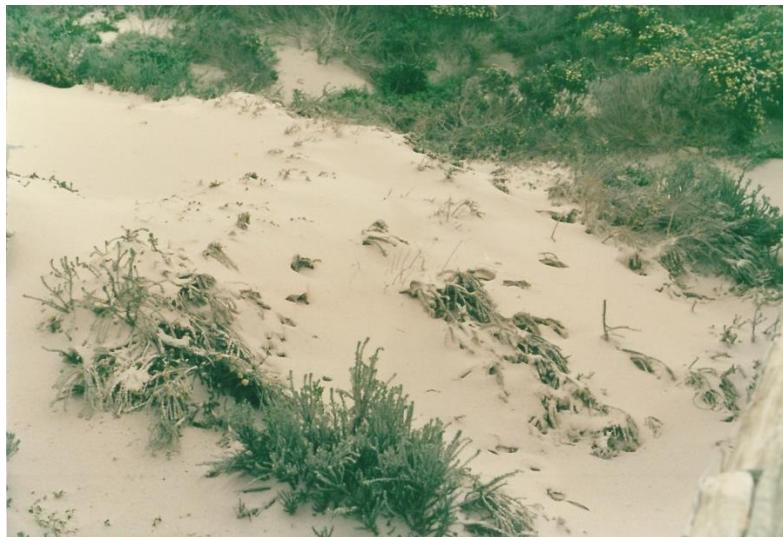
**Photo 2:** Shows the smothering of natural vegetation on the primary dune near Buffelsjachts Bay on the SW coast during one storm event (gale force winds). Such smothering can result in the indigenous strand plants dying. Note that the inundation of windblown sand over rooikrans shrubs does not result in the dying off of such plants, which grow through the sand cover.

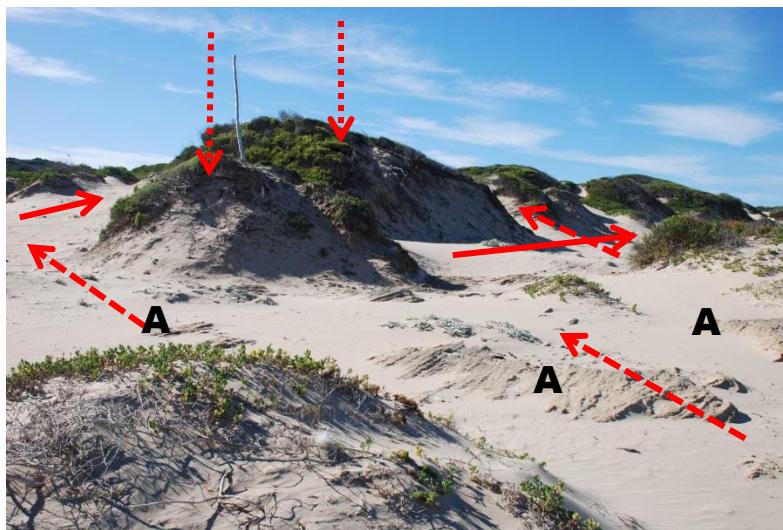
**Photo 3:** Shows the huge amount of dune sand lost from blow-out wind erosion on the frontal dune system just east of the access road to the Preekstoel beach. Note the typical blow-outs resulting from SW winds (solid arrows) and SE winds (dashed arrows). Such a "maturely" eroded dune system often leaves remnants of the dune system as "stacks" (dotted arrows). The winnowing of sand between the stacks has exposed the underlying aeolianite of the Waenhuiskrans Formation (**A**).

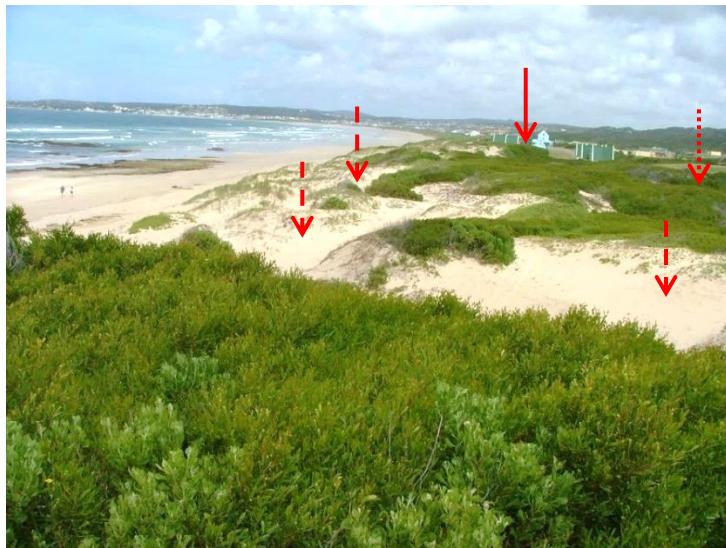
**Photo 4:** Shows the significant impact of human trampling on the frontal dune system between the caravan park (solid red arrow) and the tar road access point to the Preekstoel beach (blow-outs as dashed arrows). Note the thicket of rooikrans within the back-dune area (dotted red arrow) and foreground.

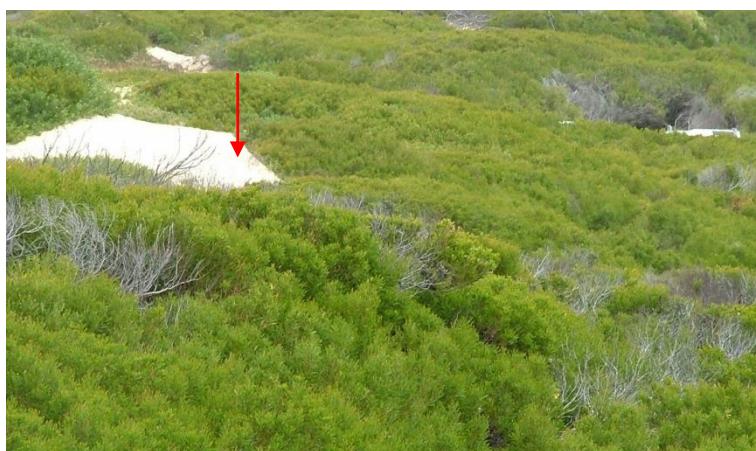
**Photo 5:** Shows the cascading sand (red arrow) from a blow-out filling the lee of a dune infested with rooikrans. The rooikrans “holds” the sand at an acute angle of repose. As the blow-outs persist, the dune gets higher and higher together with the growth of the rooikrans.

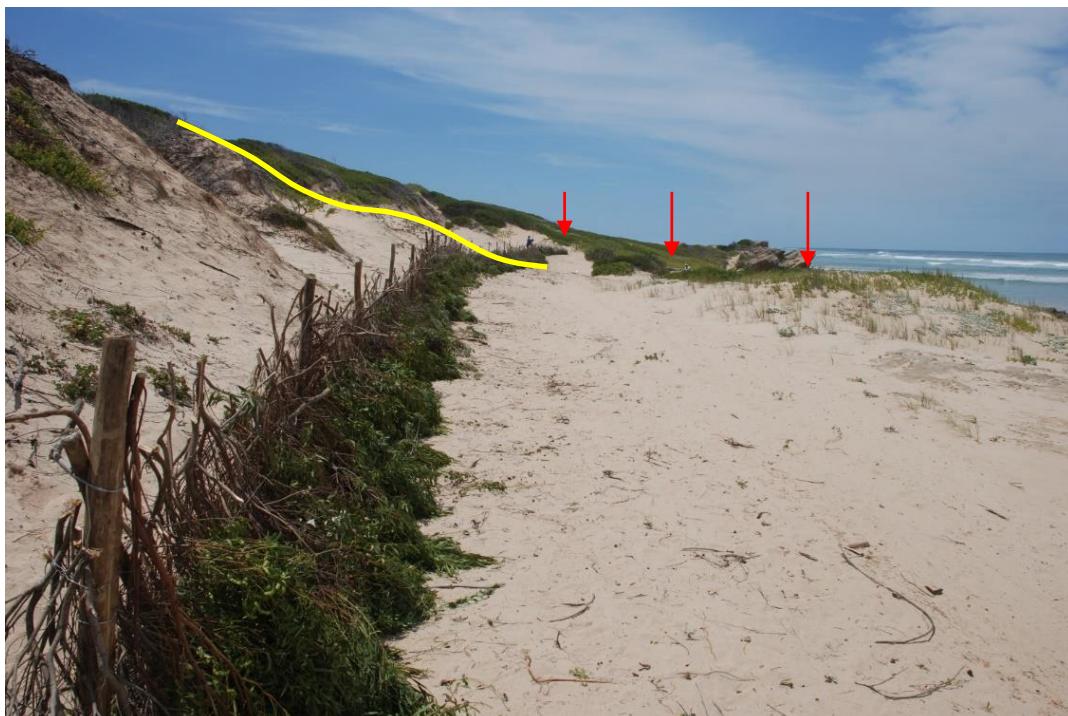
**Photo 6:** This photo was taken of the frontal dunes at Preekstoel where a brushwood fence was erected in front of the dunes just landward of the hummocky dunes (red arrows). The brushwood comprises rooikrans bushes that have been removed from the backdune system to be woven between the horizontal strands of wire. The idea was that the brushwood fences would trap sufficient sand (yellow line) so that the front of the dune could be rehabilitated by planting climax Strandveld plants and various hardy pioneer strand plants (**Photo 6** was taken on 5 November 2021).

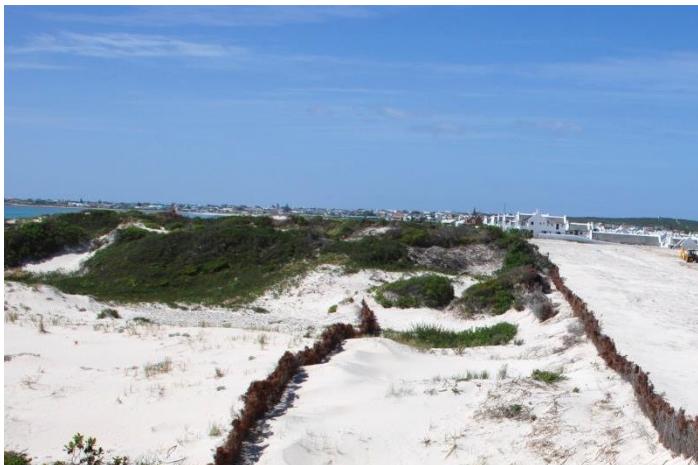
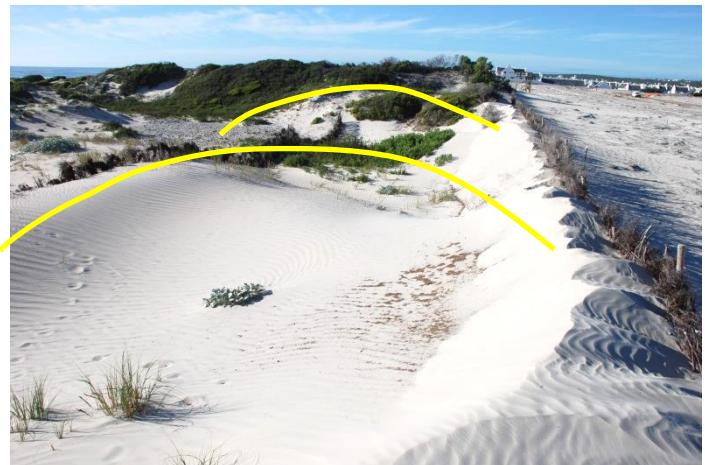
**Photo 7:** **A:** Shows two brushwood fences that were constructed across a large blow-out structure within the frontal dune system in the Langezandt Phase 2 project (Struisbaai) area to trap sand. **B:** Shows the same area, three months later. Note how much sand was trapped by both brushwood fences. The aim here was to recreate a stable back-dune across the blow-out as shown by the yellow lines. Once sufficient sand has been accumulated, the dune would be planted with locally indigenous strand plants (pioneers) and more climax strandveld plants.

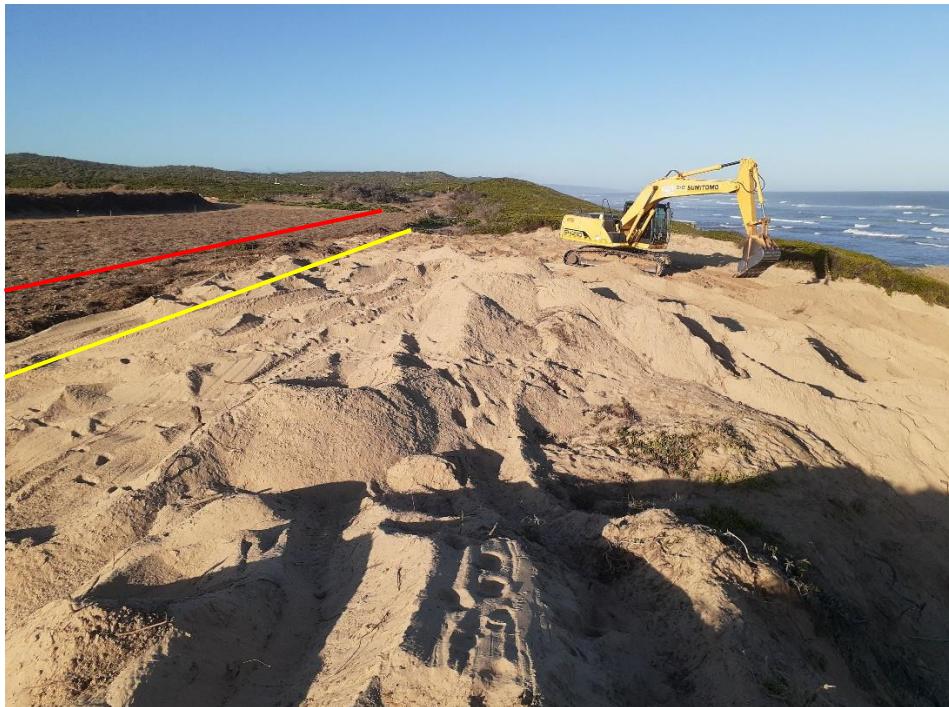
**Photo 8:** Shows the movement of sand from the back dune area towards the hummocky dunes just above the spring tide mark with an excavator. The stable platform for the construction of houses is seen to the left of the photo, which has been covered with chipped rooikrans mulch. The yellow line represents the conservation setback line or ecological setback line that was determined for the development. The area between the yellow line and the high water mark represents Erf 2341. The red line represents the 5m building line.

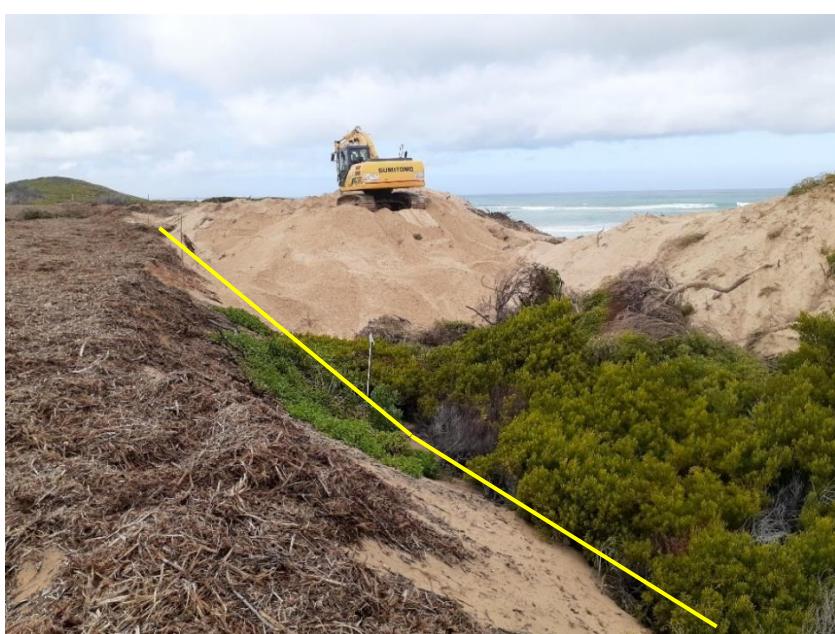
The sand trapped and supported by rooikrans from blow-outs in the back dune area is much steeper than the angle of repose of sand, which is generally about  $26^\circ$  from the horizontal. In **Photo 9** below, one can see the steep angle of repose of the windblown sand is about  $50^\circ$  to  $60^\circ$  from the horizontal (to the right of the photo).

**Photo 9:** Shows the movement of sand from the back dune area by excavator. Note the steep angle of repose of the dune to the right which is caused by the rooikrans vegetation that holds the sand as it cascades over the back of the dune caused by wind erosion from blow-outs. Note the stabilised building platform covered in mulch from the chipping of rooikrans removed from the development area. The wooden stakes at the edge of the building platform is the alignment of the conservation setback line (8 August 2022). The area between the stabilised platform and the dune to the right was filled in with sand removed from the back area of Erf 2343.

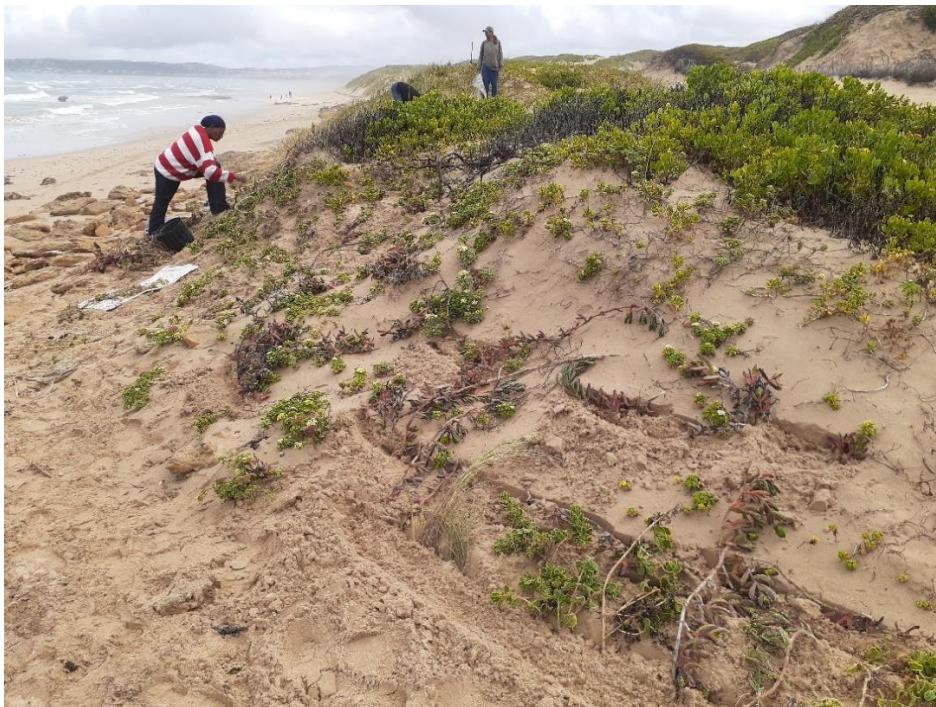
**Photo 10:** Shows the temporary transplanting of harvested strand plants on the sides of a hummocky dune which is located just above the spring high tide mark (8 August 2022)

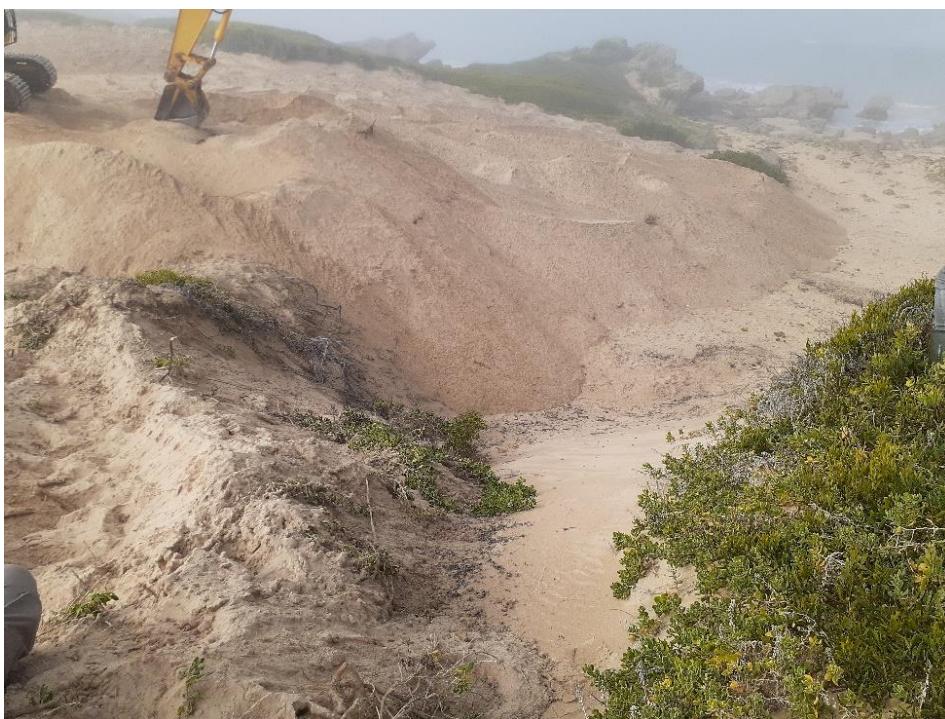
**Photo 11:** Shows the filling in of large blow-outs with sand moved from the back dune area. Most of the remnant dune system had originally been stabilised by planting rooikrans in the early 1900's (8 August 2022).

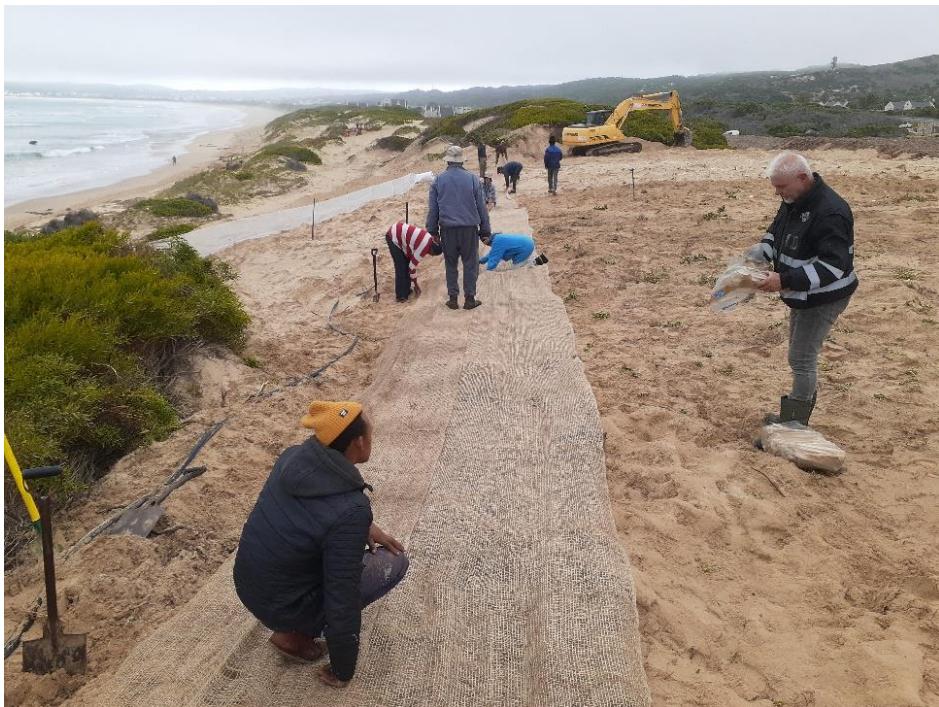
**Photo 12:** Once all the back dune sand had been moved to the hummocky dunes, shade netting was erected near the hummock dunes. A “soil-saver” hessian blanket was pegged to the sand at the apex of the slope of the frontal dune system to prevent erosion (10 August 2022). Deon van Eeden is seen to the right of the photo, supervising the specialist rehabilitation team from Still Bay.

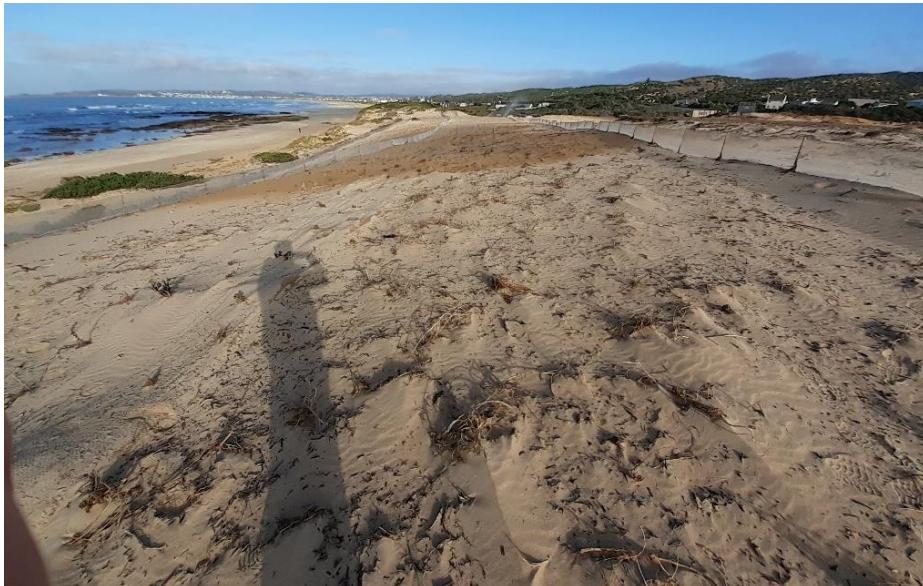
**Photo 13:** Photo shows the rehabilitated frontal dune system that has been planted with typical locally indigenous strand plants. A temporary irrigation system was also put in place (8 September 2022)

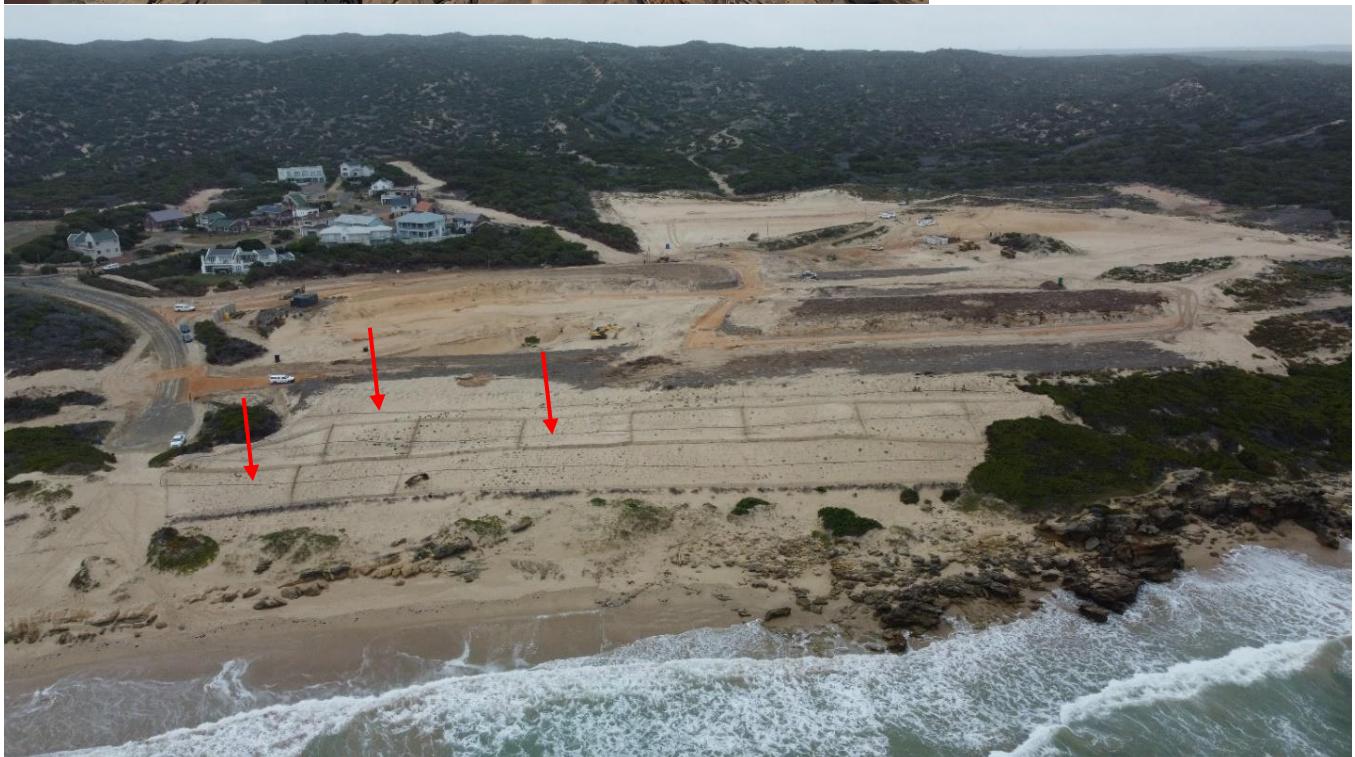
**Photo 14:** A drone photo of the rehabilitated dune system showing the erosion prevention netting in place and the temporary irrigation system (red arrows). Note the hummocky dunes (photo taken on 10 November 2022).

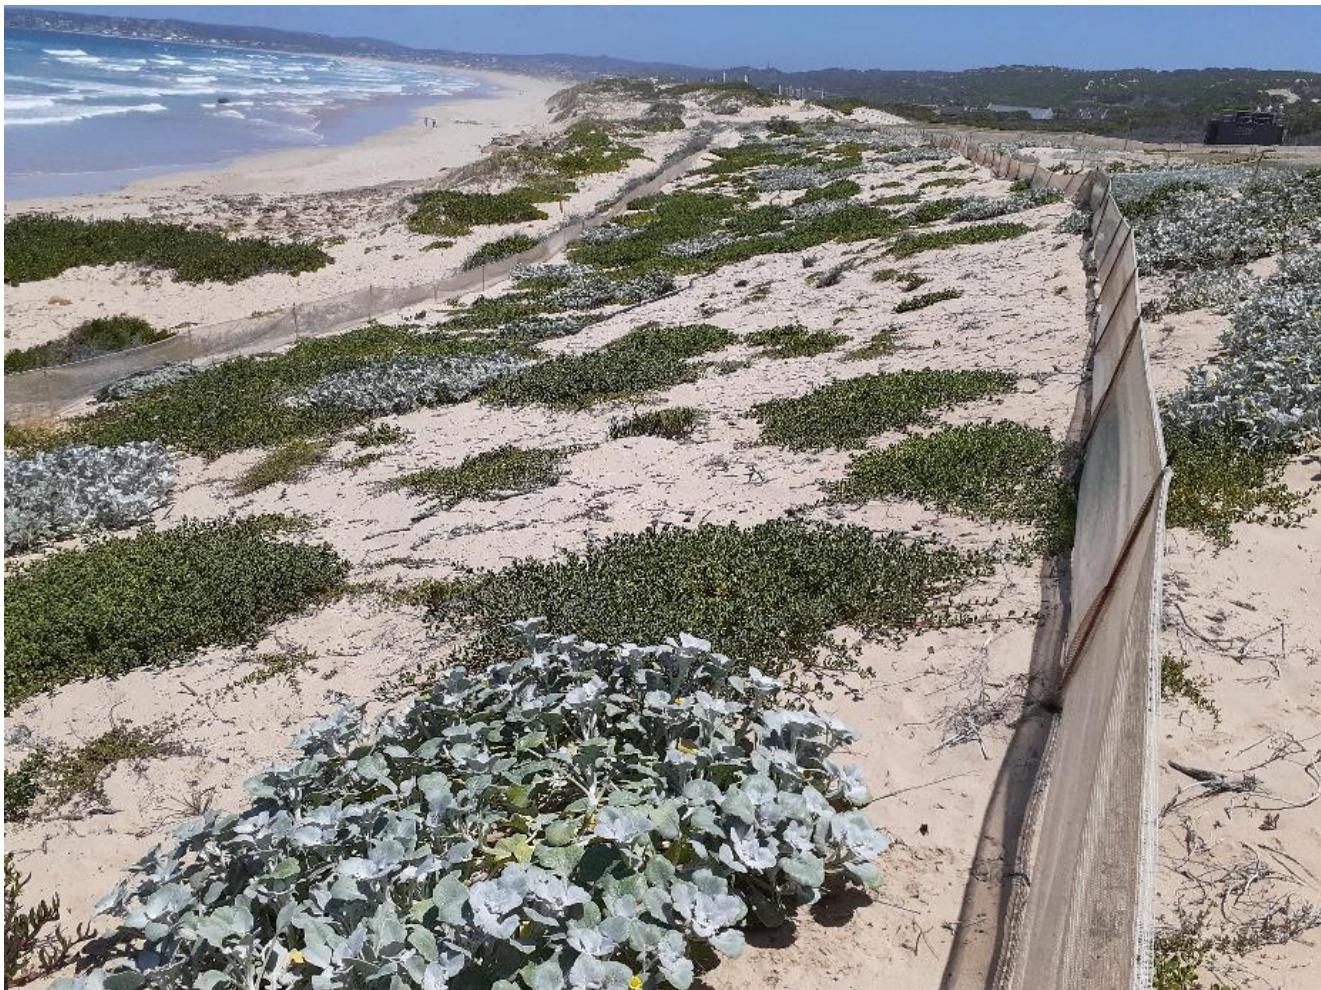
**Photo 15:** Note the excellent coverage of strand plants over the rehabilitated frontal dune system. It was hoped that the more climax Strandveld plants could have been planted between the strand plants to coincide with the winter period of 2023. Photo taken on 31 January 2023. Given that the EMPr had not been approved, the more climax plants were not planted. It should be noted that the current cover of the strand plants is about 99% of the rehabilitated dune (refer to **Photo 18** below).

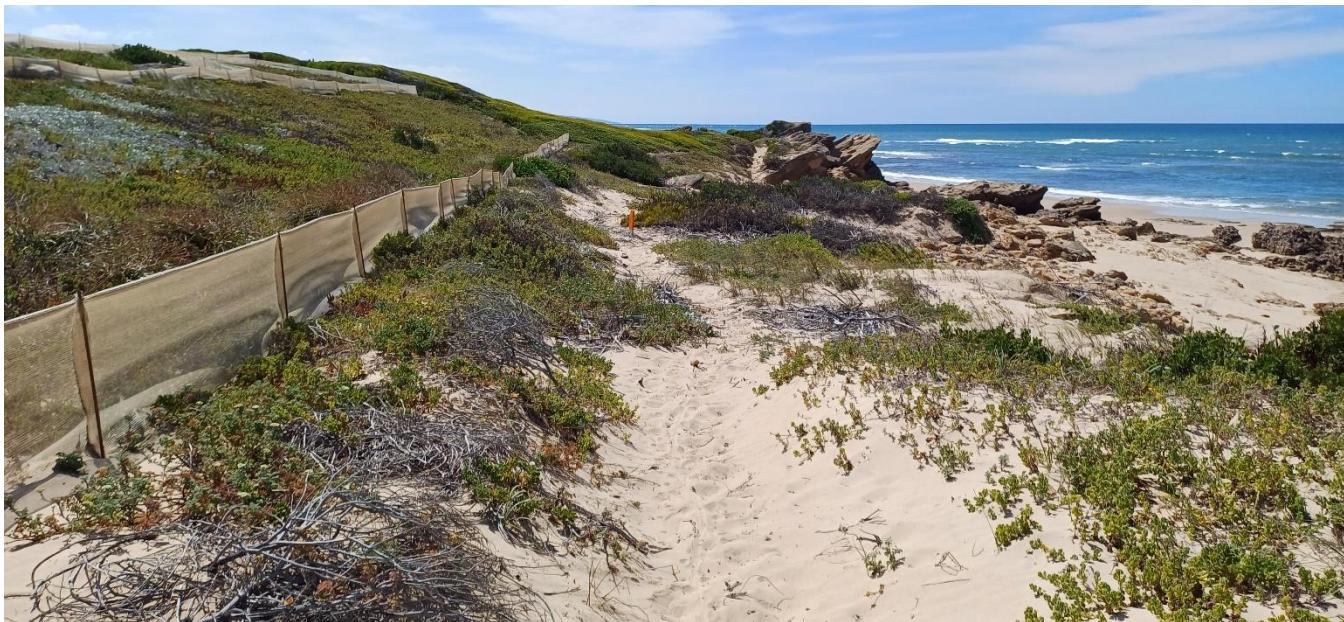
This has resulted in the trampling of pioneer vegetation at the back of the hummocky dunes, with resultant erosion (**Photo 18**).

**Photo 18:** Shows the pedestrian path between the hummocky dunes and the toe of the dune system. This is the most sensitive part of the dune system and the pedestrian path has already caused die-off of the strand plants and resulted in sand erosion. It is recommended that brushwood should be placed over the pathway to prevent access. Note the prolific growth of strand plants on the reformed lower slope of the frontal dune.

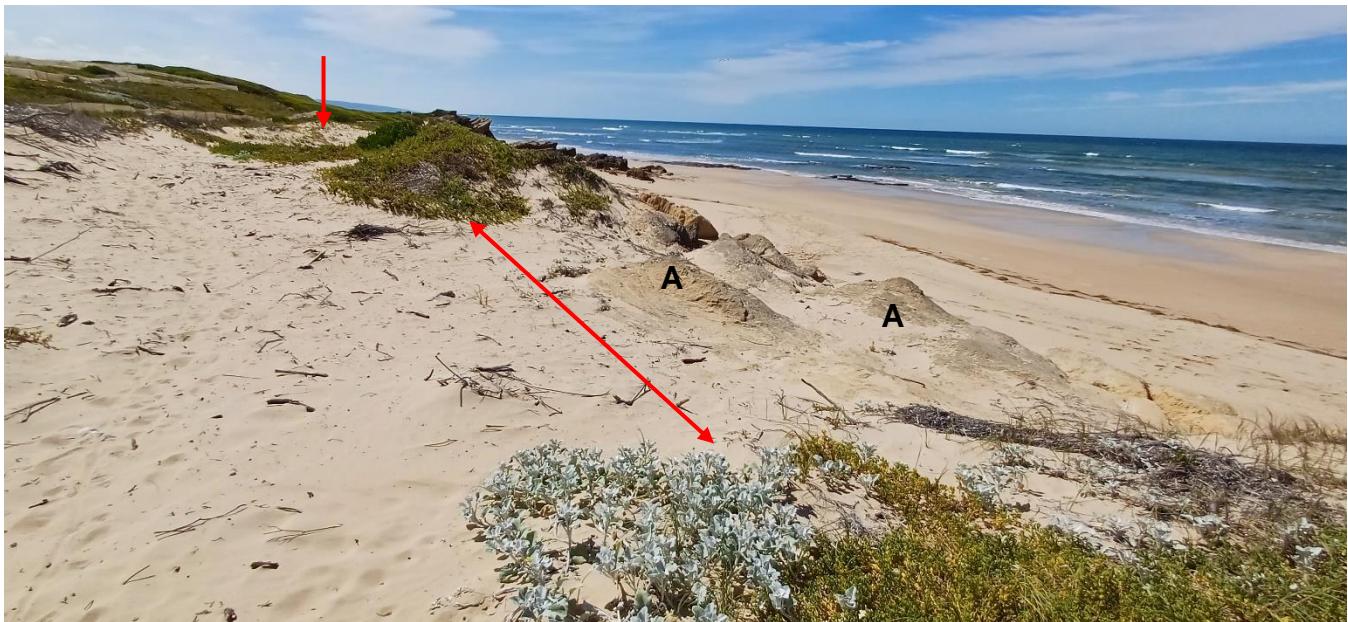
**Photo 19:** The blow-outs currently seen within the hummocky dunes (red arrows) must be rehabilitated before they reach the state seen in this photo. Note the exposure of aeolianite just above the highwater mark (A). The aeolianite occurs below the frontal dune, which will assist in reducing erosion by the sea when anticipated sea level rises. The aeolianite was exposed during the late September 2023 storm event that swept along the Southern Cape's coastline, removing vast amounts of sand from the beach and upper shore area and depositing such sand in off-shore bars just off the coastline. The bare sandy area behind the hummocky dunes must also be packed with brushwood to trap sand blown off the upper beach area.

Continued, vigilant checks on the formation of blow-outs must be carried out after each storm event by the Developer's permanent Site Agent of the Preekstoel Beach Estate. Should such blow-outs occur, the Site Agent is to employ the trained, dedicated dune rehabilitation team from Still Bay to implement the necessary mitigation measures as noted above.

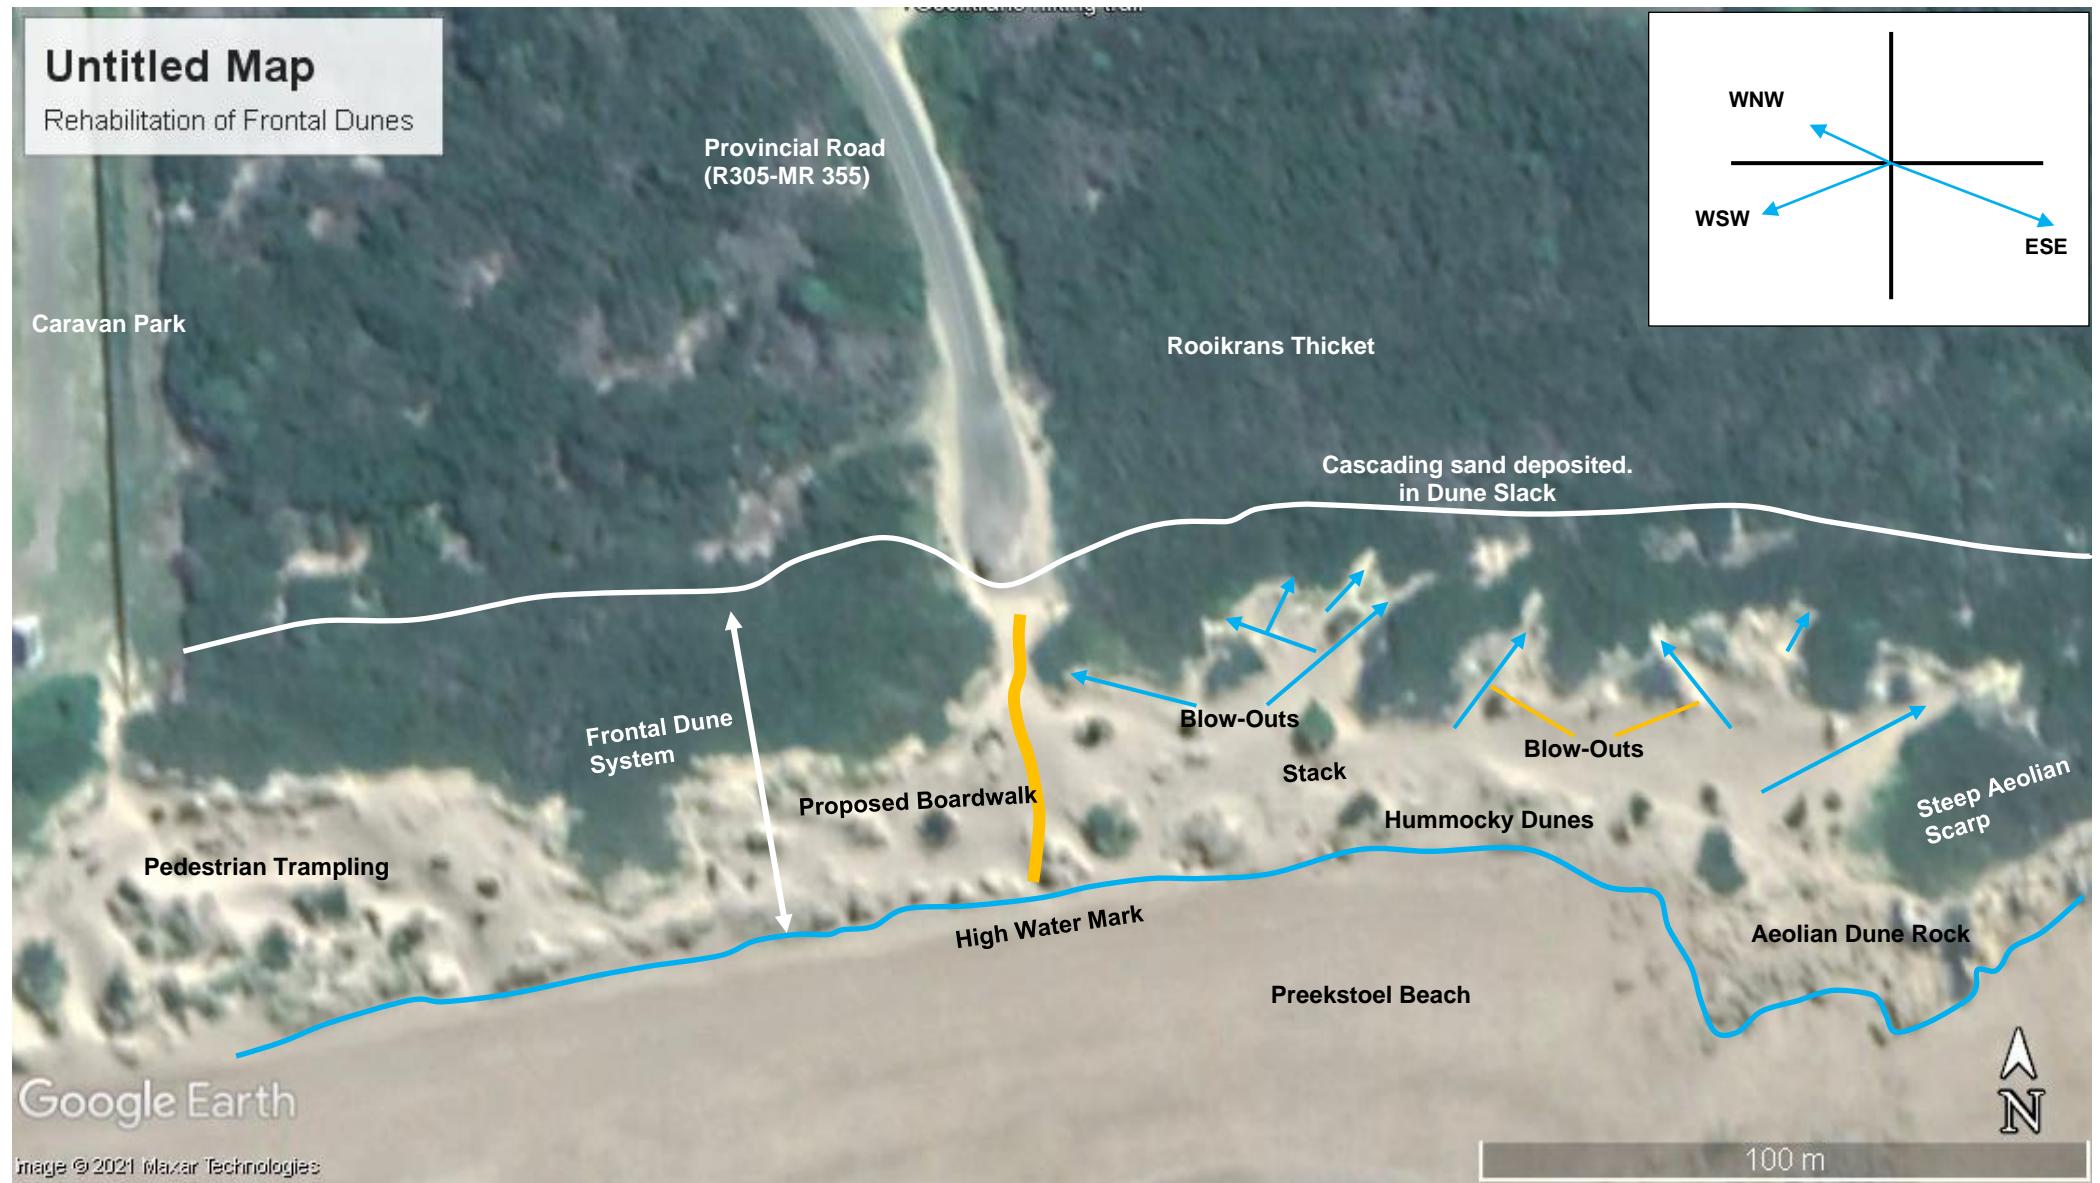
**FIGURE 4:** Google Image of the Badly Eroded Preekstoel Beach Estate Frontal Dune System (10 April 2019)

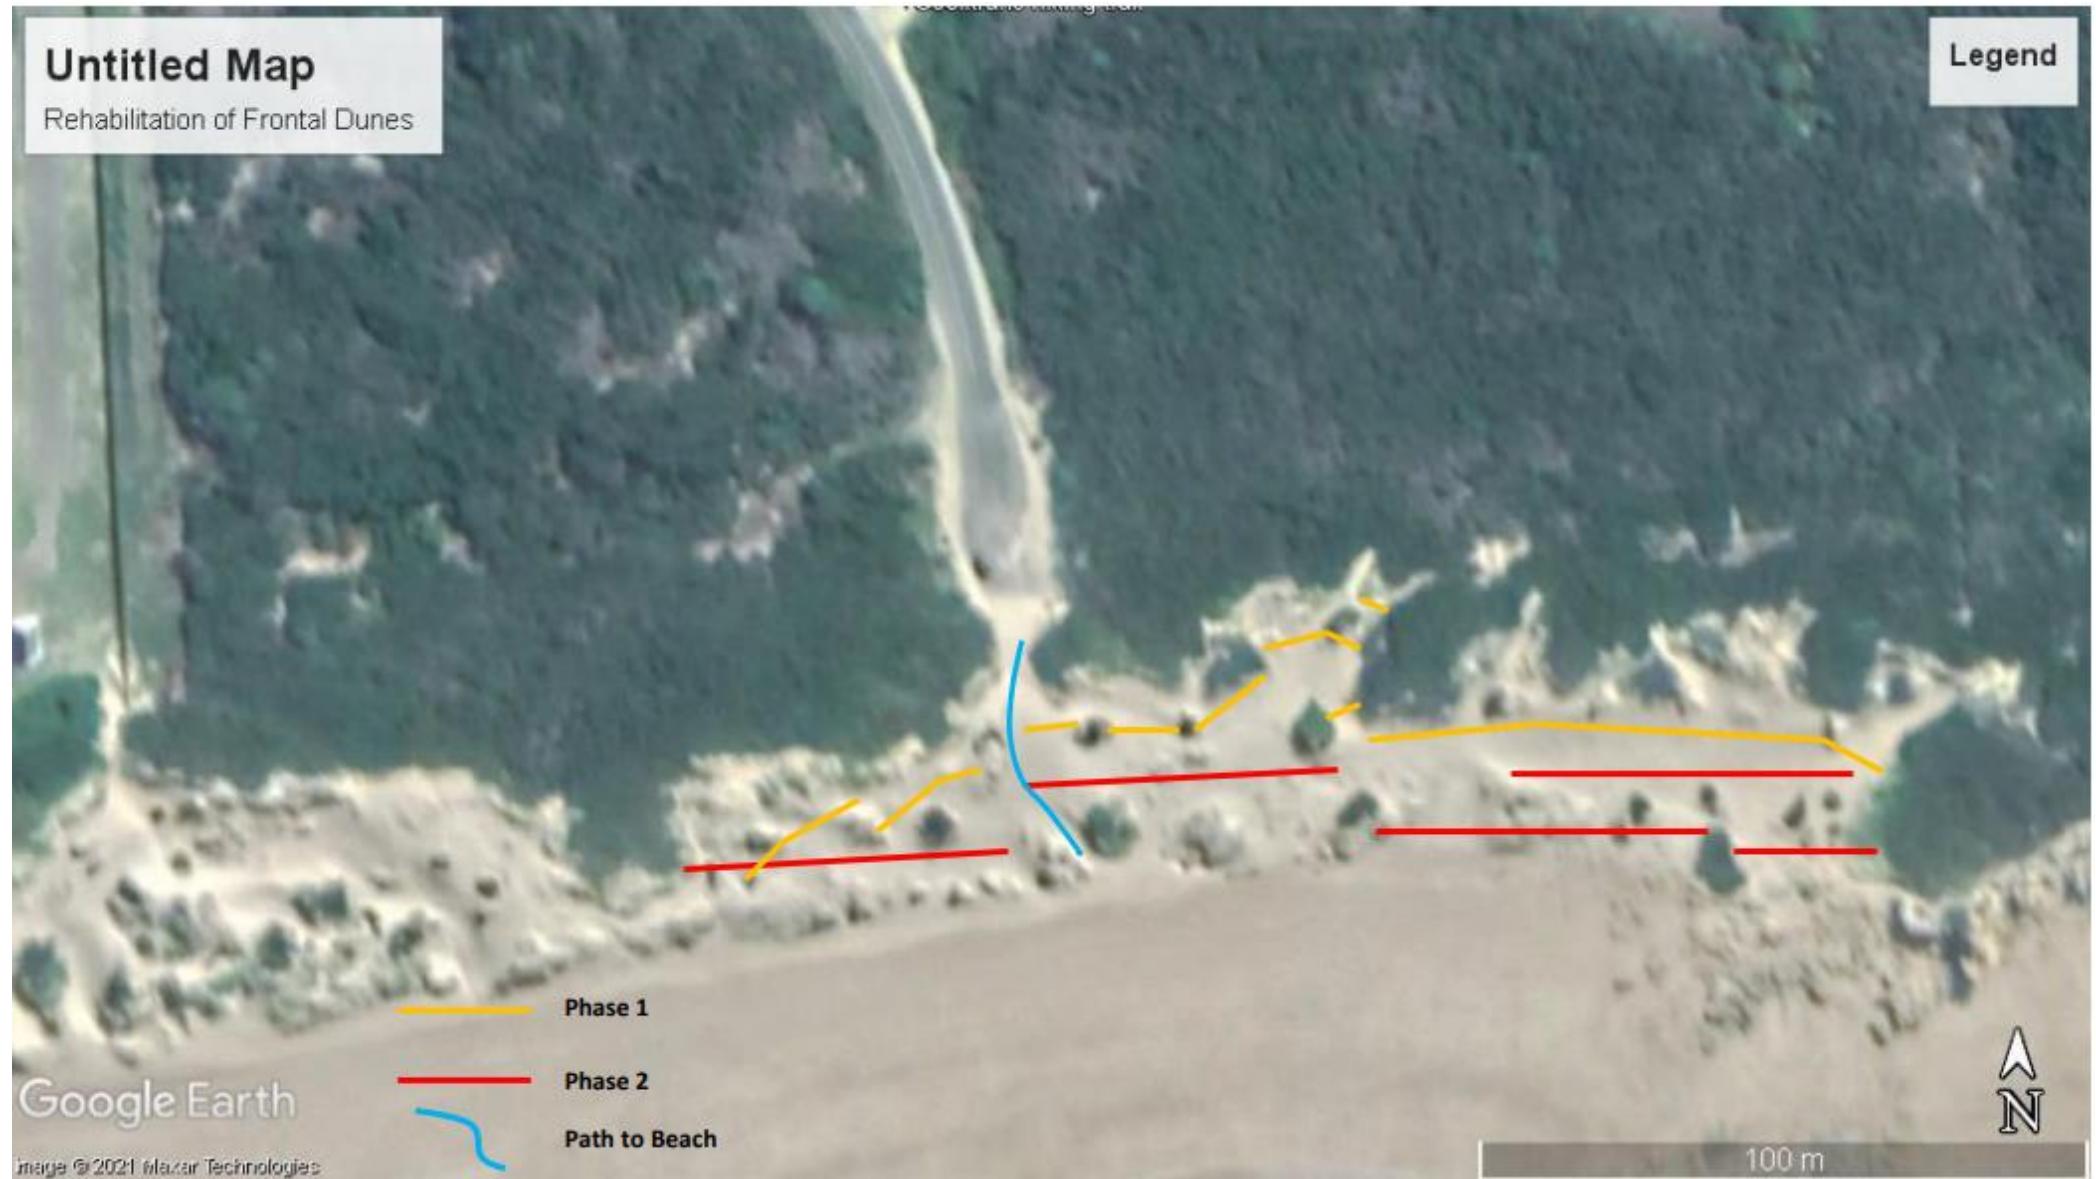
**FIGURE 5:** Phased Approach for the Rehabilitation of the Preekstoel Frontal Dune System (Google Image dated 10 April 2019) (Note: this methodology was abandoned because of the low accumulation of sand by the erected brushwood fences.
