MAINTENANCE MANAGEMENT PLAN

PERIODIC MAINTENANCE OF TR03105 FROM LADISMITH TO CALITZDORP (KM 0.9 TO KM 47.63) WESTERN CAPE

Deputy director
Western Cape Government:
Department of infrastructure
PO Box 2603
Cape Town
8000

11/MMP/TR3105/LDC/25

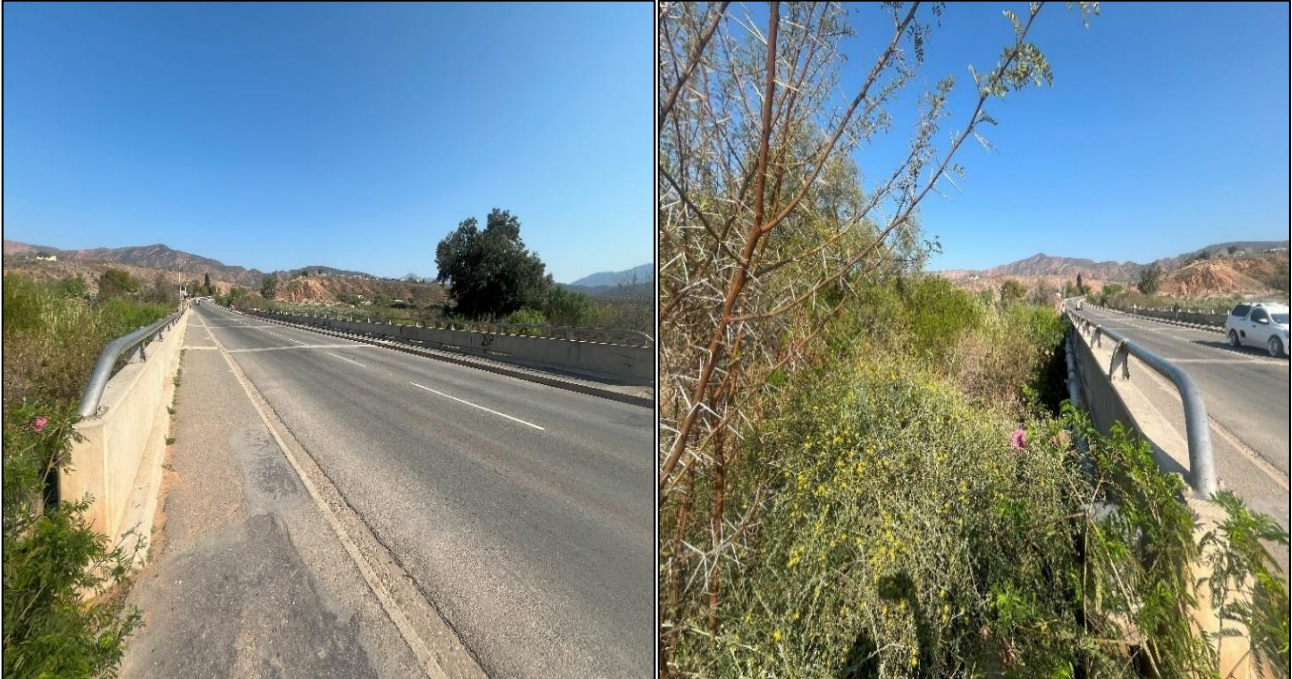
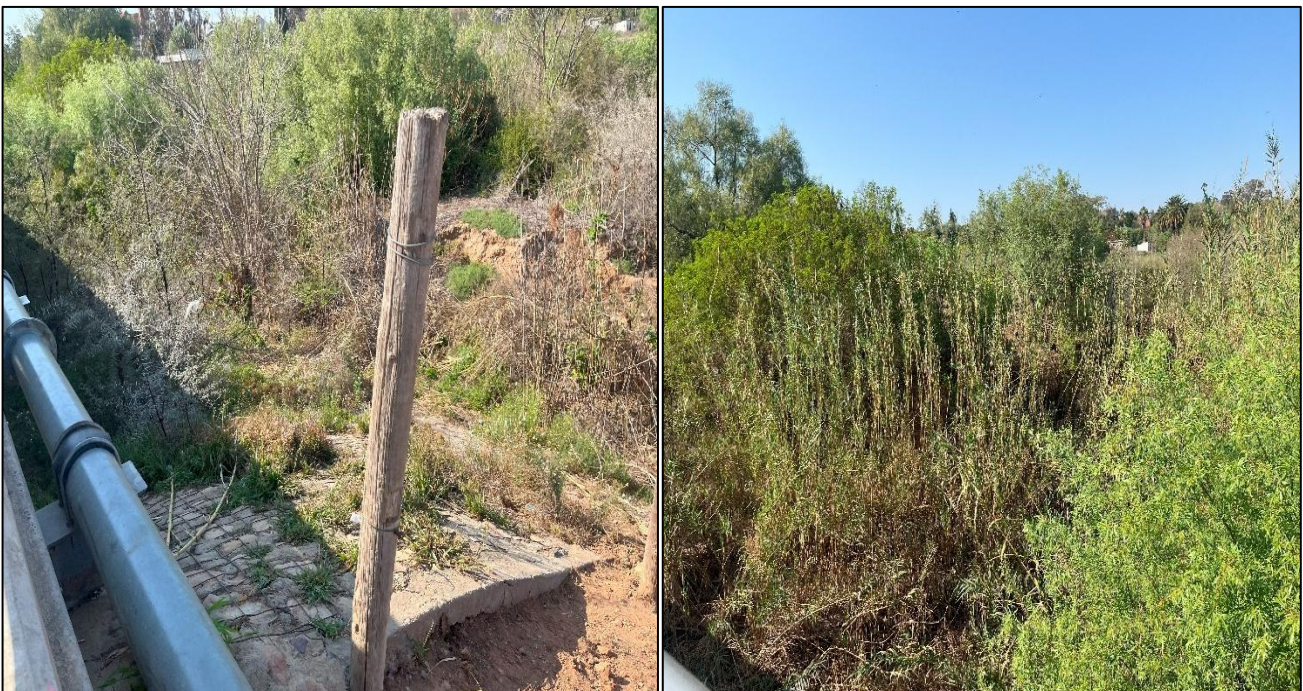
BRIDGE B4942: Nels River

Figure 7 and 8: Nels River Bridge.

Figure 9 and 10: Nels River Bridge

Bridge No 4942 over the Nels River at km 47.87 has a simply supported deck with 5 spans for a total length of 96 m. The structure is generally in a sound condition. The following defects have been noted and described along with proposed rehabilitation measures for this contract:

- Clear thick reeds below all spans.
- No agreement plate displayed on bridge.
- No river sign board placed at bridge.
- Replace expansion joints
- Retrofit the structure numbers to the inside elevation of the end blocks as per current standard plans.

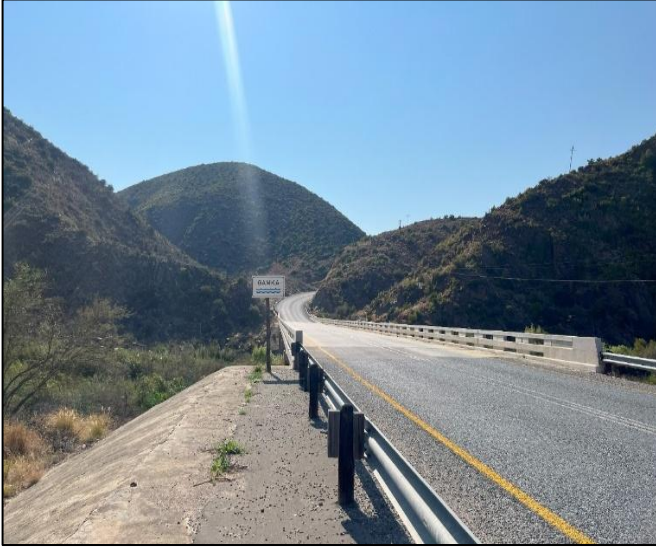
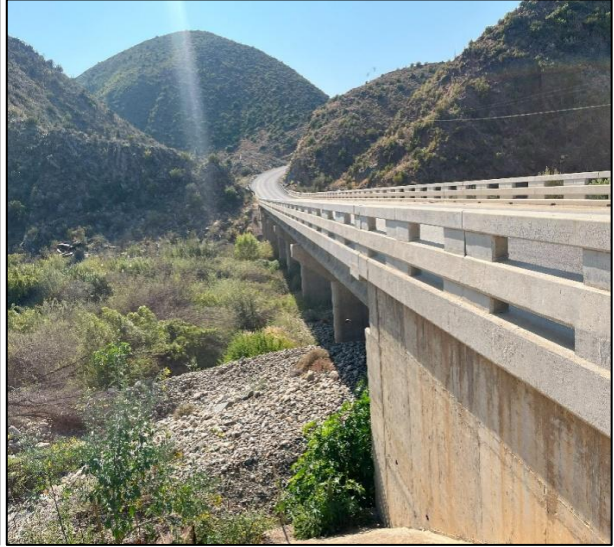
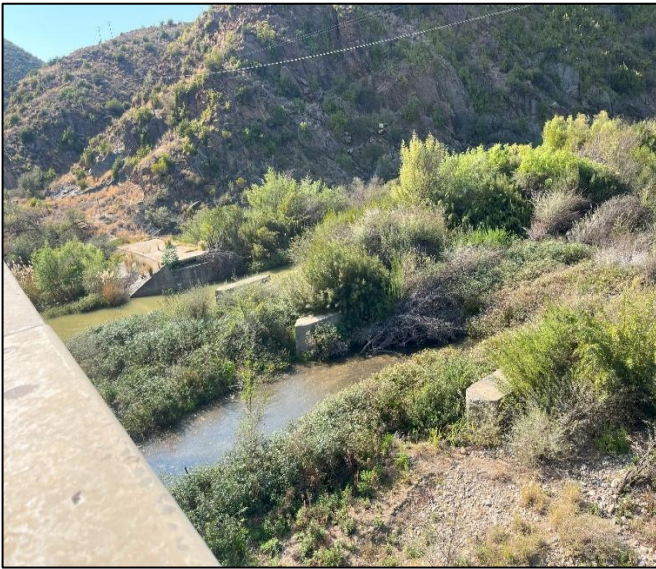
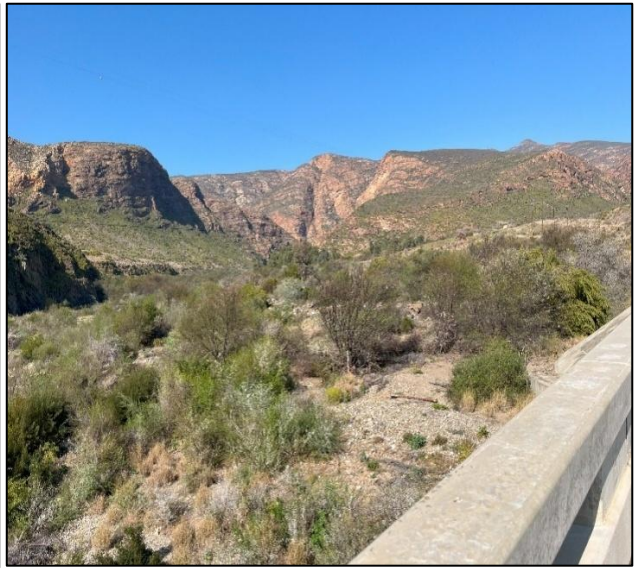
Figure 11 and 12: Gamka River bridge

Figure 13 and 14: Gamka River bridge

Bridge No 4342 over the Gamka River at km 40.15 has a simply supported deck with 5 spans for a total length of 96 m. The structure is generally in a sound condition. The following defects have been noted and described along with proposed rehabilitation measures for this contract:

- Clear trees and vegetation below all spans.
- Vertical cracks (0.65mm and 0.75mm) on return wall.
- Loose bolts at guard rail bridge adapter.
- Clear blocked drainage scuppers.
- Local spalling of concrete on parapets and exposed reinforcement.
- Replace expansion joints
- Reinstate bridge number by retrofitting the structure numbers to the inside elevation of the end blocks as per current standard plans.

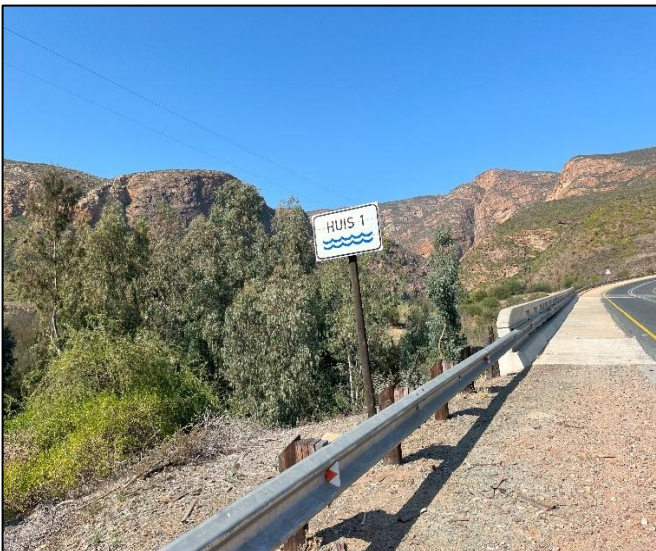
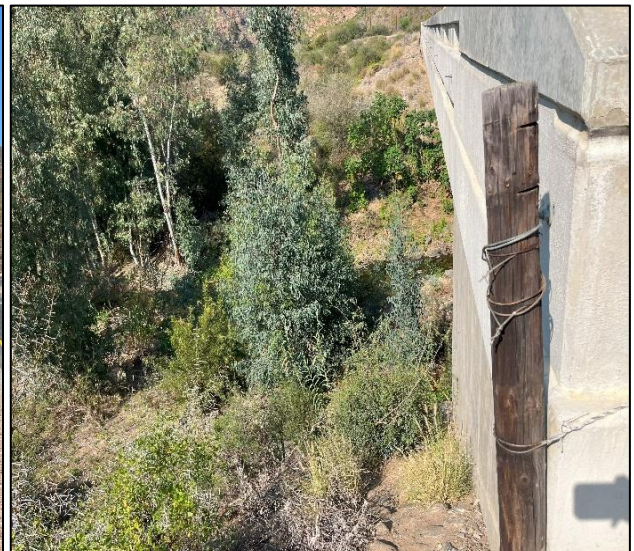
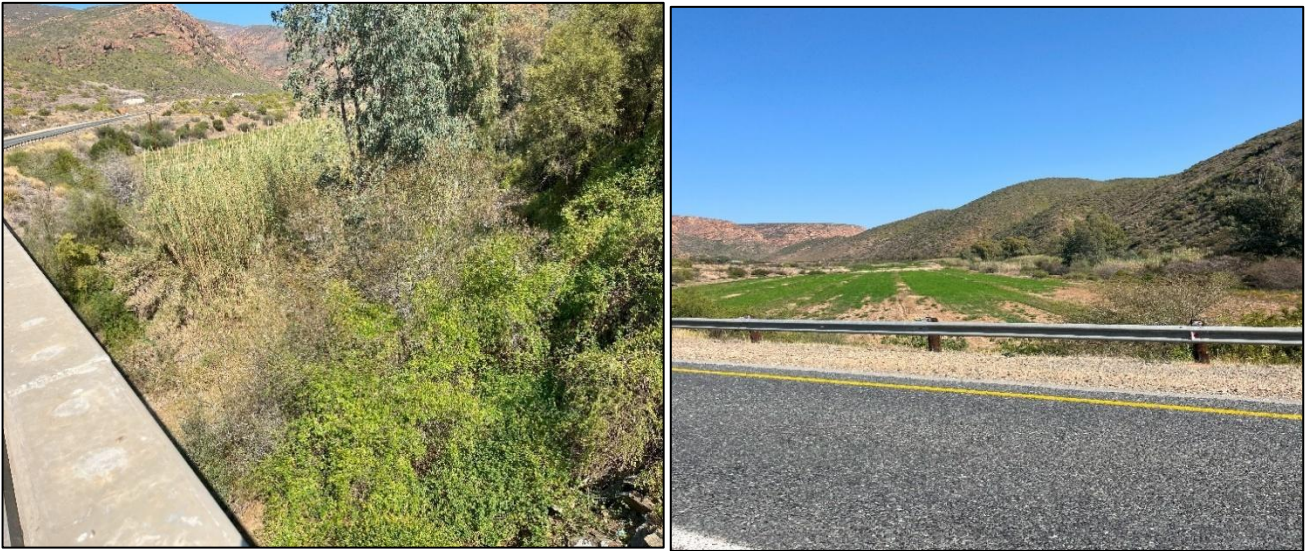
Huis River No. 1

Figure 15 and 16: Huis River 1 Bridge

Figure 17 and 18: Huis River 1 Bridge.

Bridge No B4941 over the Huis River No.1 at km 39.68 has a simply supported deck with 3 spans, for a total length of 45m. The following defects have been noted and described along with proposed rehabilitation measures for this contract:

- River board at bridge refers to Huis 1, road logs indicate section labelled Huis 2.
- Clear trees and vegetation below all spans.
- Crack to soffit of bridge deck.
- Concrete spalling to pier.
- No agreement plates.
- Replace expansion joint.
- Reinstate bridge number by retrofitting the structure numbers to the inside elevation of the end blocks as per current standard plans.

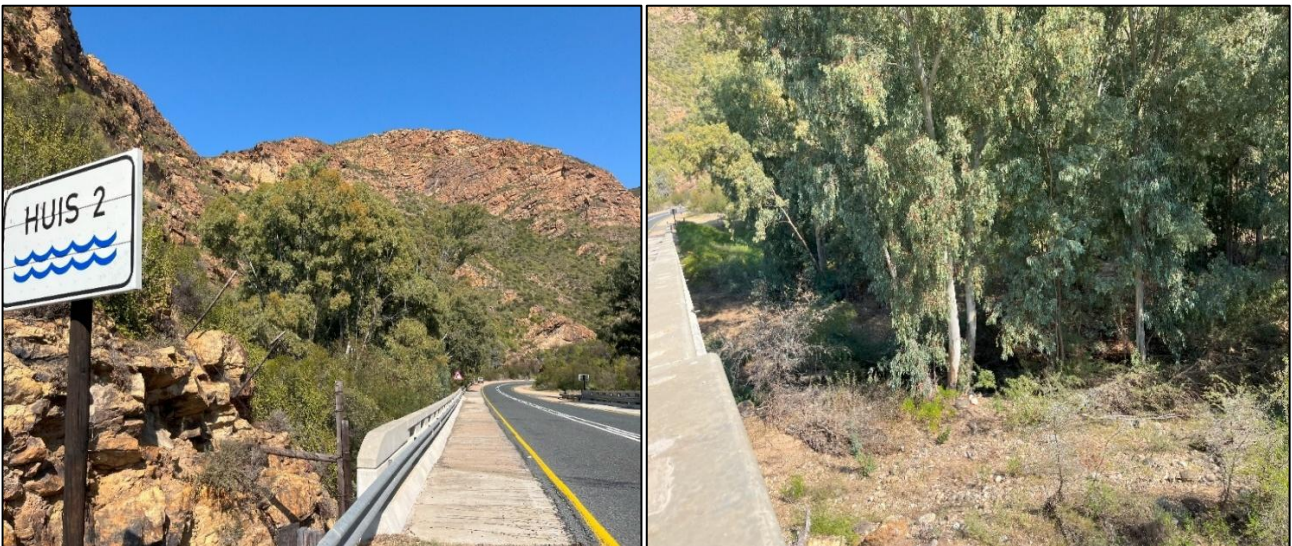
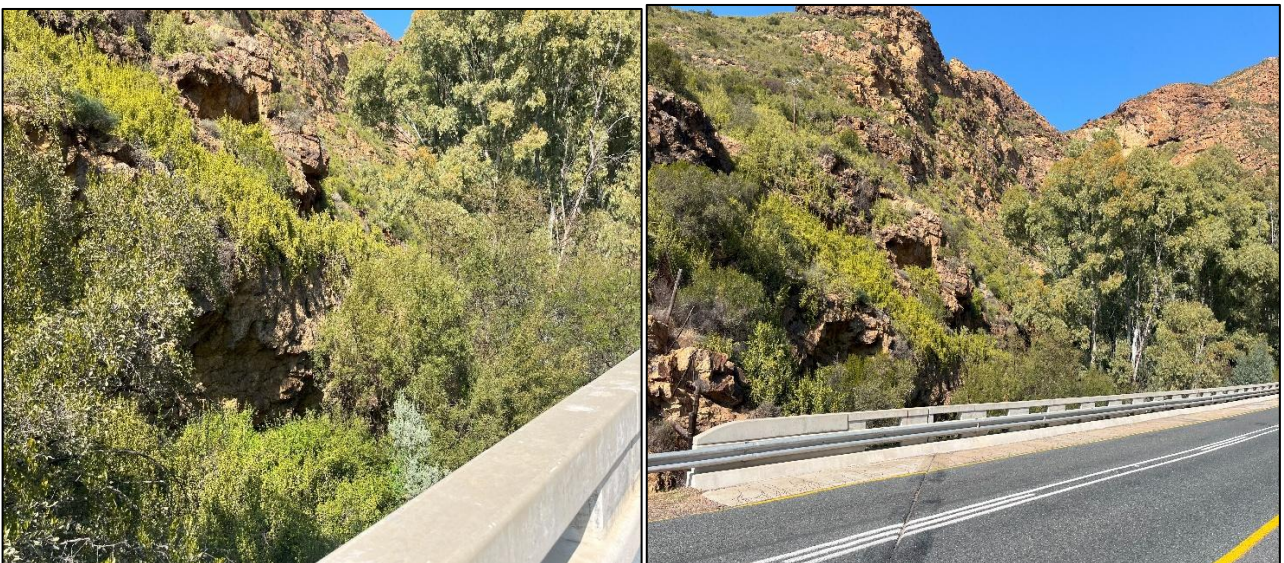
Huis River No.2

Figure 19 and 20: Huis River Bridge.

Figure 21 and 22: Huis River 2 Bridge.

Bridge No 4940 over the Huis River 2 at km 37.52 has a simply supported deck with 3 spans for a total length of 58.8 m. The structure is generally in a sound condition. The following defects have been noted and described along with proposed rehabilitation measures for this contract:

- River board at bridge refers to Huis 2, road logs indicate section labelled Huis 1.
- Clear trees and vegetation below all spans.
- Local concrete crack (0.3mm) at return wall.

- Local spalling of concrete and exposed reinforcement of parapets.
- No agreement plate on bridge.
- Shrinkage cracks on bridge where remedial work has previously been undertaken.
- Guardrails missing reflector plates, missing bolts and spacer blocks to be corrected.
- Replace expansion joints
- Reinstate bridge number by retrofitting the structure numbers to the inside elevation of the end blocks as per current standard plans.

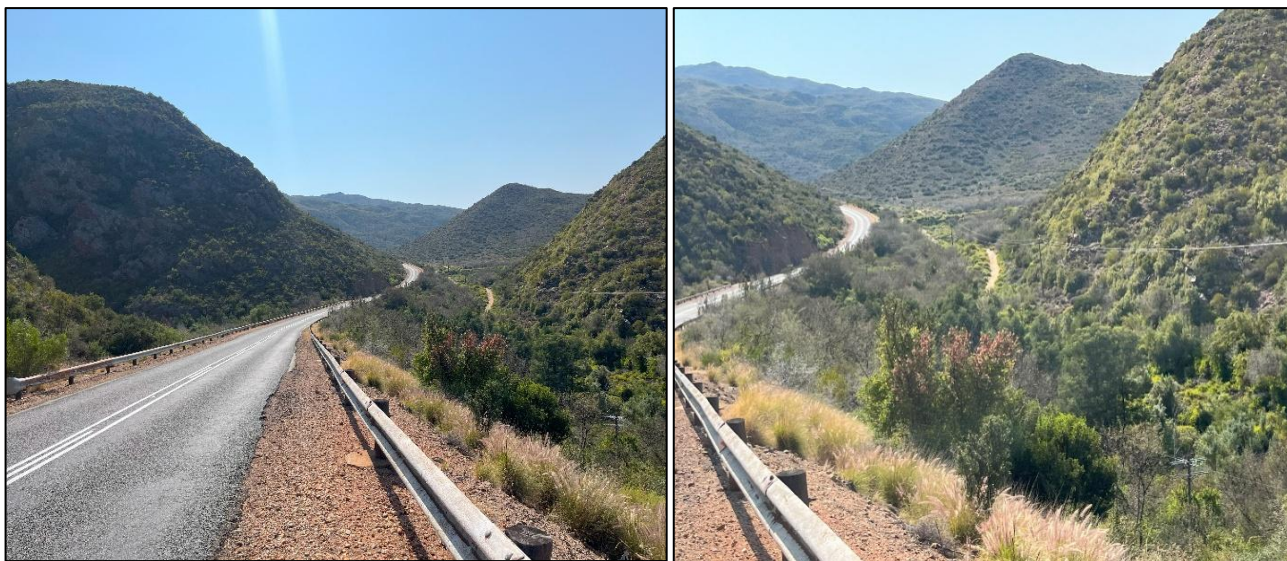
Bridge B6095 Vaarwel River

Figure 23 and 24: Vaarwel River Bridge.

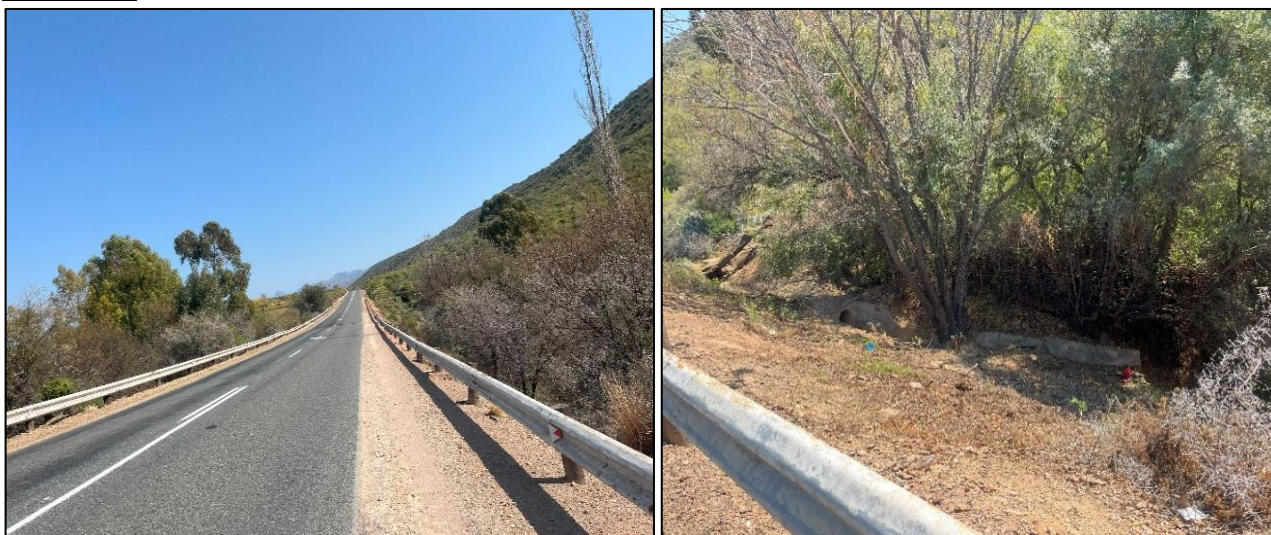
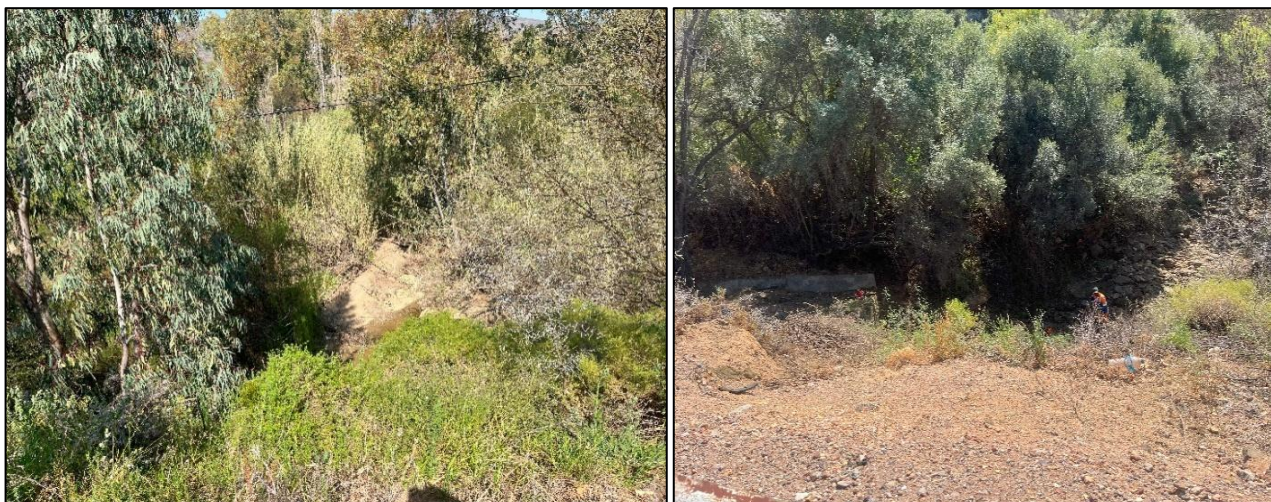
Wilge river

Figure 25 and 26: Wilge River Bridge.

Figure 27 and 28: Wilge River Bridge.

Bridge No 6094 over the Wilge River at km 24.63 has a simply supported deck of 1 Span, for a total length of 5.95 m. The structure is generally in a sound condition. The following defects have been noted and described along with proposed rehabilitation measures for this contract:

- The Clear trees and vegetation below all spans.
- Guardrails corroded, missing reflectors, missing spacer blocks, height to be rectified to align with required height.
- Terrain and vegetation do not enable access to bridge.
- Reinstate bridge number by retrofitting the structure numbers to the inside elevation of the end blocks as per current standard plans.

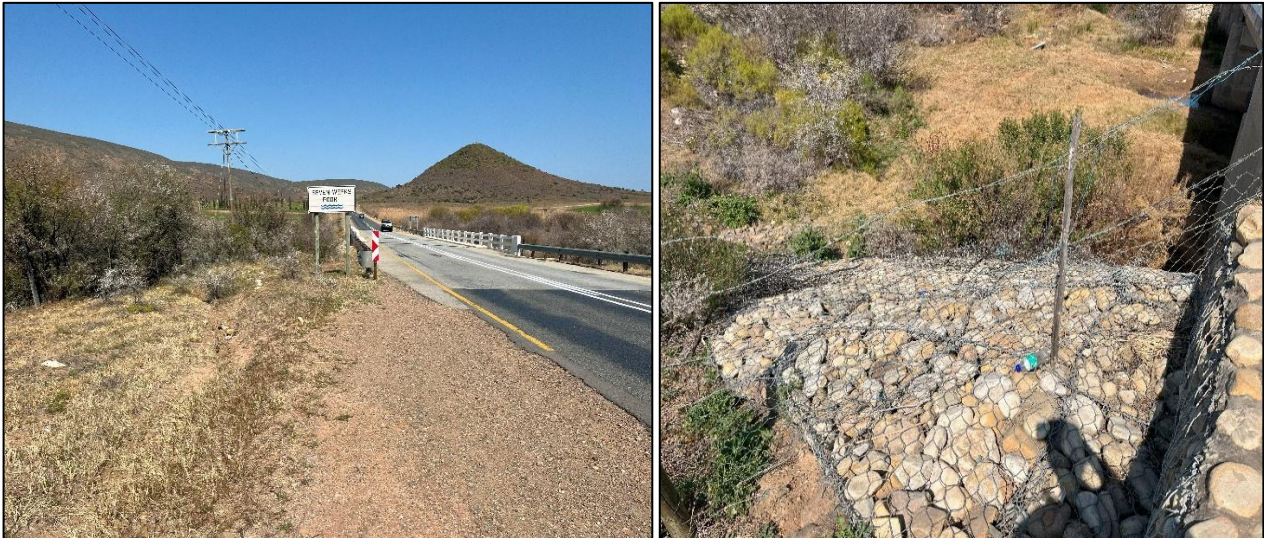
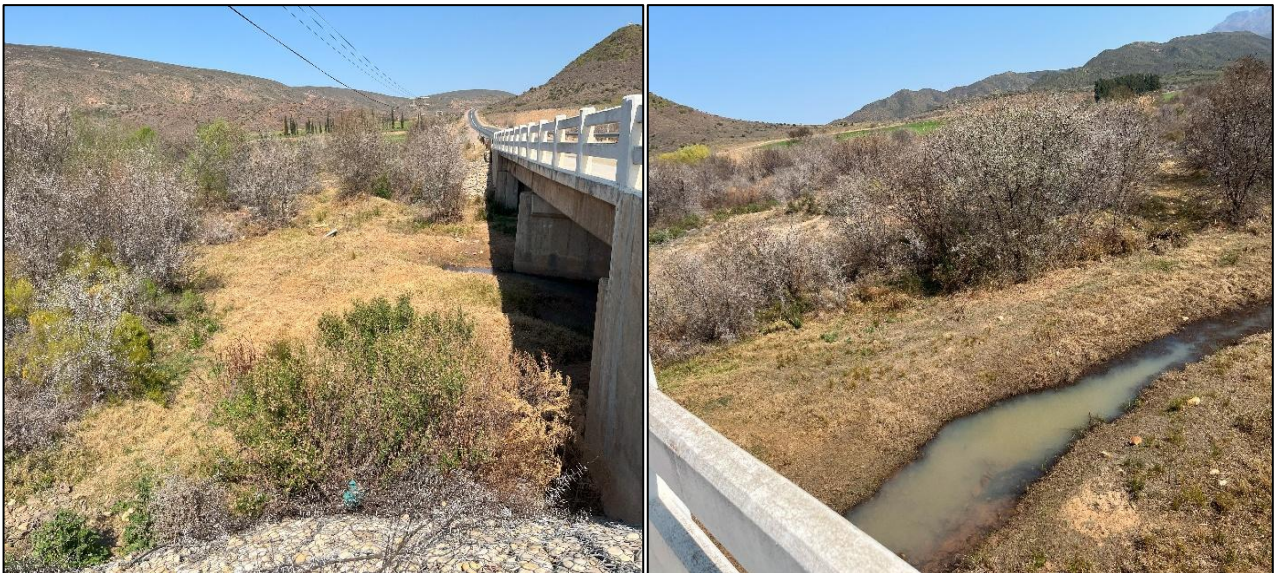
Figure 29 and 30: Seven Weeks Port River Bridge.

Figure 31 and 32: Seven weeks port River Bridge.

Bridge No 2665 over the Seven Weeks Poort River at km 20.48 has a simply supported deck with 2 spans, for a total length of 26 m. The structure is generally in a sound condition. The following defects have been noted and described along with proposed rehabilitation measures for this contract:

- Clear vegetation and reeds in waterway
- Local spalling of bridge deck at intersection with abutment.
- Reinstate fence at bridge.
- Concrete surface erosion at return walls.
- 0.3mm crack width measured on return walls.
- Loss of fines at end block, crack in asphalt surface.
- Local spalling and exposed reinforcement at parapets.
- Clear blocked drainage scuppers.
- Missing bolts and reflectors at guardrail, height of guardrail to be rectified.
- Replace Thorma bridge expansion joint in bridge and sidewalk.
- Reinstate bridge number by retrofitting the structure numbers to the inside
- elevation of the end blocks as per current standard plans.

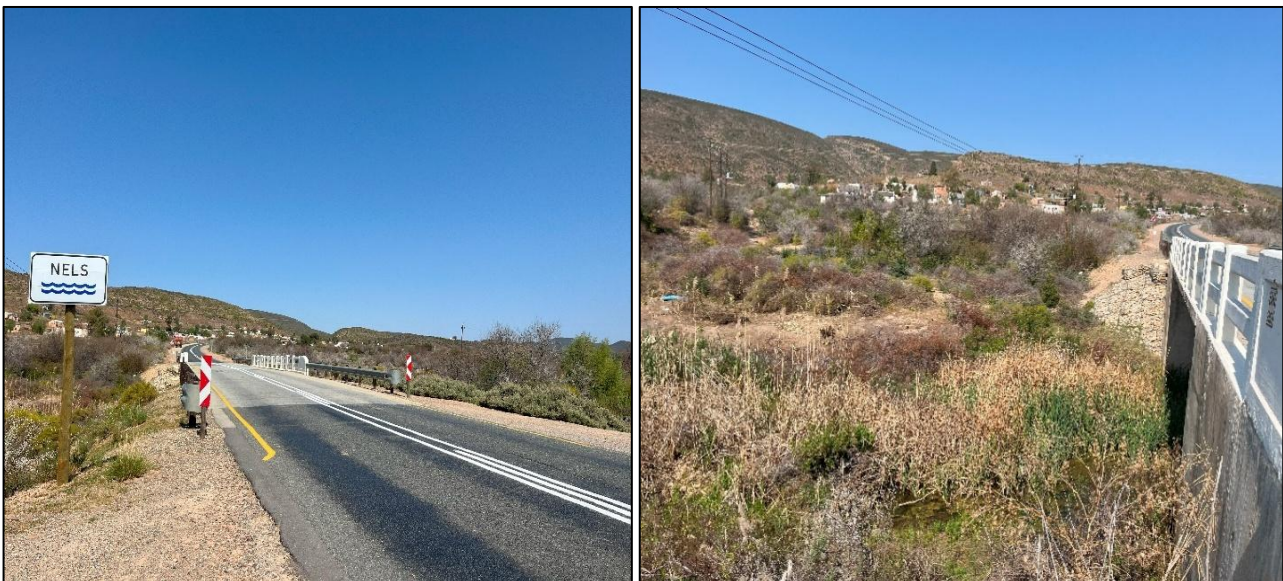
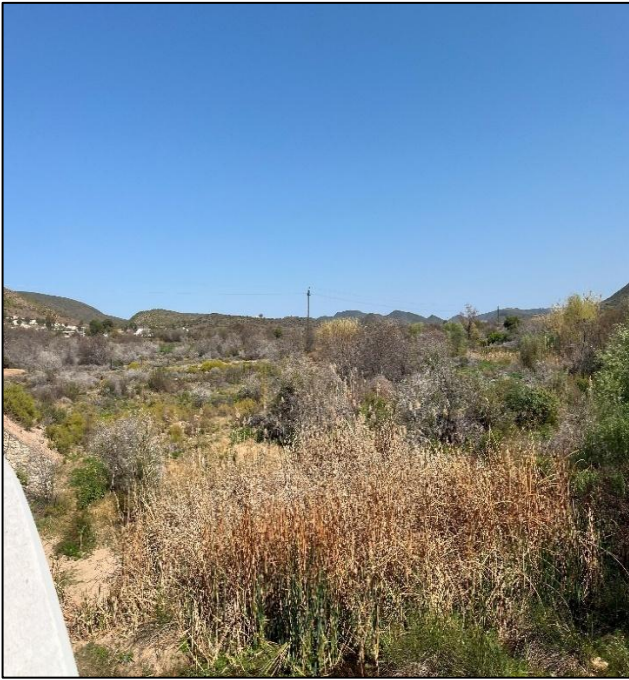
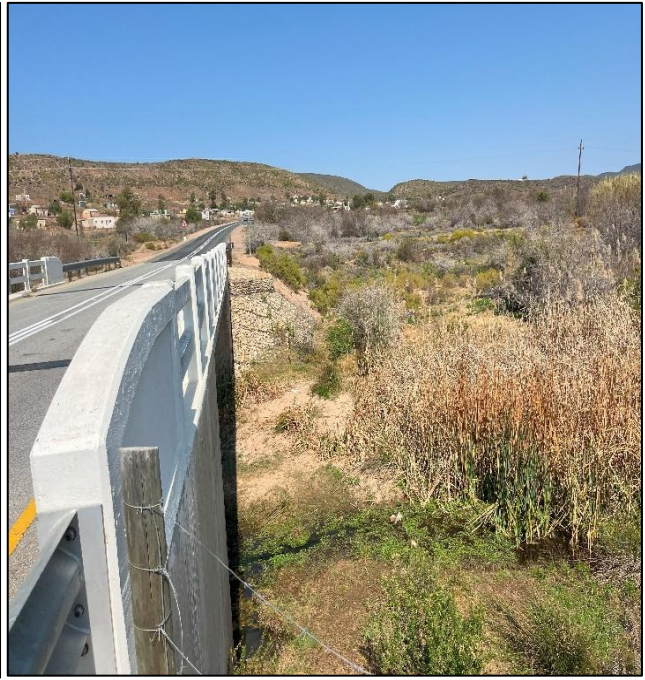
Nels river at Zoar:

Figure 33 and 34: Nels River Bridge at Zoar

Figure 35 and 36: Nels River Bridge at Zoar

Bridge No B2664 at the Nels River at Zoar at km 18.53 has 1 span, for a total length of 12.8 m. The structure is generally in a sound condition. The following defects have been noted and described along with proposed rehabilitation measures for this contract:

- Clear vegetation and reeds in waterway.
- Gabion basket damaged and loss of gabion stone. Local erosion between gabion and wingwall.
- Seal "gap" between all return walls and abutting grouted stone pitching.
- Localised cracking at return wall upstream.
- Concrete surface erosion to return walls, local spalling of concrete and exposed reinforcement at return wall.
- Missing bolts at guardrail bridge adapter. Washers at guardrail bridge adaptor indicating signs of corrosion.
- Clear blocked drainage scuppers.
- Local concrete spalling at abutment and exposed reinforcement.
- Reinstate bridge number by retrofitting the structure numbers to the inside elevation of the end blocks as per current standard plans
- Replace Thorma bridge expansion joint in bridge and sidewalk.

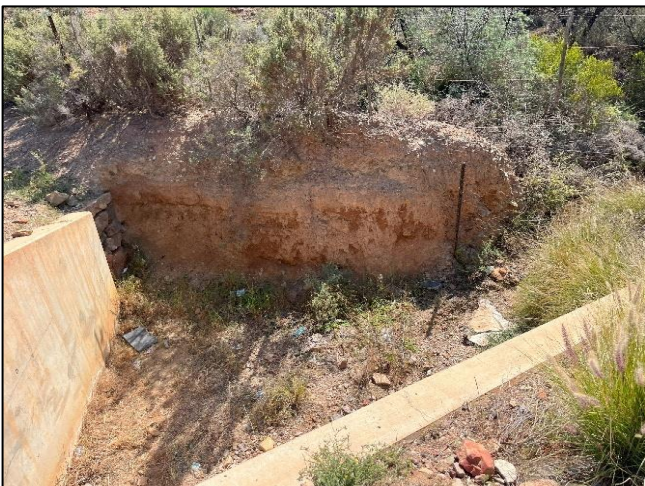
Figure 37: C10939

CHAINAGE (km)	STRUCTURE NO.	SPAN	OBSERVATIONS	REMEDIAL ACTIONS
4.14	C10939	4.6m	<ul style="list-style-type: none"> Minor siltation in cell Concrete surface erosion on culvert walls and headwall Horizontal crack on abutment on downstream Mound of sediment and tree hinders flow downstream Missing reflector plates and missing bolts on guardrails 	<ul style="list-style-type: none"> Clear siltation Clean and prepare the eroded surfaces and Apply a suitable concrete repair mortar to restore the eroded areas. Seal the crack with epoxy resin to prevent water ingress. Vegetation Clearing and removal of sediment mound Replace missing reflector plates and bolts

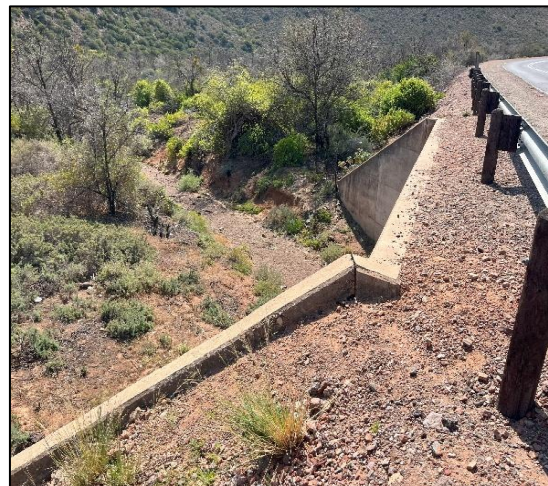
Figure 38: C10938

5.1	C10938	2/4.6m	<ul style="list-style-type: none"> Minor siltation in cell Concrete surface erosion on culvert wall and wingwall Vertical hairline crack on culvert wall Mound of sediment and vegetation hinders flow downstream Missing reflector plates on guardrails Height of guardrail 	<ul style="list-style-type: none"> Clear siltation Clean and prepare the eroded surfaces and apply a suitable concrete repair mortar to restore the eroded areas. Seal the crack with epoxy resin to prevent water ingress. Replace missing reflector plates Realignment of guardrail

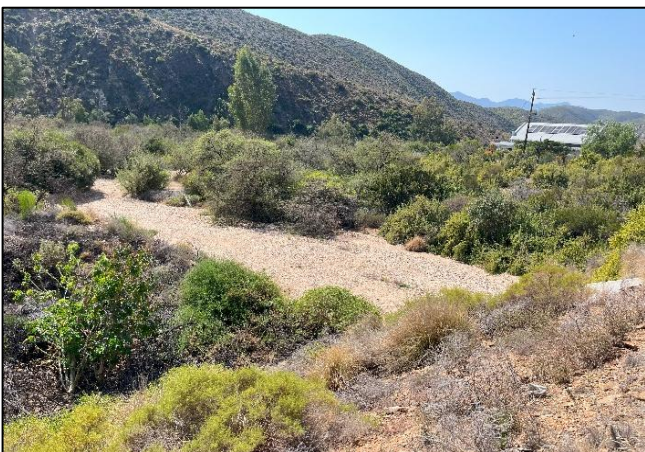
Figure 39: C11034

CHAINAGE (km)	STRUCTURE NO.	SPAN	OBSERVATIONS	REMEDIAL ACTIONS
37.75	C11034	3.0m	<ul style="list-style-type: none"> 0.7mm crack width to wing wall at outlet structure Sediment to be removed in culvert. 0.3mm crack width measured to soffit of culvert deck. 0.8mm crack width measured to wingwall at inlet structure. Dense vegetation at inlet structure. Guardrails: Missing bolts, damaged and missing reflectors, spacer blocks to be rectified. 	<ul style="list-style-type: none"> Clear vegetation and sediment. Crack repair to be undertaken, methodology relative to crack width measured. Replace missing reflector plates and bolts, realignment of guardrail and replace spacer blocks.

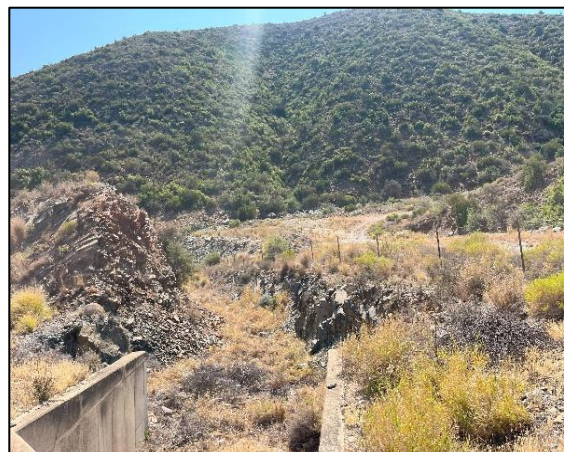
Figure 40: C11036

CHAINAGE (km)	STRUCTURE NO.	SPAN	OBSERVATIONS	REMEDIAL ACTIONS
40.56	C11036	3.5m	<ul style="list-style-type: none"> Localised cracking at headwall at inlet and outlet structure. Concrete surface erosion and localised spalling of concrete to outlet structure. Concrete surface erosion to inlet structure. Localised spalling of concrete at culvert wall. Vegetation and trees to be removed from waterway. Guardrails: Damaged reflectors, spacer blocks to be rectified. 	<ul style="list-style-type: none"> Crack repair to be undertaken, methodology relative to crack width measured. Clean and prepare the eroded surfaces and apply a suitable concrete repair mortar to restore the eroded areas. Spalled concrete to be removed, reinforcement to be inspected for corrosion. Appropriate methodology to be undertaken for treatment of reinforcement and reinstatement of concrete surface. Clear vegetation. Replace missing reflector plates, realignment of guardrail and replace spacer blocks.
