BIODIVERSITY SURVEY: EXTENSION OF THE GOUE AKKER CEMETERY, BEAUFORT WEST

April 2020

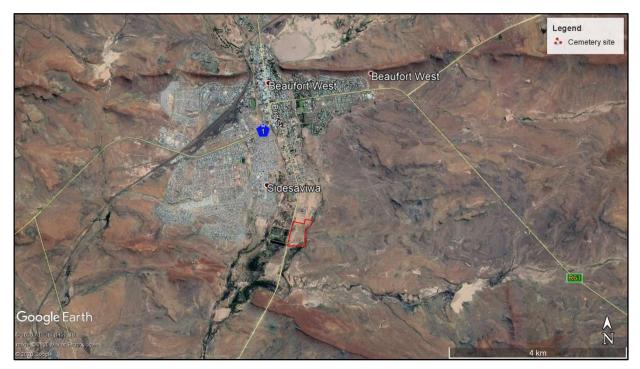
Map 1 Satellite photo showing the position of the site (outlined in red) on the southern side of Beaufort West.

This report investigates the biodiversity aspects of a site (±10 ha) on the southern side of Beaufort West earmarked for the extension of the Goue Akker cemetery (see Map 1). Goue Akker cemetery is located directly north of the site. The aim of the study, which was requested by Sharples Environmental Services (EAP), is to determine the biodiversity value of the site and to identify mitigation measures to ameliorate the impact. The site is located inside Southern Karoo Riviere (i.e. low-lying saline areas associated with watercourses), with Gamka Karoo vegetation found to the east of the bypassing Kuilsrivier.

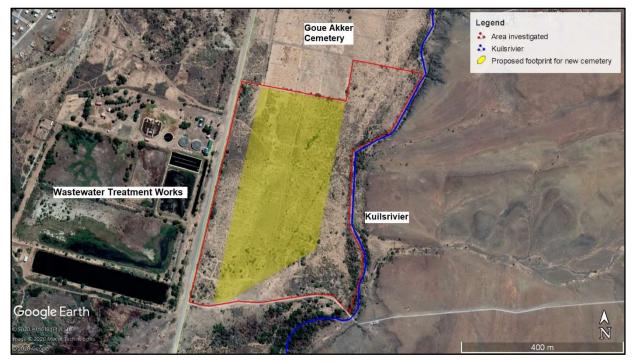
Map 2 Satellite photo showing the position of the study area and proposed footprint for the cemetery.

The project entails the establishment of a new ± 10 ha cemetery directly next to the Goue Akker cemetery on the southern side of Beaufort West (see Map 2). It is directly accessible from the bypassing Blyth Street, with the Kuilsrivier skirting the eastern side. No further details are available.

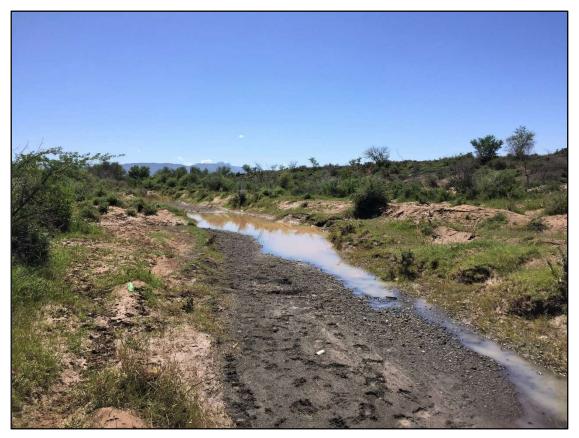
Photo 1 Kuilsrivier after recent rains.

The watercourses in the area are lined with *Vachellia karroo* and *Lycium* thorn trees (see Photo 1). The Kuilsrivier, a tributary of the Gamka River, skirts the eastern boundary of the site, while the wastewater treatment works is found on the western side (see Map 2). An area around the wastewater treatment works has been mapped as a natural wetland on the NFEPA layer (see Map 3). However, no evidence of any wetlands was found on or directly adjacent to the site during the site survey. Significant waste dumping (especially excavated rock and building rubble) was noted in the southern part of the site.

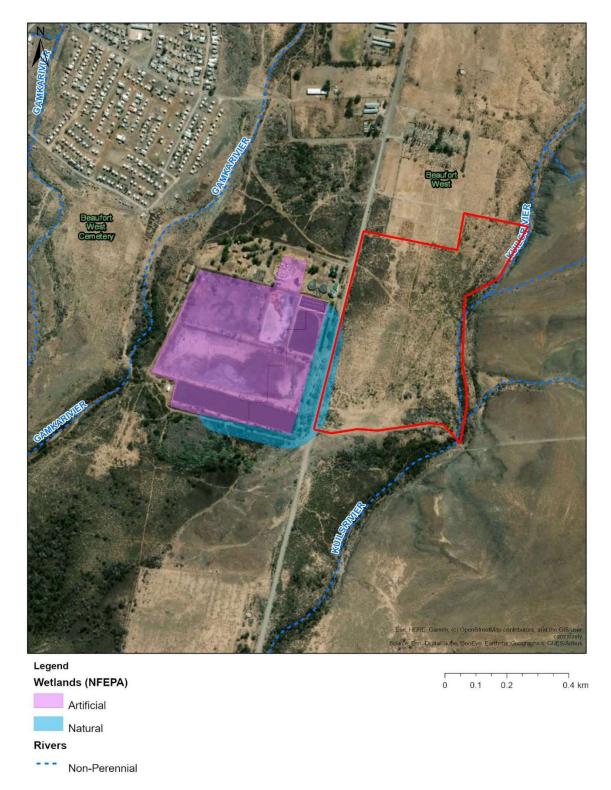
Map 3 Satellite photo illustrating the surface hydrology of the study area. Source: Cape Farm Mapper

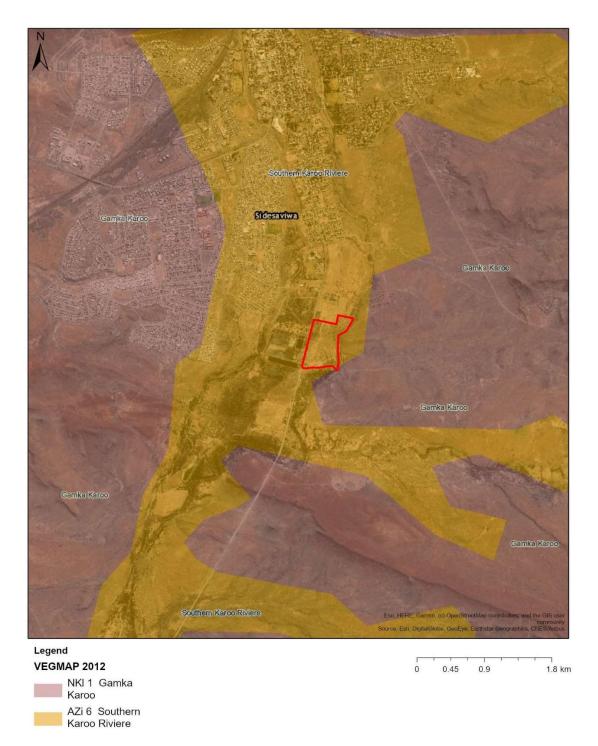
Map 4 Extract of the 2012 SA Vegetation Map (Source: Cape Farm Mapper), showing the position of the site (outlined in red) inside Southern Karoo Riviere, with Gamka Karoo on the eastern side.

The study site is located inside the Nama-Karoo Biome, a vast arid shrubland area extending from the Cape Fold Mountains in the Western and Southern Cape deep into the Northern Cape. The Vegetation Map of South Africa (Mucina & Rutherford 2006) classifies the main vegetation types found in the general area as Southern Karoo Riviere and Gamka Karoo (see Map 4).

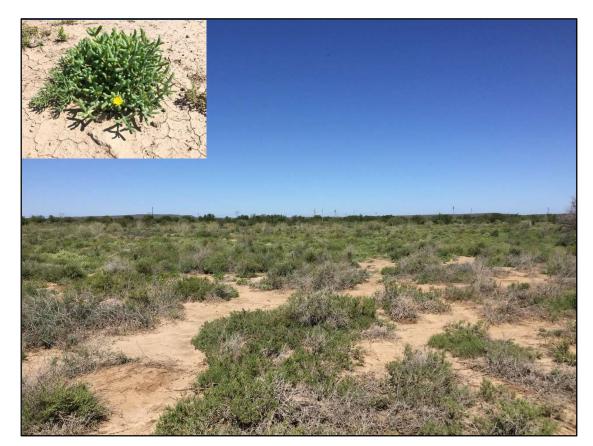
Photo 2 Southern Karoo Riviere, as viewed from the bypassing Blyth Street. Insert: Malephora latipetala

The study site falls within Southern Karoo Riviere, while the slightly elevated (rockier) area west of the Kuilsrivier is covered by Gamka Karoo (see Photo 2). The Kuilsrivier riverbed neatly separates the two vegetation types. The general condition of the Riviere vegetation is fair to good. Structurally, it can be described as a short (±0.6 m) closed (±40% cover) shrubland following Edward's (1983) classification of structural formations. *Vachellia karroo* (Karoo thorn) and *Prosopis glandulosa* (muskietboom) are prominent (2-4 m) emergent species in the area. Small clumps of the latter species were observed along the Kuilsrivier and in the south-western corner of the site (see Photo 3). *Prosopis glandulosa* is a declared invasive thorn tree from north-east Mexico and the south-western parts of the USA (Henderson *et al.* 1987). From a distance it closely resembles *V. karroo*, and also invades the riverine areas.

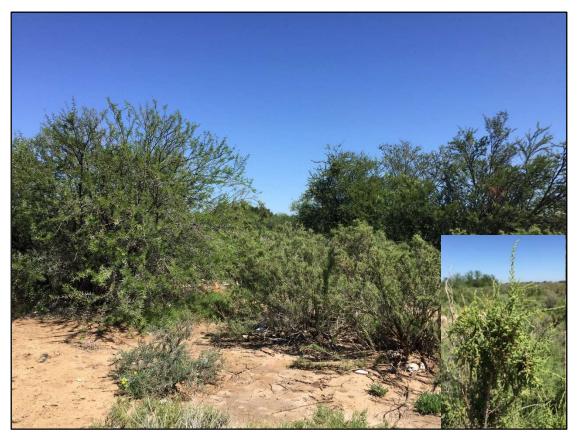
Photo 3 Vachellia karroo thicket in the south-western corner of site. Insert: Caroxylon aphyllum

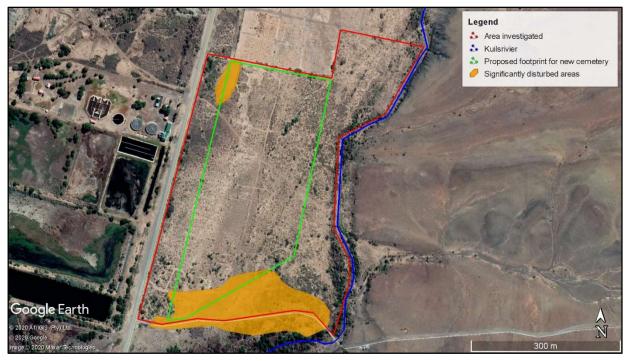
Map 5 Aerial photograph showing the biodiversity attributes of the site.

Considerable disturbance was noted in the southern part (waste dumping), as well as in the north-western corner (vegetation stripped next to the existing cemetery) (see Map 5; Photos 4-6). The site enjoys easy and unrestricted access from the town. A few dirt tracks and an Eskom powerline also cross the site. A significant presence of invasive cacti and *Prosopis glandulosa* was noted, especially in and around the waste dumping area and along the Kuilsrivier. Invasive cacti (escaped from garden refuse!) recorded include *Opuntia elata*, *Cylindropuntia fulgida* var. *mamillata* (boxing glove cactus), *Tephrocactus articulatus* and *Trichocereus spachianus*. Exotic weeds recorded include *Atriplex nummularia* (old man salt bush), *A. lindleyi* subsp. *inflata*, *A. semibaccata*, *Salsola kali*, *Tribulus terrestris*, *Argemone ochroleuca*, *Xanthium spinosum*, *Solanum elaeagnifolium* and *Portulaca oleracea*. Nearly all these species are listed invasive

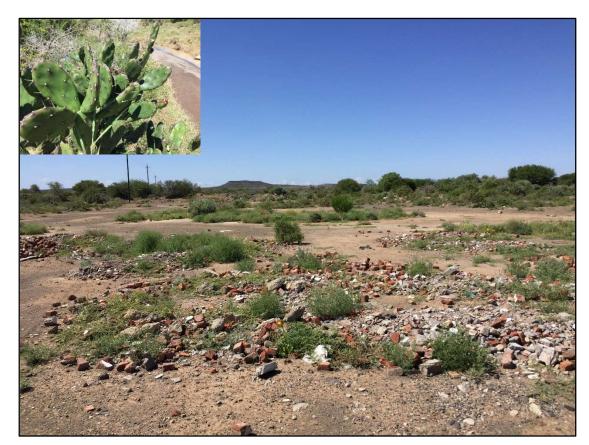
Photo 4 Disturbed southern part of site. Insert: Opuntia elata

The local authority should make an effort to prevent illegal dumping in this area by providing suitable waste disposal facilities where waste, including garden refuse, can be recycled and disposed off in a controlled manner. Evidence of past agricultural activities (cultivation!) was noted on a historical Google Earth photograph (see Map 6). The vegetation has recovered remarkably well as little evidence of this past disturbance was found during the site survey.

Mitigation measures: Rehabilitate the disturbed area and section of the Kullsrivier on the southern side of the site where waste dumping occurred; control aliens as a long-term management requirement; prohibit further waste dumping in the area.

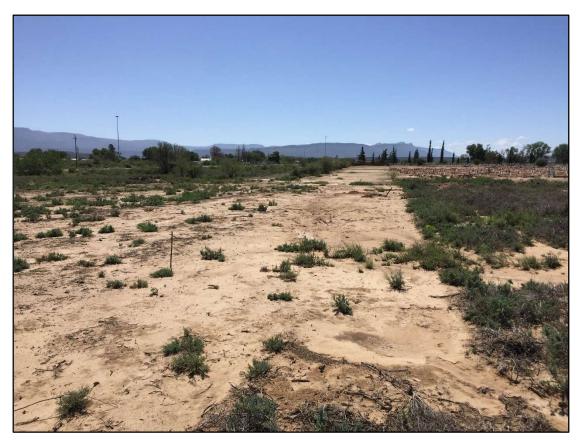
Photo 5 Disturbed north-western corner of site, with the Goue Akker cemetery in background.

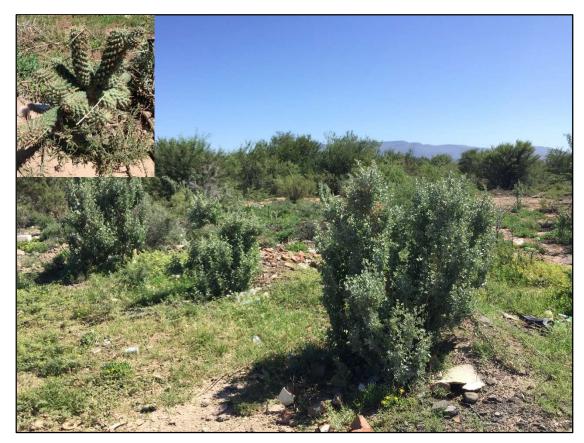
aliens in terms of the National Environmental Management: Biodiversity Act (Act 10 of 2004) Alien and Invasive Species List (2016). The harbouring of *Atriplex nummularia* (Category 2 invader) on a property is prohibited without a permit.

Photo 6 Atriplex nummularia in a disturbed part of the site. Insert: Cylindropuntia fulgida var. mamillata

impact. As an operational phase impact, alien control will be required on and around the site as an ongoing management concern.

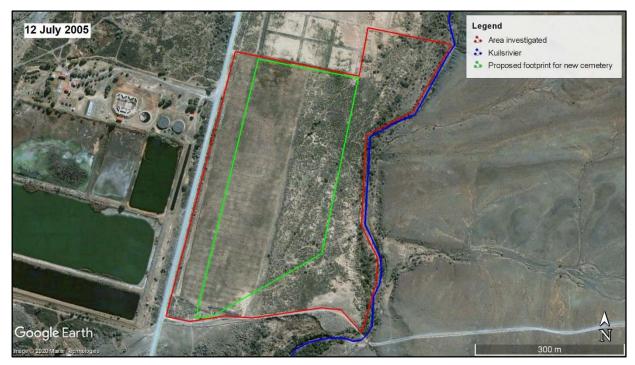
Map 6 Historical 2005 Google Earth photo illustrating past agricultural activities on the site.

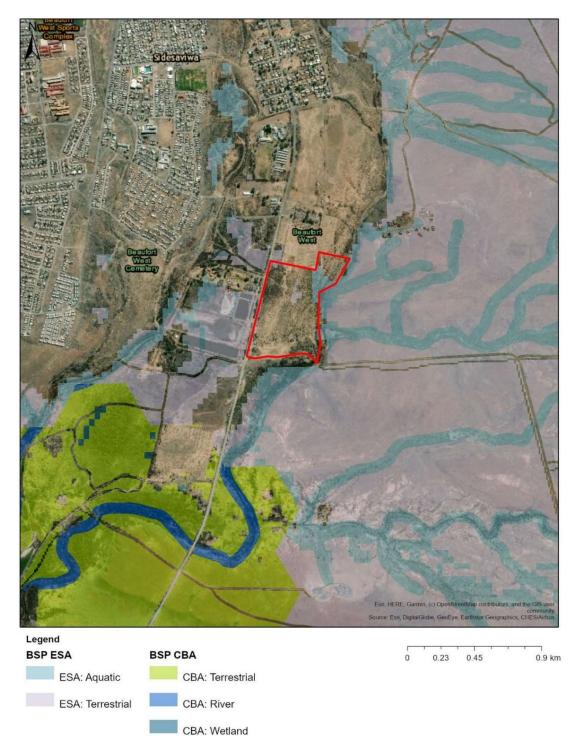
Map 7 Biodiversity network map (Source: Cape Farm Mapper), with the site outlined in red.

The site forms part of the Beaufort West biodiversity network (see Map 7). It marginally affects mapped ESA's (ecological support areas, indicated as wetland, watercourse or water recharge
