*Geohydrological and geotechnical
assessment for the proposed expansion of
the Melkhoutfontein Cemetery, Still Bay.*

GEOSS Report No: 2020/07-04

03 July 2020

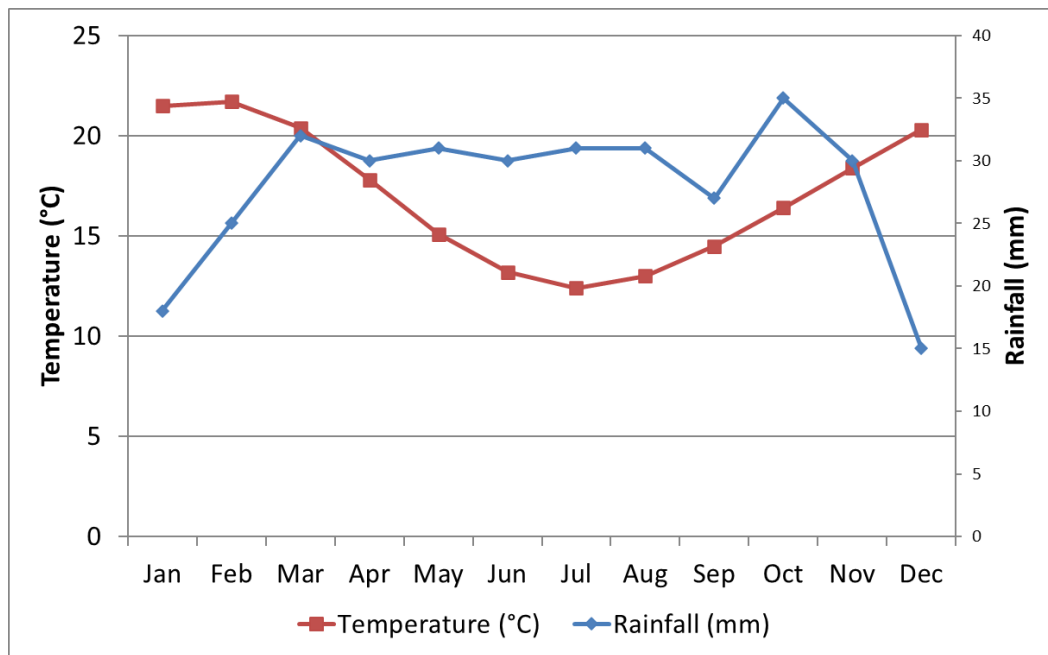
Figure 1: Monthly average air temperature and rainfall distribution for Melkhoutsfontein (Schulze, 2009).

The Melkhoutsfontein area experiences a semi-arid climate with low rainfall occurring throughout the year. **Figure 1** shows the monthly average air temperature and rainfall distribution and **Figure 2** shows the monthly median rainfall and evaporation distribution for the Melkhoutsfontein area (Schulze, 2009). Melkhoutsfontein receives a mean annual precipitation average of 433 mm/a. In terms of monthly averages, the rainfall does not exceed evaporation during the year.

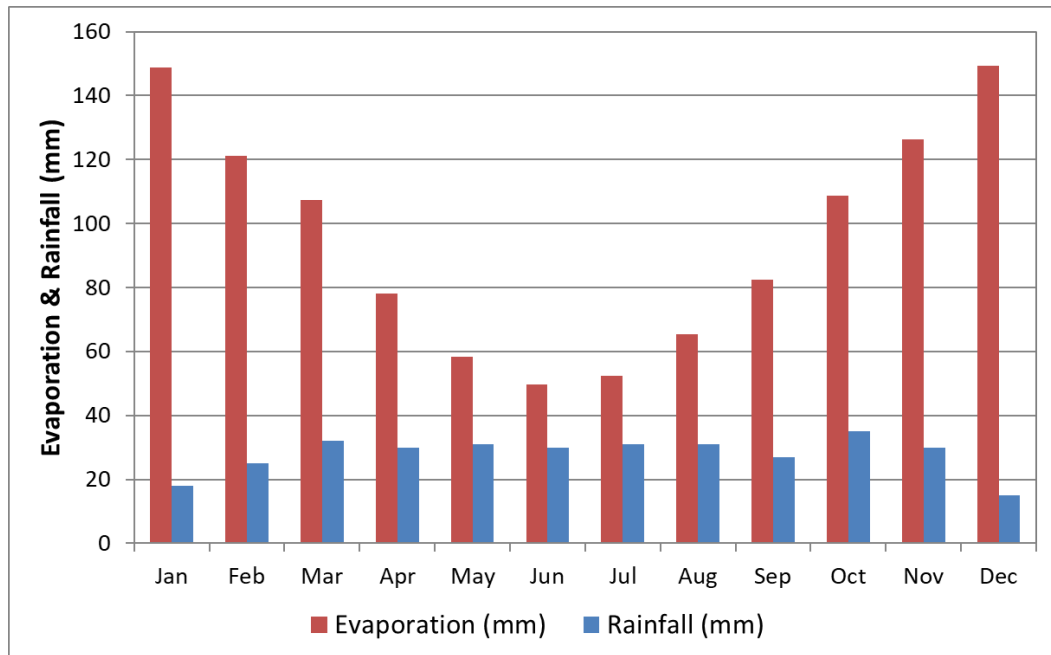
Figure 2: Monthly average rainfall and evaporation distribution for Melkhoutsfontein (Schulze, 2009).

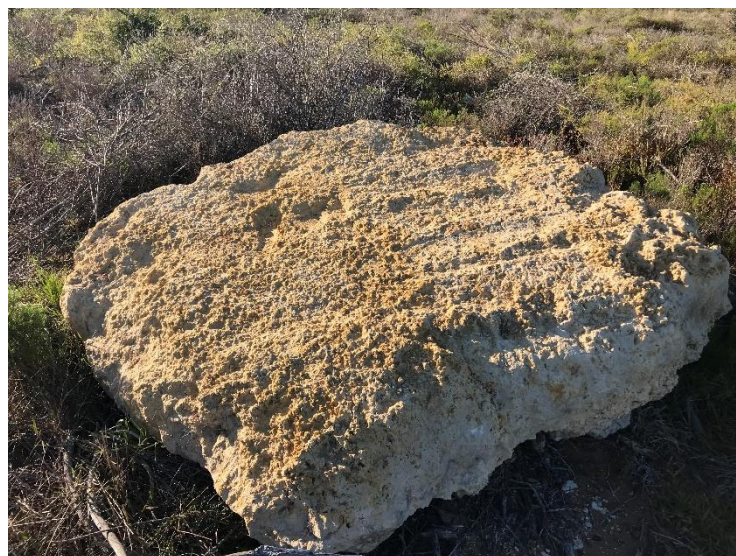
Figure 3: Calcarenite from the study area.

The number indicated in parenthesis at the end of each factor description is the weighting or relative importance of that factor. This “high” rating is associated with relatively shallow groundwater level (observed on and near the site, including the presence of a natural spring down-gradient of the site). The Wankoe Formation comprises largely unconsolidated sands and calcarenite (clastic or detrital sedimentary rock consisting largely of calcium carbonate grains). The aquifer is therefore classified as intergranular and therefore more susceptible to point and non-points sources of contamination. **Figure 3** shows a large piece of calcarenite observed on site.

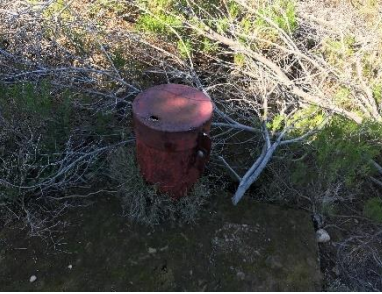
BH01B	-34.323436	21.434382	11.4	3.5	139.7	24	Privately drilled borehole. Yield tested by GHT in 2019.

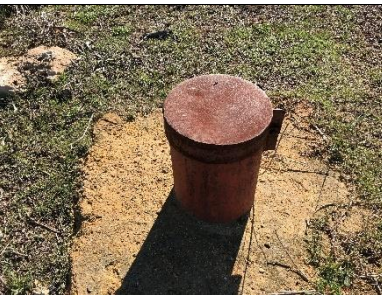
Site Label	Latitude (DD, WGS84)	Longitude (DD, WGS84)	WL (mbgl)	Yield (L/s)	EC (mS/m)	Depth (m)	Comments	Photo
BH01A	-34.323459	21.434329	-	-	-	-	Exploration borehole.

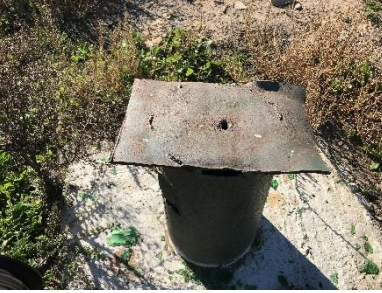
Site Label	Latitude (DD, WGS84)	Longitude (DD, WGS84)	WL (mbgl)	Yield (L/s)	EC (mS/m)	Depth (m)	Comments	Photo
BH4	-34.32699	21.42646	2.58	7	165	40	Drilled by GHT in 2019. Solution cavity within conglomerate well developed. Water strike at 10 and 13 mbgl.

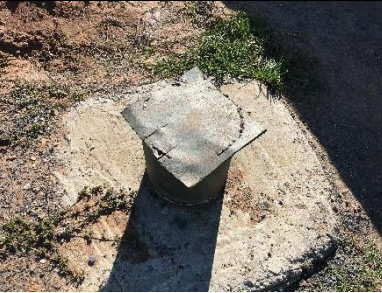
BH5	-34.32855	21.42365	Dry	-	-	18	Drilled by GHT in 2019. Bh drilled directly into shale and drilling was stopped. No water.	No photo.
BH36	-34.32609	21.4288	3.85	7	151	43	Drilled by GHT in 2019. Solution cavity within conglomerate well developed. Water strike at 13 mbgl.

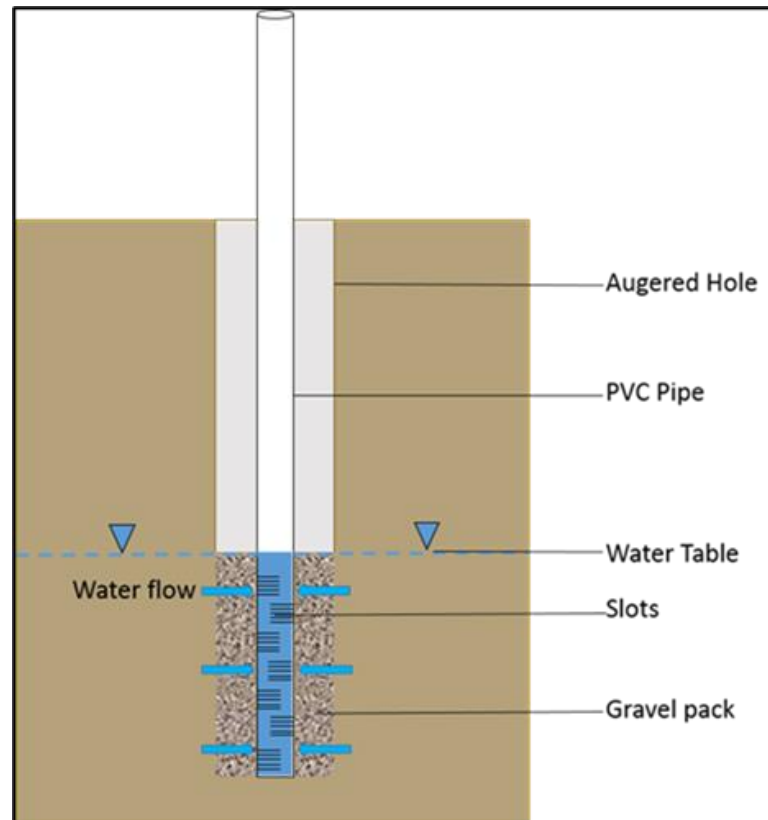
Figure 4: Typical piezometer installation.

Piezometer installation involves installing a 50 mm PVC pipe as deep as possible below the groundwater level. The PVC pipe is slotted (i.e. screened) to allow groundwater to flow into the pipe. The general construction of such a screened piezometer can be seen in **Figure 4**.

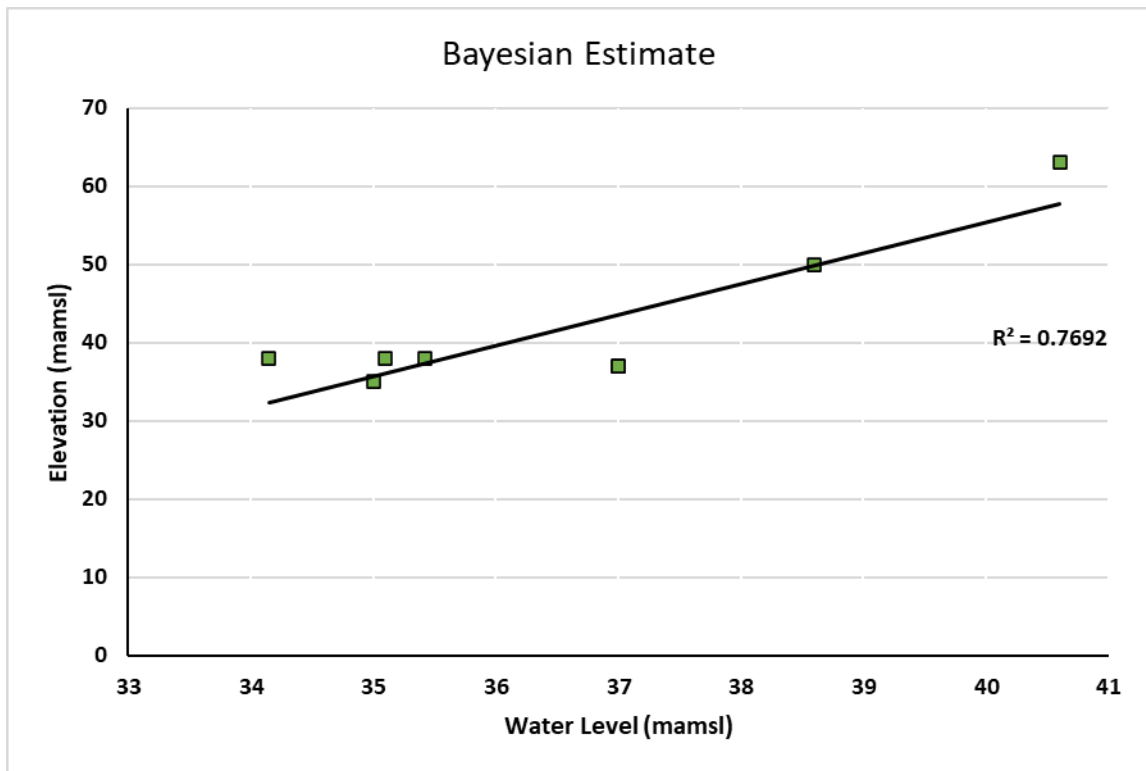
Figure 5: Correlation between surface topography and groundwater elevation for boreholes proximal to study site.

In order to evaluate the relationship between groundwater levels and topography, and the applicability of the interpolation technique, the surface elevations and water table elevations are plotted relative to each other. The data is presented in **Figure 5**, and indicates a 76.9% correlation between surface topography and water level elevation. While not suitably high, Bayesian interpolation is considered an acceptable interpolation technique for indicative purposes only.

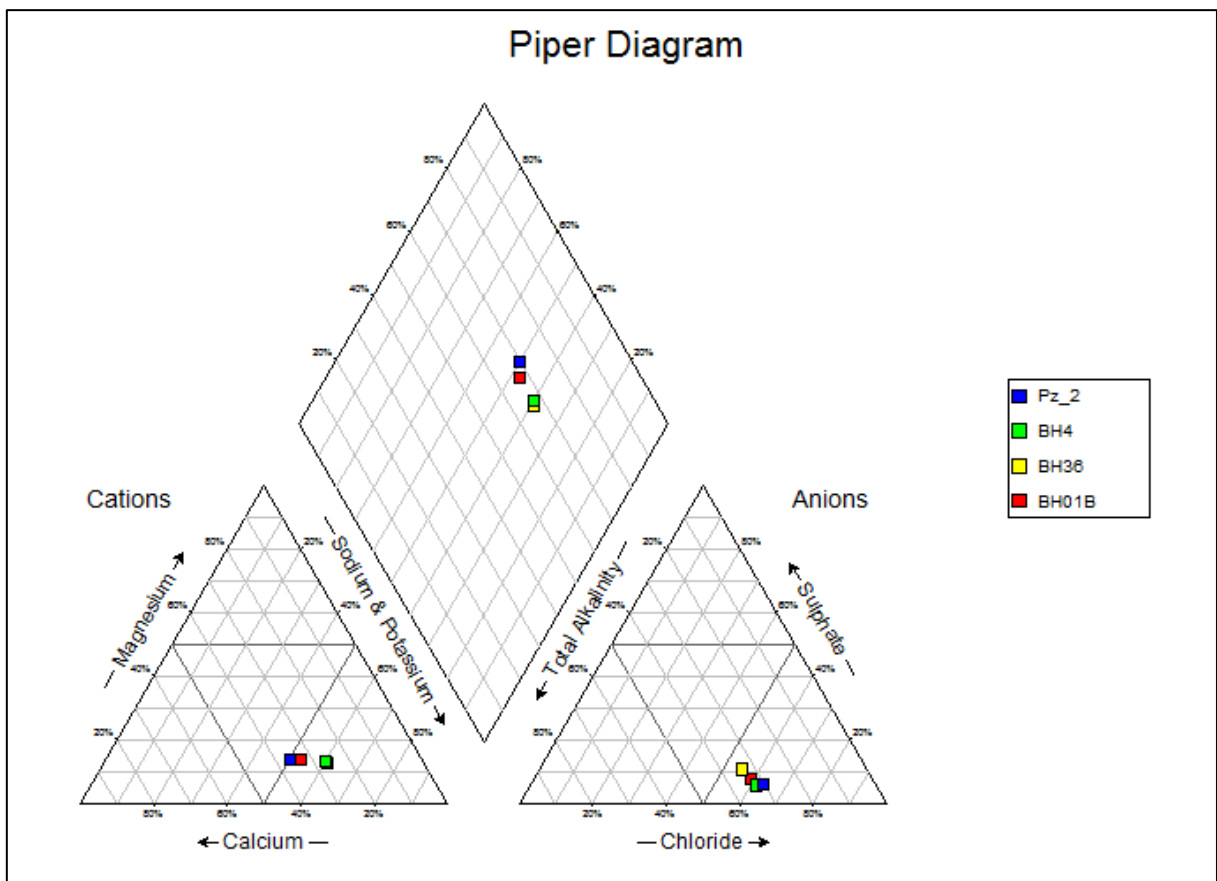
Figure 6: Piper diagram of the production borehole groundwater samples.

A number of chemical diagrams have been plotted for the groundwater samples and these are useful for chemical characterisation of the water. The chemistry of the samples has been plotted on a tri-linear diagram known as a Piper diagram. This diagram indicates the distribution of cations and anions in separate triangles and then a combination of the chemistry in the central diamond. From **Figure 6** (central diamond) the piezometer and borehole groundwater samples, Pz_1, BH01B, BH4 and BH36 is classified as having a mixed to sodium chloride hydrofacies.

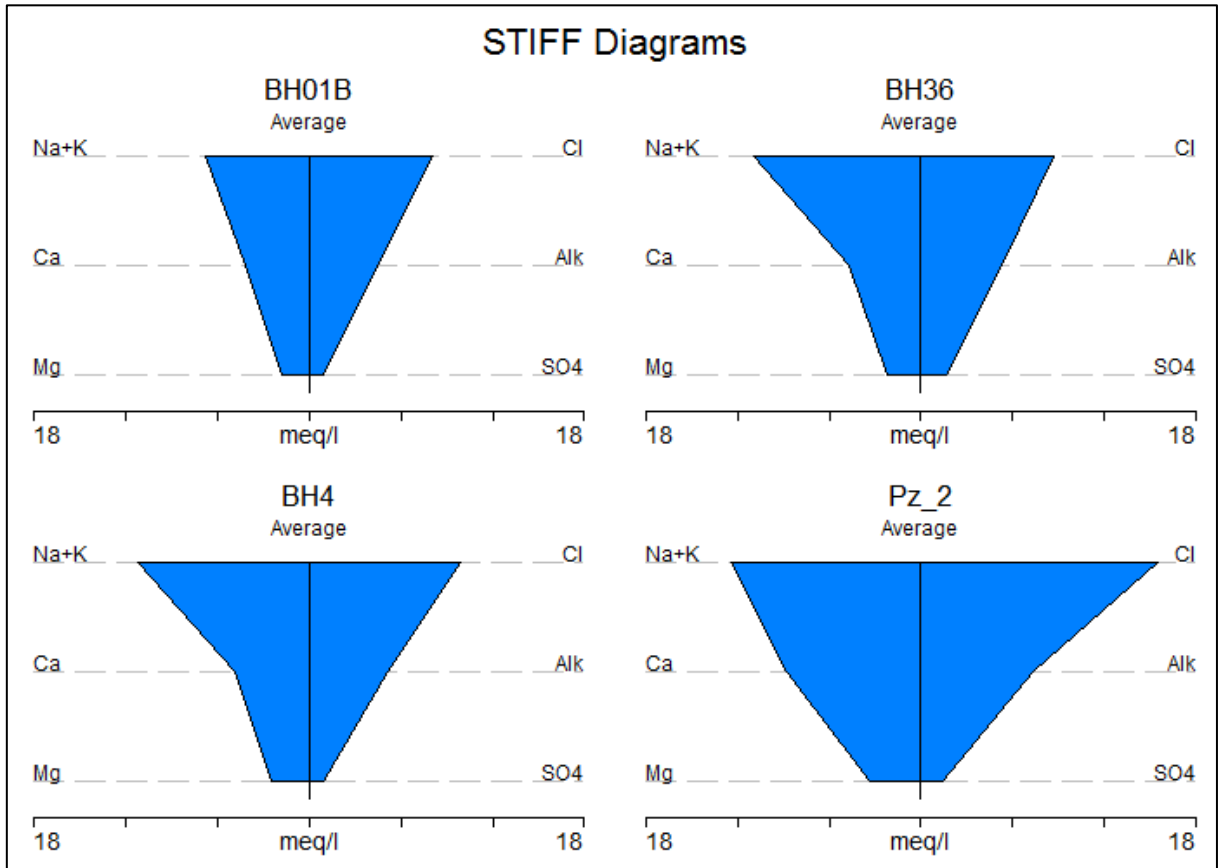
Figure 7: Stiff diagram of the borehole groundwater sample.

The Stiff Diagram is a graphical representation of the relative concentrations of the cations (positive ions) and anions (negative ions). This diagram shows concentrations of cations and anions

relative to each other and direct reference can be made to specific salts in the water. The Stiff Diagram for the samples from the boreholes and piezometer is shown in **Figure 7**. It is clear that the groundwater samples are dominated by Na+K and Cl⁻ and that the groundwater has an overall high dissolved mineral concentration.

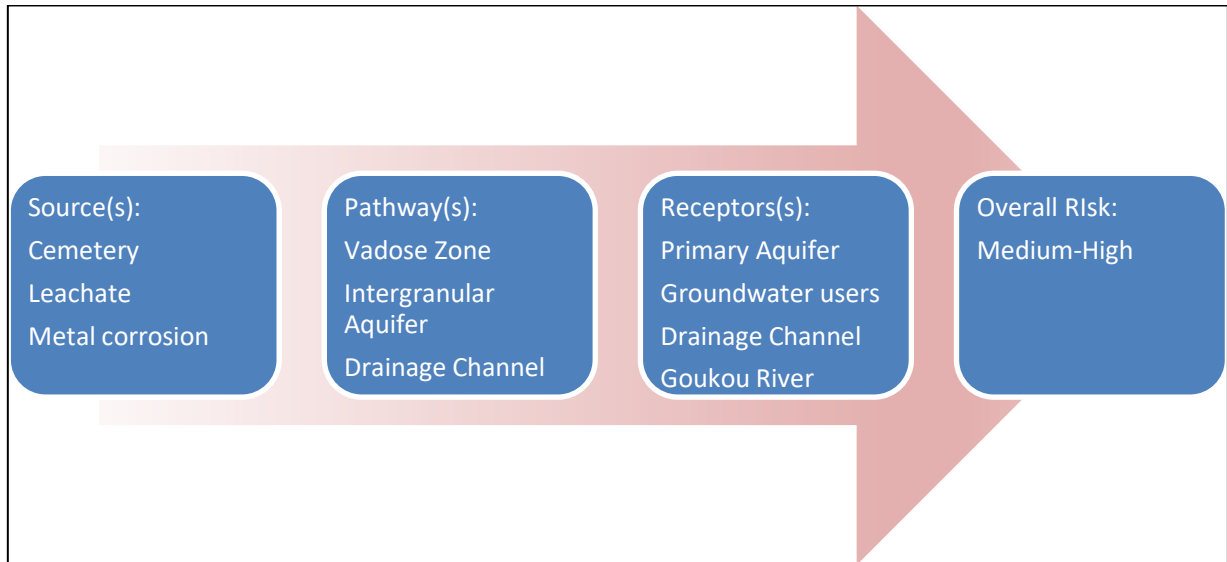
Figure 8: Source, Pathway and Receptor assessment.

Given the “high” vulnerability of the underlying aquifer, the risk of contamination is considered. For a risk to exist there must be a source (s), pathway(s) and receptor(s); these are presented in **Figure 8**. All three are present in this case (an SPR linkage exists). The cemetery and proposed expansion represent potential sources of contamination. The underlying aquifer, proximal drainage channel and Goukou River represent both a potential pathway and receptor. Groundwater users represent an additional receptor of potential contamination.

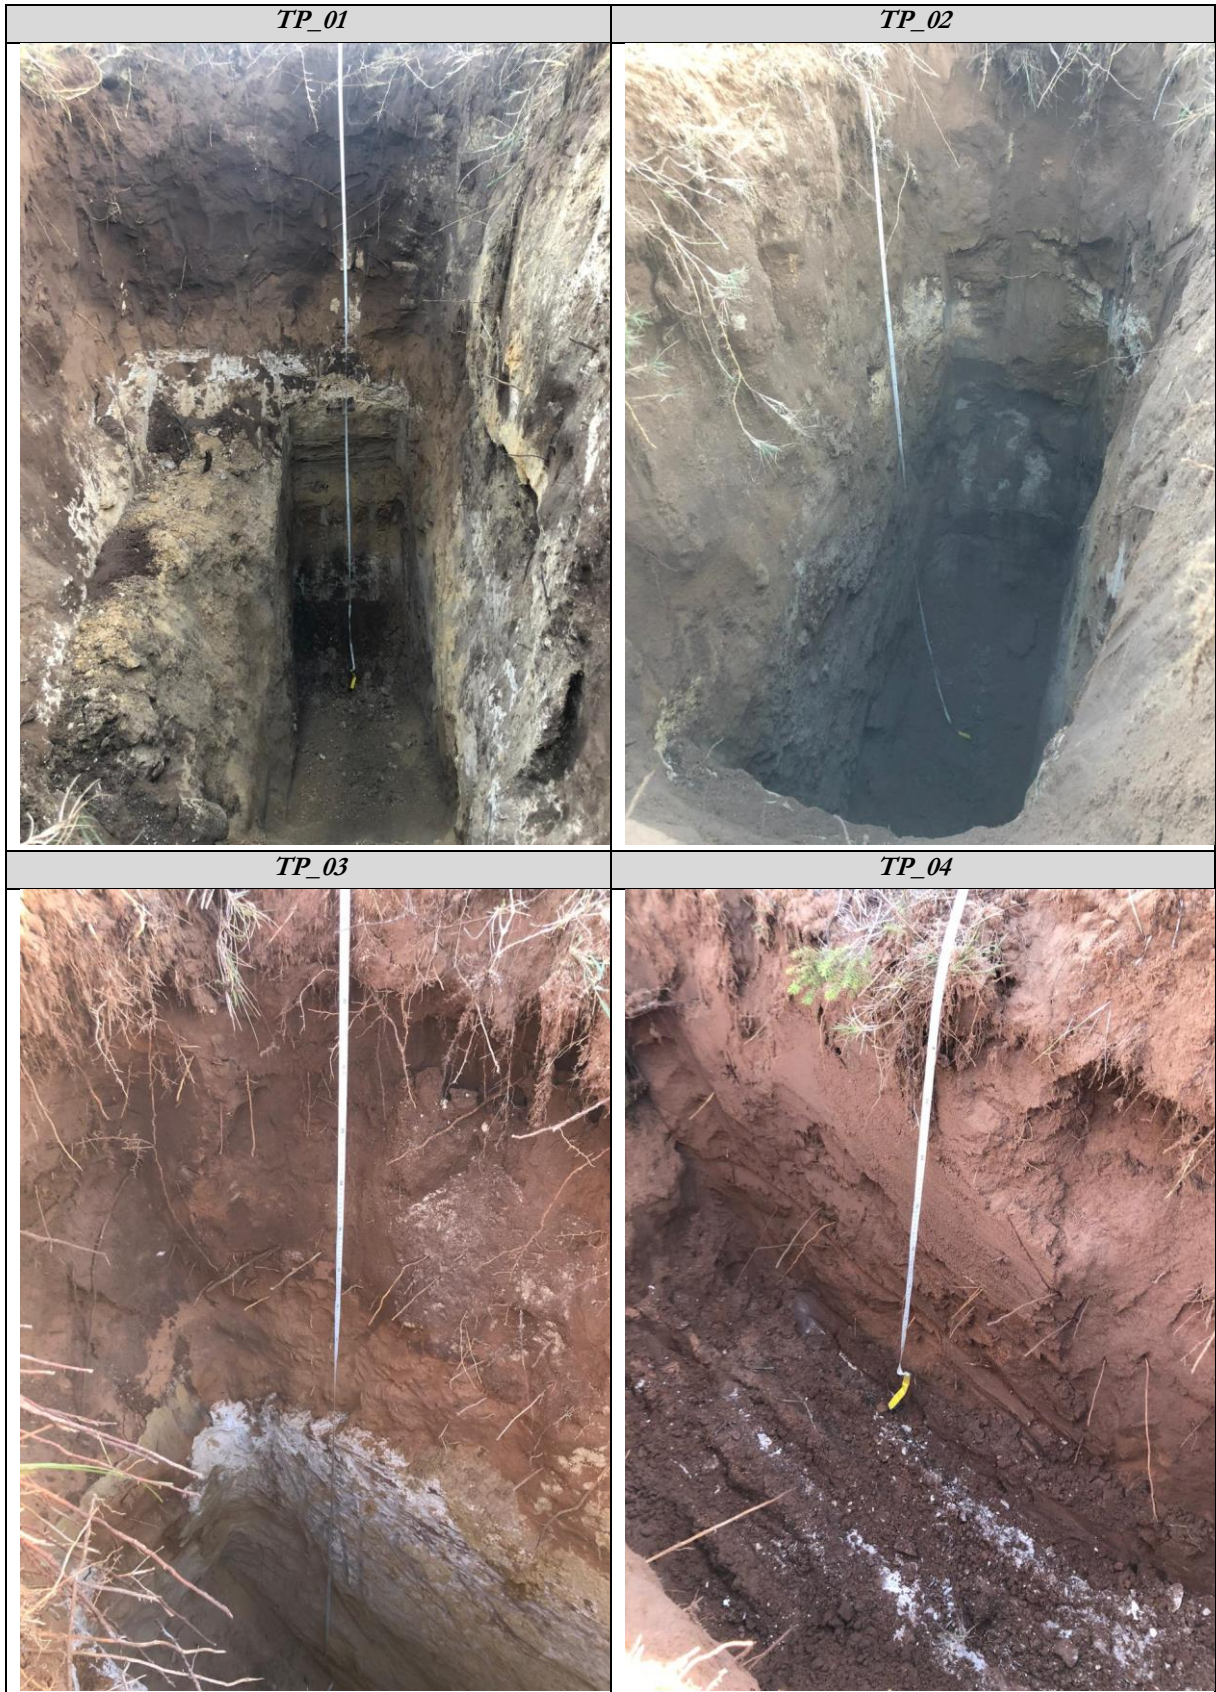
Figure 9: TP_01 to TP_04.

Log of Trial Pit No.:		TP01	
Location:	Melkhoutfontein Cemetery	Latitude:	-34.32398703
Date:	24-Jun-20	Longitude:	21.42649102
Client:	SES	Ground Elevation:	43
Lithological Description	Lithology (mbgl)	Construction	Comments
Unit 1: 0.00 - 1.30 Dry, brown & orange brown, loose, bedded, fine SAND. Transported sediments.			
Unit 2: 1.30 - 3.10 CALCRETE, soft rock			
Unit 3: 2.10 - 3.10 Dry, pale orange & white, medium dense, bedded, silty fine SAND. Transported sediments.			
			End of Hole = 3.10 mbgl
Excavated By: Drill Method: Logged By:	GEOSS TLB Excavator CM/ MB	Remarks: No groundwater

Log of Trial Pit No.:		TP02	
Location:	Melkhoutfontein Cemetery	Latitude:	-34.324327
Date:	24-Jun-20	Longitude:	21.42668699
Client:	SES	Ground Elevation:	42
Lithological Description	Lithology (mbgl)	Construction	Comments
Unit 1: 0.00 - 0.80 Dry, brown & orange brown, loose, bedded, fine SAND. Transported sediments.			
Unit 2: 0.80 - 1.00 CALCRETE, soft rock			
Unit 3: 1.00 - 2.90 Dry, brown & white, medium dense, bedded, silty fine SAND. Transported sediments.			
Unit 4: 2.90 - 3.1 Slightly moist, dark brown, medium dense, intact, clayey silty Fine SAND. Transported sediment.		End of Hole = 3.10 mbgl	
Excavated By: Drill Method: Logged By:	GEOSS TLB Excavator CM/ MB	Remarks: No groundwater

Log of Trial Pit No.:		TP03	
Location:	Melkhoutfontein Cemetery	Latitude:	-34.32485397
Date:	24-Jun-20	Longitude:	21.42682697
Client:	SES	Ground Elevation:	41
Lithological Description	Lithology (mbgl)	Construction	Comments
Unit 1: 0.00 - 1.20 Dry, brown & orange brown, loose, bedded, fine SAND. Transported sediments.			Piezometer Installed
Unit 2: 1.20 - 1.80 CALCRETE, soft rock		Sample S1 @ 1.0 mbgl	
Unit 3: 1.80 - 3.20 Dry, pale brown & white, medium dense, bedded, silty fine SAND. Transported sediments.		Sample S2 @ 2.0 mbgl	
Unit 4: 3.20 - 3.50 Slightly moist, dark brown, medium dense, intact, clayey silty Fine SAND. Transported sediment.		End of Hole = 3.50 mbgl	
Excavated By: GEOSS Drill Method: TLB Excavator Logged By: CM/ MB	Remarks: No groundwater

Log of Trial Pit No.:		TP04	
Location:	Melkhoutfontein Cemetery	Latitude:	-34.32504499
Date:	24-Jun-20	Longitude:	21.42663502
Client:	SES	Ground Elevation:	40
Lithological Description	Lithology (mbgl)	Construction	Comments
Unit 1: 0.00 - 1.20 Dry, brown, loose, intact, fine SAND. Transported sediments.			TLB Refusal on Calcrete
Unit 2: 1.20 CALCRETE, medium hard rock			
Excavated By: Drill Method: Logged By:	GEOSS TLB Excavator CM/ MB	Remarks: No groundwater

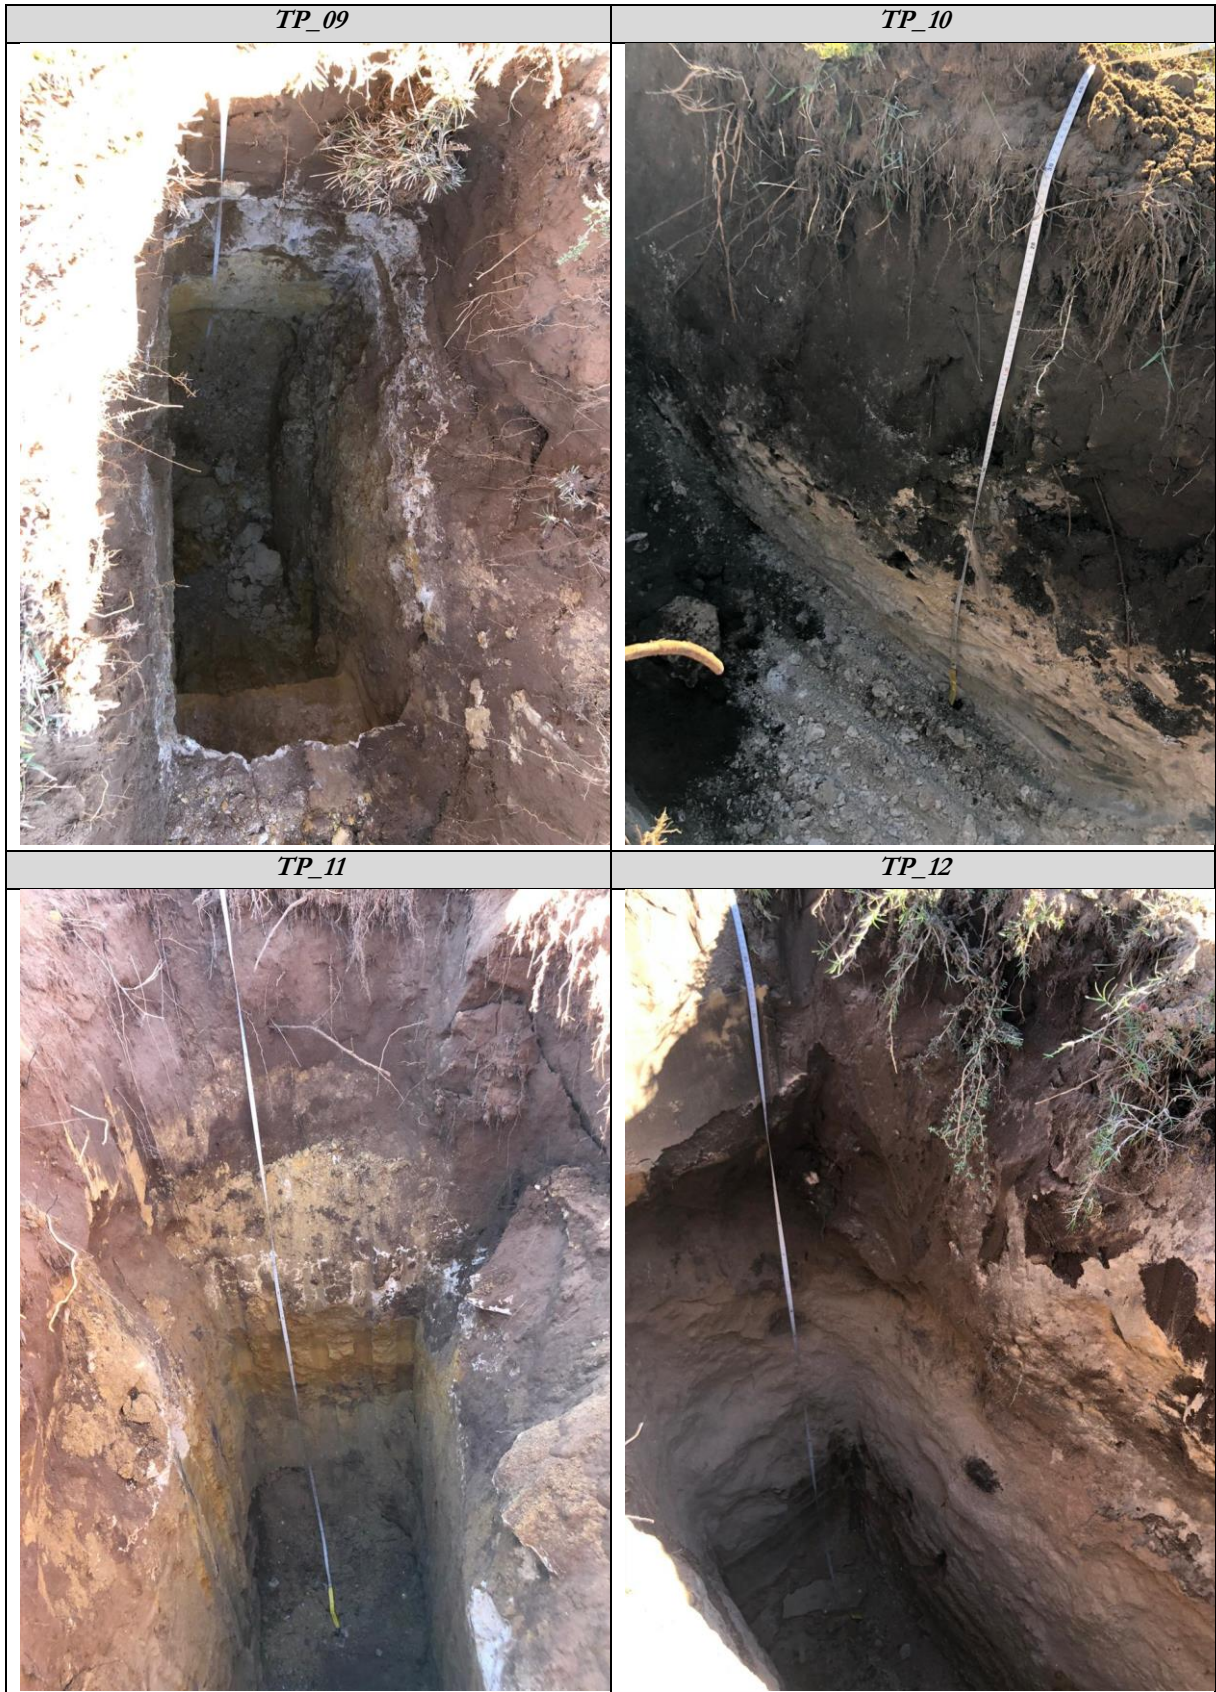
Figure 11: TP_09 to TP_12.

Log of Trial Pit No.:		TP12	
Location:	Melkhoutfontein Cemetery	Latitude:	-34.32391897
Date:	24-Jun-20	Longitude:	21.42609296
Client:	SES	Ground Elevation:	43
Lithological Description	Lithology (mbgl)	Construction	Comments
Unit 1: 0.00 - 0.80 Dry, brown & orange brown, loose, bedded, fine SAND. Transported sediment.			Piezometer Installed
Unit 2: 0.80 - 1.00 Dry, off white, loose, intact, fine SAND. Transported sediment.			
Unit 3: 1.00 - 2.90 Slightly moist, dark brown, medium dense, intact, clayey silty Fine SAND. Transported sediment.			
			End of Hole = 3.10 mbgl
Excavated By: GEOSS Drill Method: TLB Excavator Logged By: CM/ MB	Remarks: No groundwater

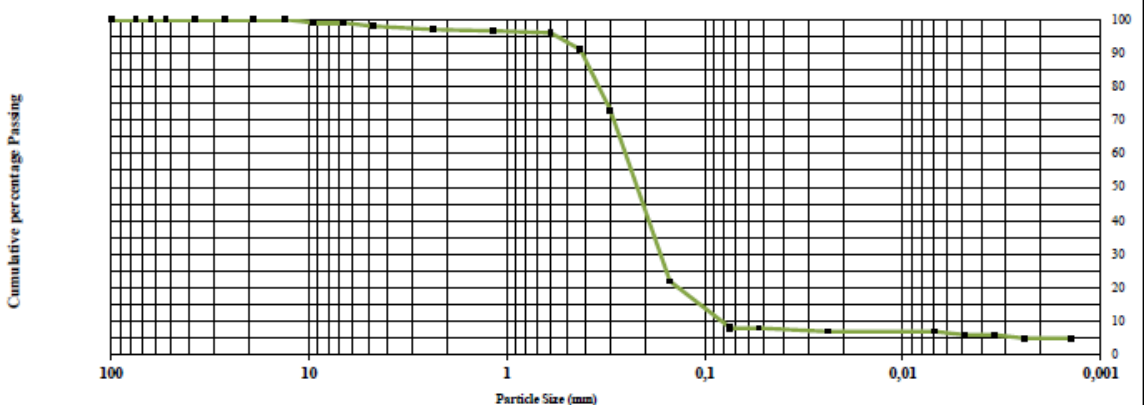
Particle Size Distribution

% Gravel	3	% Sand	89	% Silt	3	% Clay	5
----------	---	--------	----	--------	---	--------	---

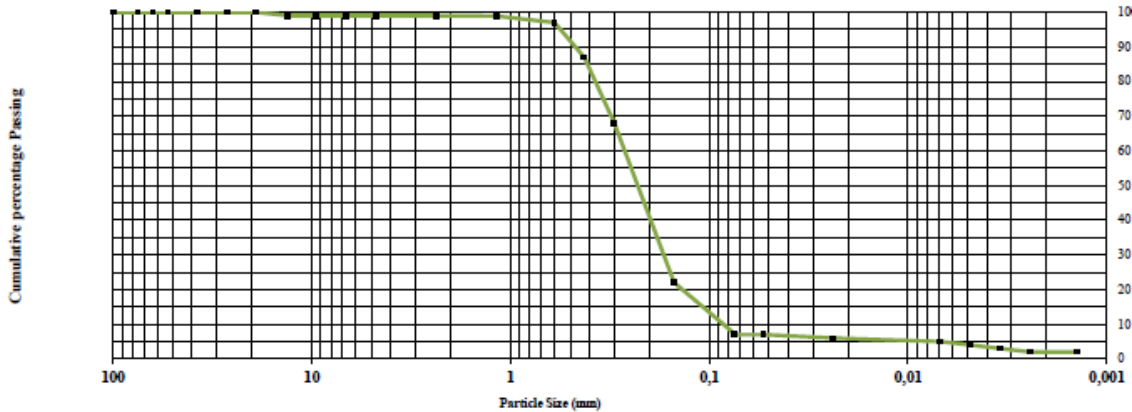
Particle Size Distribution

% Gravel	1	% Sand	92	% Silt	5	% Clay	2
----------	---	--------	----	--------	---	--------	---
