# WATER USE LICENSE APPLICATION

PROPOSED DUST SUPPRESSION, DEWATERING OF  
THE QUARRY AND WIDENING OF A BRIDGE AT  
GRAN SASSO QUARRY, MILNERTON, WESTERN  
CAPE

## WULA TECHNICAL REPORT

December 2020

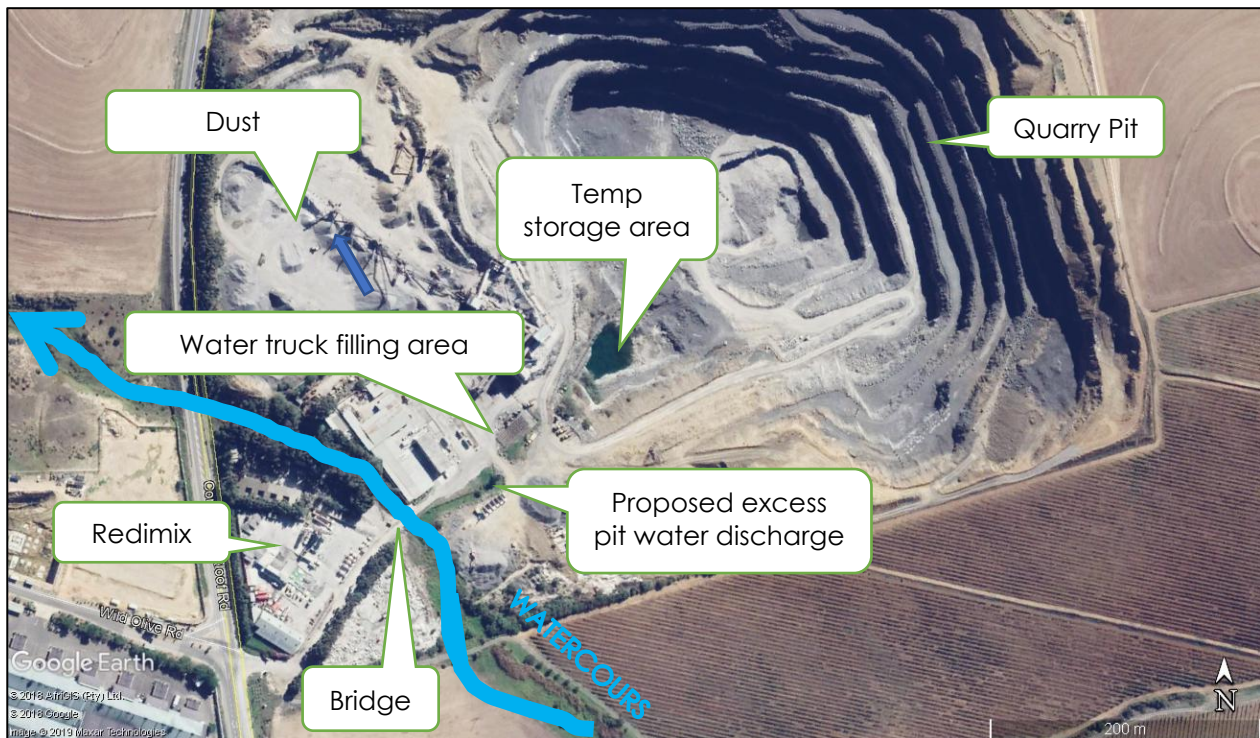
**Figure 3: The relevant features and activities associated with Gran Sasso Quarry**

The proposed water use activities include (Figure 3):

- Widening of the existing single lane entrance bridge crossing a watercourse;
- Pumping out water that collects in the quarry pit into a storage area from where it will be re-used for dust suppression and Redimix production; and
- Pumping excess water left after re-use into a vegetated drain towards a watercourse. The excess discharge is not expected but applied for as a precaution.

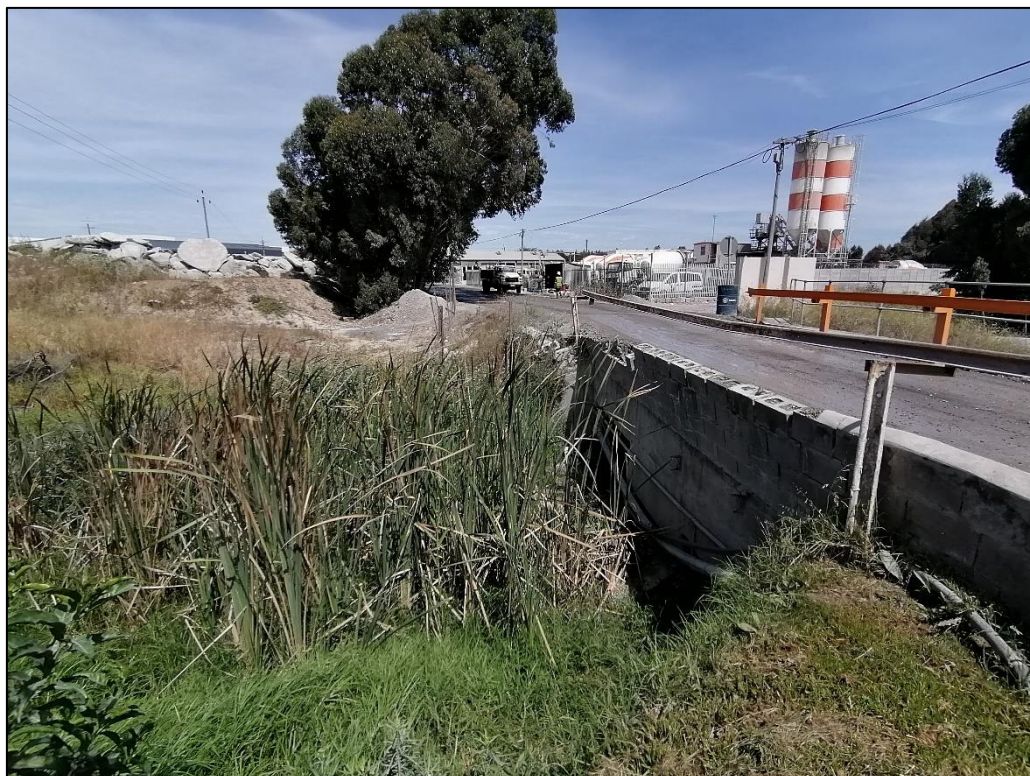
**Figure 4: The bridge proposed to be widened**

The existing bridge is proposed to be widened on the upstream (southern) side of the crossing. Figure 4 below shows the bridge that is proposed to be widened. The bridge is currently single lane which means that traffic gets held up when needing to cross here since trucks cannot pass each other on the bridge. Therefore, in order to improve traffic flow of the mine it is proposed to widen this bridge.

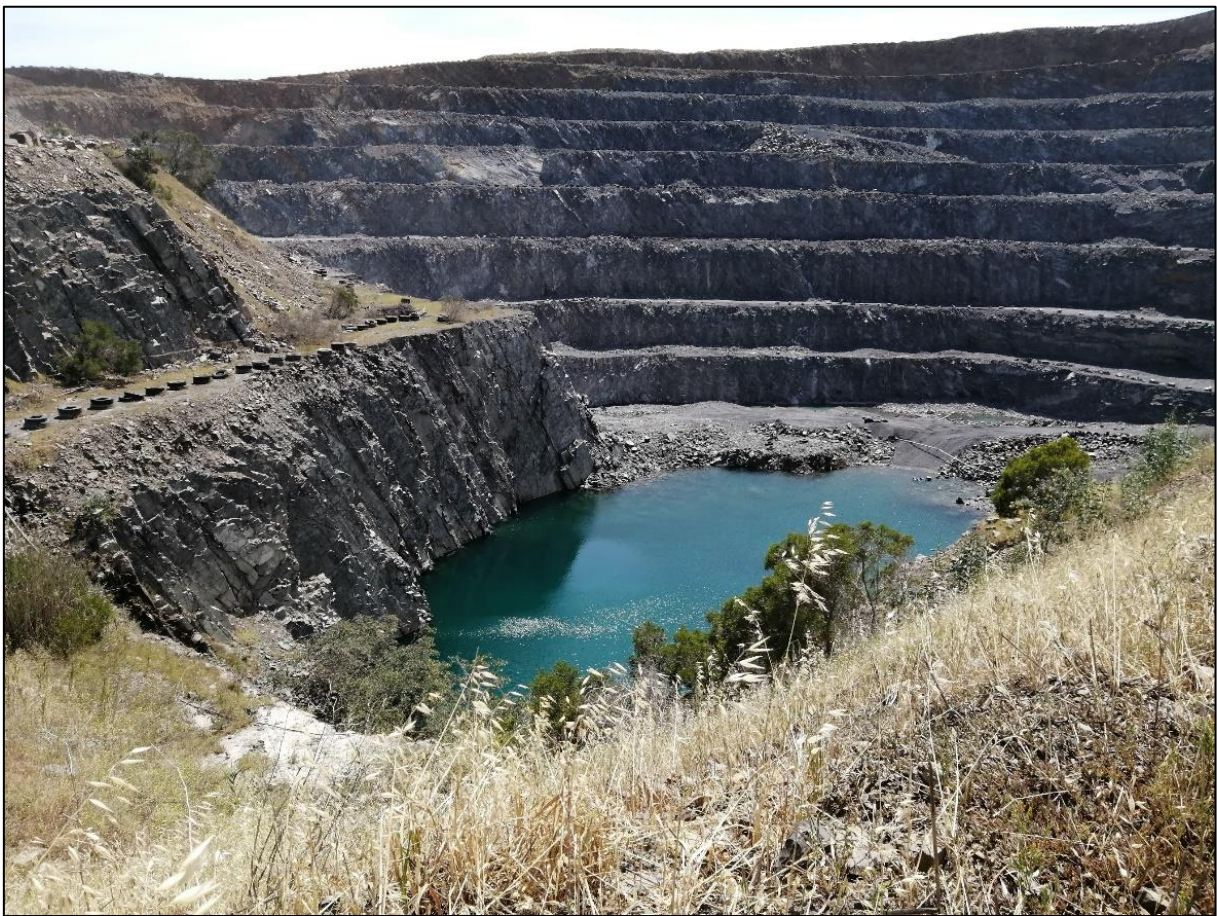
**Figure 5: A photo of the quarry temporary water storage pit, during the site visit, following a rainfall event**

The applicant wishes to continue mining within the quarry pit. However, stormwater runoff accumulates in the pit and hinders further excavations. Therefore, they are proposing to dewater the pit by piping the water to the temporary storage facility, which will hold up to 50 000m<sup>3</sup>, and re-use it from there for Redimix production and dust suppression. Figure 5 is a photograph of the quarry pit where surface runoff collects.

The water in the quarry is not used within any mining processes. It is stormwater runoff from the walls of the quarry/micro-catchment that accumulates in the lowest area. The company wants to continue with excavation activities in the pit that is sometimes inundated, and they would therefore need to dewater, mostly after rainfall events. The water from the pit was not used directly in any mining activities.

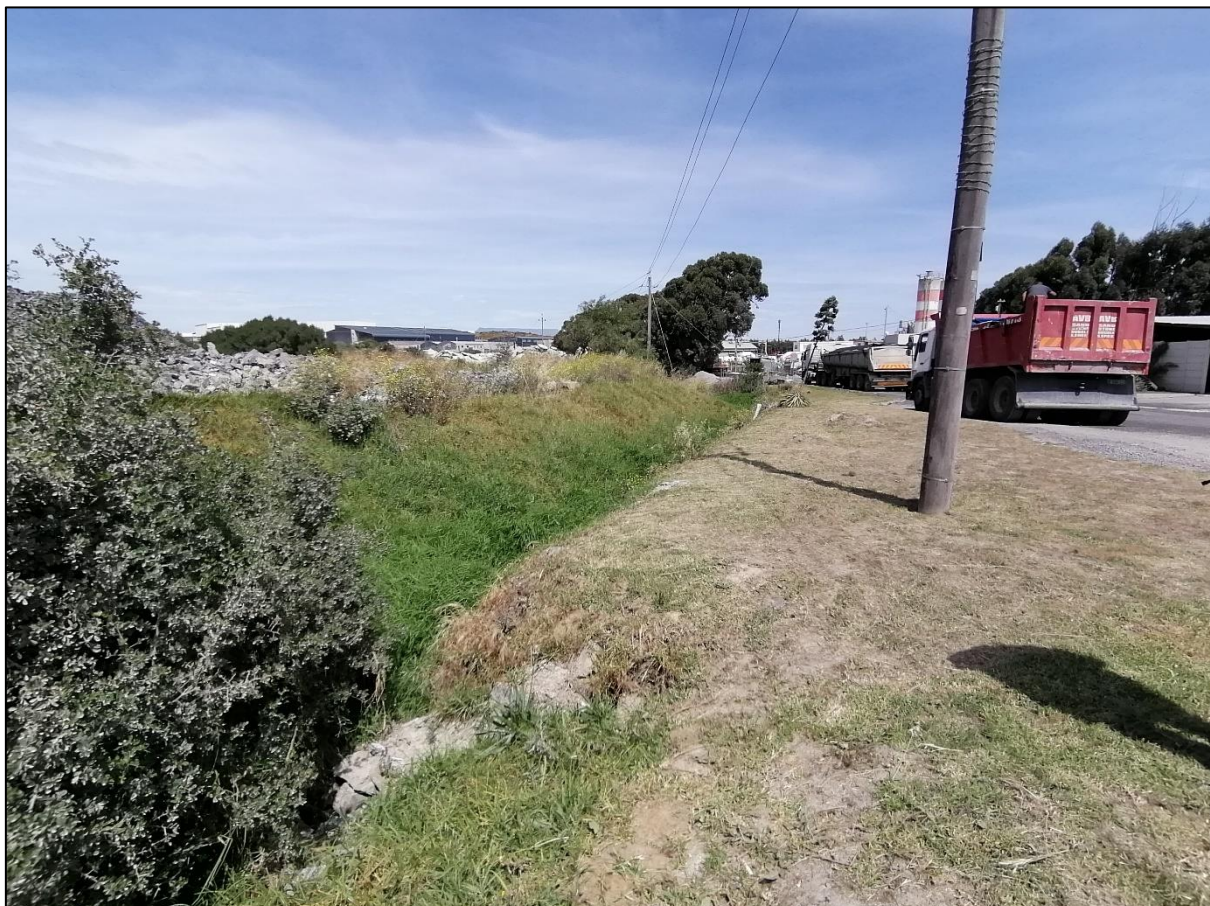
**Figure 7: The existing vegetated stormwater drain directing stormwater towards the watercourse near the bridge**

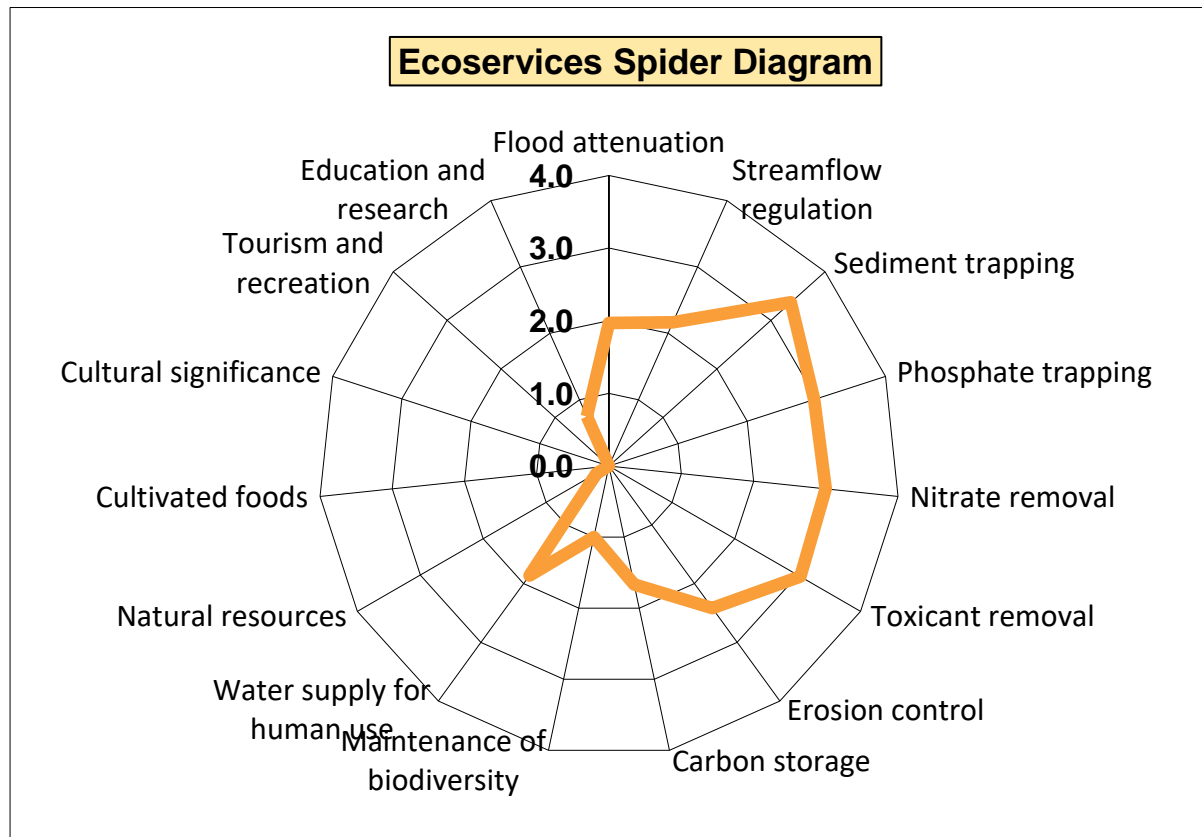
Figure 15: Functional importance results for the UCVB1 wetland

The wetlands' ability to provide Ecoservices has been compromised by the decrease in the wetland health. The wetland habitat and ecological processes have been seriously impacted. However, due to the significant disturbances within the catchment, and the importance of the downstream wetlands, the remaining wetland habitat has a high functional importance. The wetland does not contribute directly to goods and services for society (excepting the use of water from the dam upstream of

the site). Functions performed by the system are however significant as it indirectly provides ecological services.

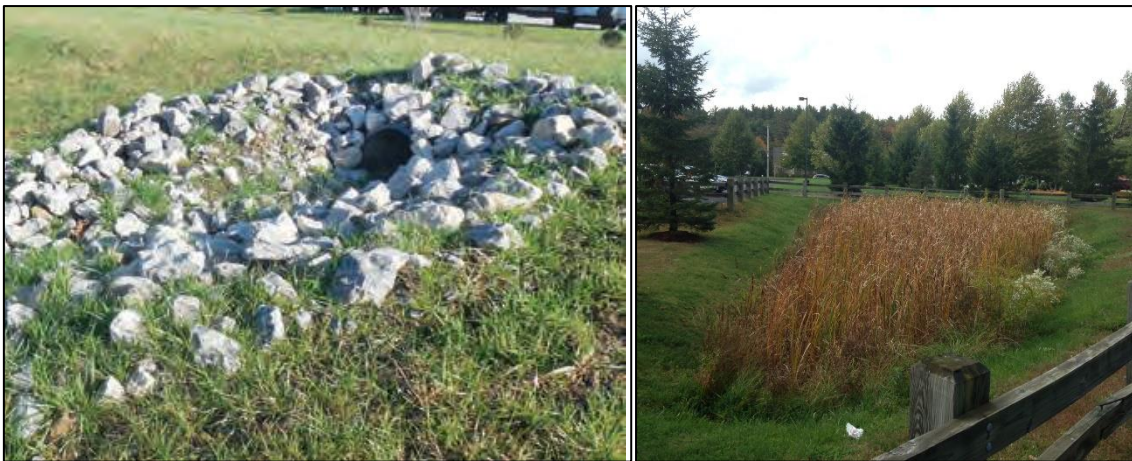
**Figure 16: Examples of erosion protection and pollution control measures for consideration in pit water discharge management through the existing stormwater drain towards the wetland.**

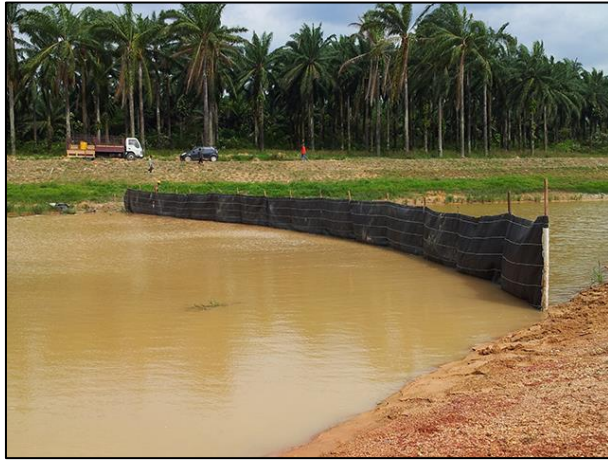
**Figure 18: An example of a silt fence placed securely, directly downstream of construction to trap sediment that will then be removed from the riparian habitat**
