AQUATIC BIODIVERSITY RISK ASSESSMENT

**PERIODIC MAINTENANCE OF TR03103, MR00295, MR00294,
DR01356, OP06046 AND ASSOCIATED INFRASTRUCTURE
NEAR MONTAGU, LANGEBERG LOCAL MUNICIPALITY,
WESTERN CAPE**

PREPARED FOR: Western Cape Government:
Department of Transport and Public
Works: Road Network Management
Branch

DATE: 6th of August 2021

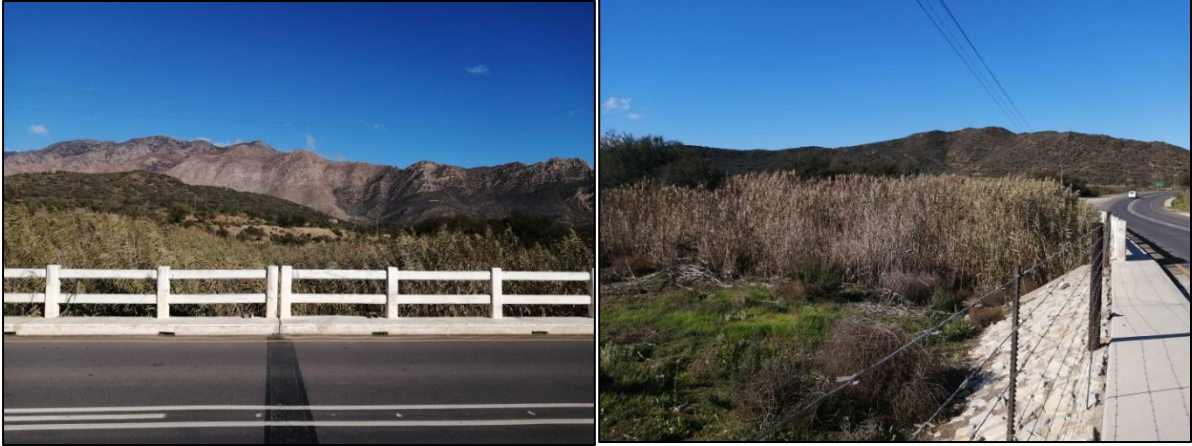
of this project it is sufficient that the status quo is maintained and no further degradation allowed due to the project.
Description of reach impacted	Unchannelled valley bottom wetland dominated by <i>Phragmites australis</i> surrounded by urban infrastructure. Receives significant amount of pollutants from stormwater runoff and a malfunctioning wastewater pump station. The banks are gentle and the bridge is easily accessible for maintenance activities. The vegetation is likely to naturally re-establish after any disturbances in this area. It is important that the gradient of the watercourse is not altered during maintenance (i.e. no humping or hollowing) to avoid initiating erosion.

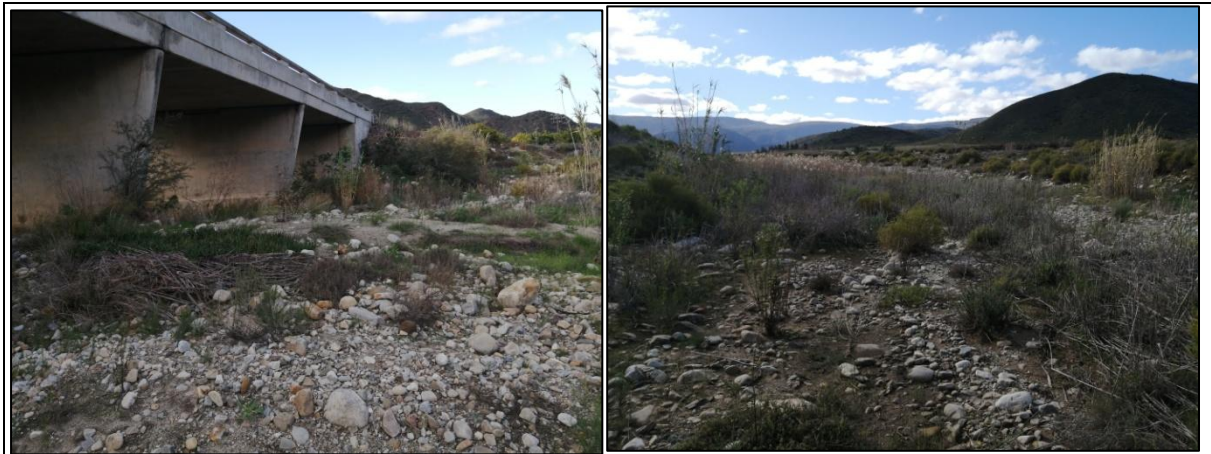
River Name		Kiesie
Quaternary catchment		H20D
Order		1
Flow		Perennial
Geomorphological zonation		Upper Foothills River
PES	1999	C – Moderately Modified
	2018	D – Largely Modified
EIS		Moderate – important for its provision of water from agriculture but ecologically degraded and there are no known endemic or sensitive species.
Ecosystem Threat Status		Endangered
Ecosystem Protection Level		Partially Protected
Management Objective		Recommended ecological category is C and future management of the system should strive to improve the ecological health, but for the purposes of this project it is sufficient that the status quo is maintained and no further degradation allowed due to the project
Description of reach impacted (Crossing 1 near Montagu town)		Non perennial lower foothills river with broad and shallow channel on a boulder and sand substrate. Loss of riparian zone and possible over abstraction in the catchment due to agriculture. Apart from the indigenous <i>Phragmites australis</i> within the river bed, the alien reed species <i>Arundo donax</i> is also present. <i>Arundo donax</i> can cause soil erosion within the narrow floodplain and channel incision (as these reeds are more robust compared to indigenous species and do not allow uniform flow during flood events). The loss of permanent flow within this system is likely from reduced inflow from the upper mountain areas where streams are captured and from over abstraction throughout the catchment. The degradation (from clearer areas and invasion of alien species) contributes drastically to flood damage. In this reach the changes have resulted in flash flooding which has impacted this bridge during periods of high rainfall.

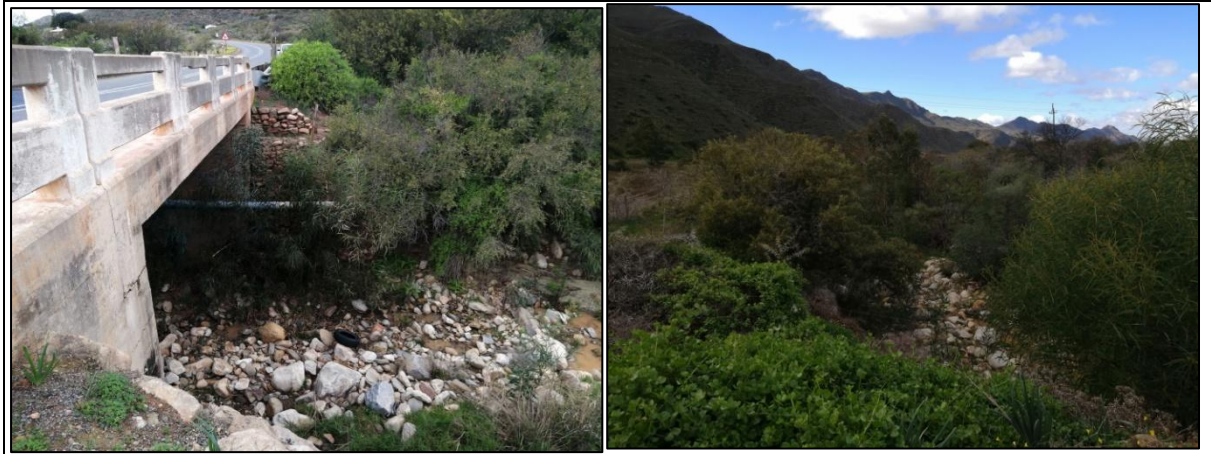
Description of reach impacted (Crossing 2 in the Koo Valley) Non perennial uplands river with a narrow boulder and cobble channel. Incised and eroding banks due to agricultural impacts as well as some alien invasive tree infestation. There has been a change in flow regime from perennial inundation to intermittent flows as a result of increased upslope water use and an increase in droughts.

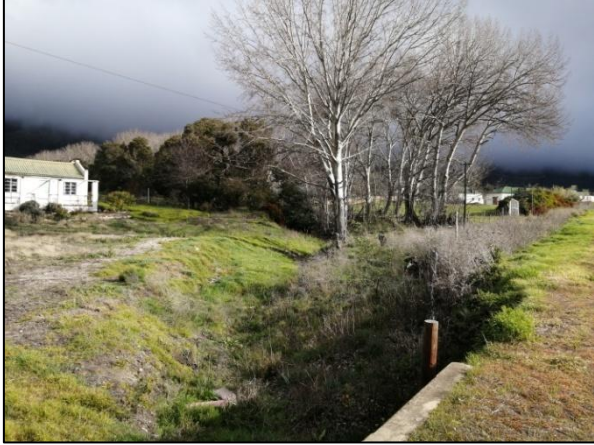
the system should strive to maintain the ecological health with no further degradation allowed due to the project.
Description of reach impacted	Road crossing is in the upper source zone of the river as it is diverted beneath the road through a box culvert. The channel has been modified for conflicting agricultural land uses and flow is intermittent. There is a moderate level of alien invasive infestation, largely from planted Oak and Poplar trees.

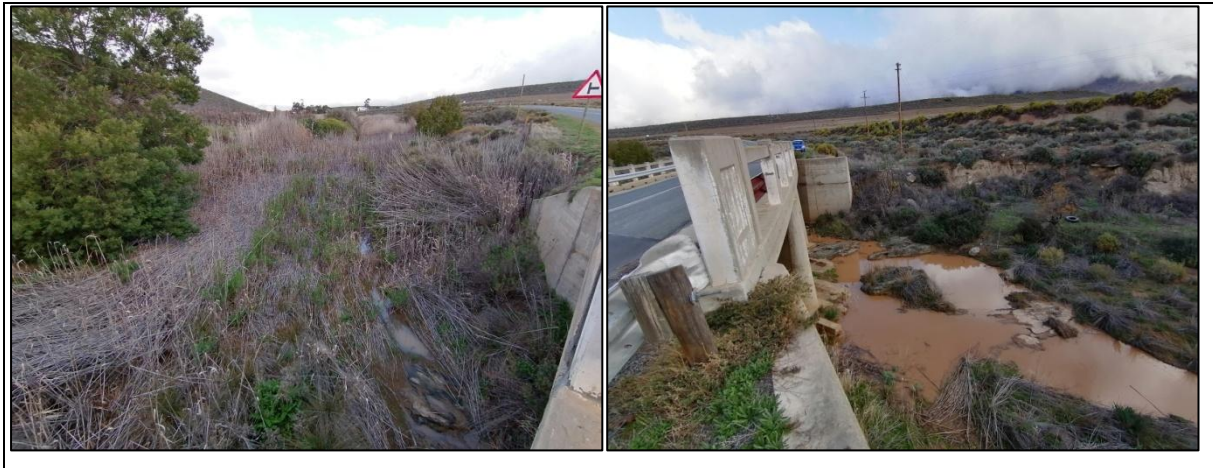
River Name	Koo River	
Quaternary catchment	H40B	
Order	1	
Flow	Perennial	
Geomorphological zonation	Uplands river	
PES	1999	C – Moderately Modified
	2018	D – Largely Modified
EIS (of reach affected)	Moderate	
Ecosystem Threat Status	Endangered	
Ecosystem Protection Level	Partially Protected	
Management Objective	Recommended ecological category is C and future management of the system should strive to improve the ecological health, with no further degradation allowed due to the project.	
Description of reach impacted	Road crossing is in the upper zone of the river as it.
