BIODIVERSITY SURVEY: PROPOSED DANA BAY ACCESS ROAD

December 2019 (updated on 9 May 2022 with the inclusion and comment on
Screening Report list of SCC)

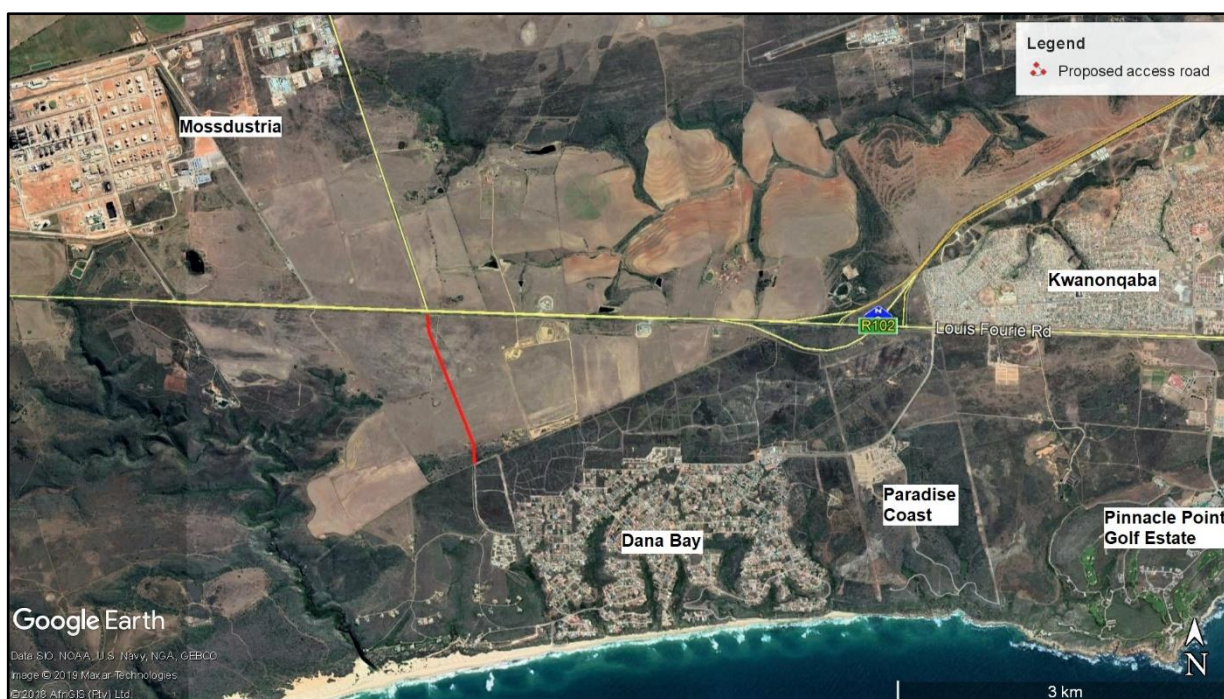
Map 1 Satellite photo showing the position of the proposed access road (indicated in red) on the north-western side of Dana Bay.

This report investigates the biodiversity aspects of the proposed route for a second access road to Dana Bay through the remainder of Portion 7 of Farm 225, northwest of Dana Bay (see Map 1). The proposed route passes through a grazing field (pasture), with a short passage through natural vegetation at the southern end and some fallow land on the northern side. The aim of the study, which was requested by Sharples Environmental Services (EAP), is to determine the biodiversity value of the site and to identify mitigation measures to ameliorate the impact. The main concern is that the route runs through areas mapped as critical biodiversity areas (CBA's). The latter forms part of a coastal biodiversity corridor that runs from Mossel Bay westwards around the northern side of Dana Bay.

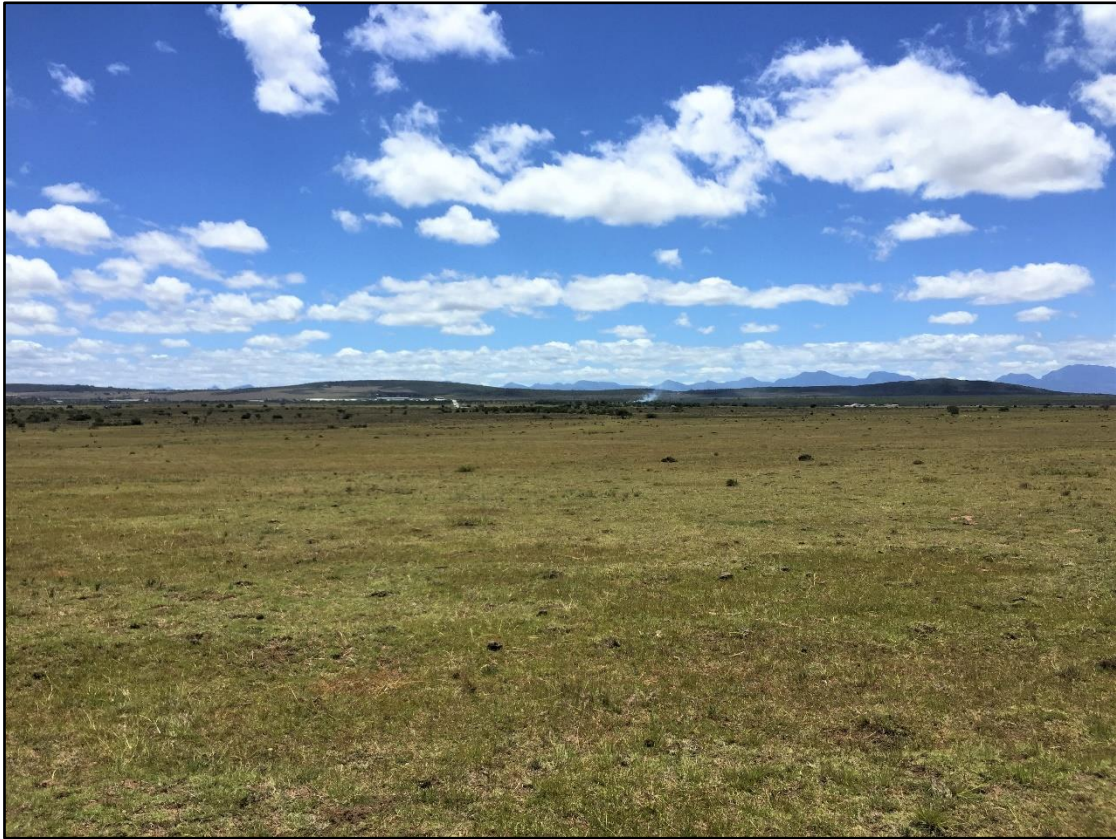
Photo 1 Pasture, looking north towards the proposed junction with the N2.

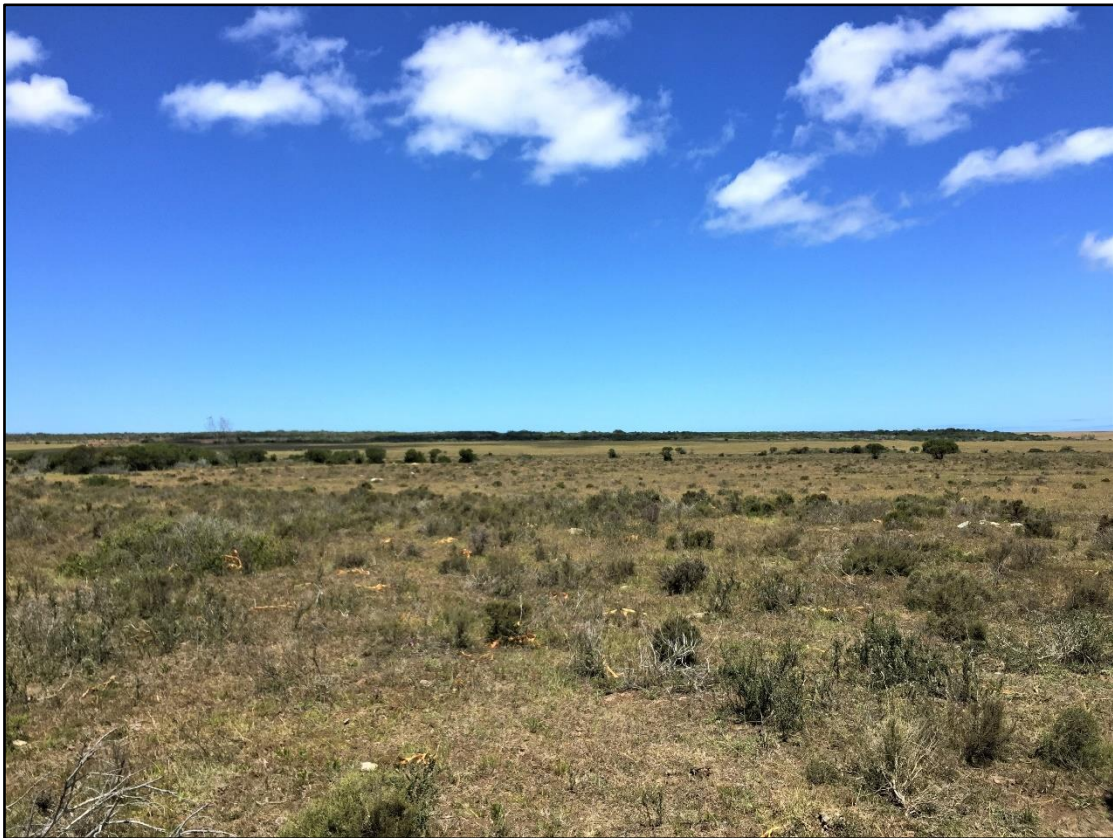
Photo 2 Looking south across the fallow land portion of the site.

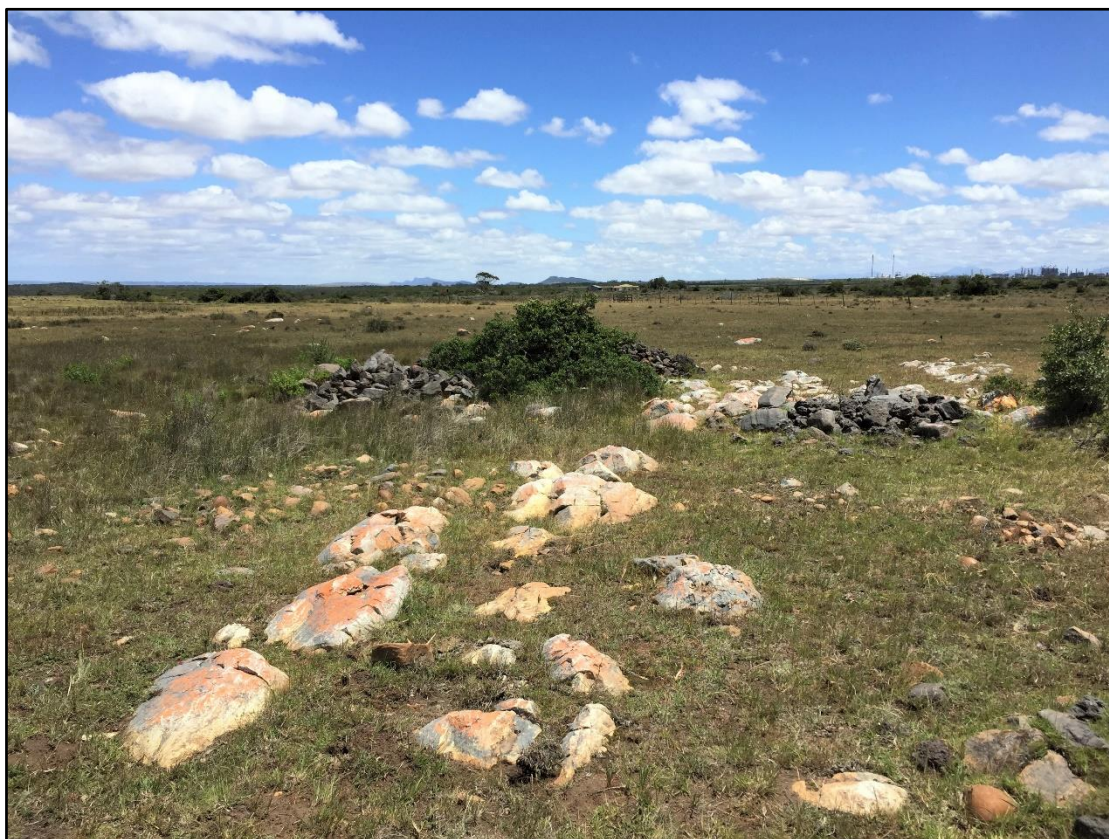
Photo 3 Exposed Table Mountain Group sandstone in the fallow land.

Rainfall in the region ranges from 350 mm in the west to 750 mm per annum in the east, with about 40% of the rain falling in summer (October-March) and 60% in the winter (April-September) as per Mucina & Rutherford's (2006) description of the climate for Groot Brak Dune Strandveld. It is even throughout the year, with slight peaks in March and October/November (Mucina & Rutherford 2006). Mean daily maximum and minimum temperatures are 26.8°C and 7.7°C for February and July, respectively (Mucina & Rutherford 2006). According to the 3422 AA Mossel Bay 1:50 000 geological map, the southern part of the site is underlain by non-shelly sand (a target for sand mining activities), which changes into loam and sandy loam soil in the northern part. The base rock comprises Table Mountain Group sandstone (see Photo 3).

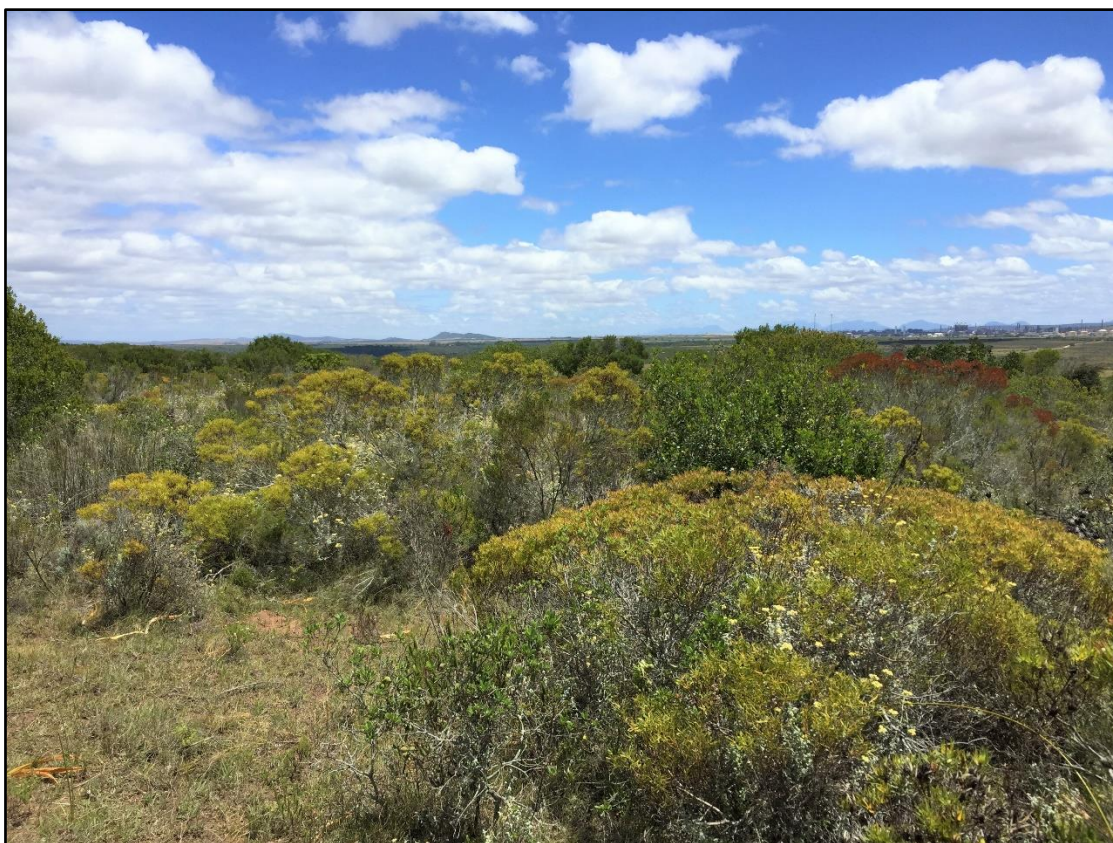
Photo 4 Fynbos at southern end of proposed route.

During the site survey it was found that the vegetation in the southernmost part of the site comprises fynbos with a strong thicket influence. The latter could be the result of senescence. With regards to vegetation type, it leans more towards Albertinia Sand Fynbos, with *Passerina corymbosa*, *Erica versicolor*, *Leucadendron salignum*, *Bobartia robusta* and *Thamnochortus insignis* important taxa in the latter type. However, there is also an affinity with Canca Limestone Fynbos and North Langeberg Sandstone Fynbos, with *Protea lanceolata* an important taxon in the former, and *Erica versicolor* and *Leucadendron salignum* important in the latter. *Carissa bispinosa*, *Diospyros dichrophylla*, *Putterlickia pyracantha*, *Pterocelastrus tricuspidatus*, *Gymnosporia buxifolia* and *Lauridia tetragona* are important Groot Brak Dune Strandveld taxa.

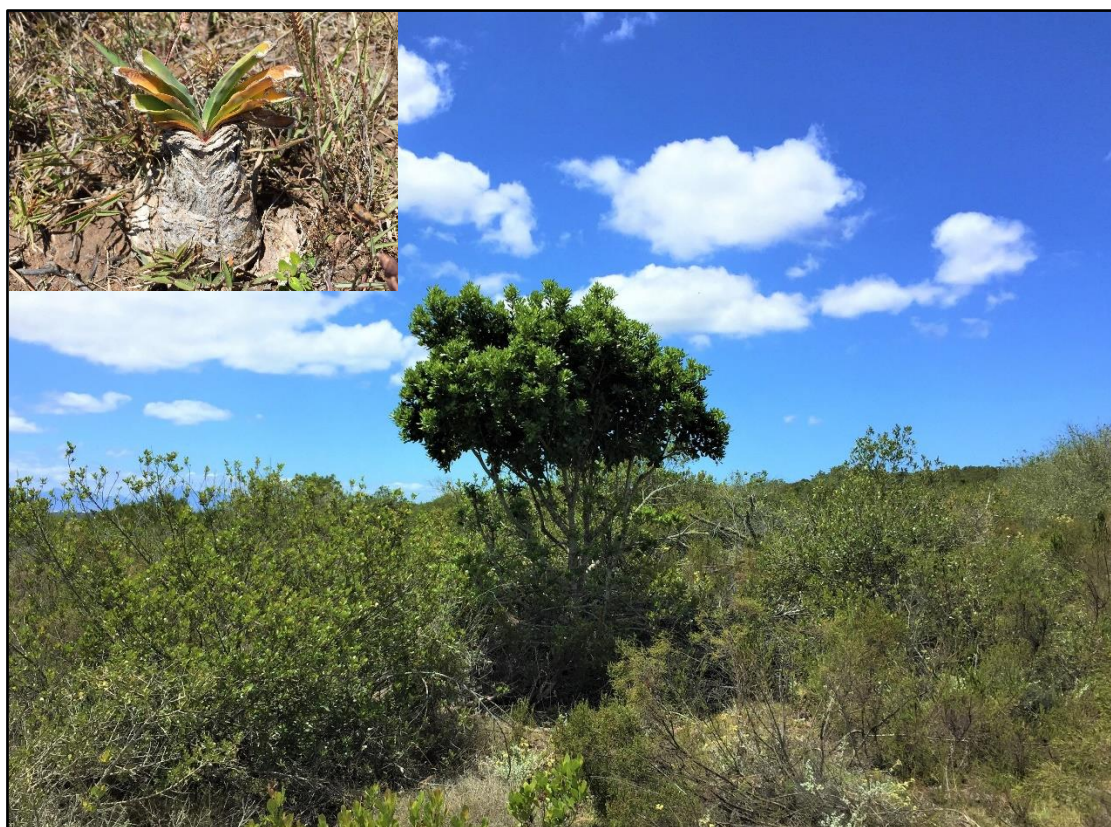
Photo 5 *Pittosporum viridiflorum* (3.5 m) inside the fynbos component. Insert: *Boophone disticha*

The history of the fallow land is not clear (see Map 4), but a fair bulb population was noted here, notably *Albuca cf. acuminata*, *Ornithogalum dubium*, *Drimia capensis*, *Haemanthus coccineus*, *Crossyne guttata* and *Boophone disticha* (see Photo 5). The shrub component (<0.4 m high) comprises scattered *Elytropappus rhinocerotis* (renosterbos), *Metalasia acuta*, *Athanasia quinqueidentata*, *Delosperma neethlingiae*, *Lampranthus elegans*, *Muraltia ericoides* and *Crassula nudicaulis*. It shows some potential to revert back to the original vegetation (presumable North Langeberg Sandstone Fynbos), but only if further farming activities on it are ceased.

No Species of Conservation Concern were recorded on site. Regional endemics recorded include *Protea lanceolata* and *Bobartia robusta*. Both these species are common in the area. A single *Pittosporum viridiflorum*, a protected tree species in terms of the National Forests Act

(Act 84 of 1998), was recorded in the fynbos in close proximity to the proposed route. No milkwoods (*Sideroxylon inerme*), another protected tree species common in the area, were recorded. The removal of these trees requires a permit from the Department of Forestry.

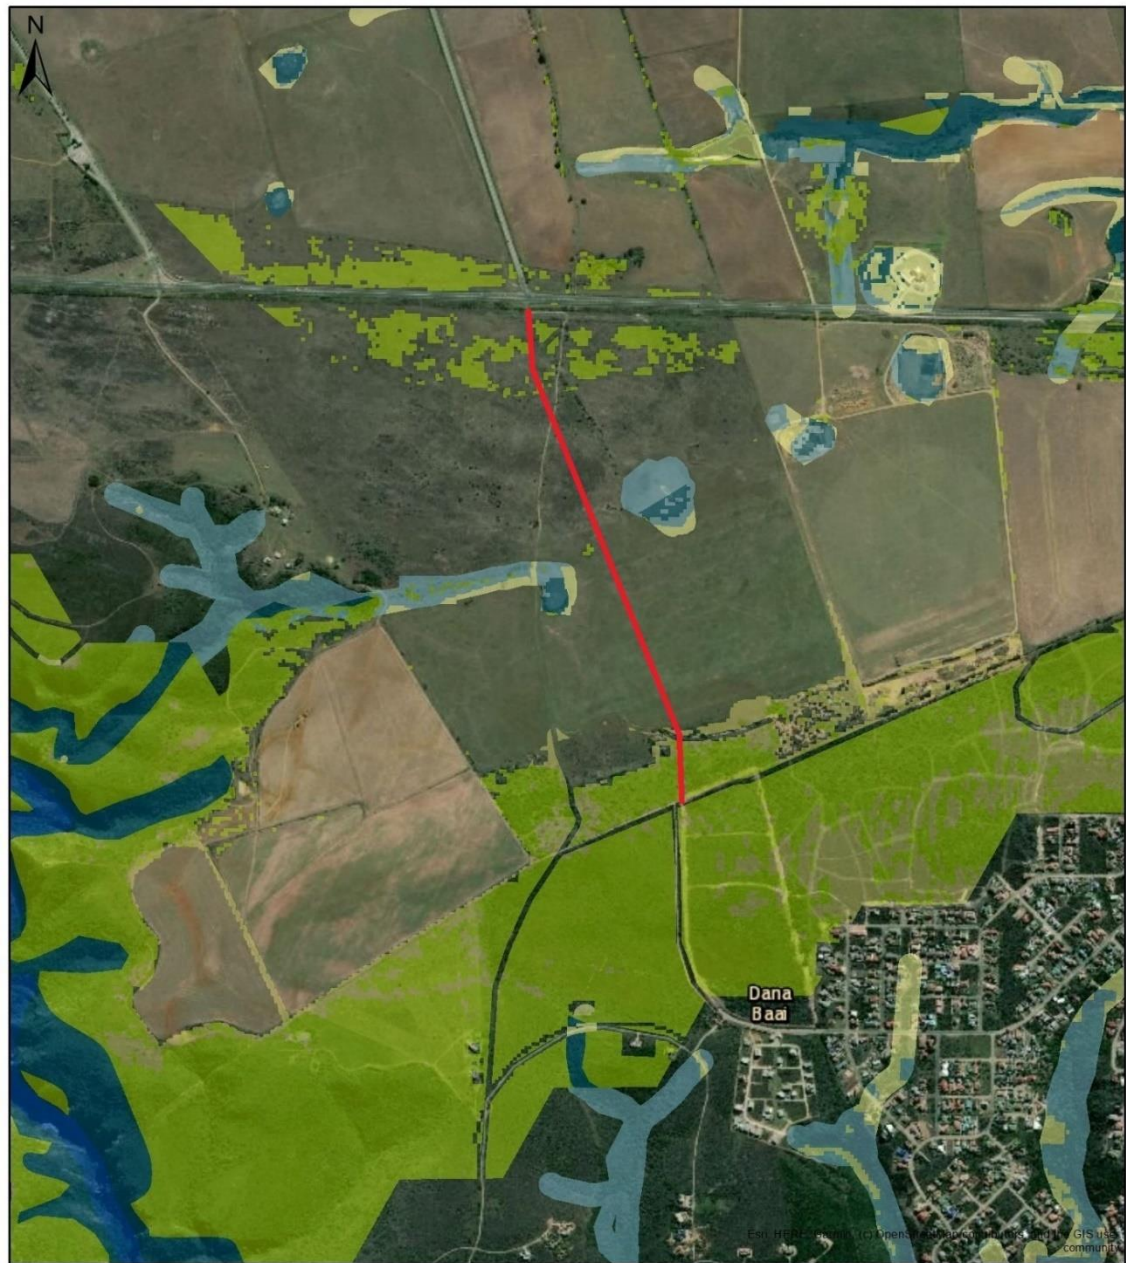
Map 5 Biodiversity network map (Source: Cape Farm Mapper), with the proposed road shown in red.

The proposed access road runs through two small areas mapped as critical biodiversity areas (CBA's) (see Map 5). The southern portion forms part of a biodiversity corridor that runs in an east-west direction past the northern side of Dana Bay. Apart from providing a backbone to the local biodiversity network, the latter corridor serves as an important passage along which fauna can migrate between the vegetation remnants. It is unclear what the rationale is behind the patchy CBA at the northern end of the route next to the N2. On the ground there does not seem to be any difference between the CBA patches and the areas in between, mapped as 'other natural areas' (see biodiversity network map on Cape Farm Mapper).

threatened plant species, and/or may be essential elements of designated ecological corridors. Loss of designated CBA's is therefore not recommended. With the proposed road running through the CBA corridor one can expect an impact on its functionality. However, compared to the road reserve extending into Dana Bay which runs through the main corridor, the portion in question is degraded and sits on the northern edge of the corridor.
