AQUATIC BIODIVERSITY IMPACT ASSESSMENT

DEVELOPMENT OF THE REMAINDER OF ERF 464, ADJACENT TO THE GARDEN ROUTE DAM, GEORGE

Sharples Environmental Services cc. 2021. Aquatic Biodiversity Impact Assessment for the development of the Remainder of Erf 464, adjacent to the Garden Route Dam, George.

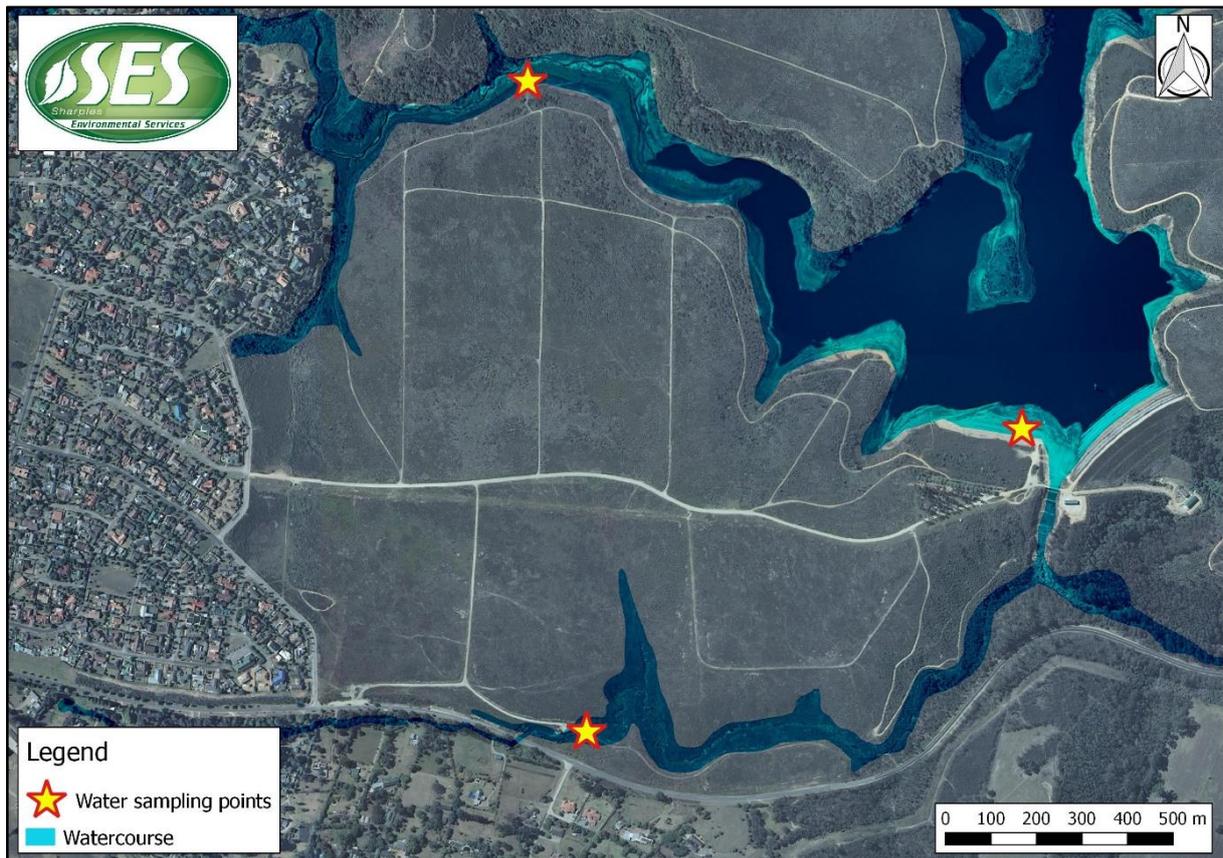
Figure 11: Map of the study area showing the three water sampling points of 2018

The once off sampling was conducted by SES to assess against the targets for aquatic ecosystems and provide a snapshot indication of chemical and physical constituents. Three water samples were collected on the 29th of August 2019 from the study area (Figure 11). Two of the samples were sourced from the dam and the other from the Klein Swart River. The results are a snapshot of the conditions at the time of sampling, and will have changed since, but provide an indication of the status quo at the time of initial site assessment in 2018. The water quality results for the sampling points Garden Route Dam and Kat River indicate fair water quality from an aquatic perspective. However, the water quality at the time of sampling in the Klein Swart River to the south of the property, was poor and indicative of potential impacts from urban development.

The TWQR for ammonia is 7 µg/L. The once off sampling effort by SES showed ammonia concentrations of well above the TWQR and the AEV at all the sampling points. The highest ammonia levels were recorded below the Glenwood pump station, where a concentration of 1010 µg/L was measured. This is approximately 10 times the suggested AEV. It is likely that the source of pollution is the Glenwood pump station and/or the associated sewage infrastructure that cross the system a few meters above the sampling point. At the time of sampling, *E.coli* levels downstream of the pump station were more than double the concentration considered safe for intermediate contact recreational (DWAF, 1996a). Nitrogen is also not tested for on a weekly basis by the municipality. The SES sampling concluded that mesotrophic conditions can be expected if the nitrate concentrations are used as indicators. The N:P ratio is indicative of unimpacted natural waters for the sampling points in the Garden Route dam and Kat River. However, the sampling point below the Glenwood pump station has a ratio of approximately 7:1. This indicates a hypertrophic or eutrophic system. These results clearly indicate the potential for pump stations to pollute nearby watercourses and the risk of constructing them in close proximity to aquatic habitat.

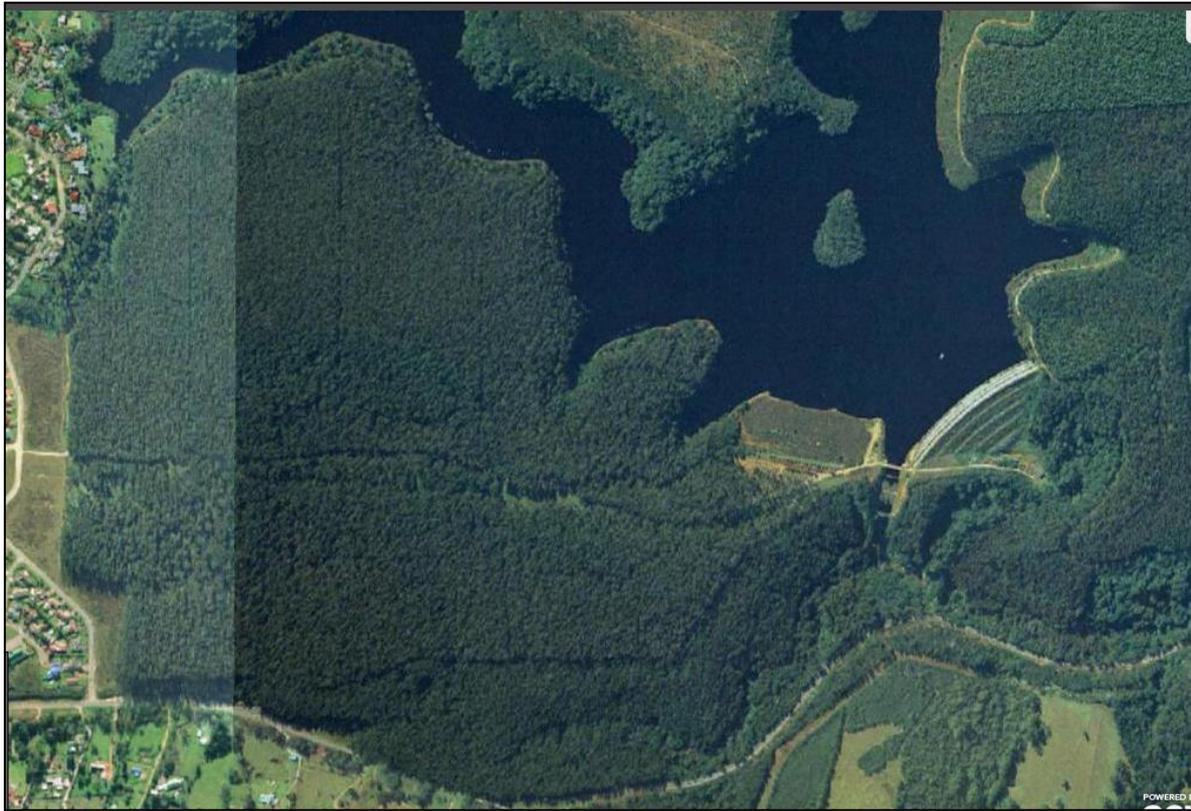
Figure 13: Historic satellite imagery from 2000 showing the plantation land cover of the site (Department of Rural Development and Land Reform, NGI 2000)

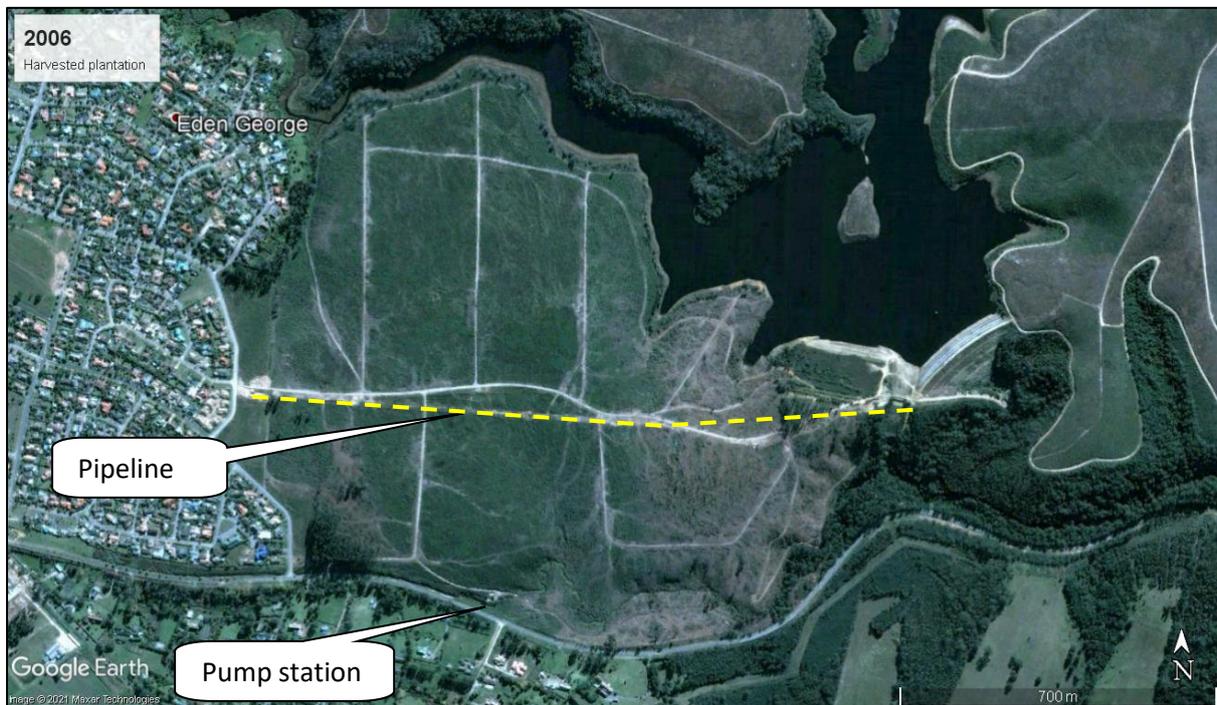
Figure 14: Google satellite imagery from 2006 when the plantation was harvested and not replanted. Note the vegetation clearance and soil disturbance within the Klein Swart River

The town of George was established as a result of the growing demand for timber and the wood used in building, transport, and furniture. Historically, the entire study area was cleared of indigenous vegetation and utilised for commercial forestry (largely pine plantation) for many decades. Figure 12 below shows the forestry activities in the study area and the topography of the site prior to the construction of the Garden Route Dam on the Swart River. Figure 13 shows that the entire site was under pine plantation in the early 2000s. Forestry continued on the site until 2006 when it was harvested but not replanted (Figure 14). The wastewater pump station near the Klein Swart River, as well as a buried pipeline from the dam wall to the west, are both visible in the 2006 imagery.

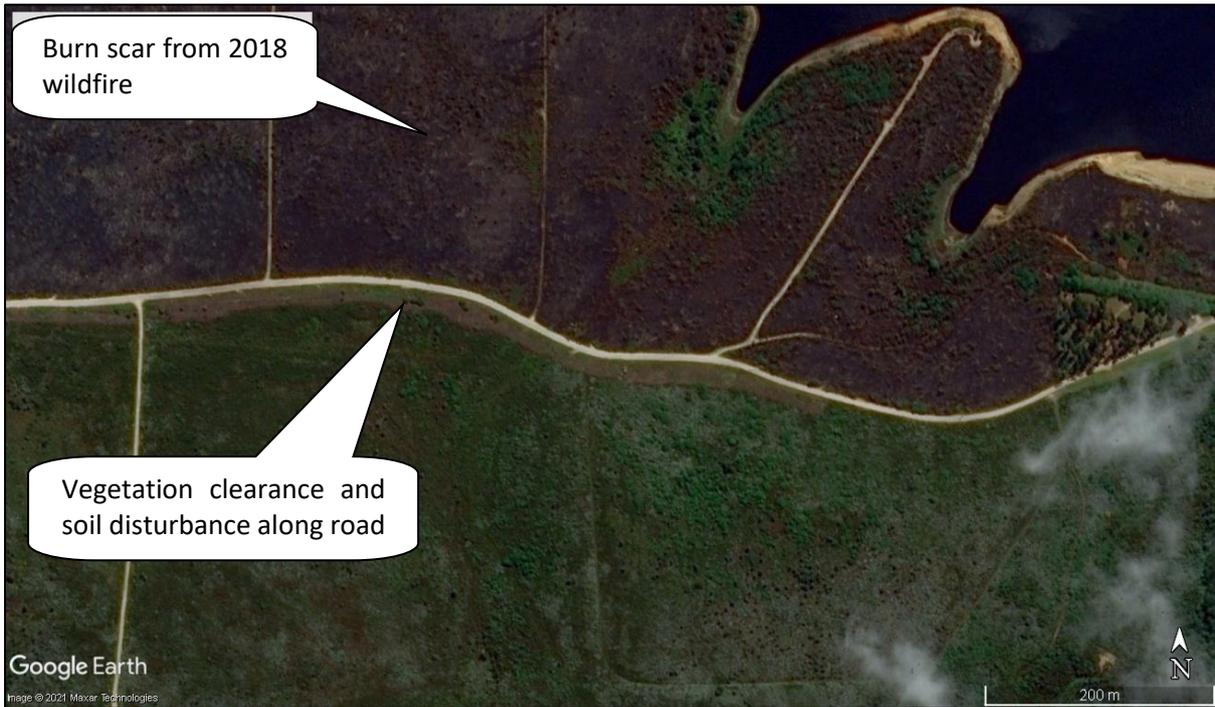
Figure 19: Google imagery from 2018 showing the burn scar from the wildfire and the cleared area alongside the road

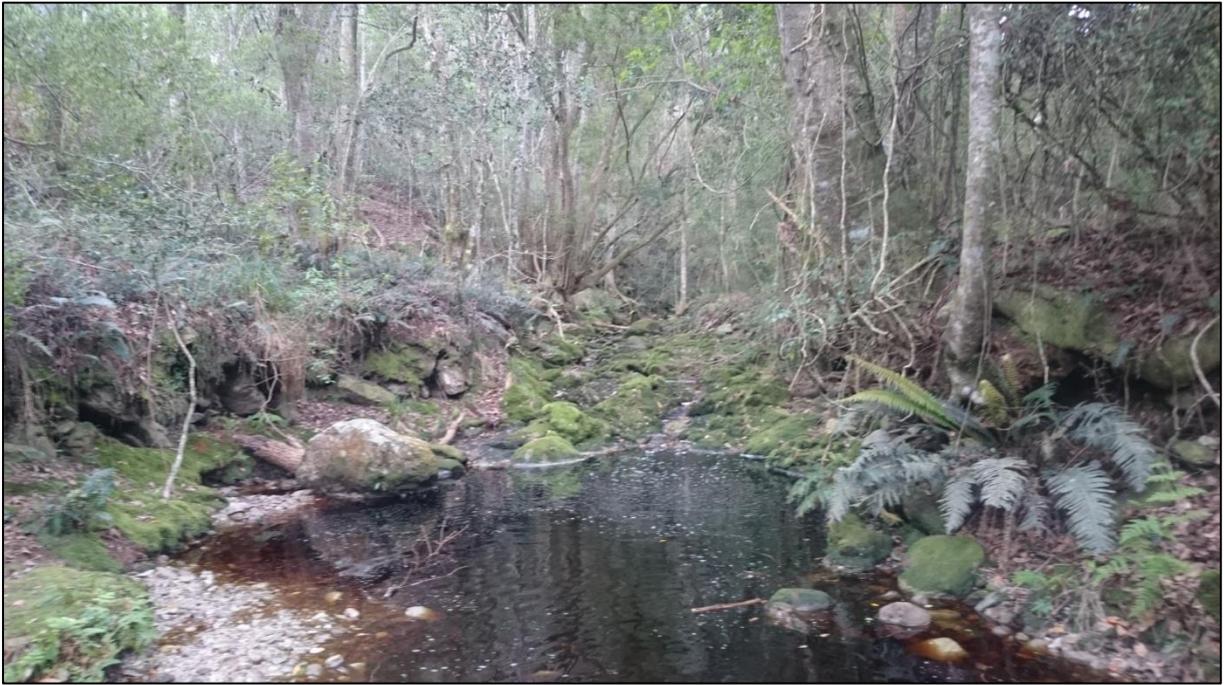
Figure 22: The pristine upper reaches of the Kat River situated on the mountain foothills above the urban area

The Kat River is a perennial stream with its source in the Outeniqua Mountains above the town of George (Figure 22). It flows along the edge of the developed area and then becomes dammed shortly upslope of the confluence with the Swart River to the south (Figure 23). The physical character of the river changes significantly over a relatively short longitudinal distance. Consequently, there is a steady decrease in the quality of river habitat in a downstream direction. The development will not affect the upstream areas. Upslope of the urban area, the Kat River has a steep gradient and a substrate dominated by bedrock and boulders. However, as the mountain stream reaches the foothills, flowing along the edge of the town, the slope lessens, and an alluvial channel develops with extensive emergent vegetation. Marginal wetland habitat forms along this reach (Figure 24). Anthropogenic changes such as an increase in hardened surfaces, vegetation clearance, and the introduction of alien invasive plants from forestry, have resulted in channel incision and loss of wetland habitat. Towards the confluence with the Swart River the channel becomes completely transformed by the dam (Figure 25). Vegetation has been cleared and replaced with garden plant species and grass. There is evidence of sediment deposition in the channel due to erosion of the bed and banks and increased inputs from the catchment. The water is receiving pollutants from urban stormwater and household drain pipes.

Figures 22 to 26 are photographs of the upstream reaches of the Kat River to indicate the longitudinal changes and general characteristics of the system. Figure 27 is a photograph of the affected area of the Kat River and dam taken from the proposed development site. The reach which may be affected by the project is the back-flooded, dammed area. The habitat upstream of the property proposed for development was not assessed in detail.

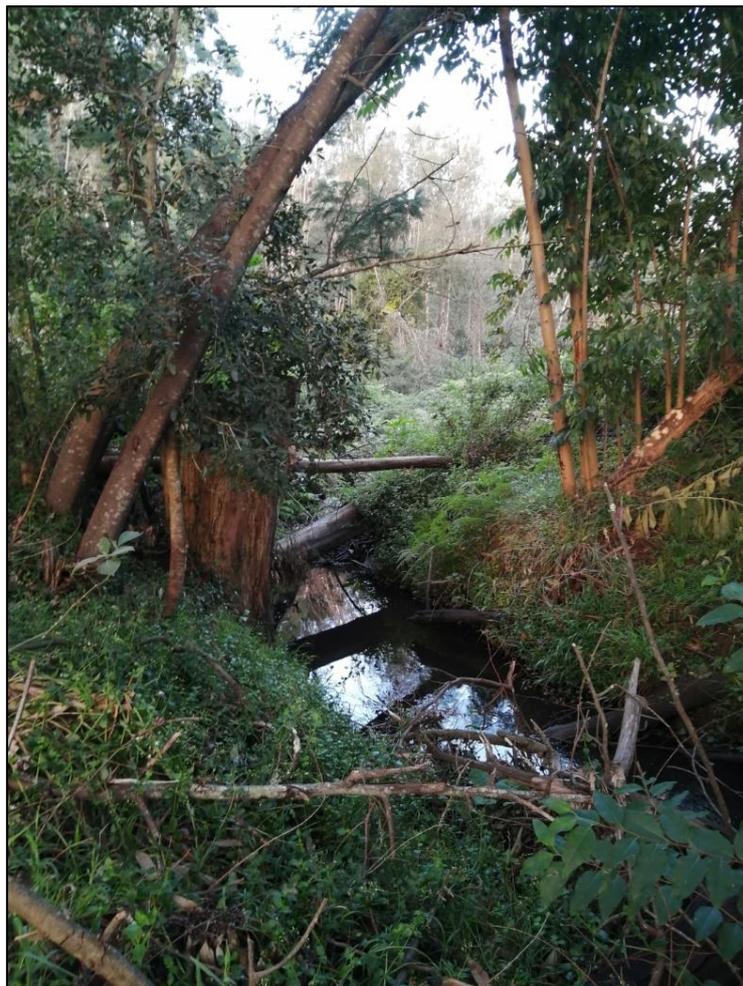
Figure 23: Photograph of the upstream reach of the Kat River as it flows alongside the urban area, prior to becoming dammed. The channel is incised and there is alien invasive plant infestation

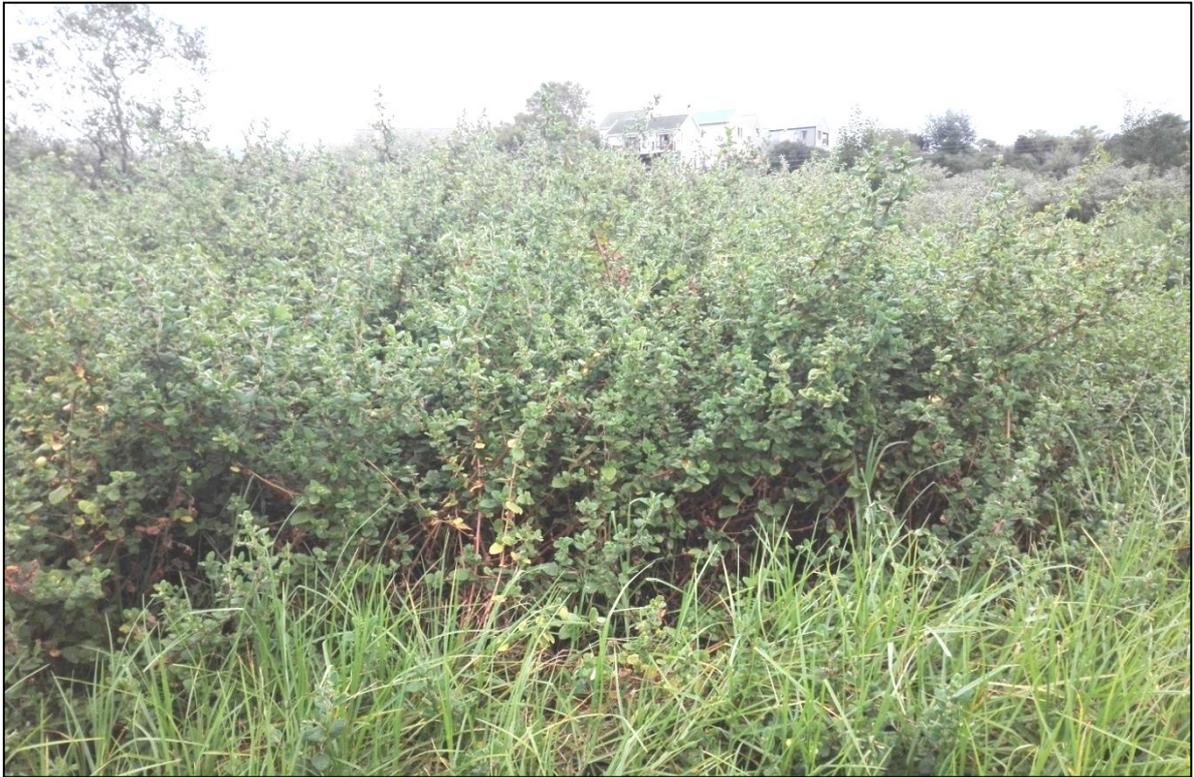
Figure 24: Photograph of the wetland habitat, dominated by indigenous *Cliffortia ondorata* within the Kat River system, upstream of the dam. The reach assessed does not have any remaining wetland habitat as it is along the dam edge.

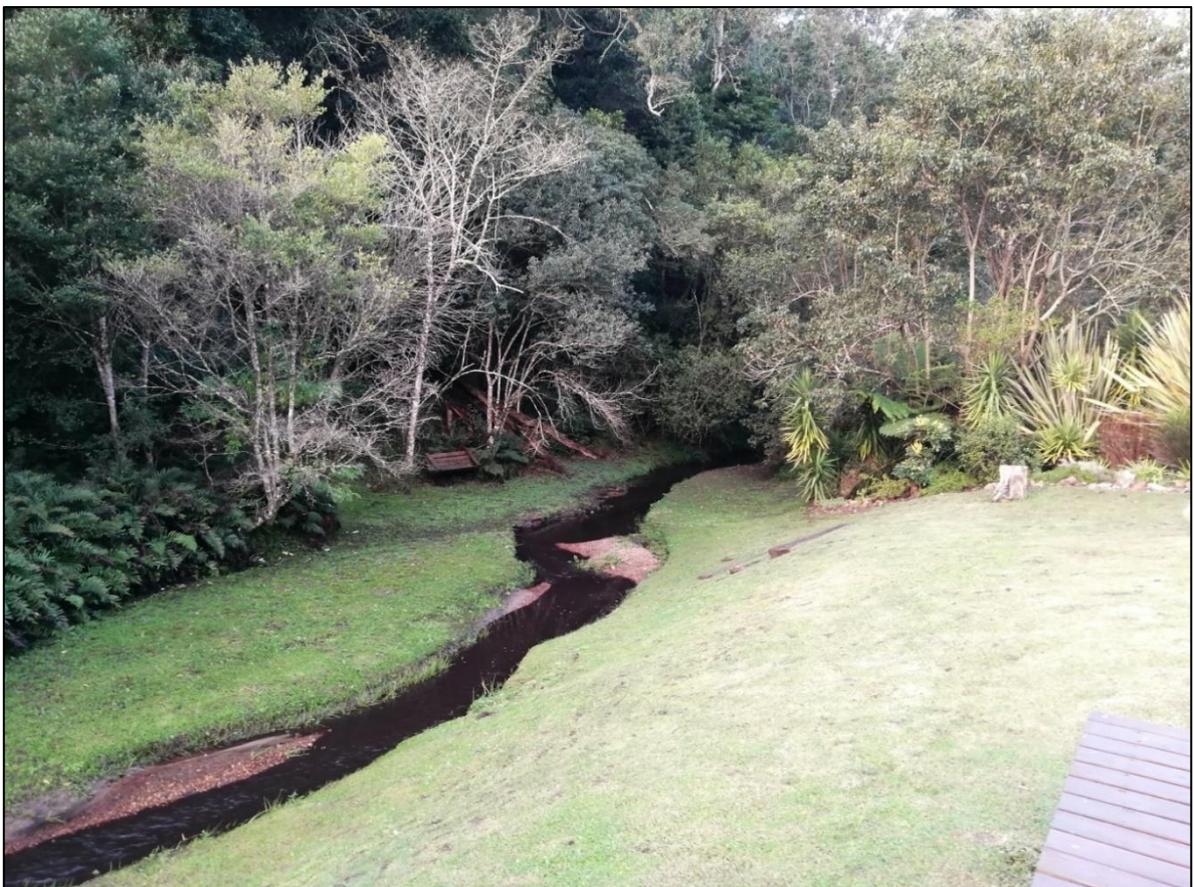
Figure 25: Photograph showing a severely modified reach of the Kat River along the urban edge. This reach is not near the site, but the photograph shows the existing impacts upon the river

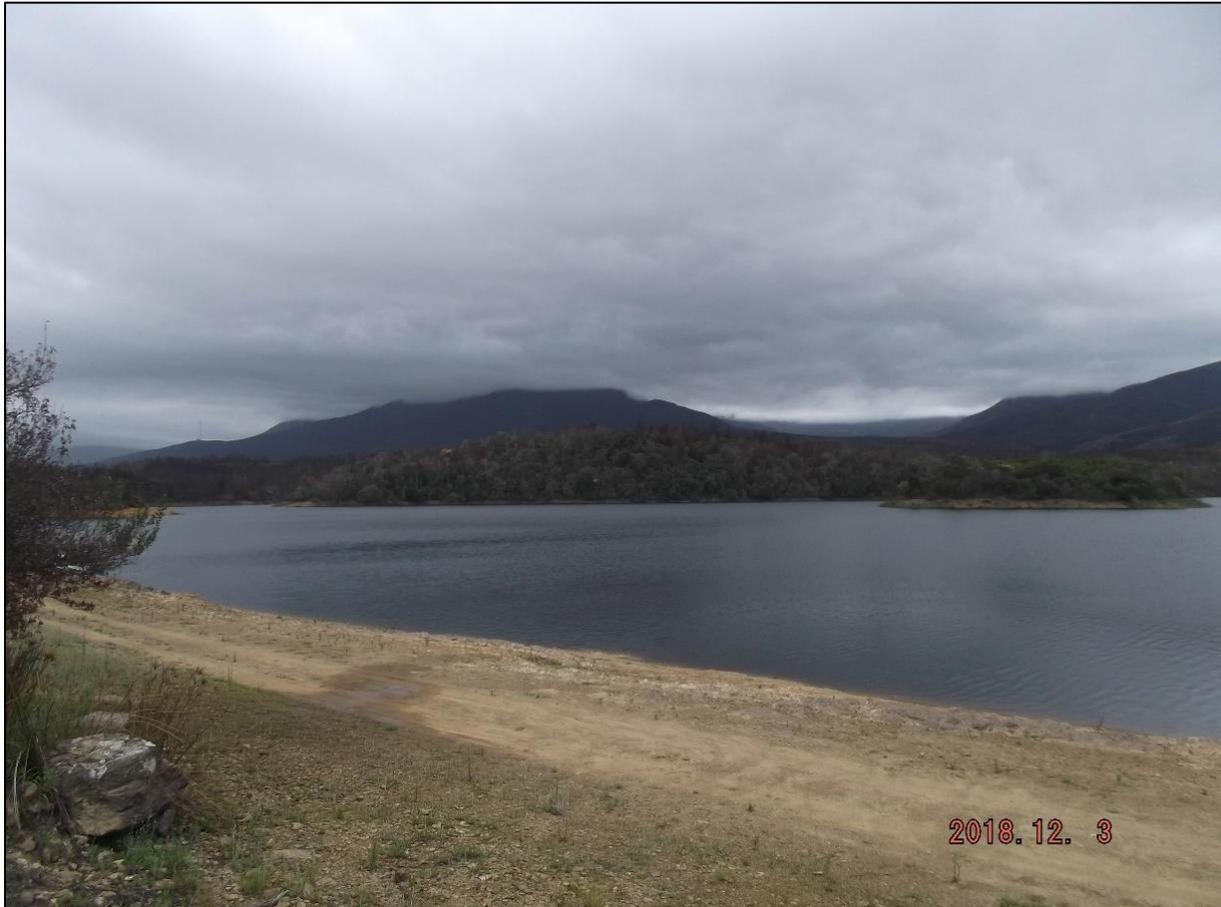
Figure 26: Photograph of the Garden Route Dam on the Kat River system

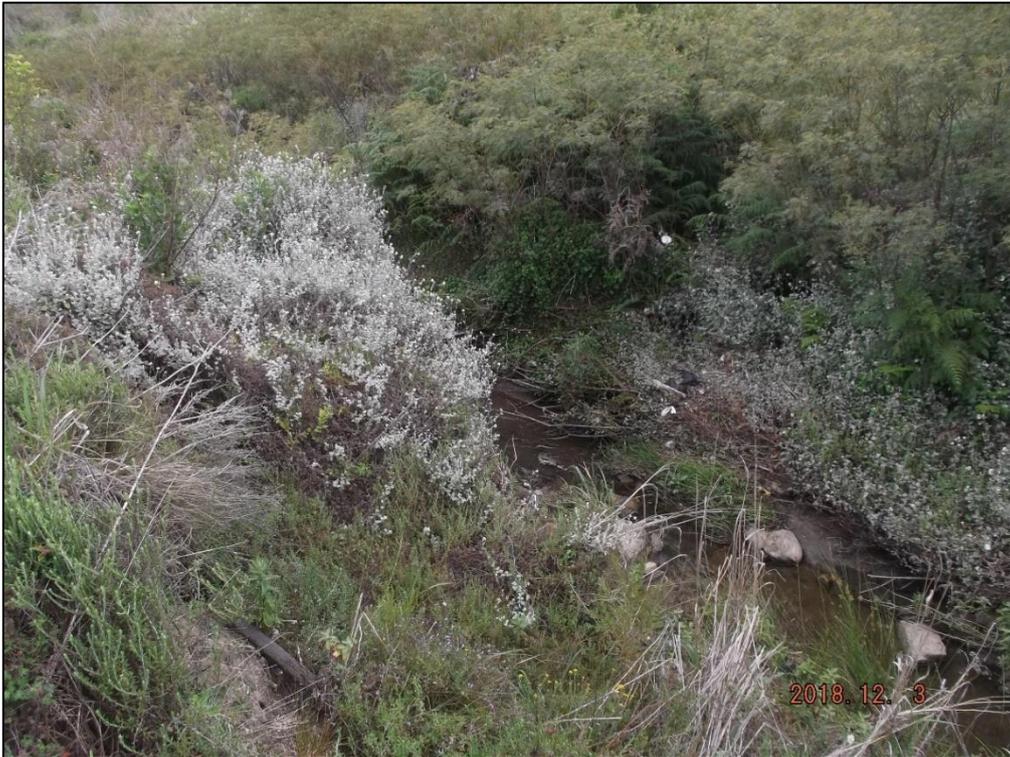
Figure 27: Photograph of the incised wetland channel near the pump station

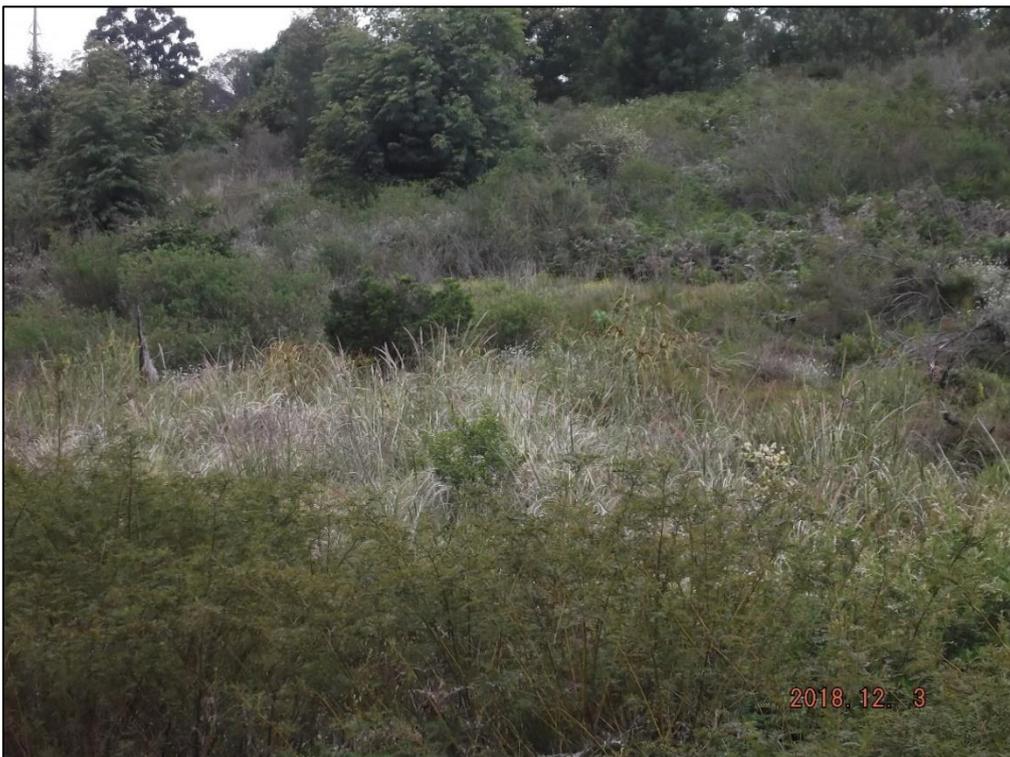
Figure 28: Photograph showing the wetland in the valley bottom with associated hydrophilic vegetation (largely sedges) in the permanent zone and the encroachment of alien invasive plant species

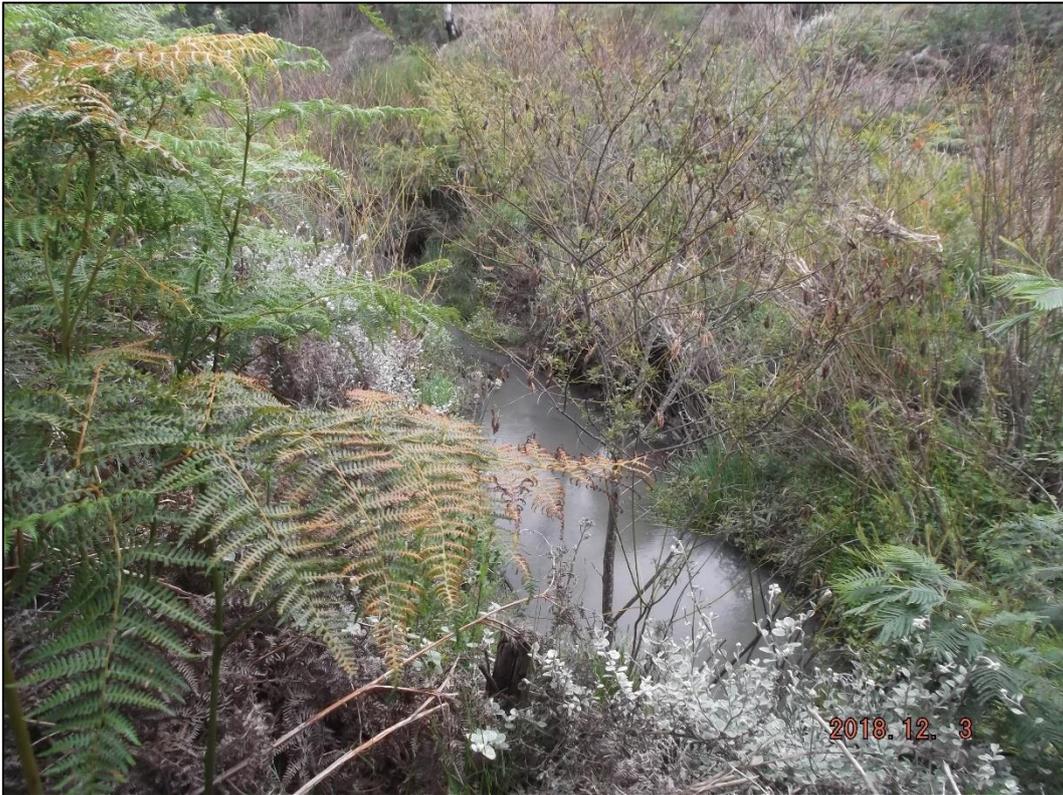
Figure 29: Photograph of the milky, polluted water flowing within the incised channel in the lower reaches of the wetland

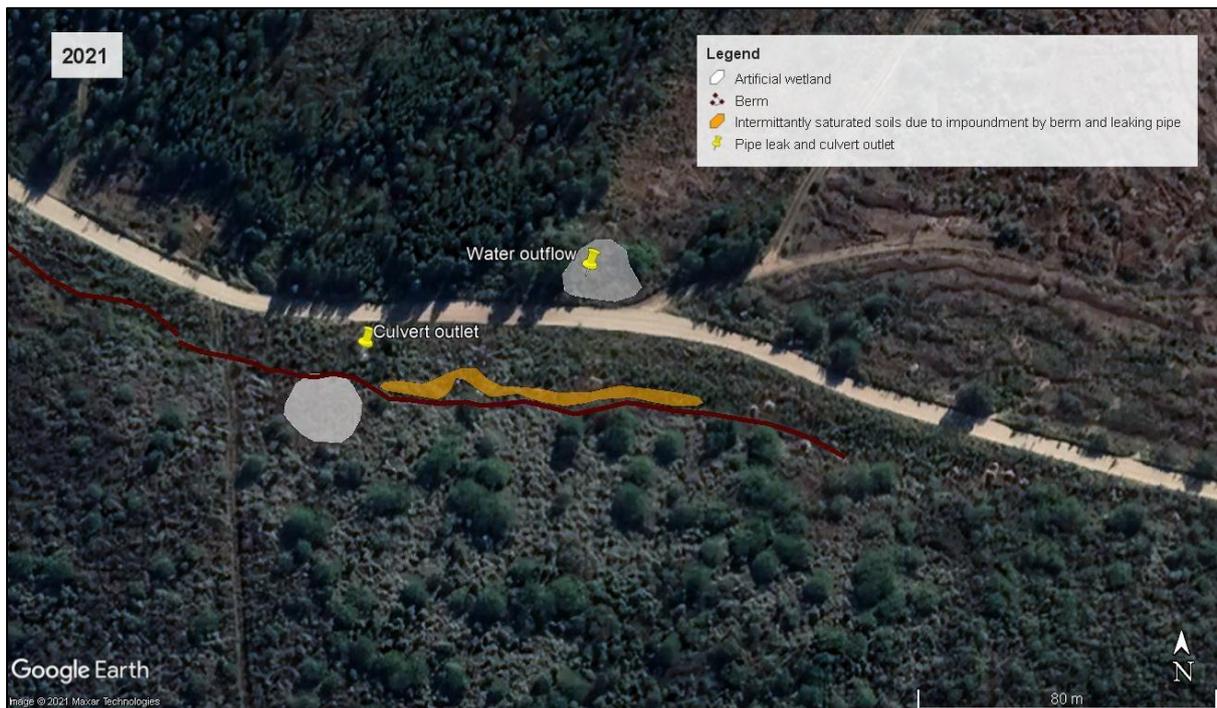
Figure 32: Imagery from 2021 showing the changes to the natural characteristics of the site due to human influences

On the property proposed for development, artificial wetland habitat has formed on the drainage divide, on the northern side of the road (Figure 31 & 32) and south of the road below a culvert outlet. It is clear that a municipal raw water pipeline has a leak in this one location (Figure 33 & 34). The constant inundation of the surrounding terrestrial soils, for a sufficiently long period of time, has resulted in the development of a small artificial ‘seep’ wetland. It is important to note that the NWA definition of a wetland provides for ‘normal circumstances’. The small wetland on the site is entirely artificial and the characteristic soils and vegetation would be terrestrial in nature under normal circumstances. The water is humic stained as it is raw water from the dam, which has dark brown coloured water. Should the pipeline be repaired or decommissioned, this patch of wetland vegetation will slowly cease to exist, and the land would revert back to terrestrial fynbos habitat again.

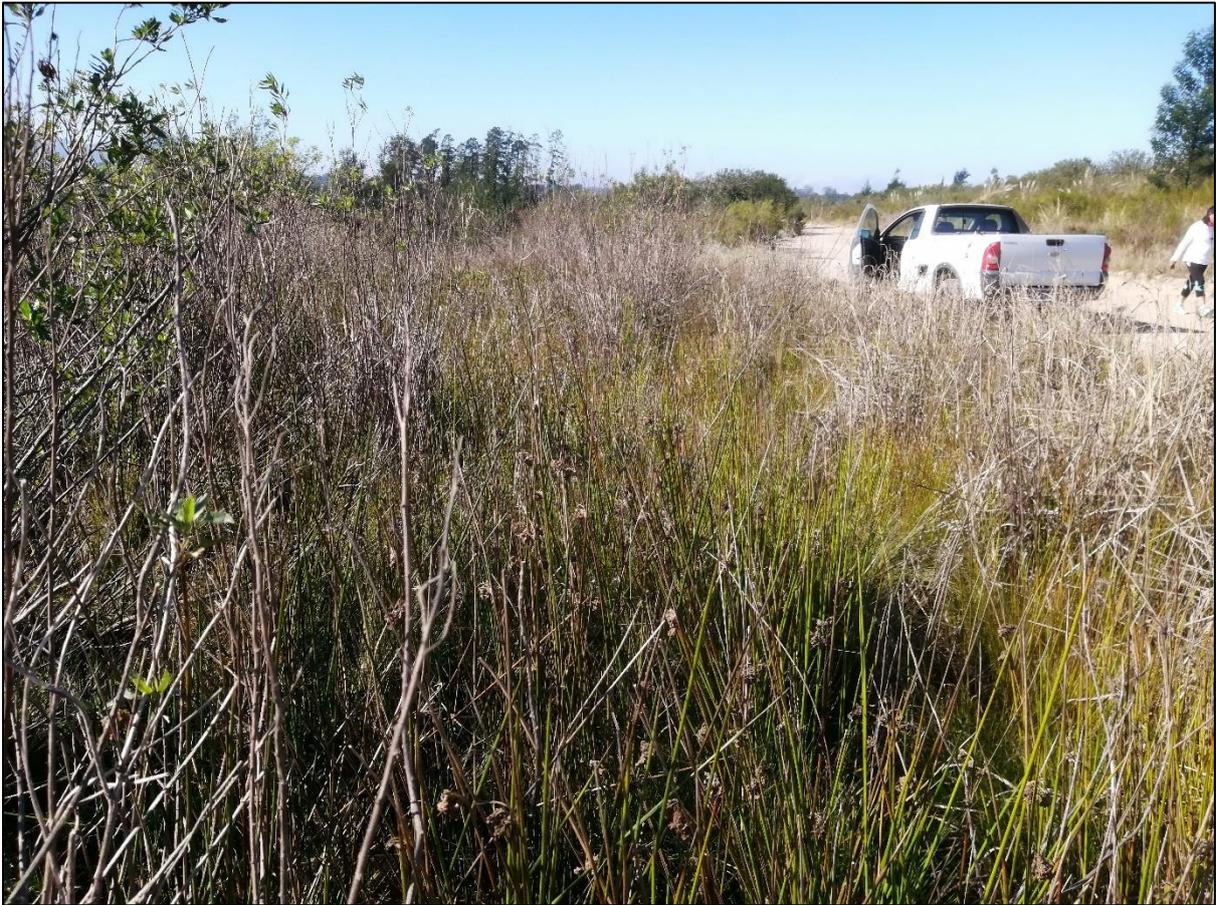
Figure 33: Photograph of the artificial wetland habitat that has formed due to prolonged inundation from a leaking water pipeline

Artificial wetland habitat occurs within the study area as a result of changes from the existing infrastructure on the property. A leaking water pipeline has created a small pocket of wetland next to the gravel road. The maintenance activities associated with the pipeline servitude and road culverts have also altered the movement of water through this location and changed soil characteristics. Any wetland characteristics in this small area are not formed under normal circumstances. Additionally, the wetland is not self-sustaining as it is entirely dependent on the water inputs of the broken pipe.

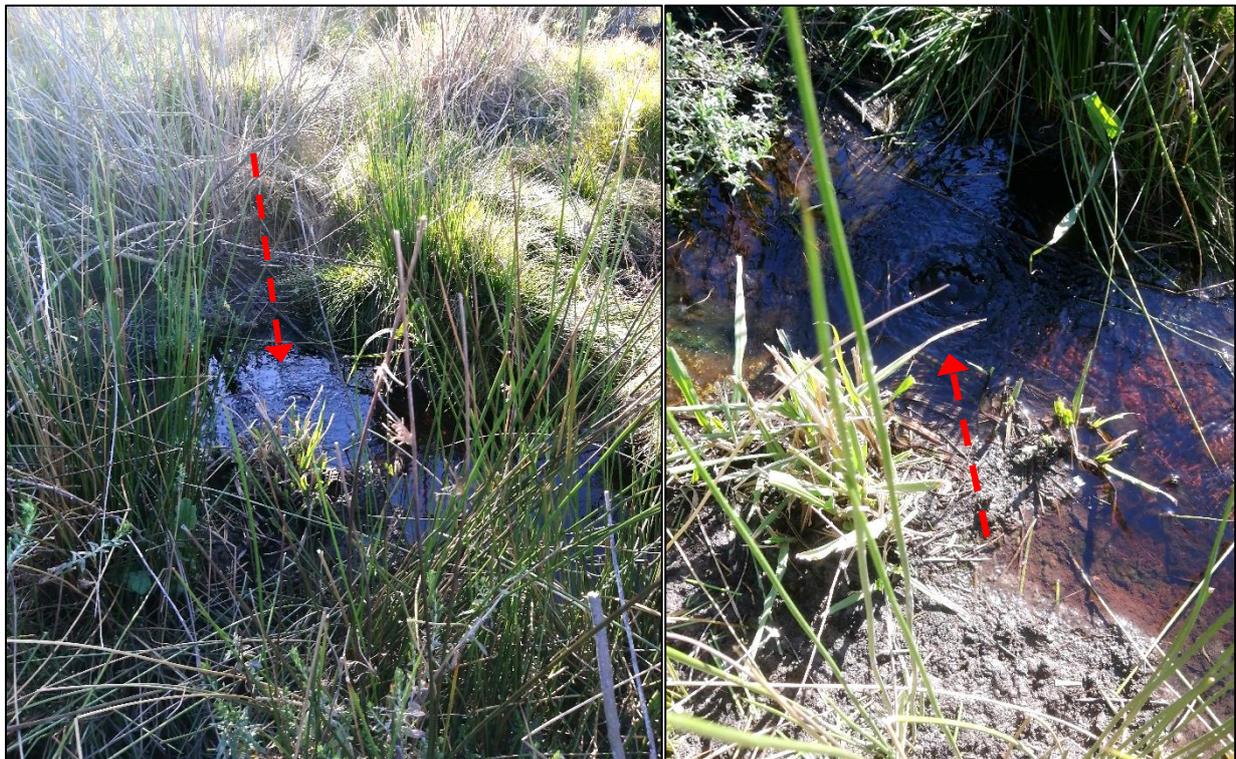
Figure 34: Photographs showing the source of water inputs from a leaking water pipeline. The water is humic stained as it is raw water from the dam, which has dark brown coloured water.

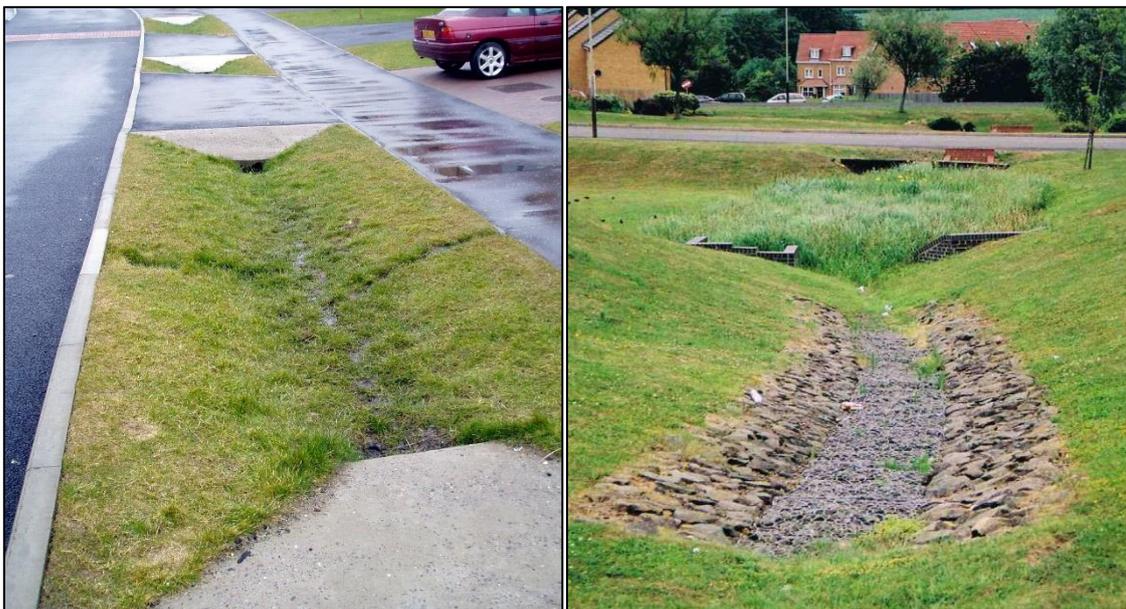
Figure 38: Examples of soft infrastructure incorporated into the stormwater management design (porous channels / swales)

- The stormwater management infrastructure must be designed to ensure the runoff from the development is not highly concentrated before entering the buffer area. The volume and velocity of water must be reduced through discharging the surface flow at multiple locations surrounding the development, preventing erosion. It is therefore recommended that the stormwater management plan be developed with the incorporation of Sustainable Drainage Systems (SUDS). The SUDS systems attempt to maintain or mimic the natural flow systems as well as prevent the wash-off of urban pollutants to receiving waters.

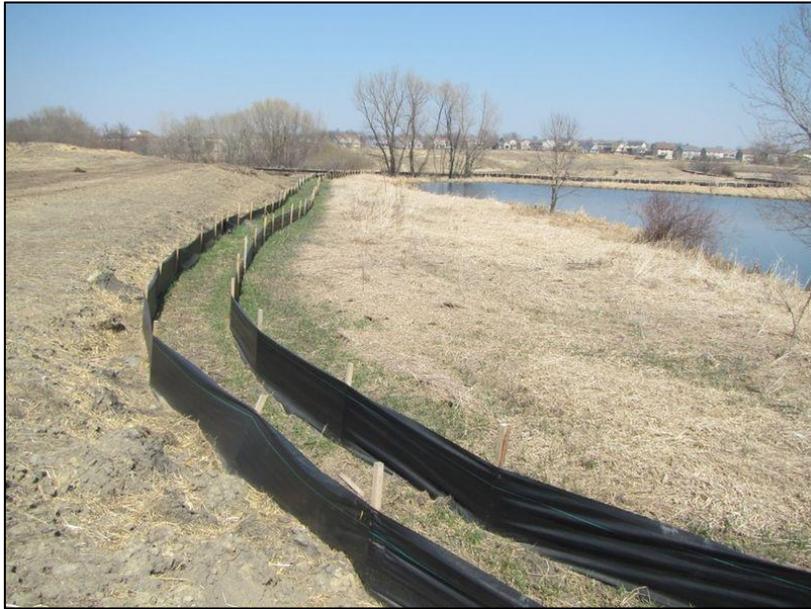
Before any work commences, sediment control/silt capture measures (e.g. bidim/silt curtains) must be installed downstream/downslope of the active working areas. Silt fences/curtains must be regularly checked and maintained (de-silted to ensure continued capacity to trap silt) and repaired where necessary. When de-silting takes place the silt must not be returned to the watercourse. An example of fibre rolls and silt fence measures for sediment control on the slopes:

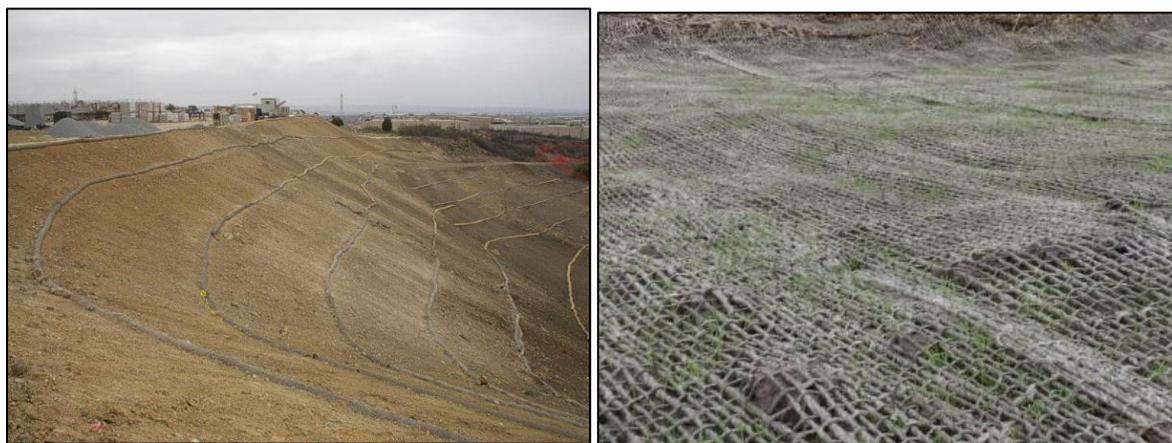
- *drainage filter material* to allow moisture to seep out of soils and other *in situ* material without the parent material moving through the cloth along with the moisture. An example is the universal use of the cloth as a separation lining between all gabion – soil interfaces. Needle pointed ‘Bidim’ should be used in preference to woven fabrics for gabion backing
- *a soil-reinforcing membrane* where berms/ embankments need to be built with side slopes steeper than the natural angle of repose of the soil involved.
- *a separation membrane* between ground surfaces and road-building material when constructing a road across unstable surfaces. This could have important application where roads are required to traverse wetland conditions.

The geotextile material is sold in standard rolls of 5 m x 150 m and with various thicknesses/strengths for the various applications required. Joints in geofabric should be made with an overlap of at least 300 mm or a 150 mm double fold over and tied with galvanized wire staples at

300 mm intervals. The joint must always lap away from the direction of flow, otherwise the joint will open.

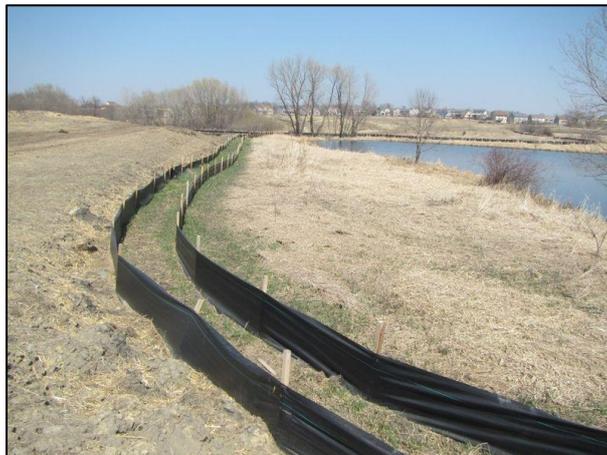
- Designed to handle sheet flow, not concentrated flow
- 6" x 6" trench should be excavated
- The bottom 12" of the fabric should be placed in the trench in an "L" shape with a 6" horizontal flap and a 6" vertical rise
- Should not be able to lift the bottom of the fence off of the ground
- Multiple rows of silt fence may not be used on a continuous slope
- Should be at least 8' from toe of slope
- Should be installed at existing level grade
- Both ends of each section must be extended 8' upslope at 45 degrees
- Sediment must be removed when accumulations reach ½ of the above ground height of the fence
- Any section of fence which has been undermined or over-topped must immediately be replaced with a rock filter outlet

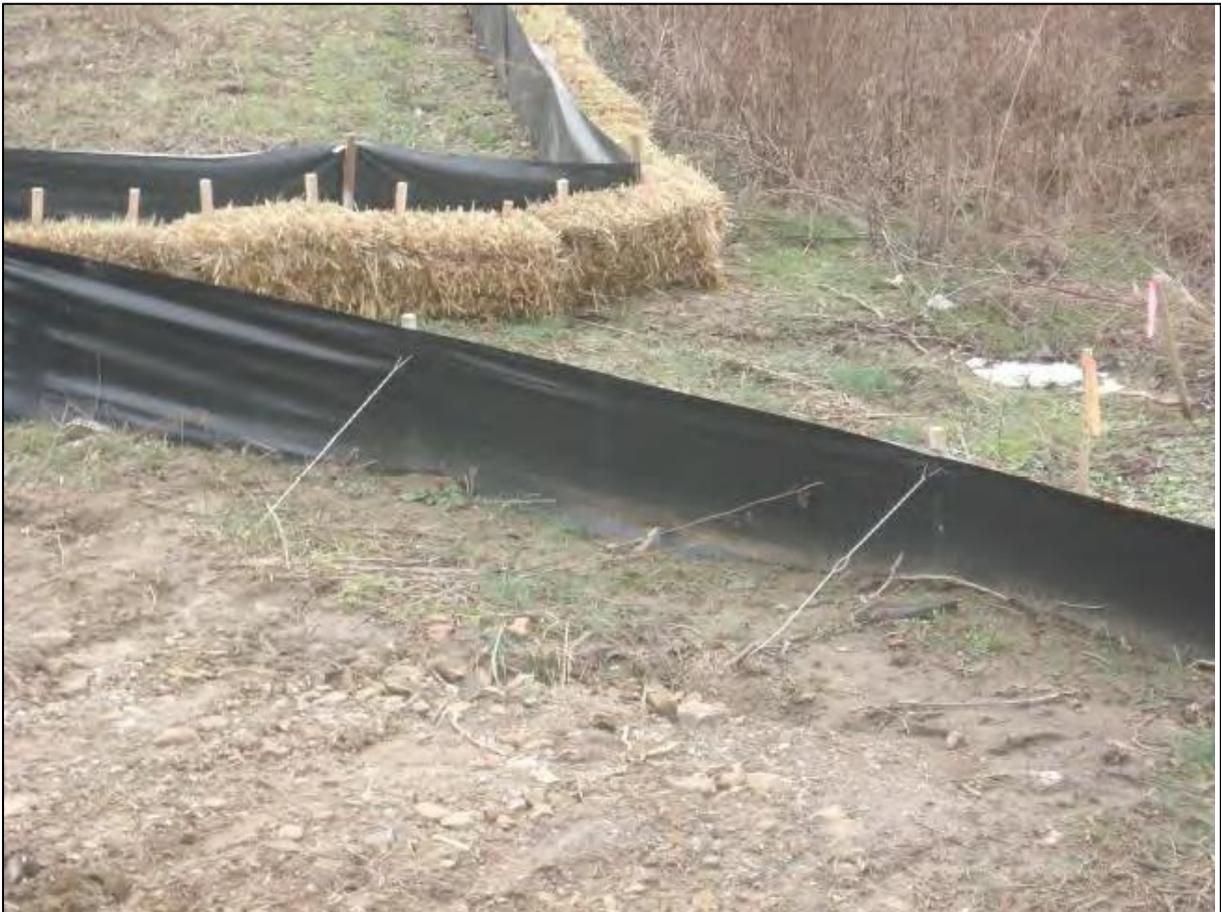
14.8 Silt Fence - Standard Silt Fence with Straw Bales

- Designed to handle sheet flow, not concentrated flow
- 6" x 6" trench should be excavated
- The bottom 12" of the fabric should be placed in the trench in an "L" shape with a 6" horizontal flap and a 6" vertical rise
- Should not be able to lift the bottom of the fence off of the ground
- Multiple rows of silt fence may not be used on a continuous slope
- Should be at least 8' from toe of slope
- Should be installed at existing level grade
- Both ends of each section must be extended 8' upslope at 45 degrees to main fence
- Sediment must be removed when accumulations reach ½ of the above ground height of the fence
- Any section of fence which has been undermined or over-topped must immediately be replaced with a rock filter outlet

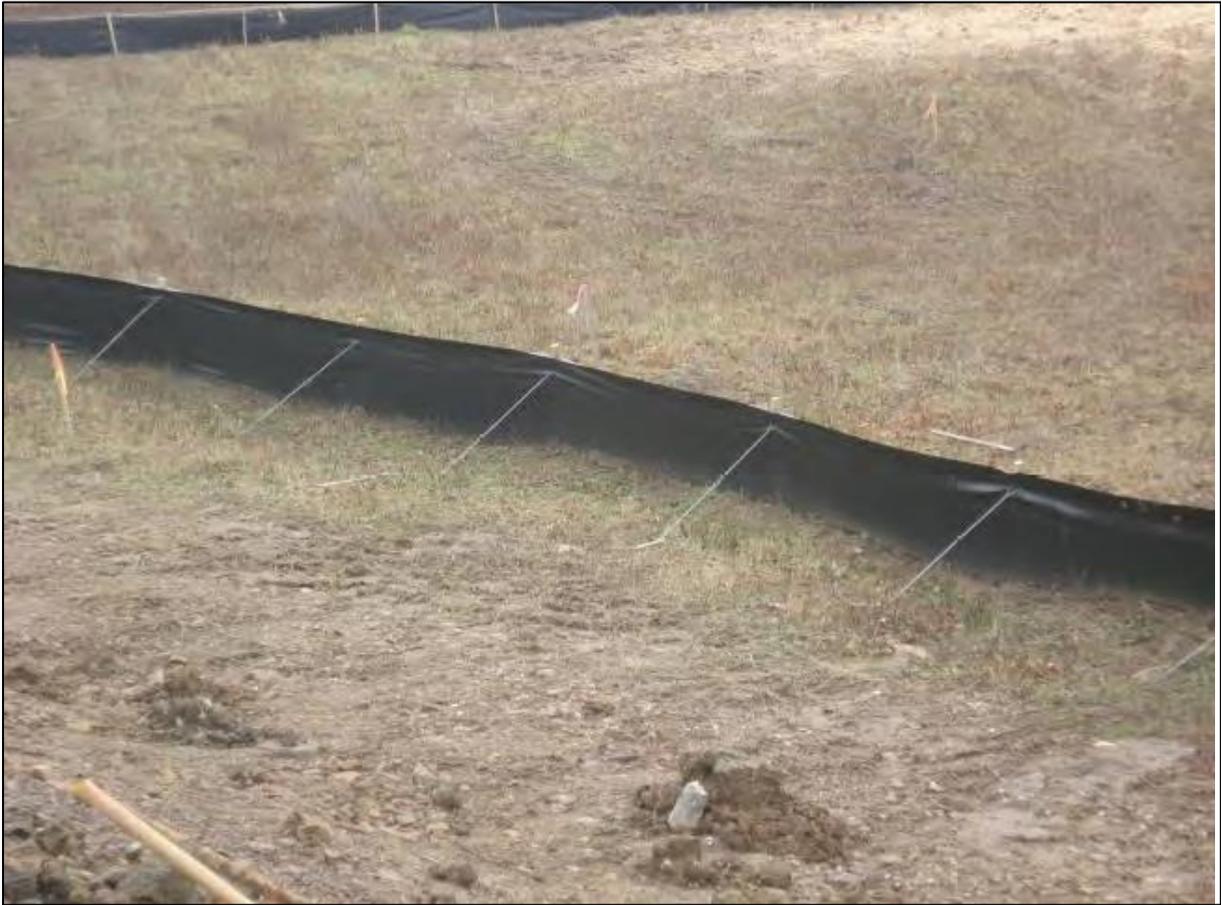
14.9 Silt Fence - Standard Reinforced 30" Silt Fence

- Designed to handle sheet flow, not concentrated flow
- 6" x 6" trench should be excavated
- The bottom 12" of the fabric should be placed in the trench in an "L" shape with a 6" horizontal flap and a 6" vertical rise
- Should not be able to lift the bottom of the fence off of the ground
- Multiple rows of silt fence may not be used on a continuous slope
- Should be at least 8' from toe of slope
- Should be installed at existing level grade
- Both ends of each section must be extended 8' upslope at 45 degrees
- Fence is reinforced with minimum 10 gauge wire
- Sediment must be removed when accumulations reach ½ of the above ground height of the fence
- Any section of fence which has been undermined or over-topped must be replaced immediately with rock filter outlet

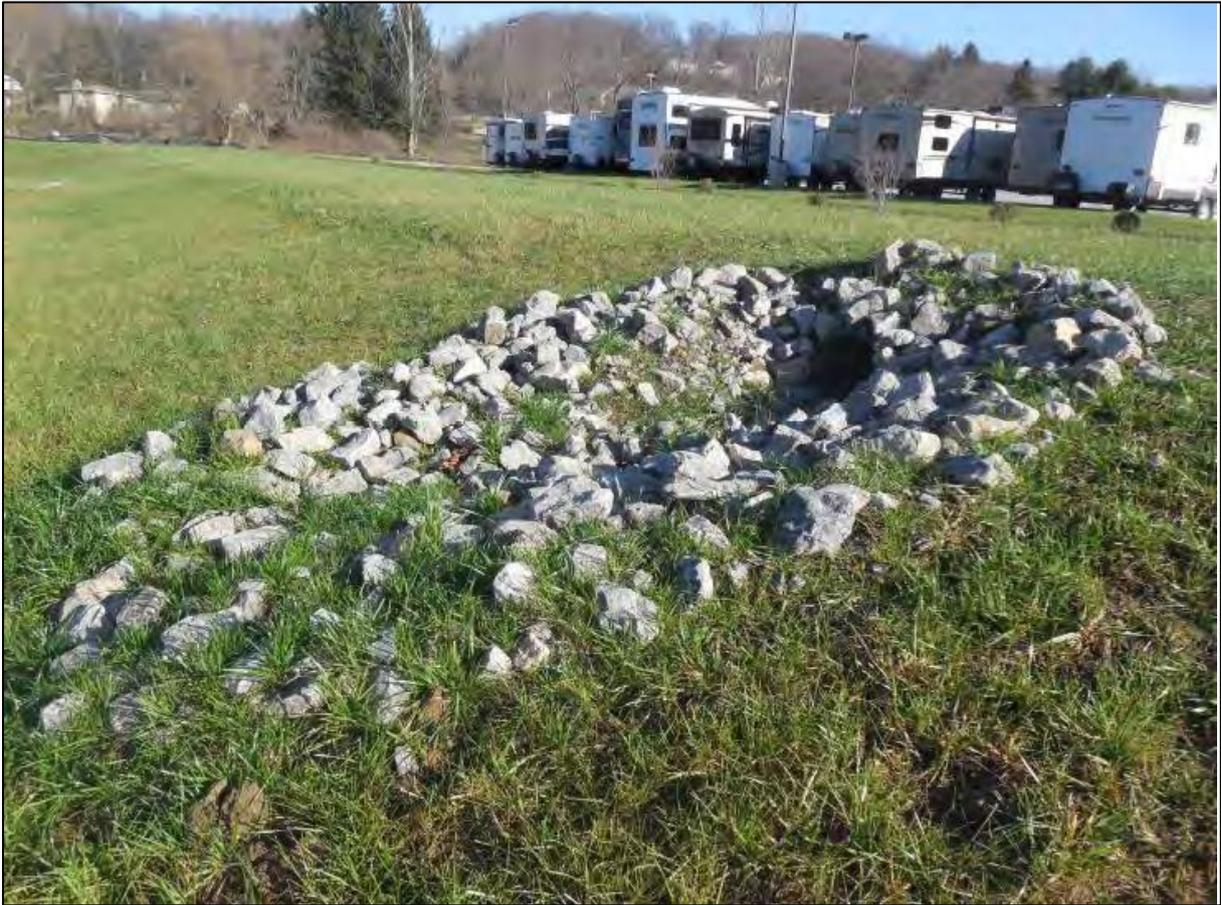
- Rock rip-rap sized to dissipate energy from high velocity water discharges from pipes
- Geotextile fabric is placed under the rock to prevent scour of the earth beneath
- Apron dimensions designed for slope and volume (velocity)
- Stabilized surface should extend to natural flow channel
- Sediment deposit indicates serious problem
