AQUATIC BIODIVERSITY IMPACT ASSESSMENT

DEVELOPMENT OF THE REMAINDER OF ERF 464, ADJACENT TO THE GARDEN ROUTE DAM, GEORGE

Sharples Environmental Services cc. 2021. Aquatic Biodiversity Impact Assessment for the development of the Remainder of Erf 464, adjacent to the Garden Route Dam, George.

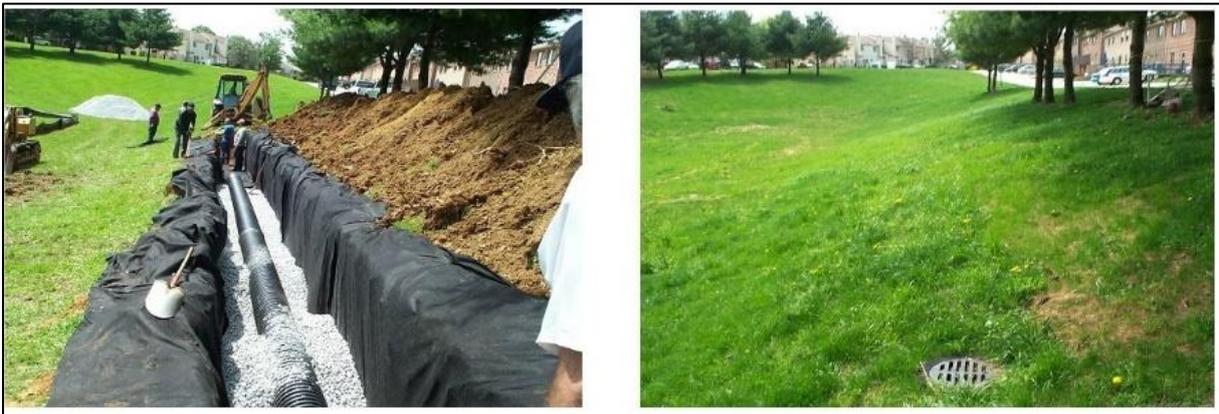
- Protect area from compaction
- Protect device from siltation during and after construction
- Continuous perforated pipe at minimum slope
- Drainage layer of clean, washed, uniform grade aggregate wrapped in geotextile fabric
- Engineered soil media
- Dense vegetation for stabilization
