BOTANICAL ASSESSMENT

PROPOSED GREEN VALLEY AFFORDABLE HOUSING PROJECT ON PORTIONS 28 & 32 OF ERF 306, PLETTENBERG BAY

October 2017

BIODIVERSITY ASSESSMENT: PROPOSED GREEN VALLEY ACCESS ROAD & SEWER LINE, PLETTENBERG BAY

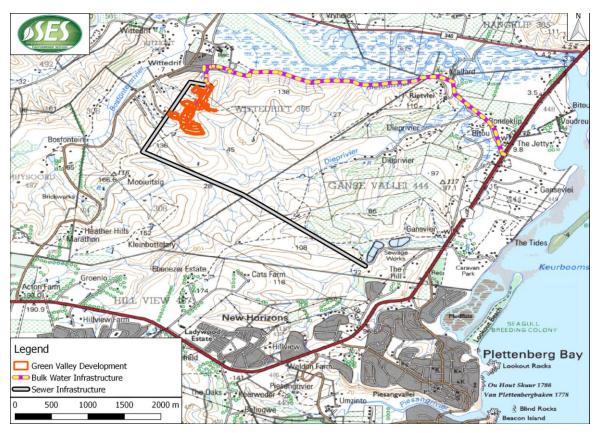
Map 2 Overall layout plan showing the position of proposed development and sewage and water supply pipelines.

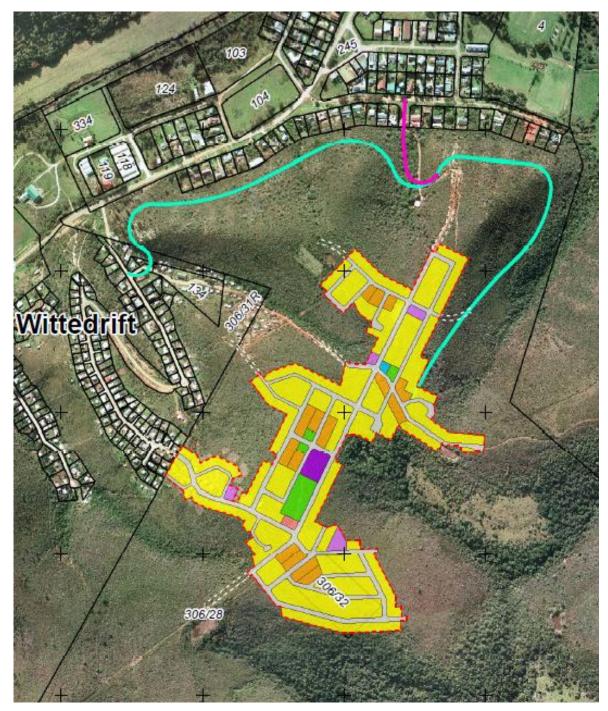
Map 3 Layout plan of the proposed mixed use development and access roads (blue and pink).

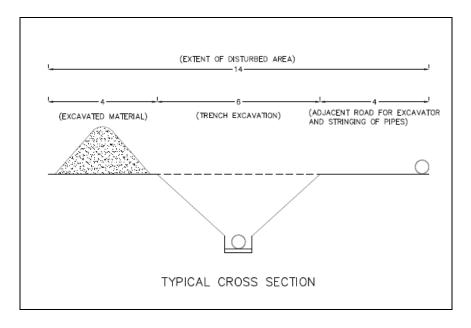
Anticipated construction activities along the pipeline route include trench excavation,

stockpiling of excavated material and road for use by excavator and stringing of pipes. A typical cross section is proposed to look like the cross section shown in the figure below:

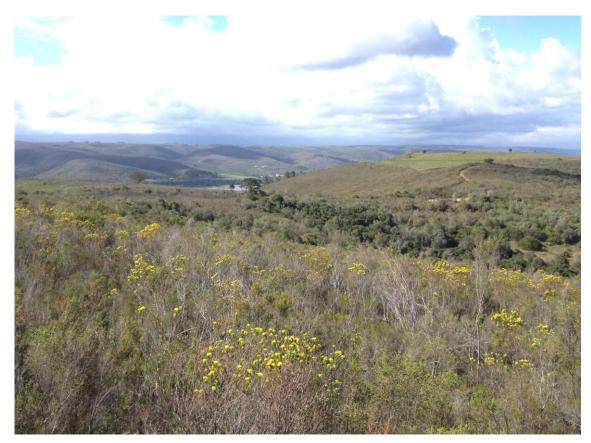
Photo 1 Good quality fynbos in the centre of site overlooking a patch of forest inside the small valley directly east of site.

and in the valleys around Plettenberg Bay, are still covered with good quality fynbos and forest, urban development and agriculture has transformed large parts of the landscape. Stretches of good quality fynbos, and Afrotemperate forest elements in the valleys, were recorded on site (see Photo 1). A large part of the site was affected by a recent veld fire (March 2017, see Photo 2). Considerable alien infestation was recorded, especially on the slopes directly above Wittedrif (see Photo 3).

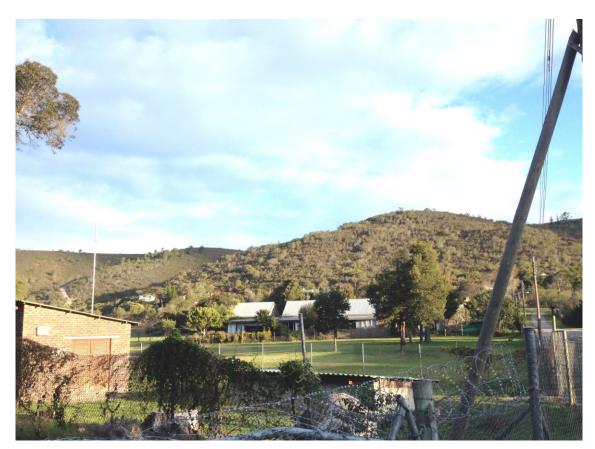
Photo 3 A section of the hillslope above Wittedrif, with the lower slope infested with rooikrans.

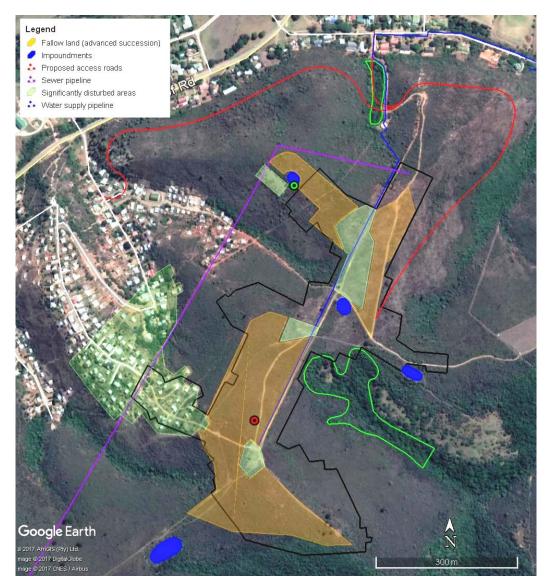
Map 5 Satellite photo showing the proposed development site (outlined in black) and associated infrastructure. The areas outlined in green are forest areas, while the red marker indicates the position of a single *Euphorbia procumbens* and the green marker a milkwood tree. The remainder of site not shown as disturbed is considered good quality fynbos.

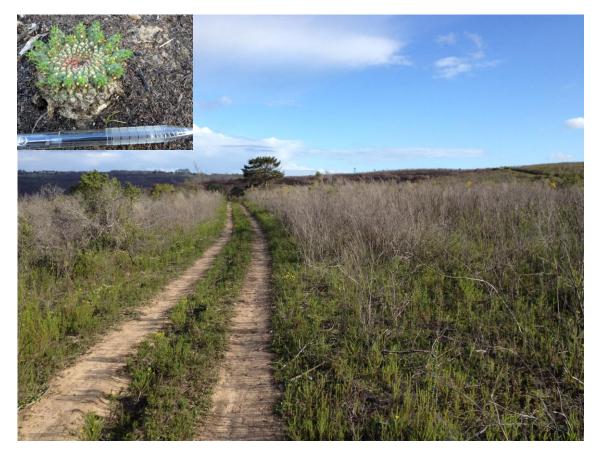
Photo 4 One of several farm tracks through the site. Insert: Euphorbia procumbens

Significant areas on site have been disturbed by past farming activities (see Photos 4 & 5), some of which are in an advanced stage of succession. A recent veld fire (March 2017) has made an assessment of the condition of the veld in some areas difficult or impossible. A small area (540 m²) of forest is being encroached by the development on the eastern side. Good quality fynbos, however, remains on a significant part of the site and adjacent areas. The proposed access roads also run through relatively undisturbed fynbos, with the section directly above the village infested with rooikrans and some pines at the western end before the proposed road enters the village.

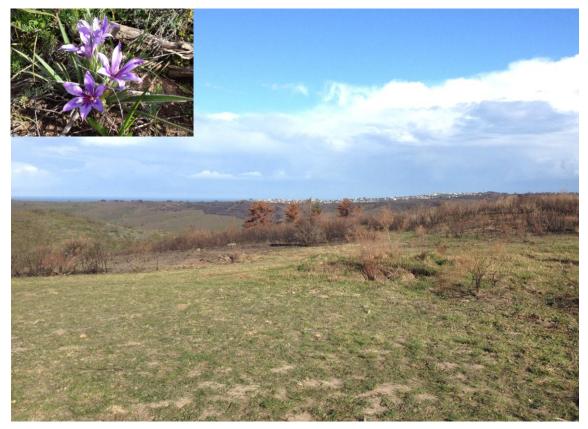
Photo 5 An area on site disturbed by past farming activities. Insert: Babiana sambucina

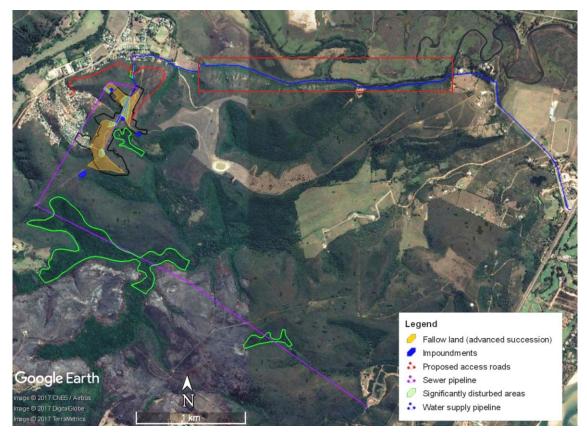
Map 6 Satellite photo of the overall study area. The areas outlined in green are perceived forest areas. The red boxed area is regarded as botanically highly sensitive, as well as the almost entire sewer line route which runs through undisturbed fynbos.

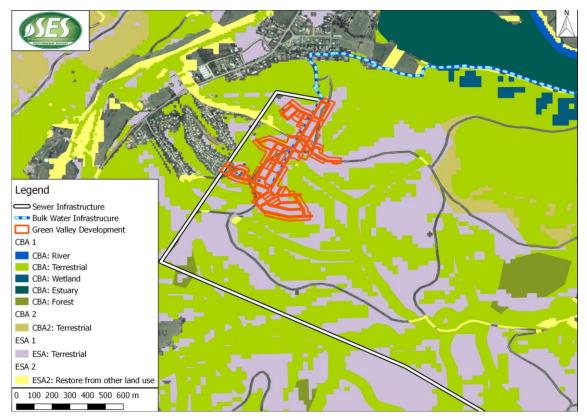
Map 7 Critical Biodiversity Areas (CBA) map², showing the proposed development site (orange) and associated sewer and water supply pipelines superimposed on CBA's (green) and ESA's (purple).

Map 7 shows the Critical Biodiversity Area's (CBA's) and Ecological Support Areas (ESA's) that are affected by the project. Being positioned mainly on the hilltop, the proposed development site is located mainly inside a mapped ESA. The CBA's are associated with the steeper slopes below the development site. The associated infrastructure, such as the access roads, sewage and water supply pipelines, are located inside a mixture of CBA's, ESA's and transformed areas. A section of the water supply pipeline runs along a boundary between an aquatic CBA (Bietou River floodplain) and terrestrial CBA (Garden Route Shale Fynbos). The terrestrial CBA's are associated with the main drainage courses and steeper slopes, while the ESA's fill out the areas in between. The authors of the CBA map argue that the drainage courses and steeper slopes, being cooler and moister, serve as refuges for biodiversity during climate change and that it should be protected.

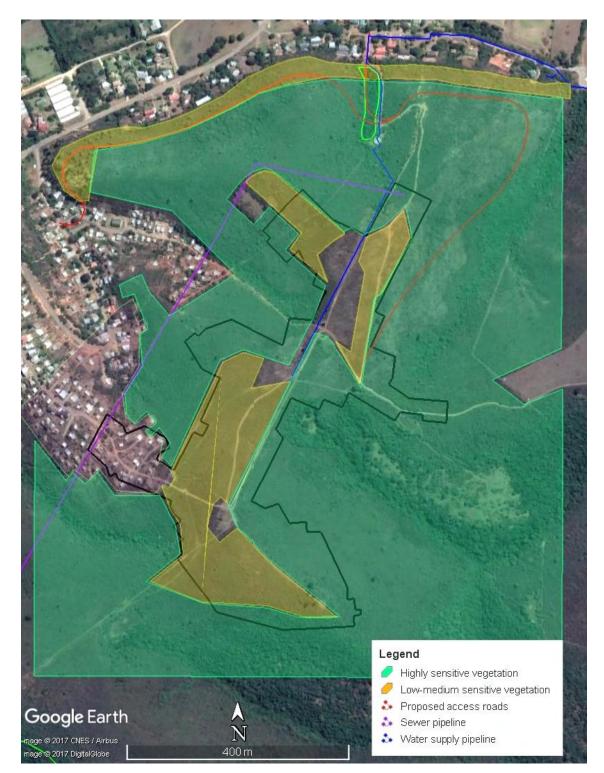
Map 8 Botanical sensitivity map, with the development footprint outlined in black. The green areas are regarded as highly sensitive and the yellow areas as low to medium sensitive. Please note that the survey focussed on the proposed development area and immediate adjacent areas and not the entire area in view. The majority of the bulk services pipelines are also located in highly sensitive vegetation.

The impact on the fynbos and forest vegetation types can potentially be lessened by adjustments to the layout, e.g. by slightly pulling back the development from the forest edge on the eastern side and by utilising the fallow areas outside the development footprint in favour of the good quality fynbos currently inside the footprint. With regards to the access roads, shorter route options to the village below will certainly lessen the impact and should be investigated. While the development footprint will impact on a fairly large fynbos area, the impact posed by the sewer pipeline will be profound as a large and relatively undisturbed fynbos area will be entered. Please note that this area was not investigated during the site survey. It is strongly recommended that alternative routes or solutions be found to deal with sewage disposal. Maybe Wittedrift deserves its own treatment plant, such as a lagoon plant and the treated effluent used for irrigation! Such a plant is recommended if the daily limit of wastewater received is about 500 M^ℓ (Vilhelm Jensen of WorleyParsons pers. comm.). It will cost between R7 and 10 million to construct. If the substratum is clay, lining will probably not be needed, which will make it more affordable. Table 2 below summarises the impact on vegetation type.

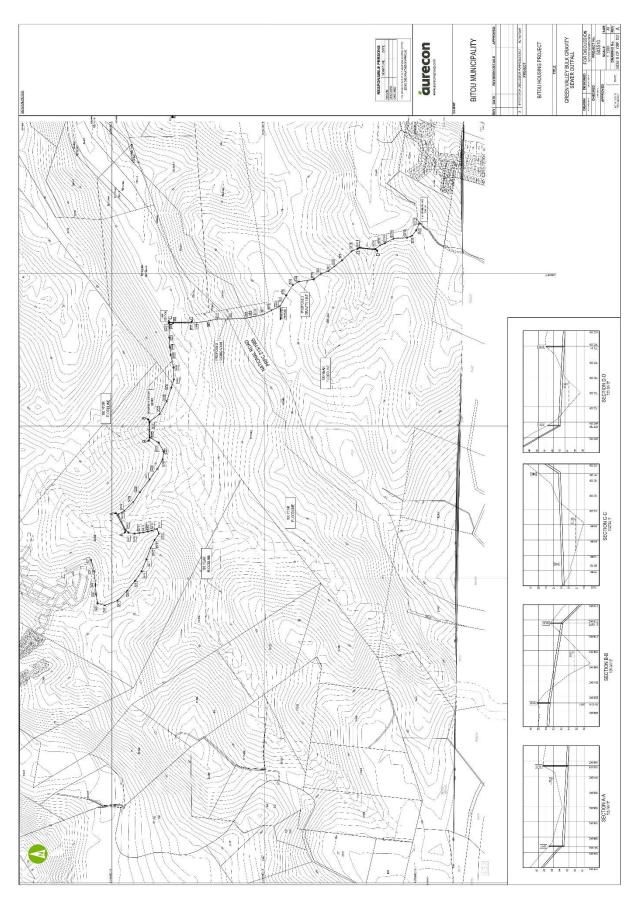
Map 2 Detailed layout plan of the proposed sewer pipeline (4.6 km) to the WWTW.

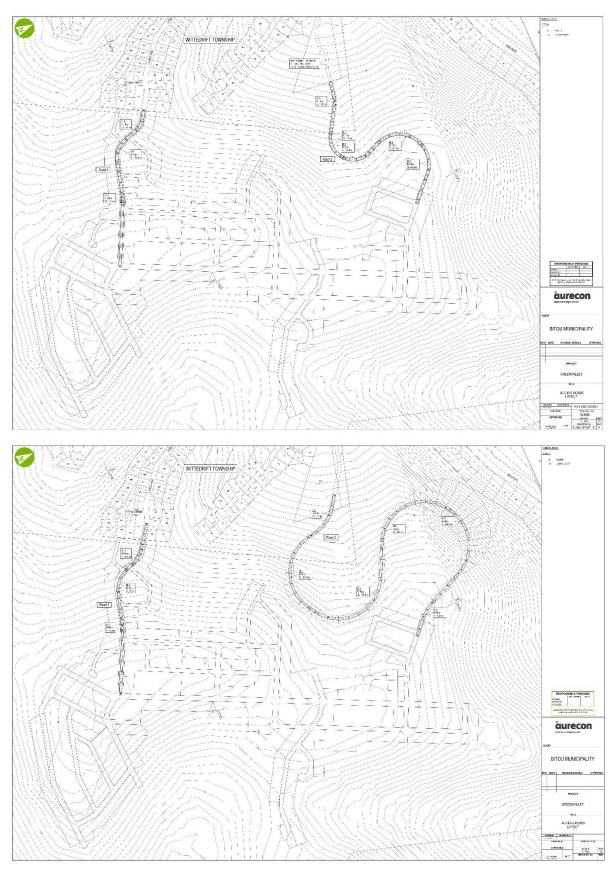
Map 3 Layout plans for the proposed access road options.

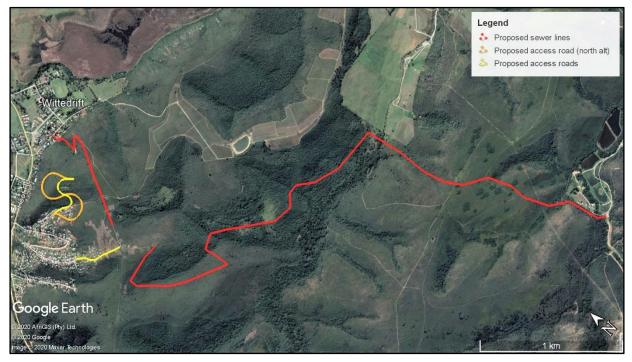
Map 4 Satellite photo showing the proposed road and sewer infrastructure in context with its surroundings.

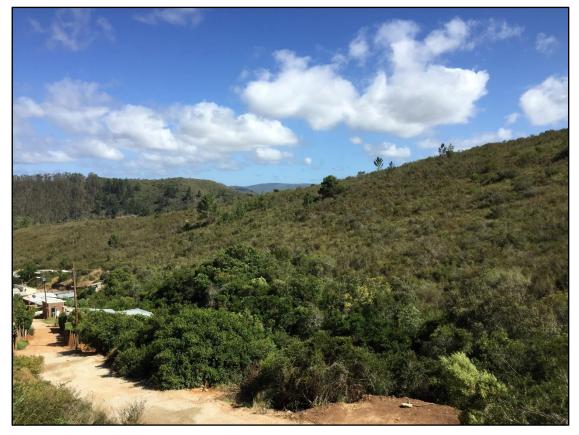
Photo 1 View of senescent fynbos across narrow strip of riverine forest in the vicinity of the proposed northern access road.

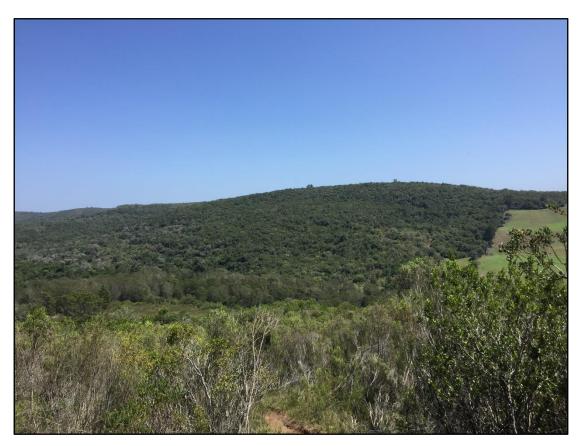
Photo 2 Small valley with Afrotemperate forest and part of the proposed sewer line route to the WWTW.

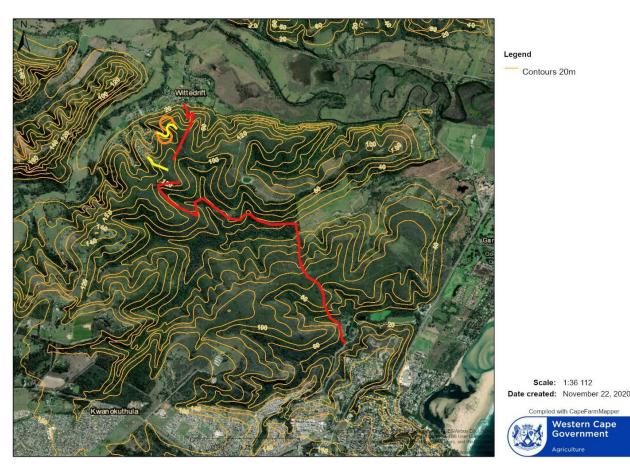
Map 5 Topographical (contour) map of study area.

The topography of the site can be described as hilly, with the Tsitsikamma Mountains forming a backdrop to the north (see Map 5). While the proposed northern access road (both alignment options) will cross one minor drainage line, the proposed sewer line to the WWTW will cross at least five drainage lines due to its length. Due to the crossing of a small valley, a pump station will be need at the bottom of the valley for the sewer line.

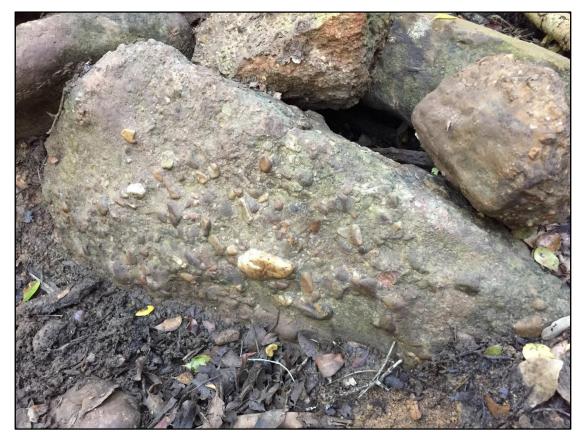
Photo 3 Exposed Enon conglomerate in the riverbed of small valley.

According to the 3322 Oudtshoorn 1:250 000 geological map, the site is underlain by Enon conglomerate of Cretaceous to Tertiary age. It comprises conglomerate, sandstone, siltstone and clay (see Photo 3).

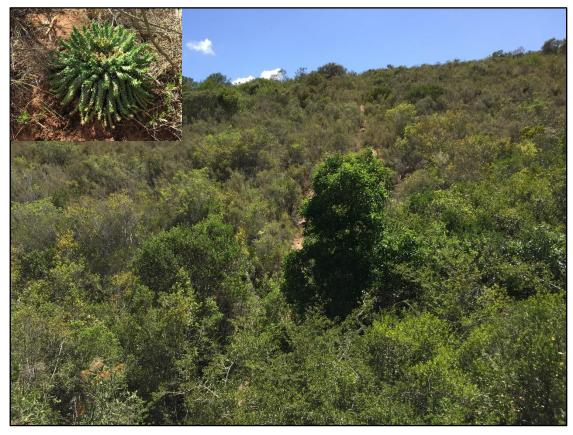
Photo 4 Close-up view of the senescent fynbos in the vicinity of proposed northern access road. Insert: *Euphorbia* procumbens

It is evident on the above maps that significant areas on site have been disturbed/transformed by past farming activities (see Photos 4 & 5), some of which are slowly recovering. Species diversity in these areas however remain low. The greatest diversity was encountered on the slope above Wittedrif where the northern access road will be located and in the Afrotemperate forest areas.

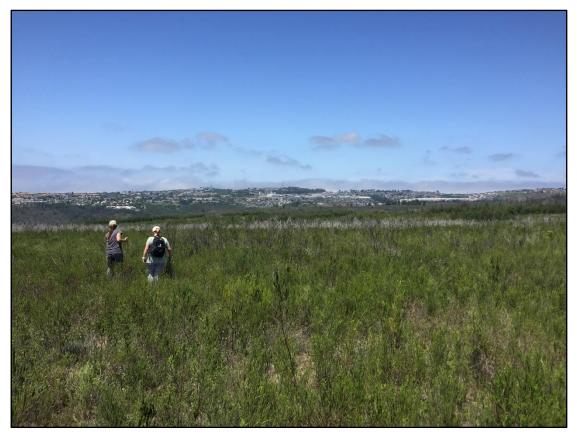
Photo 5 Regrowth in a fallow land along the proposed sewer line on route to the WWTW. Plettenberg Bay can be seen in the background.

The recovering fynbos in the previously burnt areas is currently dominated by only a few species, such as *Anthospermum aethiopicum*, *Euryops virgineus* and *Passerina* species. The fynbos regrowth is also lower (<1 m) than for the senescent fynbos and can be described as a low closed ericoid shrubland. It was recorded along the proposed gravity sewer, as well as along the south-eastern section of the proposed sewer line to the WWTW where it runs over a hill and then down the slope towards the WWTW. A part of this section appears to be fallow land as evidenced by the low number of indigenous species encountered, as well as historical Google Earth photographs (see Photo 5). It has subsequently been indicated as degraded on Map 9.

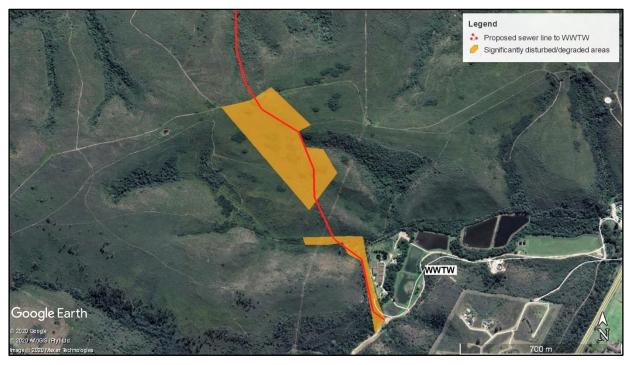
Map 9 Botanical attributes map of the south-eastern part of the study area, showing the proposed sewer line approaching the WWTW. No significant botanical features were recorded here.

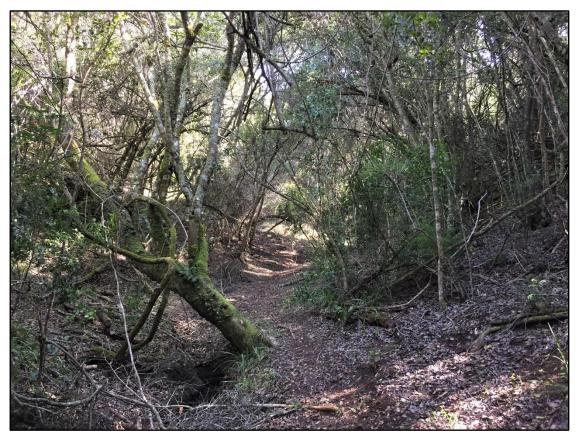
Photo 6 Inside the forest in small valley in the vicinity of the sewer line route to the WWTW.

Sections of the proposed infrastructure also runs through or alongside pockets of Afrotemperate forest (see Photo 6). The proposed northern access road (both alignment options) cuts through a narrow strip of riverine forest, while the northern end of the proposed gravity sewer runs alongside a similar, but more developed strip of riverine forest before entering the village below. The most extensive forest in the study area was encountered in the small valley, which is skirted and crossed in a few places by the north-western section of the proposed sewer line to the WWTW (see Map 8). The most mature forest was found in the valley bottom and is fortunately not significantly affected by the proposed project. Several large yellowwoods and saffrons were encountered here. Parts of the sewer line route to the WWTW are inaccessible due to dense, tall scrub, notably a section on the south-facing hill slope west of the proposed pump station.

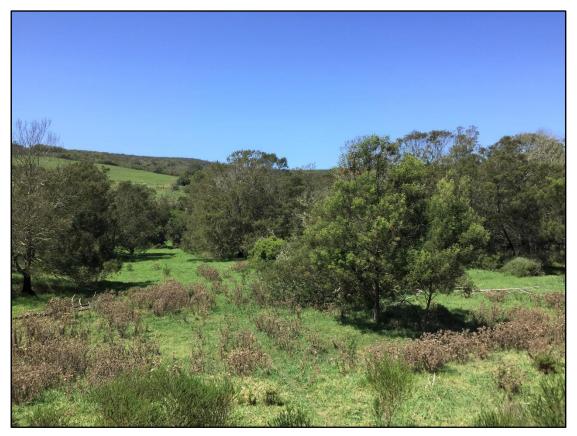
Photo 7 Black wattle infestation in the vicinity of the proposed sewer pump station for the sewer line to WWTW.

The lower hill slope directly above the village as well as certain areas along the proposed sewer line to the WWTW are infested with *Acacia mearnsii* (black wattle), *A. cyclops* (rooikrans), *Pinus* sp. (pines), *Hakea sericea* (silky hakea), *Cirsium vulgare* (Scotch thistle), *Ricinus communis* (castor-oil plant) and *Pennisetum clandestinum* (kikuyu) (see Photo 7). All these are listed invasive aliens. In terms of the National Environmental Management: Biodiversity Act (Act 10 of 2004) Alien and Invasive Species List (2016), the harbouring of black wattle and castor-oil plant on a property is prohibited without a permit. The presence of dense stands of black wattle is

indicative of past disturbances or agricultural activities. It typically invades watercourses and, along with the other woody aliens, presents a serious fire risk.

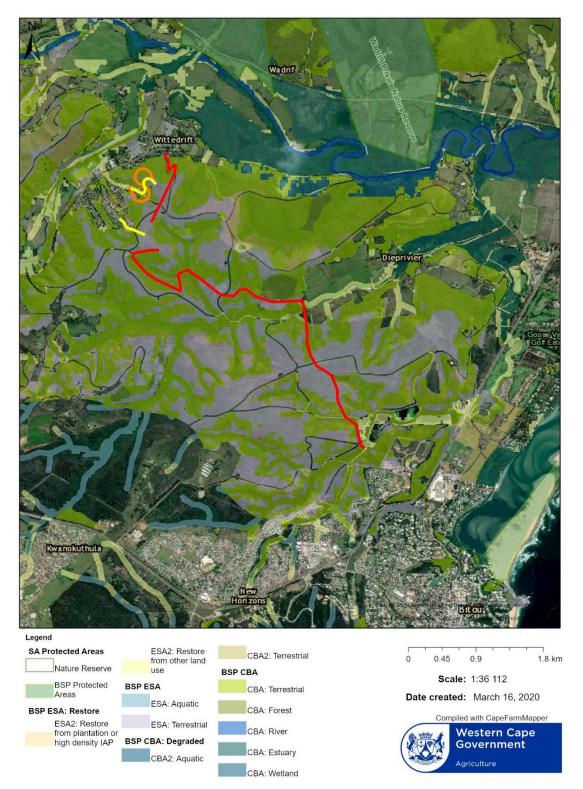
Map 10 Biodiversity network map, with the proposed sewer line and road infrastructure indicated in red and yellow/orange, respectively.
