**FEN CONSULTING**

## **FRESHWATER ASSESSMENT**

**FOR THE UNLAWFUL COMMENCEMENT OF  
ACTIVITIES ON THE REMAINDER OF FARM  
HOLLE KLOOF 91, PORTION 1 OF FARM,  
PLATTE KLOOF 131 AND PORTION 0 OF  
FARM 296, WABOOMSKRAAL, NEAR  
GEORGE, WESTERN CAPE PROVINCE**

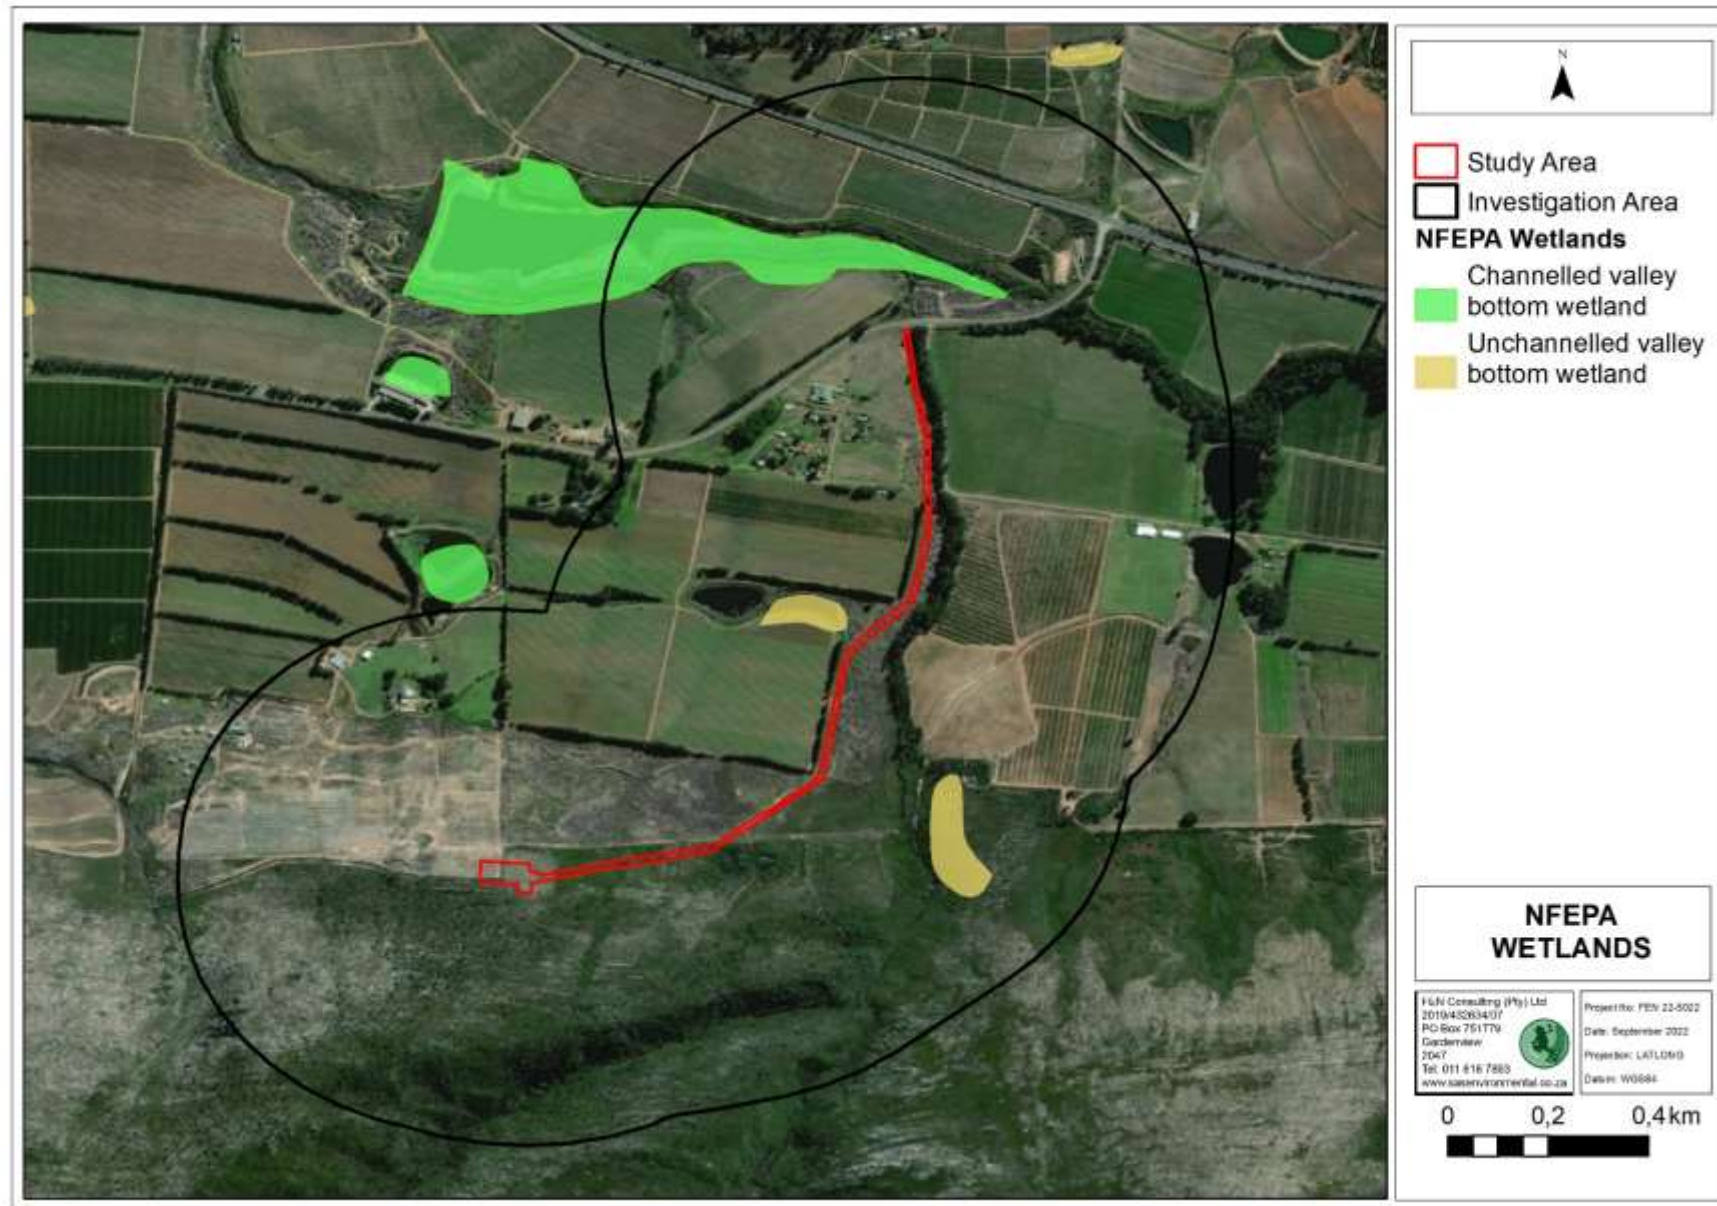
Figure 5: Wetlands associated with the study and investigation areas according to the NFEPA database (2011).

According to the NBA 2018: SAIIAE no wetlands or rivers are located in the study area. A natural unchanneled valley bottom wetland is indicated within the north eastern portion of the investigation area. This unchanneled valley bottom wetland is indicated as being affected by roads and is thus considered to be in a largely to seriously modified ecological condition (Class D, E or F). This unchanneled valley bottom wetland is indicated as critically endangered according to the ecosystem threat status (ETS) and poorly protected according to the ecosystem protection level (EPL). No rivers are indicated within the investigation area.			
National web based environmental screening tool (2020)		The study area is located in an area considered of very high aquatic biodiversity sensitivity. This is due to the study area located within a strategic water source area, and due to the presence of rivers and aquatic CBAs. According to the Strategic Water Source Area Database (2017), the study area is situated within the Outeniqua Surface Water Area.

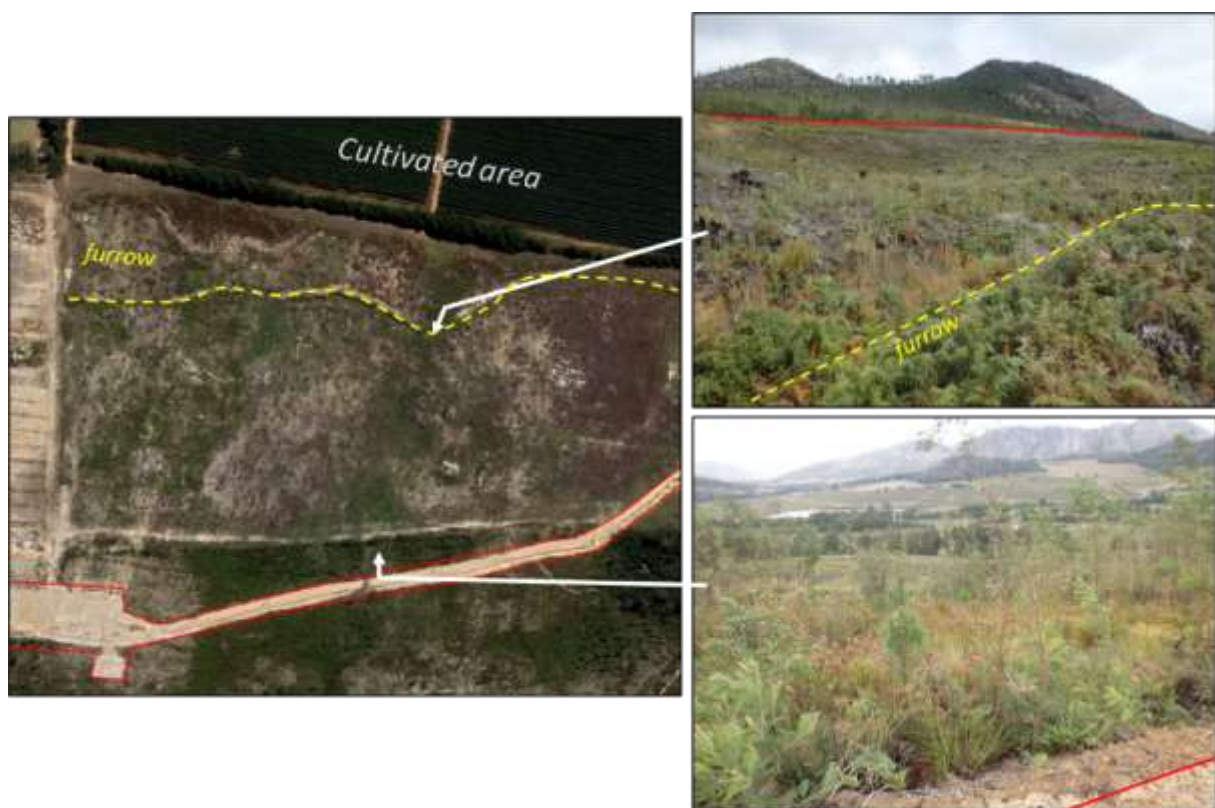
**Figure 10: The area downgradient investigated for freshwater ecosystem characteristics, of which none was noted. The relatively steep slope (Top left) allows surface flow into the downgradient furrow. (Bottom left) view of the downgradient area taken from the access road.**

The downgradient area, north of the partially upgraded road, was also investigated considering faint digital signatures noted in the historical photograph (Figure 8). Although a small valley was noted, no distinct freshwater ecosystem signatures were identified in this area (Figure 9). Considering the slope of this area it is acknowledged that surface water runoff would flow into this small valley but is not retained in the landscape for a sufficient period to encourage the establishment of a floral community that relies on an increased abundance of water within the effective rooting zone. As this water is collected in the downgradient furrow, no flow drains further towards the downgradient area. As such, the feature in this valley does not meet the definitions of a freshwater ecosystem from an ecological perspective (as defined by the National Water Act, 1998 (Act No. 36 of 1998)) and therefore does not require any further assessment.

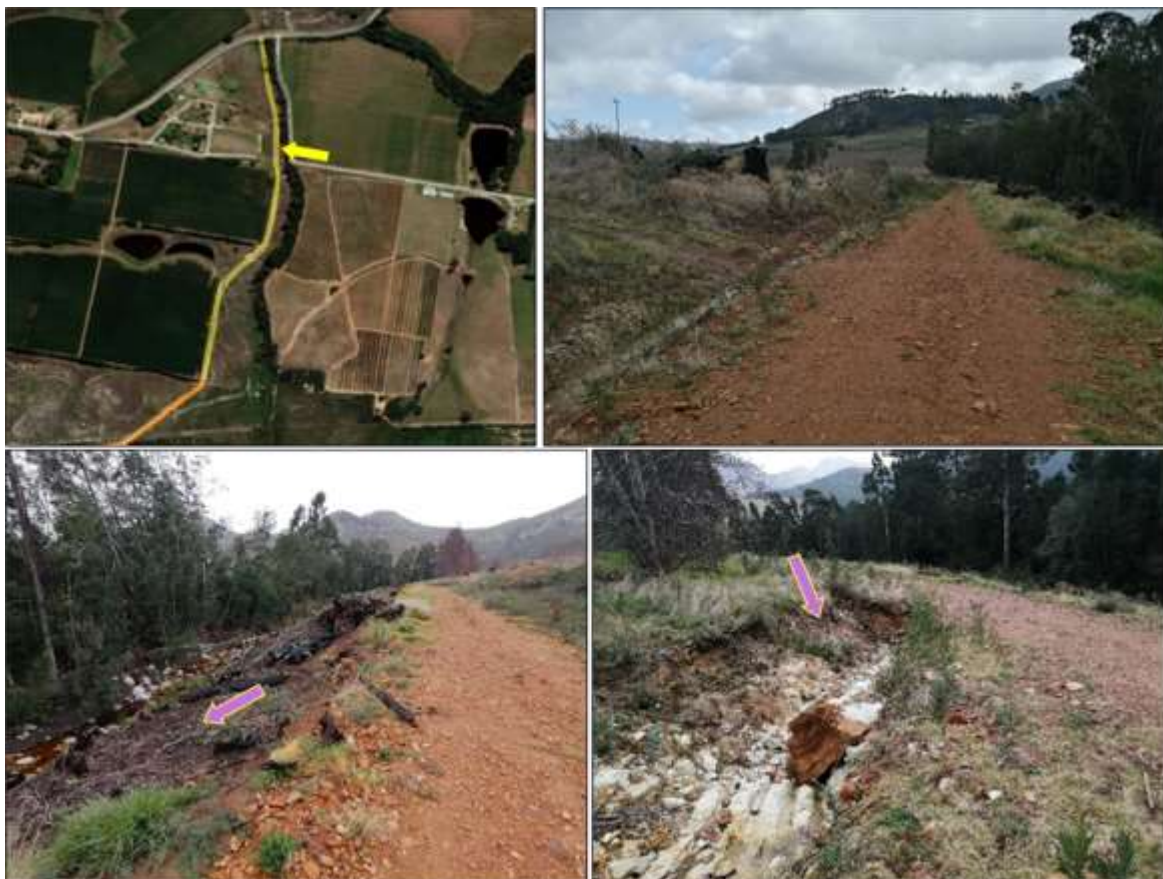
**Figure 12: The northern section of the gravel road connecting to the tarred road on Portion 0 of Farm 296 (yellow line and arrow). This section displays fewer signs of erosion. It is however evident that some erosion has occurred in areas where alien vegetation has been removed, as well as in the stormwater furrows next to the road (pink arrows).**

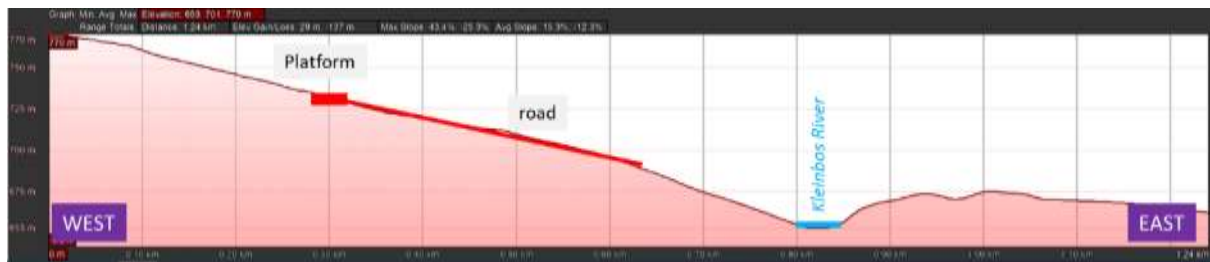
Figure 14: The elevation profile of the study area and the position of the Kleinbos River.

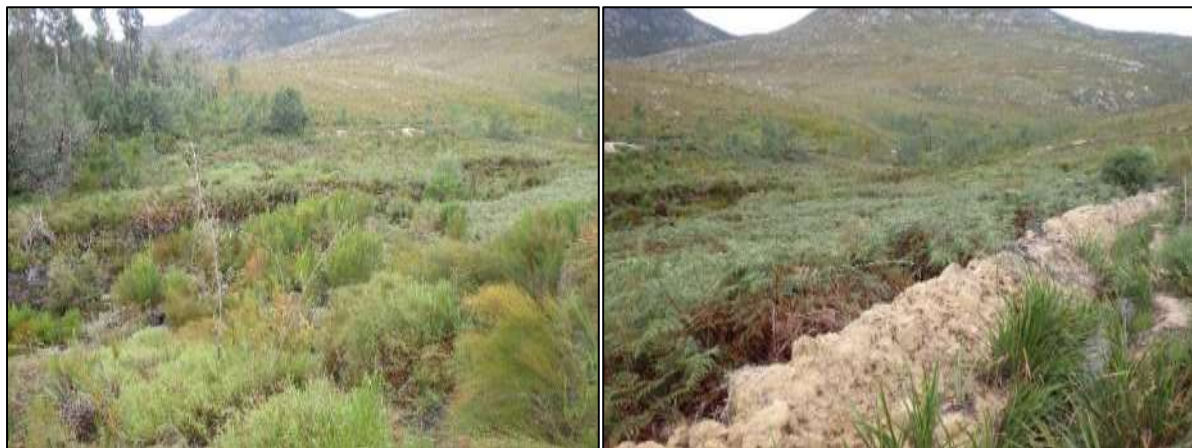
Figure 15: Overview of the vegetation component of the Kleinbos River.

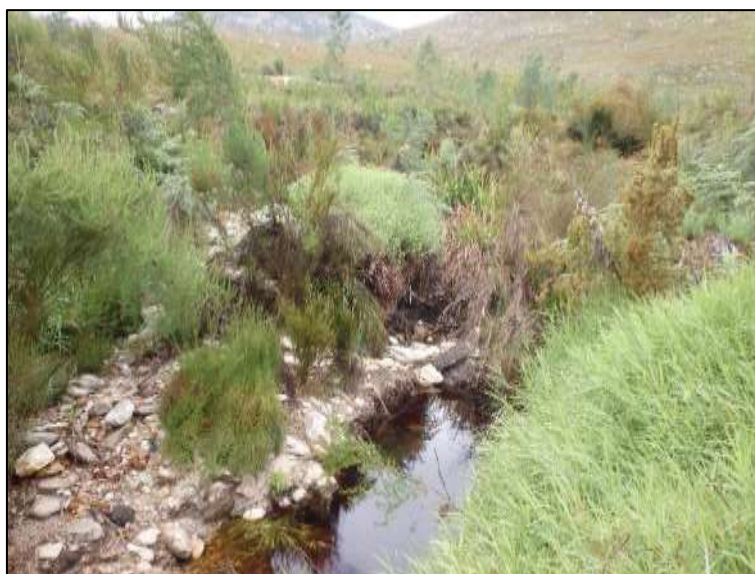
because riparian freshwater ecosystems are mainly driven by longitudinal flow, originating from its local catchment which flows through the freshwater ecosystem and does not reside in the riparian freshwater ecosystem as with wetlands. The active channel of the Kleinbos River consists of a cobble bed with alluvial soil deposited in shallow pools.

Figure 16: The active channel of the river consists mainly a cobble bed with small shallow pools.

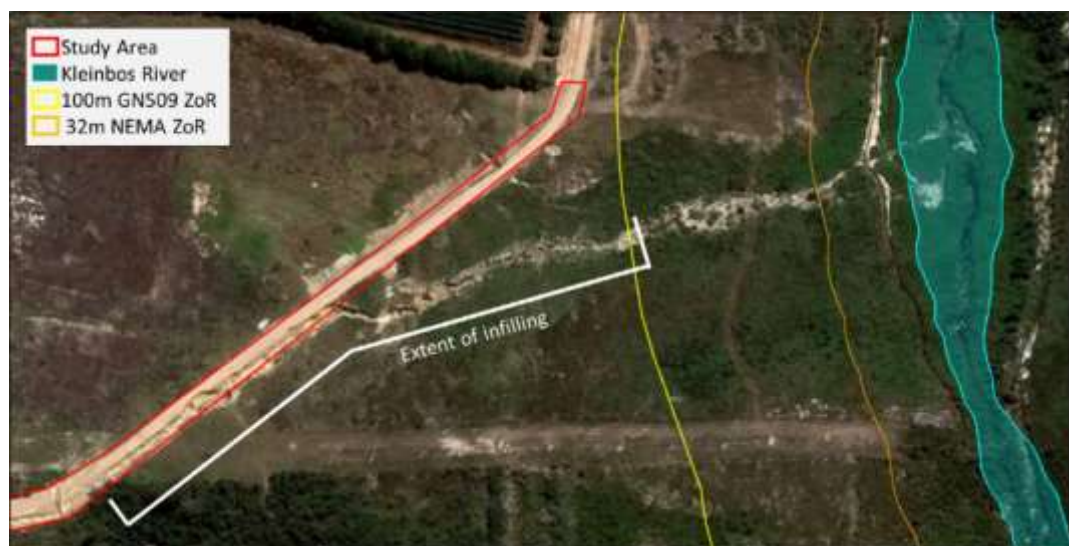
**Figure 19: The length of erosion gully proposed to be infilled with rip-rap, as per the engineering drawing (Figure 3) relative to the Kleinbos River and the 100m GN509 ZoR.**

- Infilling of the erosion gully located within the 100 m GN509 ZoR (Figure 19). As per the engineering drawings provided by DMS Consulting Structural Engineering (Figure 3) only a section of the erosion gully will be infilled with rip-rap. It is considered imperative that a further downgradient section (the extent of the erosion gully within the 100m GN509 ZoR) also be infilled to ensure that future surface runoff doesn't further erode the gully and to avoid latent impacts to the Kleinbos River. The DWS Risk Assessment was thus applied assuming that the full extent of the erosion gully in the 100m GN509 ZoR is infilled;

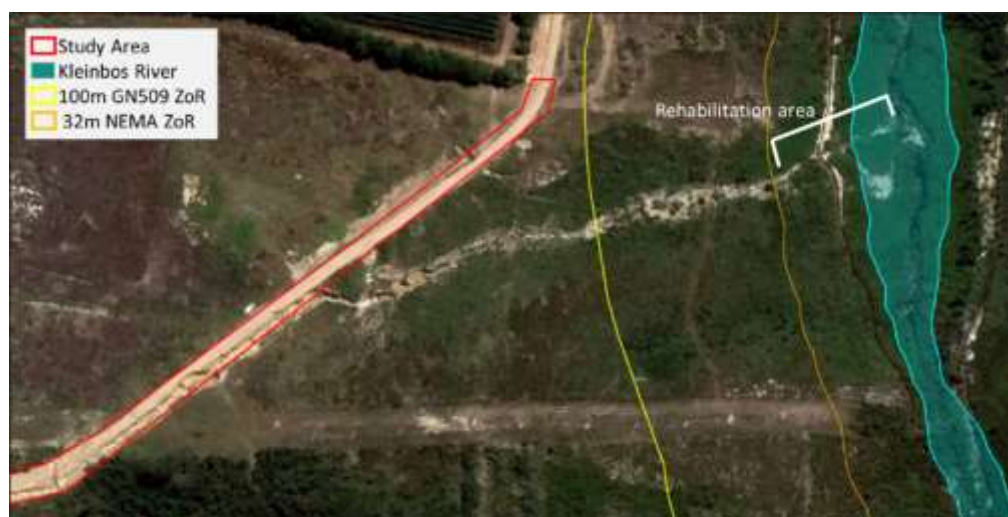
**Figure 21: Area to be rehabilitated by infilling the shallow gully/flow path with the deposited sediment and revegetating the area.**

- Rehabilitation of the erosion gully between the furrow and the Kleinbos River (Figure 21). This includes infilling the shallow erosion gully/flow path with the deposited sediment located on the western embankment of the river and revegetating all disturbed areas with suitable indigenous vegetation.
