# SECTION 24G APPLICATION FORM AND CHECKLIST

## ALLEGED UNLAWFUL CONSTRUCTION OF A ROAD AND CLEARANCE OF VEGETATION TO ESTABLISH A HOUSE ON THE REMAINDER OF FARM 91, HOLLE KLOOF AND PORTION 1 OF THE FARM 131, PLATTEKLOOF, FARM 296, WABOOMSKRAAL, GEORGE MUNICIPALITY WESTERN CAPE PROVINCE

In terms of the National Environmental Management  
Act, 1998 (Act No. 107 of 1998) and the amended (April  
2017) Environmental Impact Assessment Regulations,  
2014

**DATE:** 2 November 2022

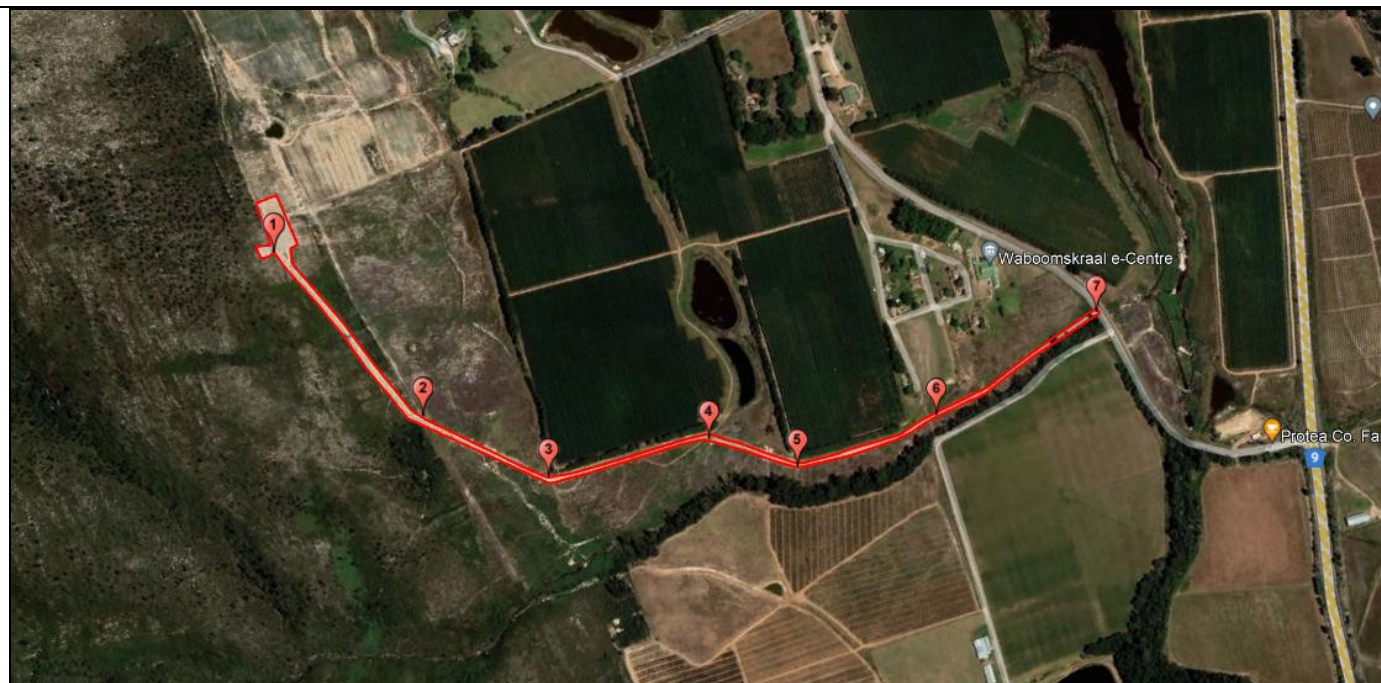
**Figure 2: Locality of GPS coordinate points**

**The co-ordinates for the site boundary are: Please refer to Figure 2 for the locality of the points**

| A Site notice was erected at the start of the access road (point 7 of Figure 2) – 3 <sup>rd</sup> August 2022 | | |

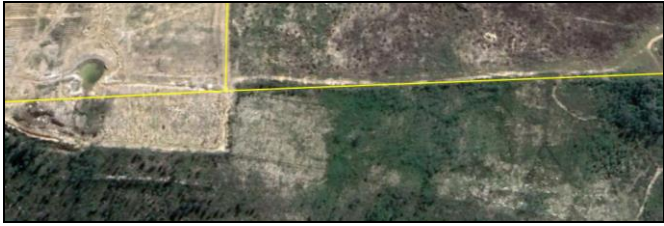
| | <p>endangered in the National Spatial Biodiversity Assessment 2004;</p> <p>ii. Within critical biodiversity areas identified in bioregional plans;</p> <p>iii. Within the littoral active zone or 100 metres inland from high water mark of the sea or an estuarine functional zone, whichever distance is the greater, excluding where such removal will occur behind the development setback line on even in urban areas;</p> <p><b>iv. On land, where, at the time of the coming into effect of this Notice or thereafter such land was zoned open space, conservation or had an equivalent zoning; or</b></p> <p>v. On land designated for protection or conservation purposes in an Environmental Management Framework adopted in the prescribed manner, or a Spatial Development Framework adopted by the MEC or Minister.</p> | <p>2022, this activity is not triggered as agricultural zoning is not considered equivalent to conservational zoning.</p> <p><b>Figure 4: The site - prior to clearance</b></p> <p><b>Figure 5: The site - post clearance</b></p> |

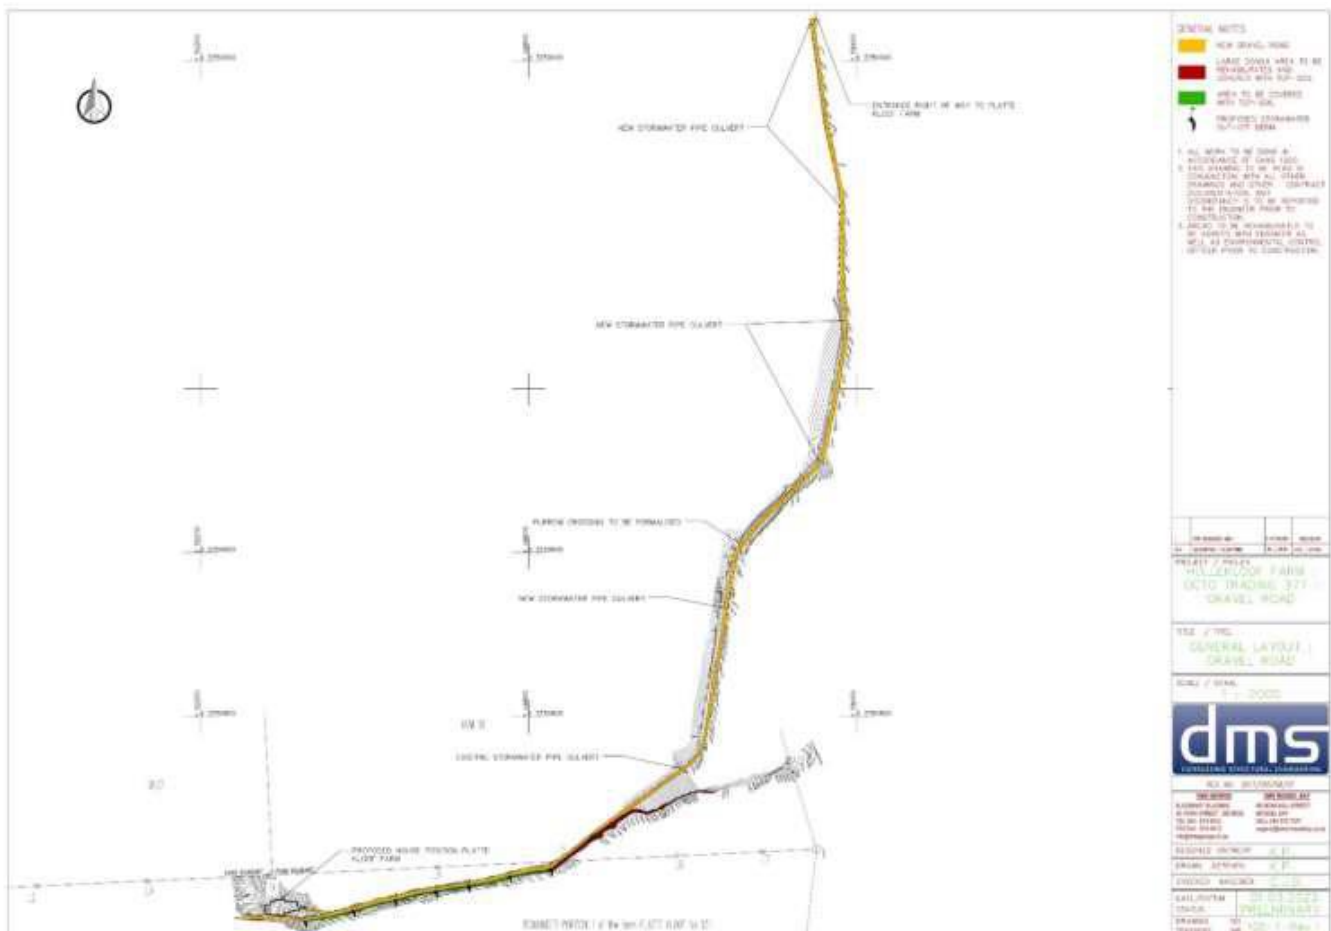
**Figure 14:** Proposed remediation actions for the erosion gully (donga – green and red) along the access road (yellow), as provided by DMS Consulting Structural Engineering (March 2022). Note that stormwater cut-off berms will be installed in the erosion gully section along the southern portion of the road (green). The gully will be infilled for the section it diverts from the road (red) toward the Kleinbos River (blue dashed line) in the east. (Figure 3 of the Freshwater Assessment)

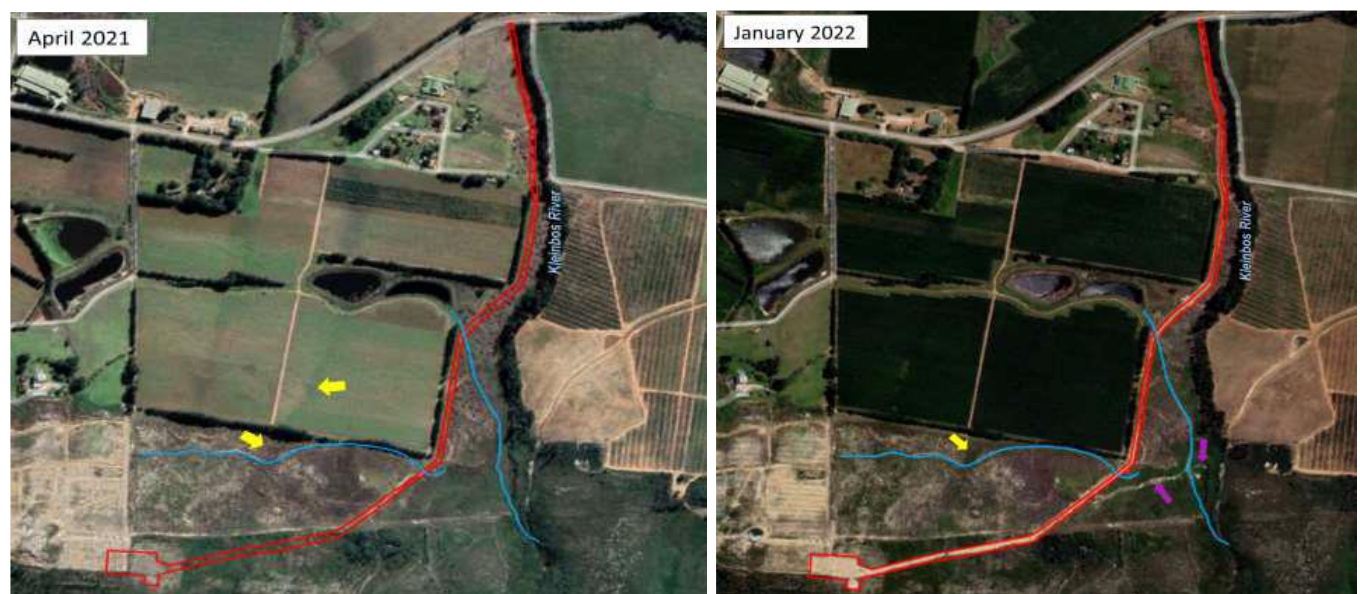
**Figure 17:** Digital satellite imagery depicting the locality of the study area (red outline) prior to the construction activities (2021) and after (2022). Furrows (white dashed lines) drain surface runoff and water from the Kleinbos River. Faint signatures (yellow arrows) associated with potential small drainage lines are evident north of the study area. An erosion gully (pink arrows) is noticeable, diverting away from the access road to the Kleinbos River. (Figure 8 of the Freshwater Assessment)

A large erosion gully was noted along the southern side of the partially upgraded access road (Figure 8). The significant flooding event in November 2021 caused the erosion gully to divert from the partially upgraded road towards the downgradient Kleinbos River (Figure 17). The gully breached an existing furrow, which resulted in sediment deposition along the western bank of the river as well as conveying sediment into the active channel of the river (Figure 17). The delineated extent of the Kleinbos River relative to the study area is presented in Figure 18.

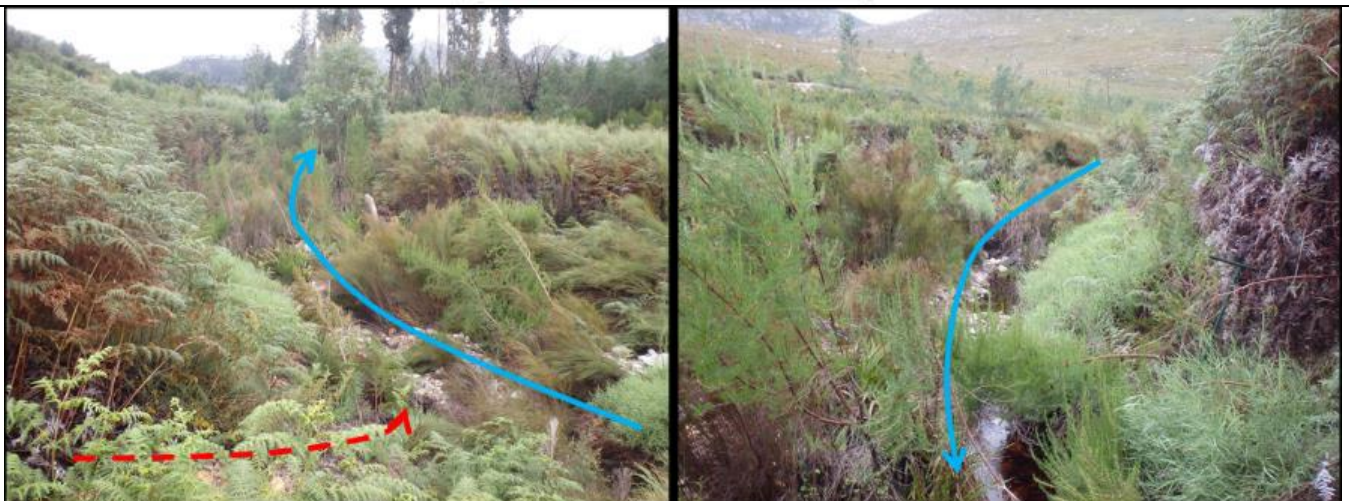
**Figure 19:** Representative photographs of the Kleinbos River. (Left) Red dashed line indicates the flow path that transported the sediment into the river. (Right) Blue lines indicate direction of flow. Note the steep western embankment of the river (on the right side of the photograph).

Ongoing erosion will result in exacerbated sedimentation of the river active channel as well as change the geomorphological characteristics of the river. It's the opinion of the freshwater specialist that that transverse gabion stabilising walls also be installed in the gully to further stabilise the gully at strategic intervals. By allowing approximately 30 cm of the gabion wall to protrude above the ground surface, siltation and sediment deposition will be encouraged on the upgradient side of each structure, thus reducing flow velocity and intensity and the potential of downgradient erosion. Should the recommended mitigation measures (as provided in the Freshwater Assessment Report) be implemented and the erosion gully and Kleinbos River be monitored until suitable vegetation cover has established, the impacts from the initial access road upgrading can be deemed reversible with limited significant cumulative and latent impacts and latent impacts expected provided that the source of sedimentation is stopped at the source through the proposed rehabilitation measures.

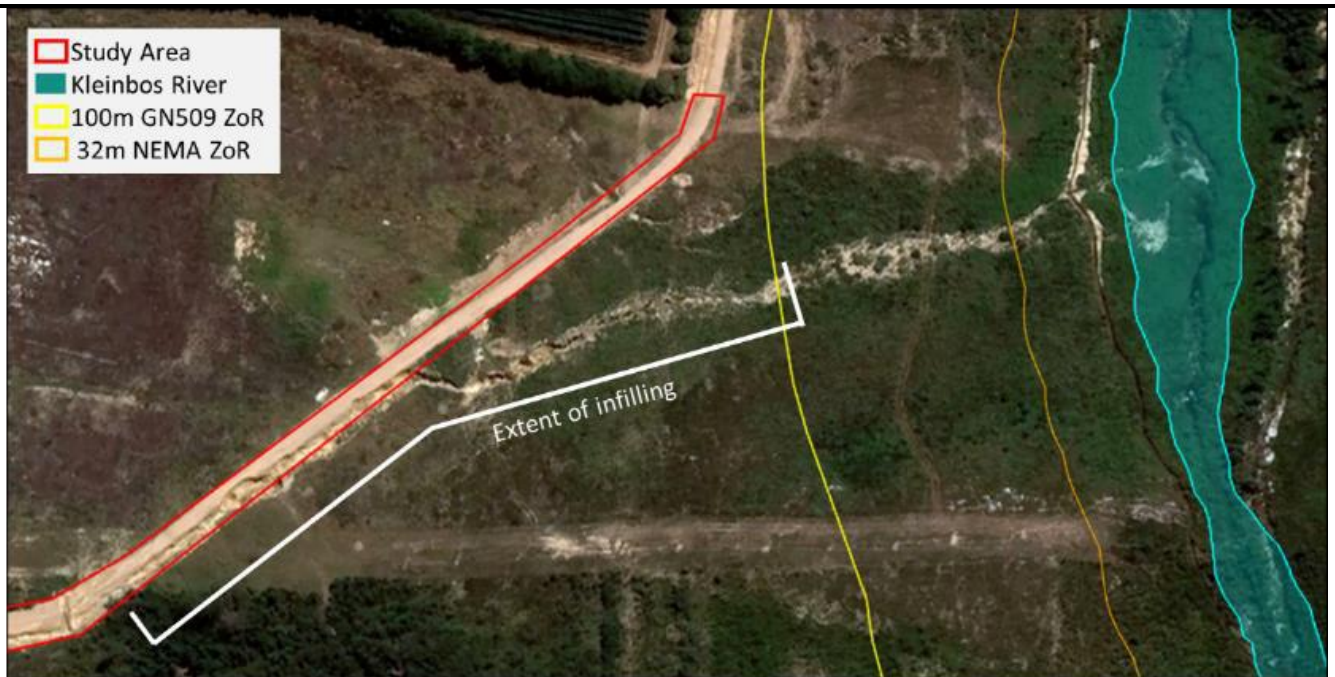
**Figure 20:** The length of erosion gully proposed to be infilled with rip-rap, as per the engineering drawing (Figure 3) relative to the Kleinbos River and the 100m GN509 ZoR.

| ONGOING CONSTRUCTION PHASE | | | | | | | | |
|---|--|--|--|--|--|--|--|--|
| <p><b>Activity:</b> Infilling of the erosion gully along the access road and the section thereof in the 100 m GN509 ZoR of the Kleinbos River and the furrow (Figure 20).</p> | | | | | | | | |

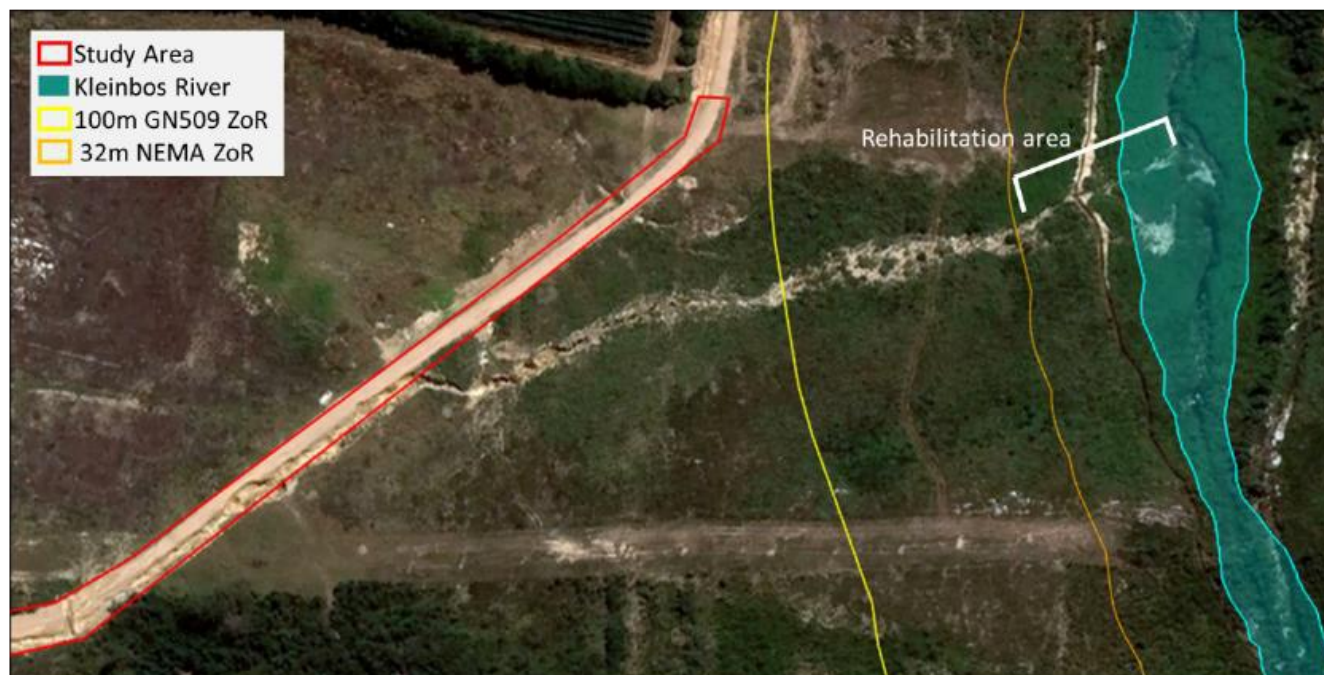
**Figure 21:** Area to be rehabilitated by infilling the shallow gully/flow path with the deposited sediment and revegetating the area.

**Activity:** Rehabilitation of the erosion gully between the furrow and the river (Figure 21)

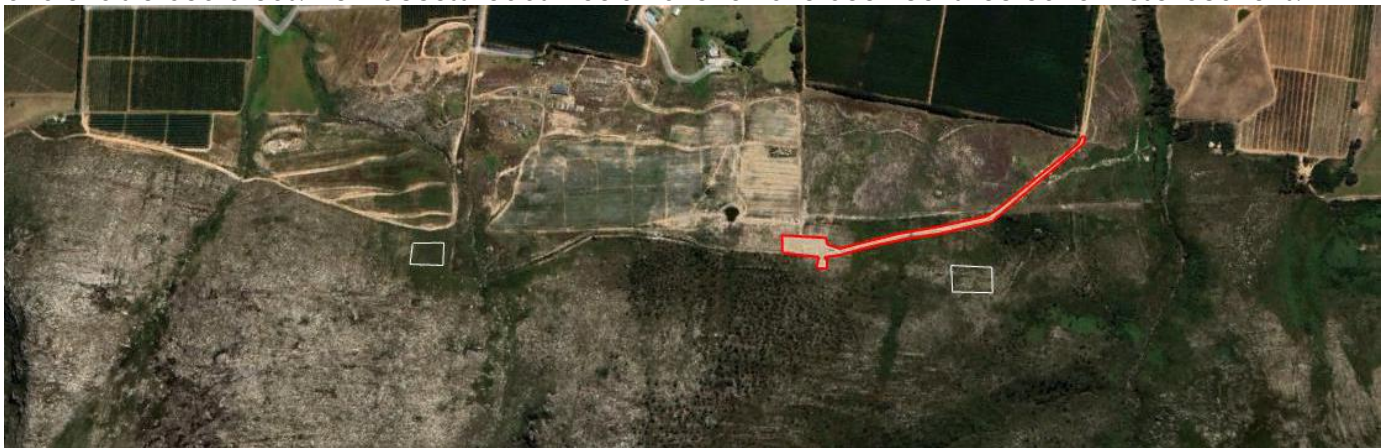
**Figure 25: Site alternatives**

Figures 25 and 26 show two Alternative site location which could have been explored if the activities were proposed in a Basic Assessment Report. These Alternative site locations would have been explored due to the relatively flat nature of the areas however both sites are located within close proximity to watercourses and undisturbed areas. New access roads would have to have been constructed to these locations.

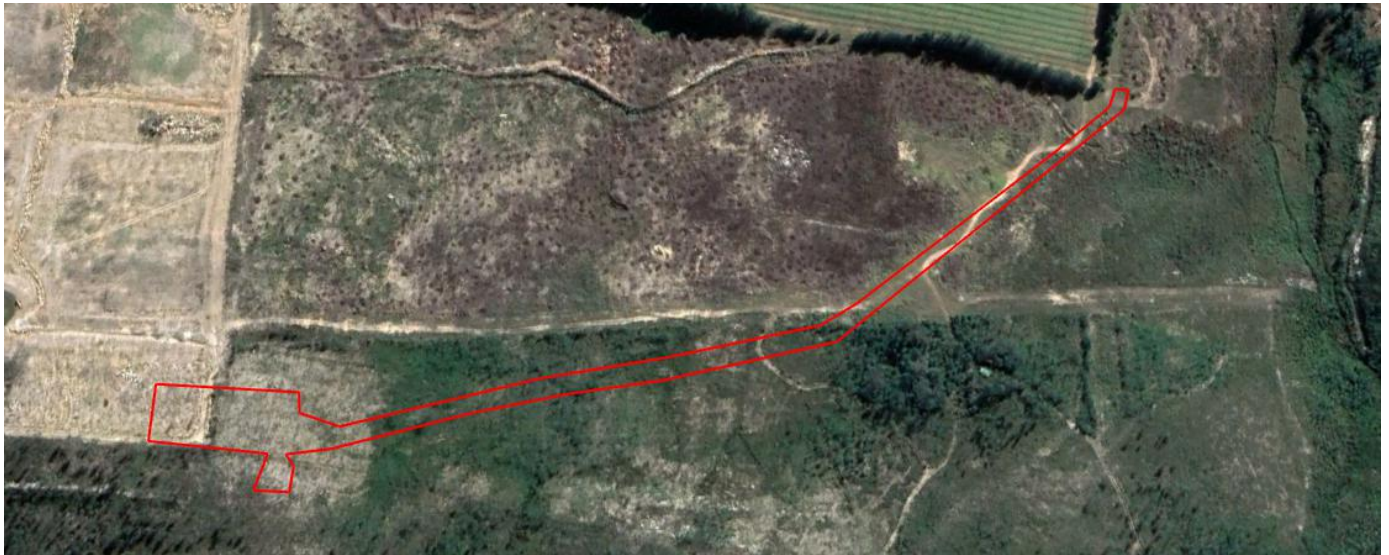
Figure 27: The site Pre-commencement

The existing jeep track was partially upgraded and material excavated from the house platform were being undertaken. After the activities we stopped the flood event of November 2021 resulted in a lot of erosion creating a donga. However even without the creation of the donga, the construction of the road triggered a listed activity.

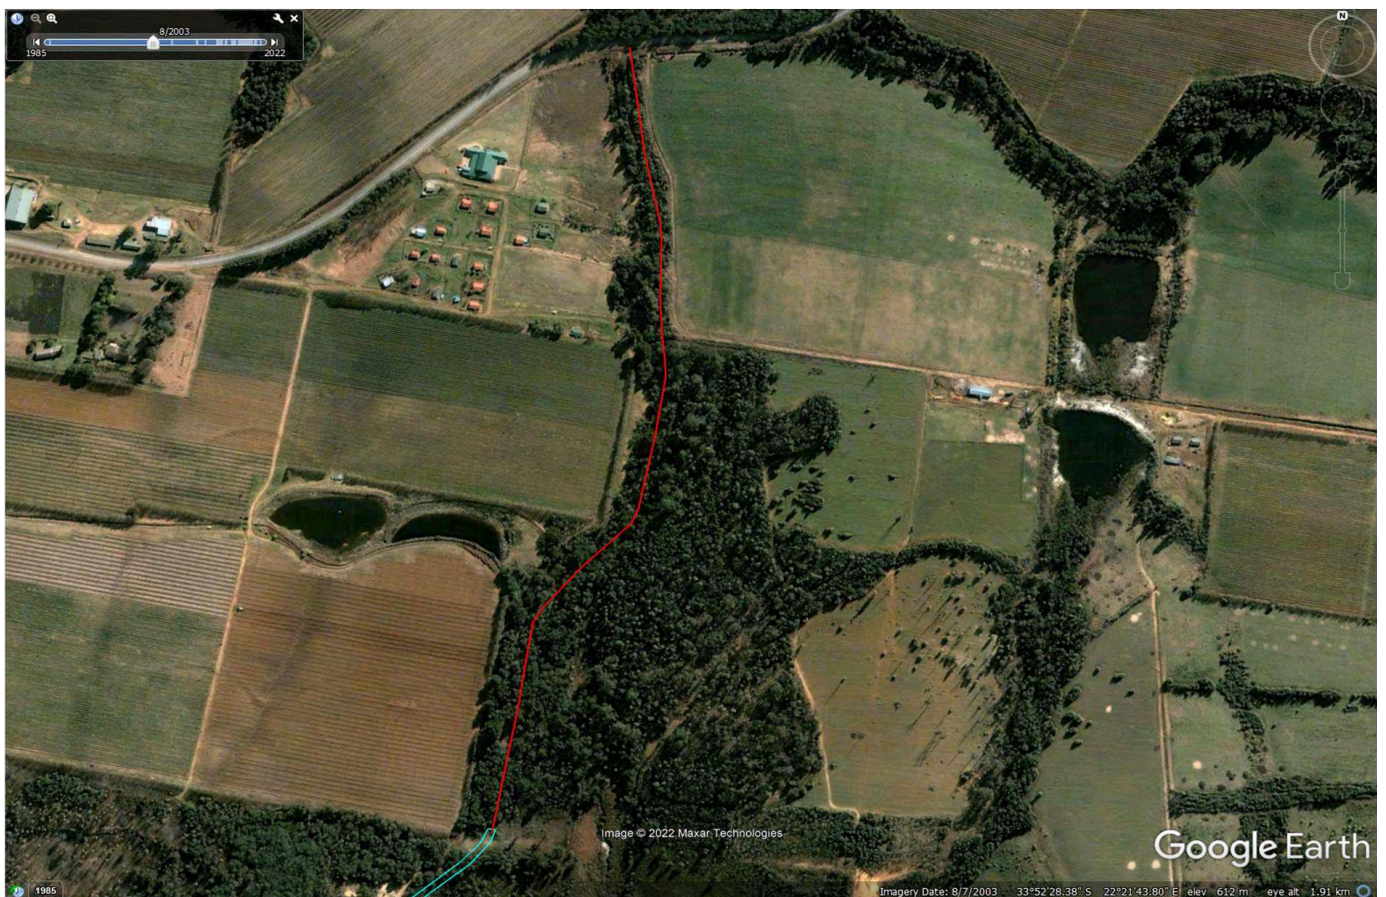
According to past satellite imagery (Google Earth ©), the section of road that was extended to the tar road was also covered with dense alien vegetation, most likely wattle (*Acacia mearnsii*) and pine (*Pinus* sp.), since the 2000s and likely since prior to 1985. The alien trees appear to have infested the Kleinbos River and immediate surroundings, leaving little indigenous vegetation remaining. There appeared to be an existing track running along the farm boundaries, which was upgraded to form the new access road. Clearing of the alien trees on the west bank of the Kleinbos River began in late 2019 and early 2020. Refer to the images taken from Google Earth historical imagery from 2003 to 2020 below. The red line refers to the route of the currently graded road.

**Figure 36: 2003 – Alien tree infestation**

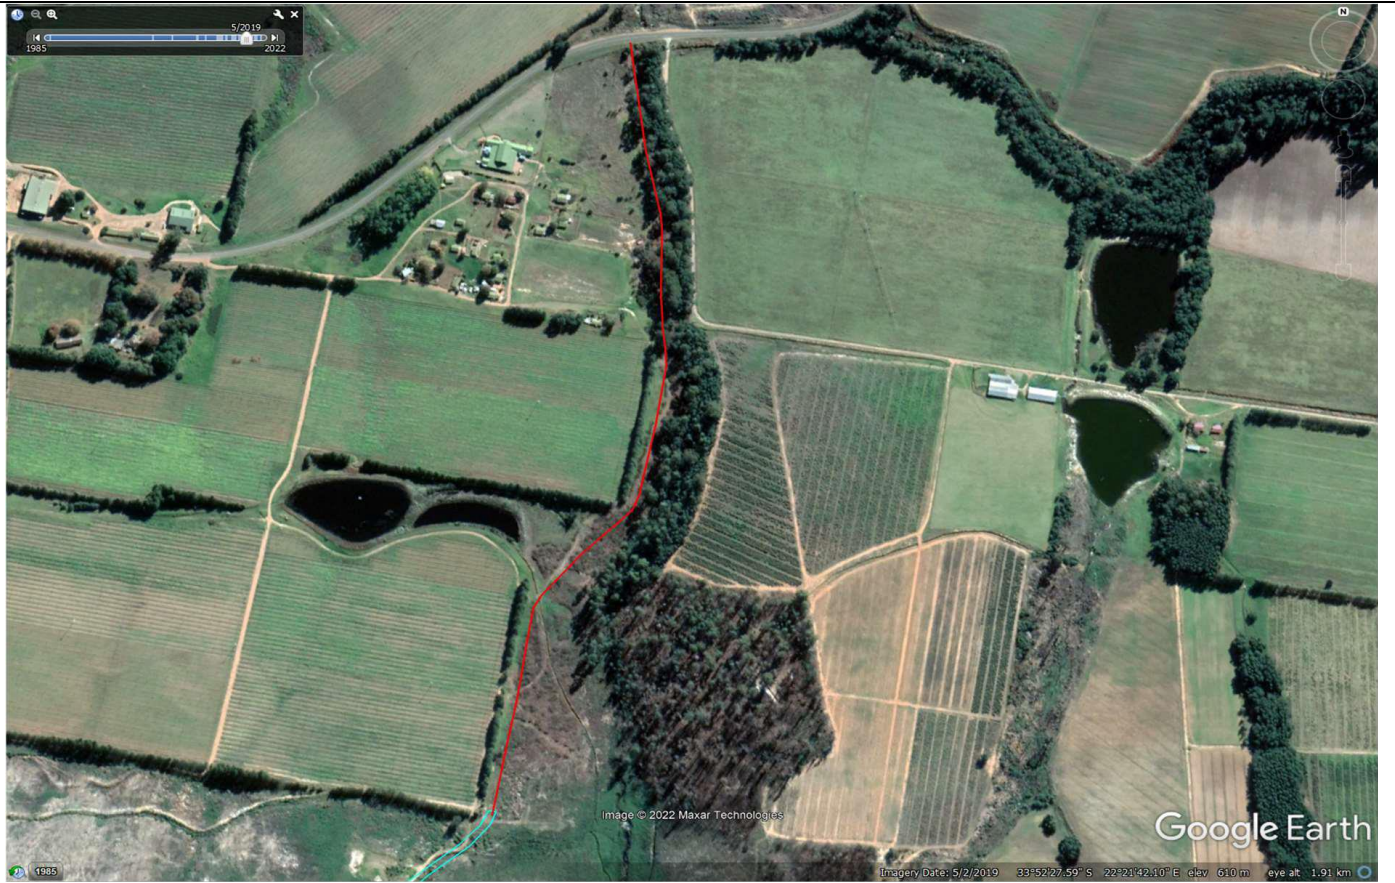
Figure 37: 2019 – Clearing of alien trees.

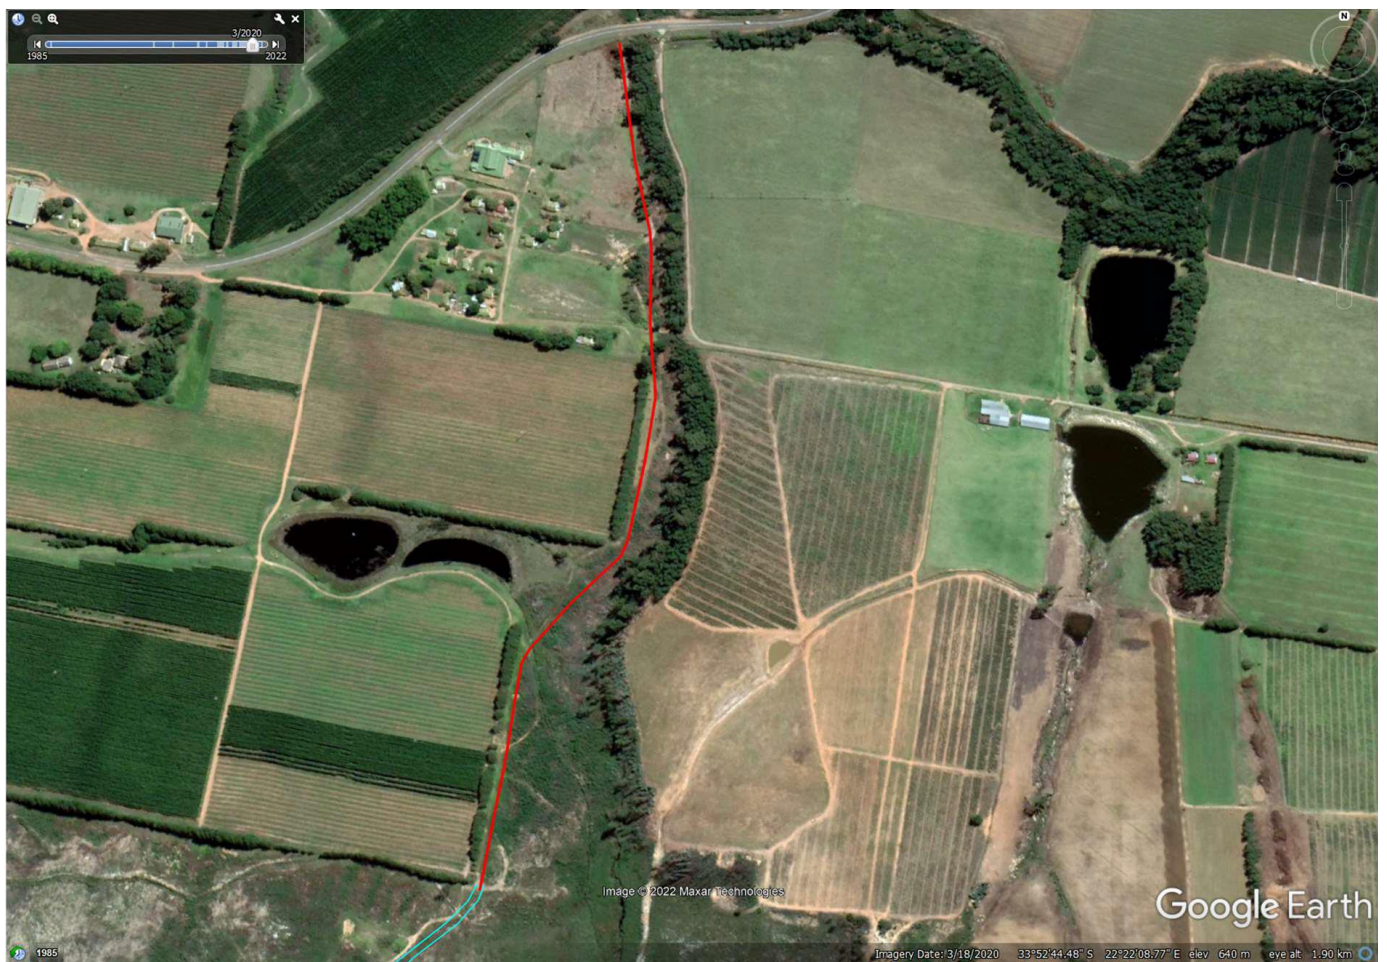
Figure 38: 2020 – More clearing of alien trees.

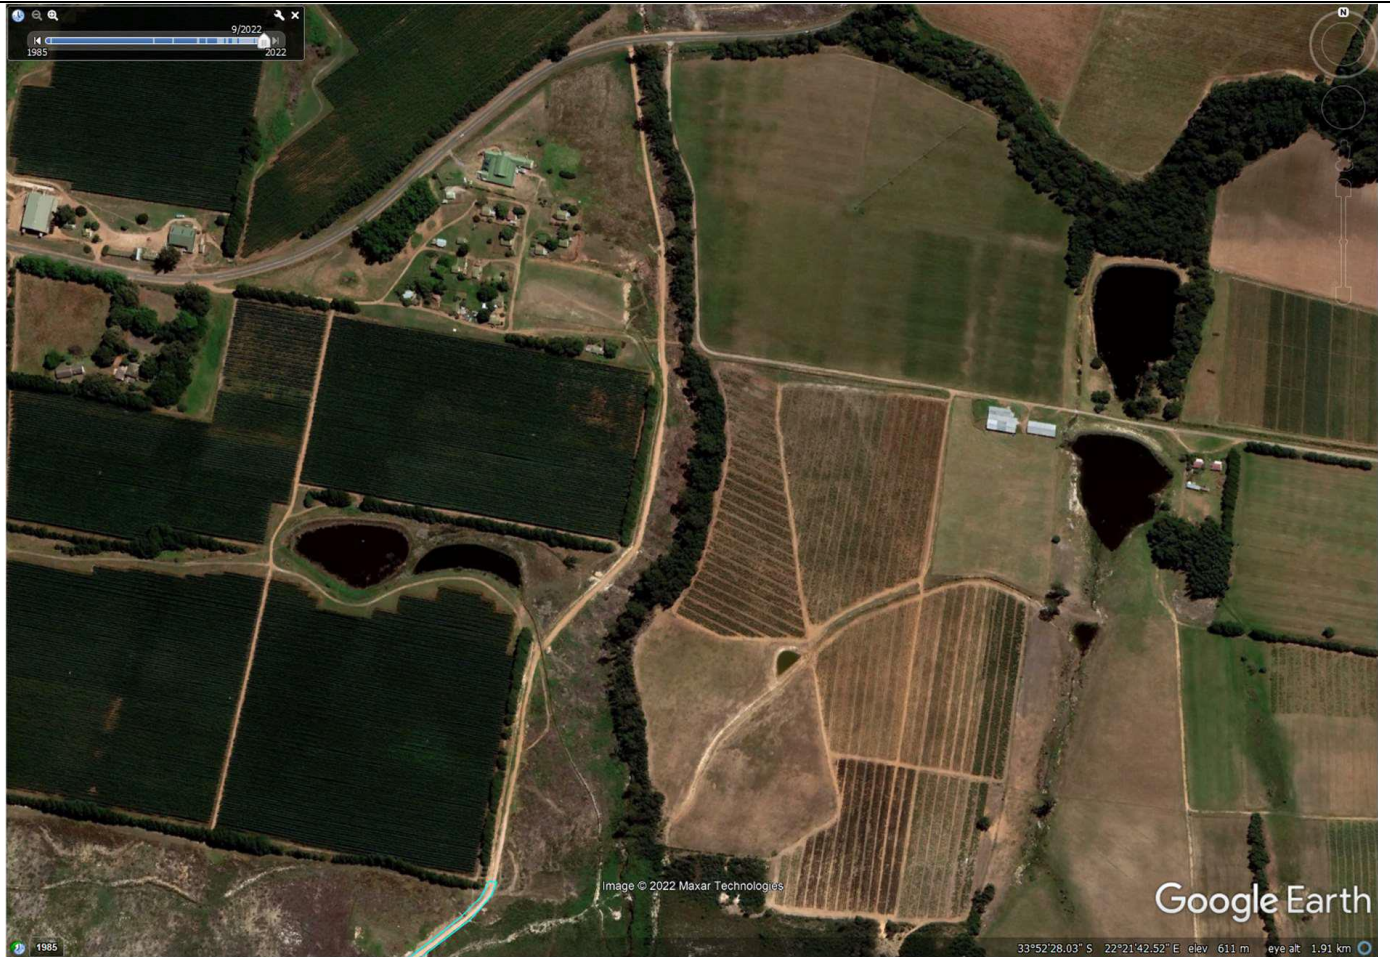
**Figure 39: 2022 – The currently graded road.**

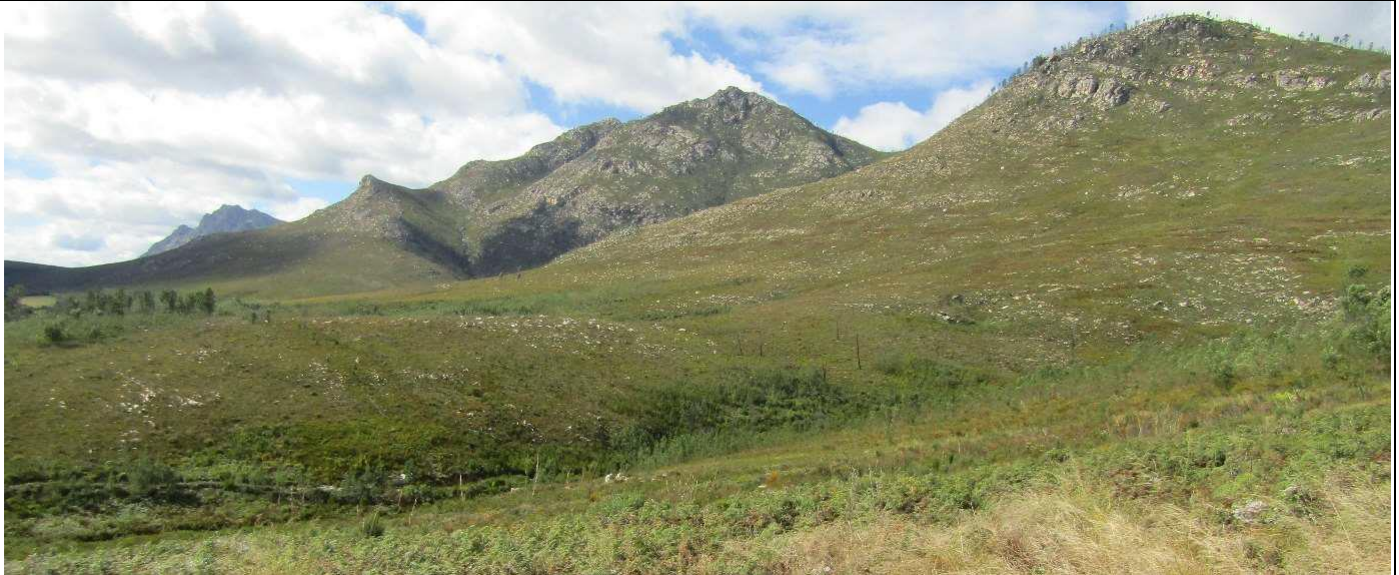
“Overall, the site (and immediate surrounds) displays a low sensitivity from a terrestrial biodiversity and faunal perspective. The site is largely in a modified state due to the previous alien tree infestations and clearing activities including burning. The vegetation secondary in nature and highly disturbed in places with alien tree re-establishing. The site has limited use by fauna and no animal SCC are expected to occur on the site. In terms of regional biodiversity, the footprint of the site is relatively small, and it is evident both from the historical satellite imagery and the site visit that the site is largely in a modified state and was so prior to the site clearing in July 2021. The site is therefore not considered a representative portion of the vegetation type or ecosystem and is not considered important for reaching biodiversity targets due to the small size. The site is therefore considered to be of low importance from a terrestrial biodiversity perspective, especially when compared to the surrounding mountain slopes that support intact mountain fynbos vegetation and have limited alien tree infestations (see example below, Figure 40).”

**Figure 40: Intact mountain fynbos on the slopes to the southeast of the site towards the Witfontein Nature Reserve**
