# PHASE 1 GEOTECHNICAL REPORT

## PROPOSED SUBSIDY HOUSING PROJECT ON ERF 562 KURLAND, BITOU MUNICIPALITY, WESTERN CAPE

17 May 2021 (Rev 0)

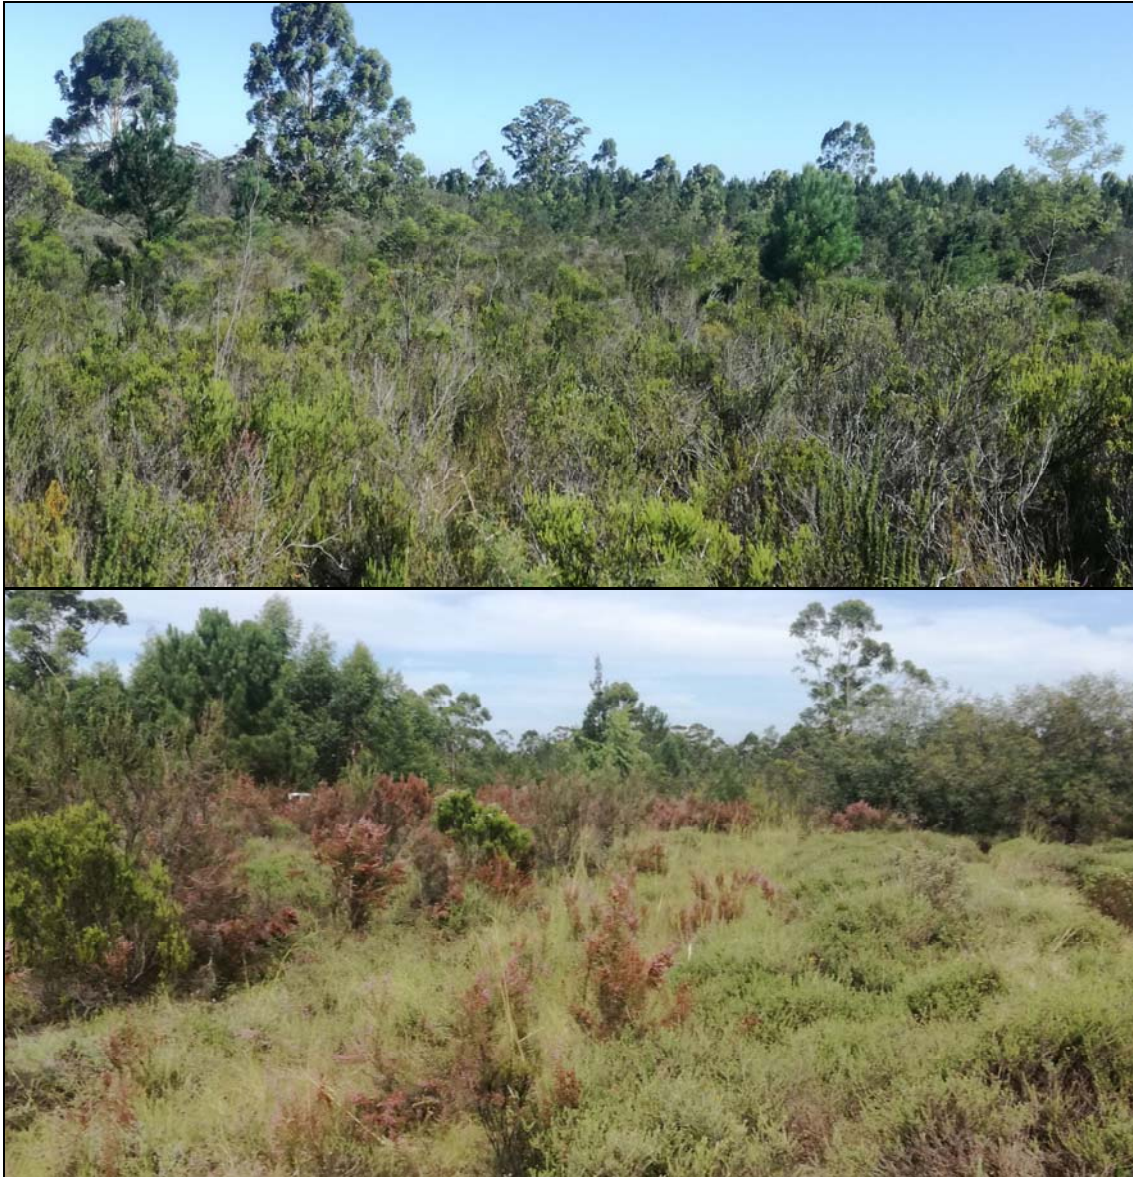
**Figure 4: Typical topography and vegetation cover on the site**

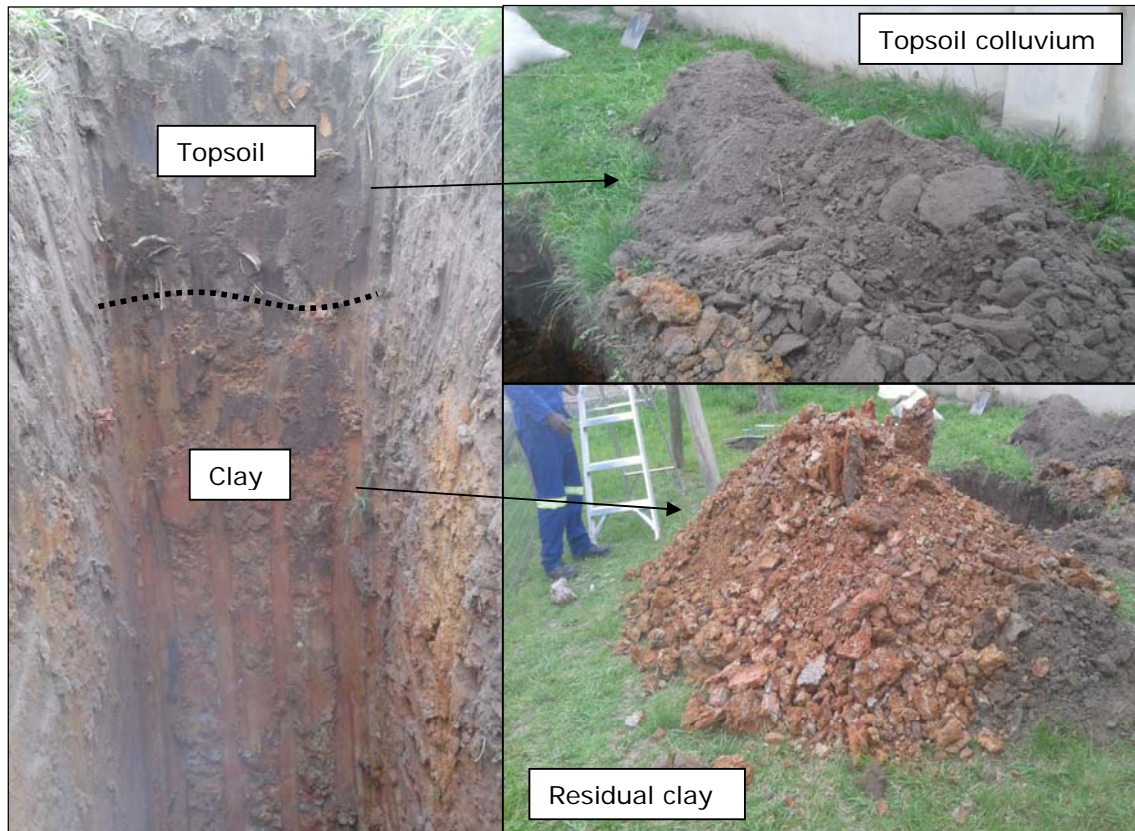
profile is fairly consistent across site, with only minor localized variation. No bedrock was encountered in any of the test pits.

**Figure 6: Typical soil profile observed in test pits**

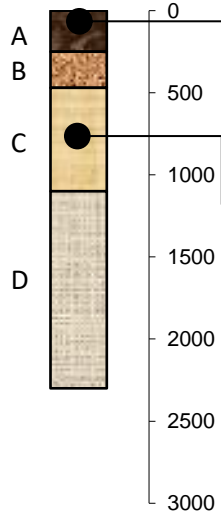
Photo of Test Pit

(0 to 250)	Moist, light grey, loose, fissured, <b>SILTY SAND</b> , transported. → <b>MOD/CBR/Indicator</b>
(250 to 470)	Moist, light reddish brown, dense, intact, <b>CLAYEY GRAVELLY SAND</b> , pedogenic (ferricrete)
(470 to 1100)	Moist, dark yellowish orange, stiff, micro-shattered, slickensided, <b>SANDY SILTY CLAY</b> , residual. → <b>Foundation Indicator, PH &amp; Conductivity</b>
(1100 to 2300)	Moist, pale red, light reddish orange, stiff, shattered, slickensided, <b>SANDY CLAY</b> , residual.

**TP Stopped**  
**No Water**
