# **AQUATIC COMPLIANCE STATEMENT**

Erf 56 and 57, Mossdustria, Mossel Bay, Western Cape.

Prepared for Sharple Environmental Services

(Confluent Environmental)

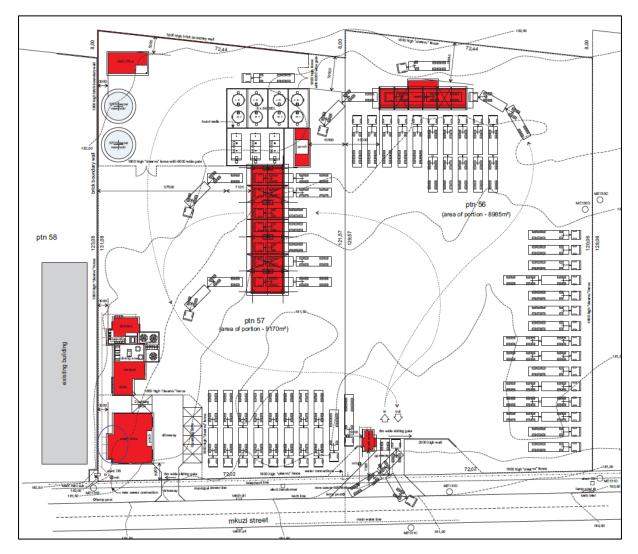
The total area covered by the erven is 18155 m<sup>2</sup> and the total area reported in the site development plan (SDP; Figure 1) is 1477.28 m<sup>2</sup>. This means that the proposed development coverage schedule is ca. 8% of the site. This coverage does not account for the driveways, fences, basic services installation (like water and electricity), or parking areas for cars and trucks. The actual area that will be affected by the development of the site will therefore be substantially larger than the 8% reported in the SDP. A breakdown of the planned development is summarized below. Both erven will require new sewer, electricity (including a mini substation in the south-western corner of Erf 57), and water connections.

Figure 1: The site development plan (SDP) for the proposed development on Erven 56 and 57 in the Mossdustria complex.

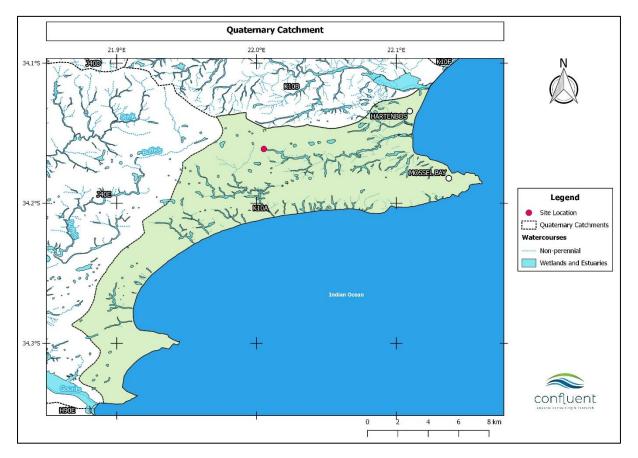
The site falls within Primary Catchment K (Kromme) area and in quaternary catchment K10A, which is a coastal catchment. Numerous, mostly non-perennial, rivers drain the catchment area and terminate at the coastline (Figure 2). No freshwater features are indicated to occur within the footprint of the properties or within close proximity to the properties (Figure 3).

Figure 2: Map indicating the location of the proposed development relative to quaternary catchments.

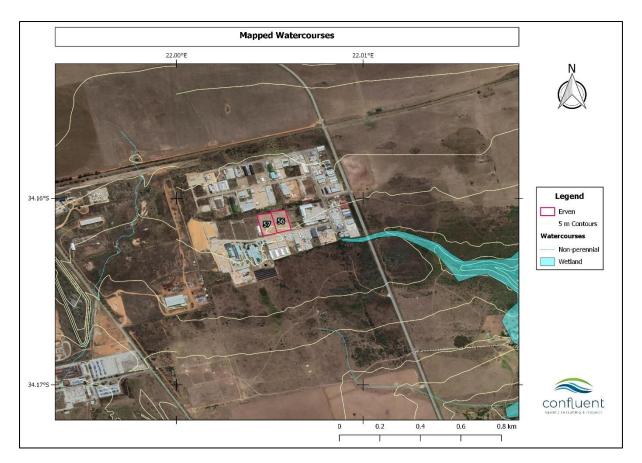
Figure 3: Location of the properties in relation to mapped freshwater features.

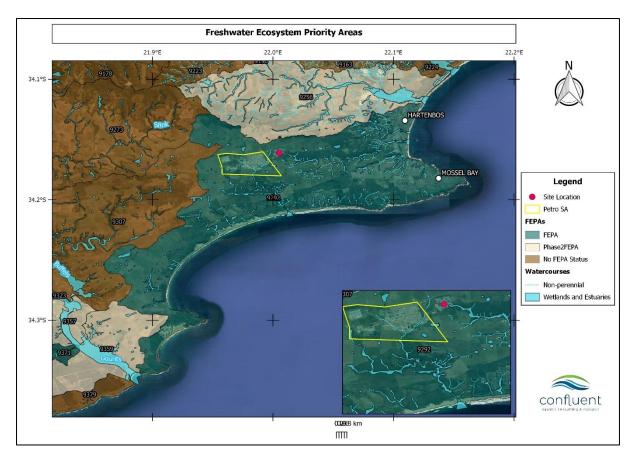
From the perspective of SQC 9292, the main unnamed river reach for which a FEPA status was assigned runs south of the Petro SA refinery into the Indian Ocean (Figure 4). This river originates from within the refinery and runs south towards the coast and the Indian Ocean.

Figure 4: Location of site relative to FEPAs (inset shows the specific river reach for which FEPA status has been assigned).

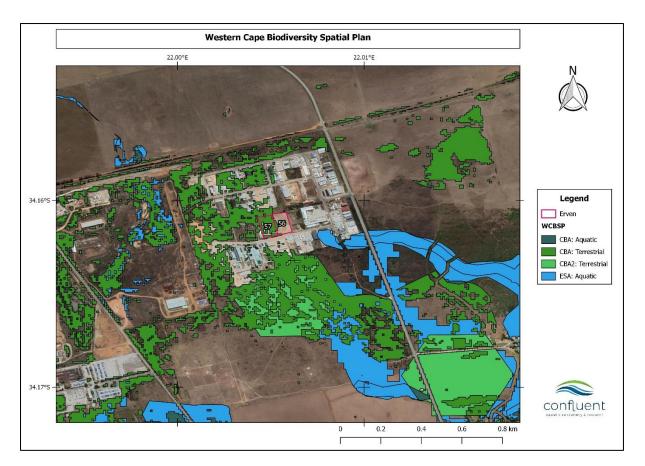
No aquatic biodiversity spatial planning units are indicated to occur within either of the property boundaries (Figure 5). There are therefore no management objectives relevant to aquatic biodiversity associated with either of the properties.

Figure 5: Map of the properties in relation to the Western Cape Biodiversity Spatial Plan (WCBSP)

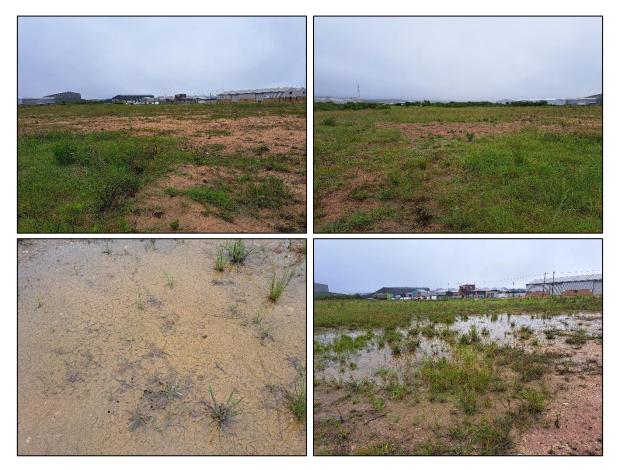
A site visit was undertaken on the 15<sup>th</sup> of March 2023. During the visit, the entire property was traversed by foot. Both properties had been cleared of vegetation and graded to a very flat profile. Currently the entire site represents disturbed vegetation that is just starting to recover following the clearance of vegetation and grading of the site in late 2022. Recent rains had resulted in water pooling in a small, shallow depression on Erf 57. The presence of some isolated *Cyperus sp.* suggests that water may collect here fairly regularly. Formation of this depression is however likely to be associated with the clearing and grading of the site. The small depression was very sparsely vegetated and there was no indication of a well-established hydrophilic plant community indicative of permanent or seasonal water saturation. Soil was heavily compacted (augering of the soil profile was not possible) which presumably results in the periodic accumulation of water in the depression following rainfall. In addition, analysis of historical imagery found no evidence of the presence of any historical wetland or watercourse. There were no other topographical or vegetation indicators indicating the presence of a watercourse on either of the two properties.

In summary, no natural freshwater features were identified within the footprint of the property. The closest confirmed aquatic feature is mapped as a channelled valley-bottom wetland (located outside of the perimeter of the Mossdustria complex to the south-east), but given the very flat topography of the area (i.e. no associated valley slopes), the wetland area is more consistent with a drainage line that has developed wetland features due to inputs of stormwater derived from the industrial complex. This watercourse (which is not considered a

natural wetland) is located approximately 235 m away from the proposed development. The development is therefore located more than 100 m away from the watercourse and, according to GN509 (See Section 2.2), does not fall within the regulated area of a watercourse.

Figure 6: Photographs showing view of the site to the south (top left) and north (top right), the shallow depression filled with water following a period of heavy rainfall (bottom left and right).

Given the isolation of the site from freshwater features, no additional mitigation measures, beyond the adequate management of stormwater generated from the site (during both the construction and operational phases) is required.
