**Proposed Rehabilitation of the Road TR75/1 (N12 Highway)
Near Oudtshoorn, Oudtshoorn Local Municipality, Garden
Route District Municipality, Western Cape**

Terrestrial Animal Species Compliance Statement

Cossypha
Ecological

April 2023

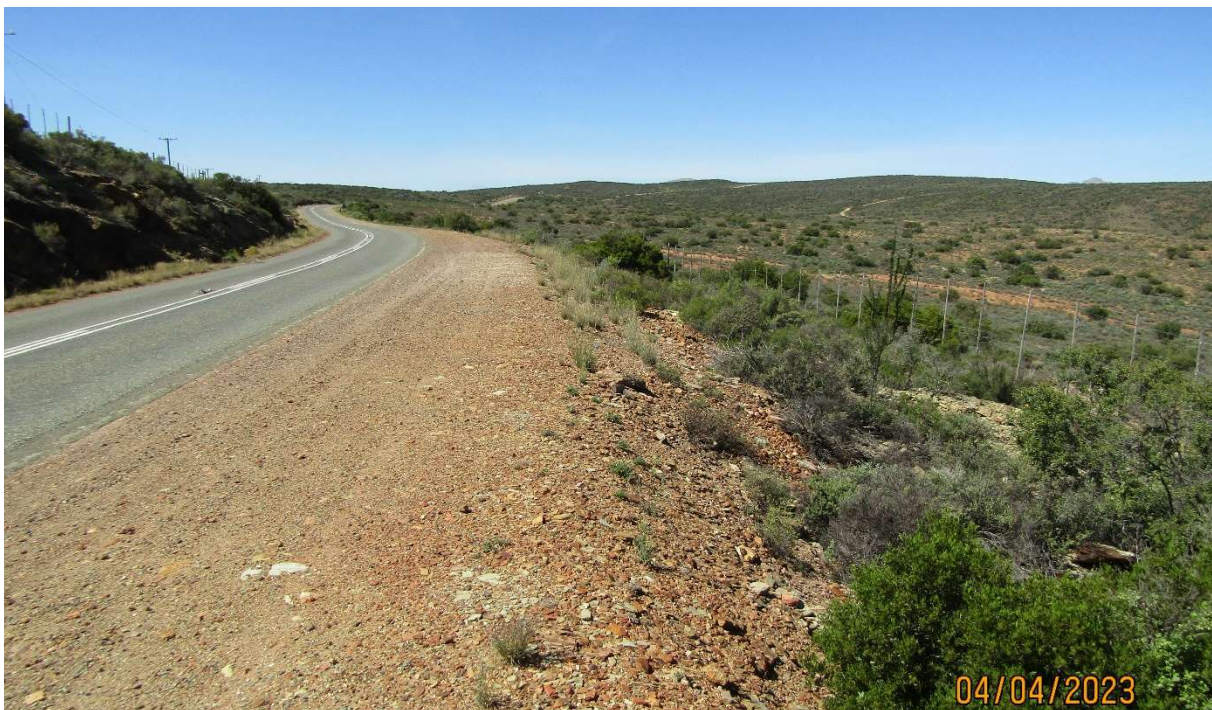
Typical example of the disturbed roadside with a strip of indigenous vegetation and rocky ledges forming the cut slope

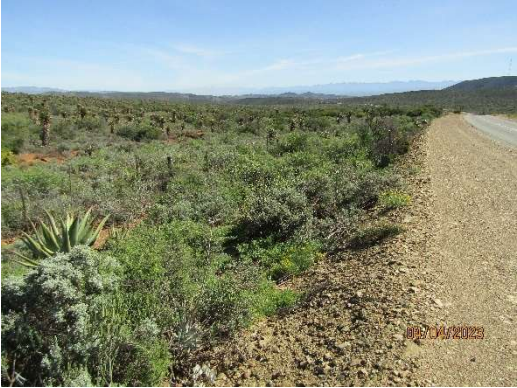
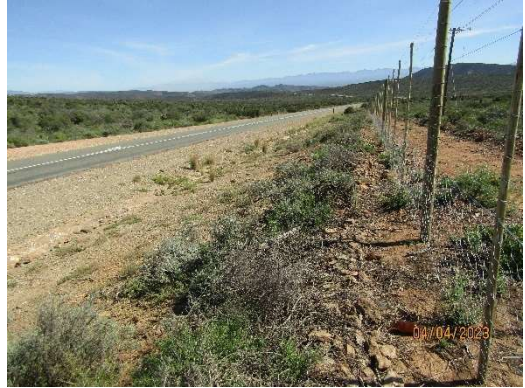
| Sample Site | Habitat Description | Likelihood of SCC | Photo 1 (North-bound lane) | Photo 2 (South-bound lane) |
|--|--|---|---|---|
| S1 04-Apr-23 33°42'12.06"S 22°17'17.75"E | Photo 1: Disturbed roadside with narrow strip of indigenous Little Karoo vegetation (with some succulents and <i>Aloe</i> sp.) up to the fence line. Continuous Little Karoo vegetation occurs beyond the fence. Photo 2: Disturbed fence line with dirt track | Low | | |

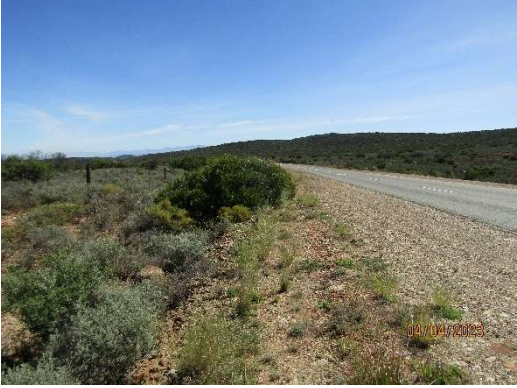
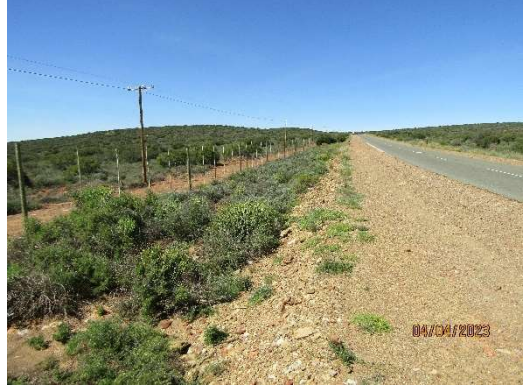
| Sample Site | Habitat Description | Likelihood of SCC | Photo 1 (North-bound lane) | Photo 2 (South-bound lane) |
|--|--|---|---|---|
| S2 04-Apr-23 33°41'50.22"S 22°17'0.20"E | Photo 1: Disturbed roadside with narrow strip of indigenous Little Karoo vegetation up to the fence line. Continuous Little Karoo vegetation occurs beyond the fence. Photo 2: Disturbed fence line with narrow strip of indigenous vegetation dirt track beyond the fence. | Low | | |

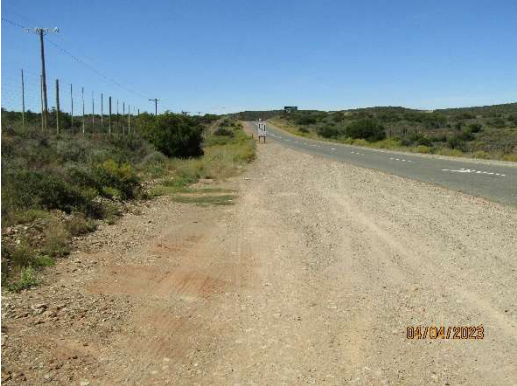
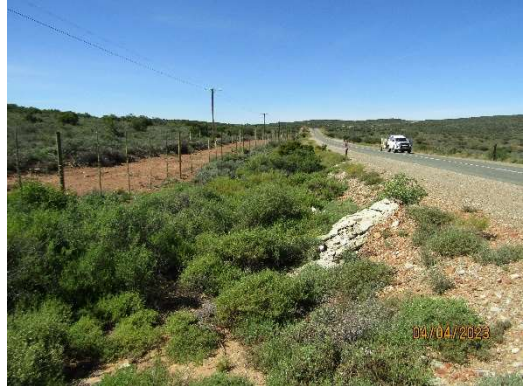
| Sample Site | Habitat Description | Likelihood of SCC | Photo 1 (North-bound lane) | Photo 2 (South-bound lane) |
|--|--|---|---|---|
| S3 04-Apr-23 33°41'28.68"S 22°16'12.73"E | Photo 1: Disturbed roadside with little vegetation up to the fence line. Photo 2: Disturbed fence line with narrow strip of indigenous vegetation dirt track beyond the fence. | Low | | |

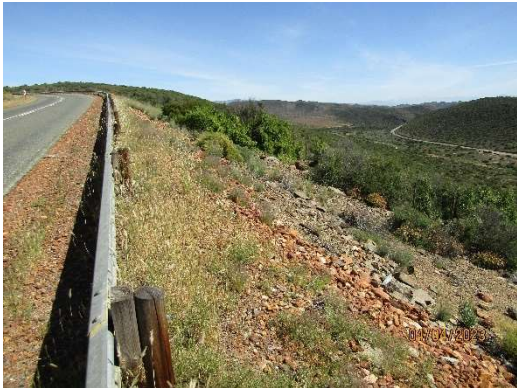
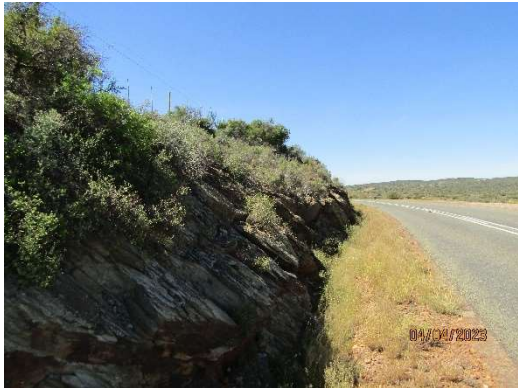
| Sample Site | Habitat Description | Likelihood of SCC | Photo 1 (North-bound lane) | Photo 2 (South-bound lane) |
|--|--|---|---|---|
| <p>S4 04-Apr-23 33°41'20.56"S 22°16'4.05"E</p> | <p>Photo 1: Disturbed roadside with Armco barrier and very little vegetation.</p> <p>Photo 2: Disturbed roadside and rocky cut-slope with indigenous vegetation.</p> | <p>Low</p> | | |

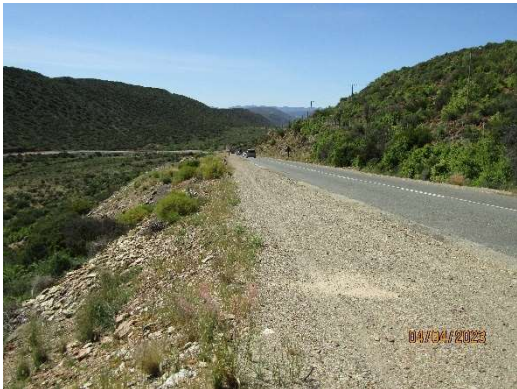
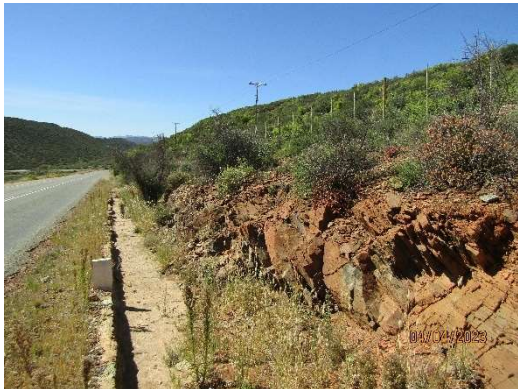
| Sample Site | Habitat Description | Likelihood of SCC | Photo 1 (North-bound lane) | Photo 2 (South-bound lane) |
|--|--|---|---|---|
| <p>S5 04-Apr-23 33°41'14.20"S 22°16'14.05"E</p> | <p>Photo 1: Disturbed roadside with gravel fill-slope and very little vegetation, mostly weedy and alien species.</p> <p>Photo 2: Disturbed roadside with stormwater drain and rocky cut-slope with indigenous vegetation up to the fence line.</p> <p>Road descending into river valley between two large ridges.</p> | <p>Low</p> | | |

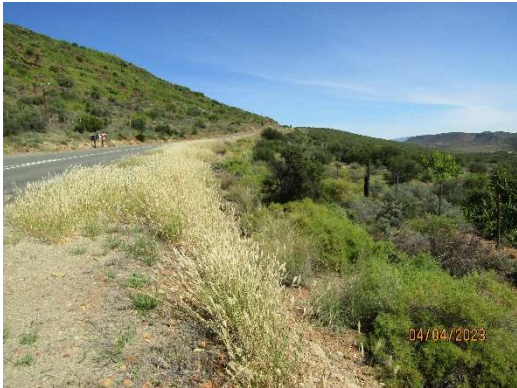
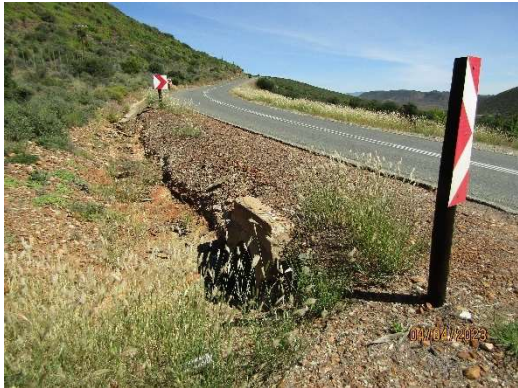
| Sample Site | Habitat Description | Likelihood of SCC | Photo 1 (North-bound lane) | Photo 2 (South-bound lane) |
|--|--|---|---|---|
| <p>S6 04-Apr-23 33°41'8.27"S 22°16'29.81"E</p> | <p>Photo 1: Disturbed roadside with gravel fill-slope and very little vegetation, mostly weedy and alien species.</p> <p>Photo 2: Disturbed roadside with culvert and little vegetation, mostly weedy and alien species.</p> | <p>Low</p> | | |

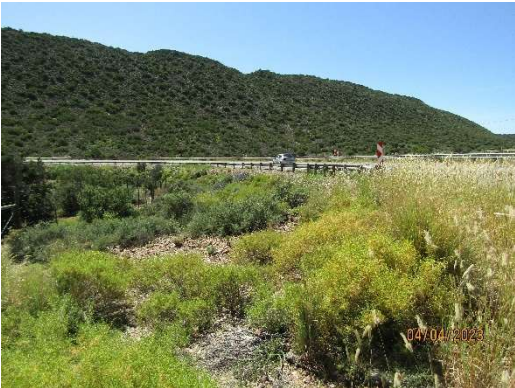
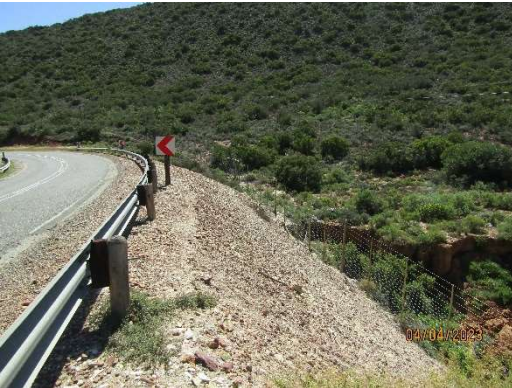
| Sample Site | Habitat Description | Likelihood of SCC | Photo 1 (North-bound lane) | Photo 2 (South-bound lane) |
|---|---|---|---|---|
| <p>S7 04-Apr-23 33°41'4.01"S 22°16'30.43"E</p> | <p>Photo 1: Disturbed roadside with weedy and alien species.</p> <p>Photo 2: Disturbed roadside with gravel fill-slope and very little vegetation. Riverbed and wetland beyond the fence line.</p> <p>Bend of road in river valley bottom.</p> | <p>Low</p> | | |

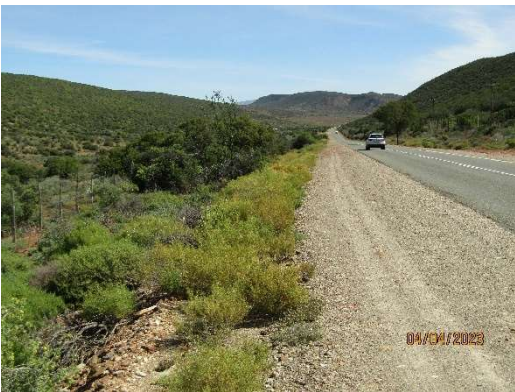
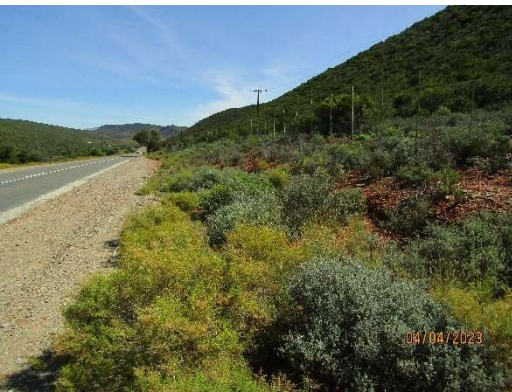
| Sample Site | Habitat Description | Likelihood of SCC | Photo 1 (North-bound lane) | Photo 2 (South-bound lane) |
|---|---|---|---|---|
| <p>S8 04-Apr-23 33°41'2.69"S 22°16'11.25"E</p> | <p>Photo 1 &2: Disturbed roadsides with narrow strip of disturbed vegetation up to the fences, mostly weedy and alien species.</p> | <p>Low</p> | | |

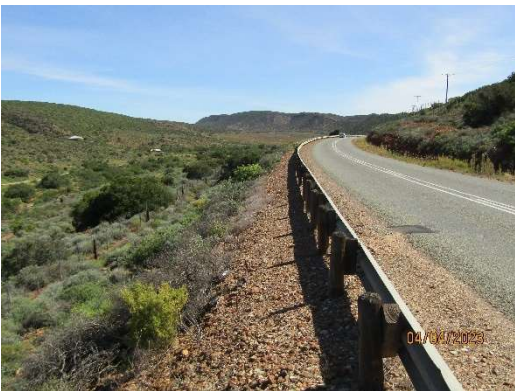
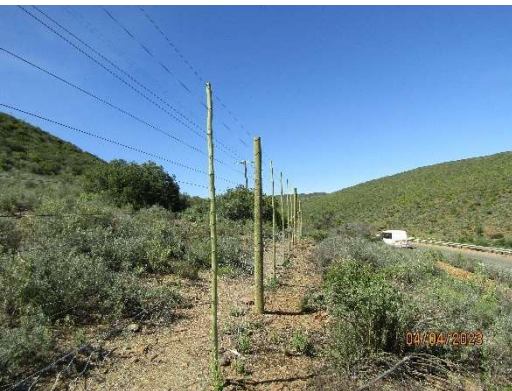
| Sample Site | Habitat Description | Likelihood of SCC | Photo 1 (North-bound lane) | Photo 2 (South-bound lane) |
|---|---|---|---|---|
| <p>S9 04-Apr-23 33°41'3.19"S 22°15'20.89"E</p> | <p>Photo 1: Disturbed roadside with Armco barrier and narrow strip of disturbed vegetation up to the fence line.</p> <p>Photo 2: Disturbed roadside with gravel fill-slope and disturbed fence-line with mostly weedy and alien vegetation.</p> | <p>Low</p> | | |

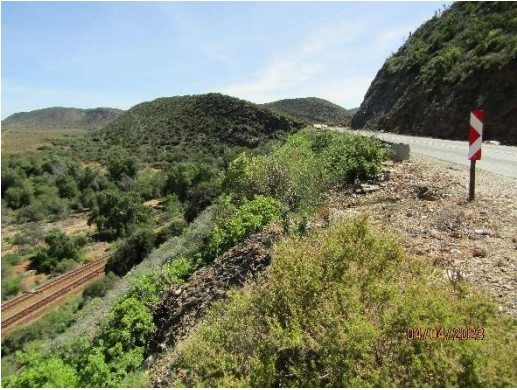
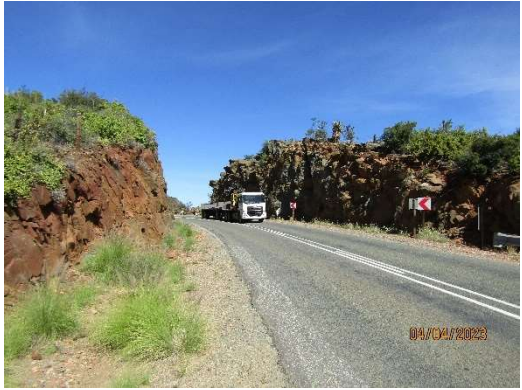
| Sample Site | Habitat Description | Likelihood of SCC | Photo 1 (North-bound lane) | Photo 2 (South-bound lane) |
|---|---|---|---|---|
| <p>S10 04-Apr-23 33°40'56.76"S 22°15'3.18"E</p> | <p>Photo 1: Road curves to enter Klip River valley. Disturbed roadside with railway line and Klip River below to the west.</p> <p>Photo 2: Disturbed roadside with mostly weedy and alien vegetation, and rocky cliff-like cut-slopes with indigenous vegetation.</p> | <p>Low</p> | | |

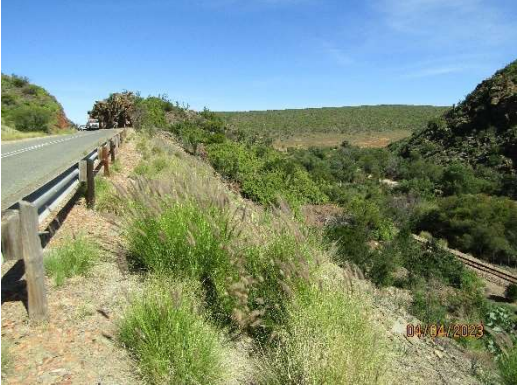
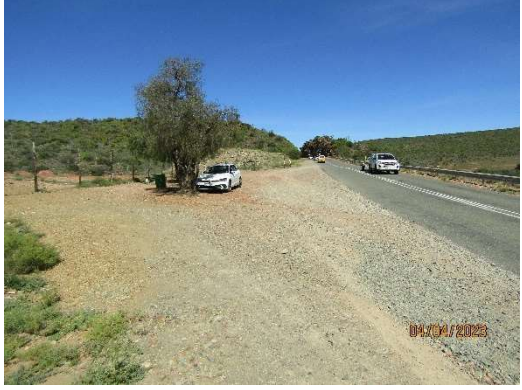
| Sample Site | Habitat Description | Likelihood of SCC | Photo 1 (North-bound lane) | Photo 2 (South-bound lane) |
|---|---|---|---|---|
| <p>S11 04-Apr-23 33°40'49.58"S 22°15'0.50"E</p> | <p>Photo 1: Disturbed roadside with Armco barrier with gravel fill-slope with mostly weedy and alien vegetation. Railway line and Klip River below on the west side.</p> <p>Photo 2: Disturbed roadside and picnic site with little vegetation.</p> | <p>Low</p> | | |

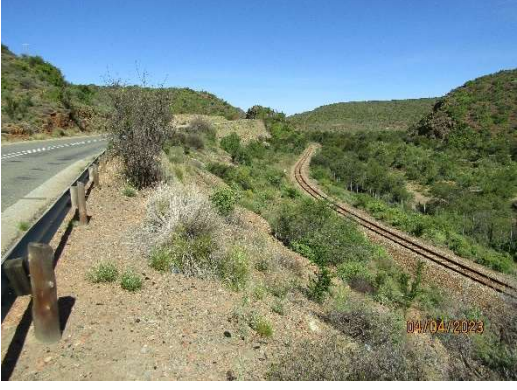
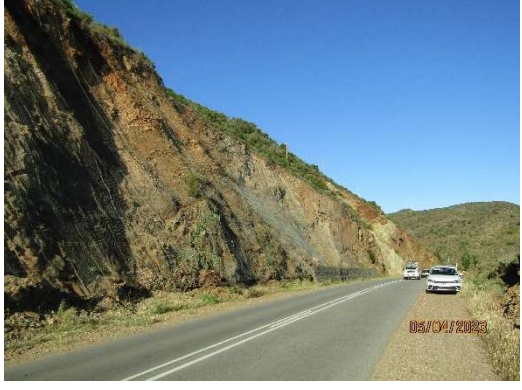
| Sample Site | Habitat Description | Likelihood of SCC | Photo 1 (North-bound lane) | Photo 2 (South-bound lane) |
|---|---|---|---|---|
| <p>S12 04-Apr-23 33°40'40.61"S 22°14'49.31"E</p> | <p>Photo 1: Disturbed roadside with Armco barrier with gravel fill-slope with mostly weedy and alien vegetation. Railway line and Klip River below on the west side.</p> <p>Photo 2: Disturbed roadside with high rocky cliff-like cut-slope with rock-fall prevention netting.</p> | <p>Low</p> | | |

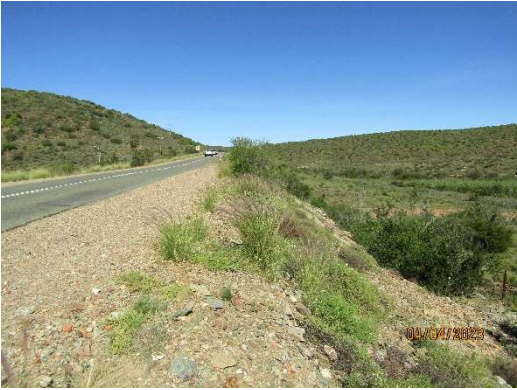
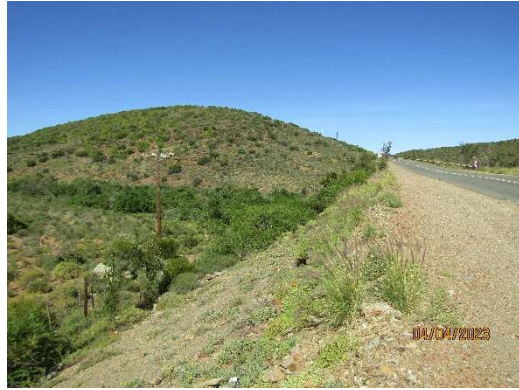
| Sample Site | Habitat Description | Likelihood of SCC | Photo 1 (North-bound lane) | Photo 2 (South-bound lane) |
|---|--|---|---|---|
| S13 04-Apr-23 33°40'31.86"S 22°14'39.33"E | Photo 1 & 2: Disturbed roadside with gravel fill-slope with little vegetation, mostly weedy and alien species. | Low | | |

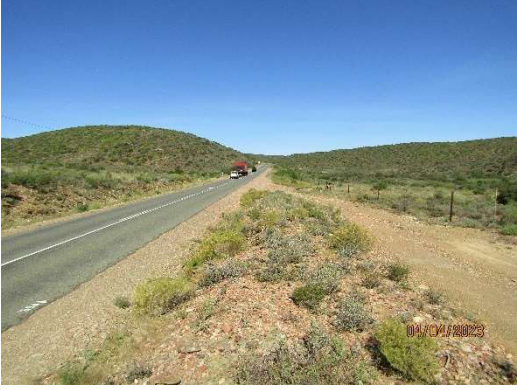
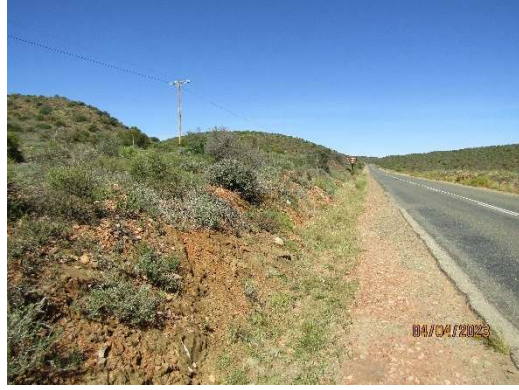
| Sample Site | Habitat Description | Likelihood of SCC | Photo 1 (North-bound lane) | Photo 2 (South-bound lane) |
|---|--|---|---|---|
| S14 04-Apr-23 33°40'25.83"S 22°14'34.80"E | Photo 1: Disturbed roadside with thin strip of disturbed vegetation and gravel track on fence line. Photo 2: Disturbed roadside with rocky slope disturbed indigenous vegetation. | Low | | |

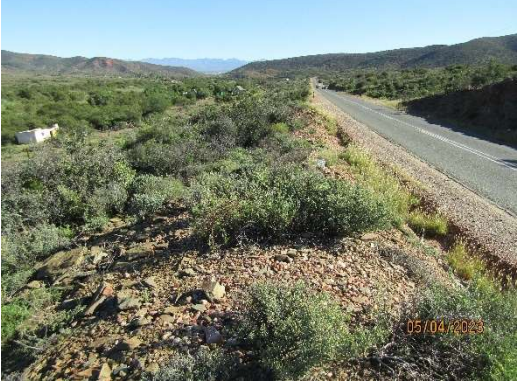
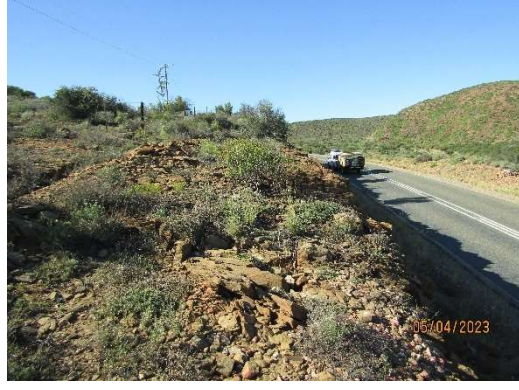
| Sample Site | Habitat Description | Likelihood of SCC | Photo 1 (North-bound lane) | Photo 2 (South-bound lane) |
|---|--|---|---|---|
| S15 05-Apr-23 33°40'18.12"S 22°14'30.24"E | Photo 1 & 2: Disturbed roadside with high rocky cut-slope with disturbed indigenous vegetation. | Low | | |

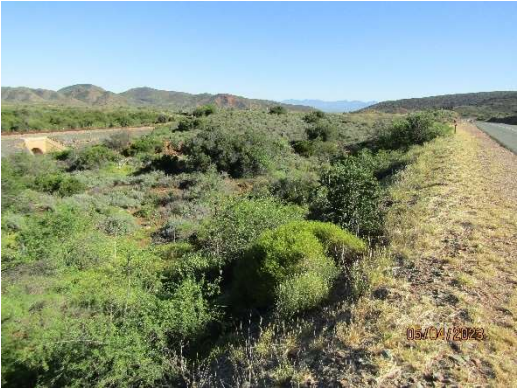
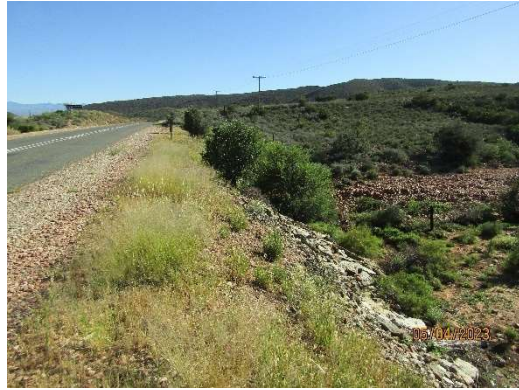
| Sample Site | Habitat Description | Likelihood of SCC | Photo 1 (North-bound lane) | Photo 2 (South-bound lane) |
|---|--|---|---|---|
| <p>S16 05-Apr-23 33°40'6.33"S 22°14'25.71"E</p> | <p>Photo 1: Disturbed roadside with narrow strip of disturbed vegetation, mostly weedy and alien species. Riparian area with large culvert and railway line on the west side.</p> <p>Photo 2: Disturbed roadside with weedy and alien vegetation on gravel fill slope, with riparian area and culvert below.</p> | <p>Low</p> | | |

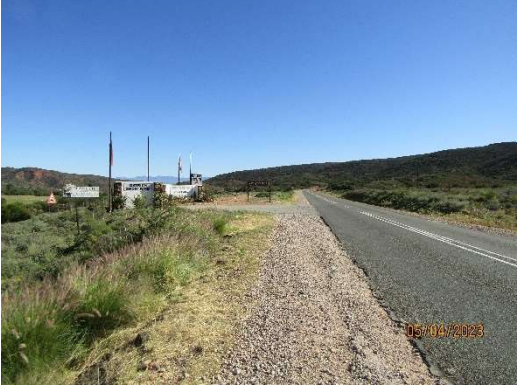
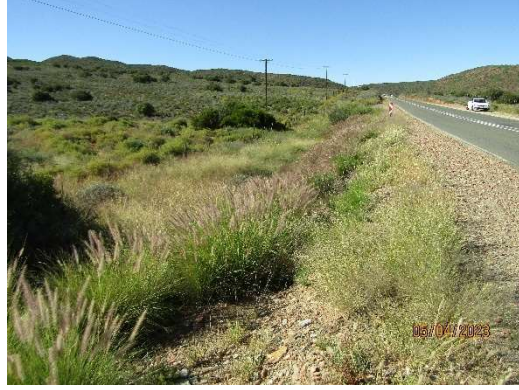
| Sample Site | Habitat Description | Likelihood of SCC | Photo 1 (North-bound lane) | Photo 2 (South-bound lane) |
|---|--|---|---|---|
| <p>S17 05-Apr-23 33°39'56.68"S 22°14'21.89"E</p> | <p>Photo 1: Disturbed roadside with weedy and alien vegetation, with gravel road entrance to guest farm.</p> <p>Photo 2: Disturbed roadside with weedy and alien vegetation.</p> | <p>Low</p> | | |

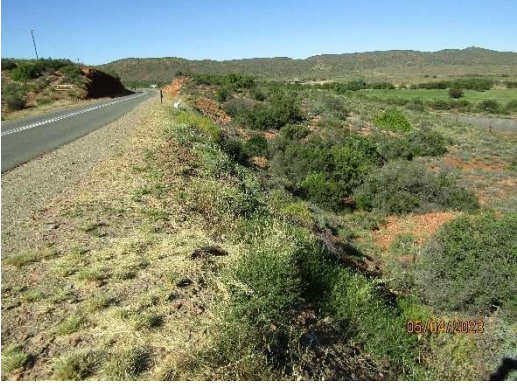
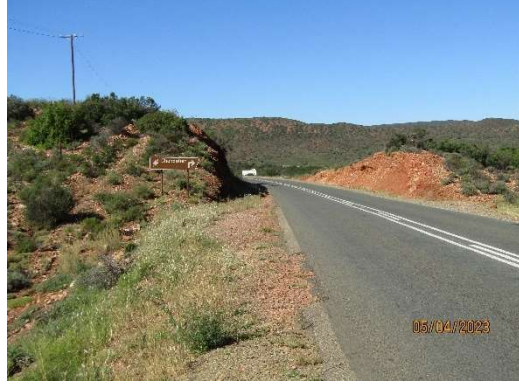
| Sample Site | Habitat Description | Likelihood of SCC | Photo 1 (North-bound lane) | Photo 2 (South-bound lane) |
|---|--|---|---|---|
| <p>S18 05-Apr-23 33°39'42.62"S 22°14'18.59"E</p> | <p>Photo 1: Disturbed roadside with narrow strip of disturbed vegetation, mostly weedy and alien species.</p> <p>Photo 2: Disturbed roadside with weedy and alien vegetation and rocky cut slopes with disturbed indigenous vegetation.</p> | <p>Low</p> | | |

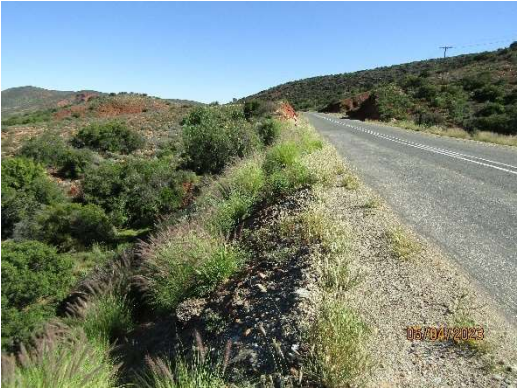
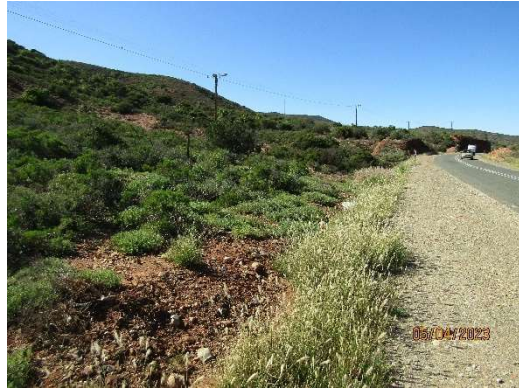
| Sample Site | Habitat Description | Likelihood of SCC | Photo 1 (North-bound lane) | Photo 2 (South-bound lane) |
|---|---|---|---|---|
| S19 05-Apr-23 33°39'29.69"S 22°14'13.77"E | Photo 1 & 2: Disturbed roadside with narrow strip of disturbed vegetation, mostly weedy and alien species. | Low | | |

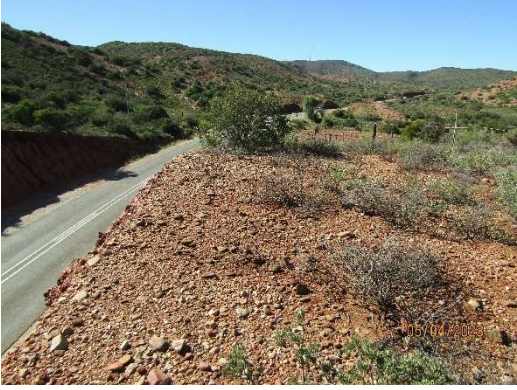
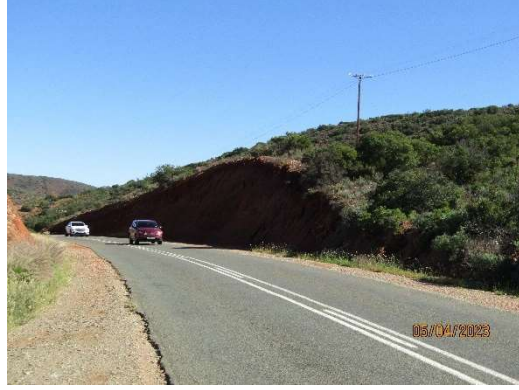
| Sample Site | Habitat Description | Likelihood of SCC | Photo 1 (North-bound lane) | Photo 2 (South-bound lane) |
|---|---|---|---|---|
| S20 05-Apr-23 33°39'22.96"S 22°14'3.74"E | Photo 1 & 2: Disturbed roadside with high rocky cut-slope with disturbed indigenous vegetation. | Low | | |

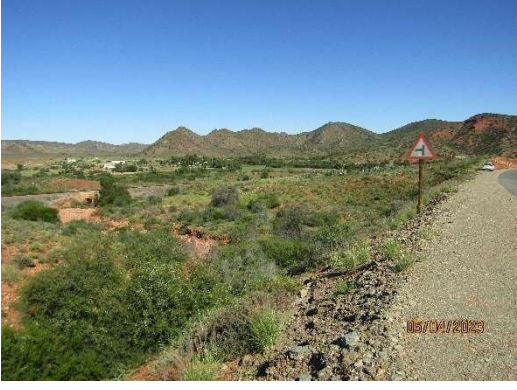
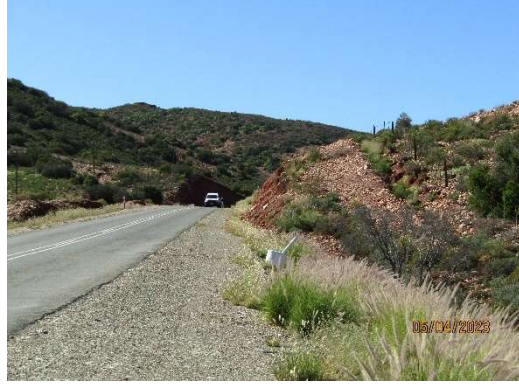
| Sample Site | Habitat Description | Likelihood of SCC | Photo 1 (North-bound lane) | Photo 2 (South-bound lane) |
|---|---|---|---|---|
| S21 05-Apr-23 33°39'20.94"S 22°13'52.43"E | Photo 1: Disturbed roadside with gravel fill-slope with disturbed vegetation. Riparian area with large culvert and railway line on the west side. Photo 2: Disturbed roadside with rocky cut-slope with disturbed indigenous vegetation. | Low | | |

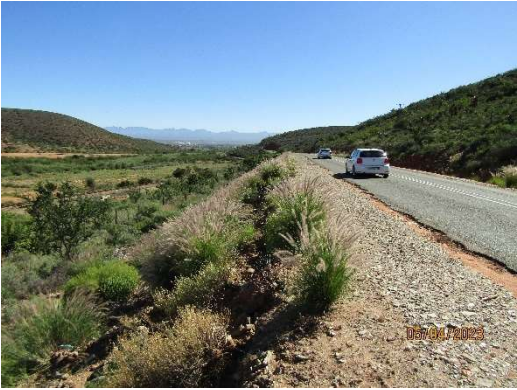
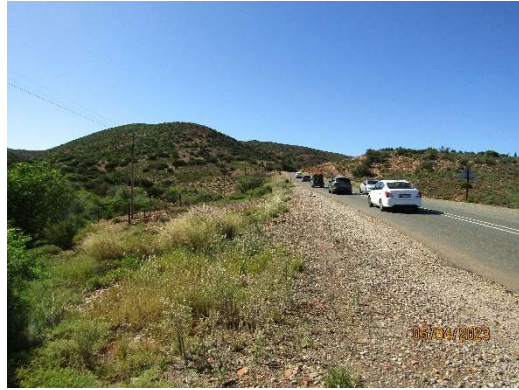
| Sample Site | Habitat Description | Likelihood of SCC | Photo 1 (North-bound lane) | Photo 2 (South-bound lane) |
|---|---|---|---|---|
| <p>S22 05-Apr-23 33°39'11.58"S 22°13'40.55"E</p> | <p>Photo 1 & 2: Disturbed roadside with gravel fill-slope with mostly weedy and alien vegetation.</p> | <p>Low</p> | | |

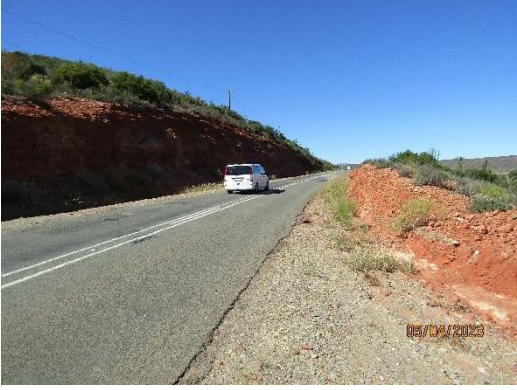
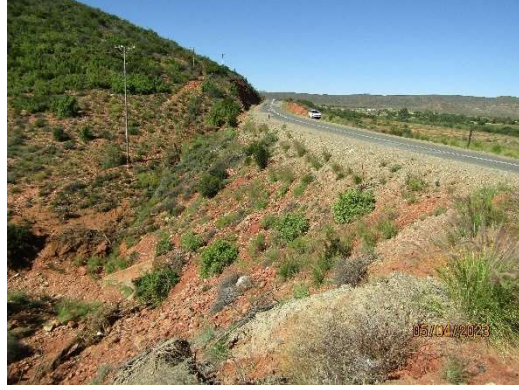
| Sample Site | Habitat Description | Likelihood of SCC | Photo 1 (North-bound lane) | Photo 2 (South-bound lane) |
|---|---|---|---|---|
| <p>S23 05-Apr-23 33°38'57.67"S 22°13'35.79"E</p> | <p>Photo 1: Disturbed roadside with rocky cut-slopes with little vegetation, mostly weedy and alien species.</p> <p>Photo 2: Disturbed roadside with gravel fill-slope with disturbed vegetation. Riparian area with large culvert and river valley on the east side.</p> | <p>Low</p> | | |

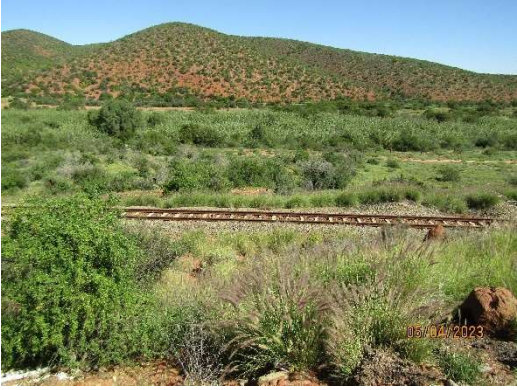
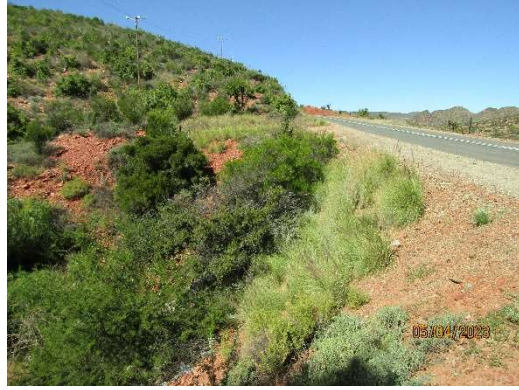
| Sample Site | Habitat Description | Likelihood of SCC | Photo 1 (North-bound lane) | Photo 2 (South-bound lane) |
|---|---|---|---|---|
| <p>S24 05-Apr-23 33°38'45.75"S 22°13'30.07"E</p> | <p>Photo 1: Disturbed roadside with gravel fill-slope with disturbed (mostly alien) vegetation. Riparian area with large culvert and railway line on the west side.</p> <p>Photo 2: Disturbed roadside with gravel fill-slope with disturbed vegetation. Riparian area with large culvert and drainage valley on the east side.</p> | <p>Low</p> | | |

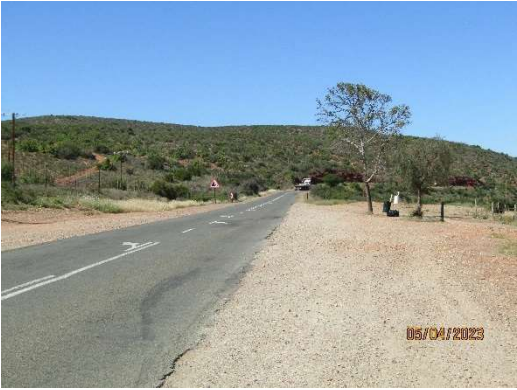
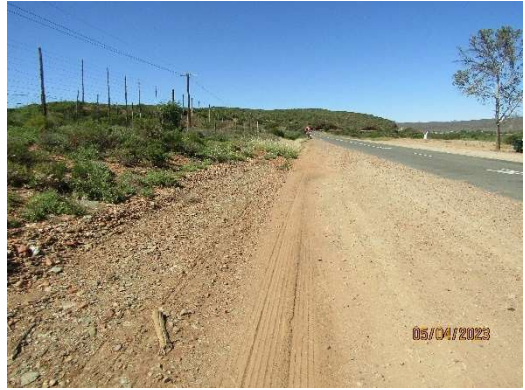
| Sample Site | Habitat Description | Likelihood of SCC | Photo 1 (North-bound lane) | Photo 2 (South-bound lane) |
|---|---|---|---|---|
| <p>S25 05-Apr-23 33°38'23.64"S 22°13'21.01"E</p> | <p>Photo 1: Disturbed roadside and large picnic site with little vegetation.</p> <p>Photo 2: Disturbed roadside with little vegetation.</p> | <p>Low</p> | | |

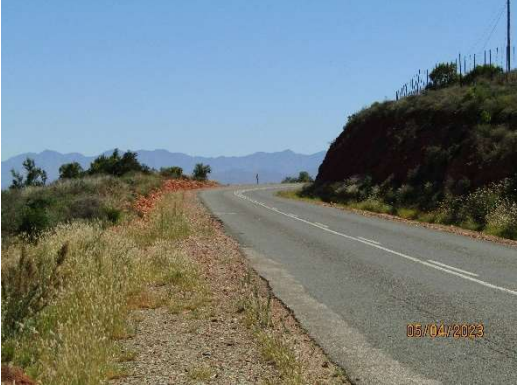
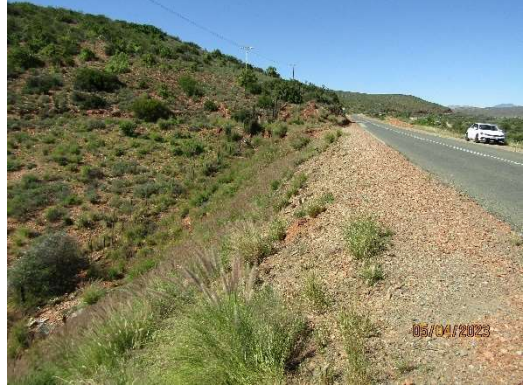
| Sample Site | Habitat Description | Likelihood of SCC | Photo 1 (North-bound lane) | Photo 2 (South-bound lane) |
|---|---|---|---|---|
| <p>S26 05-Apr-23 33°38'10.70"S 22°13'9.75"E</p> | <p>Photo 1: Disturbed roadside with rocky cut-slopes with little vegetation, mostly weedy and alien species.</p> <p>Photo 2: Disturbed roadside with gravel fill-slope with disturbed vegetation. Riparian area with large culvert and river valley on the east side.</p> | <p>Low</p> | | |

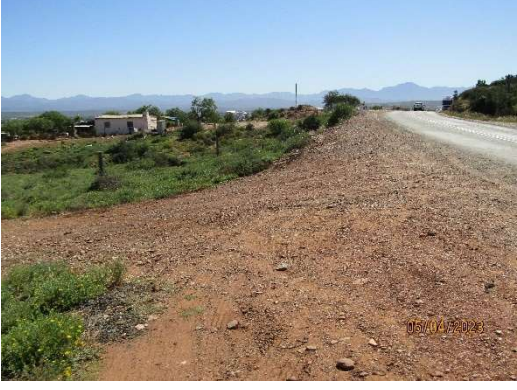
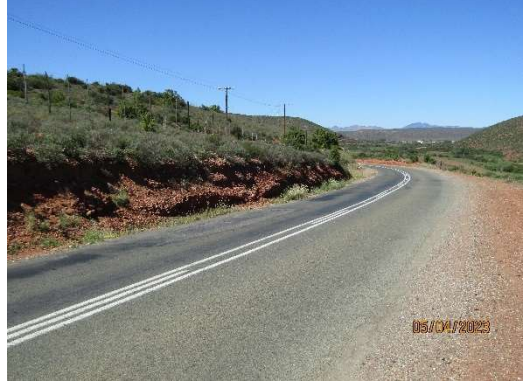
| Sample Site | Habitat Description | Likelihood of SCC | Photo 1 (North-bound lane) | Photo 2 (South-bound lane) |
|---|---|---|---|---|
| <p>S27 05-Apr-23 33°37'55.00"S 22°13'5.15"E</p> | <p>Photo 1: Disturbed roadside with gravel entrance to homestead with little vegetation, mostly weedy and alien species.</p> <p>Photo 2: Disturbed roadside with rocky cut-slopes with disturbed vegetation, mostly weedy and alien species.</p> | <p>Low</p> | | |

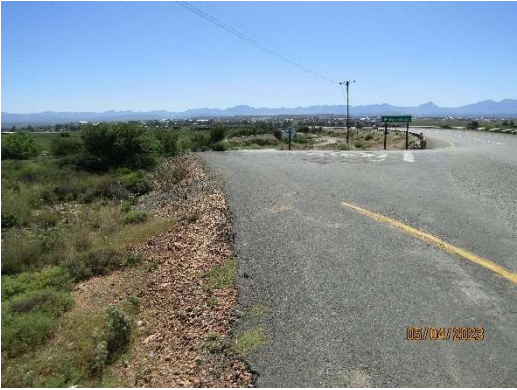
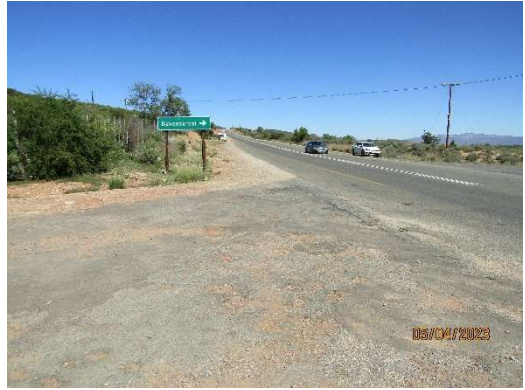
| Sample Site | Habitat Description | Likelihood of SCC | Photo 1 (North-bound lane) | Photo 2 (South-bound lane) |
|---|---|---|---|---|
| S28 05-Apr-23 33°37'43.68"S 22°13'13.91"E | Tar road intersection to Bakenskraal with little vegetation, mainly alien species. | Low | | |

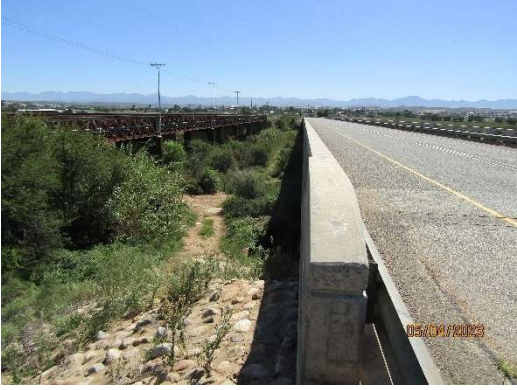
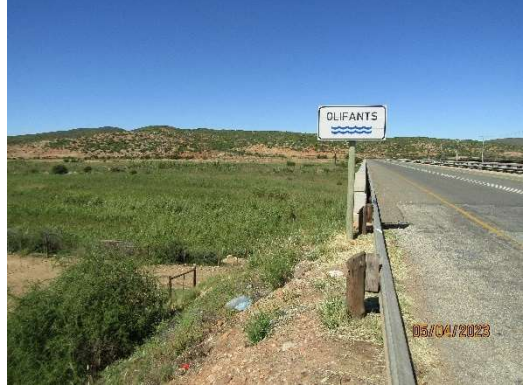
| Sample Site | Habitat Description | Likelihood of SCC | Photo 1 (North-bound lane) | Photo 2 (South-bound lane) |
|---|---|---|---|---|
| S29 05-Apr-23 33°37'28.58"S 22°13'15.43"E | Olifants River bridge with disturbed riparian habitat below. Many alien species such as Giant Reed <i>Arundo donax</i> . | Low | | |

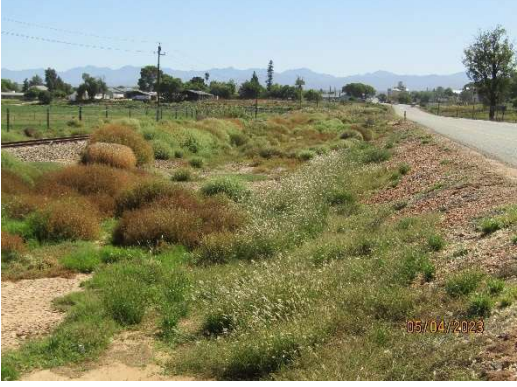
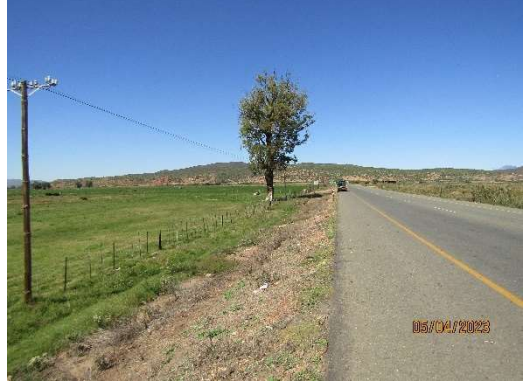
| Sample Site | Habitat Description | Likelihood of SCC | Photo 1 (North-bound lane) | Photo 2 (South-bound lane) |
|---|---|---|---|---|
| S30 05-Apr-23 33°37'3.97"S 22°13'4.83"E | Photo 1: Disturbed roadside with alien vegetation and railway line on the west side. Photo 2: Disturbed roadside little vegetation, and agricultural pastures beyond the fence on the east side. | Low | | |
