CONCEPT & VIABILITY REPORT

CONTRACT No. C1117

PAVEMENT STRENGTHENING OF TR75/1 (KM 16.50
TO KM 31.20) NEAR OUDTSHOORN

CHIEF DIRECTORATE: ROAD PROGRAMME MANAGEMENT
ROADS BRANCH

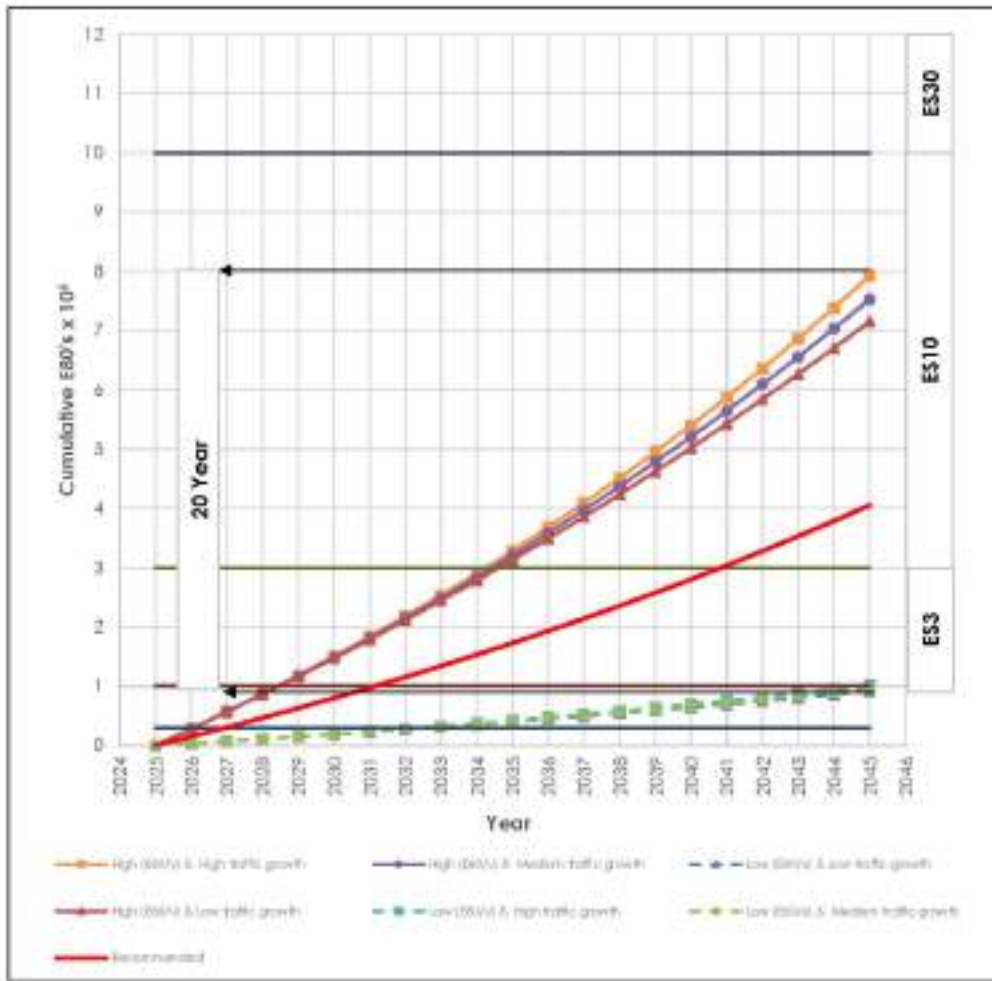
Figure 2.1
CUMULATIVE PAVEMENT TRAFFIC LOADING

The detailed pavement traffic analysis is described under section 3 of the Inception Report. A pavement loading calculation was undertaken with a road opening year 2025, resulting in an ES10 pavement based on 20-year structural design period as shown in **Figure 2.1** overleaf (a repeat of *Figure 3.1* of the Inception Report).

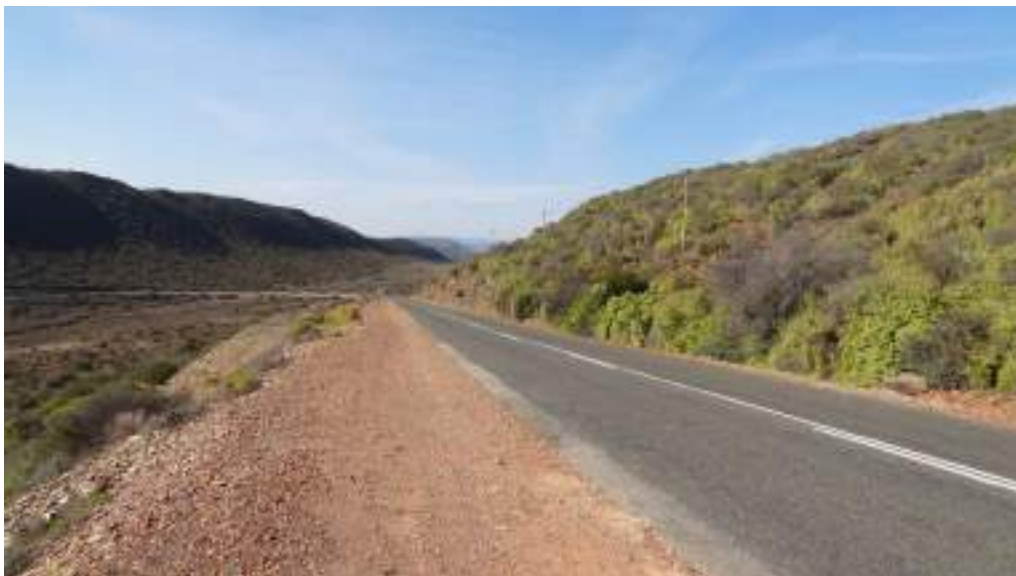
Photo 4.1
TYPICAL CROSS SECTION (km 19.40) LOOKING TOWARDS OUDTSHOORN

Along most of the route, the road prism is typically in cut on the RHS and fill on the LHS. Widening the cut on the RHS often results in chasing the natural topography and consequently very high cuts, while fill widening on the LHS results in high and narrow fills being constructed. A typical example of this can be found near km 19.80 on the decent to the hair pin bend, as shown in **Photo 4.1**.

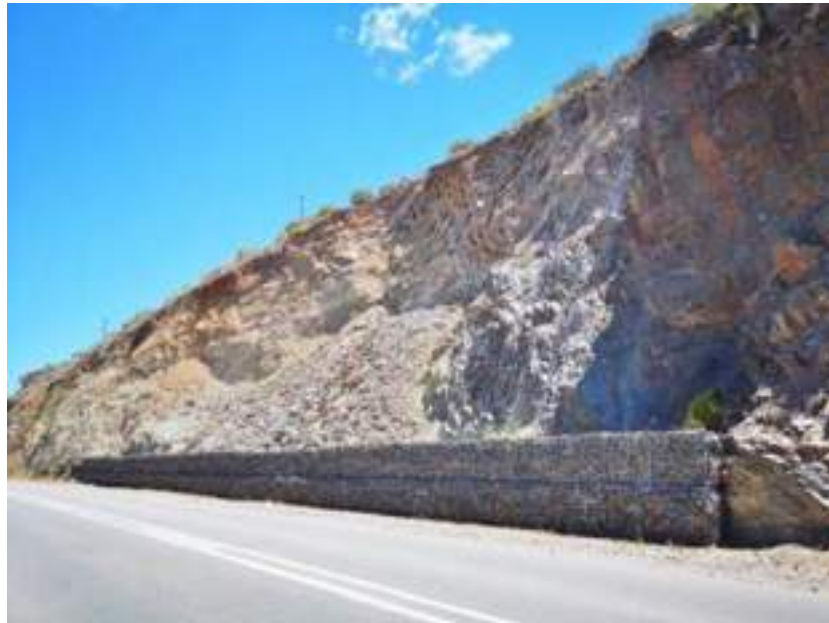
Photo 4.2
MESH DRAPERY SYSTEM AND GABION WALL AT KM 23.0

The section between km 22.0 and km 23.3 is constrained on the LHS by the railway reserve and on the RHS by deep cuts which are potentially unstable, as observed by the mesh drapery system and gabion catchment wall at km 23.0 shown in **Photo 4.2**. A widening of the road prism beyond a Class 3 cross section would require the removal of this system and the reshaping of the cut faces in this vicinity as realignment of the railway is not considered a viable alternative due to it being constrained by the adjacent Kliprivier.

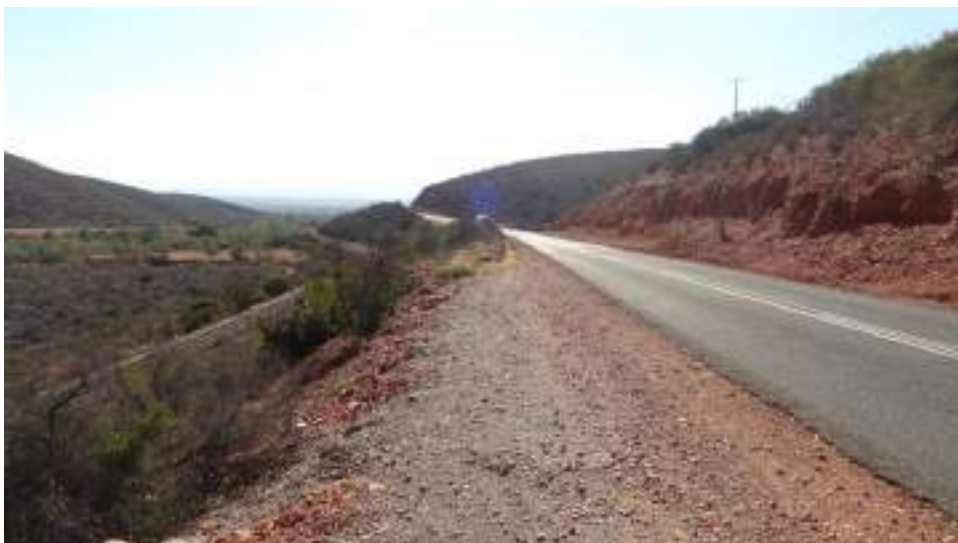
Photo 4.3
TYPICAL CROSS SECTION (km 24.90) LOOKING TOWARDS OUDTSHOORN

The railway reserve further constrains widening of the road prism on the LHS up to km 29.55. **Photo 4.3** illustrates the proximity of the reserve to the road reserve.

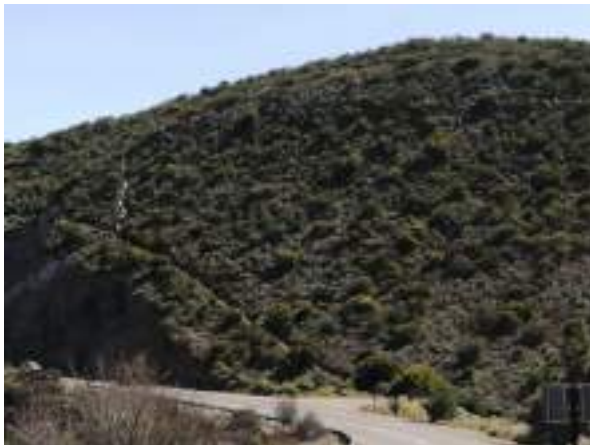
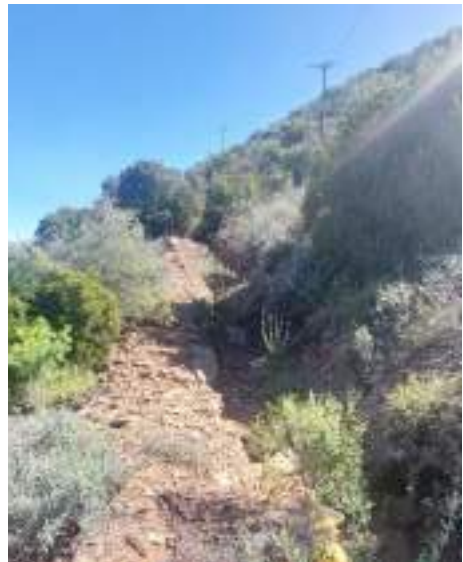
Photo 9.1
TYPICAL CUT-OFF DRAINS

Cut-off drains were observed above numerous cut faces, particularly from km 22.8 onwards. The photos below show a typical cut-off drain along TR75/1 in the vicinity of km 23.0.

Perspective view of cut-off drain.

Close-up of cut-off drain.

It is recommended that debris be removed from the drains and they be re-shaped and then stone pitched. This will aid the maintenance agent with clearing the cut-off drains and the side drains through cuttings where material build up is an issue noted by the DRE.

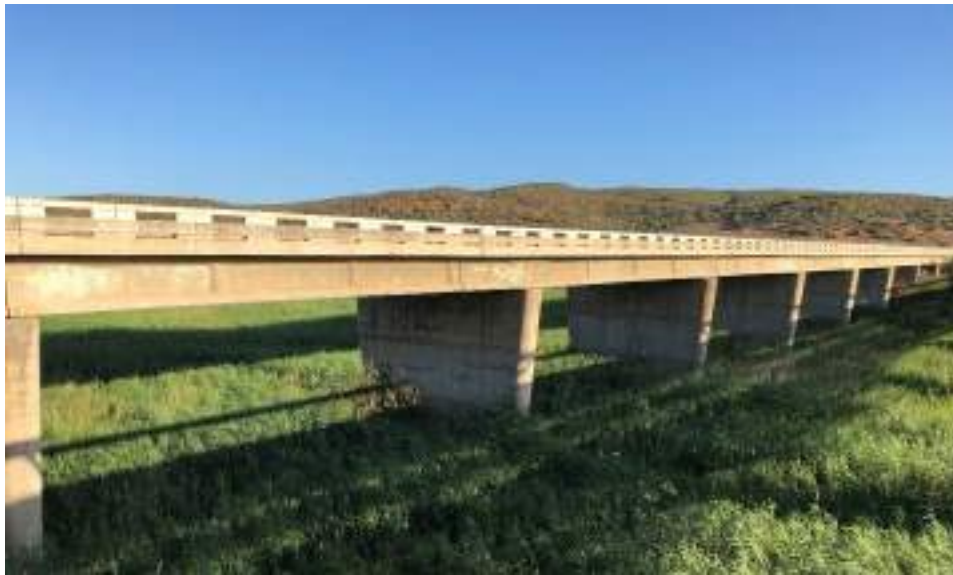
Photo 10.1
PART ELEVATION OF BRIDGE B4691

The existing bridge along the section of TR75/1 under consideration is summarised in **Table 10.1** and shown in **Photo 10.1**.

Bridge 4691 at km 30.02 on TR75/1 is in a good condition and only selected remedial activities are proposed. The following key defects were identified:

- Deck surfacing at end of service life
- Honey combing on northern abutment face
- Balustrade cracking, rebar corrosion and spalling
- Cracking and pavement settlement behind abutments
- Service life of bridge deck expansion joints

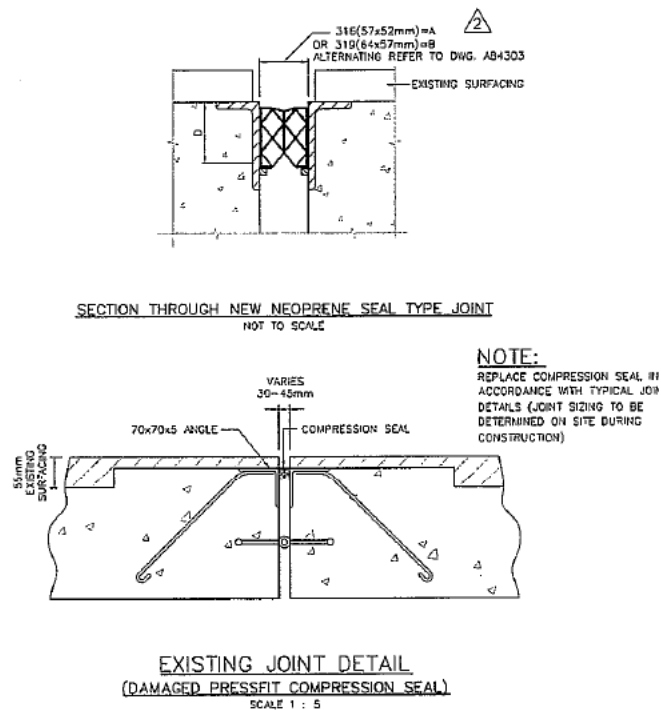
**Figure 10.1
 TYPICAL JOINT DETAIL**

The road surface seal was not replaced at that stage. The neoprene seal was severely damaged, at some locations, however. After considering various options and also consultation with joint installation contractors it was concluded that the replacement of the neoprene seals were the most suitable solution from a cost and practical perspective. At that stage resurfacing was not envisaged due to the relatively good condition thereof.

Tender rates for the replacement of the neoprene seals during the 2007 contract varied from around R600 /m to R900 /m. Currently it is estimated at around R1500 /m to R2000 /m to replace the seals and with an overall joint length of around 130m the installation cost would be R195 000 to R260 000 (excluding P&Gs).

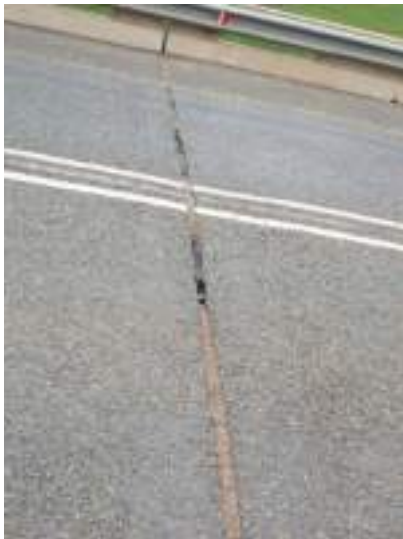
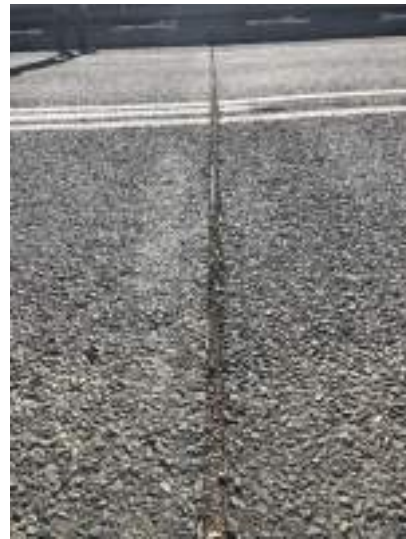
Photo 10.2
JOINT CONDITION COMPARISON

Joint condition prior to 2008 seal installation.

Joint condition at visual inspection conducted 2019.

However, in view of the overall pavement strengthening project and the recommendation to replace the deck surfacing with new asphalt, it is proposed to replace the existing joint system with new asphaltic plug joints which will be installed after completion of the asphalt deck surfacing.

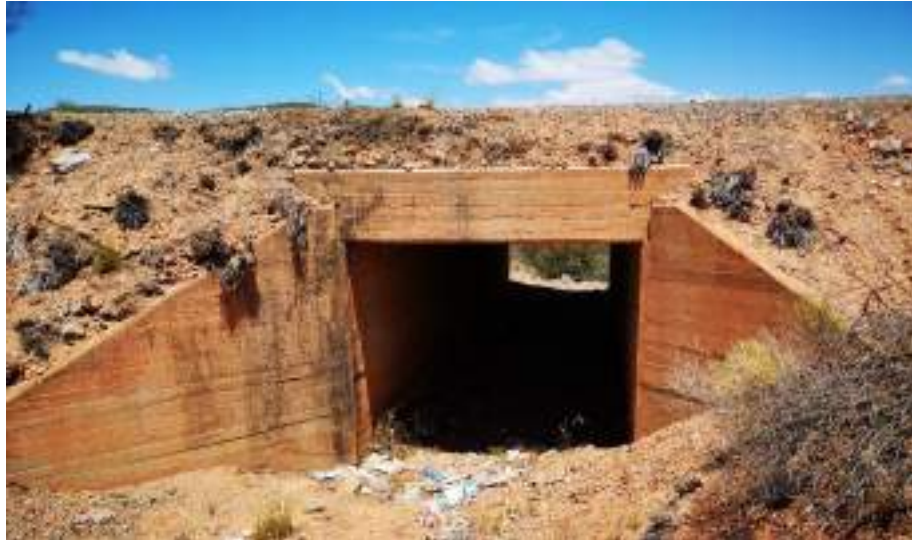
Photo 10.2
TYPICAL MAJOR CULVERT ALONG THE ROUTE

Only defects that affect the long-term durability or functionality of the structures have been considered for repairs. The following key defects were identified:

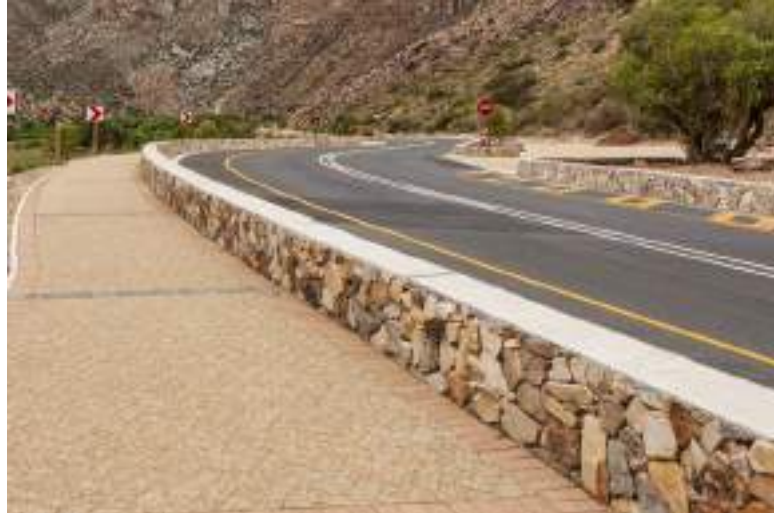
Photo 17.1
EXAMPLE OF STONE MASONRY WALL
ON TR31/2 IN COGMANSKLOOF

It is anticipated that the cost of the stone walls could be in the order of R2 800 /m, compared to approximately R600 /m for guardrails. The total increased cost for the proposal is therefore in the order of R1.71 million.

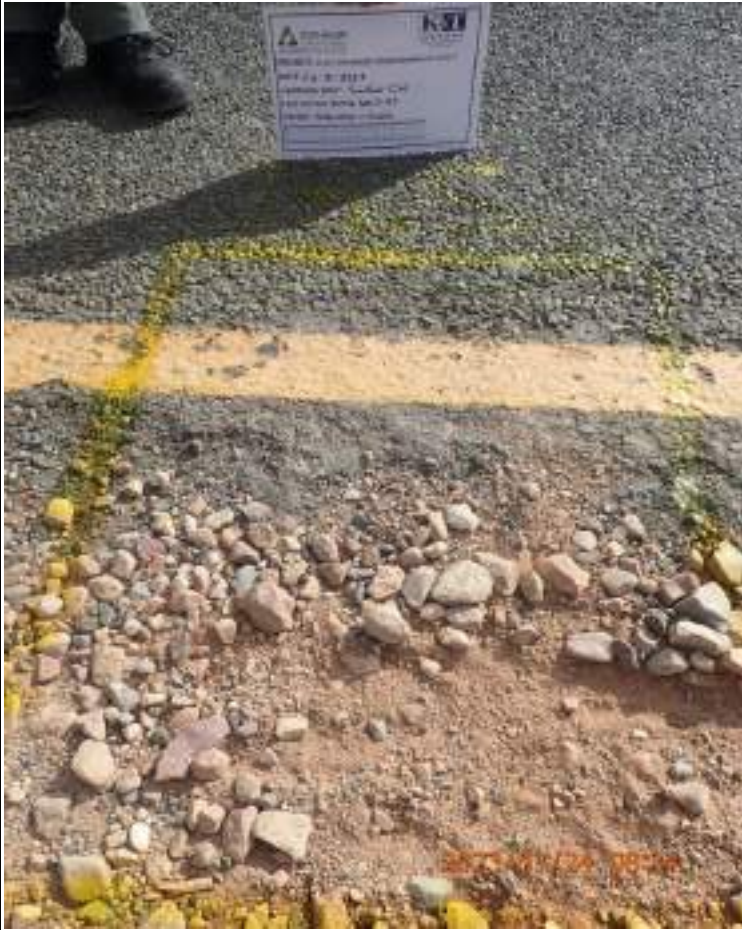
Surface Visual

Samples Taken:
 Layer 1 None Taken
 Layer 2 Sample No. 25739/1 taken at 40mm (Disturbed)
 Layer 3 Sample No. 25739/2 taken at 260mm (Disturbed)
 Layer 4 Sample No. 25739/3 taken at 460mm (Disturbed)

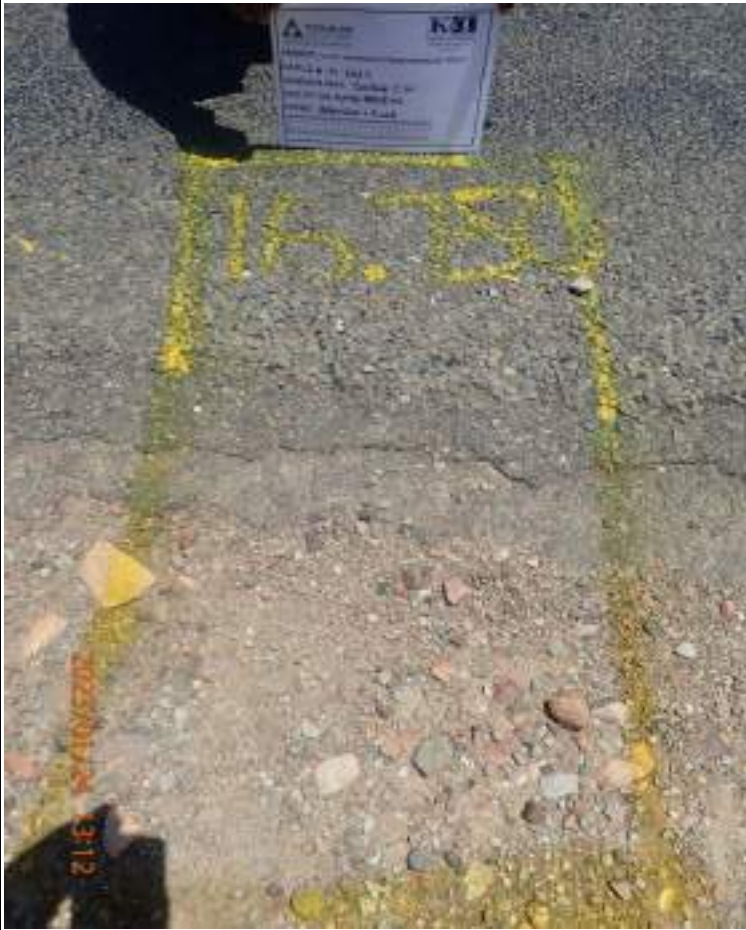
Surface Visual

0	0 - 30mm	Cape Seal, /	
100	30 - 310mm	Slightly Moist, Light Reddish BROWN, Dense, Intact, Minor Silty/Sandy fine to coarse S/Stone GRAVEL, Imported, HCL - / PHEN -, G5	25739/7
200	310 - 520mm	Slightly Moist, Dark Reddish BROWN, Dense, Intact, Clayey Sandy fine to coarse weathered Shale GRAVEL, Imported, HCL + / PHEN -, G8	25739/8
300	520 - 800mm	Slightly Moist, Light Reddish BROWN, Very Dense, Intact, Weathered Shale BEDROCK, Insitu, HCL + / PHEN -, G7	25739/9
400	Samples Taken:		
500	Layer 1	None Taken	
600	Layer 2	Sample No. 25739/7 taken at 30mm (Disturbed)	
700	Layer 3	Sample No. 25739/8 taken at 310mm (Disturbed)	
800	Layer 4	Sample No. 25739/9 taken at 520mm (Disturbed)	
900

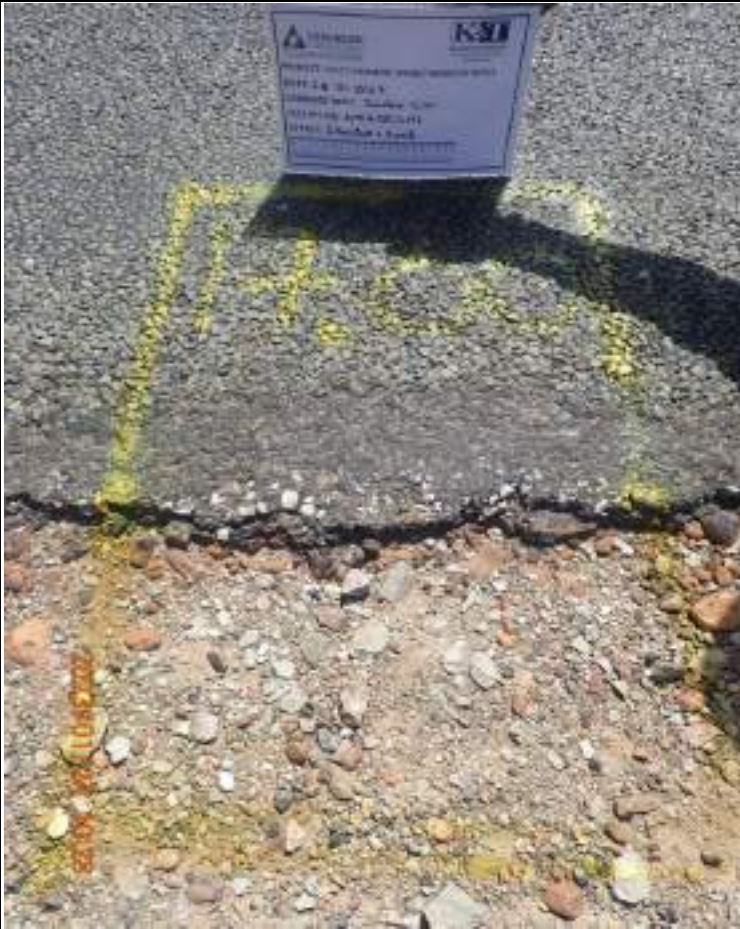
Surface Visual

Samples Taken:
 Layer 1 None Taken
 Layer 2 Sample No. 25739/4 taken at 35mm (Disturbed)
 Layer 3 Sample No. 25739/5 taken at 250mm (Disturbed)
 Layer 4 Sample No. 25739/6 taken at 430mm (Disturbed)

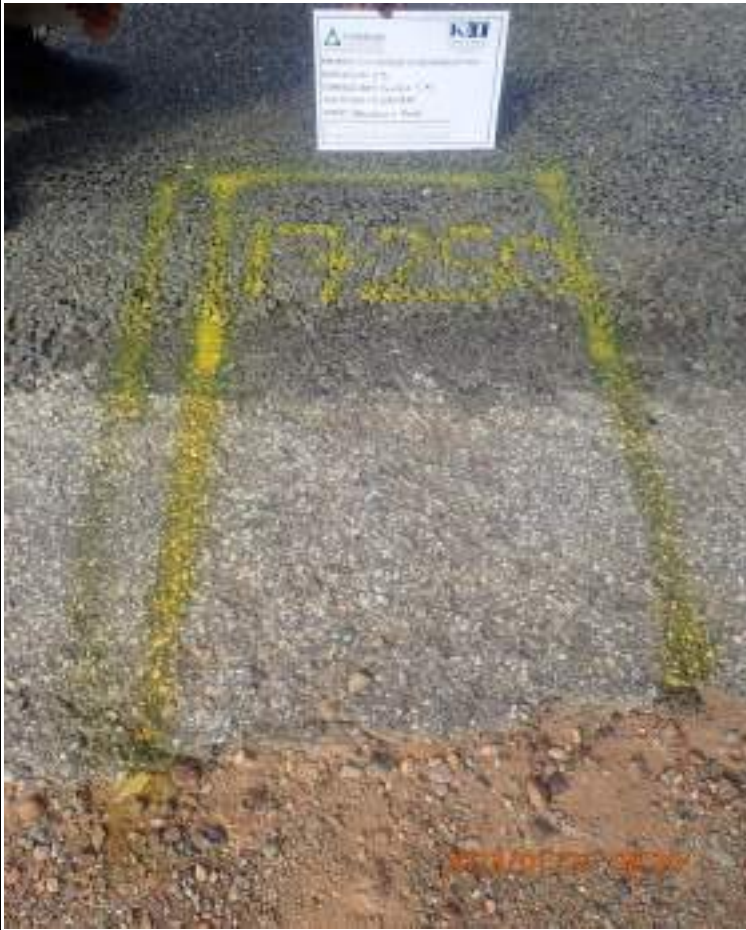
Surface Visual

Samples Taken:
 Layer 1 None Taken
 Layer 2 Sample No. 25739/10 taken at 35mm (Disturbed)
 Layer 3 Sample No. 25739/11 taken at 240mm (Disturbed)

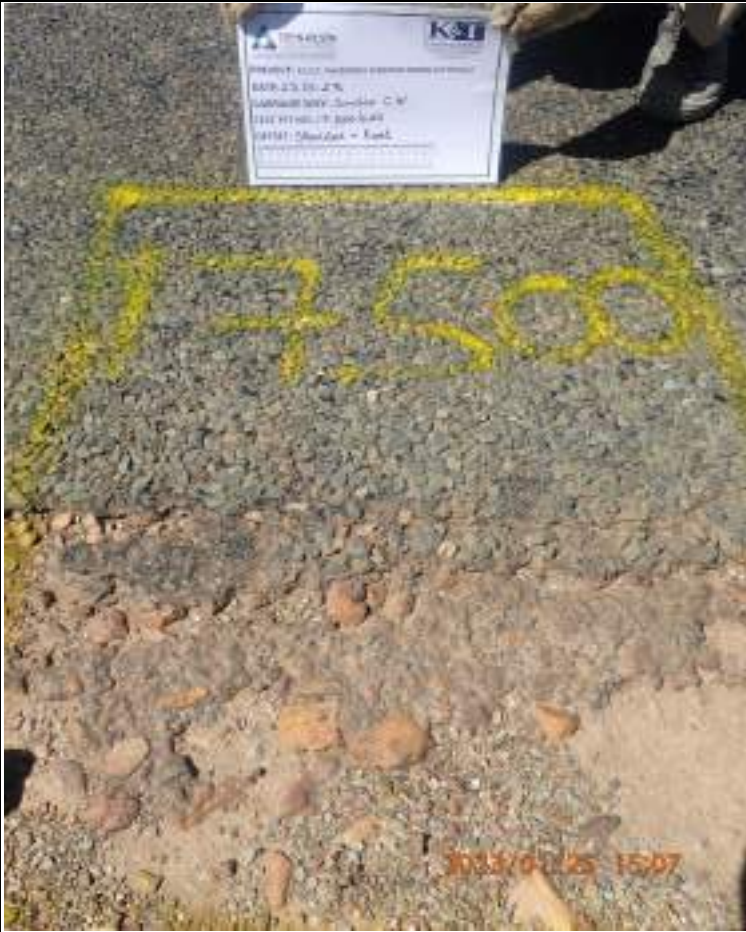
Surface Visual

<p>0 - 30mm Cape Seal, /</p> <p>30 - 235mm Slightly Moist, Dark Reddish BROWN, Very Dense, Intact, Silty Sandy fine to coarse S/Stone GRAVEL, Imported, HCL - / PHEN -, G5</p> <p>235 - 1000mm Slightly Moist, Light OLIVE, Dense, Intact, Silty Sandy fine to coarse Shale GRAVEL, Residual, HCL - / PHEN -, G8</p>	<p>Samples Taken:</p> <p>Layer 1 None Taken</p> <p>Layer 2 Sample No. 25739/14 taken at 30mm (Disturbed)</p> <p>Layer 3 Sample No. 25739/15 taken at 235mm (Disturbed)</p>	<p>25739/14</p> <p>25739/15</p>
--	--	---------------------------------

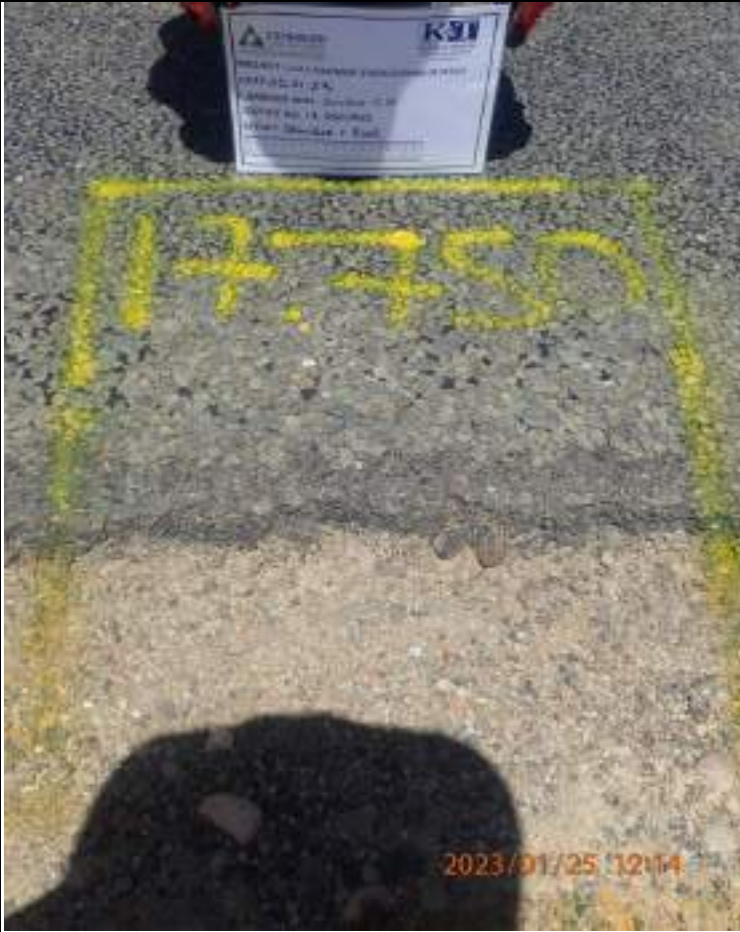
Surface Visual

Samples Taken:
 Layer 1 None Taken
 Layer 2 Sample No. 25739/12 taken at 30mm (Disturbed)
 Layer 3 Sample No. 25739/13 taken at 255mm (Disturbed)

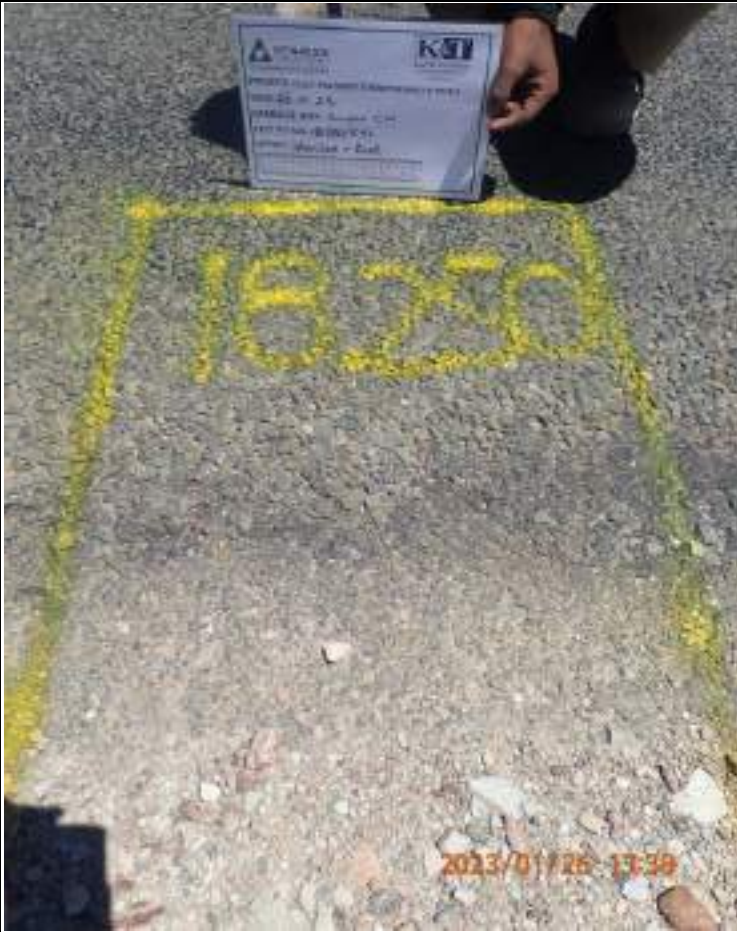
Surface Visual

Samples Taken:
 Layer 1 None Taken
 Layer 2 Sample No. 25739/21 taken at 35mm (Disturbed)
 Layer 3 Sample No. 25739/22 taken at 250mm (Disturbed)
 Layer 4 Sample No. 25739/23 taken at 700mm (Disturbed)

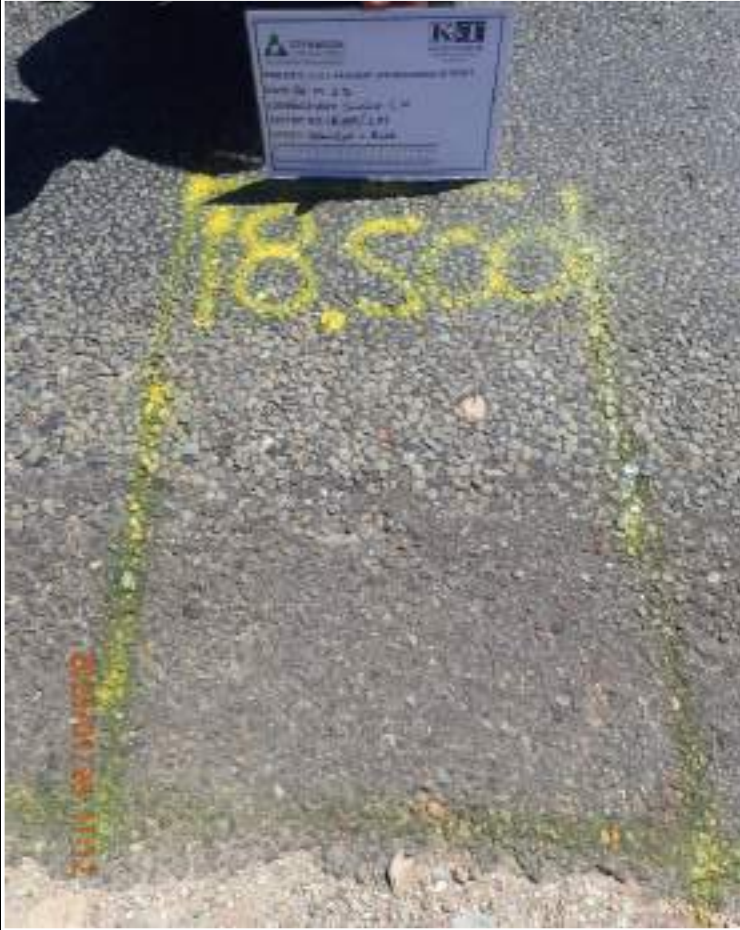
Surface Visual

Samples Taken:
 Layer 1 None Taken
 Layer 2 Sample No. 25739/19 taken at 30mm (Disturbed)
 Layer 3 Sample No. 25739/20 taken at 230mm (Disturbed)

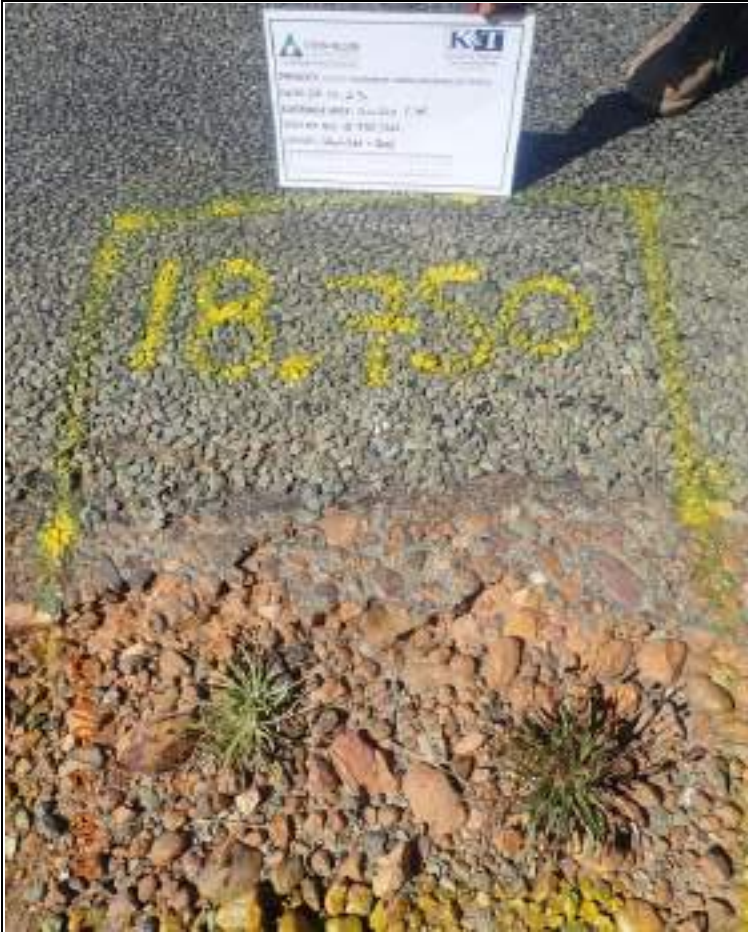
Surface Visual

<p>0 - 30mm Cape Seal, /</p> <p>30 - 230mm Slightly Moist, Light Reddish BROWN, Very Dense, Intact, Silty Sandy fine to coarse S/Stone GRAVEL, Imported, HCL - / PHEN -</p> <p>230 - 1000mm Moist, Light Yellowish BROWN, Dense, Intact, Silty Sandy fine to coarse weathered Shale GRAVEL, Residual, HCL - / PHEN -</p>	<p>Samples Taken:</p> <p>Layer 1 None Taken</p> <p>Layer 2 Sample No. 25739/24 taken at 30mm (Disturbed)</p> <p>Layer 3 Sample No. 25739/25 taken at 230mm (Disturbed)</p>	<p>25739/24</p> <p>25739/25</p>
--	---	---------------------------------

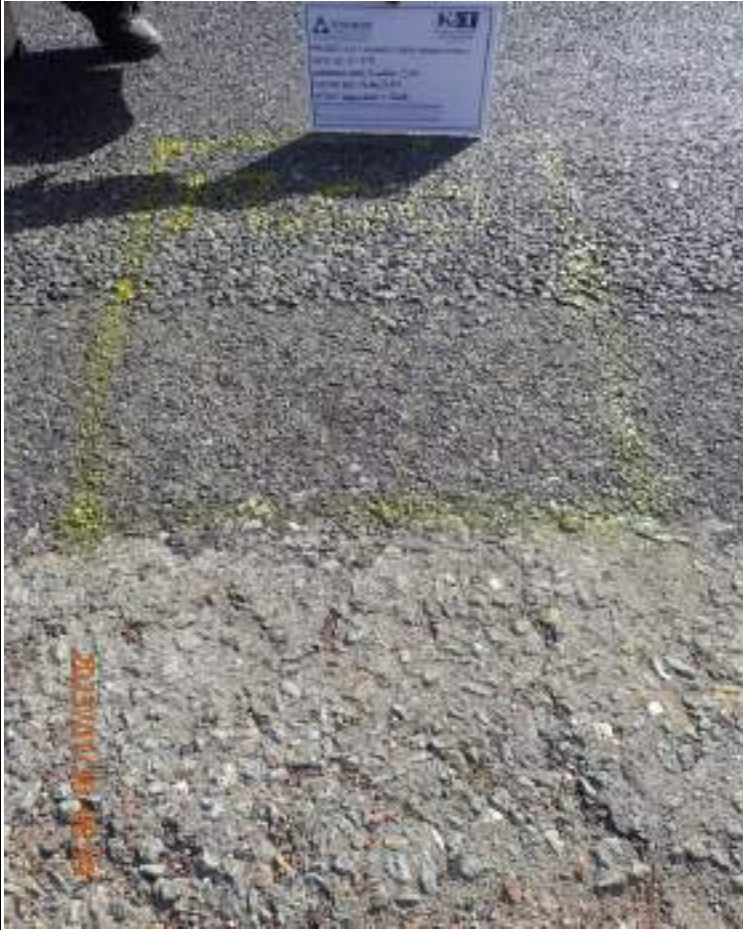
Surface Visual

Samples Taken:
 Layer 1 None Taken
 Layer 2 Sample No. 25739/40 taken at 30mm (Disturbed)
 Layer 3 Sample No. 25739/41 taken at 230mm (Disturbed)
 Layer 4 Sample No. 25739/42 taken at 470mm (Disturbed)

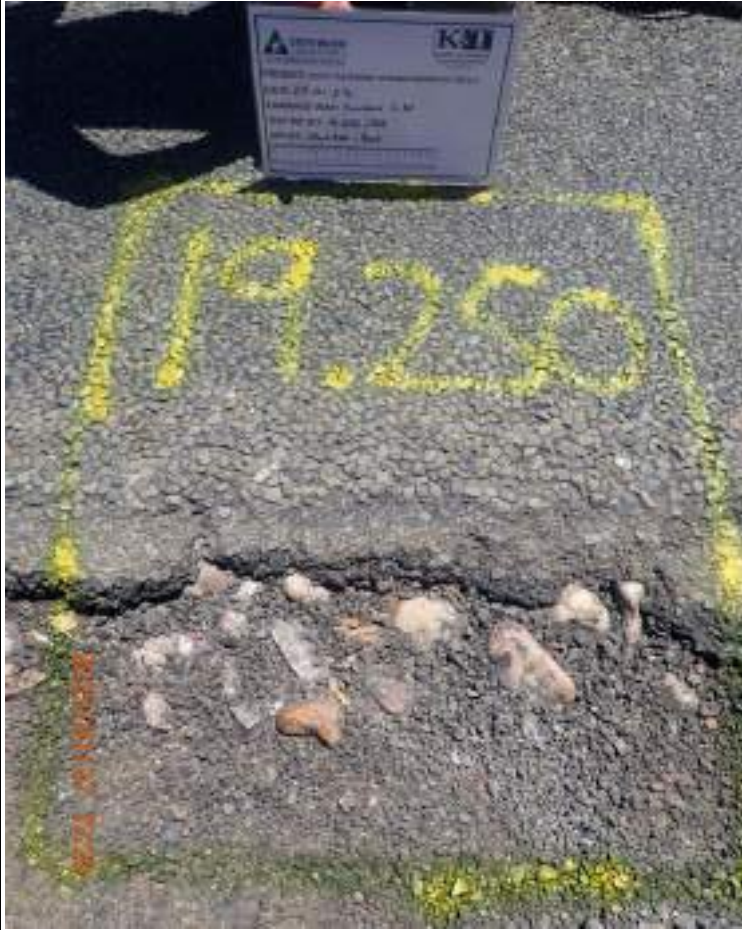
Surface Visual

Samples Taken:
 Layer 1 None Taken
 Layer 2 Sample No. 25739/26 taken at 30mm (Disturbed)
 Layer 3 Sample No. 25739/27 taken at 280mm (Disturbed)
 Layer 4 Sample No. 25739/28 taken at 400mm (Disturbed)

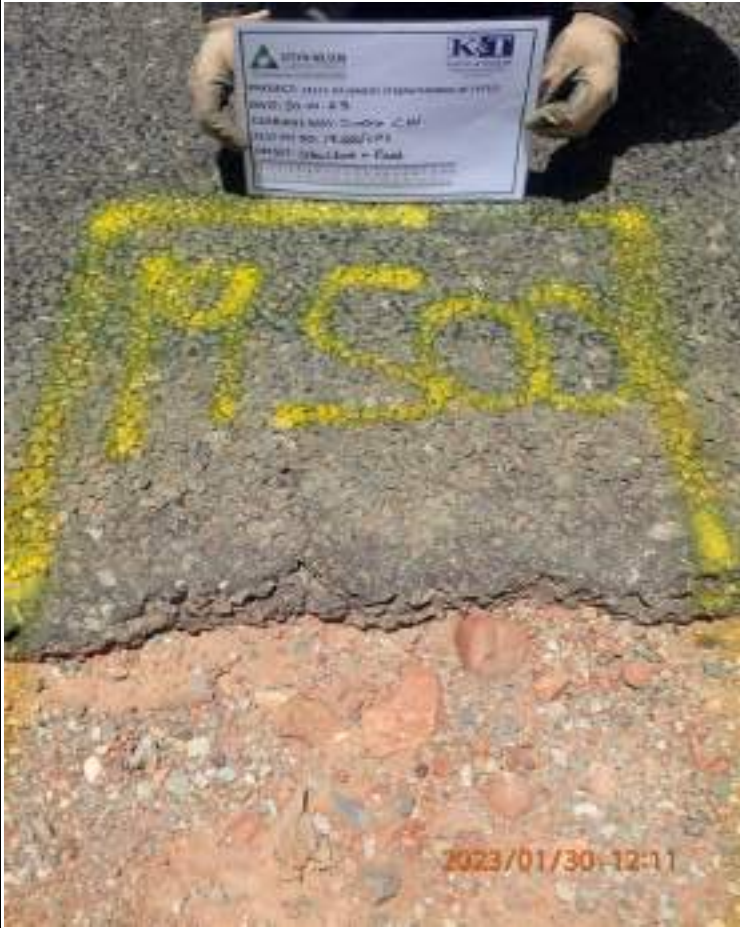
Surface Visual

0 - 30mm	Cape Seal, /	
30 - 280mm	Slightly Moist, Light reddish BROWN, Very Dense, Intact, Silty Sandy fine to coarse S/Stone GRAVEL, Imported, HCL + / PHEN -, G5	25739/43
280 - 600mm	Slightly Moist, Light OLIVE, Dense, Intact, Silty Sandy fine to coarse weathered Shale GRAVEL, Imported, HCL + / PHEN -, G8	25739/44
600 - 900mm	Moist, Light BROWN, Dense, Intact, Silty Sandy fine to coarse weathered Shale GRAVEL, Insitu, HCL + / PHEN -, G8	25739/45
	SHALE BEDROCK BELOW	
Samples Taken: Layer 1 None Taken Layer 2 Sample No. 25739/43 taken at 30mm (Disturbed) Layer 3 Sample No. 25739/44 taken at 280mm (Disturbed) Layer 4 Sample No. 25739/45 taken at 600mm (Disturbed)

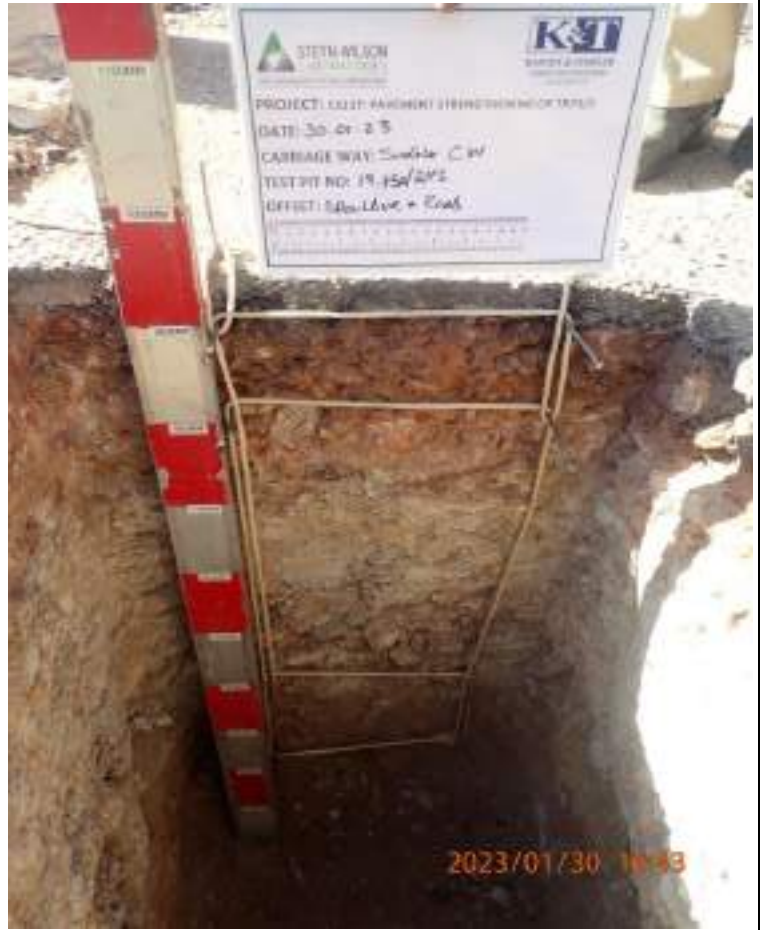
Profile Measurement

<p>0 - 30mm /</p> <p>30 - 130mm Slightly Moist, Light Reddish BROWN, Very Dense, Intact, Abundant Silty Sandy fine to coarse S/Stone GRAVEL, Imported, HCL + / PHEN -, G5</p> <p>130 - 600mm Slightly Moist, Light OLIVE, Dense, Intact, Silty Sandy fine to coarse weathered Shale GRAVEL, Residual, HCL + / PHEN -, G8</p> <p>600 - 1000mm Moist, Light BROWN, Dense, Intact, Silty Sandy fine to coarse Shale GRAVEL, Insitu, HCL + / PHEN -, G6</p>	<p>25739/46</p> <p>25739/47</p> <p>25739/48</p>
---	---

Samples Taken:
 Layer 1 None Taken
 Layer 2 Sample No. 25739/46 taken at 30mm (Disturbed)
 Layer 3 Sample No. 25739/47 taken at 130mm (Disturbed)
 Layer 4 Sample No. 25739/48 taken at 600mm (Disturbed)

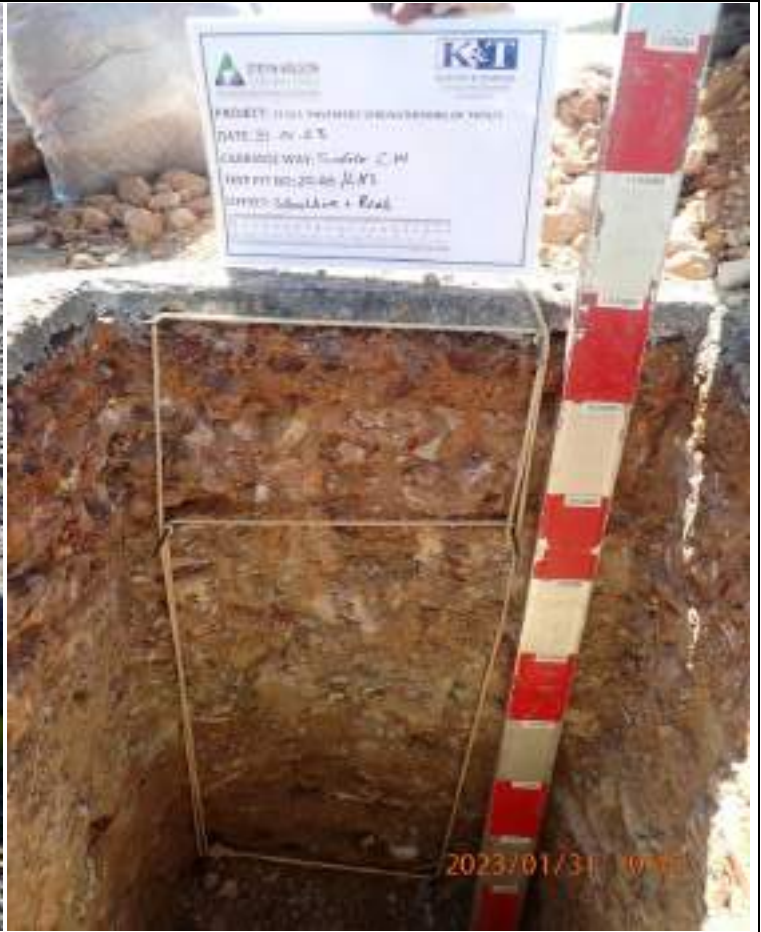
Profile Measurement

<p>0 - 35mm Cape Seal, /</p> <p>35 - 250mm Slightly Moist, Dark Reddish BROWN, Very Dense, Intact, Silty Sandy fine to coarse S/Stone GRAVEL, Imported, HCL - / PHEN -, G5</p> <p>250 - 1000mm Moist, Light Greyish BROWN, Dense, Intact, Abundant Silty Sandy fine to coarse weathered Shale GRAVEL, Residual, HCL + / PHEN -</p>	<p>25739/49</p> <p>25739/50</p>
---	---------------------------------

Samples Taken:
 Layer 1 None Taken
 Layer 2 Sample No. 25739/49 taken at 35mm (Disturbed)
 Layer 3 Sample No. 25739/50 taken at 250mm (Disturbed)

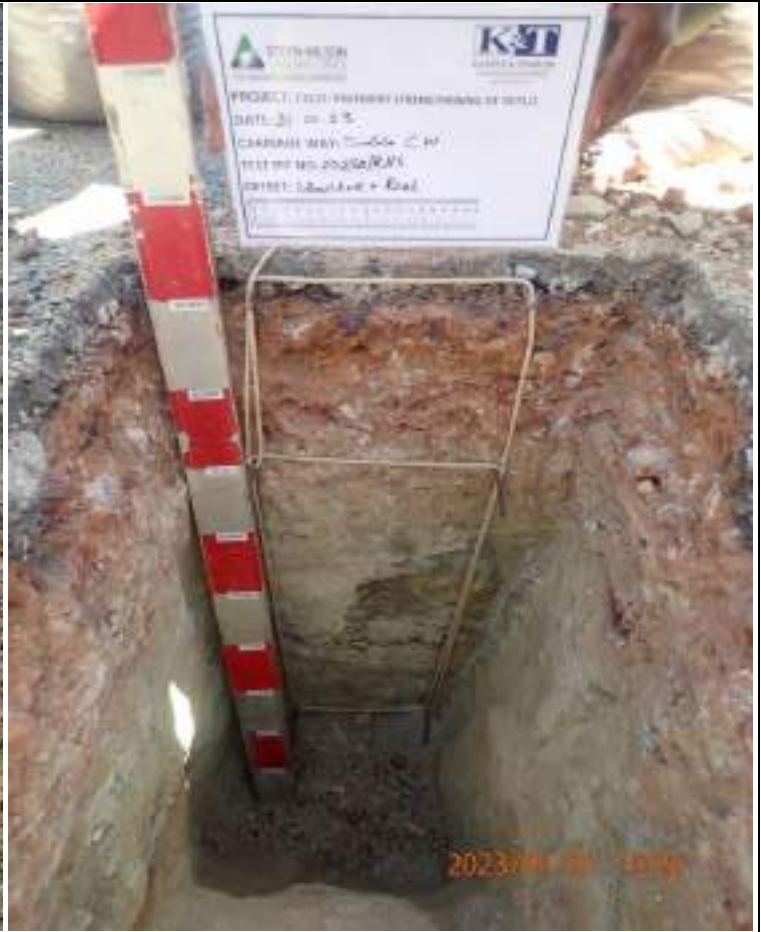
Profile Measurement

0 - 30mm	Cape Seal, /	
30 - 250mm	Slightly Moist, Light reddish BROWN, Very Dense, Intact, Silty Sandy fine to coarse S/Stone GRAVEL, Imported, HCL + / PHEN -	25739/53
250 - 1000mm	Slightly Moist, Light OLIVE, Dense, Intact, Abundant Silty Sandy fine to coarse weathered Shale GRAVEL, Residual, HCL + / PHEN +	25739/54

Samples Taken:
 Layer 1 None Taken
 Layer 2 Sample No. 25739/53 taken at 30mm (Disturbed)
 Layer 3 Sample No. 25739/54 taken at 250mm (Disturbed)

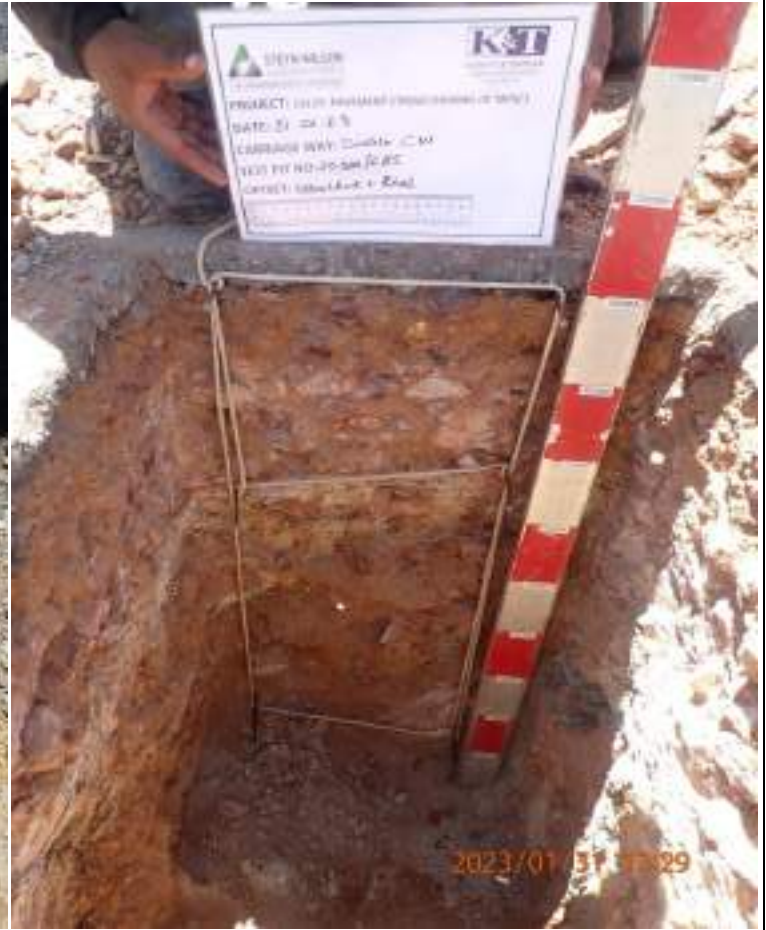
Profile Measurement

<p>0 - 35mm Cape Seal, /</p> <p>35 - 300mm Slightly Moist, Light Orange BROWN, Very Dense, Intact, Abundant Silty Sandy fine to coarse S/Stone GRAVEL, Imported, HCL + / PHEN -, G6</p> <p>300 - 900mm Slightly Moist, Light Reddish BROWN, Dense, Intact, Silty SAND with abundant Shale Gravel (weathered SHALE), Residual, HCL - / PHEN -, G8</p>	<p>Samples Taken:</p> <p>Layer 1 None Taken</p> <p>Layer 2 Sample No. 25739/51 taken at 35mm (Disturbed)</p> <p>Layer 3 Sample No. 25739/52 taken at 300mm (Disturbed)</p>	<p>25739/51</p> <p>25739/52</p>
--	--	---------------------------------

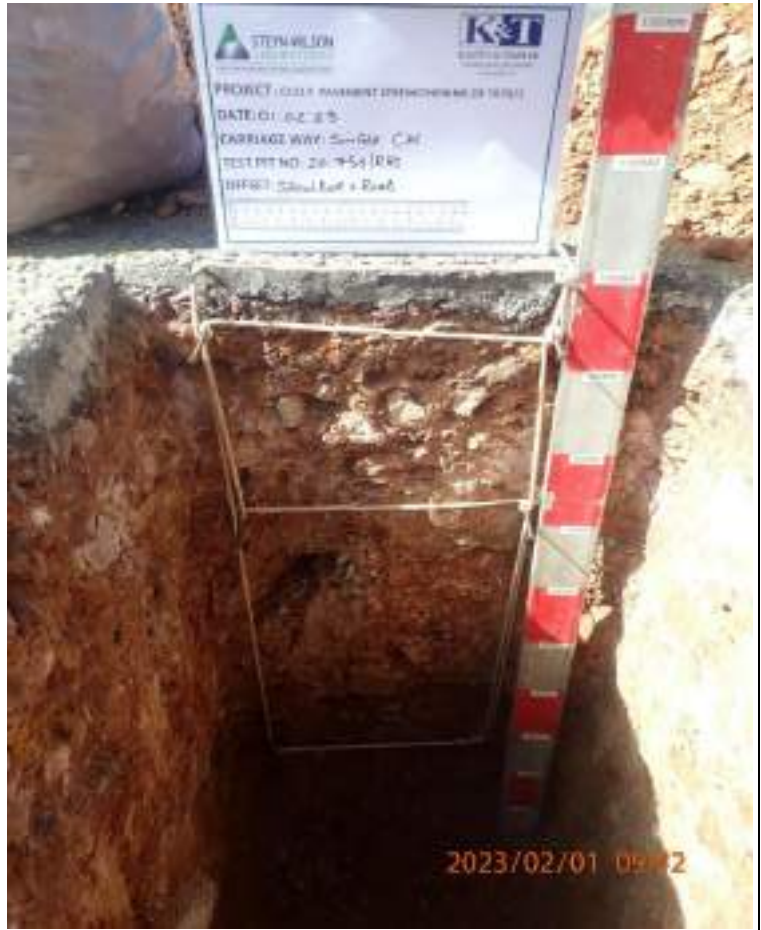
Profile Measurement

<p>0 - 50mm</p> <p>50 - 300mm</p> <p>300 - 1000mm</p>	<p>Cape Seal, /</p> <p>Slightly Moist, Light Reddish BROWN, Very Dense, Intact, Clayey Sandy fine to coarse S/Stone GRAVEL, Imported, HCL + / PHEN -, G6</p> <p>Moist, Light Orange BROWN, Dense, Intact, Abundant Silty Sandy fine to coarse Weathered Shale GRAVEL, Residual, HCL - / PHEN -, G8</p>	<p></p> <p>25739/55</p> <p>25739/56</p>
---	--	---

Samples Taken:
 Layer 1 None Taken
 Layer 2 Sample No. 25739/55 taken at 50mm (Disturbed)
 Layer 3 Sample No. 25739/56 taken at 300mm (Disturbed)

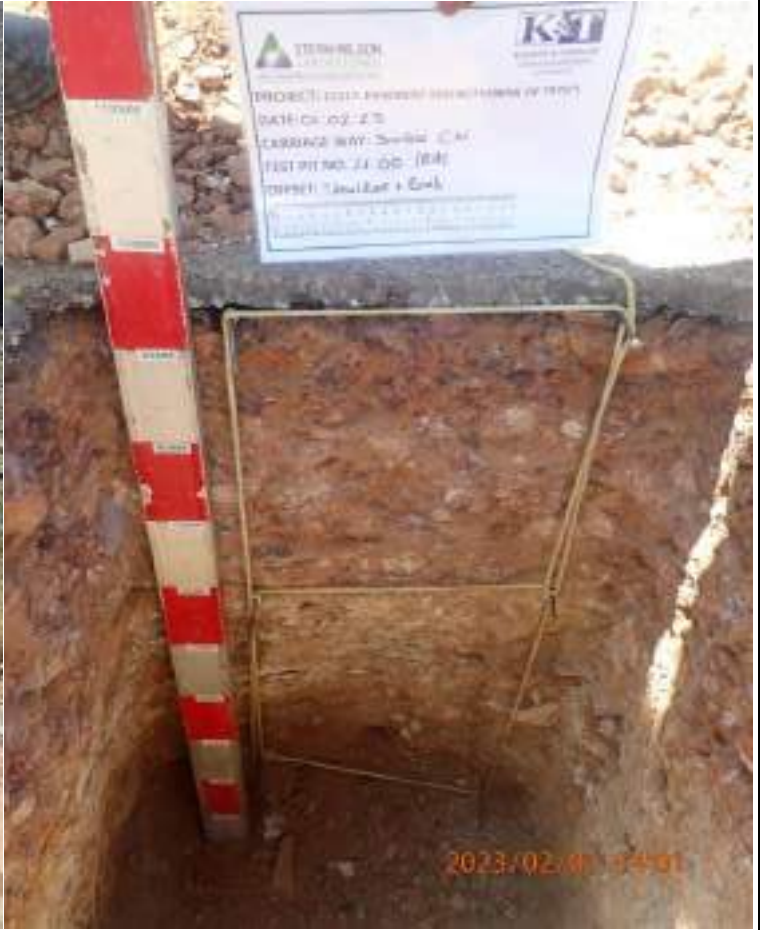
Profile Measurement

0 - 25mm	/		
25 - 400mm	Slightly Moist, Light Reddish BROWN, Very Dense, Intact, Silty Sandy fine to coarse S/Stone GRAVEL, Imported, HCL + / PHEN -, G5		25739/60
400 - 1000mm	Moist, Light Yellowish BROWN, Dense, Intact, Silty Sandy fine to coarse weathered Shale GRAVEL, Residual, HCL + / PHEN -, G8		25739/61

Samples Taken:
 Layer 1 None Taken
 Layer 2 Sample No. 25739/60 taken at 25mm (Disturbed)
 Layer 3 Sample No. 25739/61 taken at 400mm (Disturbed)

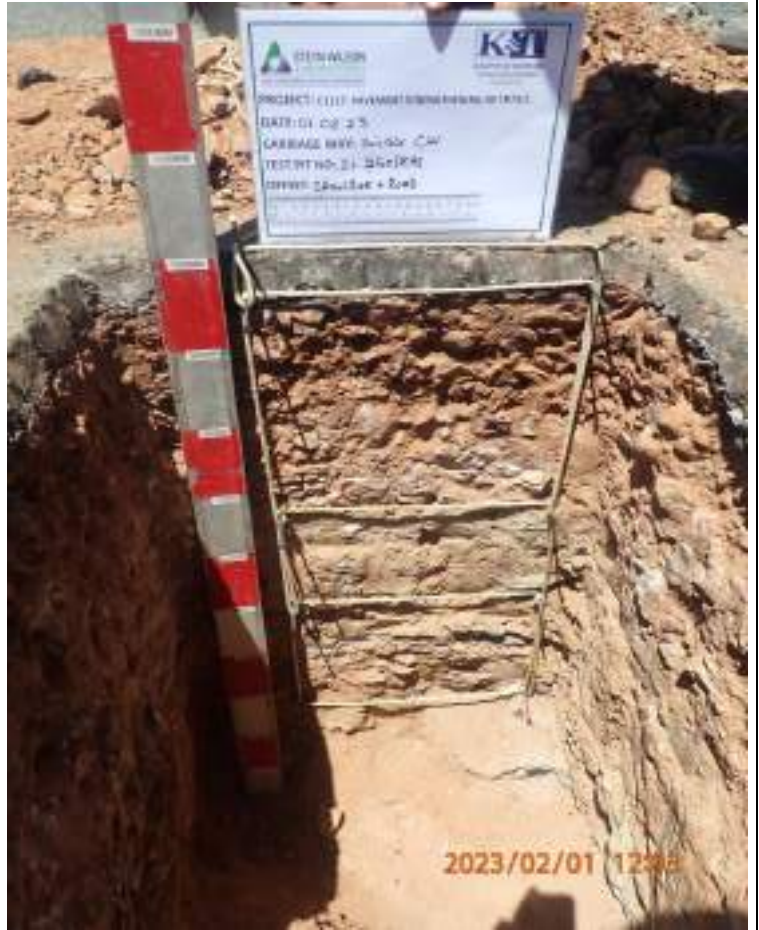
Profile Measurement

0 - 30mm	Cape Seal, /	
30 - 370mm	Slightly Moist, Light Reddish BROWN, Very Dense, Intact, Silty Sandy fine to coarse S/Stone GRAVEL, Imported, HCL - / PHEN -, G5	25739/57
370 - 550mm	Moist, Light Orange BROWN, Dense, Intact, Abundant Silty Sandy fine to coarse Weathered Shale GRAVEL, Residual, HCL + / PHEN -, G9	25739/58
550 - 1000mm	Moist, Light Orange BROWN, Dense, Intact, Abundant Silty Sandy fine to coarse Weathered Shale GRAVEL, Insitu, HCL + / PHEN -, G9	25739/59
Bedrock below		
Samples Taken: Layer 1 None Taken Layer 2 Sample No. 25739/57 taken at 30mm (Disturbed) Layer 3 Sample No. 25739/58 taken at 370mm (Disturbed) Layer 4 Sample No. 25739/59 taken at 550mm (Disturbed)
