CONCEPT & VIABILITY REPORT

CONTRACT No. C1117

PAVEMENT STRENGTHENING OF TR75/1 (KM 16.50
TO KM 31.20) NEAR OUDTSHOORN

CHIEF DIRECTORATE: ROAD PROGRAMME MANAGEMENT
ROADS BRANCH

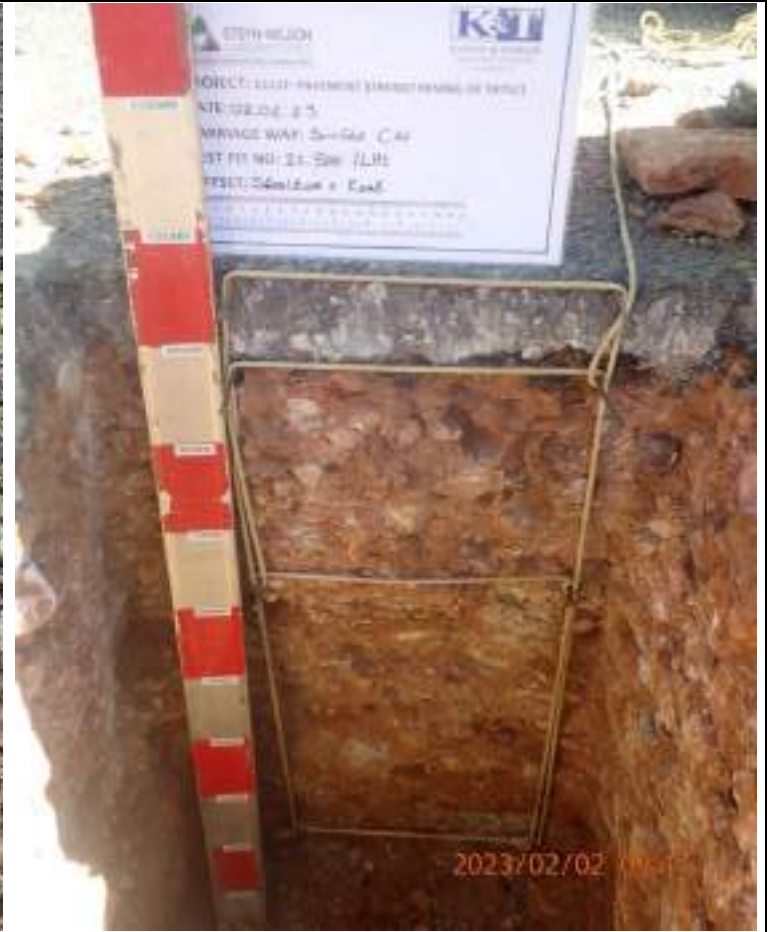
Profile Measurement

<p>0 - 50mm Cape Seal, /</p> <p>50 - 350mm Slightly Moist, Light Reddish BROWN, Very Dense, Intact, Silty Sandy fine to coarse S/Stone GRAVEL, Imported, HCL + / PHEN -, G6</p> <p>350 - 1000mm Moist, Light Orange BROWN, Dense, Intact, Silty Sandy fine to coarse Weathered Shale GRAVEL, Residual, HCL + / PHEN -, G9</p>	<p>Samples Taken:</p> <p>Layer 1 None Taken</p> <p>Layer 2 Sample No. 25739/62 taken at 50mm (Disturbed)</p> <p>Layer 3 Sample No. 25739/63 taken at 350mm (Disturbed)</p>	<p>25739/62</p> <p>25739/63</p>
--	--	---------------------------------

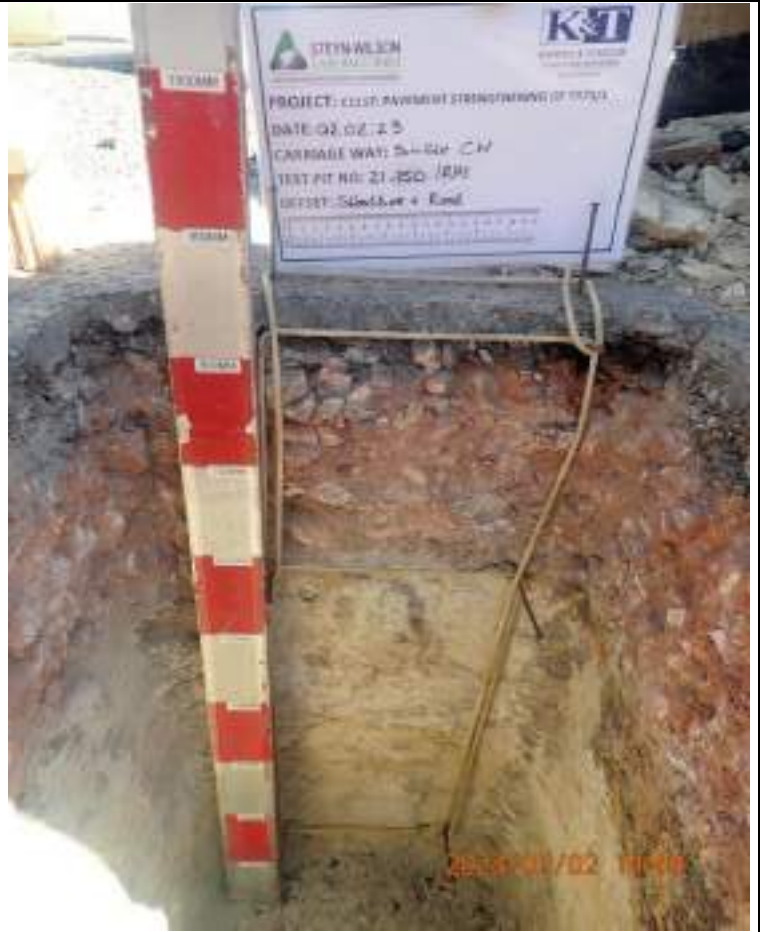
Profile Measurement

0 - 40mm	Cape Seal, /		
40 - 220mm	Slightly Moist, Light Reddish BROWN, Very Dense, Intact, Silty Sandy fine to coarse S/Stone GRAVEL, Imported, HCL - / PHEN -, G5	25739/66	
220 - 900mm	Moist, Light OLIVE, Dense, Intact, Silty Sandy fine to coarse Weathered Shale GRAVEL, Residual, HCL - / PHEN -, G9	25739/67	
Samples Taken: Layer 1 None Taken Layer 2 Sample No. 25739/66 taken at 40mm (Disturbed) Layer 3 Sample No. 25739/67 taken at 220mm (Disturbed)

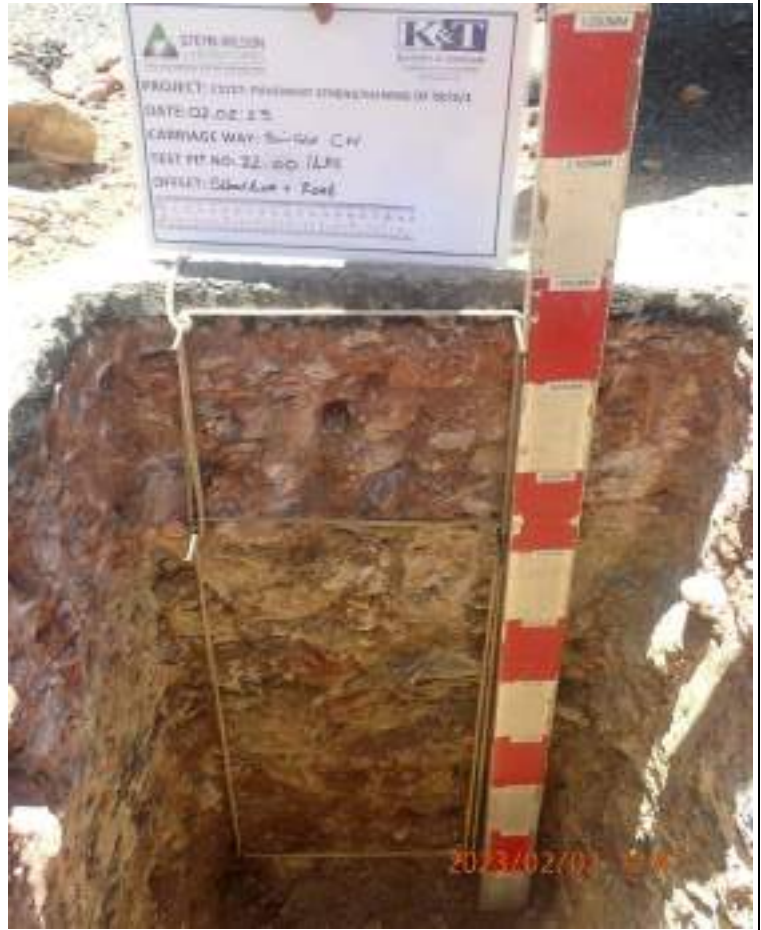
Profile Measurement

<p>0 - 30mm Cape Seal, /</p> <p>30 - 270mm Slightly Moist, Light Reddish BROWN, Very Dense, Intact, Silty Sandy fine to coarse S/Stone GRAVEL, Imported, HCL - / PHEN -, G5</p> <p>270 - 1000mm Slightly Moist, Light Olive BROWN, Dense, Intact, Abundant Silty Sandy fine to coarse weathered Shale GRAVEL, Residual, HCL + / PHEN -, G9</p>	<p>Samples Taken:</p> <p>Layer 1 None Taken</p> <p>Layer 2 Sample No. 25739/64 taken at 30mm (Disturbed)</p> <p>Layer 3 Sample No. 25739/65 taken at 270mm (Disturbed)</p>	<p>25739/64</p> <p>25739/65</p>
--	---	---------------------------------

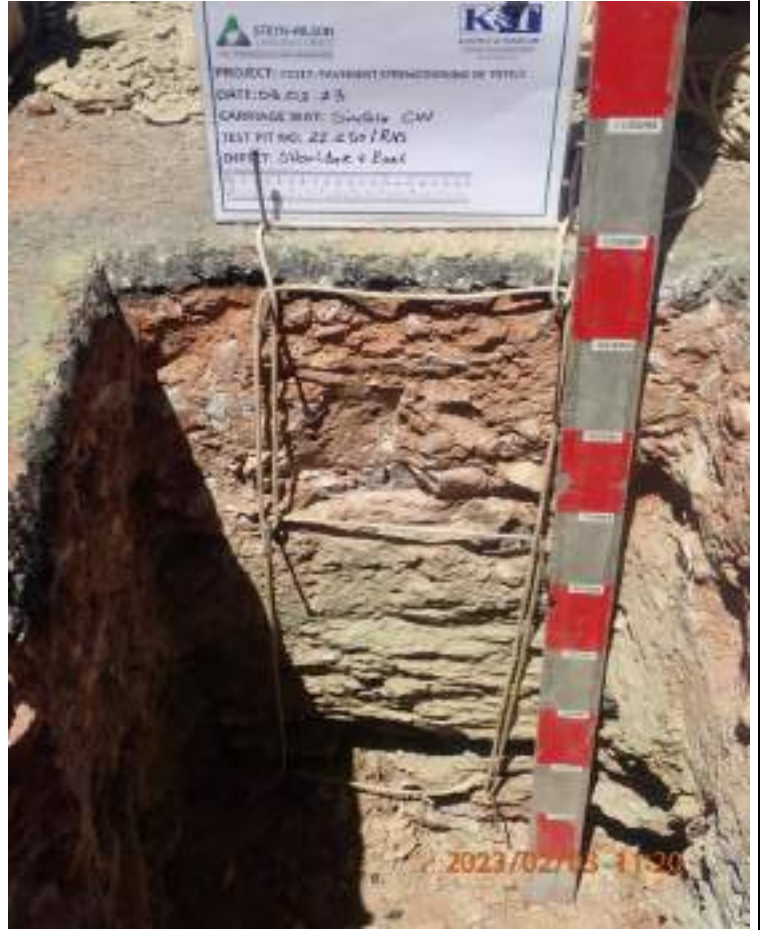
Profile Measurement

<p>0 - 35mm Cape SEAL, /</p> <p>35 - 330mm Slightly Moist, Light reddish BROWN, Very Dense, Intact, Silty Sandy fine to coarse S/Stone GRAVEL, Imported, HCL + / PHEN -, G5</p> <p>330 - 900mm Moist, Light OLIVE, Dense, Intact, Silty Sandy fine to coarse Weathered Shale GRAVEL, Residual, HCL + / PHEN -, G8</p> <p>Refusal on SHALE BEDROCK</p>	<p>Samples Taken:</p> <p>Layer 1 None Taken</p> <p>Layer 2 Sample No. 25739/68 taken at 35mm (Disturbed)</p> <p>Layer 3 Sample No. 25739/69 taken at 330mm (Disturbed)</p>	<p>25739/68</p> <p>25739/69</p>
---	--	---------------------------------

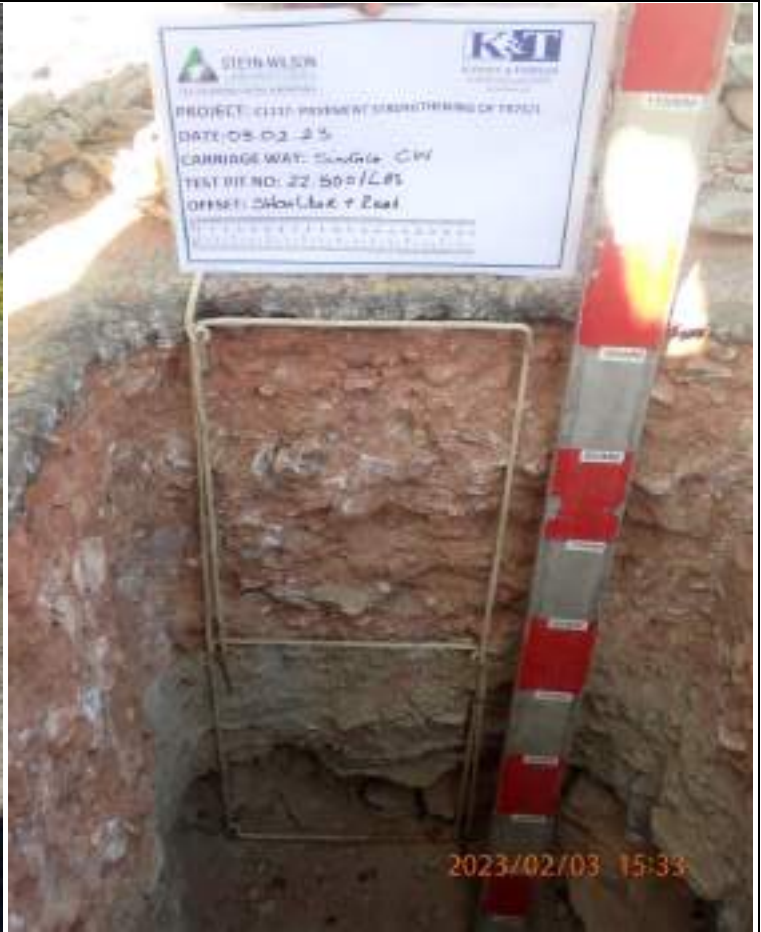
Profile Measurement

Samples Taken:
 Layer 1 None Taken
 Layer 2 Sample No. 25739/72 taken at 25mm (Disturbed)
 Layer 3 Sample No. 25739/73 taken at 430mm (Disturbed)

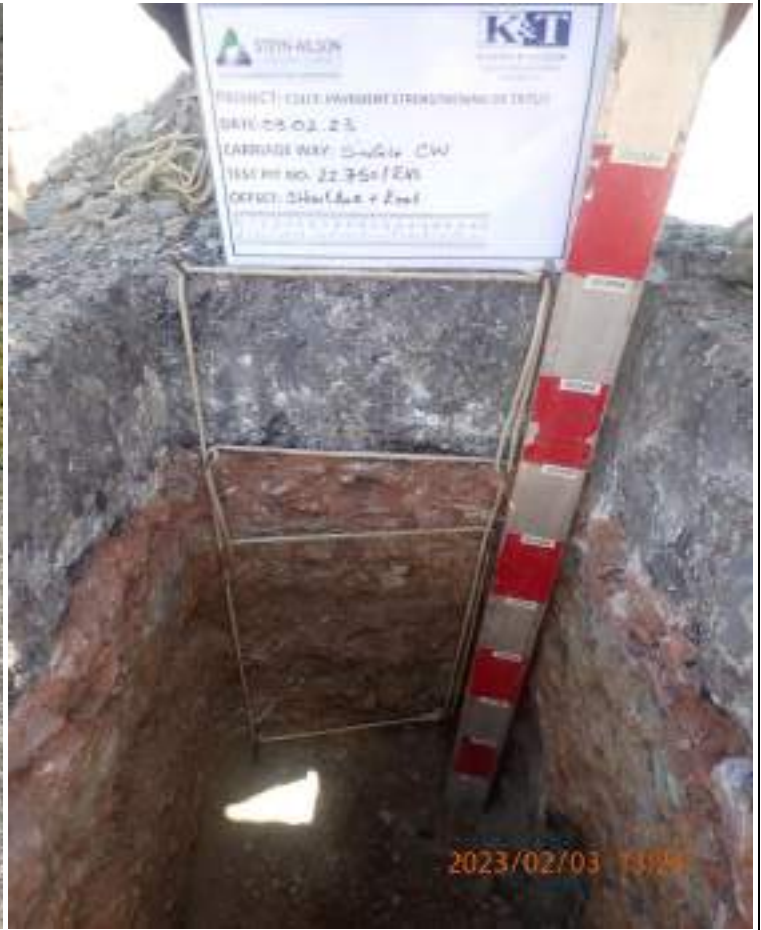
Profile Measurement

Samples Taken:
 Layer 1 None Taken
 Layer 2 Sample No. 25739/70 taken at 200mm (Disturbed)
 Layer 3 Sample No. 25739/71 taken at 300mm (Disturbed)

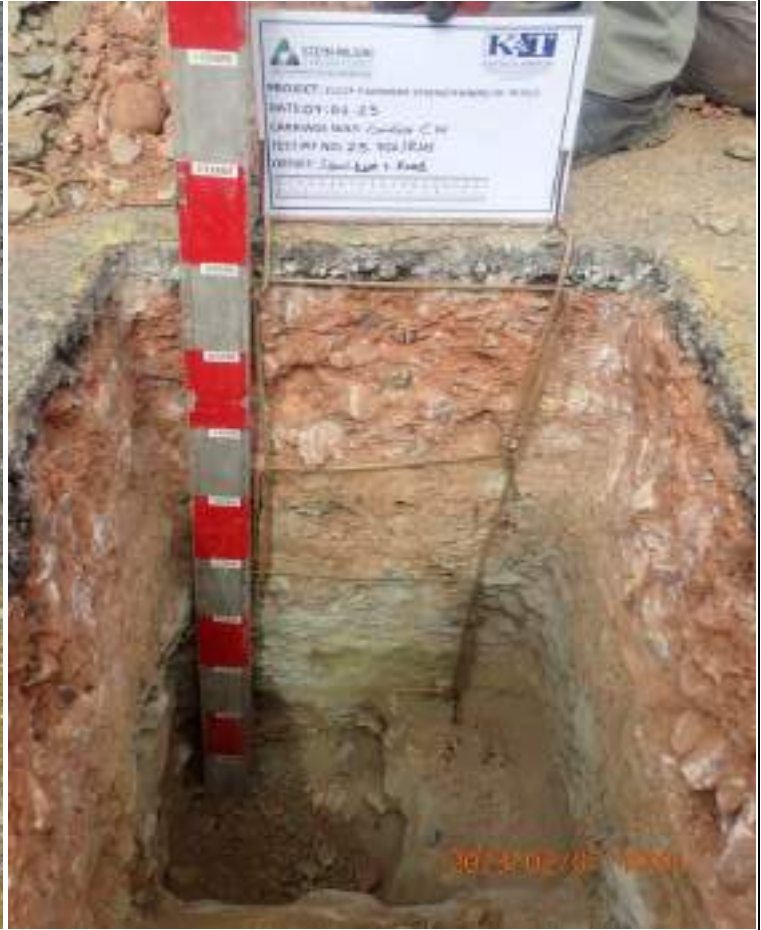
Profile Measurement

<p>0 - 40mm</p> <p>40 - 280mm</p> <p>280 - 460mm</p> <p>460 - 1000mm</p>	<p>CAPE SEAL, /</p> <p>Slightly Moist, Light Reddish BROWN, Very Dense, Intact, Silty Sandy fine to coarse S/Stone GRAVEL, Imported, HCL - / PHEN -</p> <p>Moist, Light BROWN, Dense, Intact, Silty fine to coarse grain SAND with abundant Shale Gravel, Imported, HCL + / PHEN -</p> <p>Moist, Light Yellowish BROWN, Very Dense, Intact, Silty Sandy fine to coarse Weathered Shale GRAVEL, Residual, HCL - / PHEN -</p> <p>BEDROCK BELOW</p>	<p>25739/88</p> <p>25739/89</p> <p>25739/90</p>
--	---	---

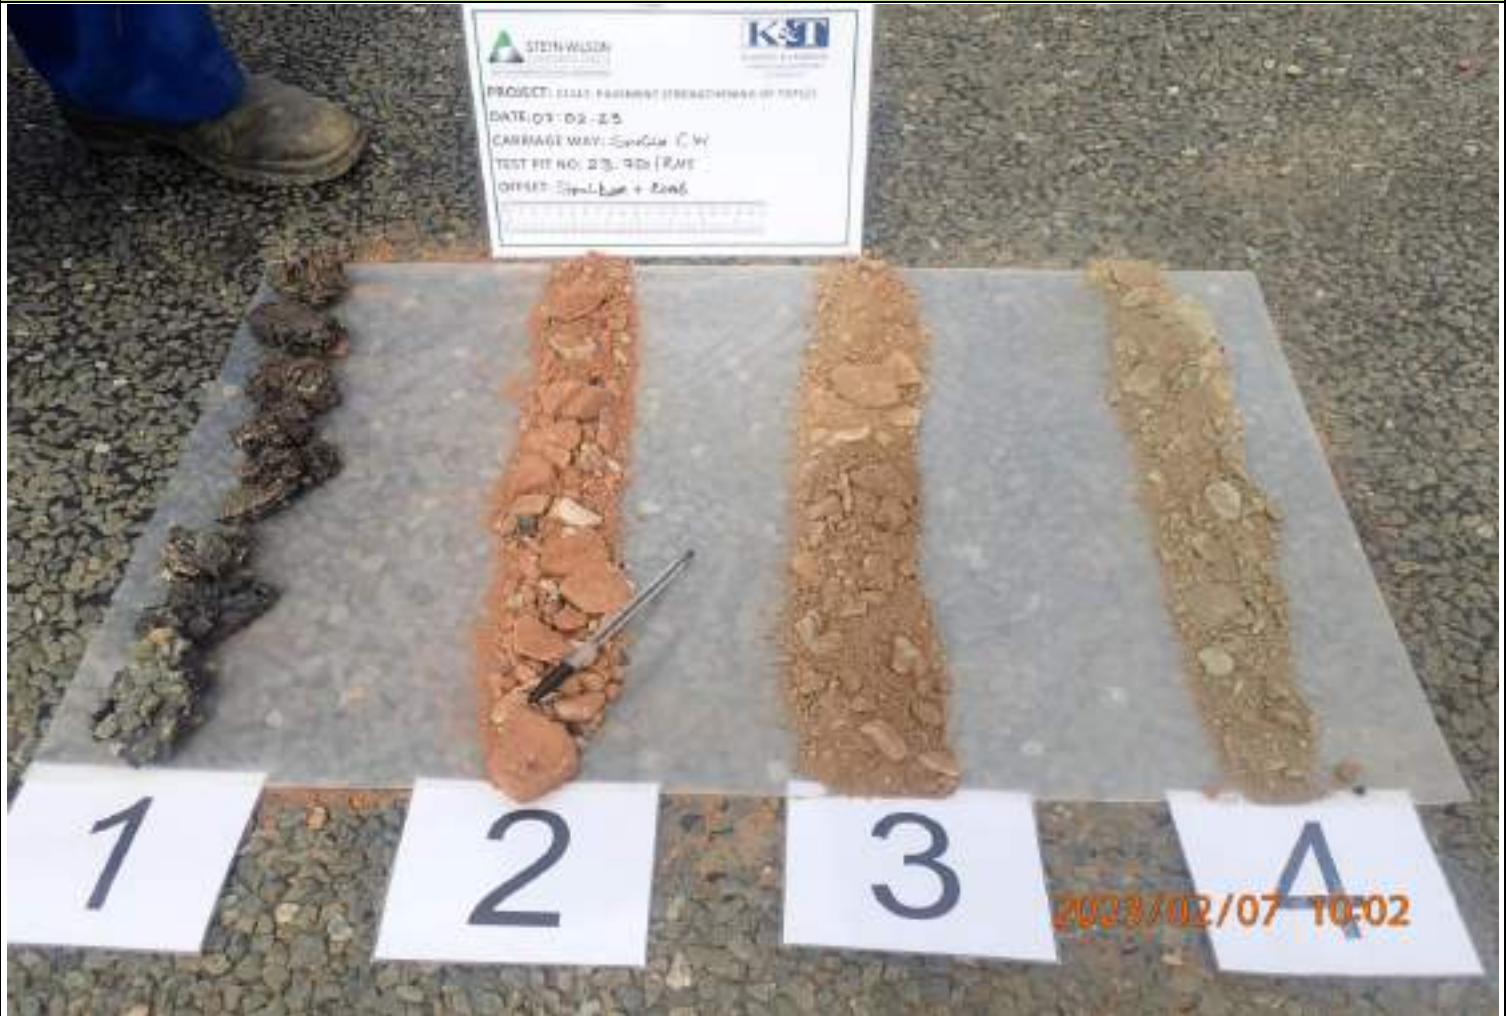
Spoils

Samples Taken:
 Layer 1 None Taken
 Layer 2 Sample No. 25739/88 taken at 40mm (Disturbed)
 Layer 3 Sample No. 25739/89 taken at 280mm (Disturbed)
 Layer 4 Sample No. 25739/90 taken at 460mm (Disturbed)

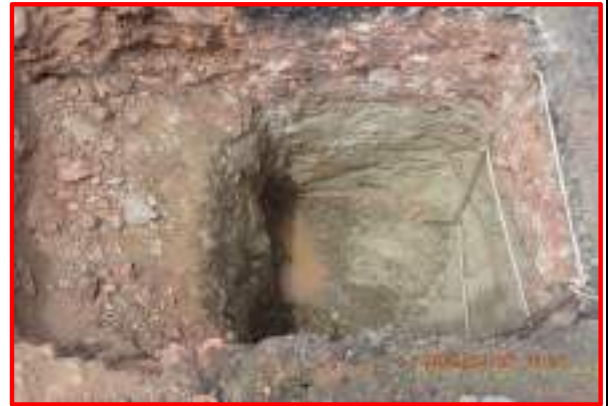
Water infiltration @ 0,7m (next to V-Drain)

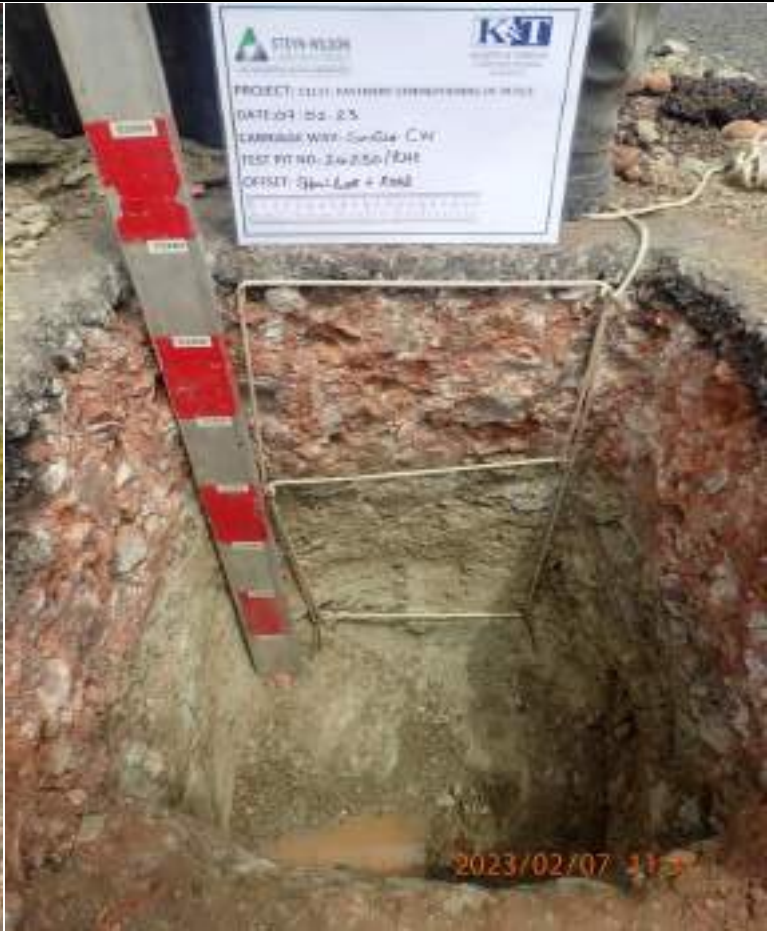
Profile Measurement

0 - 20mm	CAPE SEAL, /	
20 - 300mm	Slightly Moist, Light Reddish BROWN, Very Dense, Intact, Silty Sandy fine to coarse S/Stone GRAVEL, Imported, HCL - / PHEN -, G5	25739/91
300 - 700mm	Moist, Light Olive BROWN, Very Dense, Intact, Silty Sandy fine to coarse Weathered Shale GRAVEL, Residual, HCL - / PHEN -, G8	25739/92
Refusal on BEDROCK		
Samples Taken: Layer 1 None Taken Layer 2 Sample No. 25739/91 taken at 20mm (Disturbed) Layer 3 Sample No. 25739/92 taken at 300mm (Disturbed)

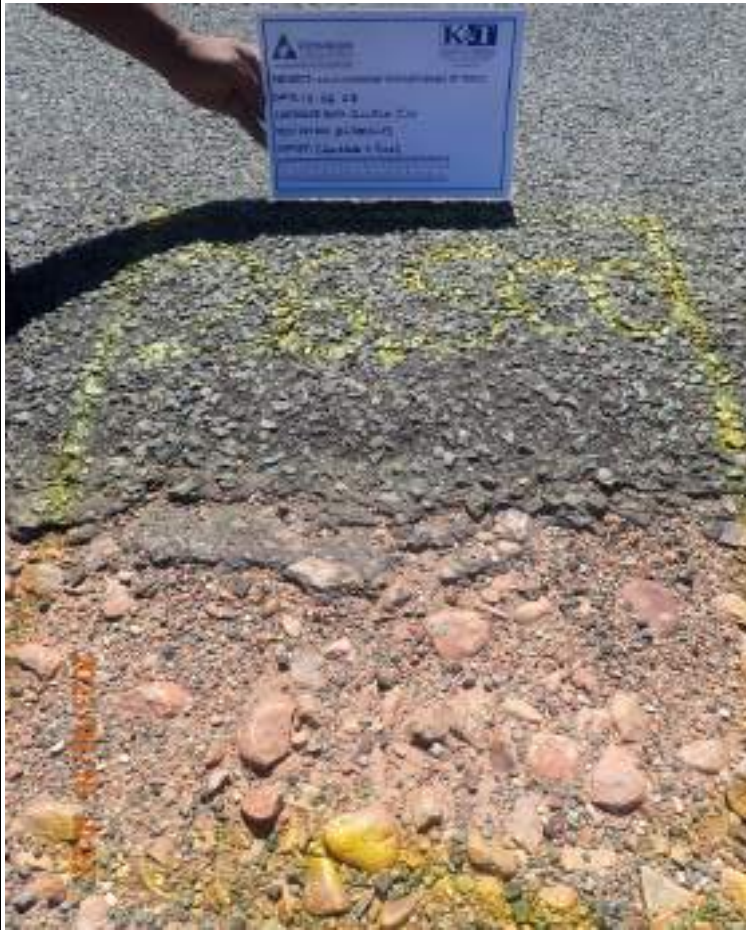
Surface Visual

<p>0 - 25mm CAPE SEAL, /</p> <p>25 - 700mm Slightly Moist, Dark Reddish BROWN, Very Dense, Intact, Silty Sandy fine to coarse S/Stone GRAVEL, Imported, HCL - / PHEN -, G5</p> <p>700 - 1000mm Moist, Light Orange BROWN, Very Dense, Intact, Silty fine to coarse grain SAND with abundant S/Stone Gravel, Imported, HCL - / PHEN -, G10</p>	<p>Samples Taken: Layer 1 None Taken Layer 2 Sample No. 25739/113 taken at 25mm (Disturbed) Layer 3 Sample No. 25739/116 taken at 700mm (Disturbed)</p>	<p>25739/113</p> <p>25739/116</p>
--	--	-----------------------------------

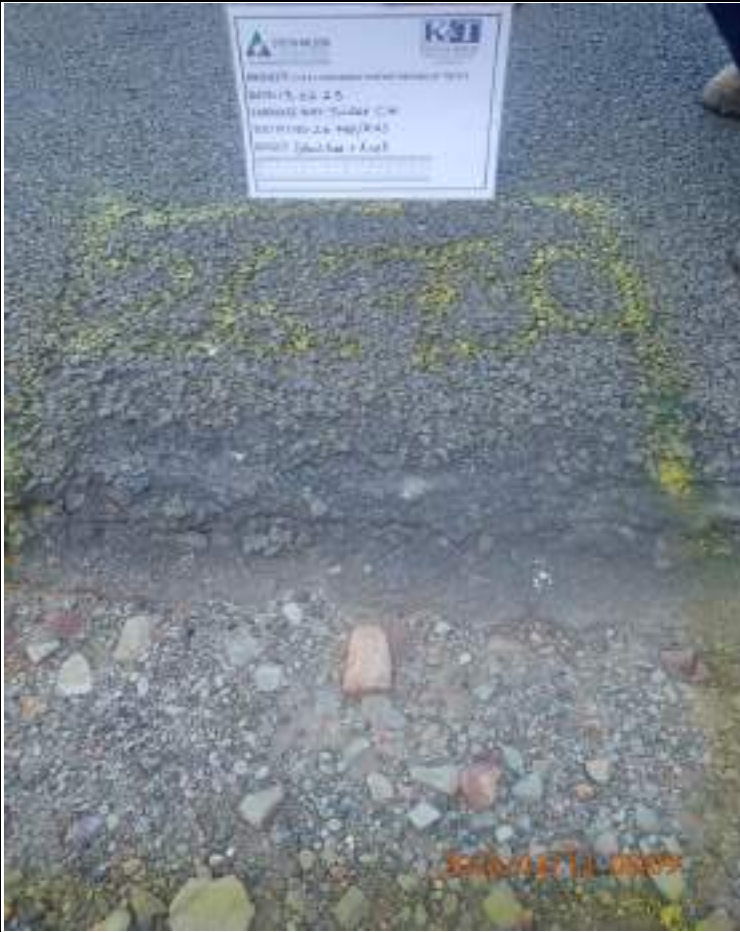
Surface Visual

<p>0</p> <p>100</p> <p>200</p> <p>300</p> <p>400</p> <p>500</p> <p>600</p> <p>700</p> <p>800</p> <p>900</p> <p>1 000</p>	<p>0 - 20mm CAPE SEAL, /</p> <p>20 - 900mm Moist, Light Reddish BROWN, Dense, Intact, Silty Sandy fine to coarse S/Stone GRAVEL with minor Cobble, Imported, HCL - / PHEN -, G6</p> <p>REFUSAL ON S/STONE BOULDERS</p> <p>Samples Taken: Layer 1 None Taken Layer 2 Sample No. 25739/126 taken at 20mm (Disturbed)</p>	<p>25739/126</p>
--	---	------------------

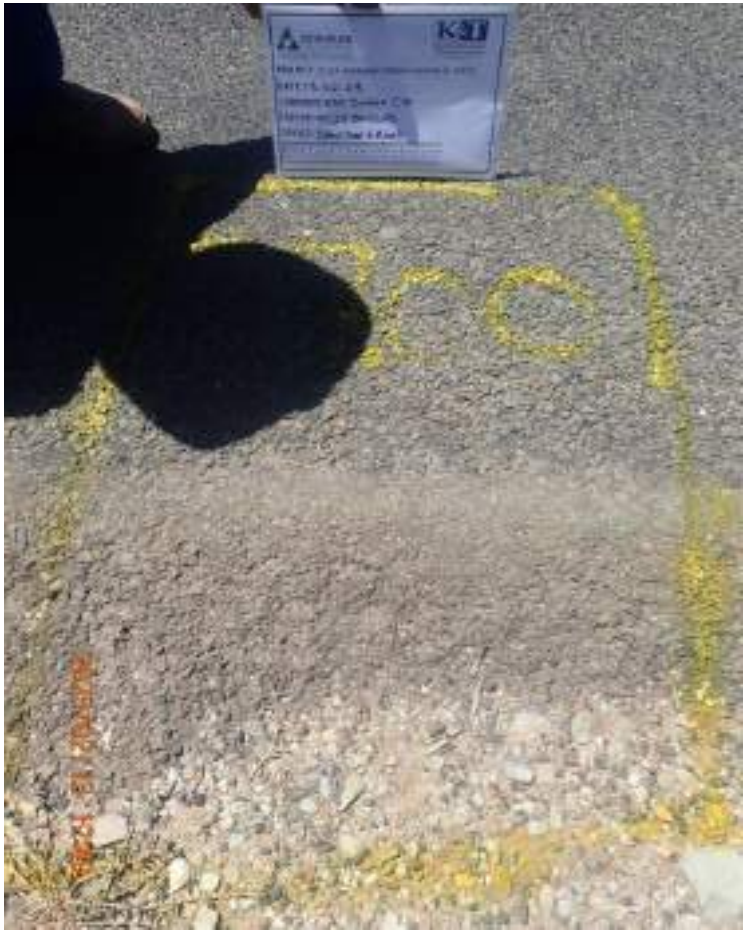
Surface Visual

<p>0 - 30mm</p> <p>30 - 200mm</p> <p>200 - 900mm</p>	<p>CAPE SEAL, /</p> <p>Slightly Moist, Light Orange BROWN, Dense, Intact, Silty Sandy fine to coarse S/Stone GRAVEL, Imported, HCL - / PHEN -, G5</p> <p>Moist, Light Reddish BROWN, Dense, Intact, Silty Sandy fine to coarse S/Stone GRAVEL with minor Cobble, Imported, HCL - / PHEN -, G7</p>	<p>25739/129</p> <p>25739/130</p>
<p>Samples Taken:</p> <p>Layer 1 None Taken</p> <p>Layer 2 Sample No. 25739/129 taken at 30mm (Disturbed)</p> <p>Layer 3 Sample No. 25739/130 taken at 200mm (Disturbed)</p>

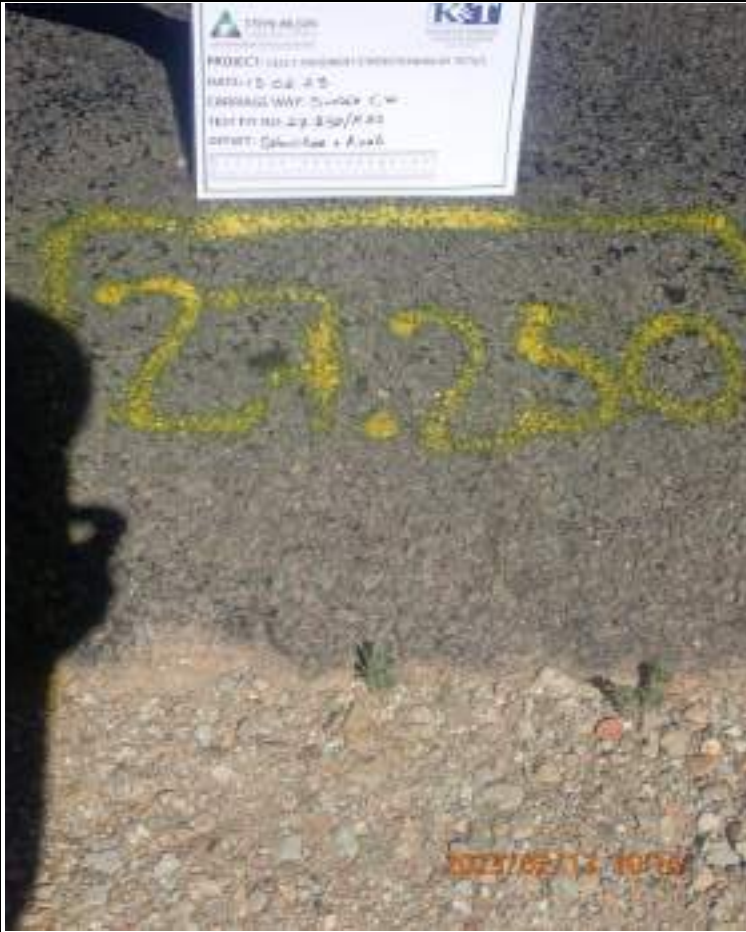
Surface Visual

0 - 20mm	CAPE SEAL, /	
20 - 150mm	Slightly Moist, Light Reddish BROWN, Dense, Intact, Silty Sandy fine to coarse S/Stone GRAVEL, Imported, HCL - / PHEN -, G5	25739/127
150 - 900mm	Moist, Dark Reddish BROWN, Dense, Intact, Silty Sandy fine to coarse S/Stone GRAVEL with minor Cobble, Imported, HCL - / PHEN -, G7	25739/128
Samples Taken: Layer 1 None Taken Layer 2 Sample No. 25739/127 taken at 20mm (Disturbed) Layer 3 Sample No. 25739/128 taken at 150mm (Disturbed)

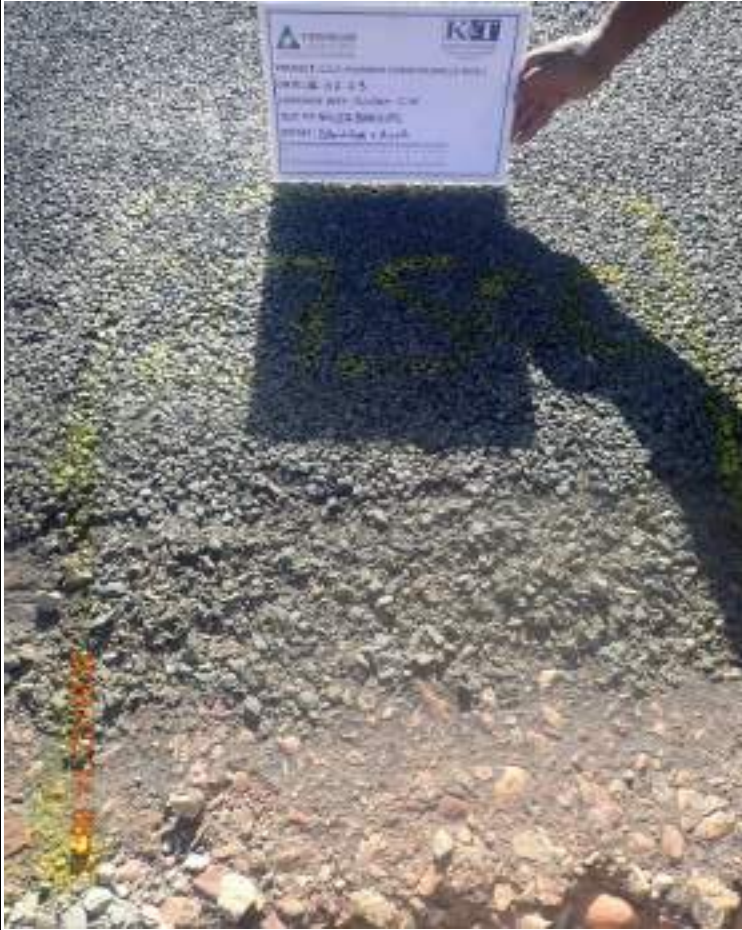
Surface Visual

<p>0</p> <p>100</p> <p>200</p> <p>300</p> <p>400</p> <p>500</p> <p>600</p> <p>700</p>	<p>0 - 20mm CAPE SEAL, /</p> <p>20 - 580mm Slightly Moist, Light Reddish BROWN, Dense, Intact, Silty Sandy fine to coarse S/Stone GRAVEL with minor Cobble, Imported, HCL - / PHEN -</p> <p>REFUSAL ON S/STONE BOULDERS</p>	<p>25739/131</p>
---	---	------------------

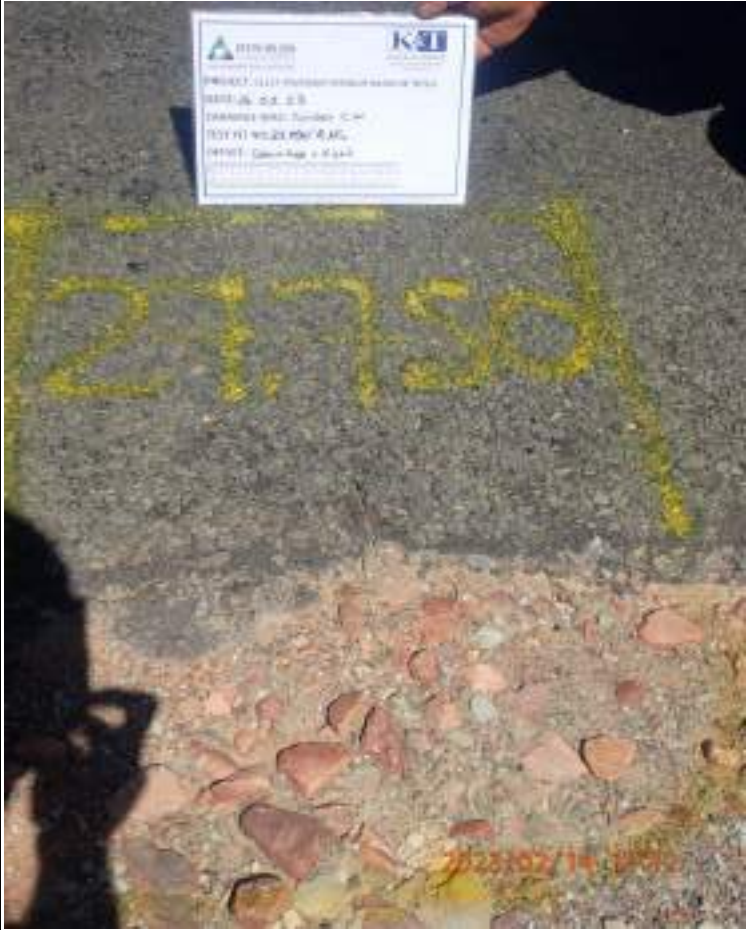
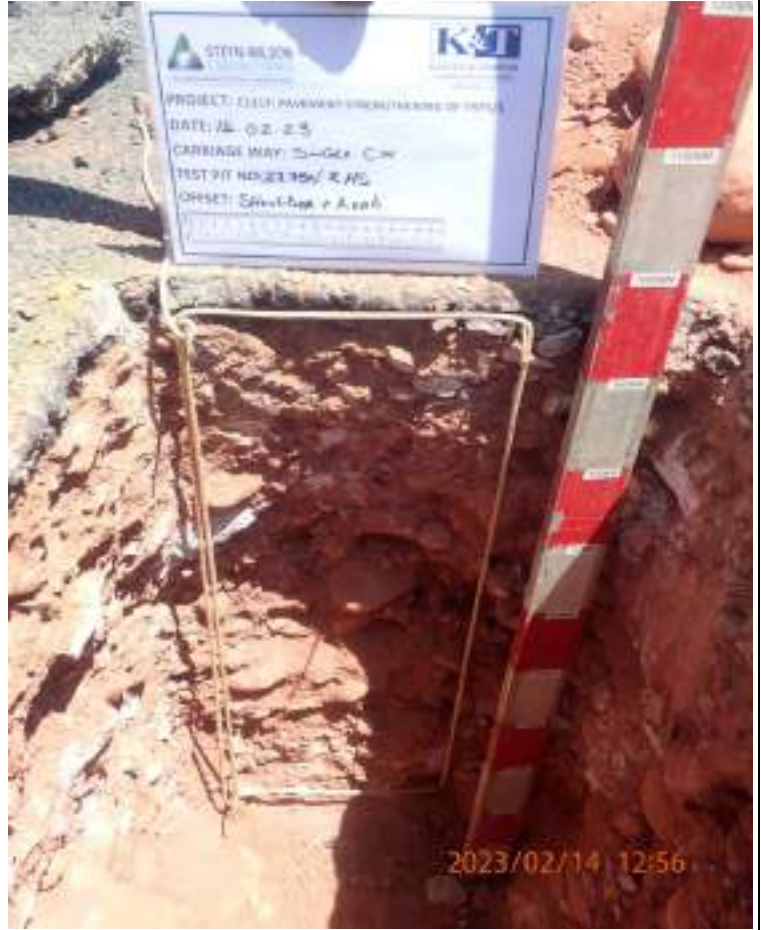
Profile Measurement

0 - 25mm	CAPE SEAL, /	
25 - 1000mm	Moist, Light Reddish BROWN, Dense, Intact, Silty Sandy fine to coarse S/Stone GRAVEL with minor Cobble, Imported, HCL - / PHEN -, G5	25739/134

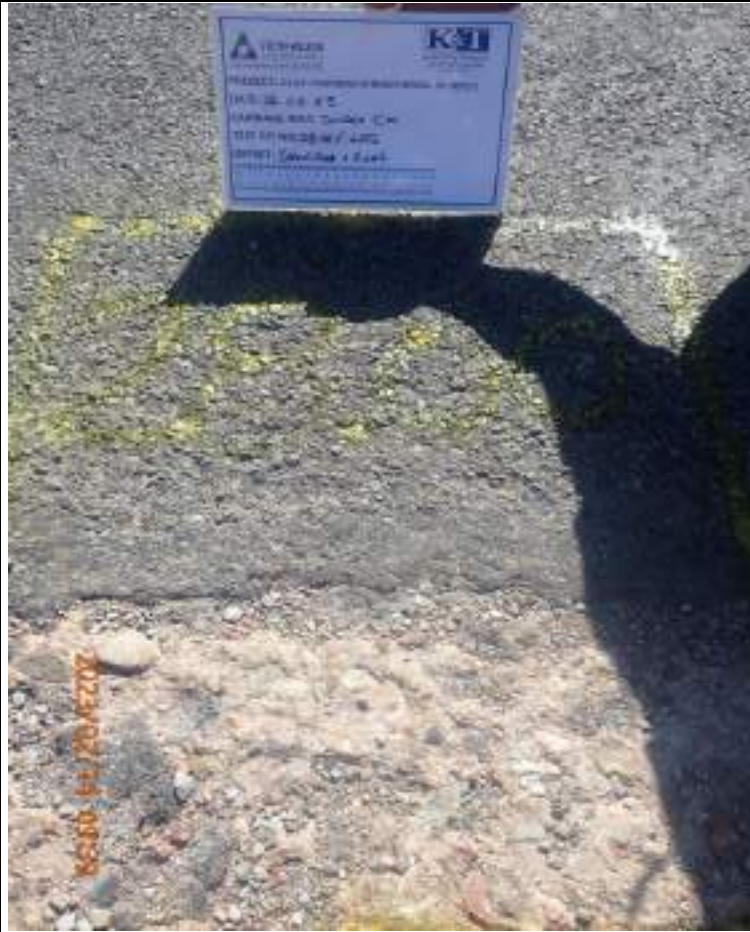
Surface Visual

0 - 30mm	CAPE SEAL, /		
30 - 300mm	Slightly Moist, Light Orange BROWN, Dense, Intact, Silty Sandy fine to coarse S/Stone GRAVEL, Imported, HCL - / PHEN -, G5	25739/132	
300 - 1000mm	Moist, Dark Reddish BROWN, Medium Dense, Intact, Abundant Silty fine to coarse grain SAND with minor Gravel, Residual, HCL + / PHEN -, G9	25739/133

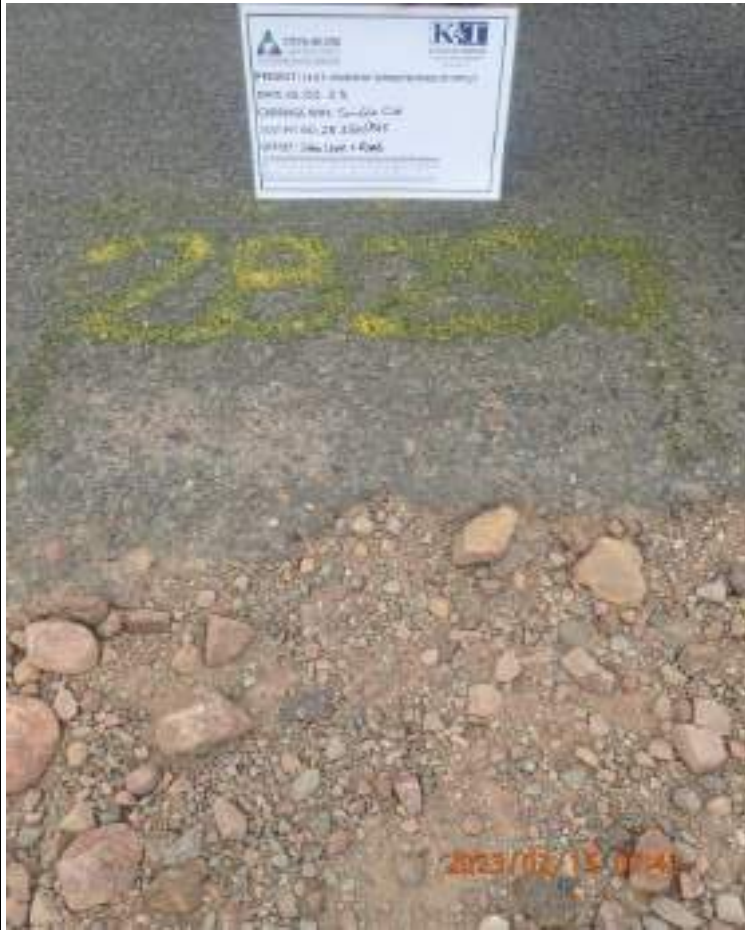
Surface Visual

0 - 30mm	CAPE SEAL, /	
30 - 400mm	Slightly Moist, Light Reddish BROWN, Dense, Intact, Silty Sandy fine to coarse S/Stone GRAVEL, Imported, HCL + / PHEN -, G5	25739/135
400 - 900mm	Moist, Dark BROWN, Dense, Intact, Silty Sandy fine to coarse S/Stone GRAVEL with minor Cobble, Imported, HCL + / PHEN -, G5	25739/136

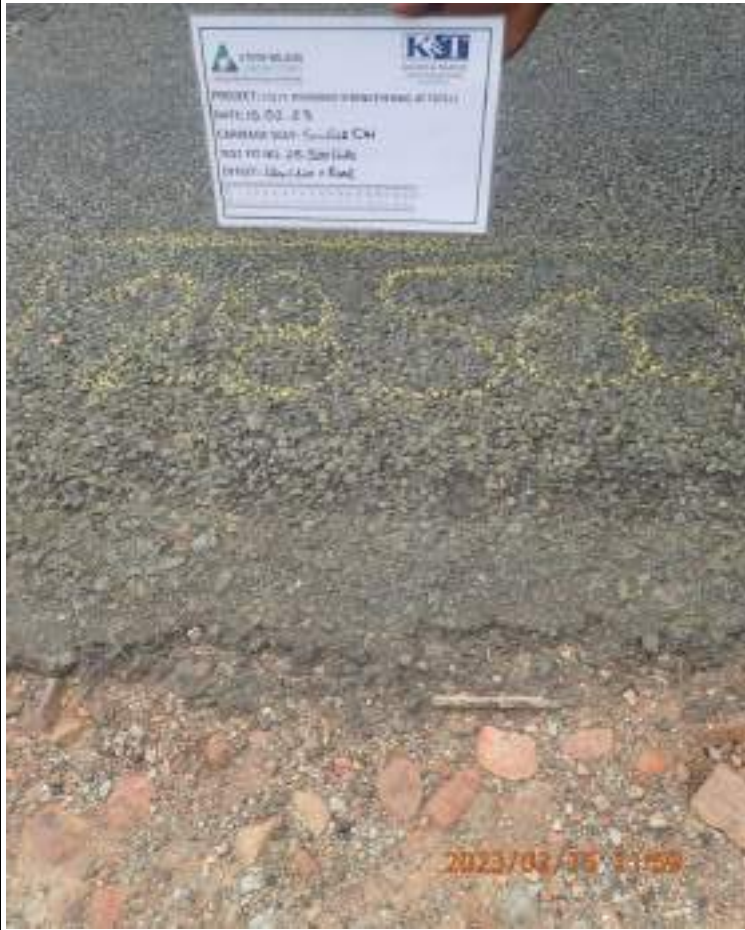
Surface Visual

30 - 1000mm Moist, Light Reddish BROWN, Dense, Intact, Clayey Sandy fine to coarse S/Stone GRAVEL with minor Cobble, Imported, HCL - / PHEN -, G6

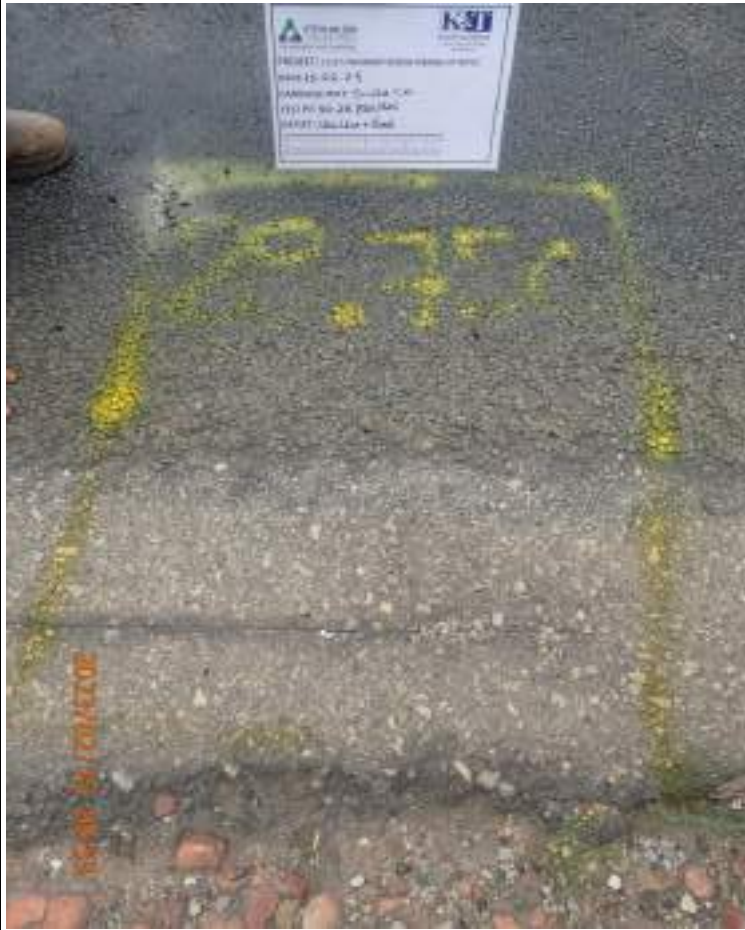
Surface Visual

0 - 30mm	CAPE SEAL, /	
30 - 350mm	Slightly Moist, Light Orange BROWN, Dense, Intact, Silty Sandy fine to coarse S/Stone GRAVEL with minor Cobble, Imported, HCL - / PHEN -, G5	25739/137
350 - 900mm	Moist, Dark Reddish BROWN, Dense, Intact, Silty Sandy fine to coarse S/Stone GRAVEL with abundant Cobble, Imported, HCL - / PHEN -, G7	25739/138

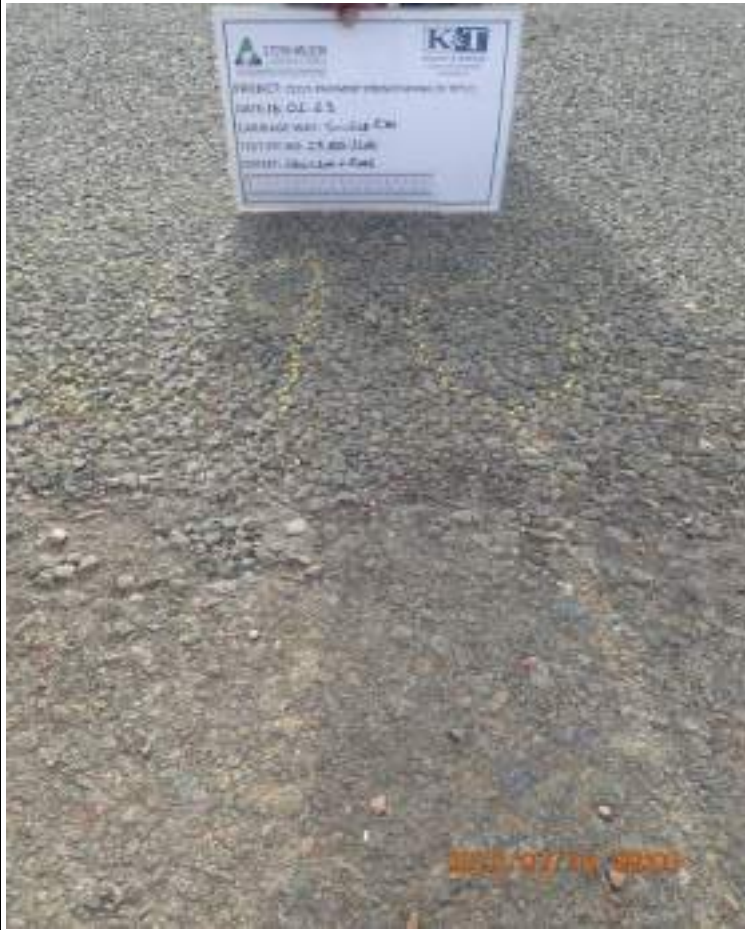
Surface Visual

0 - 25mm CAPE SEAL, /
 25 - 900mm Slightly Moist, Light Orange BROWN, Dense, Intact, Silty Sandy fine to coarse S/Stone GRAVEL, Imported, HCL + / PHEN -, G5 25739/140

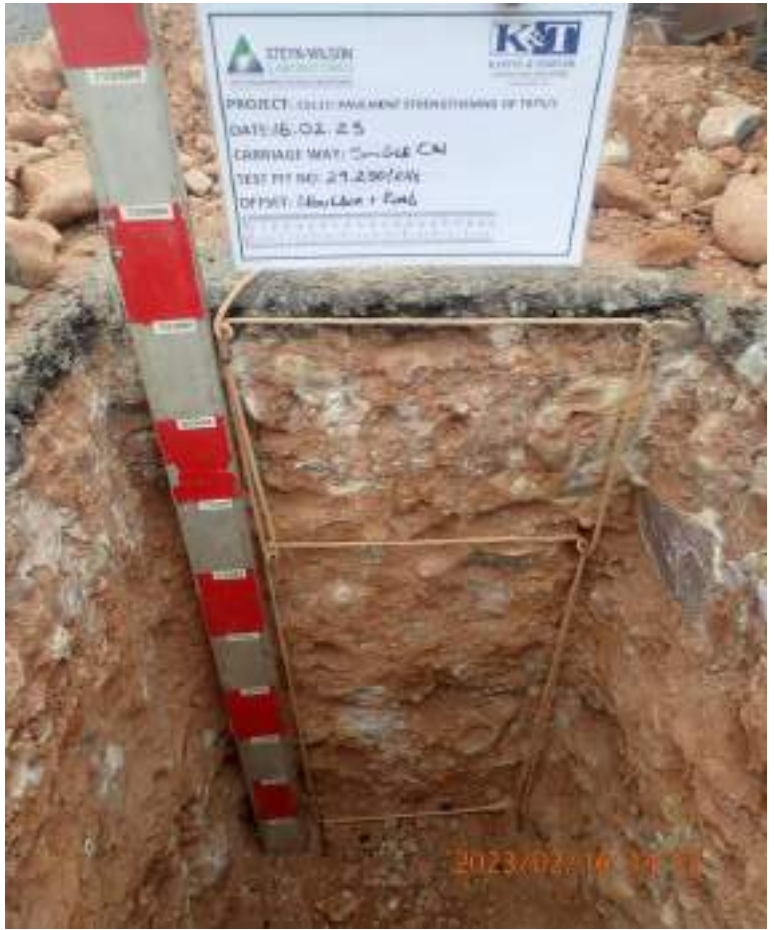
Profile Measurement

Samples Taken:
 Layer 1 None Taken
 Layer 2 Sample No. 25739/143 taken at 20mm (Disturbed)
 Layer 3 Sample No. 25739/144 taken at 320mm (Disturbed)

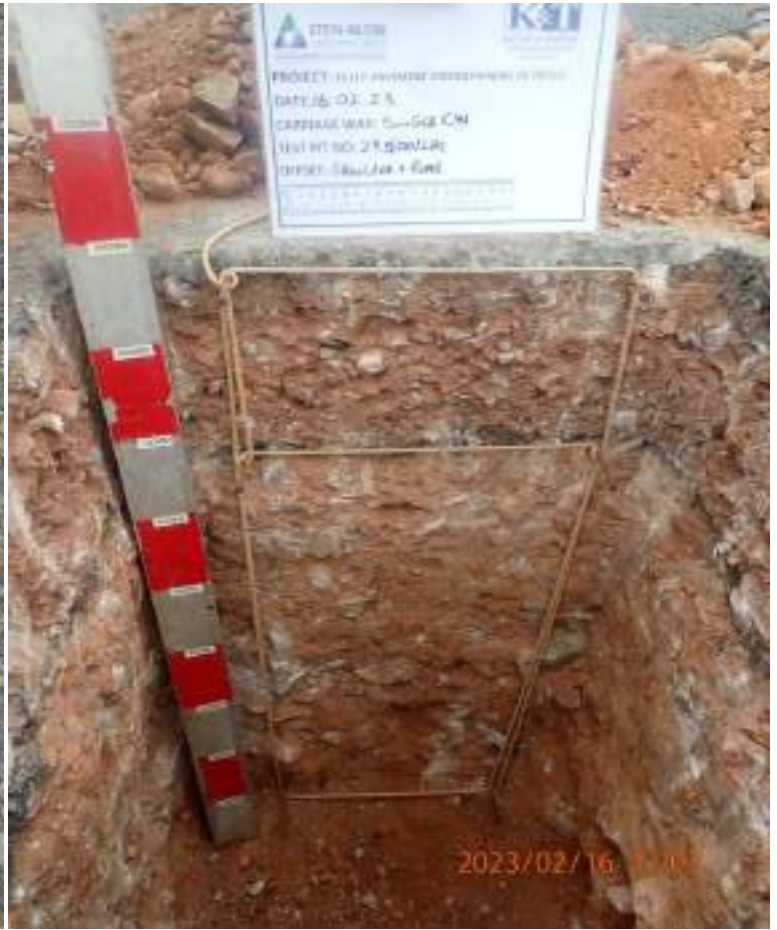
Profile Measurement

Samples Taken:
 Layer 1 None Taken
 Layer 2 Sample No. 25739/141 taken at 20mm (Disturbed)
 Layer 3 Sample No. 25739/142 taken at 250mm (Disturbed)

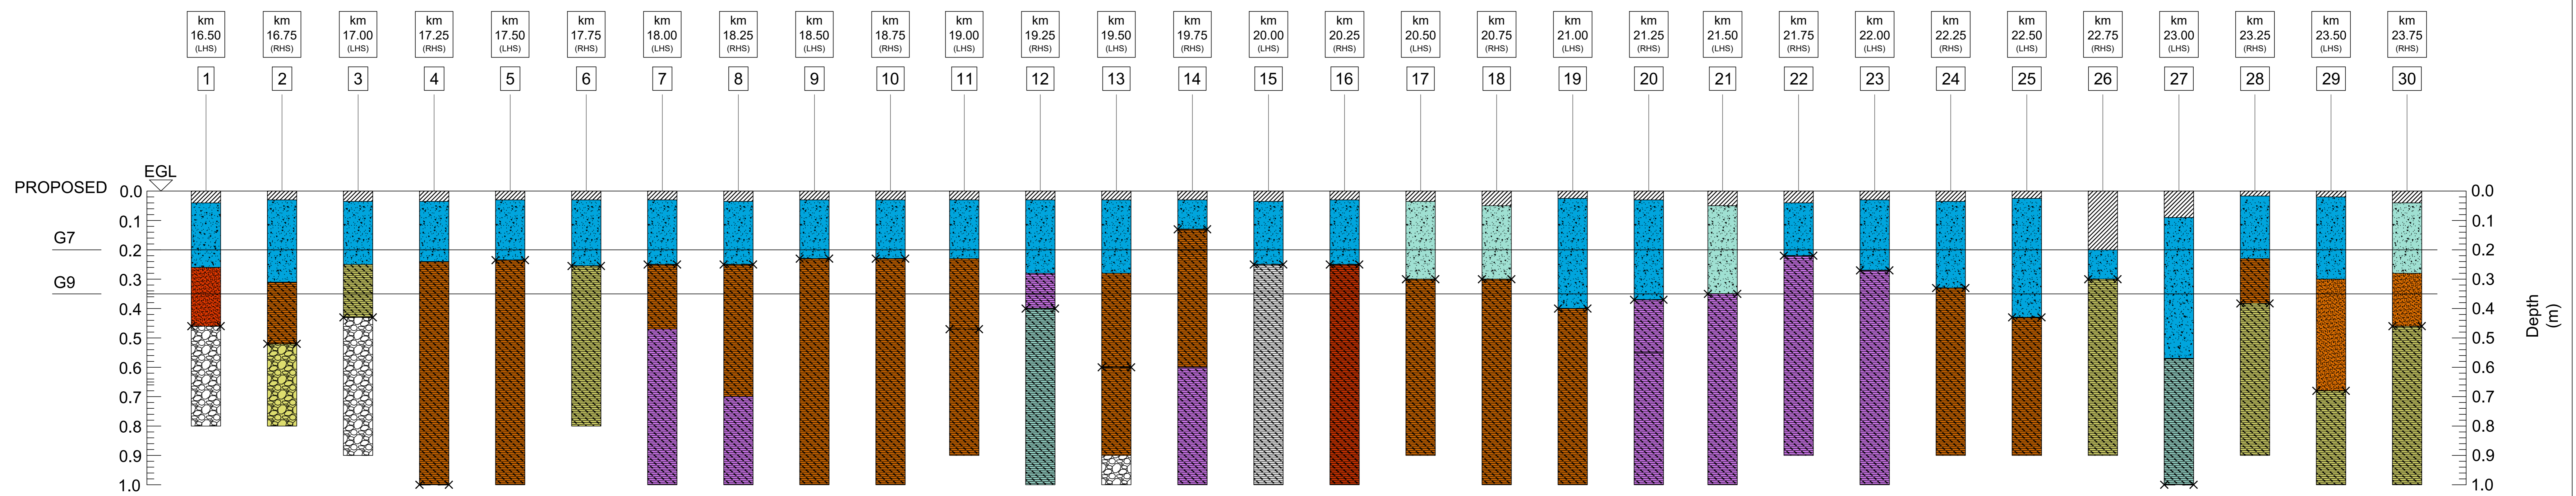
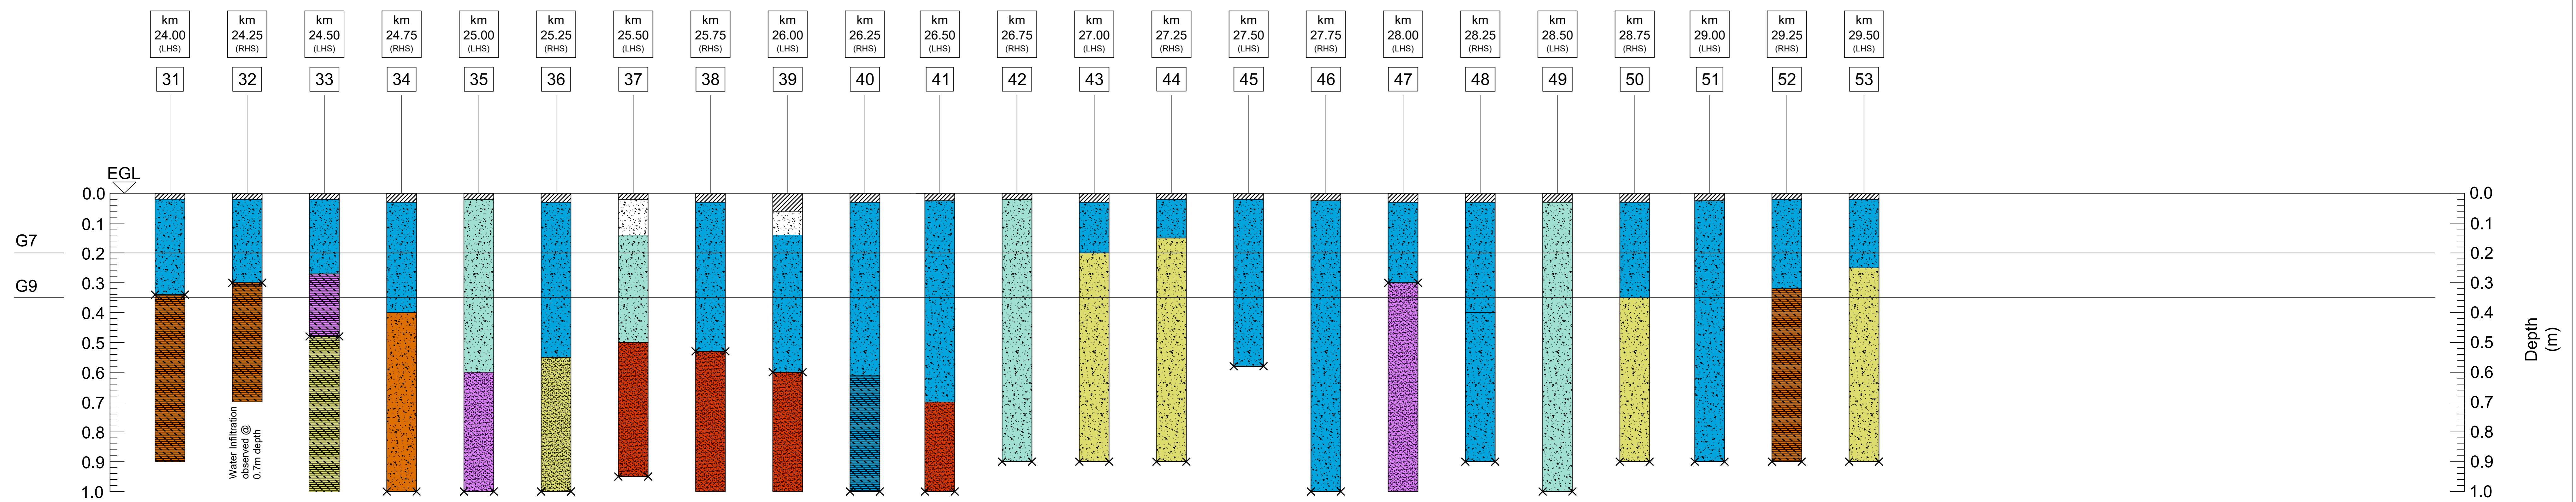
Option 2: Insitu reconstruct the existing base to comply with the requirements of an upper selected layer and construct a new cement stabilized subbase and new G2 base. A summary plan of the trial pits along the route which reflects the proposed Option 2 pavement layers is included as **Annexure 2.3**. Layers marked with "X" do not comply with the required material quality. It is noted that all layers comply in this option.

CONTRACT NO C1117: PAVEMENT STRENGTHENING OF TR75/1
(KM 16.50 TO KM 31.22) NEAR OUDTSHOORN
CENTERLINE SOILS INVESTIGATION
OPTION 2: EXISTING BASE AS NEW UPPER SSG

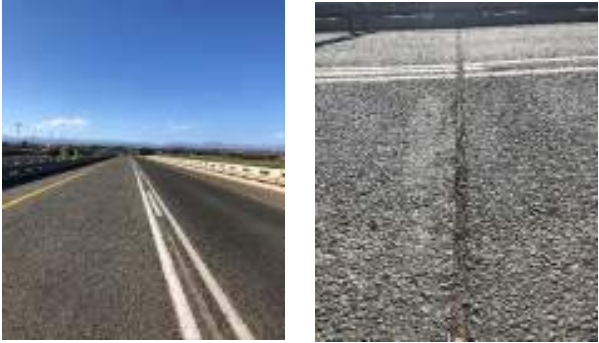
Item	Description	Photographs from Visual Inspection	WCG comments & other remarks	Proposed Remedial activities
1	Deck Surfacing

Surfacing at end of service life, done prior to joint remedial in 2008	Mill reseal and original asphalt and replace with new asphalt surfacing.
2	Deck Expansion joints

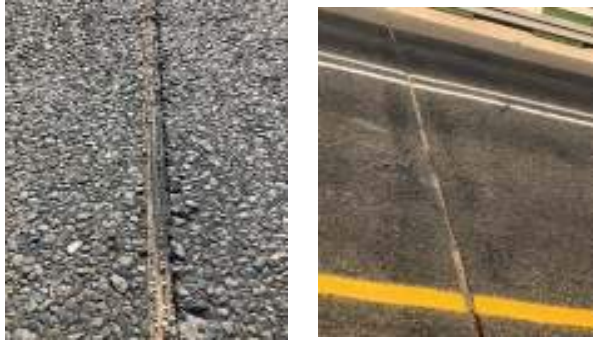
Additional clarification for proposed joint solution required	Provide new asphaltic plug joints or replace neoprene seal dependent on condition after milling operation. Refer to discussion and recommendation in Section 10.2.3 of the CV report.
3	Honey combing at abutment

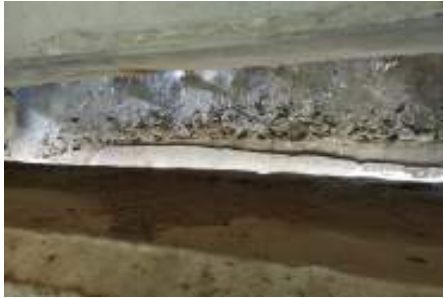
To be included if detrimental to long term.	No remedial activities recommended.
