CONCEPT & VIABILITY REPORT

CONTRACT No. C1117

PAVEMENT STRENGTHENING OF TR75/1 (KM 16.50
TO KM 31.20) NEAR OUDTSHOORN

CHIEF DIRECTORATE: ROAD PROGRAMME MANAGEMENT
ROADS BRANCH

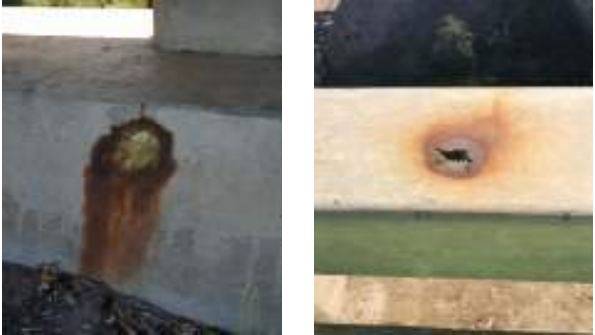
Item	Description	Photographs from Visual Inspection	WCG comments & other remarks	Proposed Remedial activities
4	Balustrade cracking, rebar corrosion & spalling

Localized rebar corrosion Spalling and staining of concrete surface	Patch repairs including rebar corrosion protection. Seal fine cracking at post base. Possible aesthetic surface coating to be confirmed during Detail design stage.
5	Approach fill cracking and settlement at abutment

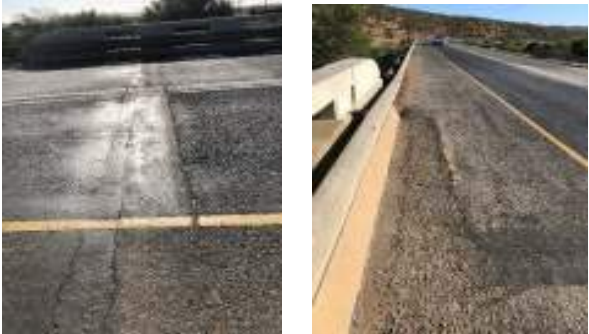
Local settlement and cracking adjacent to abutment joints	Remedial activities which include removal of deformed area, asphaltic base backfill and surfacing to be replaced with new asphalt.

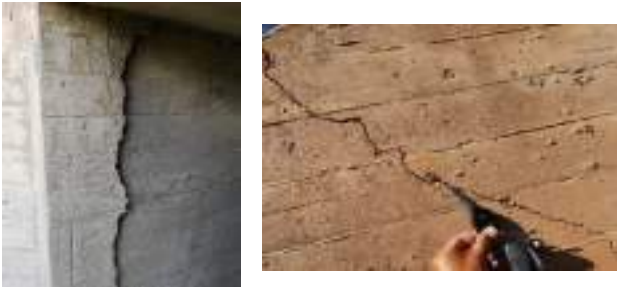
Item	Description	Photographs from Visual Inspection	WCG comments & other remarks	Proposed Remedial activities
1	Diagonal and vertical cracks at inlet / outlet wingwalls

Repairs needed if structural capacity affected.	Assess wingwall stability & strengthen / tie back if necessary. Repair crack (Surface and grout fill).
2	Vertical cracks in barrel walls

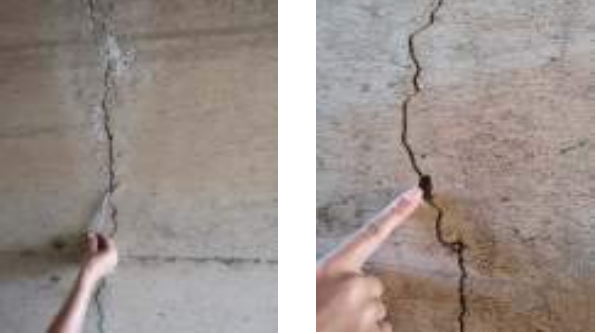
These cracks are shrinkage related due to length of cast and minimal distribution steel.	No remedial action required.
3	Spalling and longitudinal cracking of roof slab

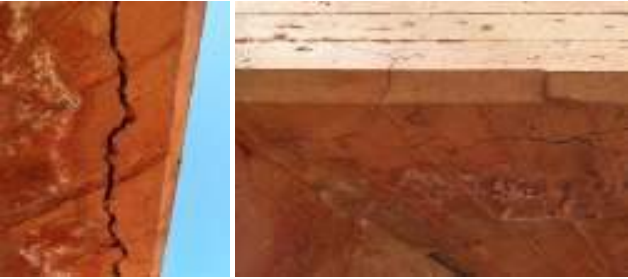
To be included if detrimental to long term. Repairs needed if structural capacity affected.	Assess structural impact. Repair corroded rebar & spalling. Inject cracks if structural. Consider widening method and related tie-in.

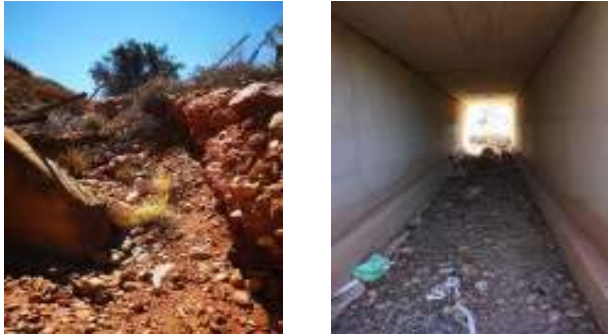
Item	Description	Photographs from Visual Inspection	WCG comments & other remarks	Proposed Remedial activities
4	Scour in barrels and inlets/outlets

Erosion protection measures to be considered.	New invert slab with cut-offs. Protection at inlet wingwalls. Protection at outlet. Consider widening method which may incorporate some of these measures.
5	Miscellaneous defects

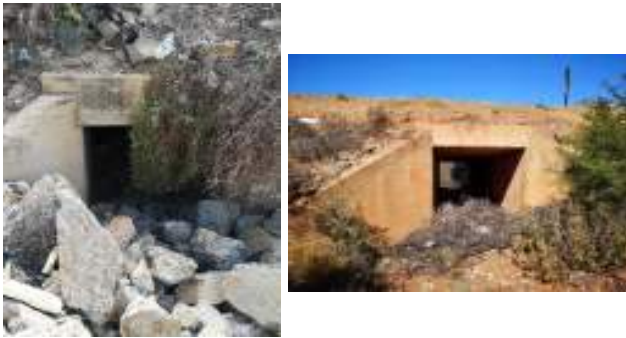
Various items related to maintenance and safe operation of the structures.	Clear boulders and debris from water way. Shape and trim embankments. Reinstate fencing. Hazard signage or guardrails as warranted.

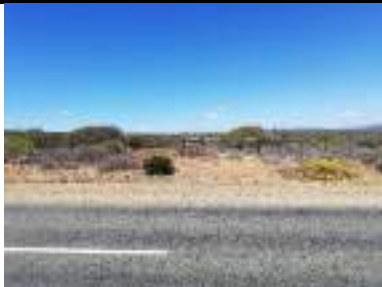
Location		Type		Use			Destination	
Km	Side	Surf.	Gravel	Freq.	Seldom	Disused	Private	Public
17.06	LHS X 2		X		X			X
Sight Distance(100km/h)		Access	RHS	>300m				
			LHS	>300m				
Access Details (WCS/11/2/C1)								
Minor Farm	X	Main Farm		>50 vpd			Intersection

Impacted by auxiliary lane: No
Proposed Action: Reconstruct minor farm access.

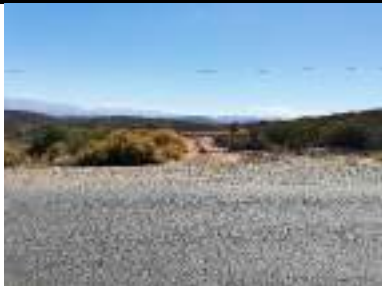
Location		Type		Use			Destination	
Km	Side	Surf.	Gravel	Freq.	Seldom	Disused	Private	Public
17.06	RHS		X		X			X
Sight Distance(100km/h)		Access	RHS	>300m				
			LHS	>300m				
Access Details (WCS/11/2/C1)								
Minor Farm	x	Main Farm		>50 vpd			Intersection

Impacted by auxiliary lane: Yes
Proposed Action: Reconstruct minor farm access.

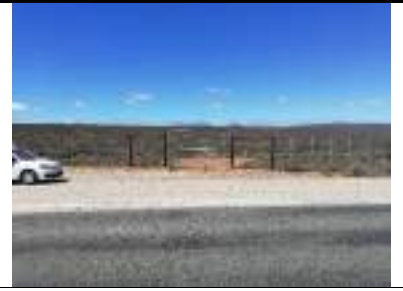
Location		Type		Use			Destination	
Km	Side	Surf.	Gravel	Freq.	Seldom	Disused		
18.13	LHS		X	X			Private	X
							Public	
Sight Distance(100km/h)		Access	RHS	>300m				
			LHS	>300m				
Access Details (WCS/11/2/C1)								
Minor Farm	x	Main Farm		>50 vpd			Intersection	
<p><u>Impacted by auxiliary lane:</u> No <u>Proposed Action:</u> Reconstruct minor farm access.</p>

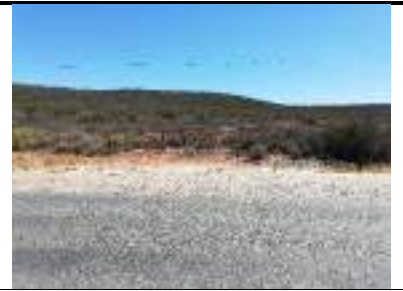
Location		Type		Use			Destination	
Km	Side	Surf.	Gravel	Freq.	Seldom	Disused		
18.13	RHS		X			X	Private	x
							Public	
Sight Distance(100km/h)		Access	RHS	>300m				
			LHS	>300m				
Access Details (WCS/11/2/C1)								
Minor Farm	x	Main Farm		>50 vpd			Intersection	
<p><u>Impacted by auxiliary lane:</u> No <u>Proposed Action:</u> Reconstruct minor farm access.</p>

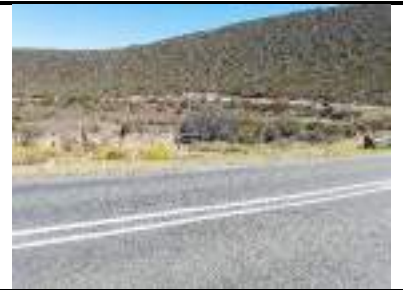
Location		Type		Use			Destination	
Km	Side	Surf.	Gravel	Freq.	Seldom	Disused		
19.92	LHS		X		X		Private	X
							Public	
Sight Distance(100km/h)		Access	RHS	>300m	Very seldom used			
			LHS	>300m				
Access Details (WCS/11/2/C1)								
Minor Farm	x	Main Farm		>50 vpd			Intersection	
<p><u>Impacted by auxiliary lane:</u> No <u>Proposed Action:</u> Close access – to confirm with DRE and landowner.</p>

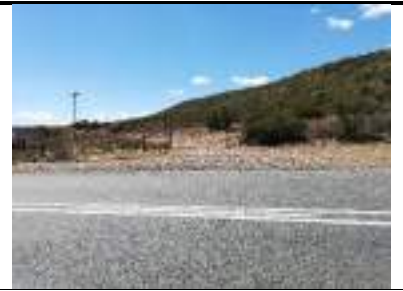
Location		Type		Use			Destination	
Km	Side	Surf.	Gravel	Freq.	Seldom	Disused		
19.92	RHS		X	X			Private	X
							Public	
Sight Distance(100km/h)		Access	RHS	>300m				
			LHS	>300m				
Access Details (WCS/11/2/C1)								
Minor Farm	x	Main Farm		>50 vpd			Intersection	
<p><u>Impacted by auxiliary lane:</u> Yes <u>Proposed Action:</u> Reconstruct minor farm access.</p>

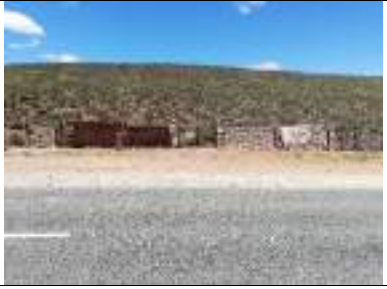
Location		Type		Use			Destination	
Km	Side	Surf.	Gravel	Freq.	Seldom	Disused	Private	Public
21.20	LHS		X	X				X
Sight Distance(100km/h)		Access	RHS	>300m	PERDESKOENDRAAI			
			LHS	>300m				
Access Details (WCS/11/2/C1)								
Minor Farm		Main Farm	x	>50 vpd			Intersection

Impacted by auxiliary lane: No
Proposed Action: Construct major farm access as per standard plan.

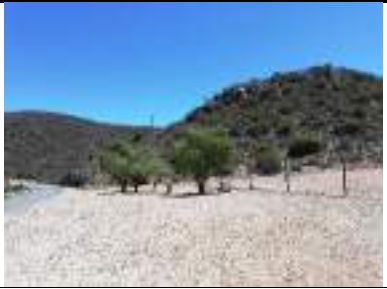
Location		Type		Use			Destination	
Km	Side	Surf.	Gravel	Freq.	Seldom	Disused	Private	Public
22.57	RHS		X	X				X
Sight Distance(100km/h)		Access	RHS	>300m	FORMAL REST AREA			
			LHS	>300m				
Access Details (WCS/11/2/C1)								
Minor Farm		Main Farm		>50 vpd			Intersection

Impacted by auxiliary lane: No
Proposed Action: Close rest area and reinstate road reserve.

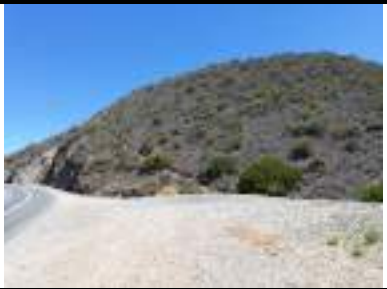
Location		Type		Use			Destination	
Km	Side	Surf.	Gravel	Freq.	Seldom	Disused	Private	Public
22.80	RHS		X	X				X
Sight Distance(100km/h)		Access	RHS	>300m	STOPPING PLACE			
			LHS	>300m				
Access Details (WCS/11/2/C1)								
Minor Farm		Main Farm		>50 vpd			Intersection

Impacted by auxiliary lane: No
Proposed Action: Close rest area and reinstate road reserve.

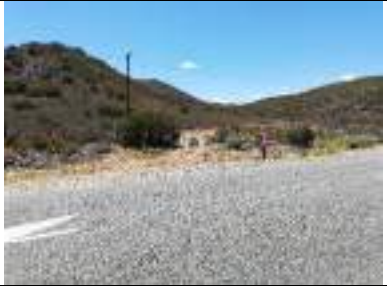
Location		Type		Use			Destination	
Km	Side	Surf.	Gravel	Freq.	Seldom	Disused		
23.49	RHS		X		X		Private	x
							Public	
Sight Distance(100km/h)		Access	RHS	>300m				
			LHS	>300m				
Access Details (WCS/11/2/C1)								
Minor Farm	x	Main Farm		>50 vpd			Intersection

Impacted by auxiliary lane: No
Proposed Action: Reconstruct minor farm access.

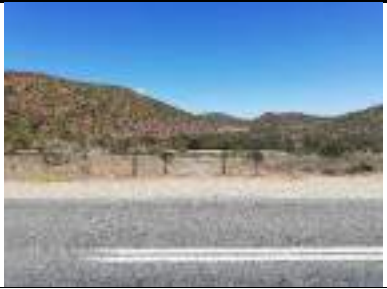
Location		Type		Use			Destination	
Km	Side	Surf.	Gravel	Freq.	Seldom	Disused		
23.51	LHS		X		X		Private	x
							Public	
Sight Distance(100km/h)		Access	RHS	>300m				
			LHS	>300m				
Access Details (WCS/11/2/C1)								
Minor Farm		Main Farm		>50 vpd			Intersection

Impacted by auxiliary lane: No
Proposed Action: Reconstruct minor farm access.

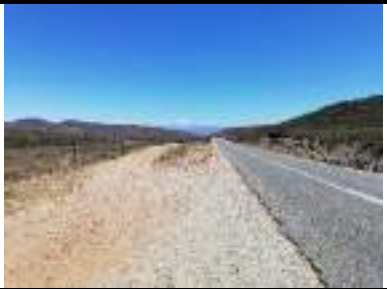
Location		Type		Use			Destination	
Km	Side	Surf.	Gravel	Freq.	Seldom	Disused		
23.53	LHS		X	X			Private	
							Public	
Sight Distance(100km/h)		Access	RHS	>300m	STOPPING PLACE			
			LHS	300m				
Access Details (WCS/11/2/C1)								
Minor Farm		Main Farm		>50 vpd			Intersection

Impacted by auxiliary lane: Yes
Proposed Action: Close rest area.

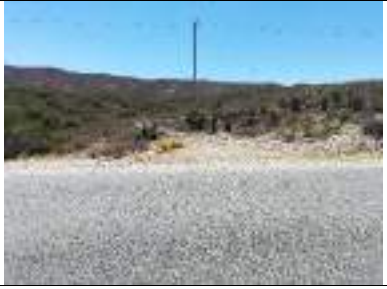
Location		Type		Use			Destination	
Km	Side	Surf.	Gravel	Freq.	Seldom	Disused		
24.09	LHS		X	X			Private	X
							Public	
Sight Distance(100km/h)		Access	RHS	>300m				
			LHS	>300m				
Access Details (WCS/11/2/C1)								
Minor Farm		Main Farm	X	>50 vpd			Intersection

Impacted by auxiliary lane: Yes
Proposed Action: Construct main farm access as per standard plan.

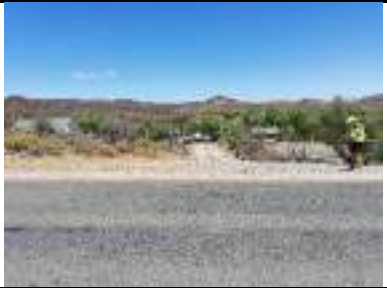
Location		Type		Use			Destination	
Km	Side	Surf.	Gravel	Freq.	Seldom	Disused		
24.09	RHS		X	X			Private	X
							Public	
Sight Distance(100km/h)		Access	RHS	>300m				
			LHS	>300m				
Access Details (WCS/11/2/C1)								
Minor Farm		Main Farm	X	>50 vpd			Intersection

Impacted by auxiliary lane: Yes
Proposed Action: Construct main farm access as per standard plan.

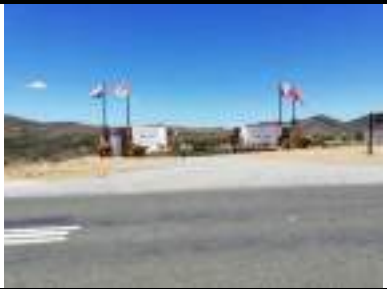
Location		Type		Use			Destination	
Km	Side	Surf.	Gravel	Freq.	Seldom	Disused		
24.59	LHS	X		X			Private	X
							Public	
Sight Distance(100km/h)		Access	RHS	>300m	CHANDELIER			
			LHS	>300m				
Access Details (WCS/11/2/C1)								
Minor Farm		Main Farm	X	>50 vpd			Intersection

Impacted by auxiliary lane: Yes
Proposed Minimum Action: Construct main farm access as per standard plan.

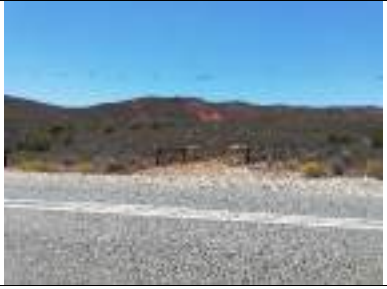
Location		Type		Use			Destination	
Km	Side	Surf.	Gravel	Freq.	Seldom	Disused		
24.67	RHS		X			X	Private	X
							Public	
Sight Distance(100km/h)		Access	RHS	170m				
			LHS	>300m				
Access Details (WCS/11/2/C1)								
Minor Farm	x	Main Farm		>50 vpd			Intersection

Impacted by auxiliary lane: Yes
Proposed Action: Relocate access to km 24.61 (opposite Chandelier).

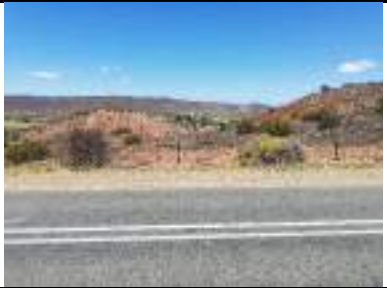
Location		Type		Use			Destination	
Km	Side	Surf.	Gravel	Freq.	Seldom	Disused		
25.72	LHS		X			X	Private	X
							Public	
Sight Distance(100km/h)		Access	RHS	<150m				
			LHS	<150m				
Access Details (WCS/11/2/C1)								
Minor Farm	x	Main Farm		>50 vpd			Intersection

Impacted by auxiliary lane: No
Proposed Action: Close – to confirm with DRE and landowner.

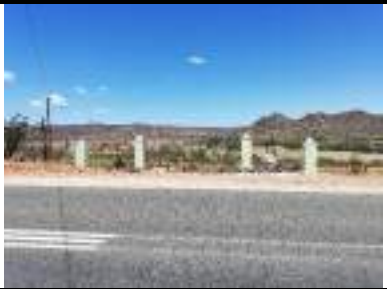
Location		Type		Use			Destination	
Km	Side	Surf.	Gravel	Freq.	Seldom	Disused		
26.29	LHS		X	X			Private	X
							Public	
Sight Distance(100km/h)		Access	RHS	180m	FRISCHGEWAAGD			
			LHS	260m				
Access Details (WCS/11/2/C1)								
Minor Farm		Main Farm	X	>50 vpd			Intersection

Impacted by auxiliary lane: Yes
Proposed Action: Construct main farm access as per standard plan.

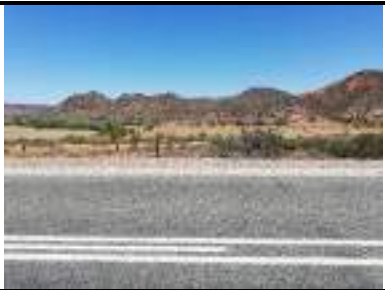
Location		Type		Use			Destination	
Km	Side	Surf.	Gravel	Freq.	Seldom	Disused		
26.46	LHS		X		X		Private	X
							Public	
Sight Distance(100km/h)		Access	RHS	180m				
			LHS	>300m				
Access Details (WCS/11/2/C1)								
Minor Farm	x	Main Farm		>50 vpd			Intersection

Impacted by auxiliary lane: Yes
Proposed Action: Close – to confirm with DRE and landowner.

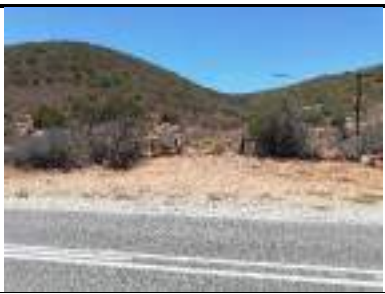
Location		Type		Use			Destination	
Km	Side	Surf.	Gravel	Freq.	Seldom	Disused		
26.50	RHS		X			X	Private	x
							Public	
Sight Distance(100km/h)		Access	RHS	<100m				
			LHS	<100m				
Access Details (WCS/11/2/C1)								
Minor Farm	x	Main Farm		>50 vpd			Intersection

Impacted by auxiliary lane: No
Proposed Action: Close – to confirm with DRE and landowner.

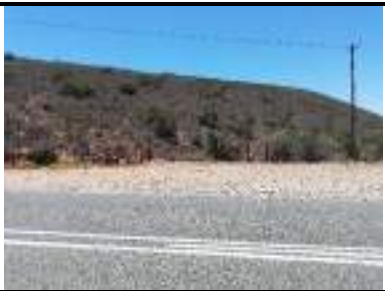
Location		Type		Use			Destination	
Km	Side	Surf.	Gravel	Freq.	Seldom	Disused		
27.01	RHS		X			X	Private	X
							Public	
Sight Distance(100km/h)		Access	RHS	<120m				
			LHS	>300m				
Access Details (WCS/11/2/C1)								
Minor Farm	x	Main Farm		>50 vpd			Intersection

Impacted by auxiliary lane: No
Proposed Action: Reconstruct minor farm access.

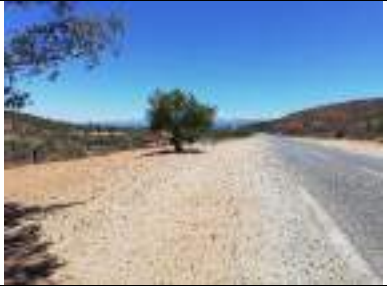
Location		Type		Use			Destination	
Km	Side	Surf.	Gravel	Freq.	Seldom	Disused	Private	Public
28.01	LHS		X	X				X
Sight Distance(100km/h)		Access	RHS	>300	FORMAL REST AREA			
			LHS	>300				
Access Details (WCS/11/2/C1)								
Minor Farm		Main Farm		>50 vpd		Intersection

Impacted by auxiliary lane: No
Proposed Action: Close rest area and reinstate road reserve.

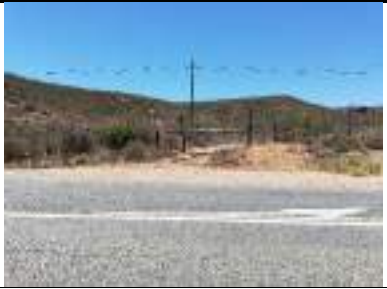
Location		Type		Use			Destination	
Km	Side	Surf.	Gravel	Freq.	Seldom	Disused	Private	Public
28.14	RHS		X		X			X
Sight Distance(100km/h)		Access	RHS	>300				
			LHS	>300				
Access Details (WCS/11/2/C1)								
Minor Farm	X	Main Farm		>50 vpd		Intersection

Impacted by auxiliary lane: Yes
Proposed Action: Reconstruct minor farm access.

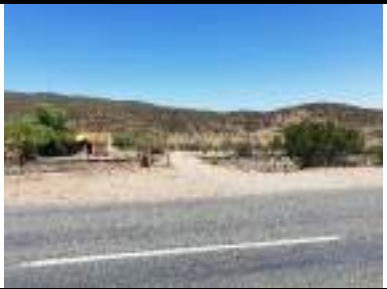
Location		Type		Use			Destination	
Km	Side	Surf.	Gravel	Freq.	Seldom	Disused	Private	Public
28.22	LHS		X	X				X
Sight Distance(100km/h)		Access	RHS	>300m				
			LHS	>300m				
Access Details (WCS/11/2/C1)								
Minor Farm		Main Farm	X	>50 vpd		Intersection

Impacted by auxiliary lane: No
Proposed Action: Construct main farm access as per standard plan.

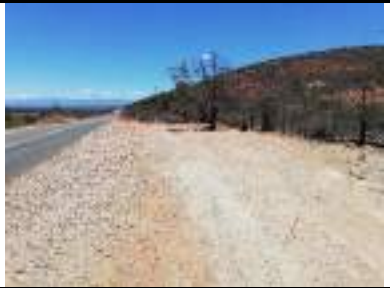
Location		Type		Use			Destination	
Km	Side	Surf.	Gravel	Freq.	Seldom	Disused	Private	Public
28.26	RHS		X	X				x
Sight Distance(100km/h)		Access	RHS	>300m	INFORMAL REST AREA			
			LHS	>300m				
Access Details (WCS/11/2/C1)								
Minor Farm		Main Farm		>50 vpd		Intersection

Impacted by auxiliary lane: Yes
Proposed Action: Close rest area and reinstate road reserve.

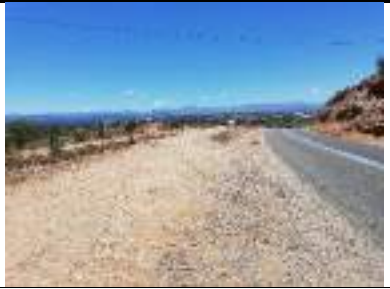
Location		Type		Use			Destination	
Km	Side	Surf.	Gravel	Freq.	Seldom	Disused	Private	Public
29.16	LHS		X	X				x
Sight Distance(100km/h)		Access	RHS	160m	LABOURER COTTAGES			
			LHS	>300m				
Access Details (WCS/11/2/C1)								
Minor Farm	X	Main Farm		>50 vpd		Intersection

Impacted by auxiliary lane: No
Proposed Action: Reconstruct minor farm access.

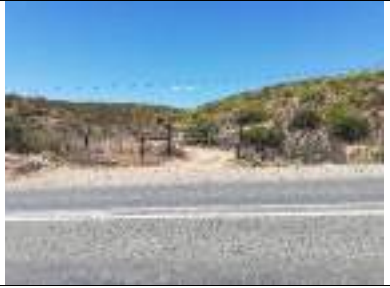
Location		Type		Use			Destination	
Km	Side	Surf.	Gravel	Freq.	Seldom	Disused	Private	Public
29.27	RHS		X	X				X
Sight Distance(100km/h)		Access	RHS	>300m				
			LHS	110m				
Access Details (WCS/11/2/C1)								
Minor Farm	x	Main Farm		>50 vpd		Intersection

Impacted by auxiliary lane: No
Proposed Action: Reconstruct minor farm access.

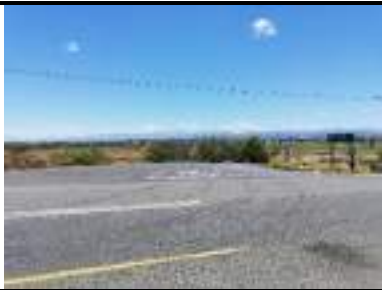
Location		Type		Use			Destination	
Km	Side	Surf.	Gravel	Freq.	Seldom	Disused	Private	Public
29.56	LHS	X		X				X
Sight Distance(100km/h)		Access	RHS	>300m	DRI 672 BAKENSKRAAL			
			LHS	>300m				
Access Details (WCS/11/2/C1)								
Minor Farm		Main Farm		>50 vpd			Intersection	X

Impacted by auxiliary lane: No
Proposed Action: Surfacing in poor condition. Resurface.

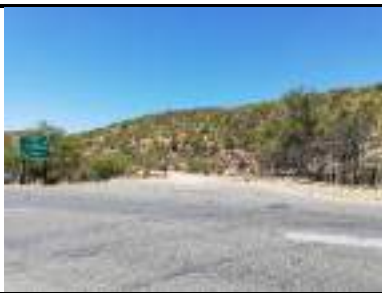
Location		Type		Use			Destination	
Km	Side	Surf.	Gravel	Freq.	Seldom	Disused	Private	Public
29.56	RHS	X		X				X
Sight Distance(100km/h)		Access	RHS	>300m				
			LHS	>300m				
Access Details (WCS/11/2/C1)								
Minor Farm		Main Farm	X	>50 vpd			Intersection

Impacted by auxiliary lane: No
Proposed Action: Surfacing in poor condition. Resurface.

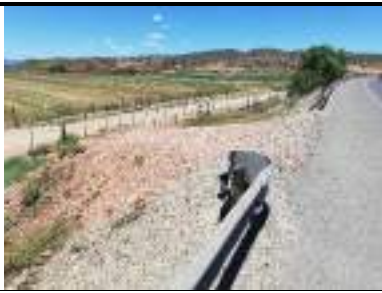
Location		Type		Use			Destination	
Km	Side	Surf.	Gravel	Freq.	Seldom	Disused	Private	Public
30.35	RHS					X		
Sight Distance(100km/h)		Access	RHS					
			LHS					
Access Details (WCS/11/2/C1)								
Minor Farm		Main Farm		>50 vpd			Intersection

Impacted by auxiliary lane: No
Proposed Action: None

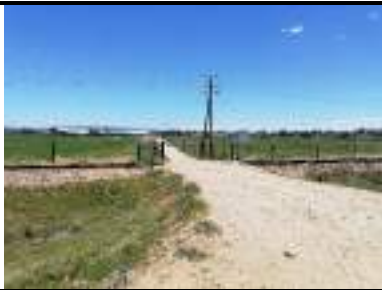
Location		Type		Use			Destination	
Km	Side	Surf.	Gravel	Freq.	Seldom	Disused		
30.61	LHS		X	X			Private	X
							Public	
Sight Distance(100km/h)		Access	RHS	>300m	KAROO VALLEY FARMS			
			LHS	>300m				
Access Details (WCS/11/2/C1)								
Minor Farm		Main Farm	X	>50 vpd			Intersection

Impacted by auxiliary lane: No
Proposed Action: Upgrade to main farm access as per standard plan.

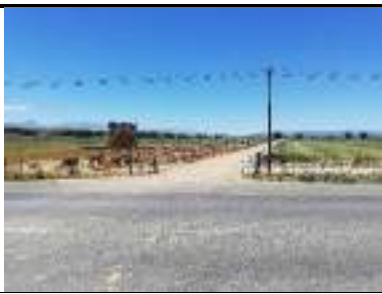
Location		Type		Use			Destination	
Km	Side	Surf.	Gravel	Freq.	Seldom	Disused		
30.61	RHS		X	X			Private	X
							Public	
Sight Distance(100km/h)		Access	RHS	>300m				
			LHS	>300m				
Access Details (WCS/11/2/C1)								
Minor Farm	x	Main Farm		>50 vpd			Intersection

Impacted by auxiliary lane: No
Proposed Action: Install concrete edge beam

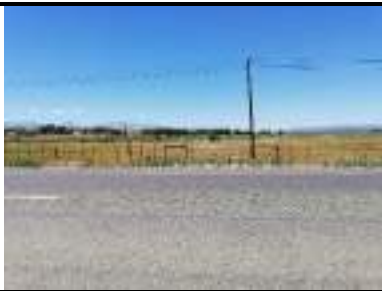
Location		Type		Use			Destination	
Km	Side	Surf.	Gravel	Freq.	Seldom	Disused		
30.70	RHS		X		X		Private	X
							Public	
Sight Distance(100km/h)		Access	RHS	>300m				
			LHS	>300m				
Access Details (WCS/11/2/C1)								
Minor Farm	x	Main Farm		>50 vpd			Intersection

Impacted by auxiliary lane: No
Proposed Action: None – potentially disused

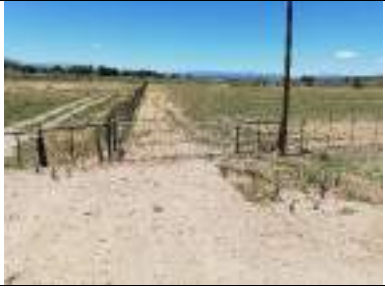
Location		Type		Use			Destination	
Km	Side	Surf.	Gravel	Freq.	Seldom	Disused		
30.81	RHS		X	X			Private	X
							Public	
Sight Distance(100km/h)		Access	RHS	>300m				
			LHS	>300m				
Access Details (WCS/11/2/C1)								
Minor Farm	x	Main Farm		>50 vpd			Intersection

Impacted by auxiliary lane: No
Proposed Action: Install concrete edge beam

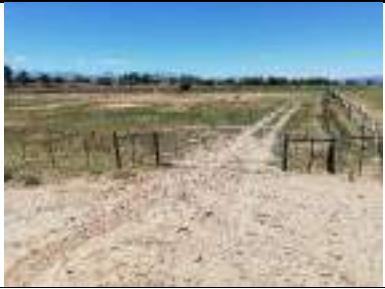
Location		Type		Use			Destination	
Km	Side	Surf.	Gravel	Freq.	Seldom	Disused		
30.82	RHS		X	X			Private	X
							Public	
Sight Distance(100km/h)		Access	RHS	>300m				
			LHS	>300m				
Access Details (WCS/11/2/C1)								
Minor Farm	x	Main Farm		>50 vpd			Intersection

Impacted by auxiliary lane: No
Proposed Action: Install concrete edge beam.
