Botanical Assessment

Proposed upgrading of the Schaapkop sewer rising main in George

January 2024

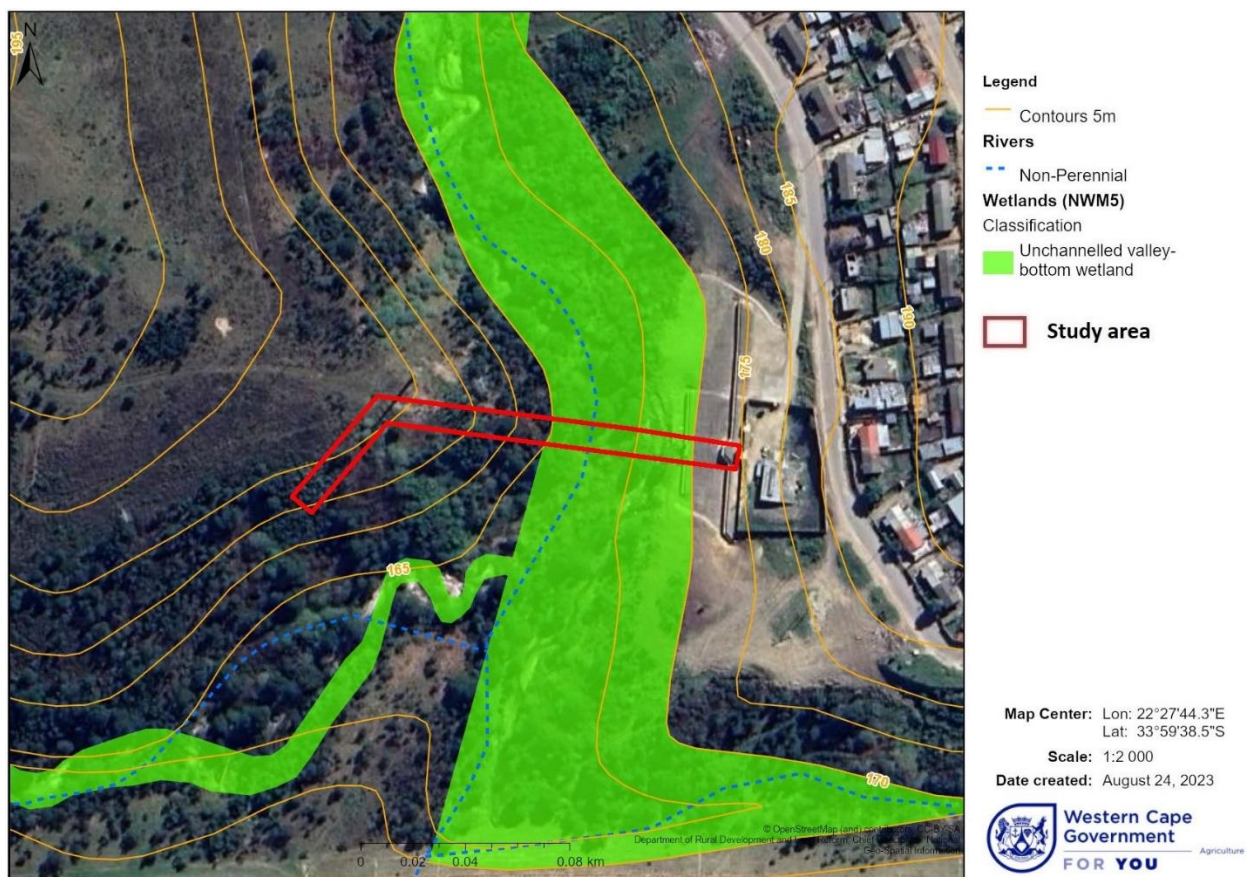
Figure 4-1: Combined topography and hydrology map.

The pipeline route is located on a grassy, partly vegetated hill slope above the Skaapkop River, directly west of Borchards township (**Figure 4-1**). The eastern end of the route crosses the Skaapkop River before connecting with the Schaapkop pump station. The general area can be described as moderately sloped. Apart from existing pipeline infrastructure and an Eskom powerline that encroaches the western end of route, the area along the pipeline route is vacant.

The proposed sewer pipe crosses the Skaapkop River which is mapped as a non-perennial watercourse (**Figure 4-1**). Another notable feature is a mapped NWM5 (National Wetland Map 5) valley-bottom wetland associated with the Skaapkop River. The proposed river crossing has already been modified somewhat by plinths and other

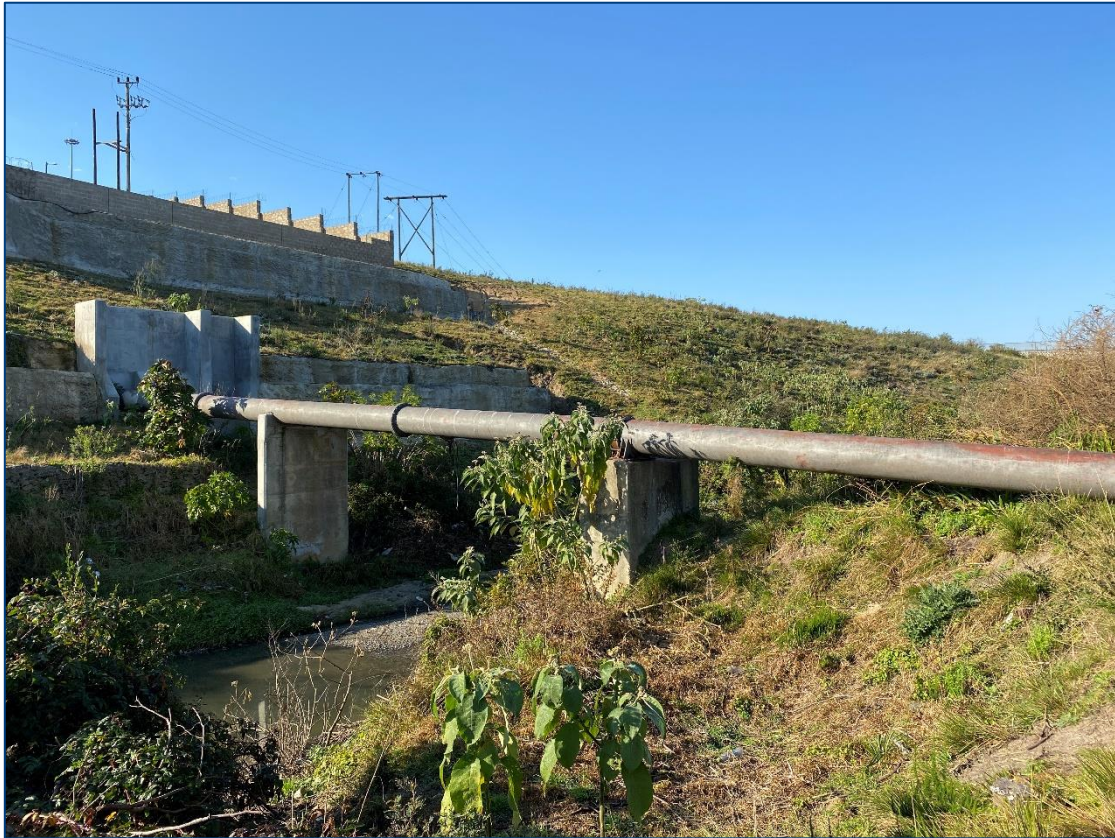
Figure 4-2: Proposed river crossing (eastern end of proposed pipeline).

concrete structures associated with an existing sewer line (**Figure 4-2**). Considerable alien infestation (bugweed and castor-oil plants) was also noted in the riverine area. The wetland and watercourses have been included in the biodiversity network.

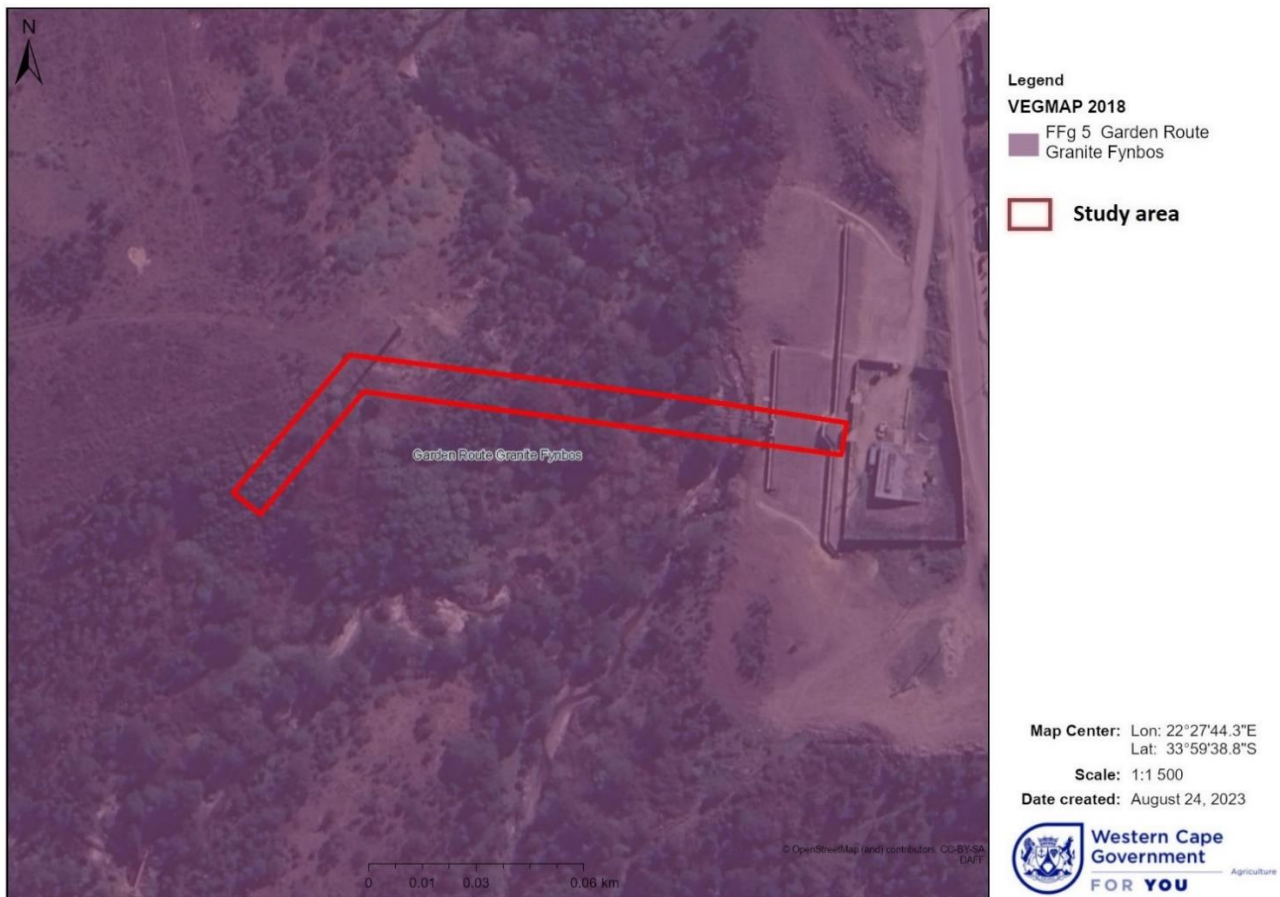
Figure 4-3: Extract of the 2018 SA Vegetation map.

The study site is located in a typical fynbos environment on the Southern Cape coastal plain. The indigenous species recorded along the proposed pipeline route are typical fynbos species, such as *Erica sparsa*, *Bobartia aphylla* and *Leucadendron salignum*. The 2018 Vegetation Map of South Africa classifies the vegetation type found on site as Garden Route Granite Fynbos (**Figure 4-3**). This vegetation type occurs as three units from Botterberg (south of Robinson Pass) in the west to Hoogekraal Pass (west of Karatara) in the east. The site is situated in the largest block between Groot Brak and Wilderness. It is described as a dense proteoid and ericoid shrubby grassland². In the west, most of the remnants are dominated by proteas (Mucina, 2006). Eastwards, graminoid and ericaceous fynbos are dominant on the flatter areas (Mucina, 2006).

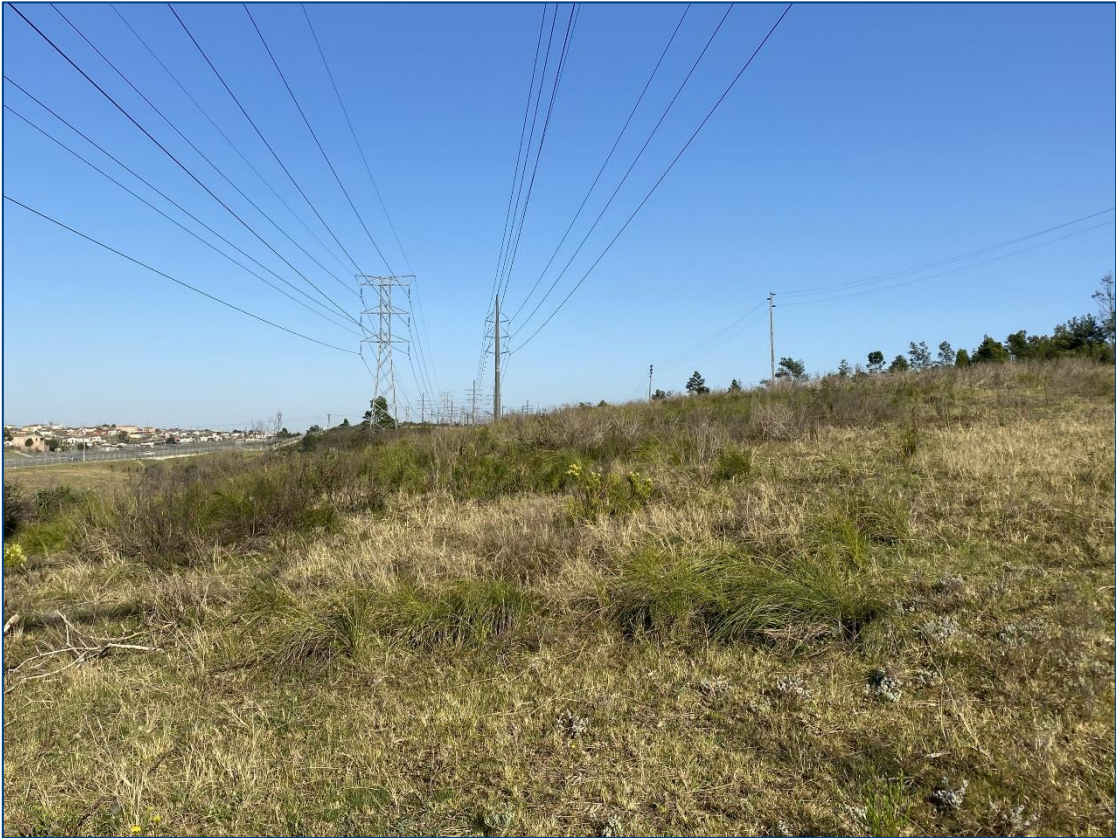
Figure 5-2: Degraded grassy fynbos (grassland) at the highest point along pipeline route near the western end.

The proposed sewer pipe is located in an area that was probably used for grazing in the past, but is now lying fallow (**Figure 5-1**). Fynbos elements are more prominent in the degraded fynbos areas. Elsewhere, only a few scattered fynbos species were noted here and there. One can distinguish between a grassier fynbos along the powerline servitude and a strip of shrubby fynbos below at the western end of the pipeline route (**Figures 5-2 & 5-3**). The grassiness can be ascribed to frequent bush-cutting during past agricultural use and probably also for safety reasons underneath the powerline. There is a high presence of invasive species, such as bugweed (*Solanum mauritanum*) and black wattle (*Acacia mearnsii*), especially in the highly degraded area (**Figures 5-4 & 5-5**). The vegetation can probably be best described as a low grassland or a degraded grassy fynbos where there is a significant fynbos component. Structurally, the shrubby fynbos can be described as a low to mid-high closed small-leaved shrubland following Campbell's classification.

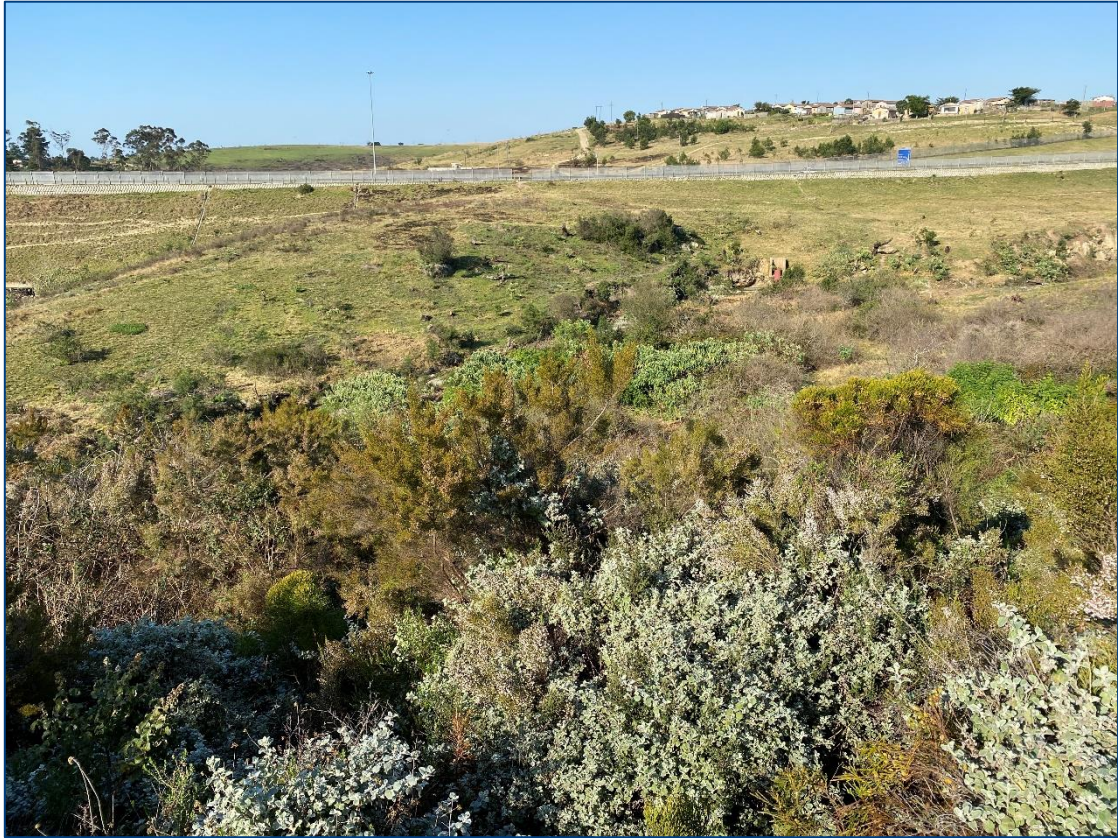
Figure 5-3: Strip of shrubby fynbos at the western end of pipeline route, dominated by *Helichrysum petiolare*, *Berzelia intermedia* and *Passerina montivaga*.

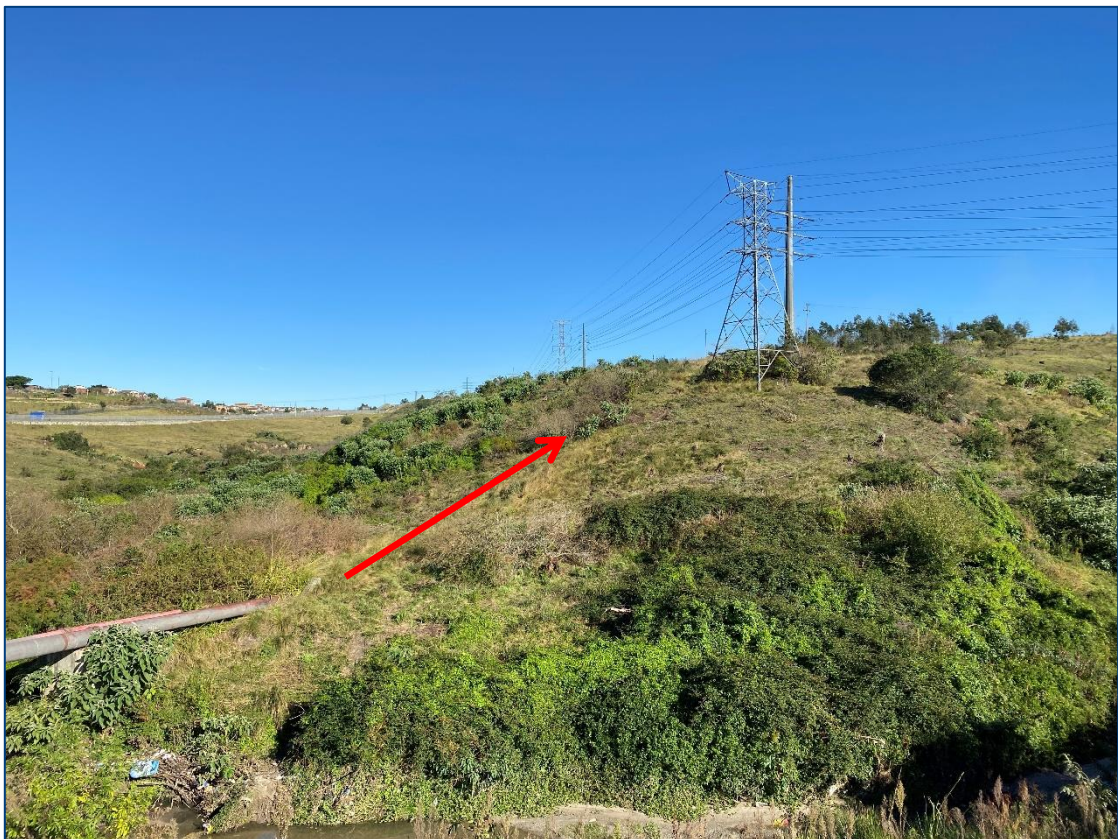
Figure 5-4: Middle section of the proposed pipeline route (red arrow).

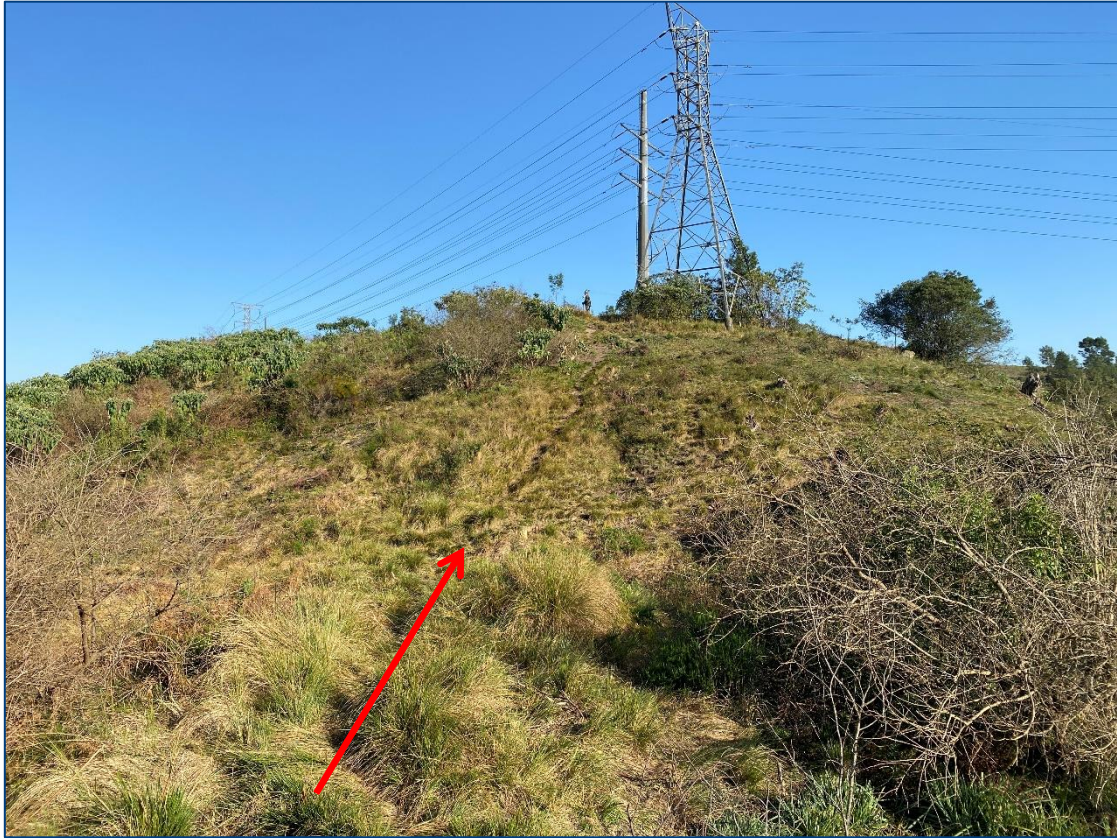
Figure 5-5: Close-up view of the middle section of pipeline route, populated by grasses and bugweed.

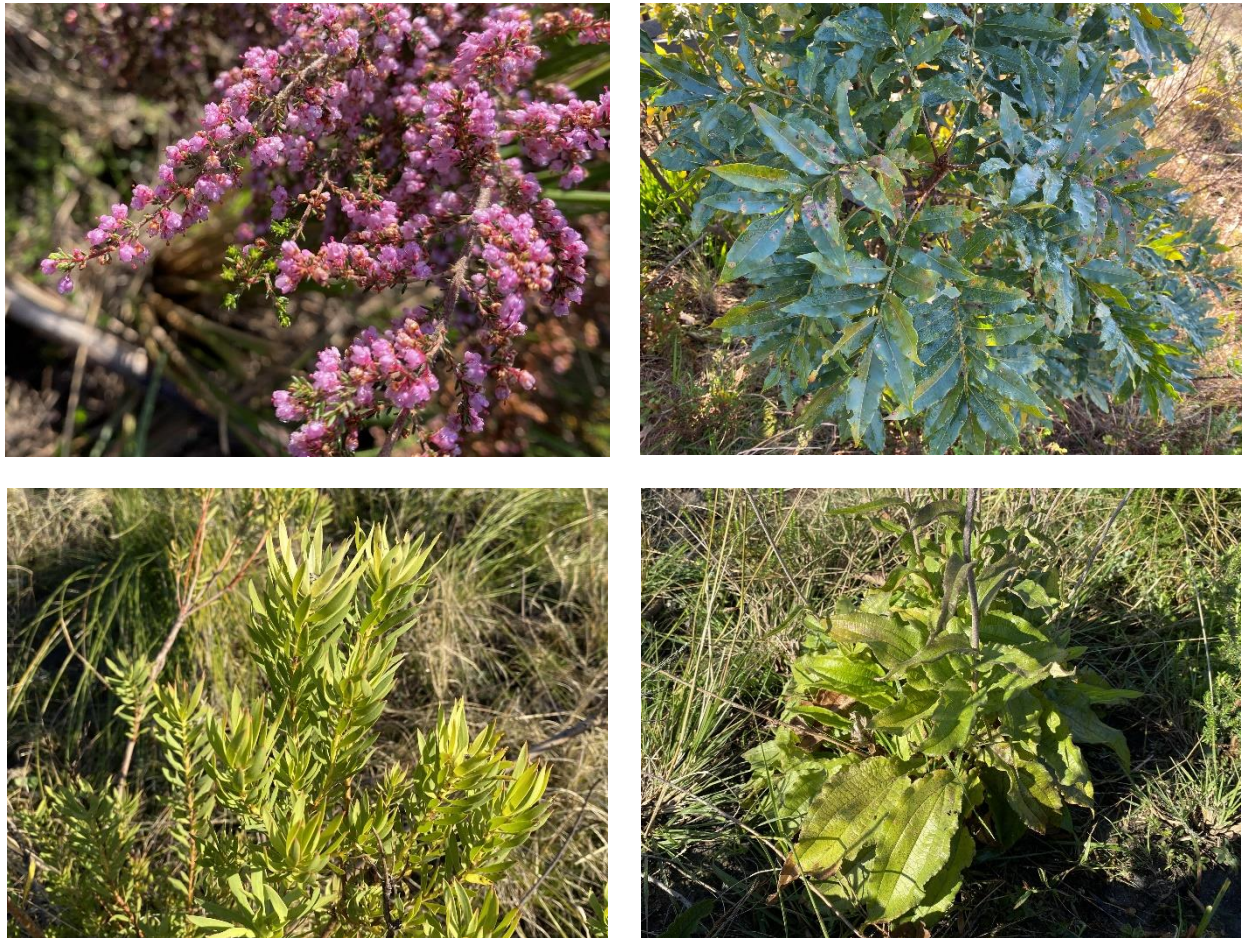
Figure 5-6: A few indigenous species recorded on site, with *Erica sparsa* (top left), *Ekebergia capensis* (top right), *Leucadendron salignum* (bottom left) and *Helichrysum nudifolium* (bottom right).

A fair number of indigenous shrub species were recorded, including *Leucadendron salignum*, *Erica sparsa*, *E. quadrangularis*, *E. scabriuscula*, *Berzelia intermedia*, *Athanasia dentata*, *Euryops chrysanthemoides*, *Metalasia acuta*, *Helichrysum foetidum*, *H. petiolare*, *H. patulum*, *H. anomalum*, *H. nudifolium*, *Ursinia discolor*, *Pseudognaphalium undulatum*, *Senecio ilicifolius*, *Nidorella ivifolia*, *Passerina montivaga*, *Gnidia setosa*, *Euclea crispa*, *Searsia rehmanniana* var. *glabrata*, *Gymnosporia buxifolia*, *Ekebergia capensis*, *Carpobrotus edulis*, *Morella humilis*, *Gomphocarpus cf physocarpus*, *Clutia* sp, *Rubus pinnatus*, *Cliffortia odorata*, *Exomis microphylla* and *Selago corymbosa*. Only a few hemicryptophytes and geophytes were recorded, namely *Restio albotuberculatus*, *Hypoxis* sp, *Eriospermum* sp and *Bobartia aphylla*. *Carpobrotus edulis* is a useful soil binder. **Figure 5-6** shows a few of the recorded indigenous species.

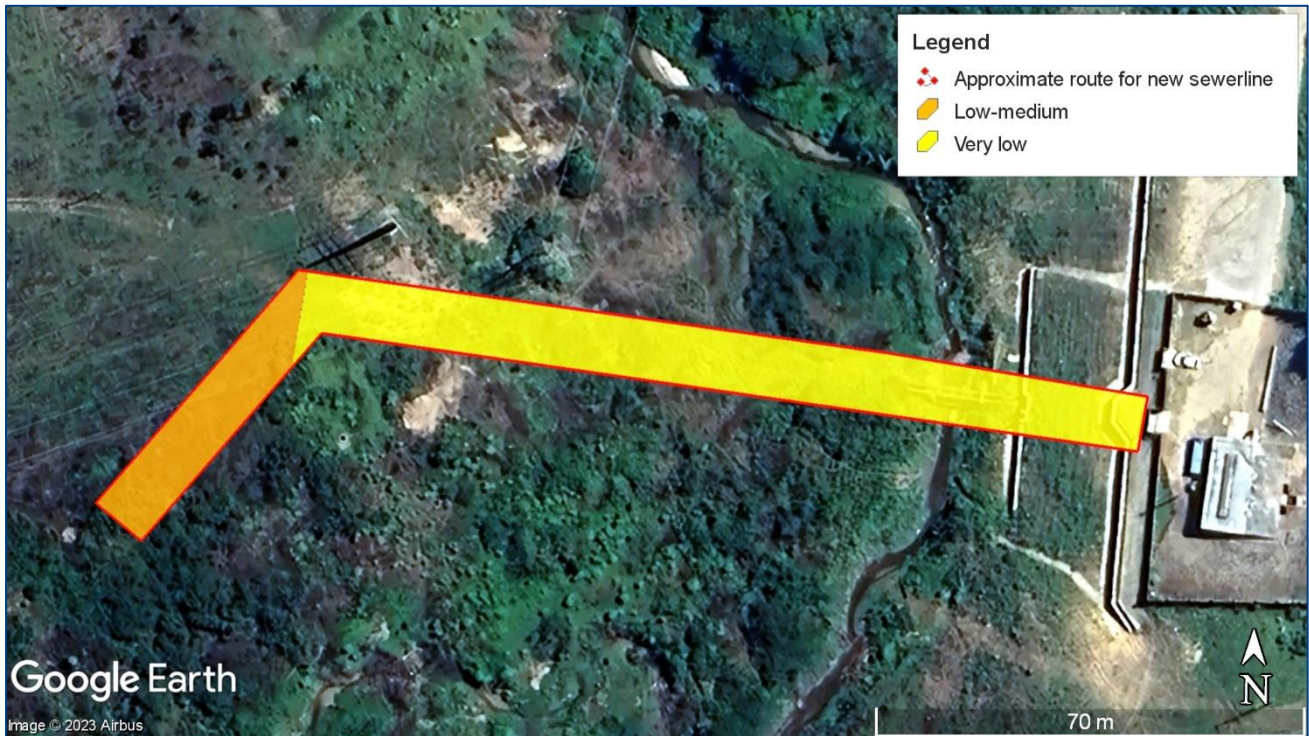
Figure 5-7: SEI map of the proposed pipeline route.

In order to show the biodiversity sensitivity of the site, a site ecological importance (SEI) map was prepared (**Figure 5-7**). This map considers the biodiversity importance (BI) of

the receptor (affected) area and its resilience to impacts (RR). The BI, in turn, is a function of conservation importance (CI) and functional integrity (FI) of the receptor area. A low-medium SEI value for the degraded fynbos area means that suitable restoration measures should be considered after construction. No active restoration is needed for the highly degraded area, which has a very-low SEI value. Please note that this map ignores the hydrological value of the Skaapkop River, crossed by the proposed pipeline.

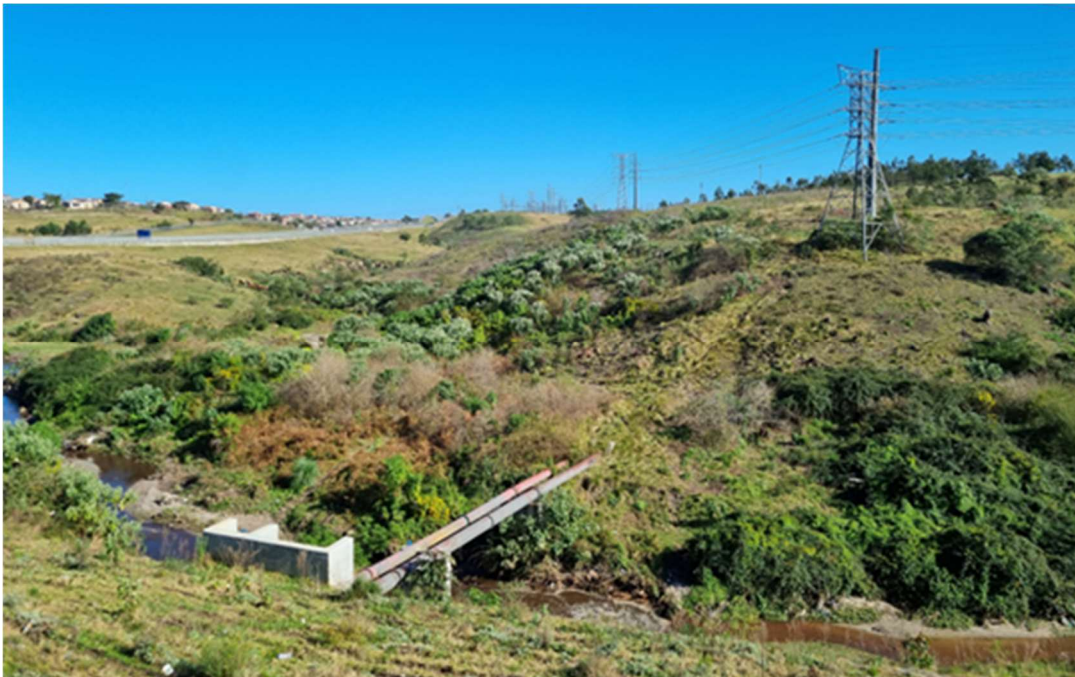
Currently the Scaapkop river is bridged with a steel pipe acting as a pipe bridge and the pipe itself simultaneously. On the eastern riverbank a concrete anchor block exists. On the Western side the pipe gradually slopes into the escarpment.

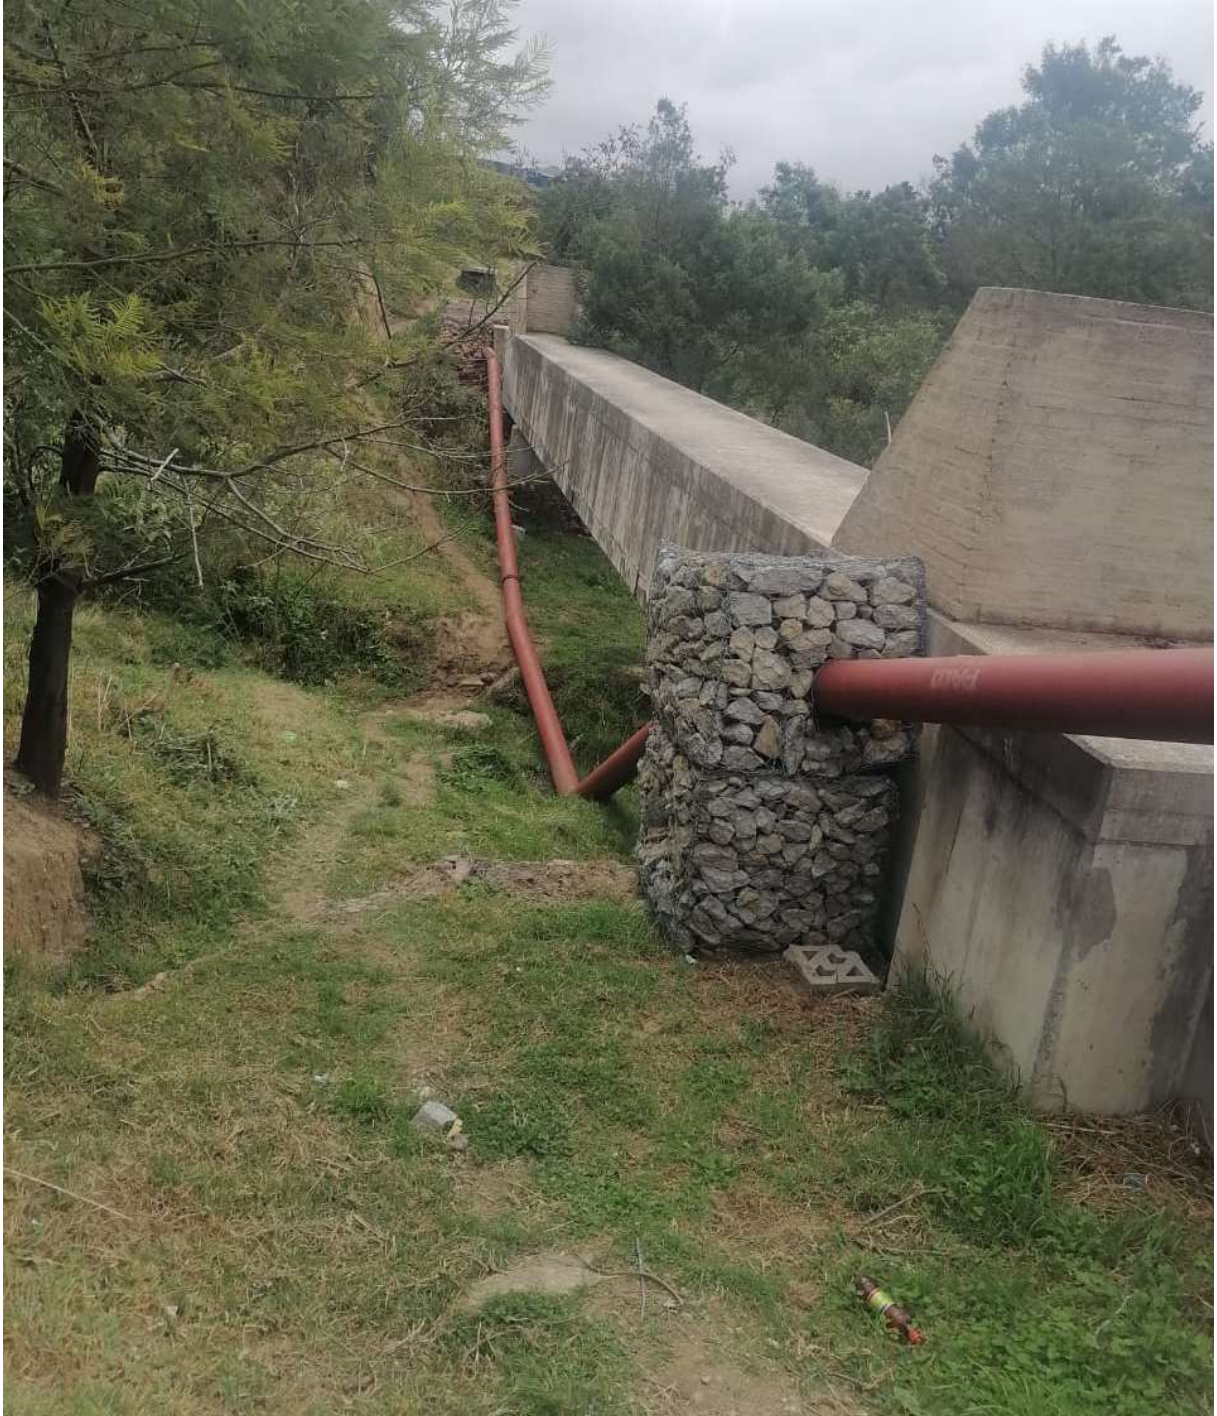
The pipeline will have a steady gradient towards the existing $\text{Ø}800\text{mm}$ connection point of the existing pipeline. The proposed pipe bridge is a concrete u channel with the pipeline covered with removeable concrete cover slabs.

At both sides of the river a foundation structure will be erected to accommodate the pipe bridge.
