Proposed Development of a Solar PV Array on Erf RE/2018, Riversdale, Western Cape.

Freshwater Compliance Statement

Date: 14 February 2024

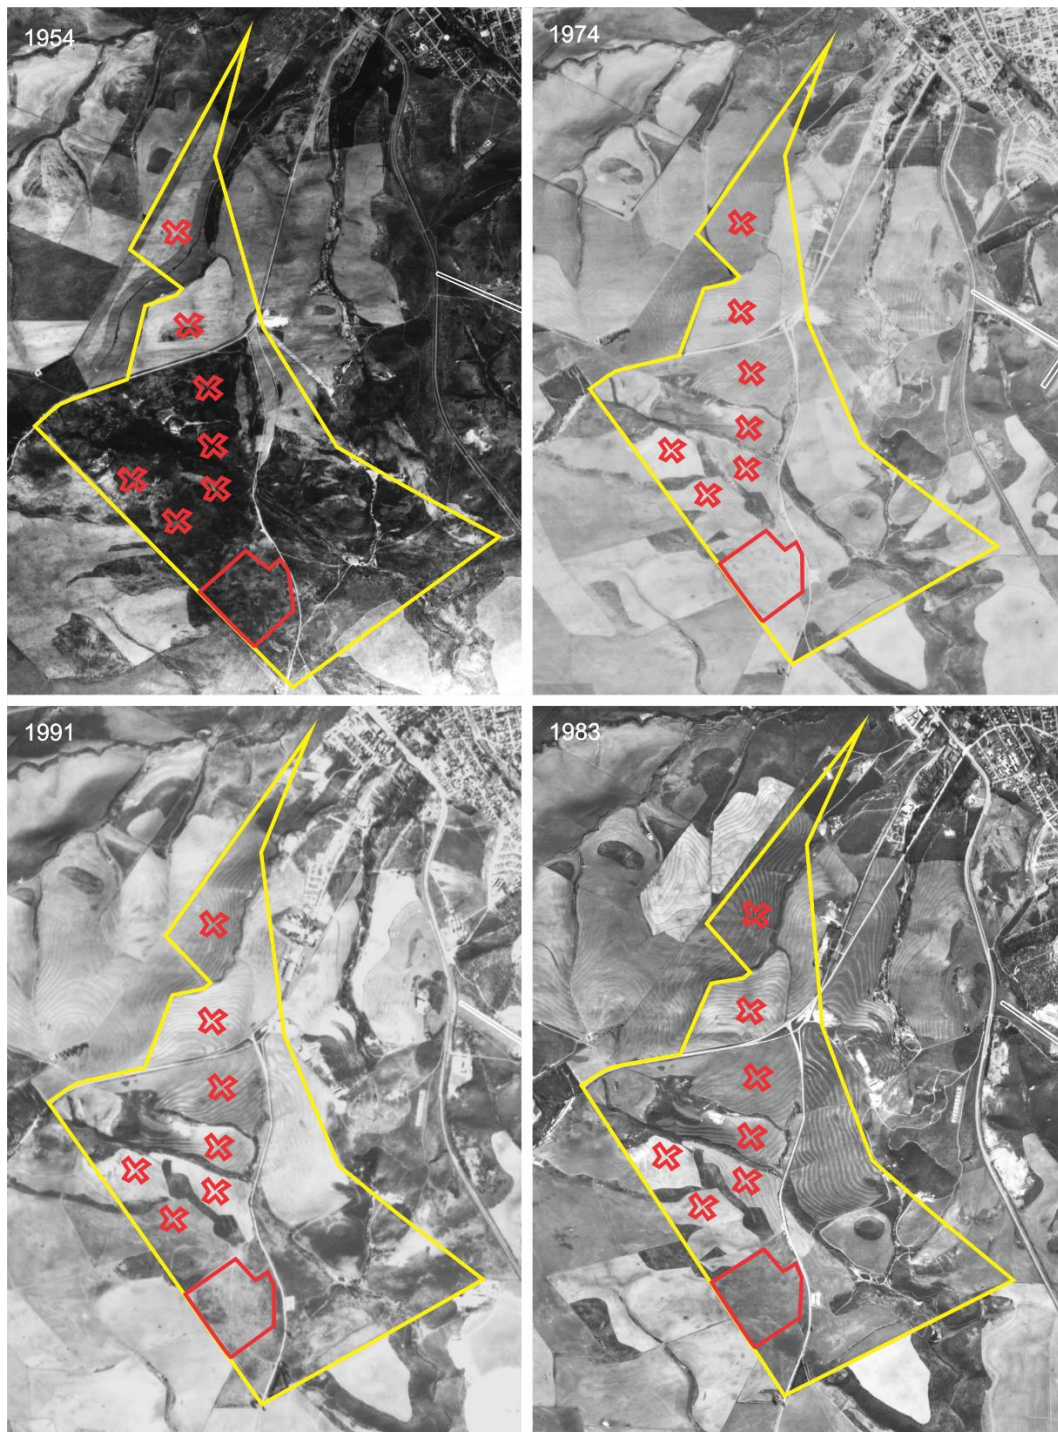
Figure 8. Historical photos showing Erf RE/2018 through notable changes between 1954 and 1983 (CD:NGI & Google Earth imagery).

Erf RE/2018 seem to have undergone minimal changes during the past 70 years from 1954 till 2024. One of the most notable changes that occurred on the property was between 1954 and 1974, when the southern part of the property was covered with indigenous vegetation in 1954 and cleared for agricultural purposes sometime between 1954 and 1974. Another notable change between 1954 and 1974 is the presence of a cut channel on the property in 1954 which ran next to stream F and was removed in the year leading up to 1974. Furthermore, a power substation was constructed on the property between 1954 and 1974 (Figure 8). Additionally, according to historical records, the Werner Frehse Nature Reserve was founded in 1967 and includes a large part of Erf RE/2018 East of the gravel road cutting through the property towards the south. However, agriculture activities only seem to have stopped in the reserved area of the property between 2005 and 2007, as observed in the historical imagery below (Figure 9).

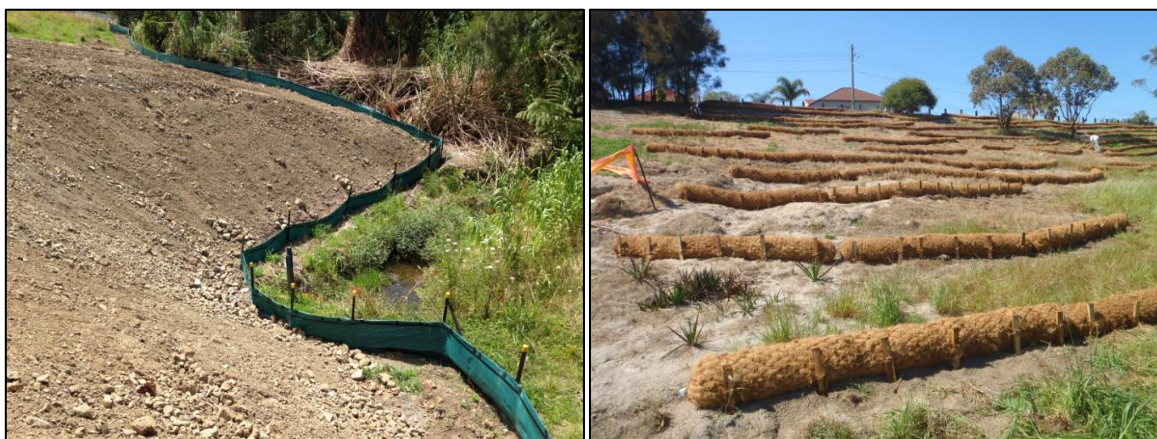
Figure 12: Examples of silt fences (left) and coir logs (right) used to trap sediment mobilised from steep slopes.

- Ensure that construction activities do not cause any preferential flow paths and concentrated surface runoff during rainfall events.
- Clearly demarcate the construction area and ensure that heavy machinery does not compact soil or disturb vegetation outside of these demarcated areas.
- Reduce transport of sediment through use of structures such as silt fences or biodegradable coir logs placed along a contour below the development footprint (Figure 12).
