**HERITAGE IMPACT ASSESSMENT
PROPOSED PV SOLAR PLANT AND BATTERY ENERGY
STORAGE SYSTEM ON RE/ERF 2018, RIVERSDALE,
HESSEQUA LOCAL MUNICIPALITY, WESTERN CAPE**

Assessment conducted under Section 38 (3) of the National Heritage Resource Act
(No. 25 of 1999)

**FEBRUARY
2024**

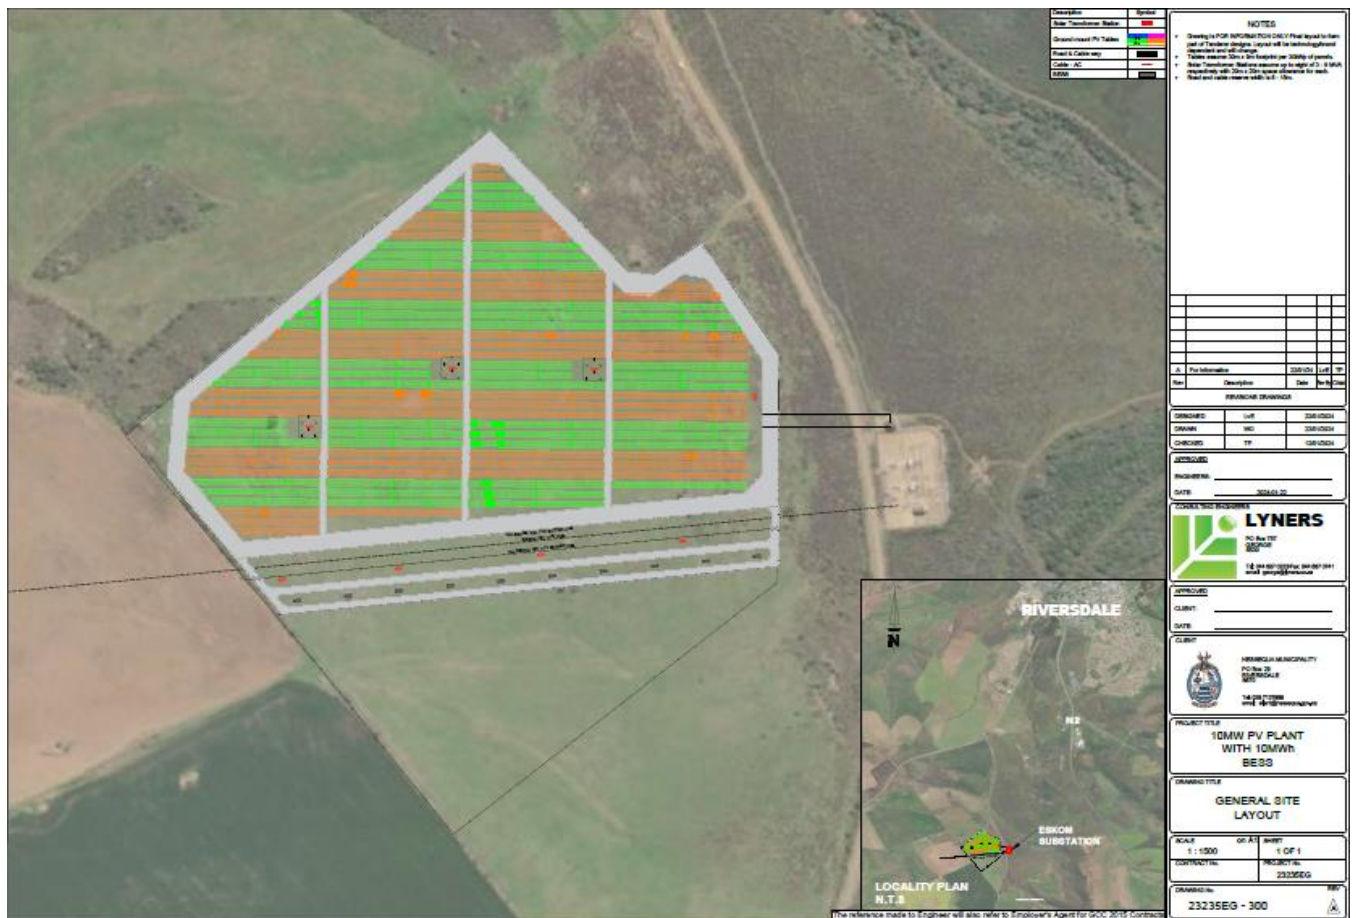
Figure 4. Proposed layout of the Riversdale 10MW Solar PV Plant with Battery Energy Storage System

A Site Layout Plan is illustrated in Figure 4.

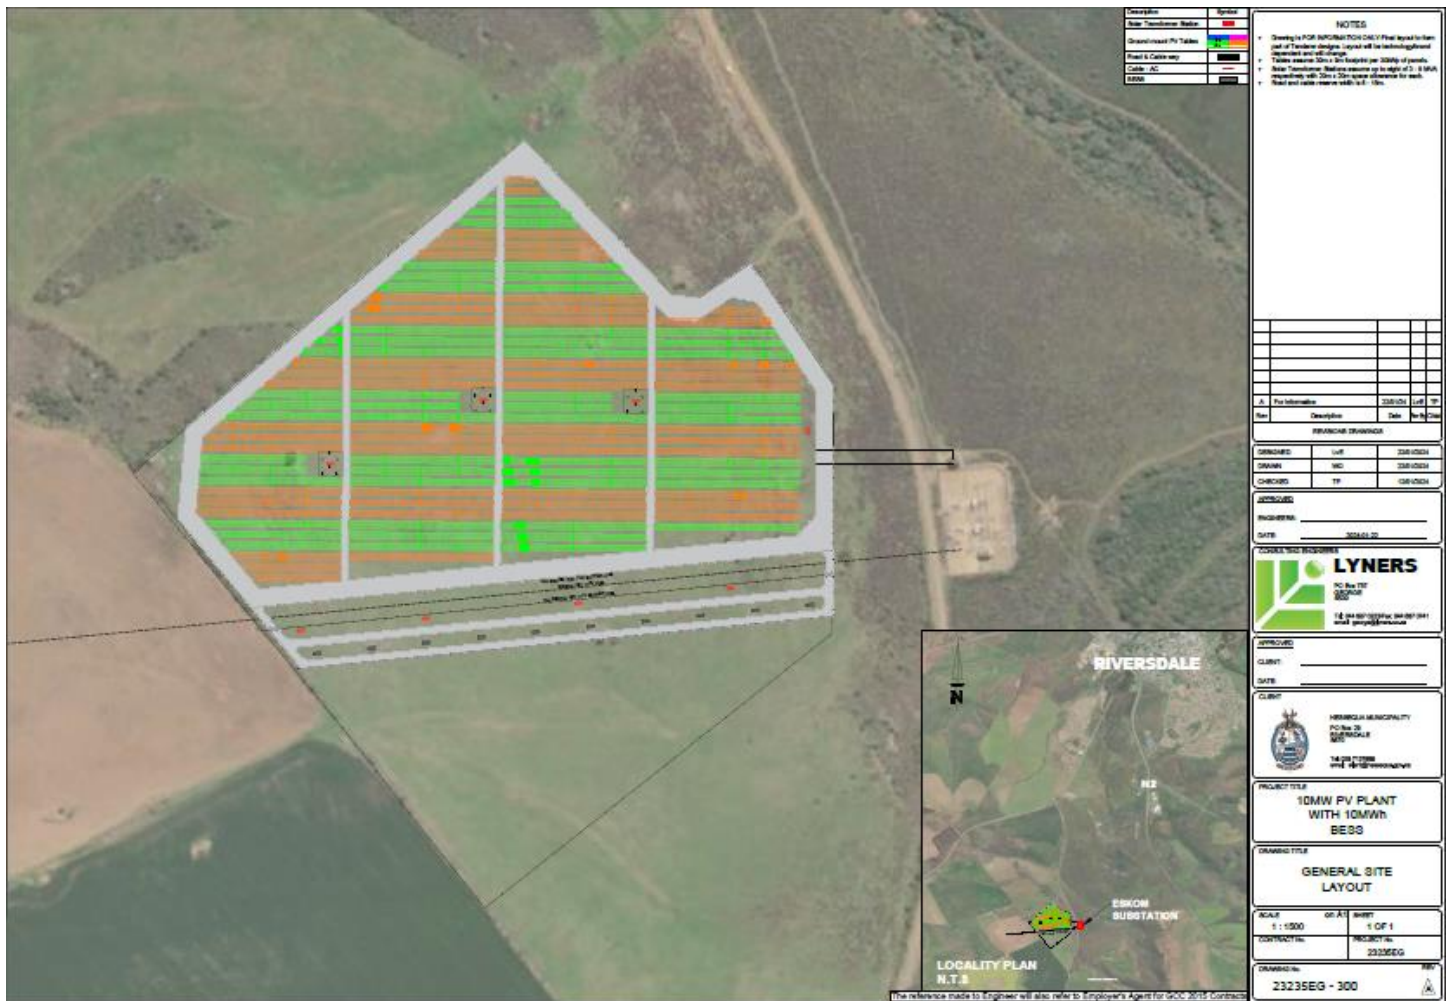
Figure 3. Proposed layout of the Riversdale 10MW Solar PV facility with Battery Energy Storage System

A Site Layout Plan is illustrated in Figure 3.

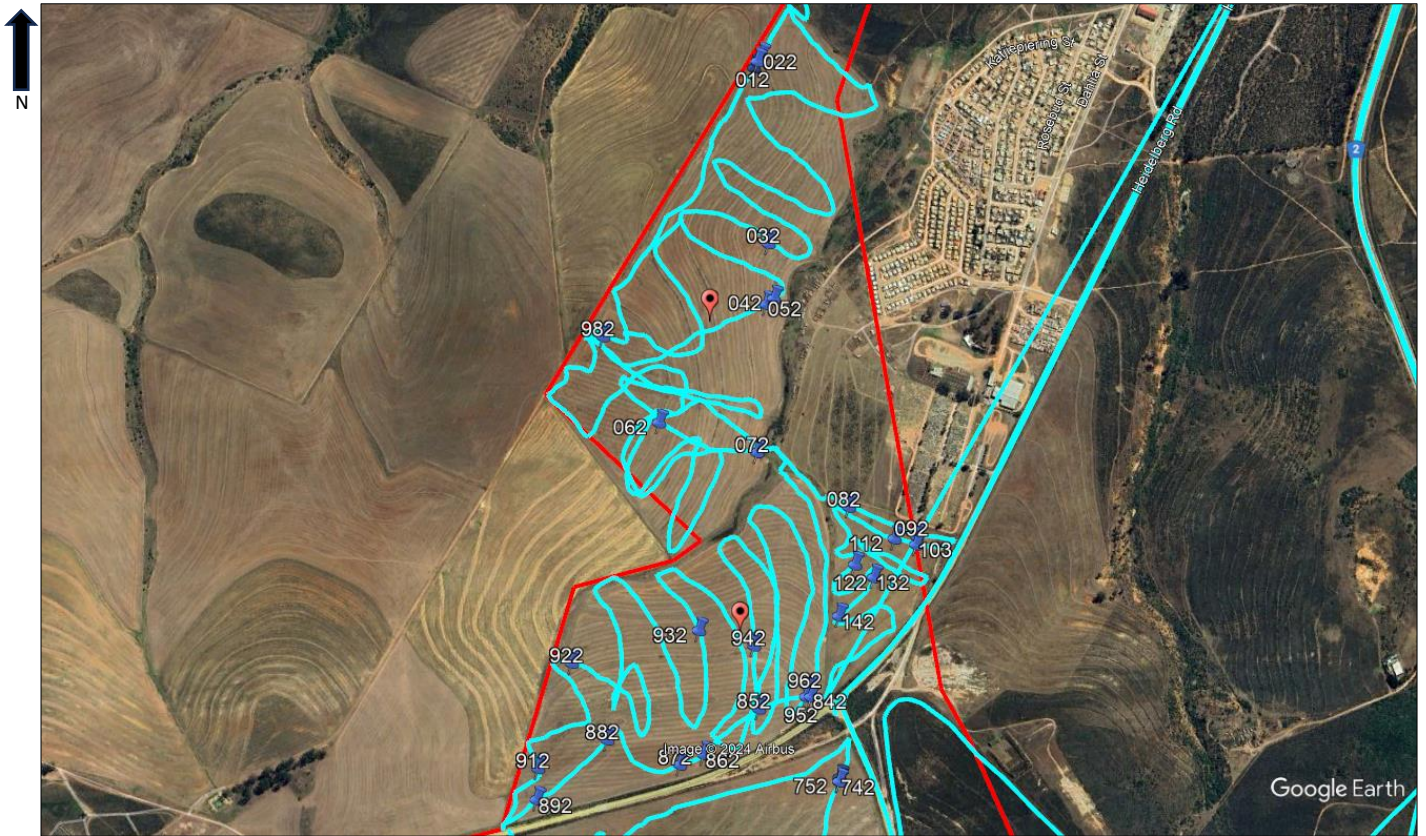
Figure 17. Close up of track path (in blue) & waypoints of archaeological finds north of

Trackpaths and waypoints of archaeological finds are presented in Figures 14-17.
