# Botanical Impact Assessment

## Proposed repairs of flood damage to the Camfersdrift River, George

21 October 2023

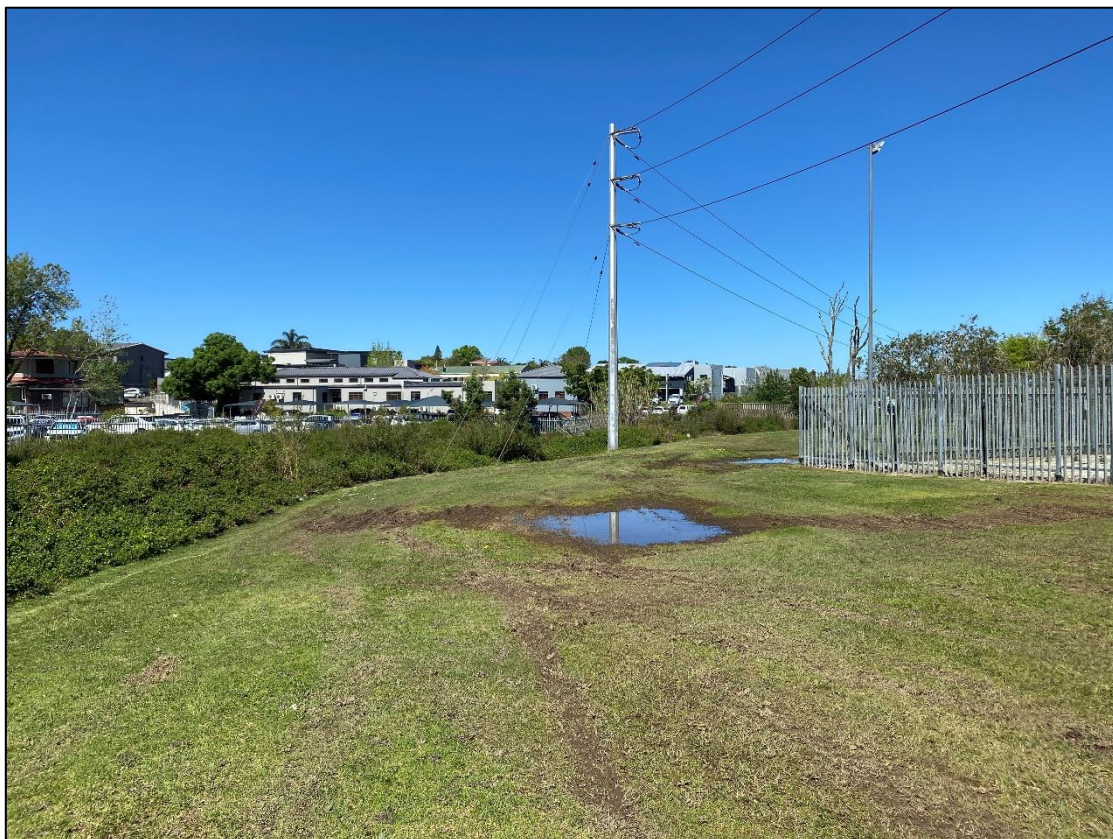
**Figure 4-2: Commercial area and fence of an electrical substation (righthand side) flanking the site just upstream of C.J. Langenhoven Road.**

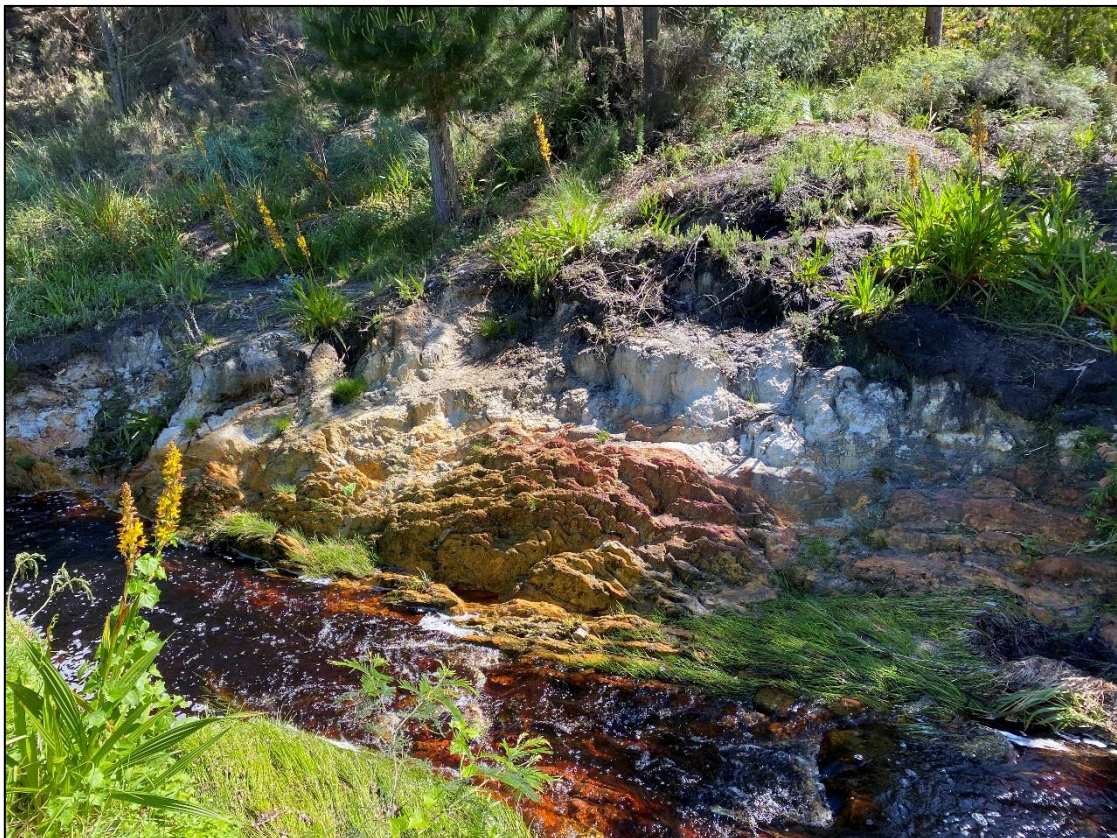
**Figure 4-3: Exposed Kaaimans Group sediments (schist!) inside the Camfersdrift River channel.**

According to the 3322 Oudtshoorn 1:250 000 geological map, the site is underlain by Kaaimans Group sediments (Saasveld Member), comprising andalusite schist, mica schist and hornfels (**Figure 4-3**). The Saasveld Member is about 600 m thick (Toerien, 1979). It is of Namibian age and are of the oldest sediments found in the region. It typically supports shale fynbos in these parts.

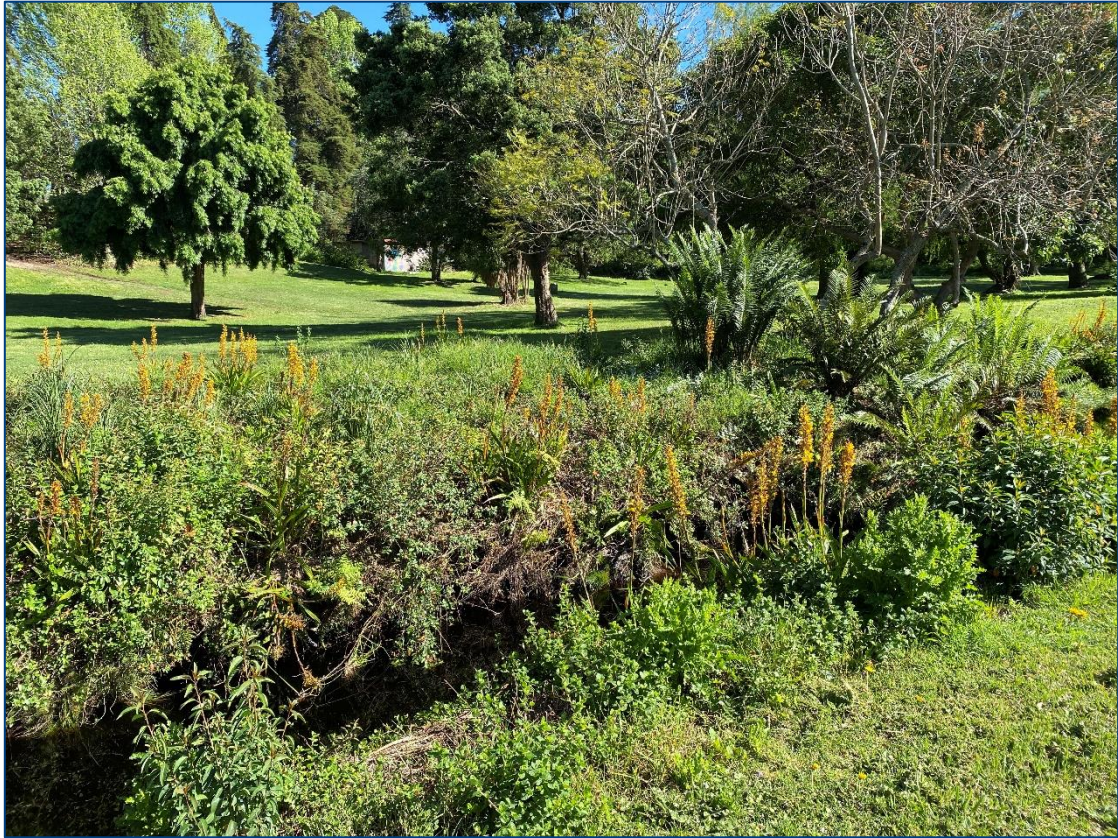
**Figure 5-2: Camfersdrift River inside Van Riebeeck Gardens, fringed by *Cliffortia obcordata* and *Wachendorfia thyrsiflora*.**

The botanical attributes of the site are presented in **Figure 5-1**. **Figures 5-2 to 5-7** illustrate the current state of the vegetation on site.

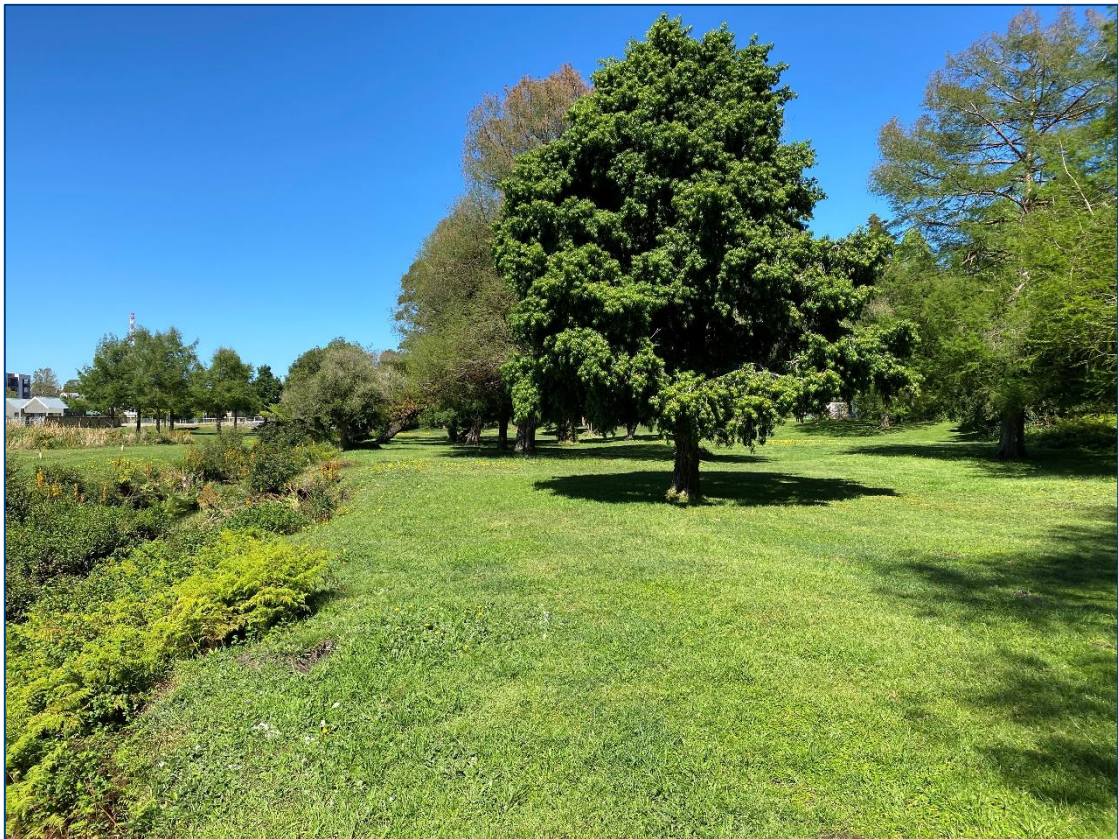
**Figure 5-3: Grassed area next to the Camfersdrift River, with a *Podocarpus henkelii* in the foreground.**

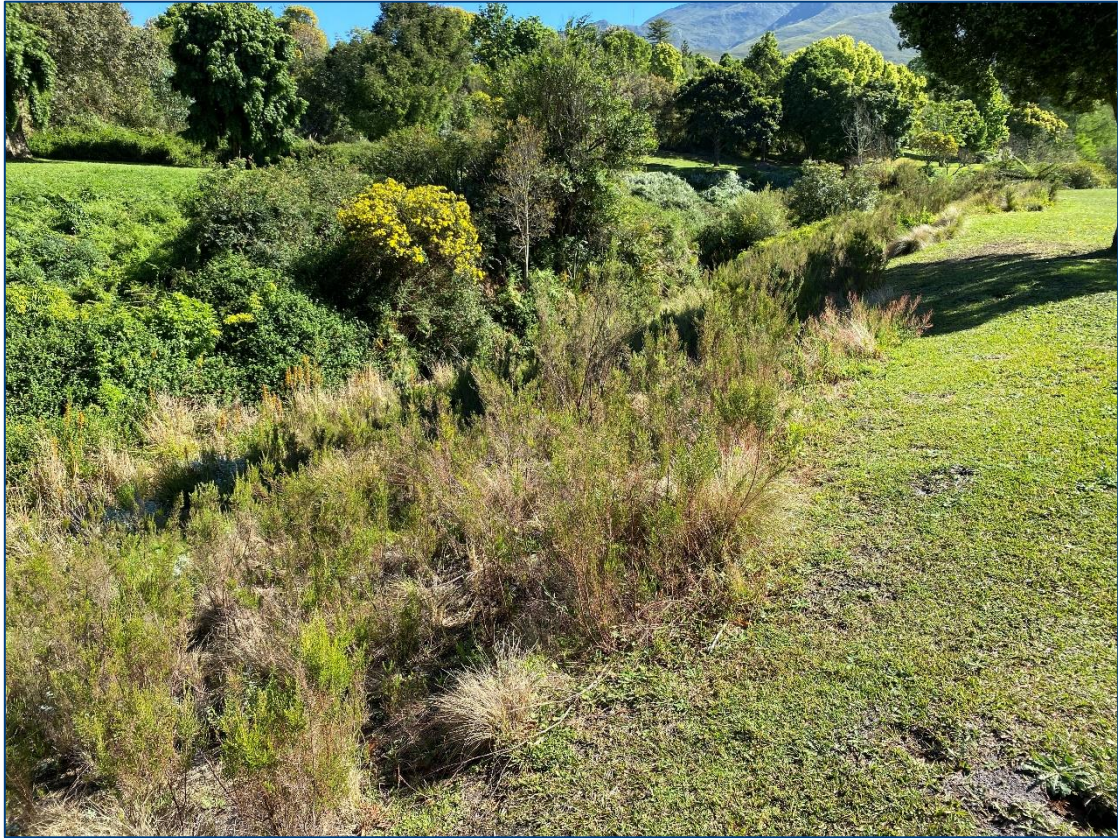
**Figure 5-4: Strip of fynbos on the embankment of the Camfersdrift River.**

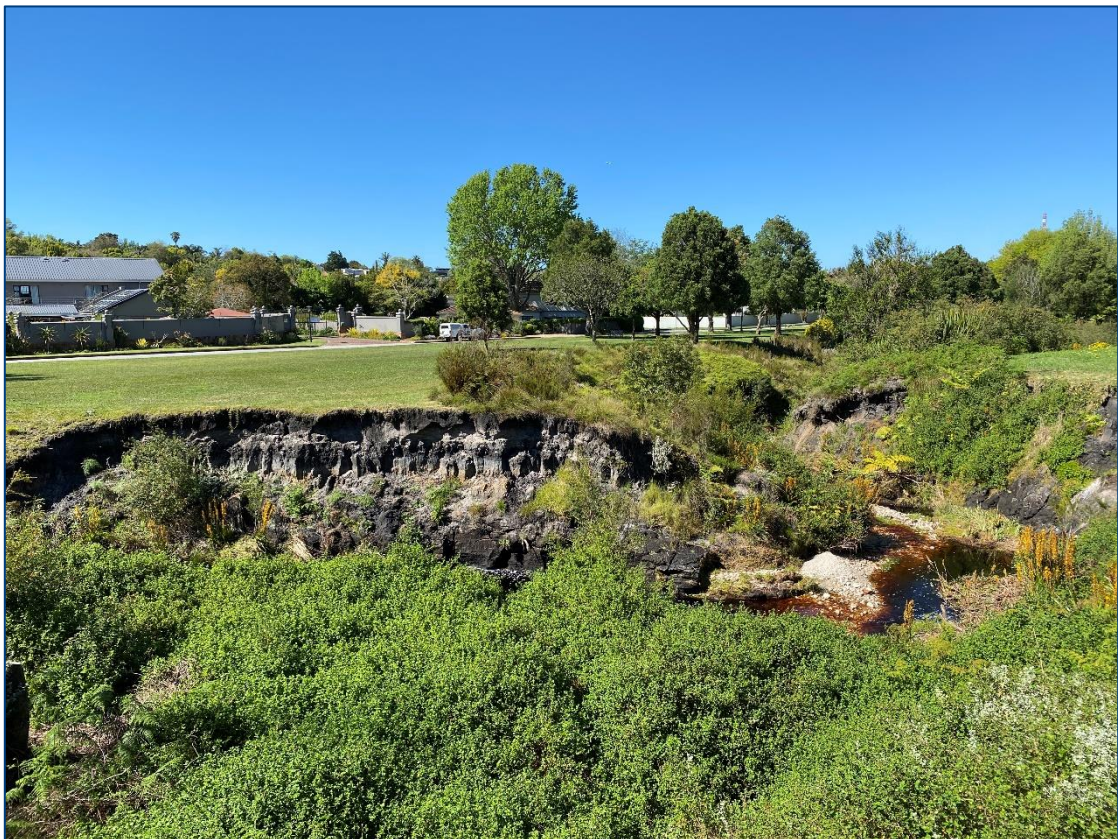
**Figure 5-5: Eroded section of the Camfersdrift River inside Van Riebeeck Gardens.**

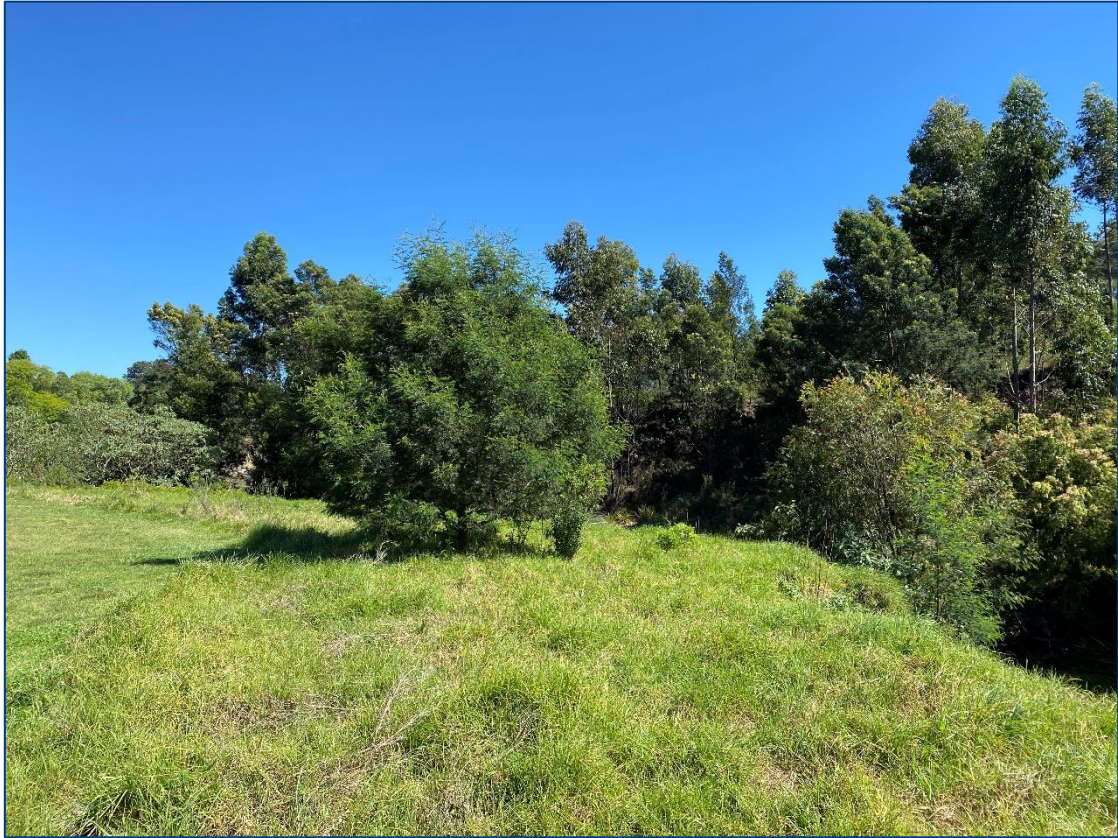
**Figure 5-6: Degraded section of the site (between Davidson Rd and C.J. Langenhoven Rd), covered by kikuyu, black wattle and bugweed.**

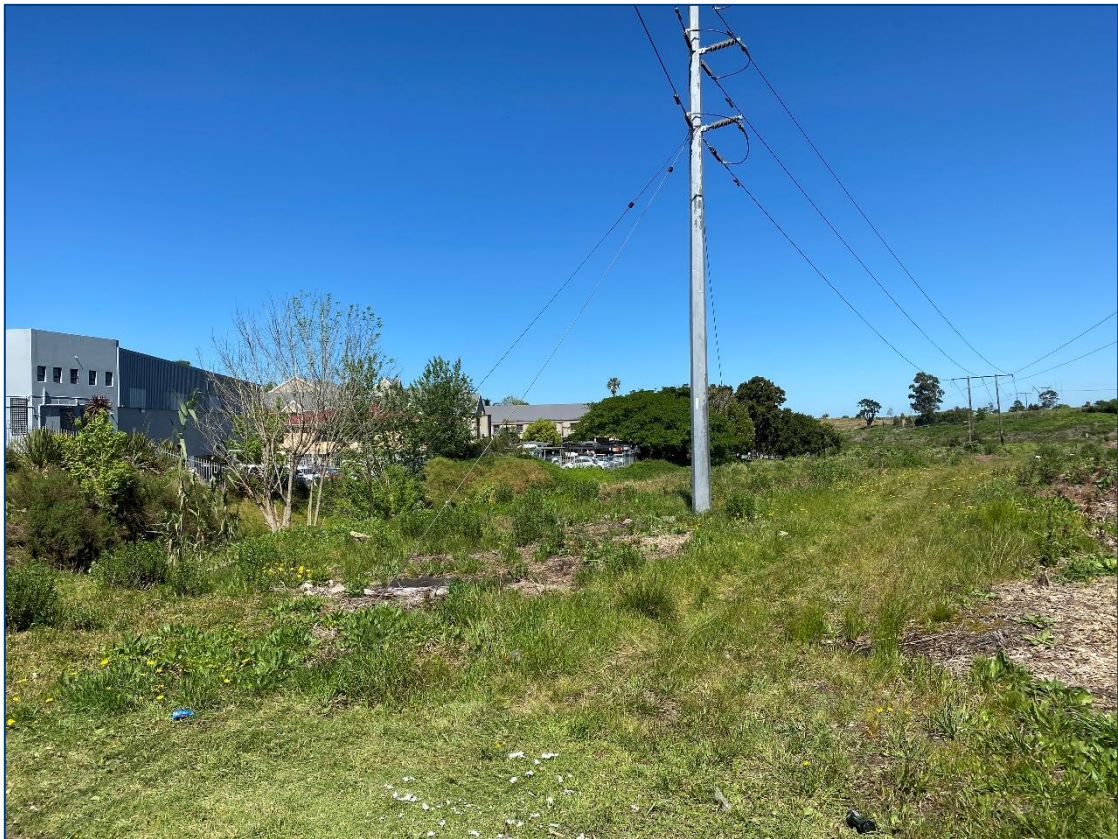
**Figure 5-7: Degraded southern end of site (south of C.J. Langenhoven Rd).**

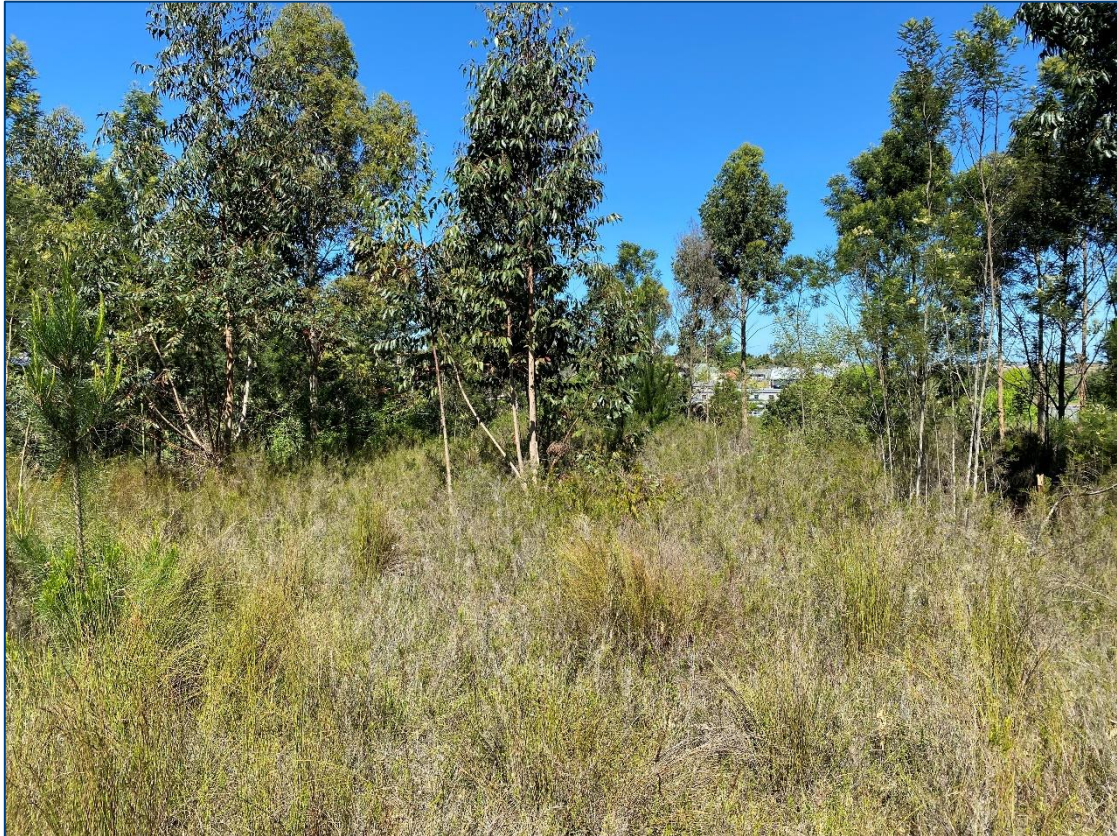
**Figure 5-8: Degraded fynbos between Davidson Rd and C.J. Langenhoven Rd, infested with gums, black wattle and pines.**

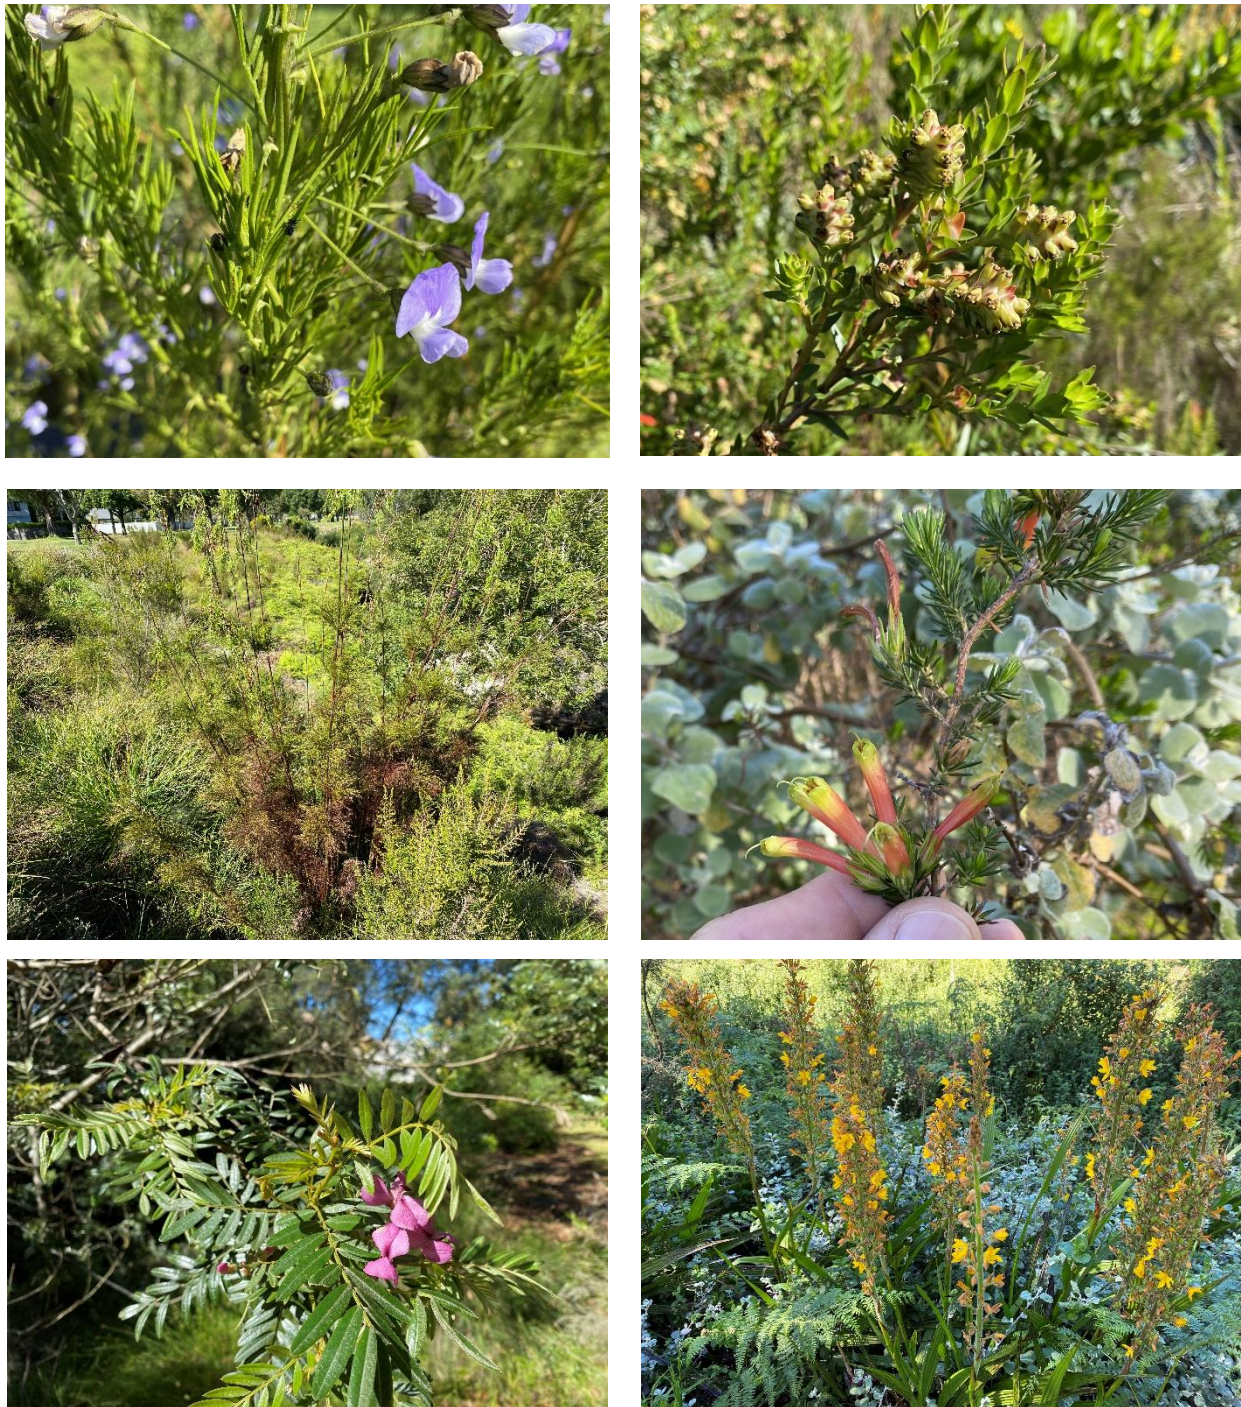
**Figure 5-9:** A few indigenous species recorded on site, with *Psoralea affinis* (top left), *Penaea cneorum* (top right), *Rhodocoma gigantea* (middle left), *Erica unicolor* ssp. *georgensis* (middle right), *Virgilia divaricata* (bottom left) and *Wachendorfia thyrsiflora* (bottom right).

*Pelargonium cordifolium* and *Pteridium aquilinum* are important taxa in Garden Route Shale Fynbos. **Figure 5-9** shows a few of the recorded indigenous species.

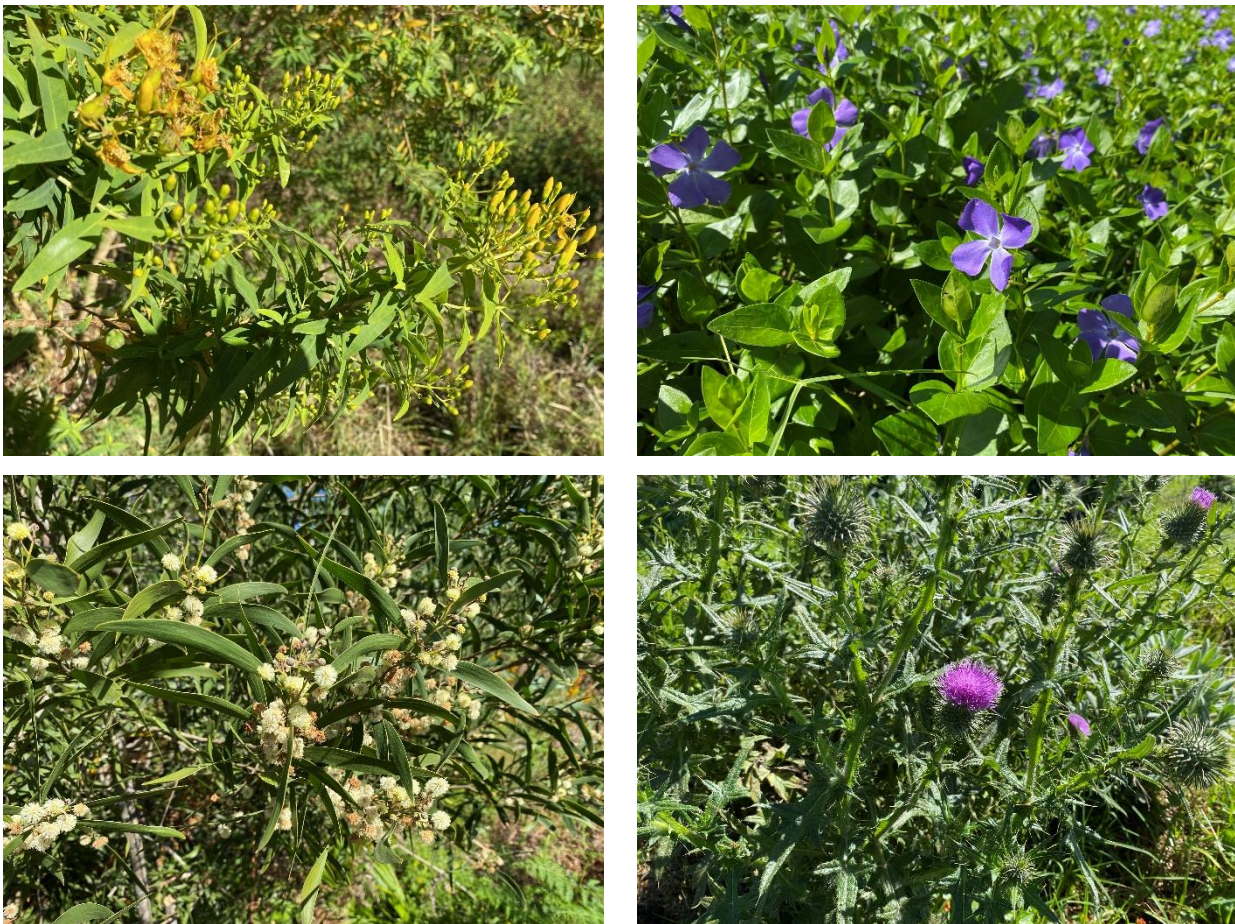
**Figure 5-10: A few indigenous species recorded on site, with *Hypericum canariense* (top left), *Vinca major* (top right), *Acacia melanoxylon* (bottom left) and *Cirsium vulgare* (bottom right).**

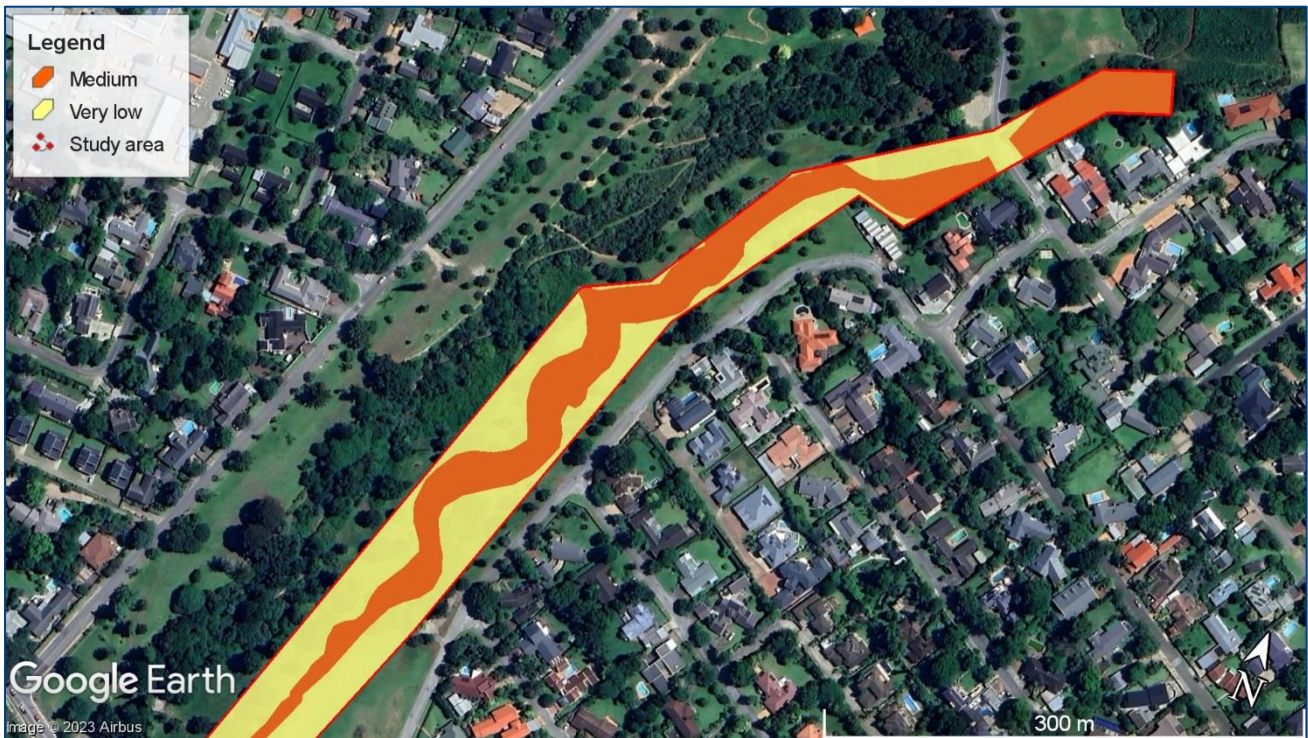
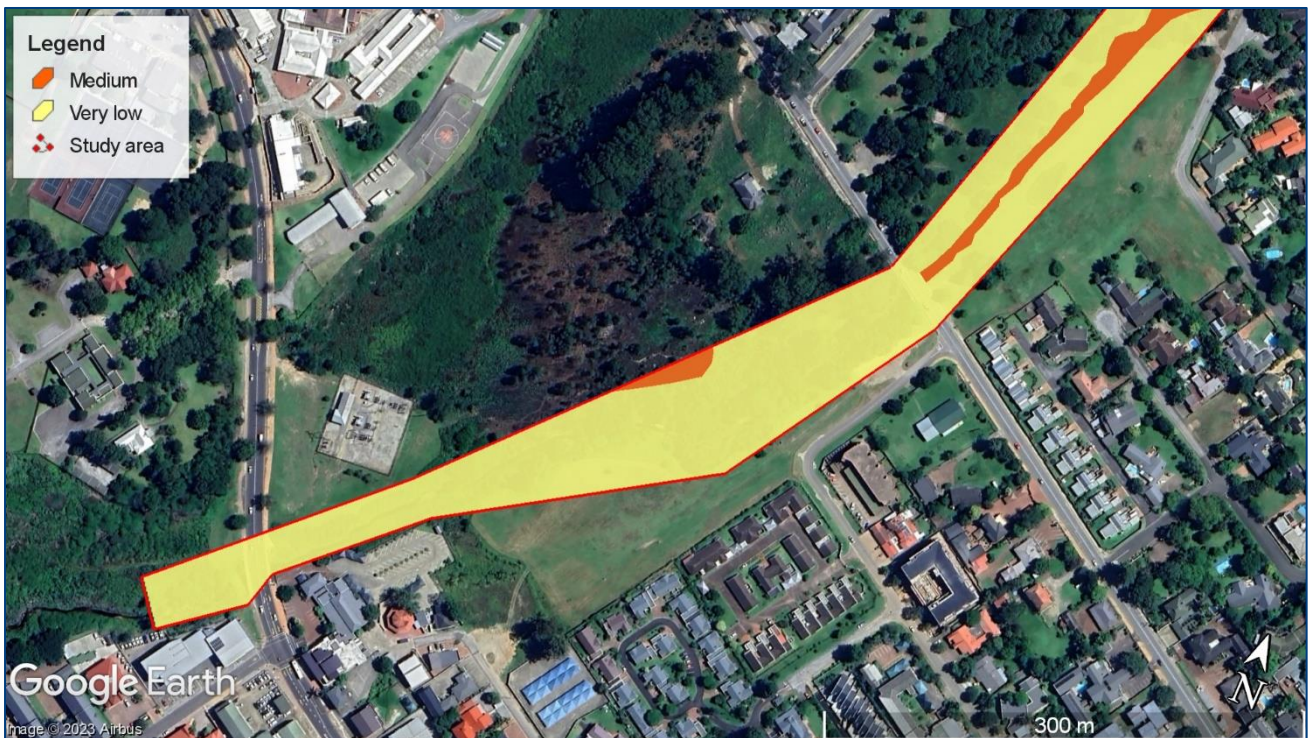
**Figure 6-11: Site ecological importance (SEI) map, with northern section on top and southern section below.**

In order to demonstrate the biodiversity sensitivity of the site, a site ecological importance (SEI) map was prepared (**Figure 5-11**). This map considers the biodiversity importance of the receptor area and its resilience to impacts. The receptor area is described as the affected habitat (riparian zone and fynbos in this instance), which may accommodate certain SCC. A Medium SEI value was allocated to the good quality riparian areas and fynbos, while the rest of the area, such as the parkland and highly degraded areas, scored a Very low value. A large portion of Van Riebeeck Gardens inside the study area is considered transformed from a biodiversity perspective. Please note that the hydrological importance of the Camfersdrift River was not considered in this evaluation. The main reasons for the Medium value areas are the threatened status of Garden Route Shale Fynbos, partial connectivity of the site with the biodiversity network, and the relatively small area(s) involved.
