# **HERITAGE IMPACT ASSESSMENT: PROPOSED MULILO KAROO WIND POWER 2 WIND ENERGY FACILITY, BEAUORT WEST MAGISTERIAL DISTRICT, WESTERN CAPE**

Required under Section 38(8) of the National Heritage Resources Act (No. 25 of 1999)

Mulilo Karoo Wind Power 2 Wind Energy Facility

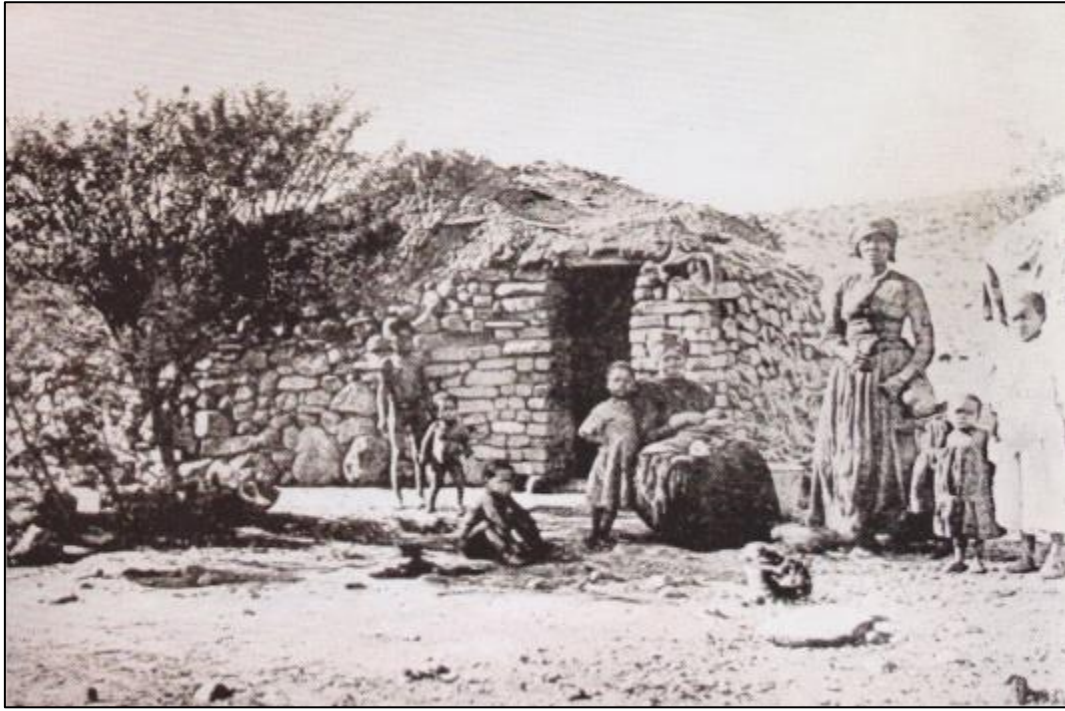
**Figure 16:** A shepherd's hut photographed near Beaufort West in the early 20th century. Note the low, narrow doorway and informal roof structure. Source: Schoeman (2013:48).

These early packed stone structures are invariably collapsed reducing them to archaeological sites in terms of the NHRA definitions. While some with taller walls may have had a formal or informal and/or temporary roof over them, others may have been hartebeeshuise with A-frame-type roofs made of branches and reeds placed above low stone or mud walls. Governor van Plettenberg, during his travels east to inspect the Colony, noted near the Sneeuwberg Mountains that the houses of the colonists consisted only of one room structures with low walls and straw roofs (Theal 1896-1911 cited in Böeseken 1975). In 1811 William Burchell illustrated a trekboer farmhouse (Van Zyl 1975), while Schoeman (2013) shows an image of such a historical stone dwelling still in use in the early 20th century (Figures 15 & 16).

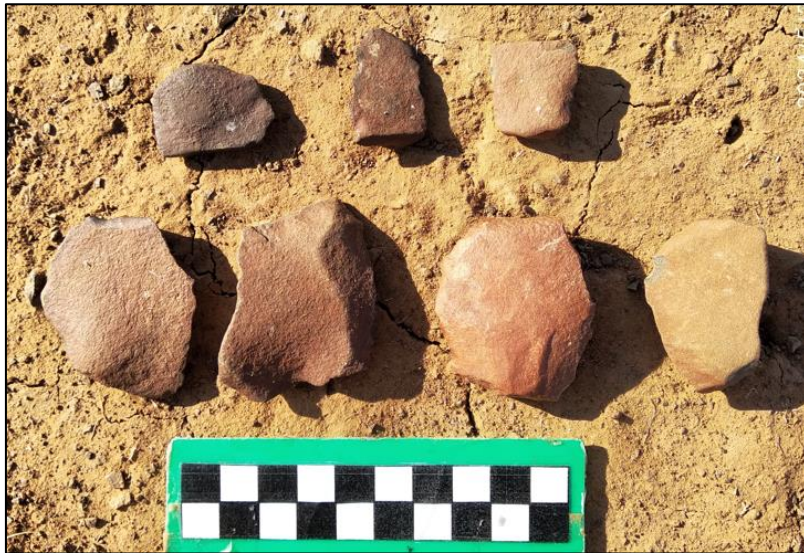
**Figure 19:** Background scatter artefacts at waypoint 475. Scale in cm.

The finds from the survey did not reveal anything entirely unexpected. Background scatter artefacts were rare, but some were seen at waypoint 475 (Figure 19). Only one artefact scatter that could be seen as a site was located. This was at waypoints 4689 to 4691. The scatter was at least 80 m by 35 m but was not fully mapped due to time constraints and that it was not located in the disturbance footprint. The artefacts are from the LSA (Figures 20 & 21). An important Stone Age find was some rock paintings. These were located in the small kloof with a waterfall where the original homestead of the farm Waterval was constructed (see waypoints 1848 to 1856). The rock paintings lie at waypoints 1857 and 1858 and are at the base of the cliff over which the waterfall plunges. One painting is a fineline painting at waypoint 1857 (Figure 22), while the second, located just a few meters away at waypoint 1858, seems like it might be a geometric painting (Figure 23).

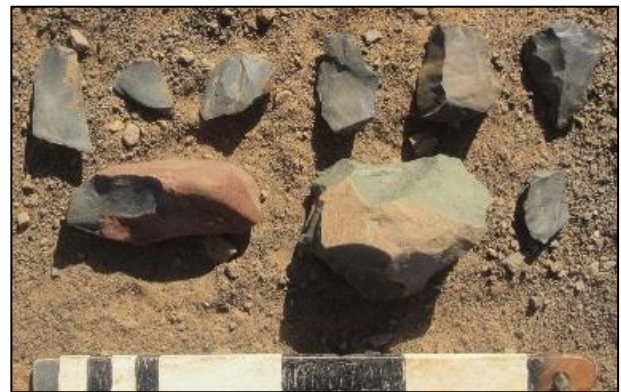
**Figure 21:** LSA artefacts at waypoints 4689-4691. Scale in 1 and 5 cm intervals.

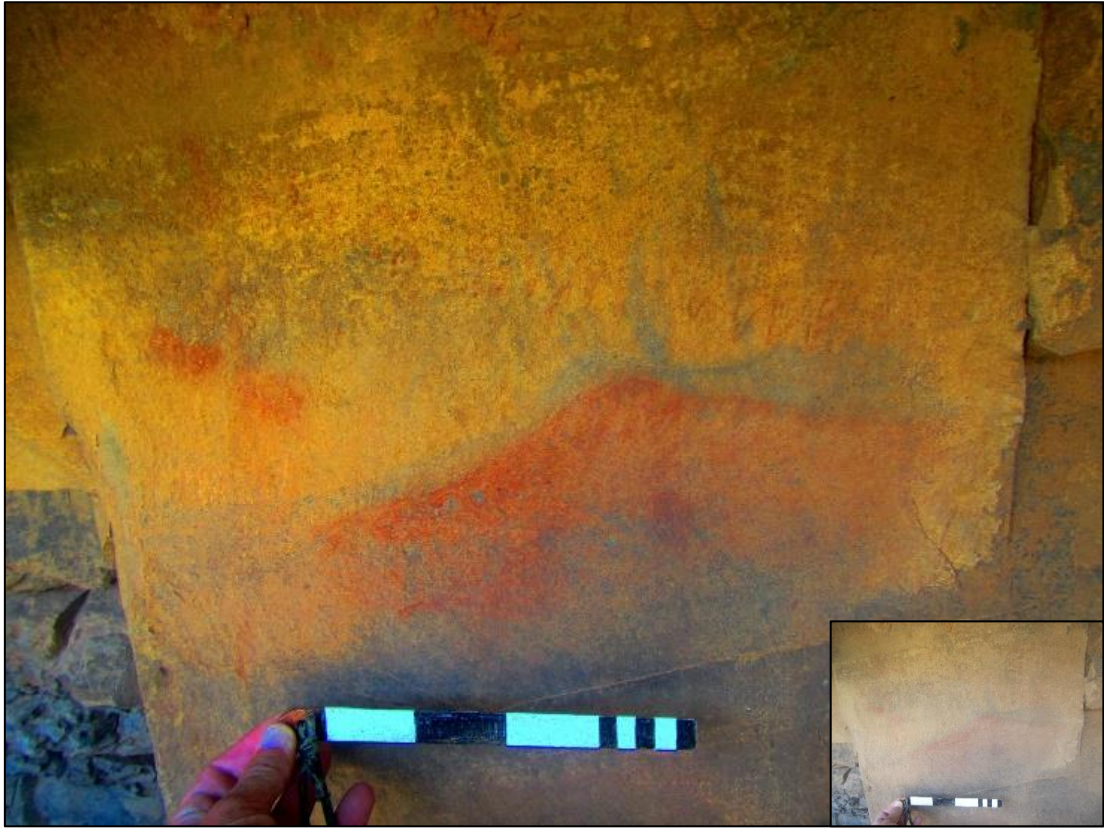
**Figure 22:** *Fineline painting showing an eland torso and other smaller motifs at waypoint 1857. Scale in 1 and 5 cm intervals.*

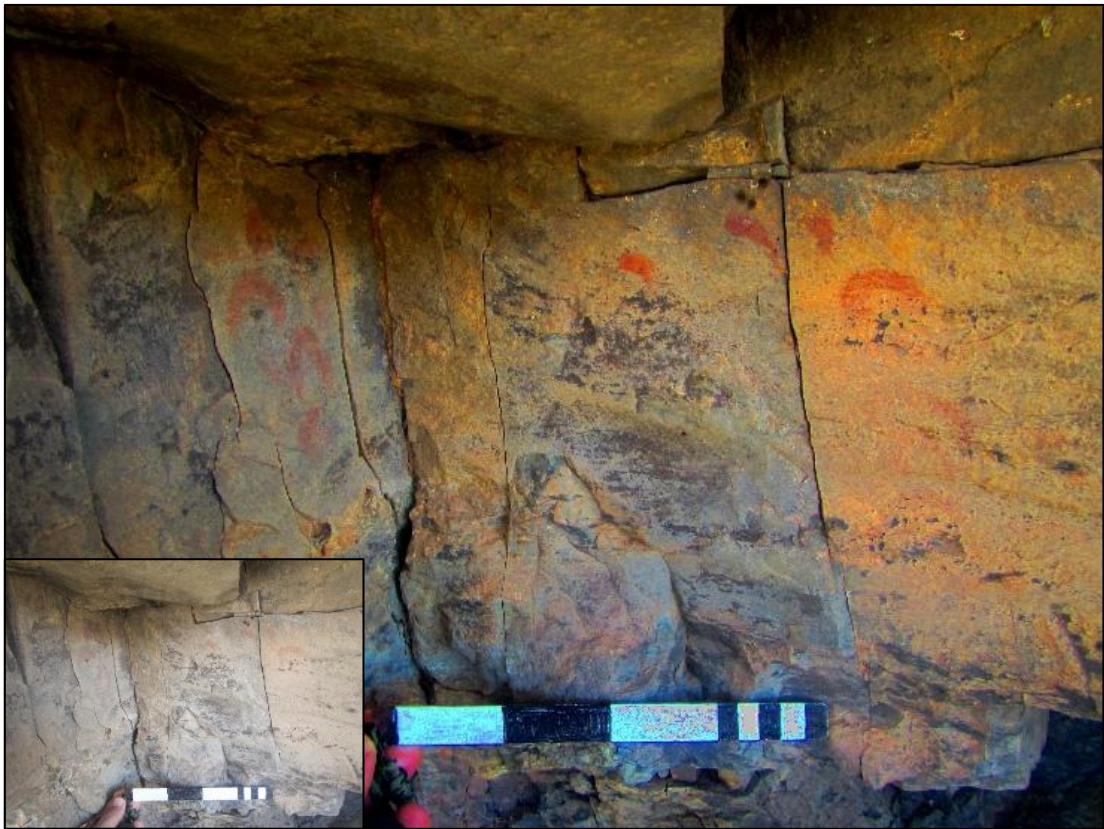
**Figure 23:** *Geometric paintings at waypoint 1858. Scale in 1 and 5 cm intervals.*

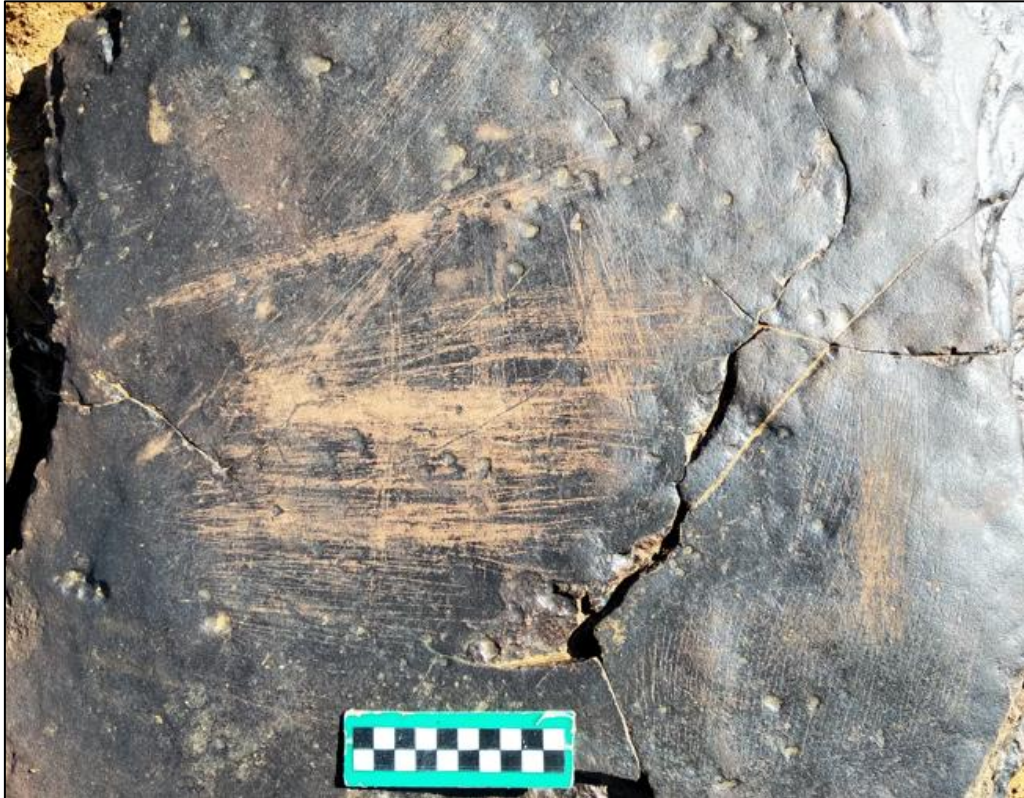
A category of rock art that is not understood is scratched rocks. A number of such rocks were found in the study area. Figure 24 shows a typical example. Whether these are historical or LSA is unknown but the latter may be more likely. Other historical materials are stone-walled features. These are residential as well as farm structures like kraals, chicken coops and other walls (Figures 25 to 27). Outside some residential ruins historical debris can be found. This is sometimes in the form of an ash and rubbish dump or, more often, a lighter scatter of artefacts. The artefacts include glass, ceramic and metal items (Figures 28 & 29). These historical materials are typical of the 19<sup>th</sup> century.

**Figure 24:** Scratched 'engravings' at waypoint 472. Scale in cm.

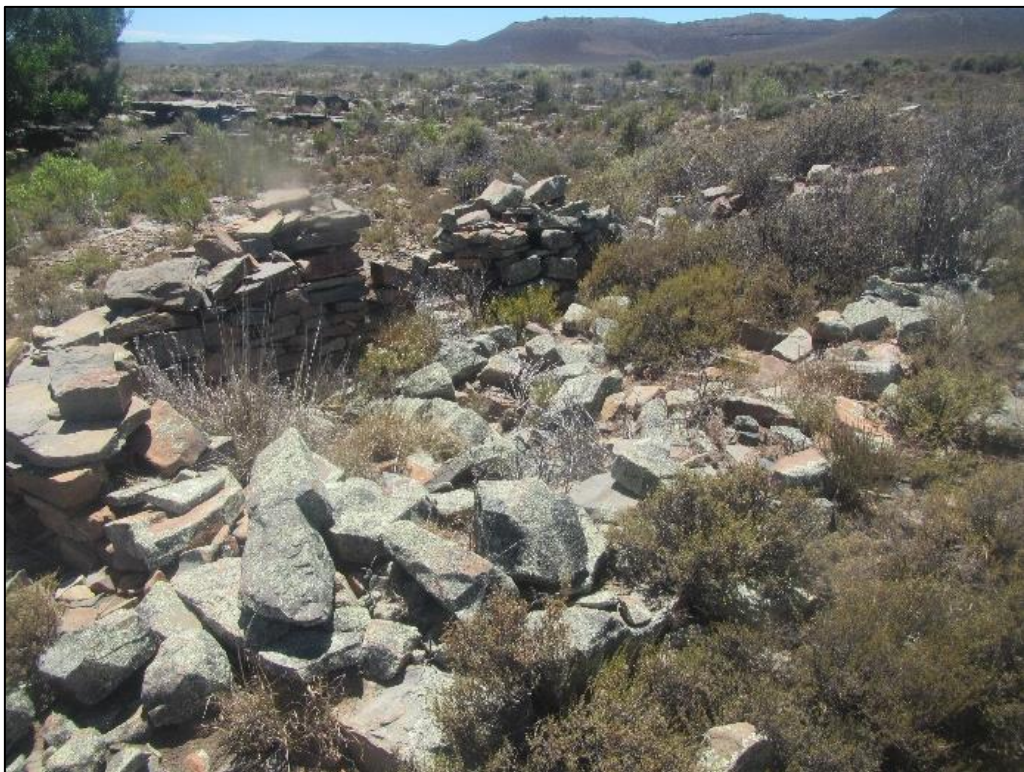
**Figure 25:** Stone-walled ruin at waypoint 1851.

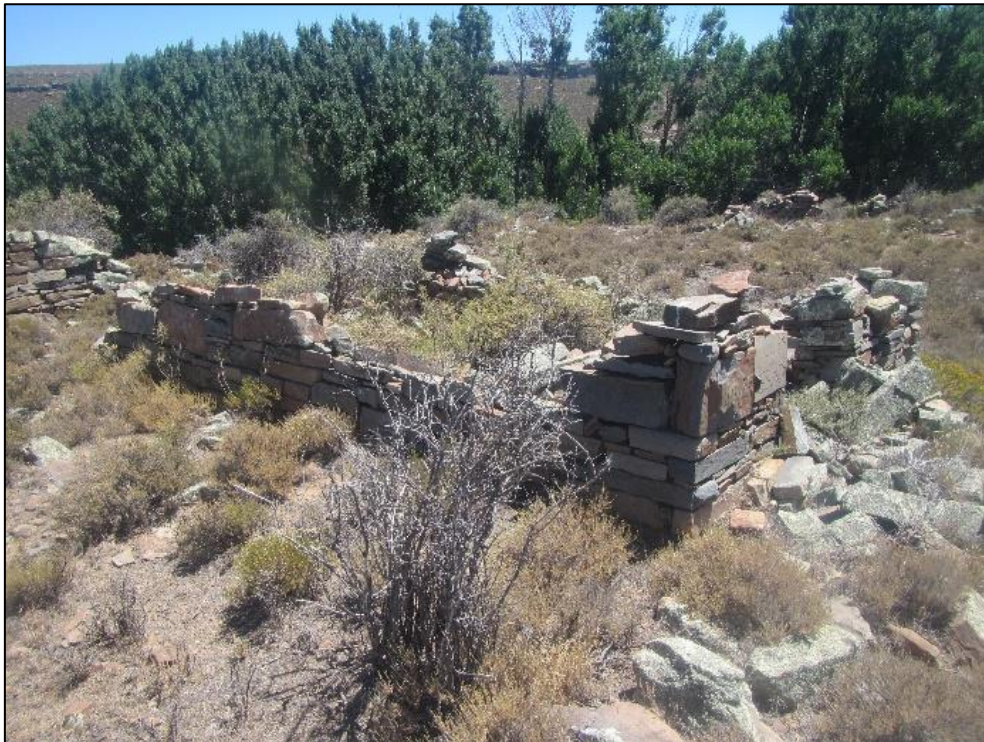
**Figure 26:** *Stone-walled ruin at waypoint 1853.*

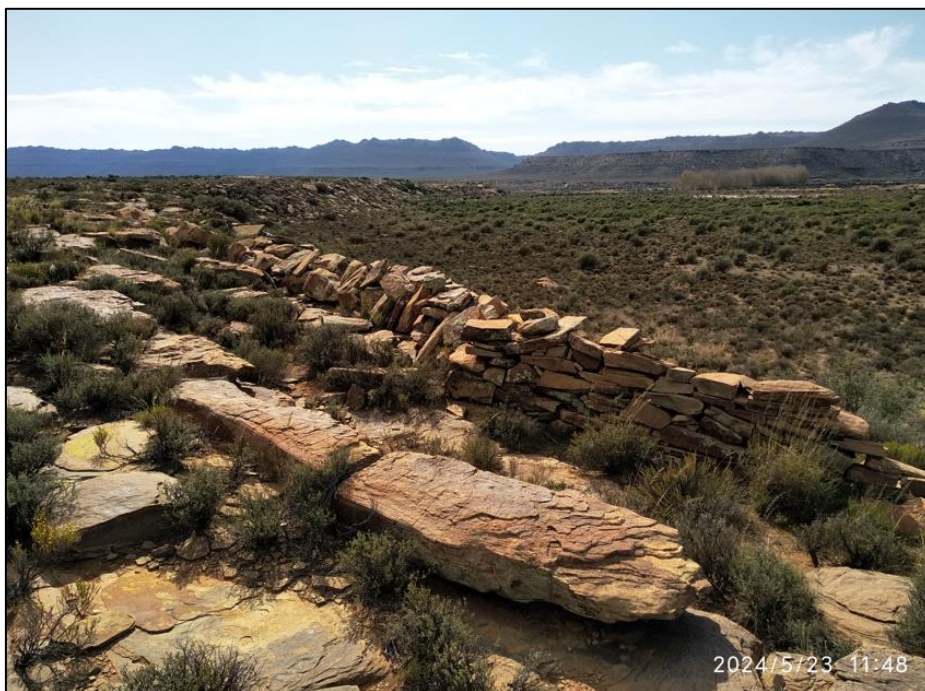
**Figure 27:** *Stone walling at waypoint 484.*

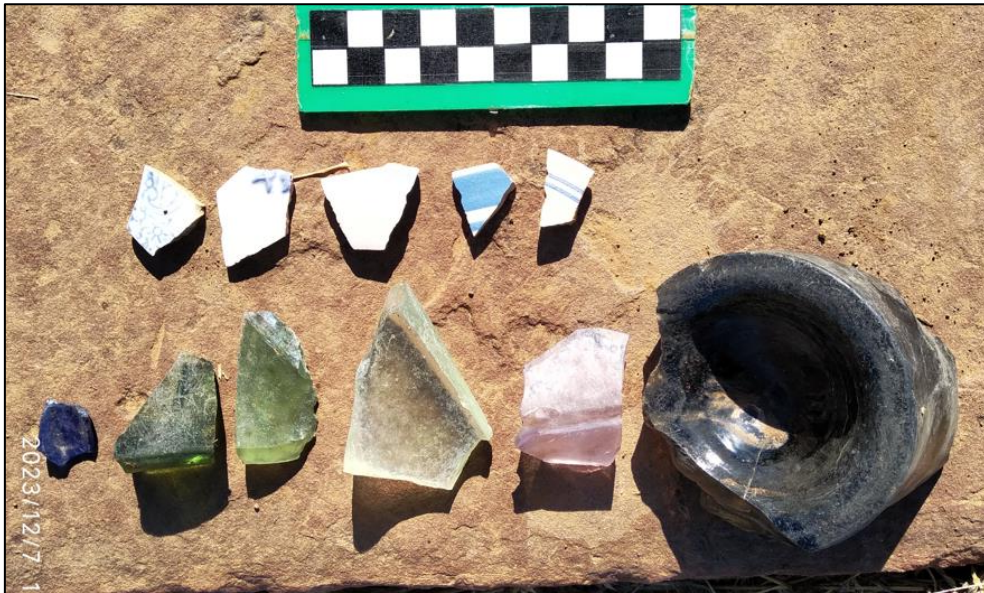
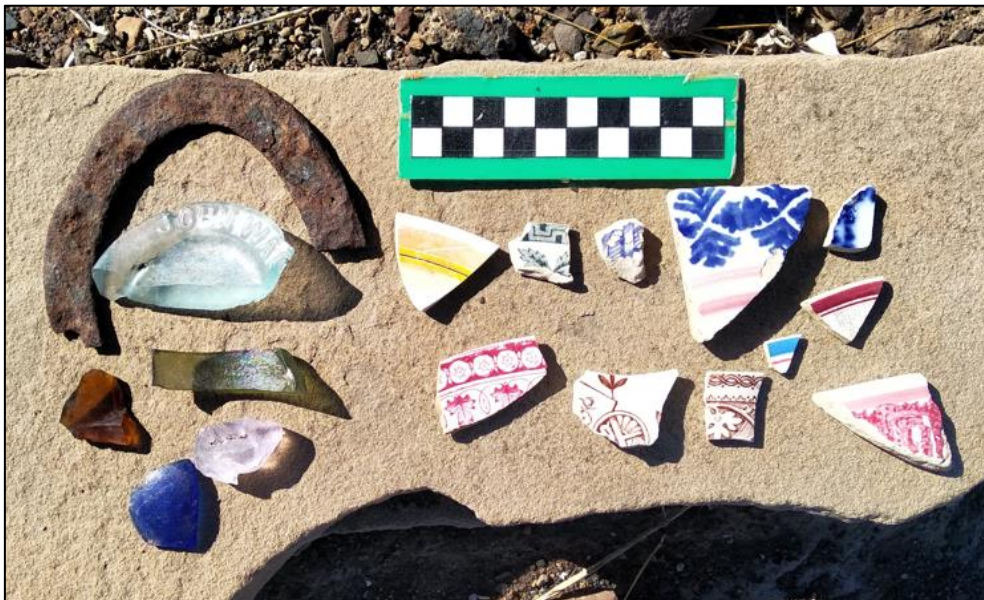
**Figure 28:** Historical artefacts from waypoint 266.

**Figure 29:** Historical artefacts from waypoint 266.

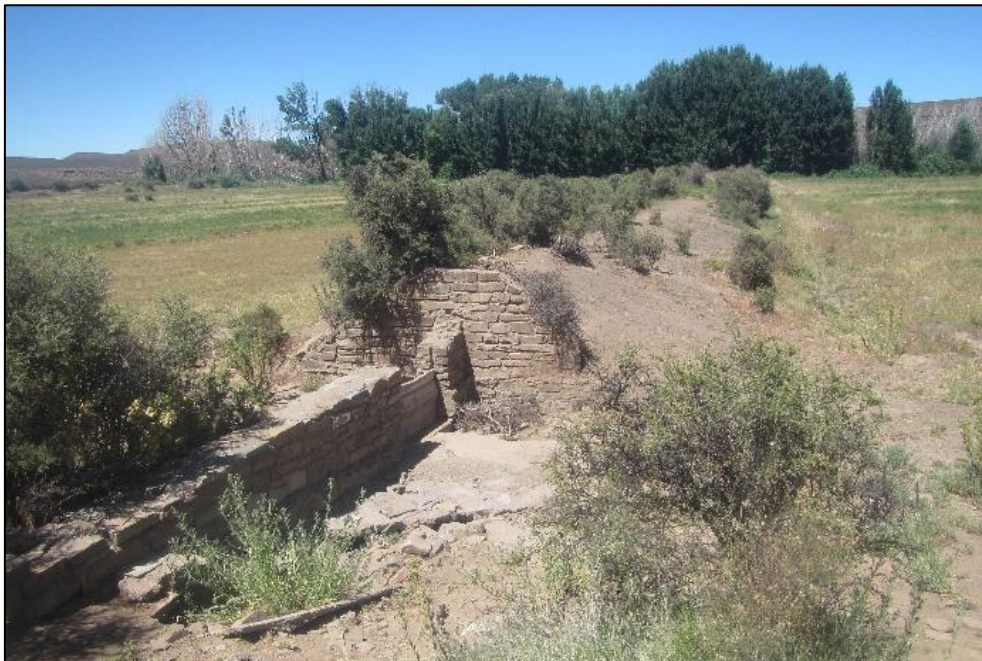
Historical resources were quite rare. Along the Sak River there were a number of earth berms with sluice gates used to trap flood waters and allow for flood irrigation of crops planted on the Sak River floodplain (waypoints 1838 to 1842; Figure 33). Such features are commonly encountered on wide floodplains along Karoo Rivers. The only other historical features recorded were a pair of mid-20<sup>th</sup> century houses at waypoint 1842. One is a traditional Karoo style house, but it bears a date of 1954 and the arrangement of its façade openings bears testimony to the newer date. It is likely that historical structures also occur at Rosedene but this farmstead was not examined.

**Figure 33:** Irrigations berm along the Sak River at waypoint 1839.

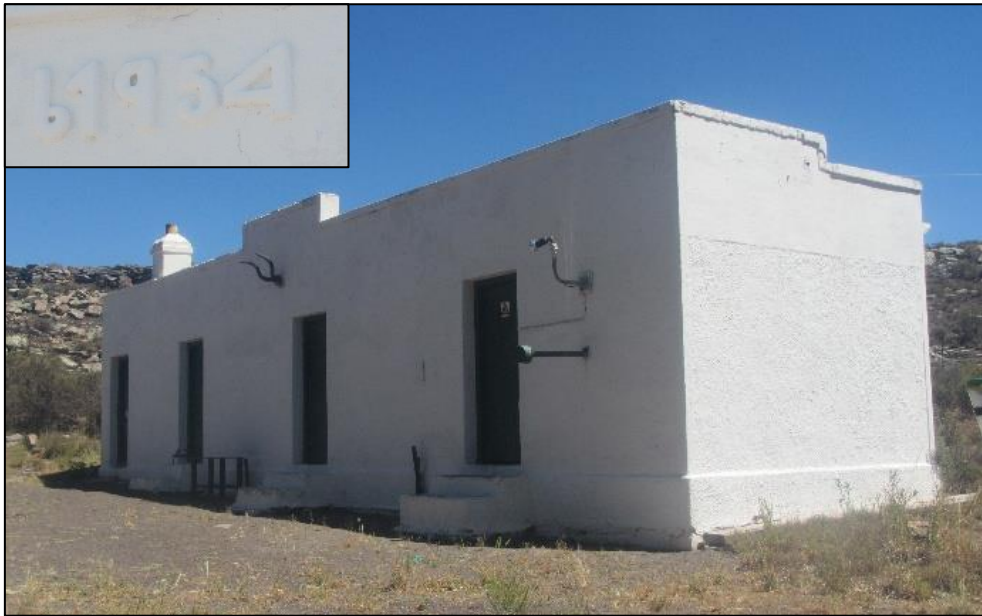
**Figure 34:** Historical house dating to 1954 at waypoint 1842.

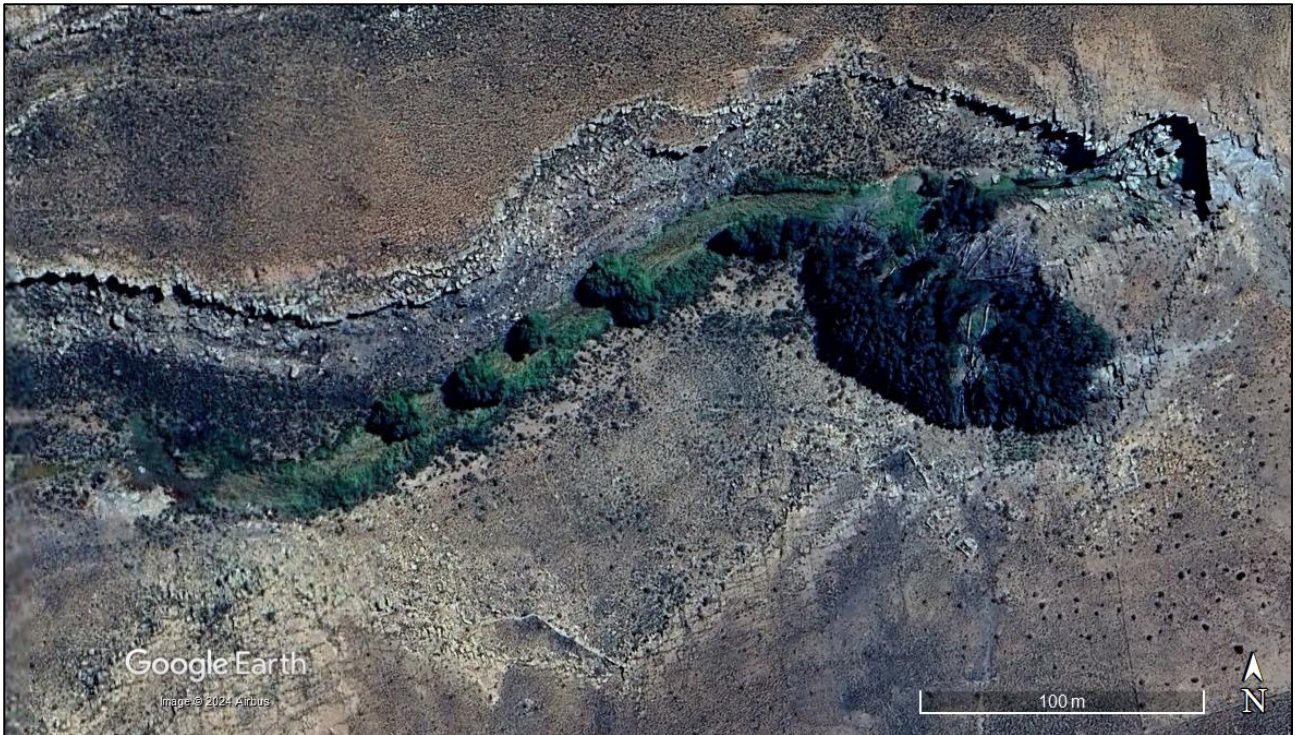
**Figure 36:** Aerial view of the historical (and now entirely archaeological) farmstead at Waterval showing the trees to the northeast of the remnant stone-walled features.

The third aspect is the modern cultural landscape of agriculture, livestock and game farming, although in many places the agricultural component is largely disused as a result of the reduction in rainfall that has occurred over several decades. This landscape is comprised of widely spaced farm complexes, and a network of farm fences and tracks. The modern farm complexes are generally marked by the presence of many trees and some agricultural lands (Figure 35). They often contain different layers of heritage and can be thought of as areas of higher density of heritage resources. Only one occupied farmstead occurs in the study area, on the farm Rosedene, while another farmstead at Waterval seems as though it may see occasional – perhaps seasonal – use. Older, ruined, farmsteads typically agricultural lands and sometimes also trees, but the original Waterval farmstead has a large grove of poplars (Figure 36).

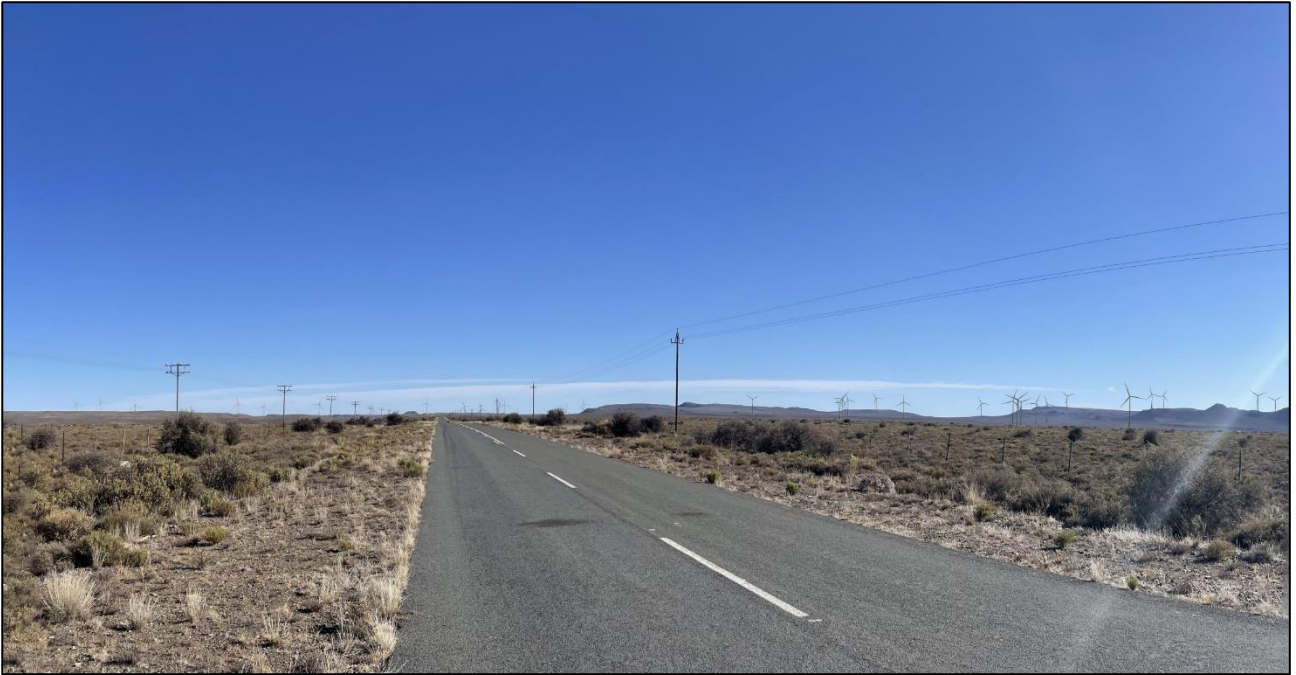
**Figure 38:** Simulated view of the proposed facility taken from a point on the R381 to the south of the study area where the nearest turbine is 4.5 km away.

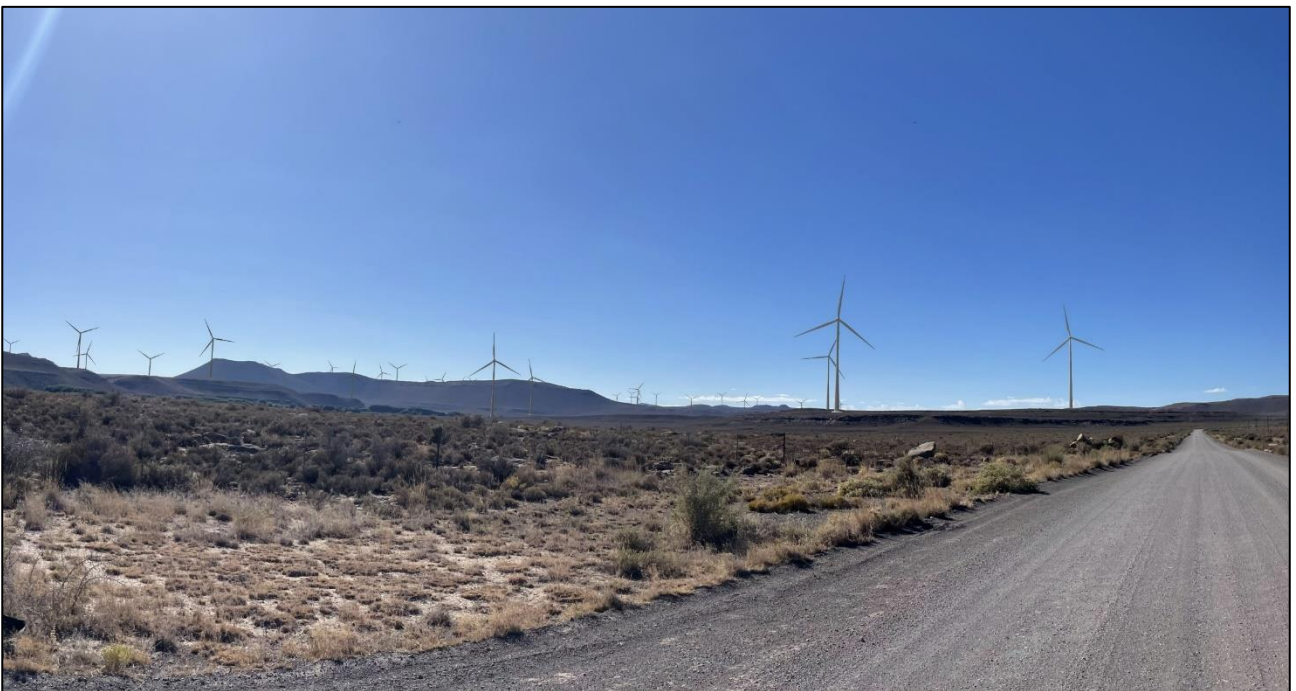
**Figure 39:** Simulated view of the proposed facility taken from a point on the R381 to the north of the study area where the nearest turbine is 1.5 km away.

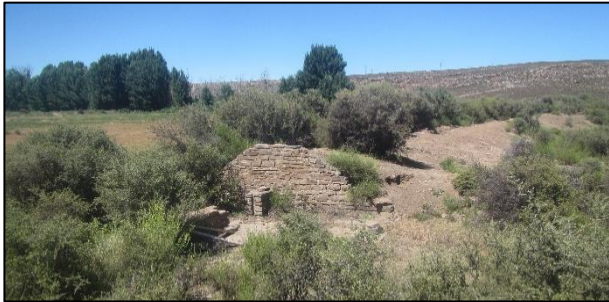
Way-point	Location	Description	Significance Grade
1838	S32 04 47.8 E22 28 07.5	<p>One of several earth berms with stone and cement weirs and sluices used for flood irrigation on the floodplain of the Sak River. According to the topographic maps, these features appear to have been built after 1987, but they do appear on the 2003 aerial photography.</p>

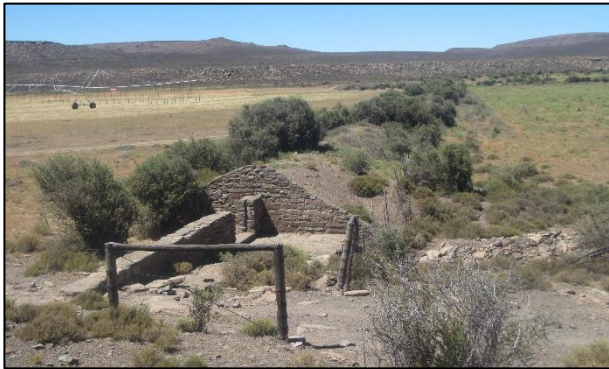
Low IIIC
1843	S32 05 00.6 E22 28 28.6	The ruin of a brick house that was built with mud mortar between the bricks but plastered with cement outside. The ruin is very overgrown and only one small section of walling is still standing. Age unknown, but possibly early 20 <sup>th</sup> century. It sits at the southern end of the present Waterval Farmstead. Aerial photography shows that the house was still roofed in 2003.

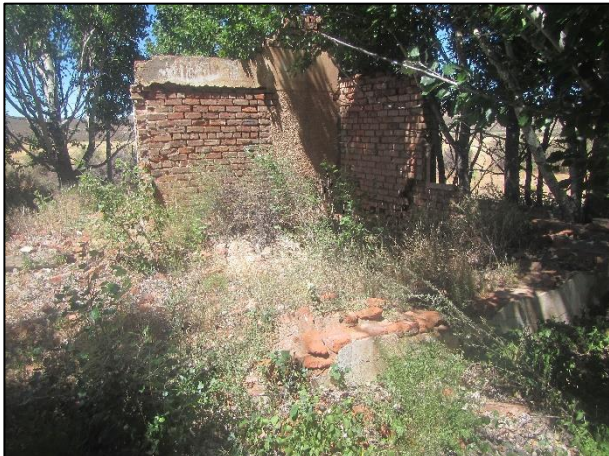
Way-point	Location	Description	Significance Grade
1844	S32 04 59.5 E22 28 30.1	<p>A stone wall encloses an agricultural field. The wall is tumbled in places. This is at the present Waterval Farmstead.</p>

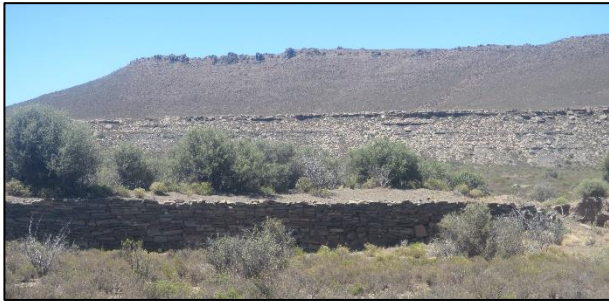
Low IIIC
1846	S32 04 59.1 E22 28 50.2	<p>There are a pair of stone-lined dam walls to the north and south of the road here. The northern one (pictured below) functioned as a dam wall across the valley bottom and, when full, would have deviated water towards the southern one which, in turn, captured a smaller stream and deviated the water towards the southwest to the arable lands there.</p>	Low IIIC

Way-point	Location	Description	Significance Grade
		Both features are present on the 1969 topographic map.

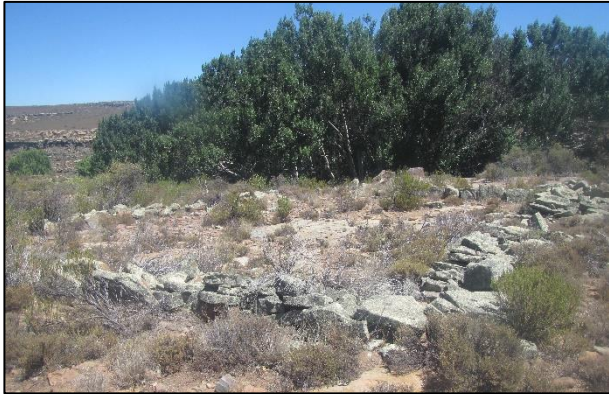
1847	S32 04 43.0 E22 29 02.4	This is a rock outcrop that has been quarried to obtain sandstone slabs for building.	Very low NCW
1848	S32 04 21.3 E22 28 41.1	Waypoints 1848 to 1856 are all part of the (presumably) original Waterval Farmstead. The site is entirely in ruin and is now archaeological in nature. Nothing is visible on the 1945 aerial photography indicating that it was already then long in disuse. There are a large number of stone-walled features present and, given their state of collapse, it is generally difficult to tell what they might have functioned as. At this waypoint is a large enclosure that was presumably a kraal.

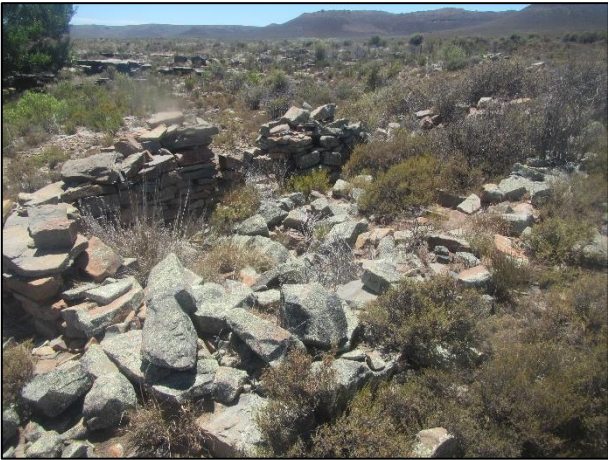
Way-point	Location	Description	Significance Grade
1851	S32 04 21.7 E22 28 39.3	<p>This ruin was almost certainly a house and measured 3 m by 6 m.</p>

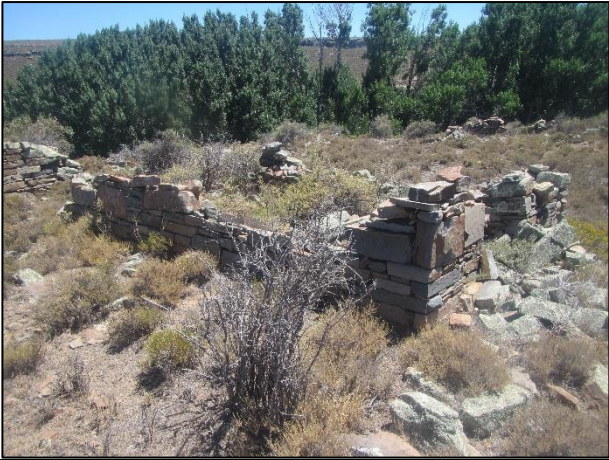
Low IIIC
1852	S32 04 21.5 E22 28 39.0	<p>A non-descript and poorly preserved stone-walled ruin of about 3 m by 4 m.</p>	Low IIIC
1853	S32 04 22.2 E22 28 39.0	<p>Although this ruin was smaller at about 6 m by 3 m, its more formal construction with carefully placed and dressed slabs suggests a residential function.</p>

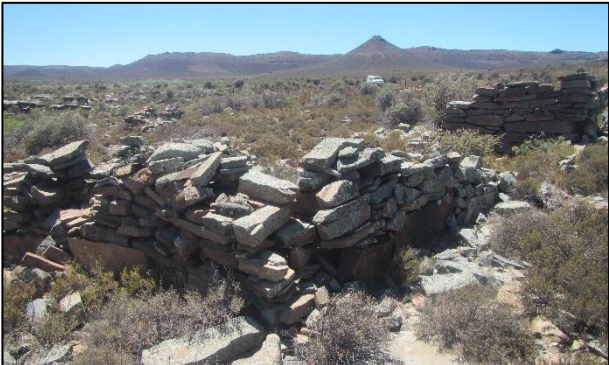
Low IIIC
1854	S32 04 21.9 E22 28 38.5	<p>This is a larger stone-walled ruin with a few rooms and an irregular shape. The overall footprint is about 5 m by 10 m. It was most likely a house.</p>

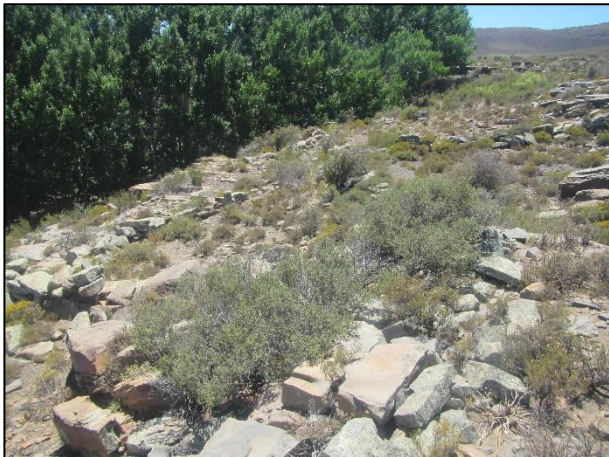
Way-point	Location	Description	Significance Grade
1855	S32 04 21.4 E22 28 38.1	<p>A kraal complex was built up against a low scarp immediately northwest of the other ruins described above.</p>

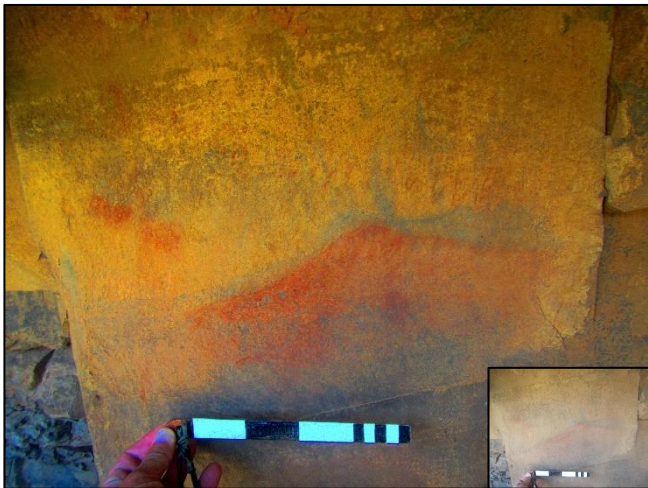
Low IIIC
1856	S32 04 21.5 E22 28 36.9	<p>Ephemeral stone walling extends towards the southwest along the lip of the low scarp.</p>	Low IIIC
1857	S32 04 18.5 E22 28 41.8	<p>Immediately south of the west-facing waterfall is an overhanging cliff. Two spots have rock art. At this waypoint there is a large indeterminate red shape and two smaller red shapes. A darker red shape overlies the large shape, and some possibly crayon-drawn red V-shapes occur in a line above the largest shape. The main image below has been manipulated to emphasise the art, while the inset shows its original appearance.</p>

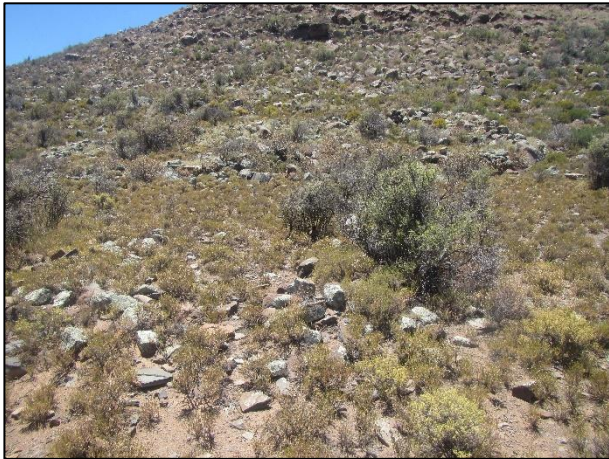
1859	S32 03 40.0 E22 30 42.6	<p>Waypoints 1859 to 1866 are part of a ruined farmstead which is now totally archaeological. It lies in a narrow valley with most features being to the south of the river with just the kraal at this waypoint being to the north. The kraal is about 18 m by 9 m and is badly tumbled (background in the photograph). Another section of walling occurs to the south of it (foreground in the photograph), but the preservation is too poor to determine its function.</p>

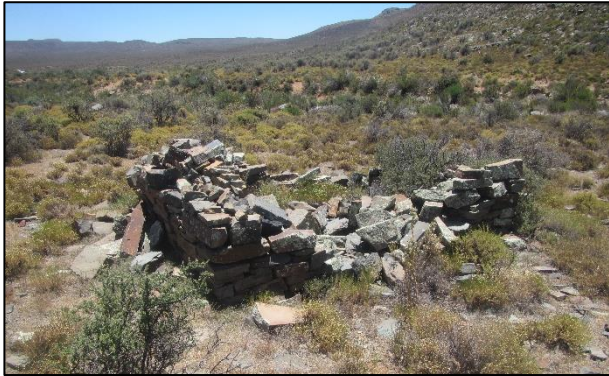
Way-point	Location	Description	Significance Grade
1865	S32 03 42.6 E22 30 41.9	<p>This is a house ruin located just west of the arable land. It measures about 3 m by 4 m.</p>

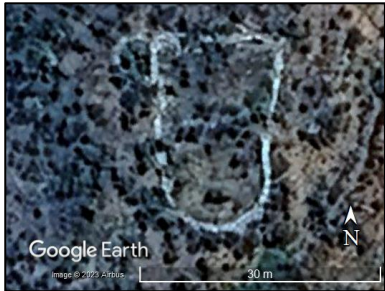
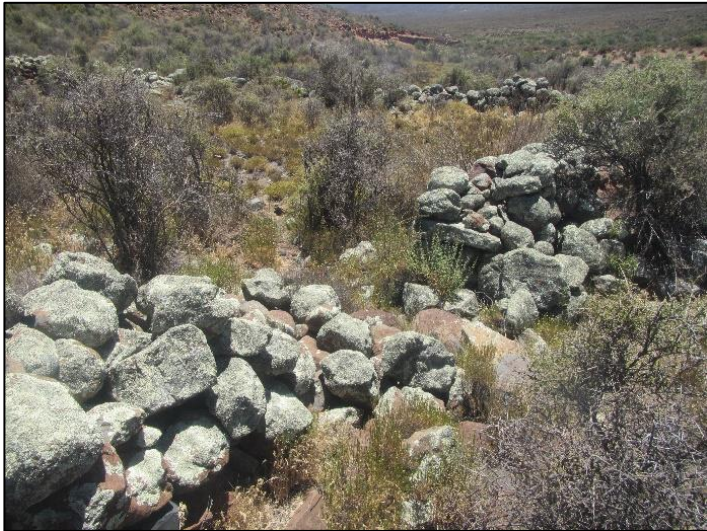
Low IIIC
1866	S32 03 41.8 E22 30 39.9	<p>At this point was a larger stone-walled kraal of piled boulders. It is better preserved than any of the other features and its unusual shape was clearly visible on aerial photography. The main kraal is about 15 m by 23 m with a straight northern end and a curved southern end. An east-west wall divides it into two enclosures and an entrance faces eastwards. A smaller enclosure of about 5 m by 5 m was added to the northern end of the west side.</p>

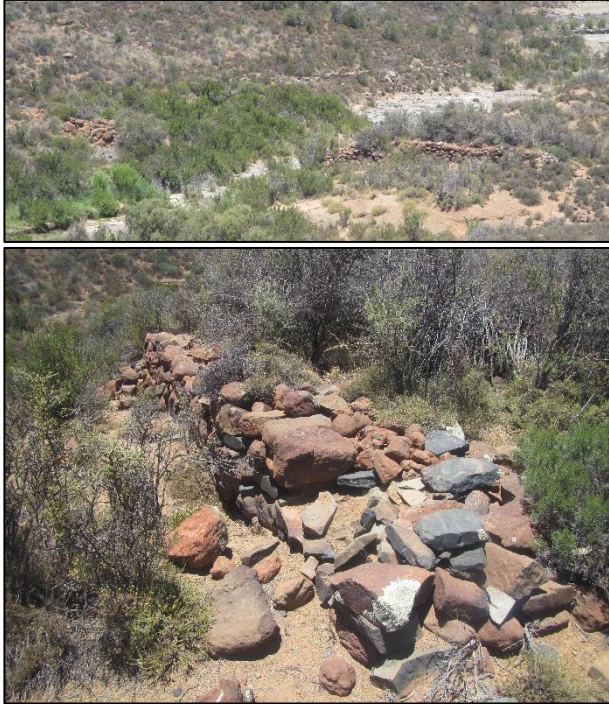
Way-point	Location	Description	Significance Grade
1868	S32 04 01.3 E22 30 41.0	This point is located 480 m up the valley to the south of the farmstead described under waypoints 1859 to 1867. At this point there was a very poorly preserved stone-walled kraal of about 10 m by 10 m.	Very low NCW
1869	S32 04 02.2 E22 30 41.4	<p>Very close to the kraal at waypoint 1868 is a stone-lined dam wall which has been breached.</p>

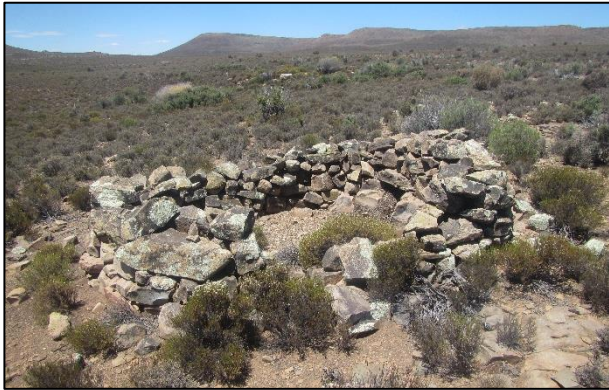
Low IIIC
1870	S32 02 42.5 E22 29 43.7	<p>This is an isolated oval stone-walled feature of about 2 m by 3 m and with an entrance facing west. It was likely a shepherd's hut.</p>

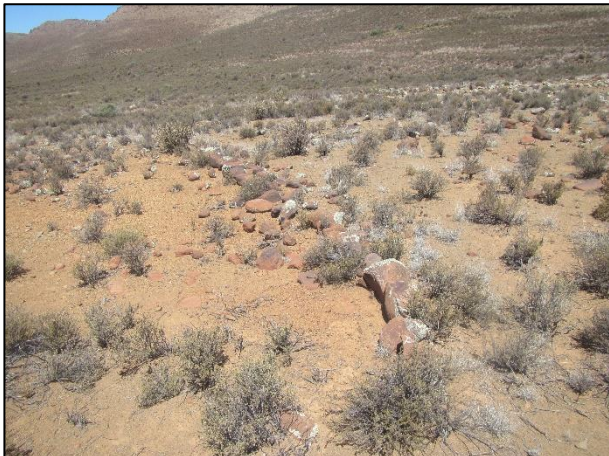
Way-point	Location	Description	Significance Grade
1871	S32 02 27.9 E22 30 49.6	<p>This is an isolated alignment of stones some 8 m long. Its function is completely unknown.</p>

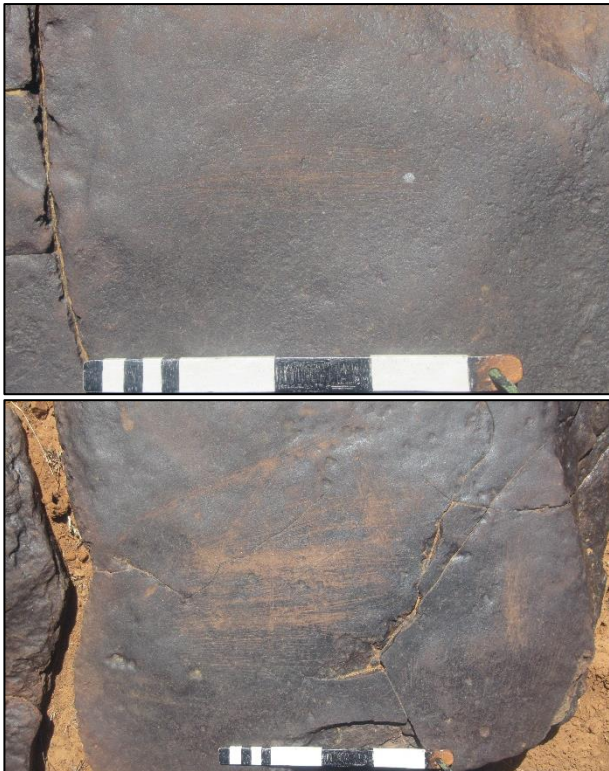
Very low NCW
1872	S32 02 08.7 E22 29 56.6	<p>A dolerite outcrop with some hard, black patinated surfaces had been scratched in a number of places. Such scratches are not generally significant but because there are many scratches the site has been assigned medium significance.</p>

If they cannot be avoided, significant archaeological resources should not be damaged or destroyed without appropriate further study.	This applies only to waypoint 1872 if it proves impossible to avoid. It will require detailed recording prior to construction if it is determined that it will be impacted.
Graves should be avoided with a buffer of at least 30 m.	No graves are known from within the project area.
Built heritage resources should be protected from all aspects of the development with a buffer of at least 30 m as far as possible. Reusing an existing road through a buffer is allowed but any widening must take place away from the structure.	This has been achieved.
Highly significant historical structures should be avoided by at least 500 m, but roads and/or powerlines may pass closer.	No highly significant structures are present.
The facility should not dominate views from multiple publicly accessible locations.	The facility will be central to views from the R381 over a number of kilometres. This is unavoidable. The project will only be visible from a very small part of the KNP.

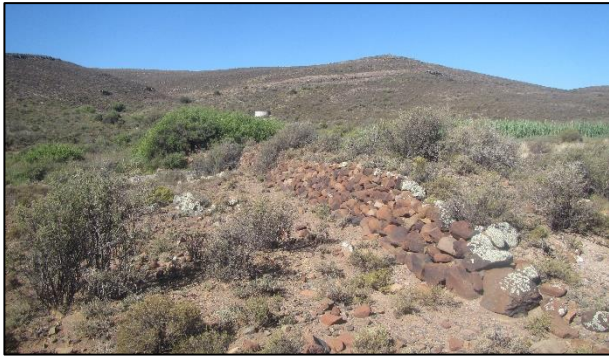
1873	S32 00 43.6 E22 29 38.0	<p>The remains of a stone-lined dam lie across the valley at this point. The total length of the wall was once about 65 m but a section of about 22 m has washed away in the centre where the dam was breached. This breach is visible on the 1945 aerial photography.</p>

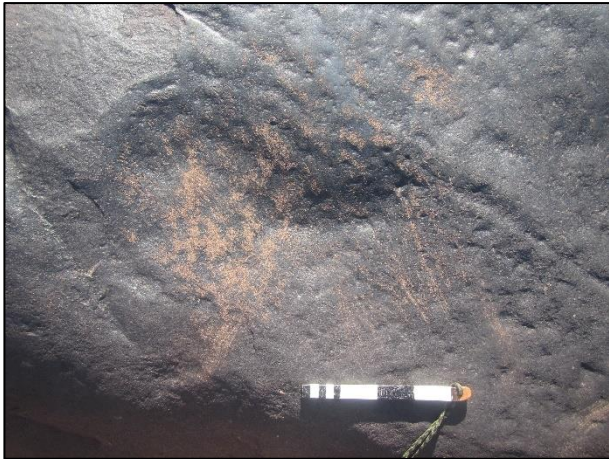
Low IIIC
1874	S32 00 42.0 E22 29 35.3	<p>Here there is a black-patinated dolerite rock with extensive scratching on its surface.</p>	Medium IIIB

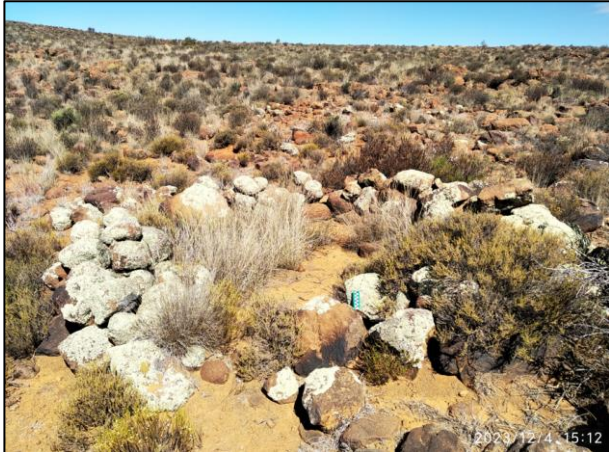
221	S32 02 11.1 E22 29 53.0	Faint, poorly preserved, indeterminate engravings on dolerite rock.	Low IIIC
222	S32 02 09.2 E22 29 43.0	Small circular stone-walled structure about 2 m in diameter.

- Destruction of the site at waypoint 221 and partial destruction of the walling at waypoint 486 are acceptable;
- The powerline may pass over the wall at waypoint 486 on either side of the road, but damage to the wall must be limited to that is required for road widening (no service track may penetrate the wall beneath the powerline);

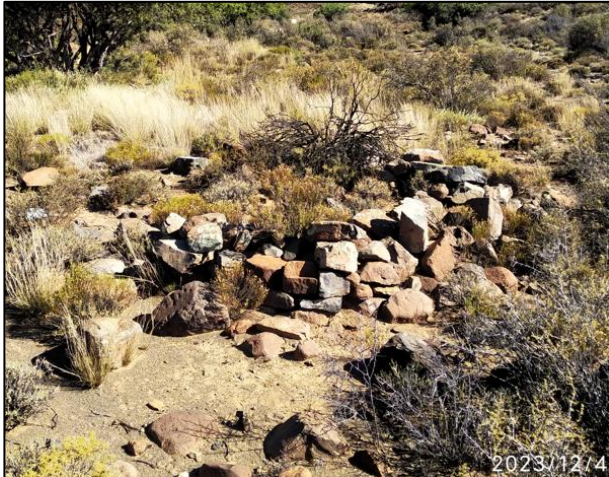
Low IIIC
223	S32 00 55.9 E22 29 47.4	Small circular stone structure about 3 m in diameter.

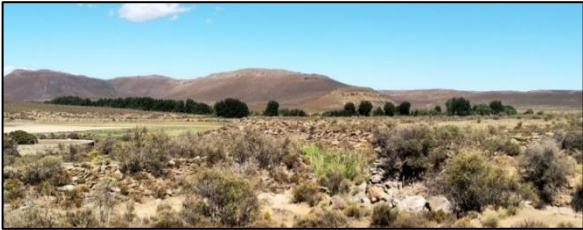
Way-point	Location	Description	Significance Grade
256	S32 01 41.3 E22 26 22.3	A dam wall lined with stones.

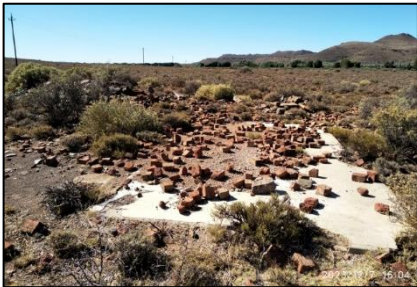
Very low NCW
258	S32 01 10.9 E22 27 23.1	Waypoints 258-266 are a ruined farm complex which is not visible on the 1945 aerial photograph. There are some older stone features which would not show up if already demolished but it is very clear that the large brick and cement structures had yet to be built and are thus not heritage. The features are placed on record though. A pile of red bricks and a cement foundation. This is not heritage.

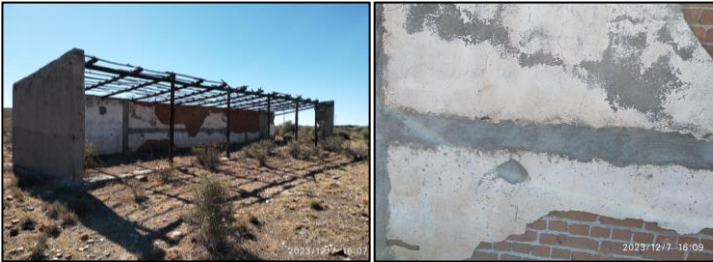
n/a
259	S32 01 12.7 E22 27 24.5	See note at waypoint 258. An old stable or animal shelter built with red bricks and cement on a stone foundation. This is not heritage.

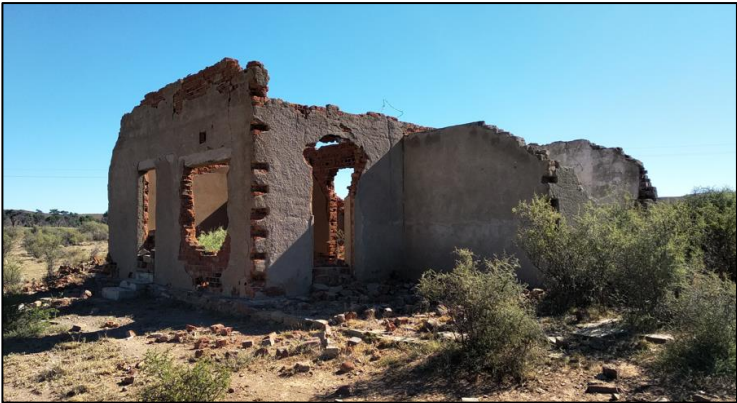
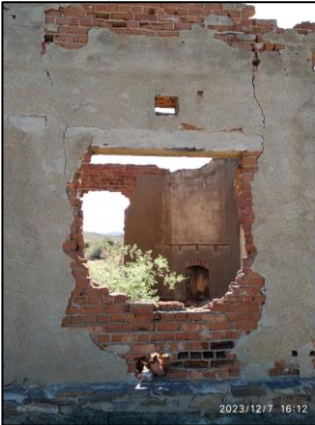
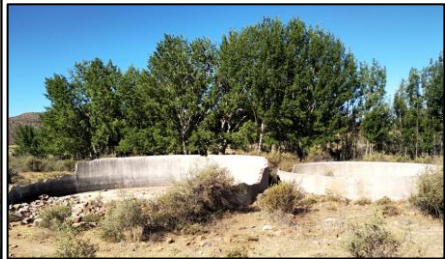
261	S32 01 12.1 E22 27 26.6	<p>See note at waypoint 258. An earth dam wall with a brick and cement spillway. It looks as though the earthen dam was there in 1945 which would make it heritage but likely had the spillway added later.</p>

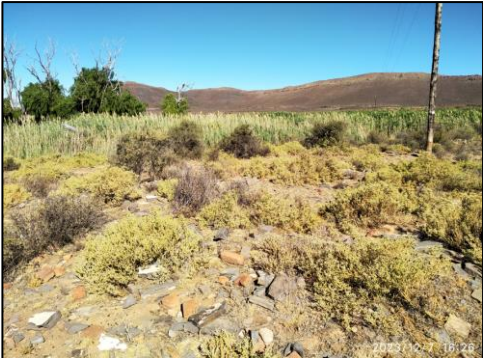
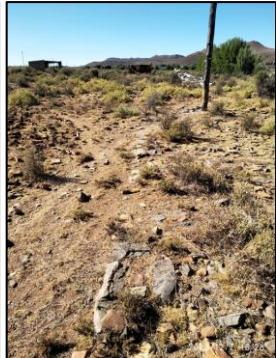
Very low NCW
262	S32 01 14.1 E22 27 25.9	<p>See note at waypoint 258. The vague remains of a double walled structure of stone with a few bricks in between. The age of this feature is unknown, but it is graded for precautionary reasons.</p>
