# **HERITAGE IMPACT ASSESSMENT: PROPOSED MULILO KAROO WIND POWER 2 WIND ENERGY FACILITY, BEAUORT WEST MAGISTERIAL DISTRICT, WESTERN CAPE**

Required under Section 38(8) of the National Heritage Resources Act (No. 25 of 1999)

Mulilo Karoo Wind Power 2 Wind Energy Facility

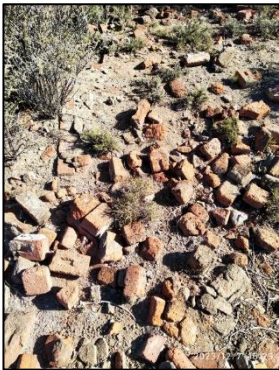
Way-point	Location	Description	Significance Grade
263	S32 01 14.9 E22 27 26.0	See note at waypoint 258. The remains of a demolished red brick structure. This is not heritage.

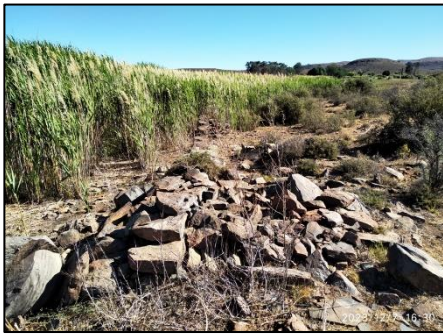
n/a
264	S32 01 15.6 E22 27 26.8	See note at waypoint 258. A double skinned stone structure alongside a canal leading into the earthen dam. It is partly obscured by reeds. It may relate to flood irrigation.

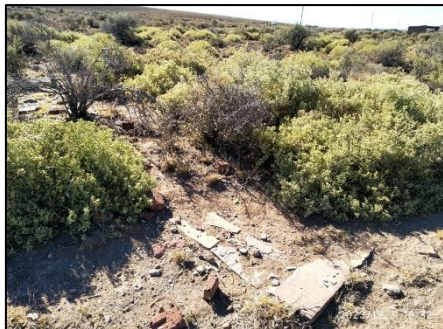
Low IIIC
265	S32 01 15.6 E22 27 26.2	See note at waypoint 258. The remains of a stone structure of indeterminate function.

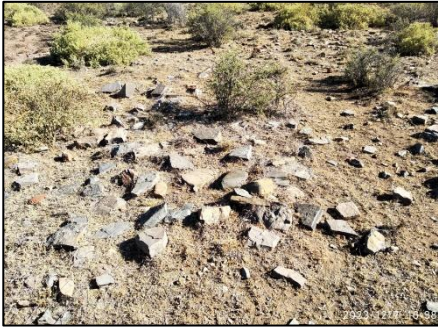
Low IIIC
266	S32 01 14.6 E22 27 25.3	See note at waypoint 258. The remains of a stone structure. An ash and rubbish midden is located approximately 15m north-west of waypoint 266. It contains metal fragments, glass fragments of blue, brown, greens, purple and translucent, and ceramics. They seem typical of 19 <sup>th</sup> century material.

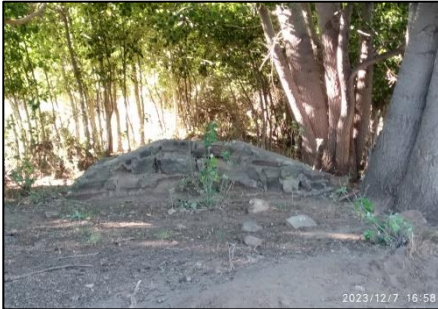
267	S32 01 34.2 E22 26 58.2	<p>A small stone and cement structure about 3m long close to the river. It looks like the end of an earthen dam wall with the wall no longer present.</p>

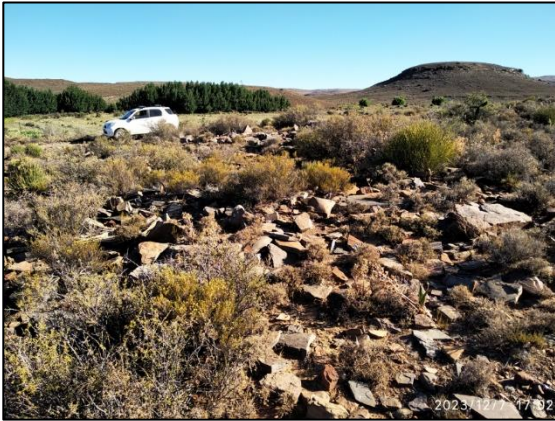
Very low NCW
268	S32 01 30.9 E22 27 14.7	<p>The remains of a rectangular stone structure.</p>

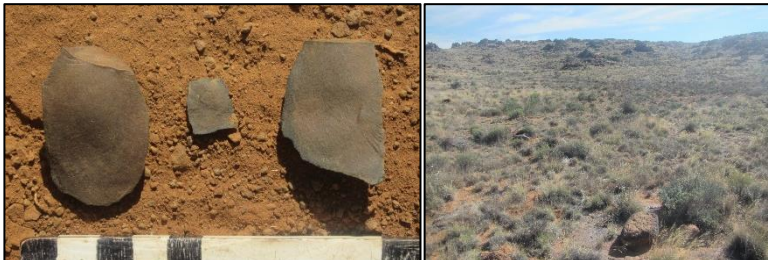
Low IIIC
4685	S31 59 55.0 E22 28 41.9	<p>An ephemeral scatter of hornfels flakes in a sandy area on a dolerite ridge.</p>

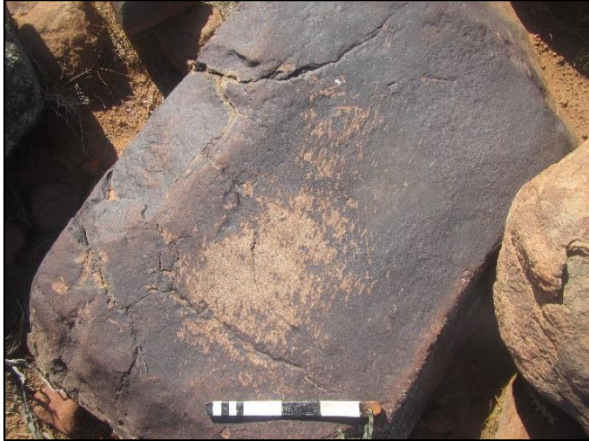
Way-point	Location	Description	Significance Grade
4686	S32 00 04.3 E22 27 48.9	<p>This is a heavily scratched/abraded dolerite rock located on top of a high mountain ridge.</p>

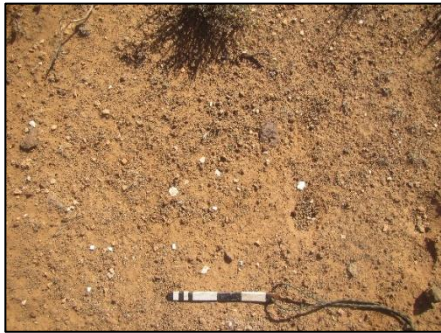
Very low NCW
4687	S32 00 00.1 E22 28 53.8	<p>A fairly extensive scatter of ostrich eggshell fragments was found in a sandy area on top of a high dolerite mountain ridge. Although there were many fragments, they are likely still less than half an eggshell altogether. No stone artefacts or other materials could be found associated.</p>

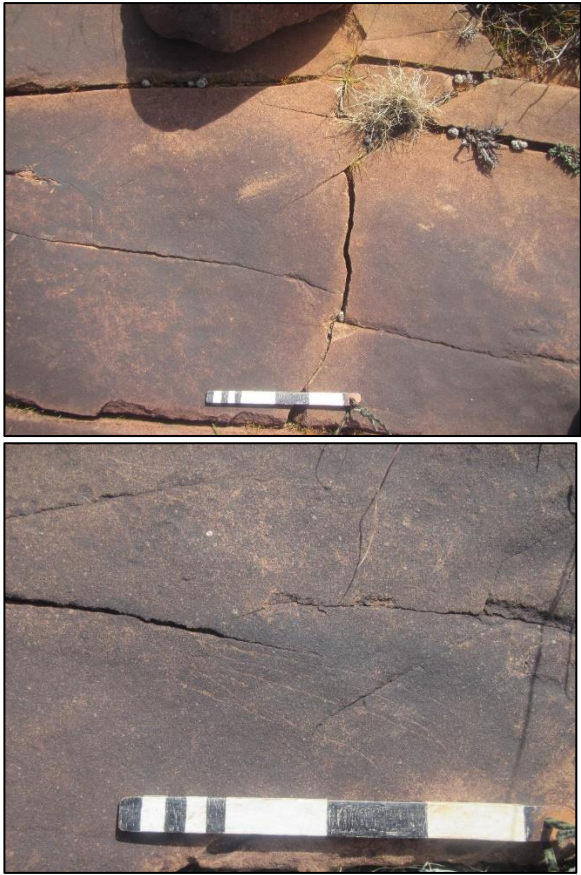
4689	S32 00 03.4 E22 29 10.9	<p>This is a large scatter of LSA stone artefacts (flakes and cores) in hornfels and tuff. The photographs were taken at waypoint 4689. The site extends at least 80 m north to south and 35 m west to east, but it is likely far larger. There is no landscape feature or other obvious reason for the location of the site and no other associated materials were seen.</p>	Low IIIC
4690	S32 00 26.9 E22 28 53.9		
4691	S32 00 28.5 E22 28 53.5

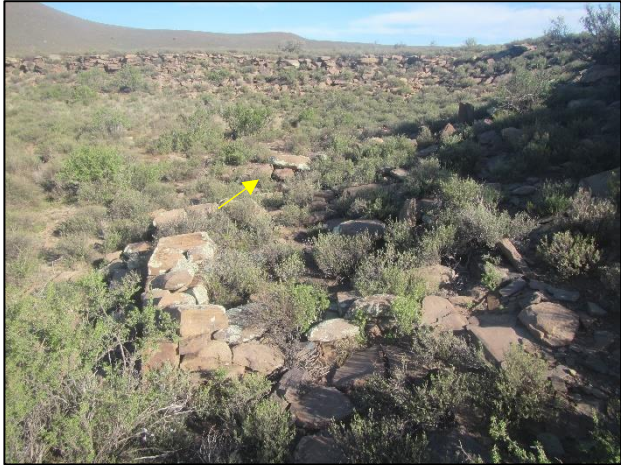
4692	S32 00 29.1 E22 28 54.5	<p>Waypoints 4692 and 4693 are adjacent to one another and part of one site. At this point is a poorly preserved rectangular enclosure about 3 m by 2 m in size. The stone wall at waypoint 4693 lies in the background of the photograph (yellow arrow). There are no associated artefacts.</p>

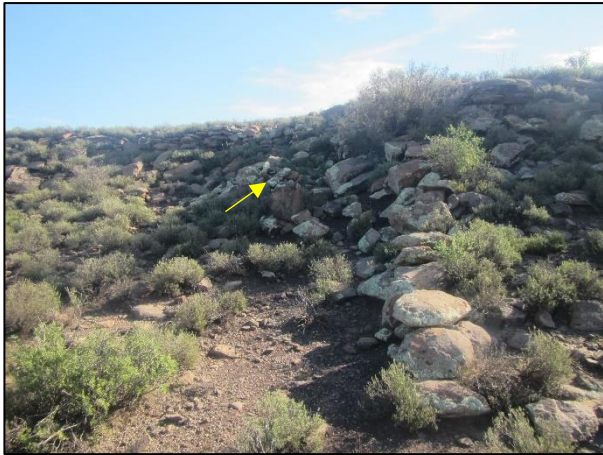
Very low NCW
4693	S32 01 29.2 E22 28 02.4	<p>Waypoints 4692 and 4693 are adjacent to one another and part of one site. This is a low piled stone wall running up the slope towards the top of the small scarp. A small enclosure is built against the scarp (yellow arrow). The feature at waypoint 4692 lies just to the right of this view. There are no associated artefacts.</p>	Very low NCW

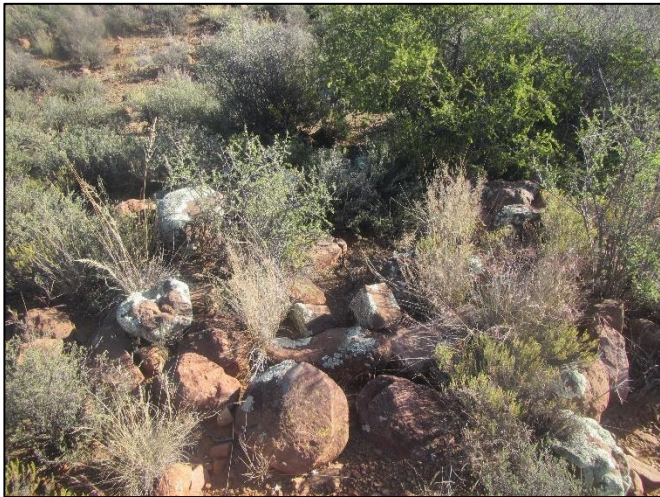
4694	S32 01 29.5 E22 28 02.3	<p>This is a small circular stone enclosure of piled dolerite cobbles. It is just over 1 m in diameter with walls only about 0.3 m high.</p>

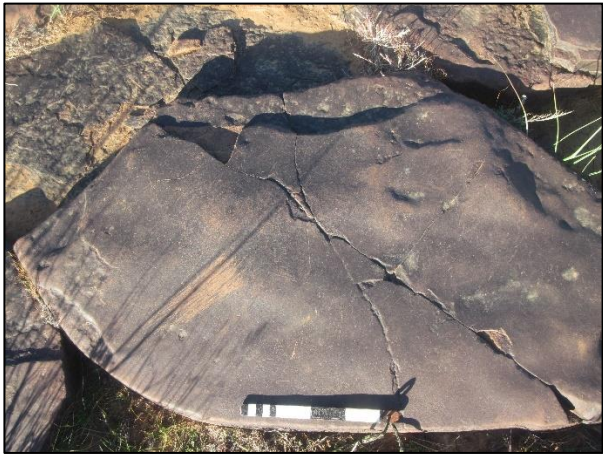
Very low NCW
472	S32 02 08.6 E22 29 56.8	<p>Scratched lines engraved on four different dolerite rocks.</p>	Low IIIC

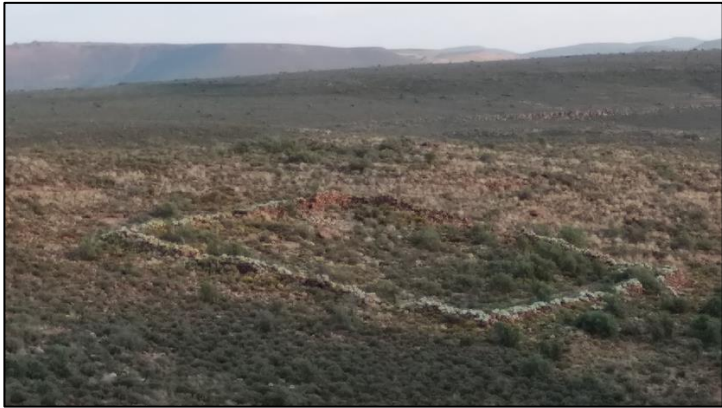
Very low NCW
474	S32 02 25.3 E22 29 25.4	<p>A stone kraal of about 26 m x 28 m on the south side of a river.</p>

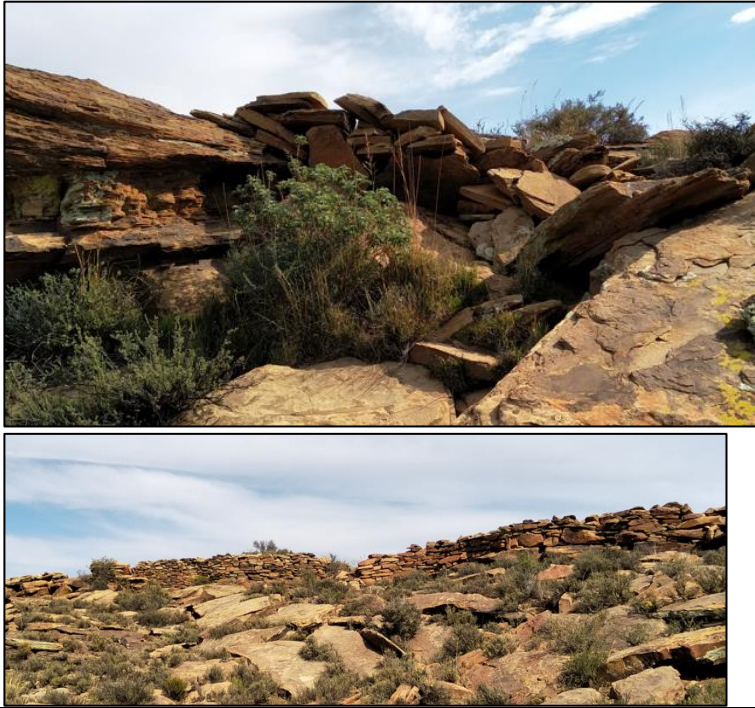
476	S32 00 39.8 E22 26 20.9	<p>Waypoints 476 to 487 belong together and represent a stone wall of about 350 m long. The stone walling runs along the edge of a ridge and extends to about 1m high in some places. The wall continues southwards up to the base of a higher ridge to the south.</p>

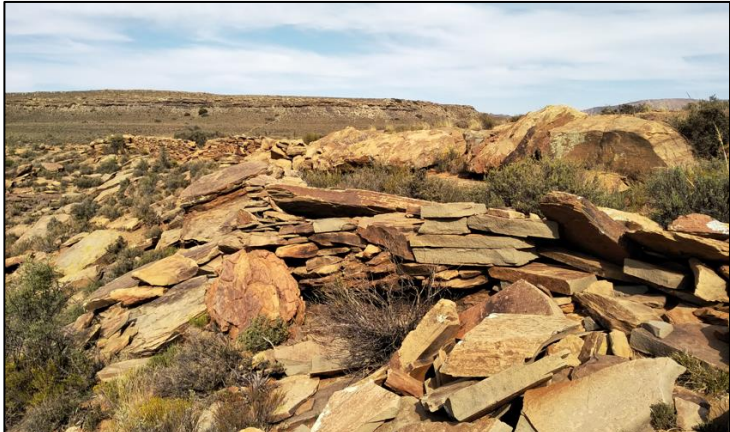
Low IIIC
477	S32 00 40.2 E22 26 20.7	<p>Waypoints 476 to 487 belong together. Stone walling along the edge of a ridge.</p>

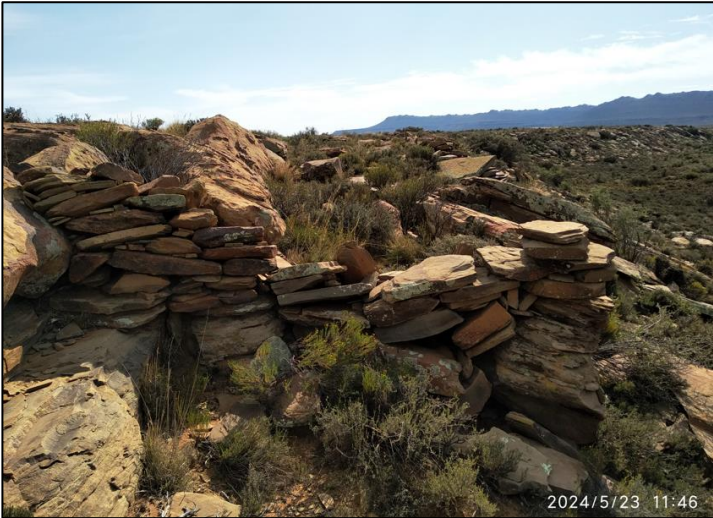
Way-point	Location	Description	Significance Grade
478	S32 00 40.7 E22 26 20.7	Waypoints 476 to 487 belong together. Stone walling along the edge of a ridge.

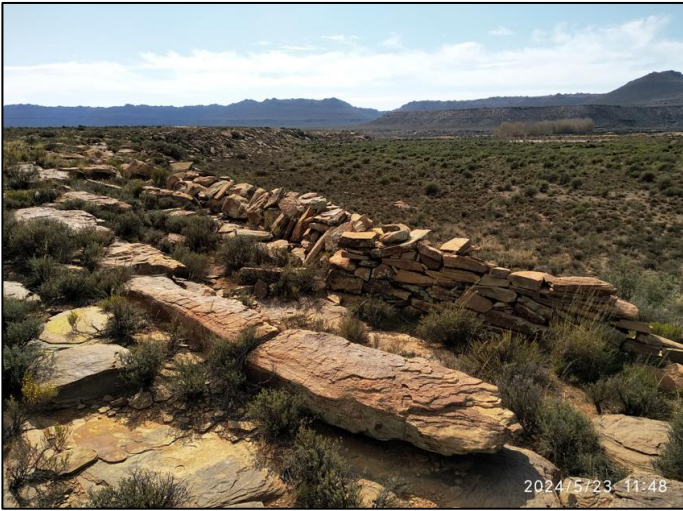
484	S32 00 44.5 E22 26 20.9	<p>Waypoints 476 to 487 belong together. Stone walling along the edge of a ridge. Just south of waypoint 184 is a stream bed. The walling continues on the southern side of the stream bed.</p>

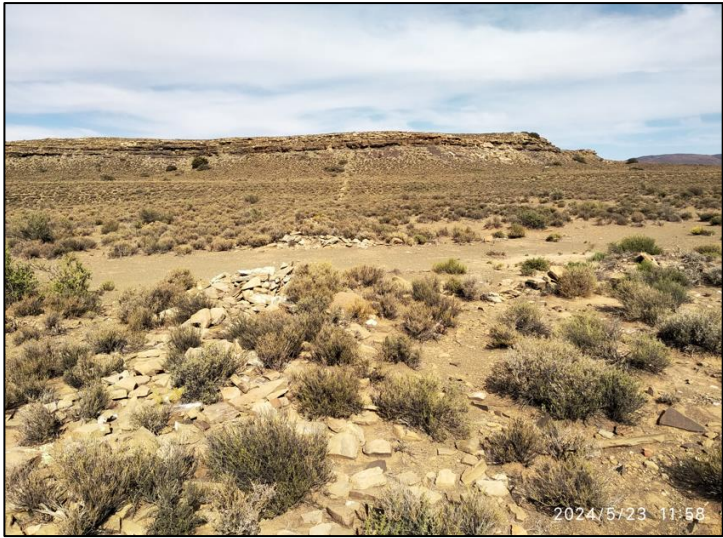
Low IIIC
485	S32 00 45.6 E22 26 20.7	<p>Waypoints 476 to 487 belong together. The stone walling continues south across the floodplain up until a higher ridge. It was not followed all the way to its southern end but it looks from historical and current aerial photography as though it does not extend onto that southern ridge but ends at its foot. It is evident that the farm road at this point was made later as there are stones pushed to the side of the road.</p>	Low IIIC

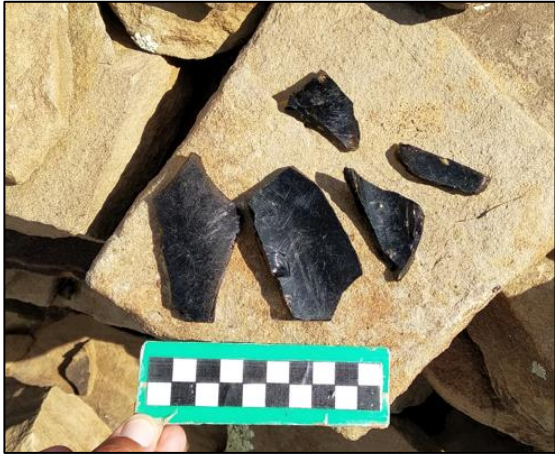
486	S32 00 46.1 E22 26 20.6	<p>Waypoints 476 to 487 belong together. Very dark olive green glass fragments next to the stone walling.</p>

- Destruction of the site at waypoint 221 and partial destruction of the walling at waypoint 486 are acceptable;
- The powerline may pass over the wall at waypoint 486 on either side of the road, but damage to the wall must be limited to that is required for road widening (no service track may penetrate the wall beneath the powerline);

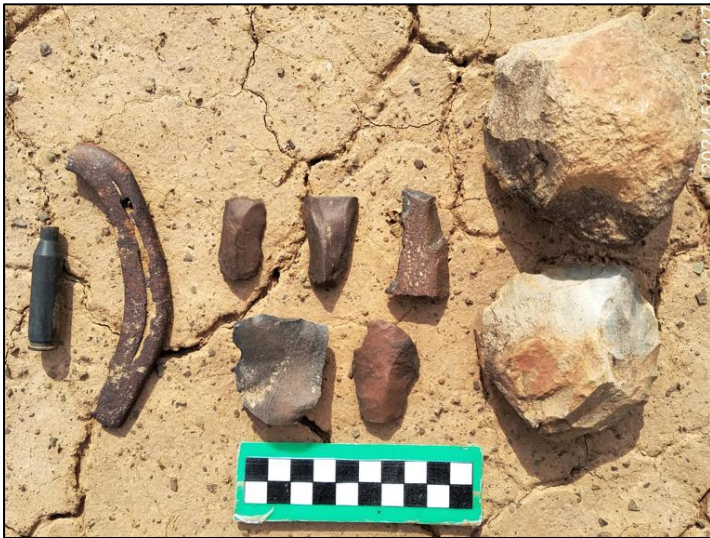
488	S32 01 07.1 E22 25 32.1	<p>A pan with an ephemeral scatter of flakes and cores, half a horseshoe and a .432 Winchester rifle cartridge.</p>
