Botanical Assessment

Proposed upgrading of the Herold's Bay pump station and sewer pipelines

March 2024

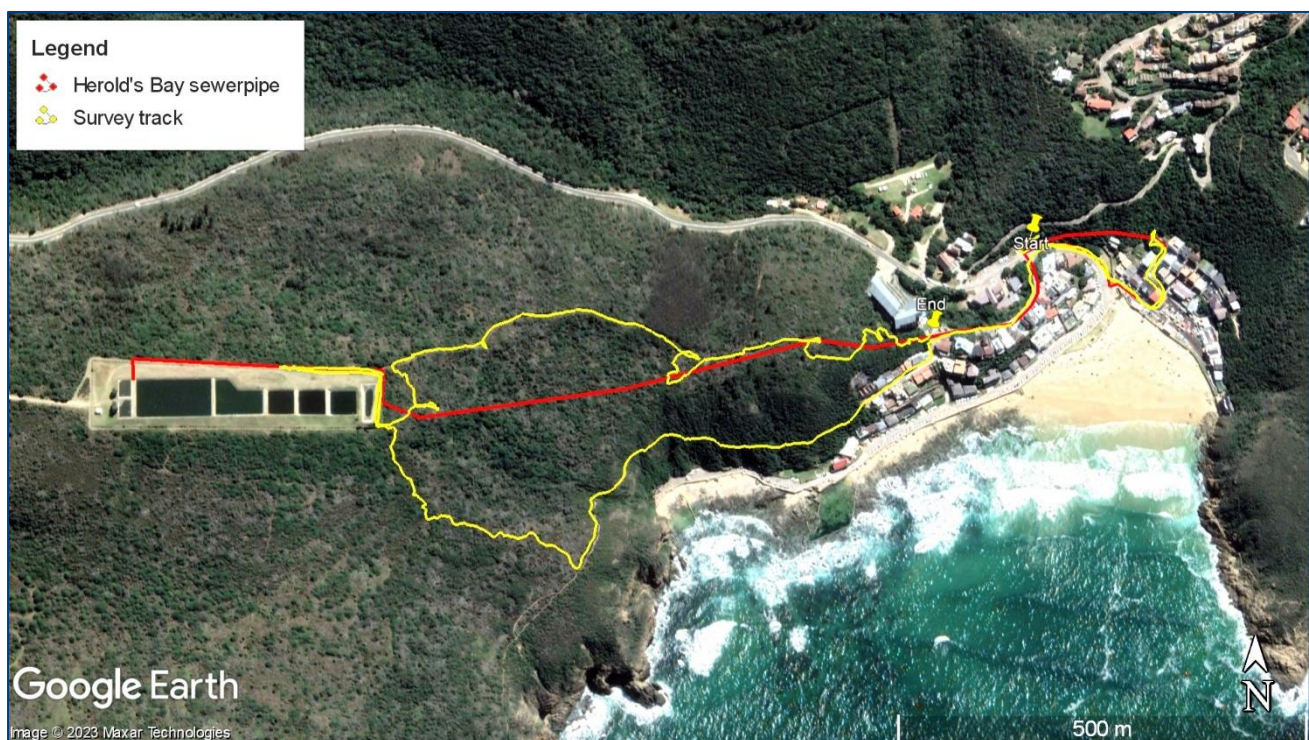
Figure 3-1: Satellite photo showing the survey track on site.

A botanical survey of the site was undertaken on 30 June 2023 by the author. A qualitative assessment of the type and condition of affected vegetation on site, disturbances and presence of alien species, SCC and protected tree species was carried out. The path walked during the survey is shown in **Figure 3-1**. Plant species not identified in the field, were collected and/or photographed and identified at the office and Compton (Kirstenbosch) Herbarium. A few of the identifications were confirmed on iNaturalist. The 2018 South African Vegetation Map and the latest floristic taxonomic literature and reference books were used for the purpose of this specialist study. Any plants classified as rare or endangered in the Red List of South African Plants online database¹ are highlighted. The assessment follows the relevant national guidelines/protocols for biodiversity assessments as listed in the Government Gazette No. 43110 on 20 March 2020.

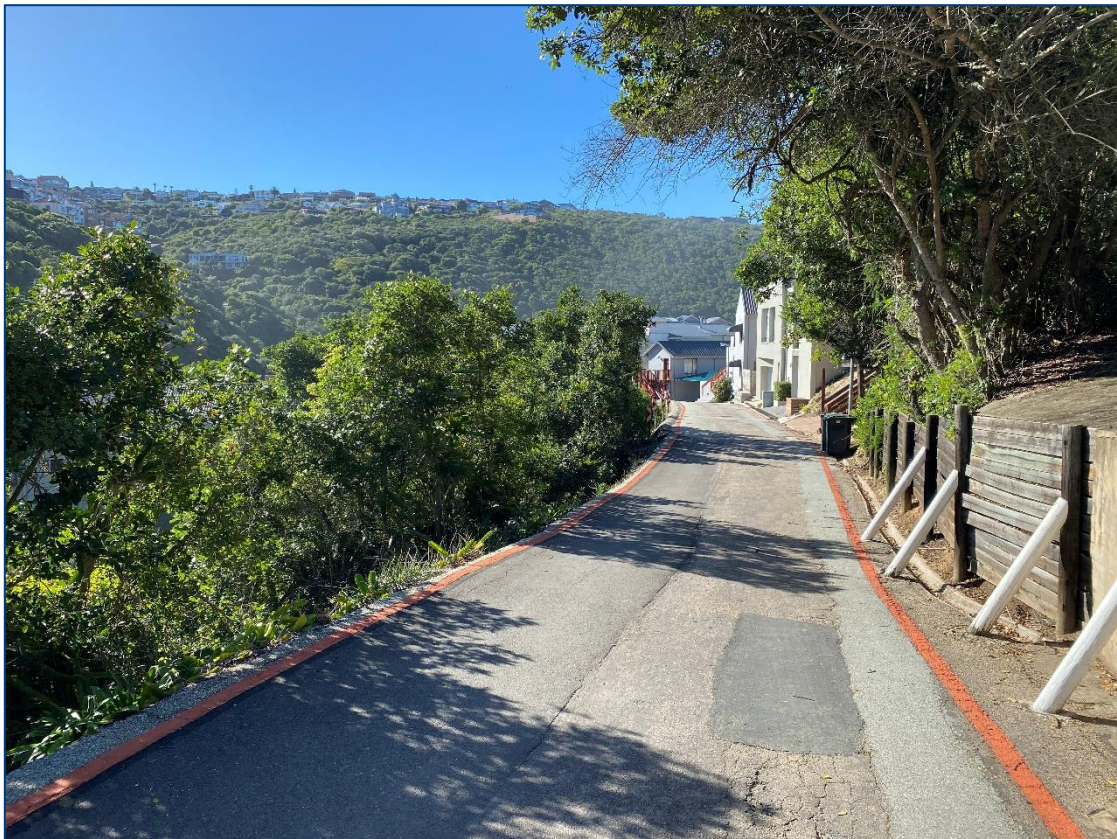
Figure 5-1: Spekie Gericke Crescent, which accommodates a section of the pipeline route between the proposed new pump station and the WWTW.

The proposed pipelines through Herold's Bay itself are located mostly inside transformed road verges (**Figures 5-1 & 5-2**). The rising main between Herold's Bay and the WWTW runs through coastal thicket in the lower part, which then transitions into granite fynbos in the upper part (**Figure 5-3 to 5-6**). The pipeline between a residential area and the proposed new pump station also runs through thicket (**Figure 5-7 to 5-9**). However, the specialist was subsequently informed that this pipeline will not be installed. The natural vegetation is of fair quality although considerable alien infestation was noted inside the granite fynbos, especially rooikrans and black wattle. Only the vegetation on the steepest bits can be described as near pristine. The site proposed for the new pump station is devoid of natural vegetation (transformed).

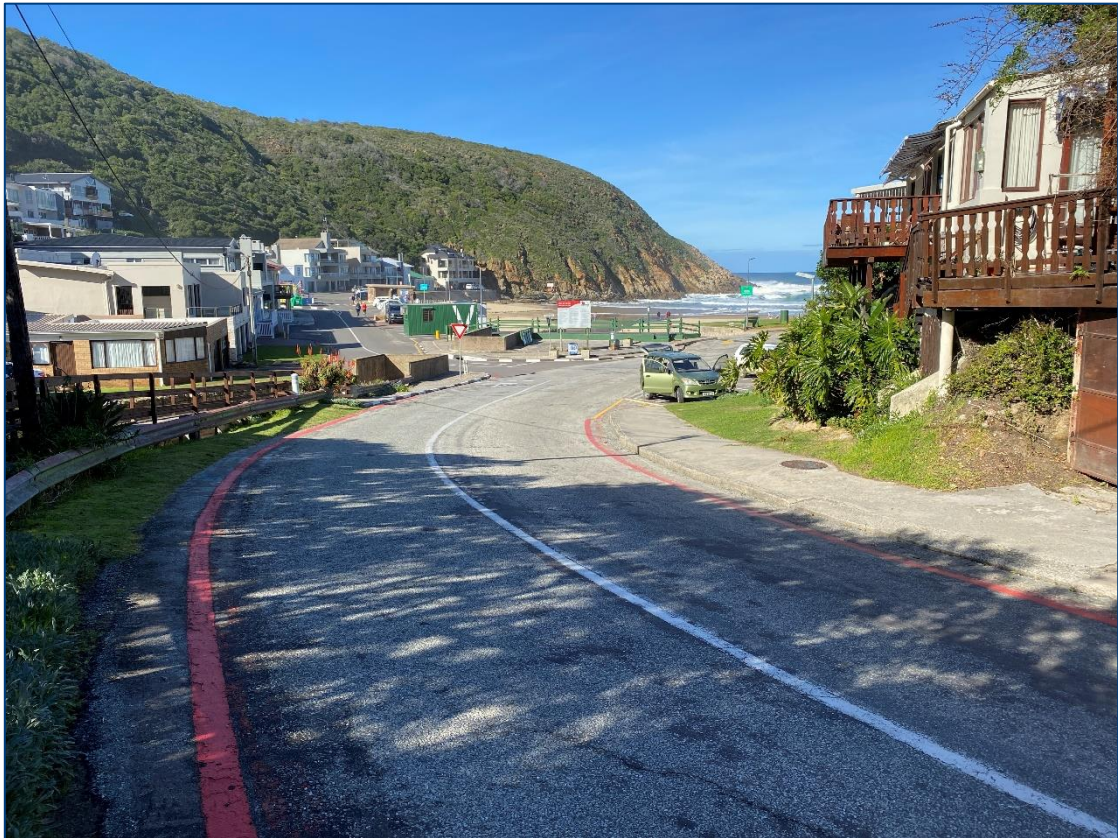
Figure 5-2: Bottom end of the pipeline route approaching the Herold's Bay PS 1.

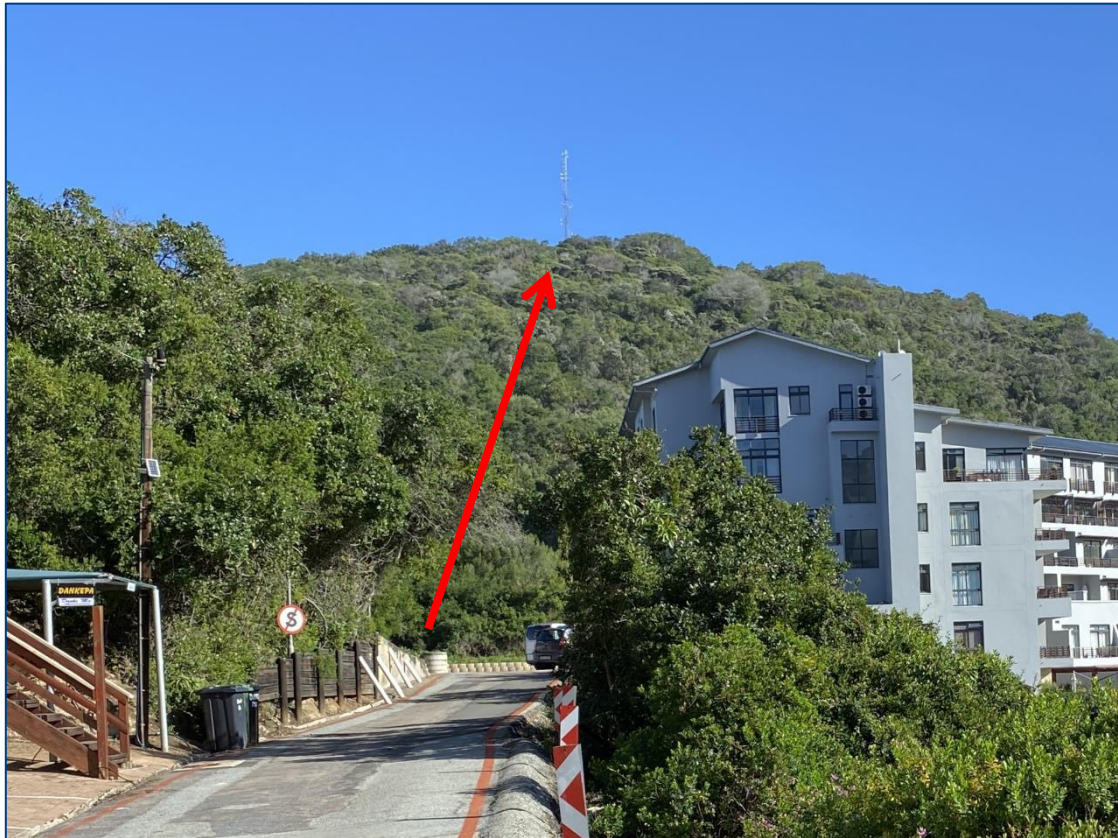
Figure 5-4: Approximate route of proposed pipeline (red arrow) through coastal thicket towards the WWTW.

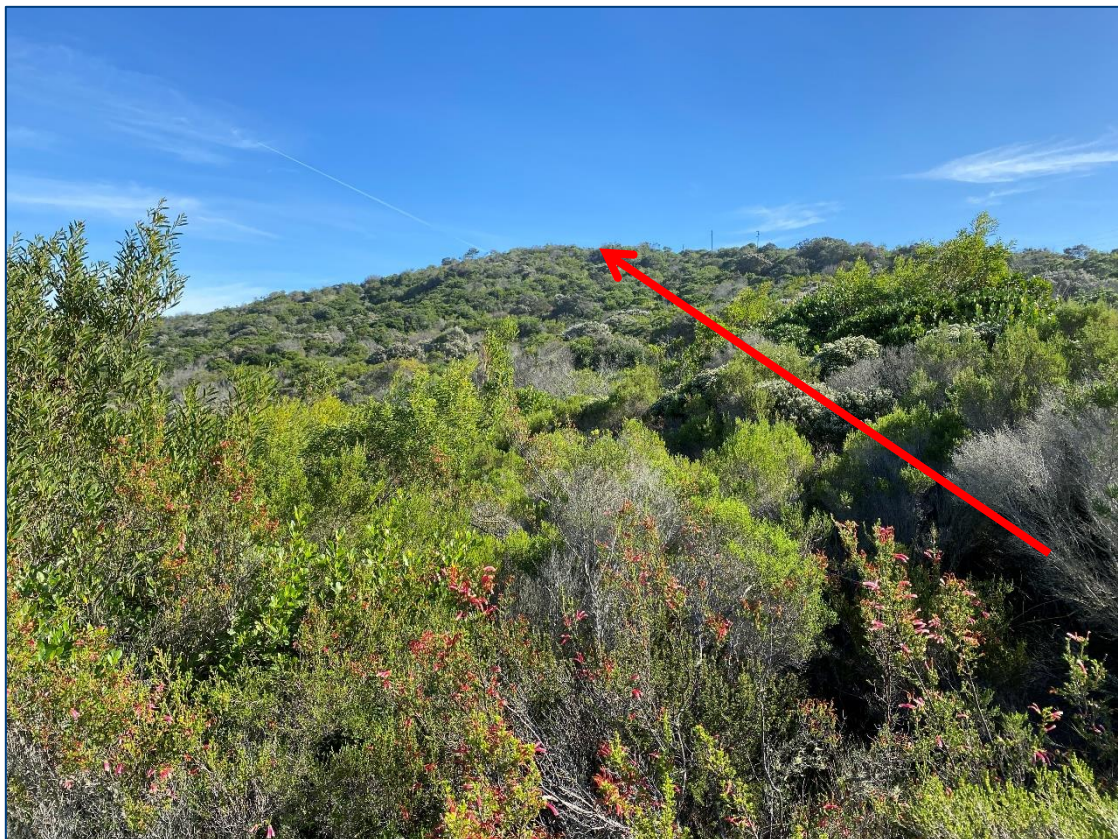
Figure 5-5: Senescent and rooikrans infested fynbos halfway up ridge towards the WWTW.

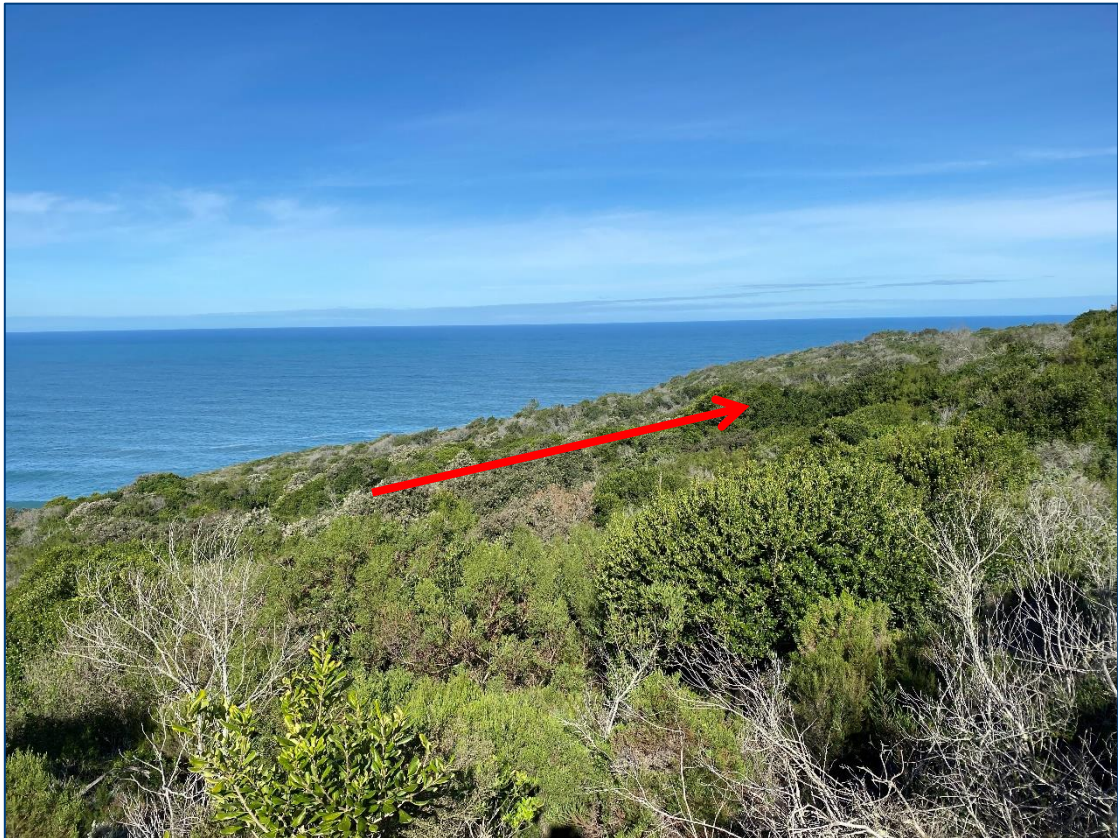
Figure 5-6: A side view of the upper section of the pipeline route through the fynbos. The arrow indicates the approximate position and direction of the pipeline.

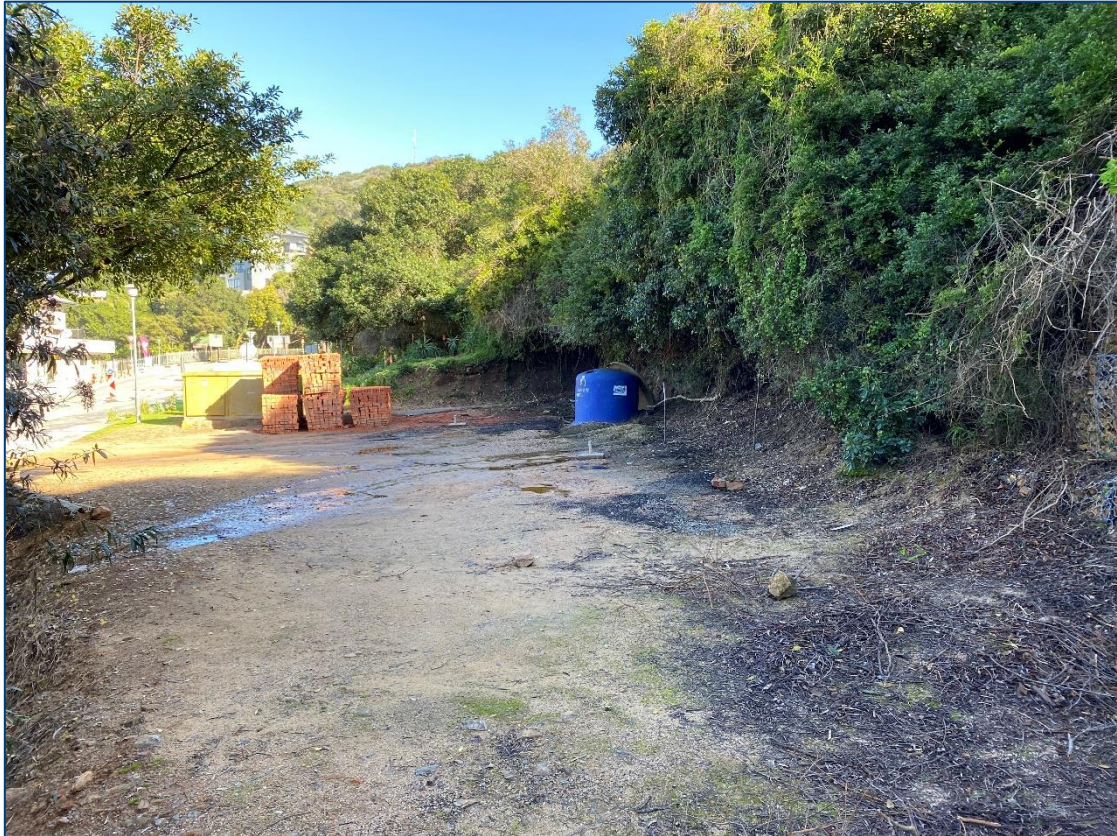
Figure 5-8: Site proposed for the new pump station.

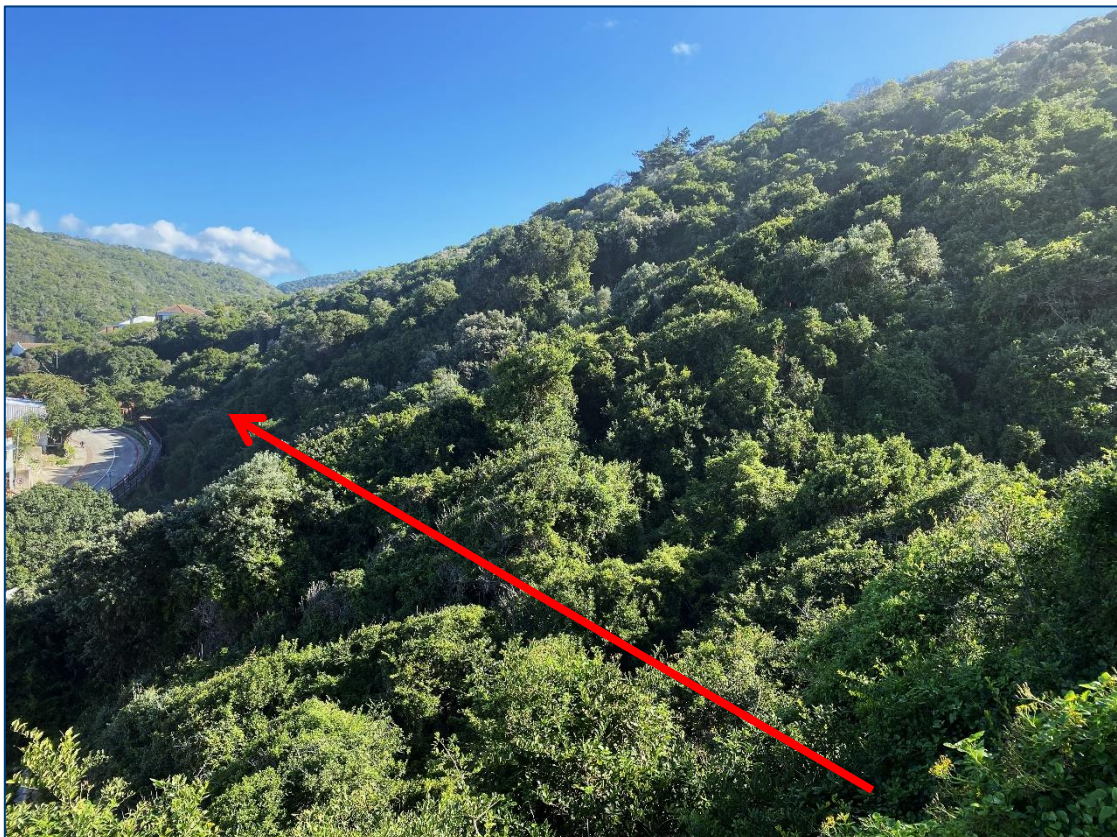
Figure 5-9: Thicket covered slope and possible route (arrow) for the pipeline between the residential area and proposed new pump station. This pipeline will not be installed.
