**ECO CHECKLIST FOR THE BULK EARTHWORKS, DUNE  
REHABILITATION AND THE CONSTRUCTION OF BULK  
SERVICES FOR THE PREEKSTOEL BEACH LIFESTYLE  
ESTATE ON PORTION 2 OF ERF 599 AND ERF 1028,  
STILL BAY EAST, WESTERN CAPE**

**File 1012 : ECO Checklist No.: 2**

**Date: 18 April 2022**

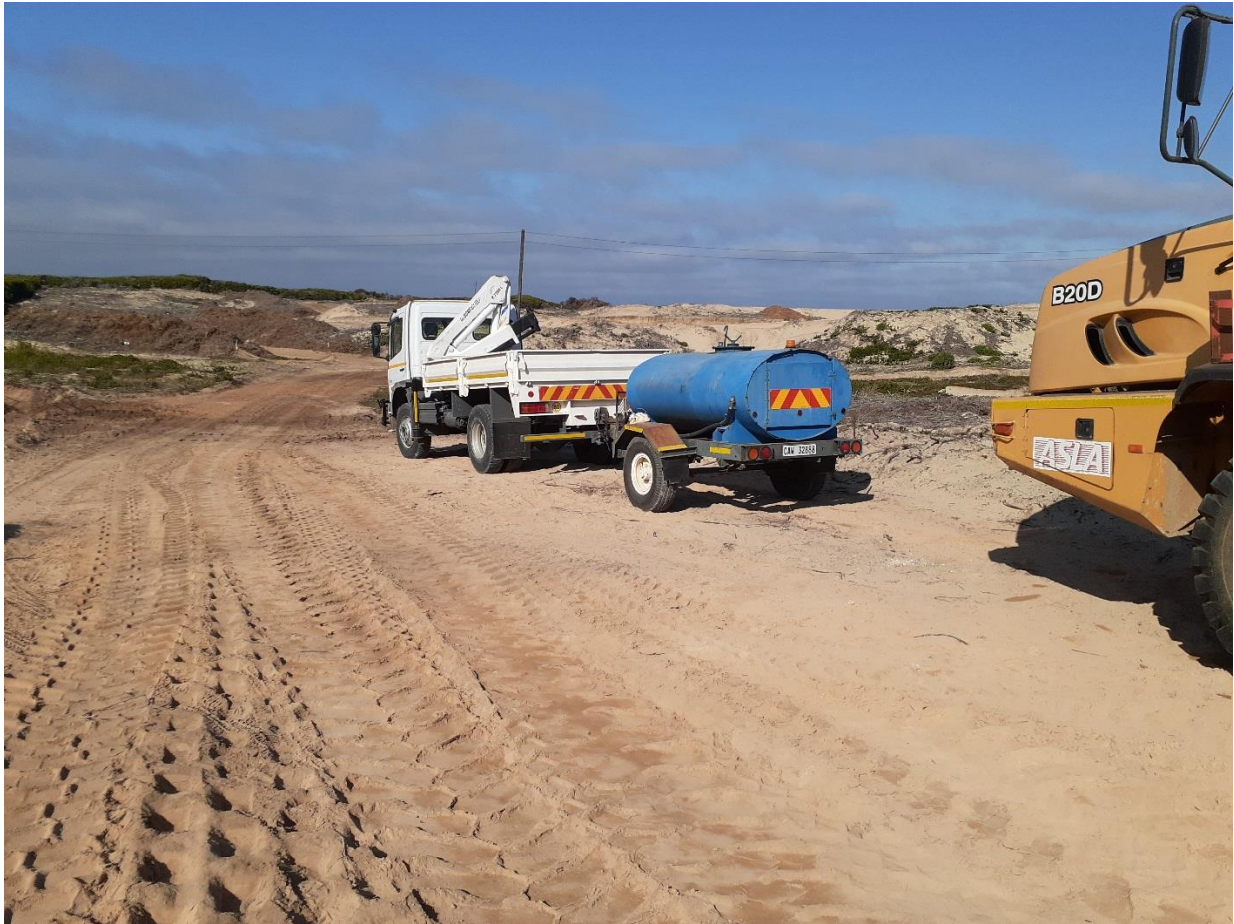
**Photo 1:** The mobile diesel bowser at the overnight parking area for all ASLA's construction vehicles.

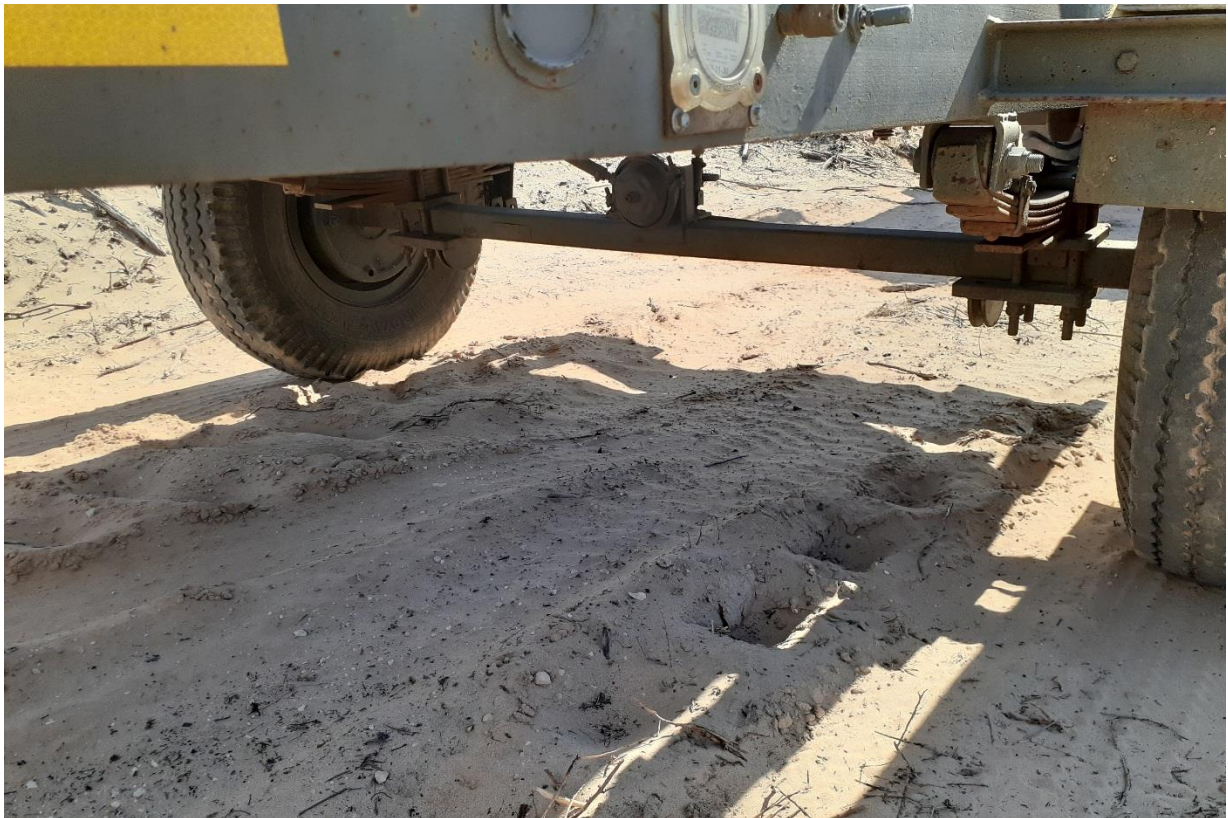
**Photo 2:** No diesel drips were noted coming from the mobile diesel bowser.

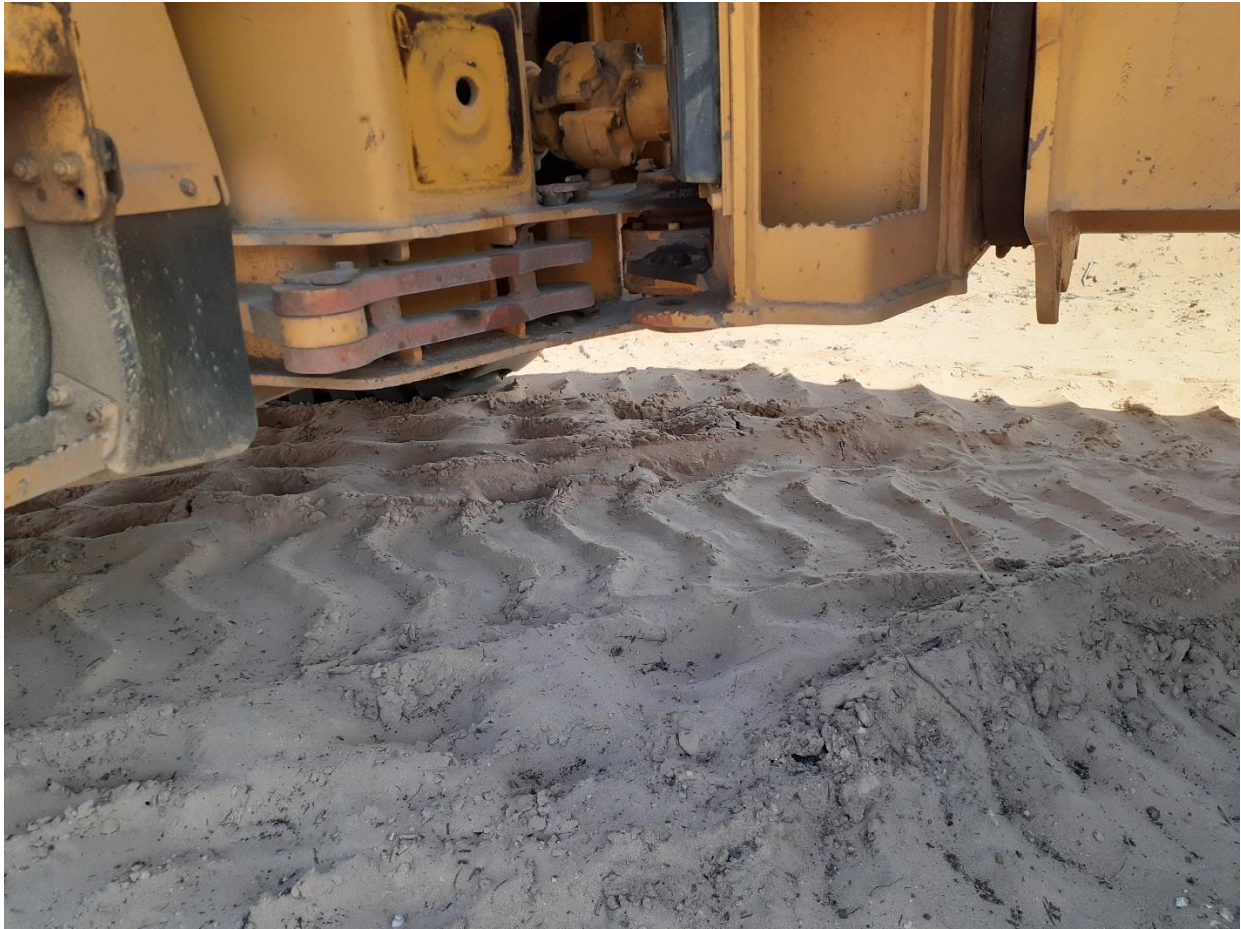
**Photo 3:** No hydraulic oil or diesel was noted dripping from the large mechanical excavator.

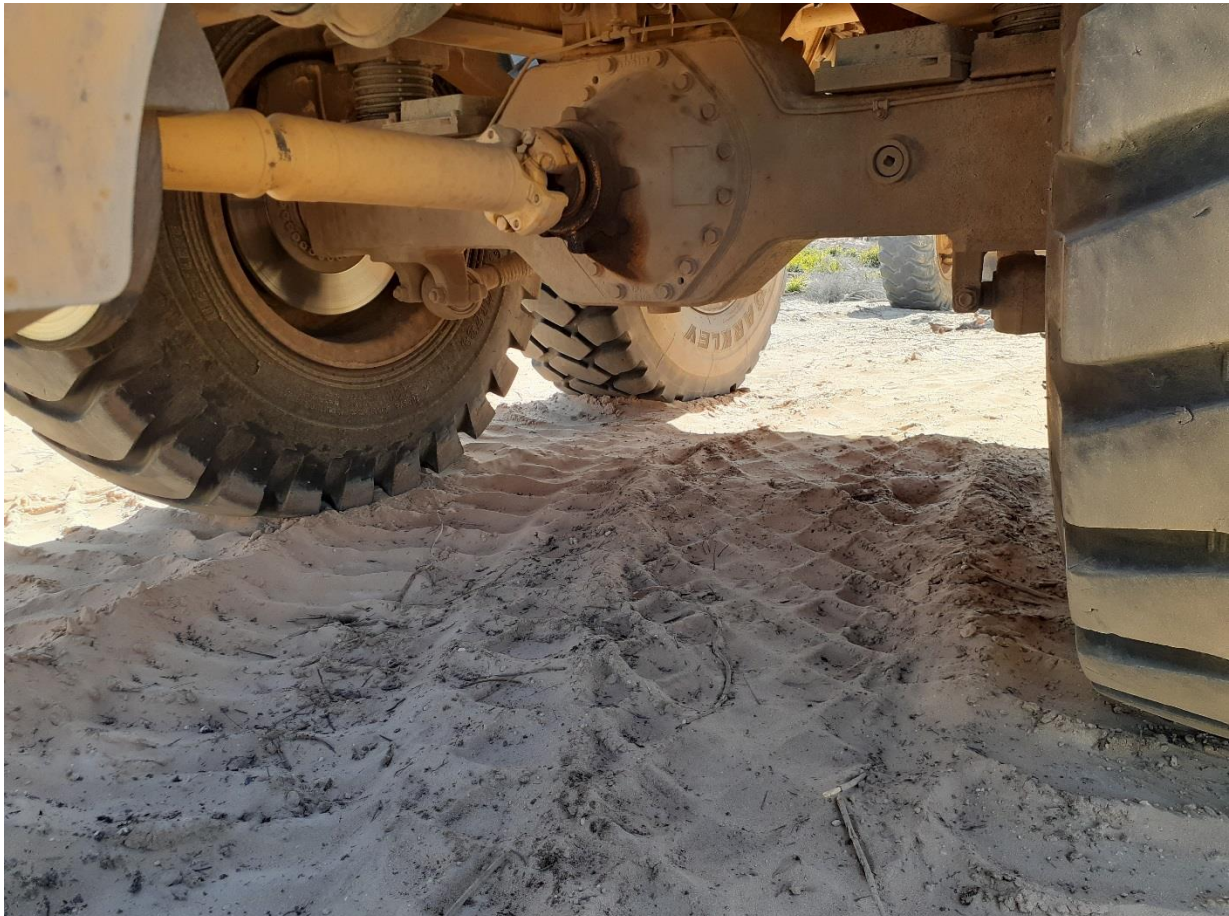
**Photo 4:** No diesel or hydraulic oil was dripping from the dump truck.

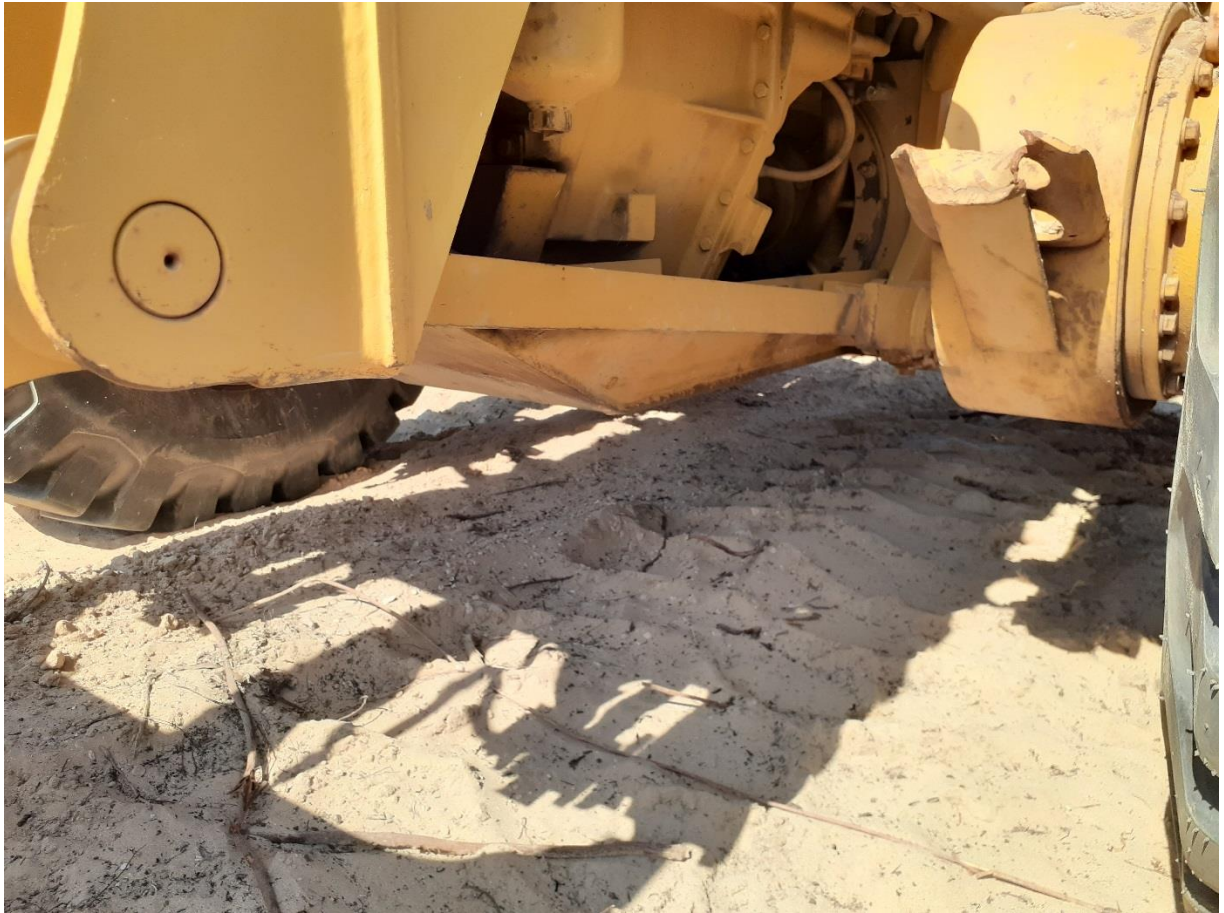
**Photo 5:** No diesel or hydraulic oil was dripping from the grader parked on site.

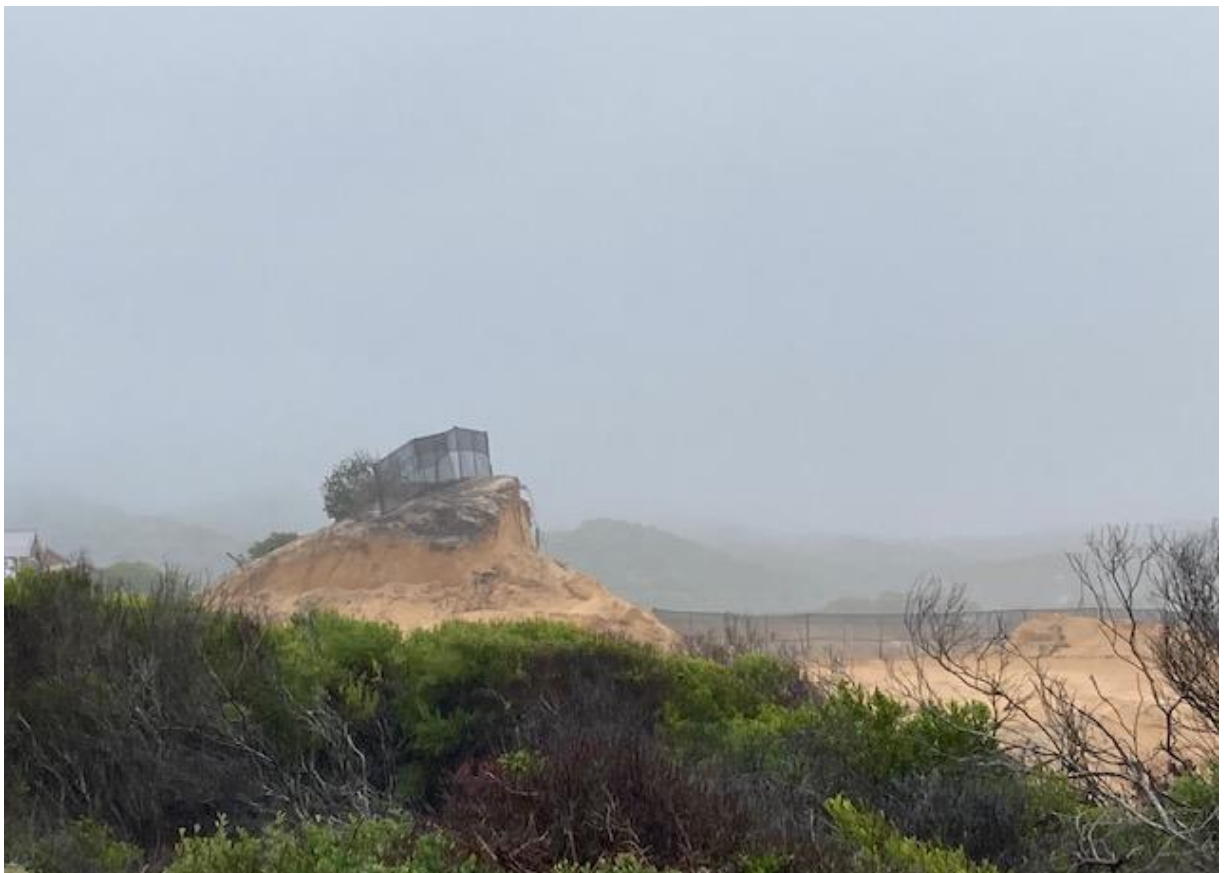
**Photo 6:** Extra effort was taken to prevent wind damage to the milkwood tree found on site. The milkwood tree was also irrigated with sprinklers to ensure the soil did not dry out.

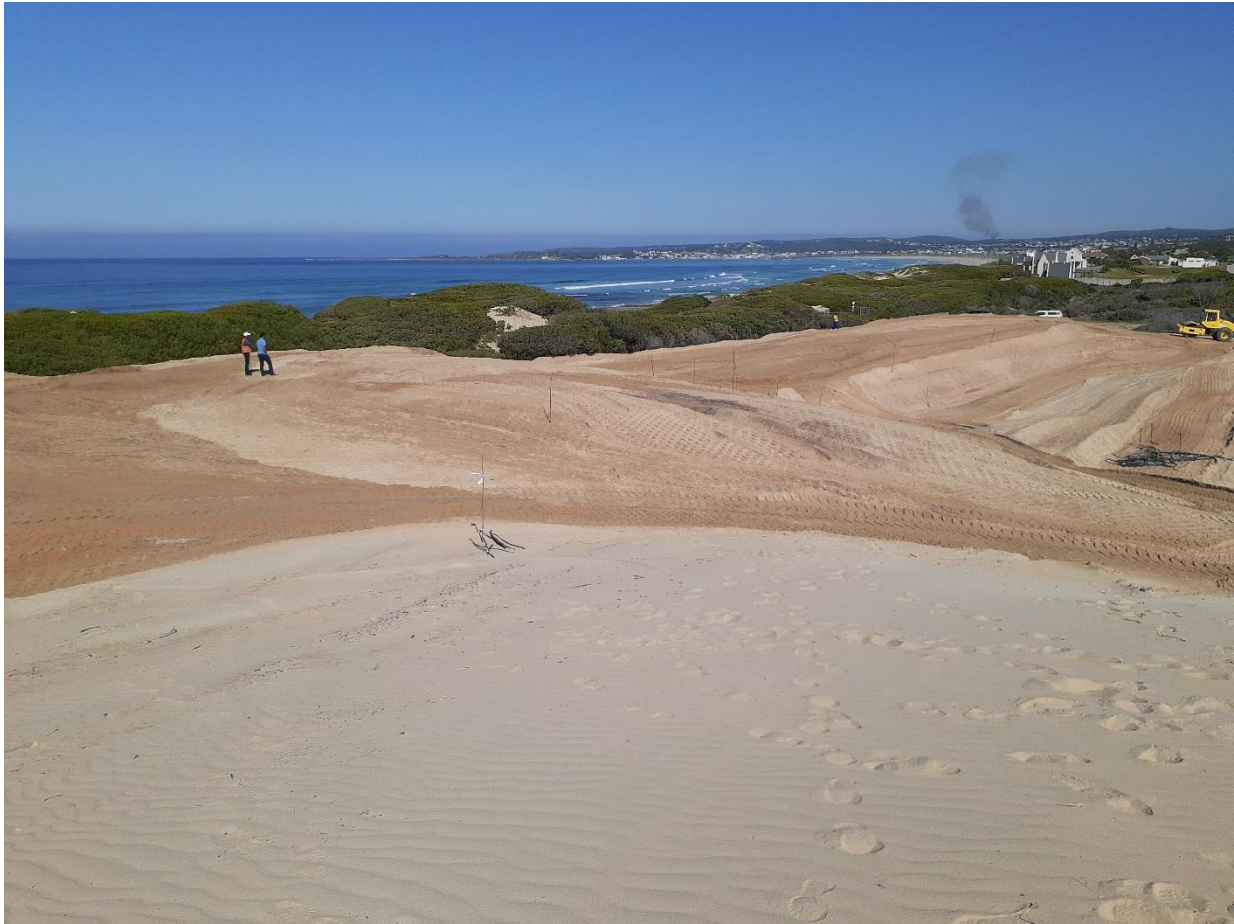
**Photo 7:** Shows the completed platform for the hotel site (right of photo) and the frontal platform for the first row of houses. The area to the right is private open space which will also include a shallow dam.

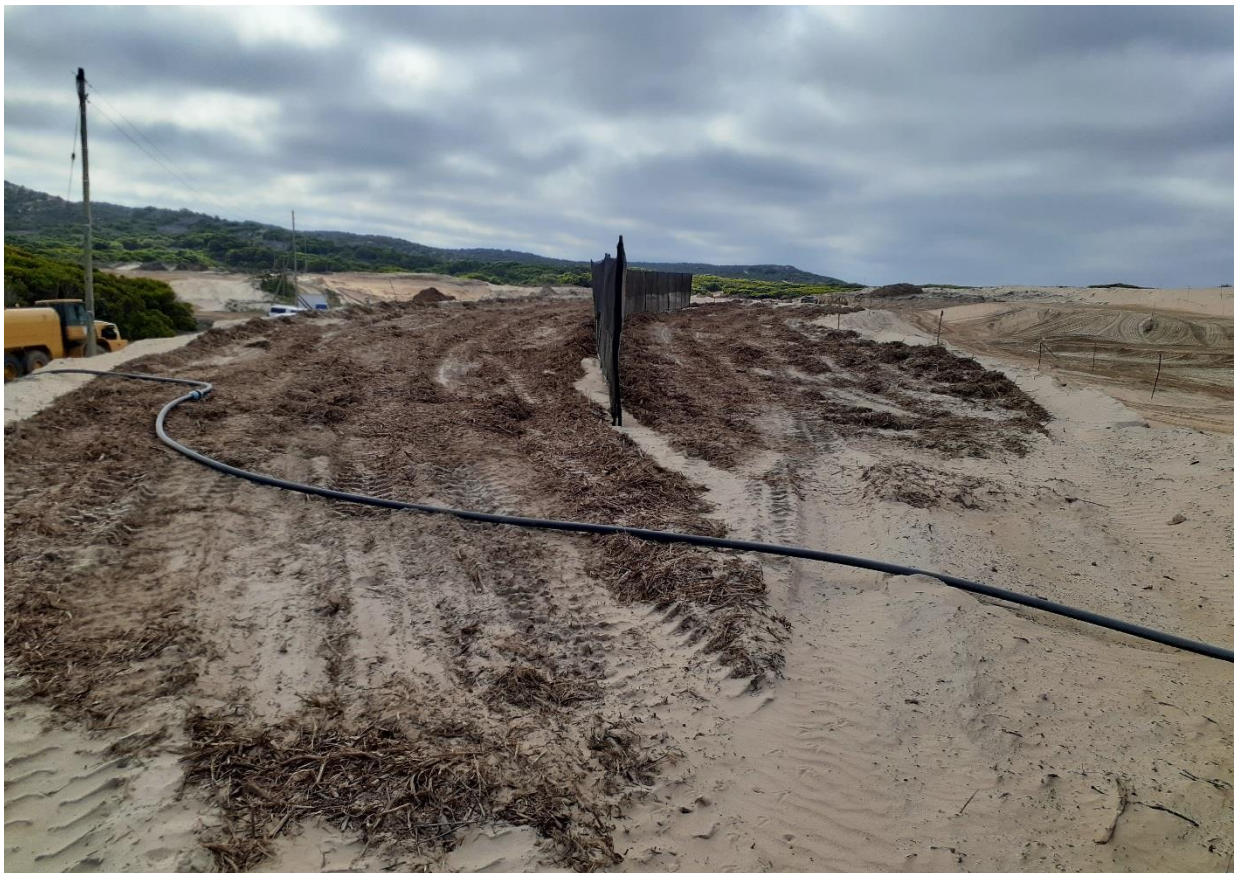
<b>F.2.3 Soil</b>				
<b>Prevent soil erosion</b>	1. The whole site has been de-grubbed of alien vegetation. When the various building platforms have been completed it may be necessary to spread the wood chips over the site that will not immediately have Municipal services installed, to prevent wind erosion.	ECO to monitor site clearing and site preparation and check for any erosion that may take place.	<b>C</b>	The whole site has been cleared of all alien vegetation and de-grubbed. The phase 1 building platforms are being prepared ( <b>Photo 7</b> ). Municipal services will be installed on these platforms. The remaining area will be covered with wood chips to prevent wind erosion of the loose sandy surface ( <b>Photo 8</b> ).

**Photo 8:** The completed platform for the group housing complex to the south of the entrance to the development. Note the spreading of topsoil and wood chips to prevent windblown sand.

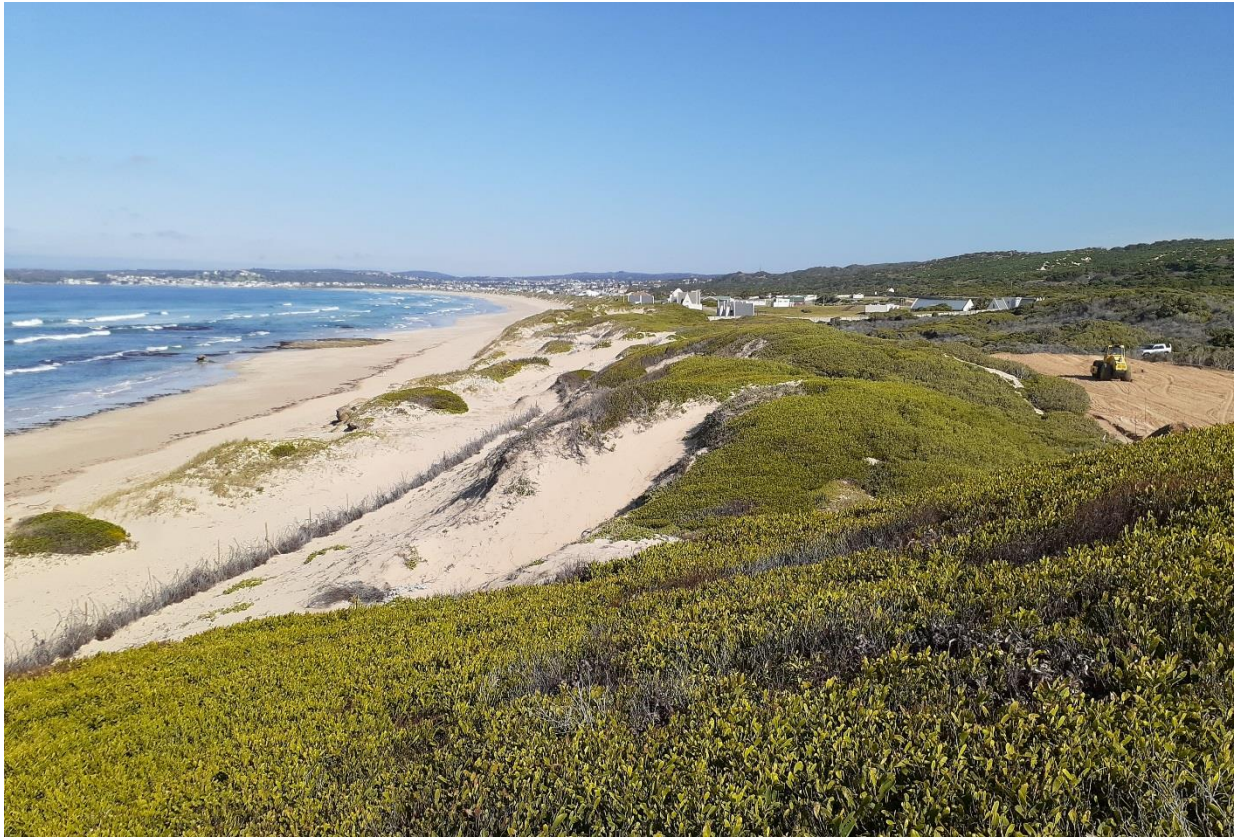
**Photo 9:** Shows the backdune area and the hotel platform to the right. The backdune will be stripped of its rooikrans growth and the exposed sand will be pulled back to fill the large blow-outs. A gentle angle of repose (about 30°) of the backdune will be shaped before covering in jute cloth and planted with salvaged natural Blombos Strandveld plants. A temporary irrigation system will be installed to ensure the transplanted plants survive.

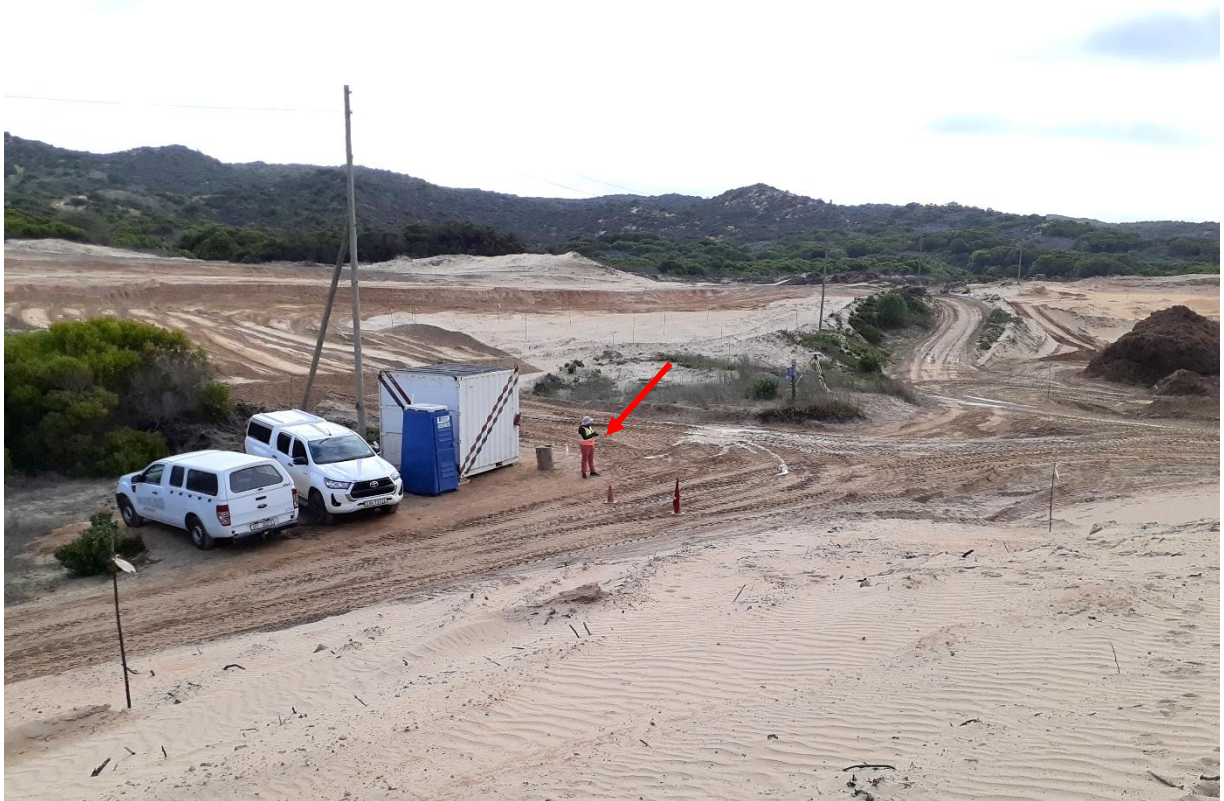
3. Any burial sites must be reported to the ECO who must investigate the site(s) and inform HWC and SAHRA.	HWC and south African Heritage Resources (SAHRA) must assess sites.	<b>C</b>	<i>Features like burials can occur in unexpected locations, and should any excavations uncover human remains; the ECO and HWC are to be notified immediately.</i>  No burial sites have been reported.
<b>E.3.2 Socio-Economic Benefits of the Development</b>				
Job opportunities should be afforded to the local community where possible	1. Both the temporary job opportunities during the construction phase and more permanent jobs (e.g. domestic staff and security) during the operational phase should be allocated to persons from the local communities wherever possible	Mass earthworks is currently being undertaken by ASLA staff. A single lady from the local community is acting as a signalman to ensure cyclists, motorists and pedestrians crossing the site do so safely.	<b>C</b>	A complaint was received from CapeNature regarding the dangerous conditions on site with the use of heavy earthmoving vehicles. Steps are being undertaken to address safer access over the site e.g. a signalman is on site during working hours ( <b>Photo 10</b> ).

2. Developer should employ a social engagement strategy. Temporary job opportunities (construction phase) should be allocated to persons from the local communities wherever possible.	Developers to ensure compliance with and monitor the local employment strategy. The RE and ECO to monitor compliance.	<b>C</b>	The contractor is currently using one lady from the local community for safety practices. More staff will no doubt be used once the installation of services takes place.
To prevent <b>injury to public using gravel access road</b> , construction staff, and delivery of materials	1. A new signboard is being designed to assist the public with access over the site	Site Agent and ECO to check on compliance once the new signboard has been erected.	<b>C</b>	The new notice board is to be erected as soon as possible. A signalman is being used to control traffic, cyclists and pedestrians on site ( <b>Photo 10</b> ).

**Photo 10:** The signalman (woman) (red arrow) is on site to control the vehicles, cyclists and pedestrians when entering and exiting the site. The existing road to the CapeNature house is noted to the right of photo.
