**ECO CHECKLIST FOR, DUNE REHABILITATION AND
THE CONSTRUCTION OF BULK SERVICES FOR THE
PREEKSTOEL BEACH LIFESTYLE ESTATE ON PORTION
2 OF ERF 599 AND ERF 1028, STILL BAY EAST,
WESTERN CAPE**

File 1012 : Development ECO Checklist No.: 3

Date: 24 August 2022

PREEKSTOEL BEACH LIFESTYLE ESTATE, STILL BAY EAST, WESTERN CAPE

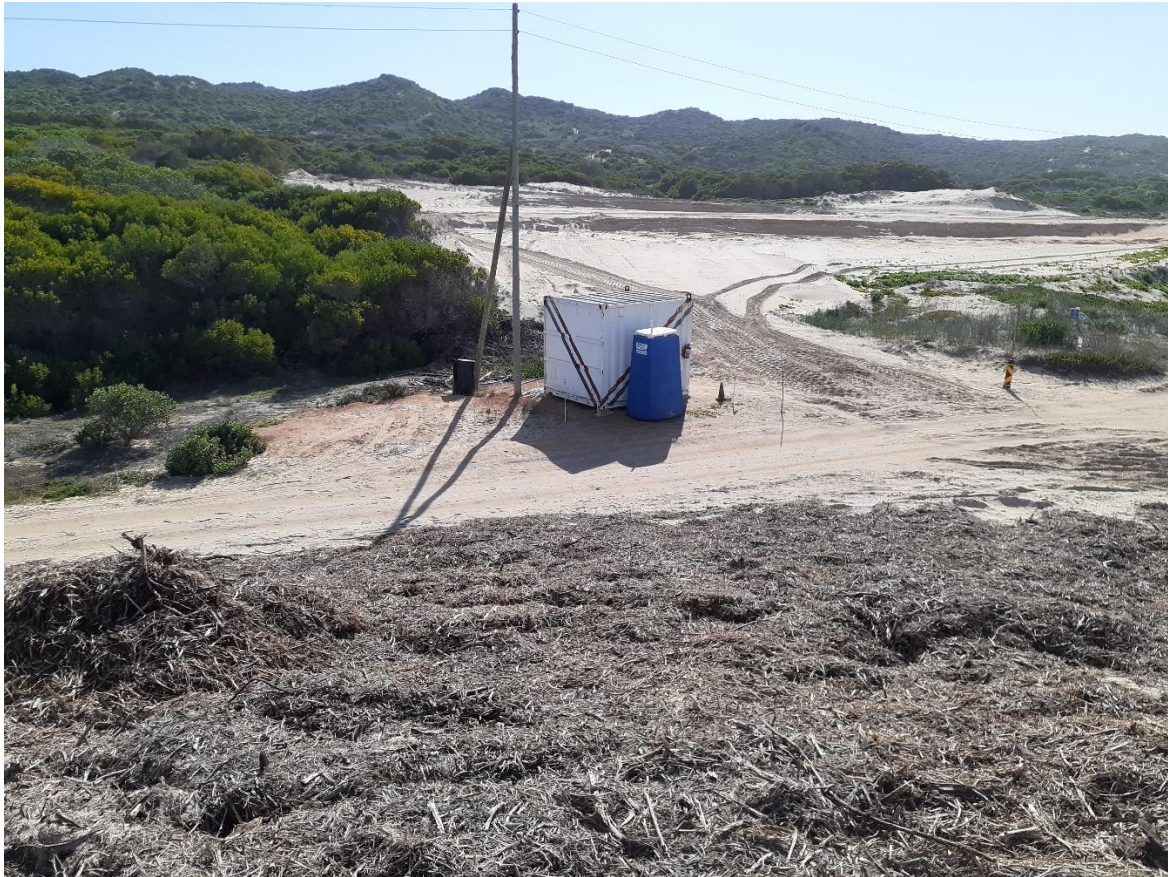
Photo 1: The small container, chemical toilet and dustbin has been provided near the Phase 2 workspace (installation of Municipal services).

2. The contractor must point out the site office and the holding yard.	To be sanctioned by the ECO and site agent before installation of services takes place.	C	A small container has been placed near the entrance of the site to act as a temporary site office, eating area, placement of toilet and waste bin (Photo 1), and a larger storage container has a been placed within the storage yard for the duration of the services contract.

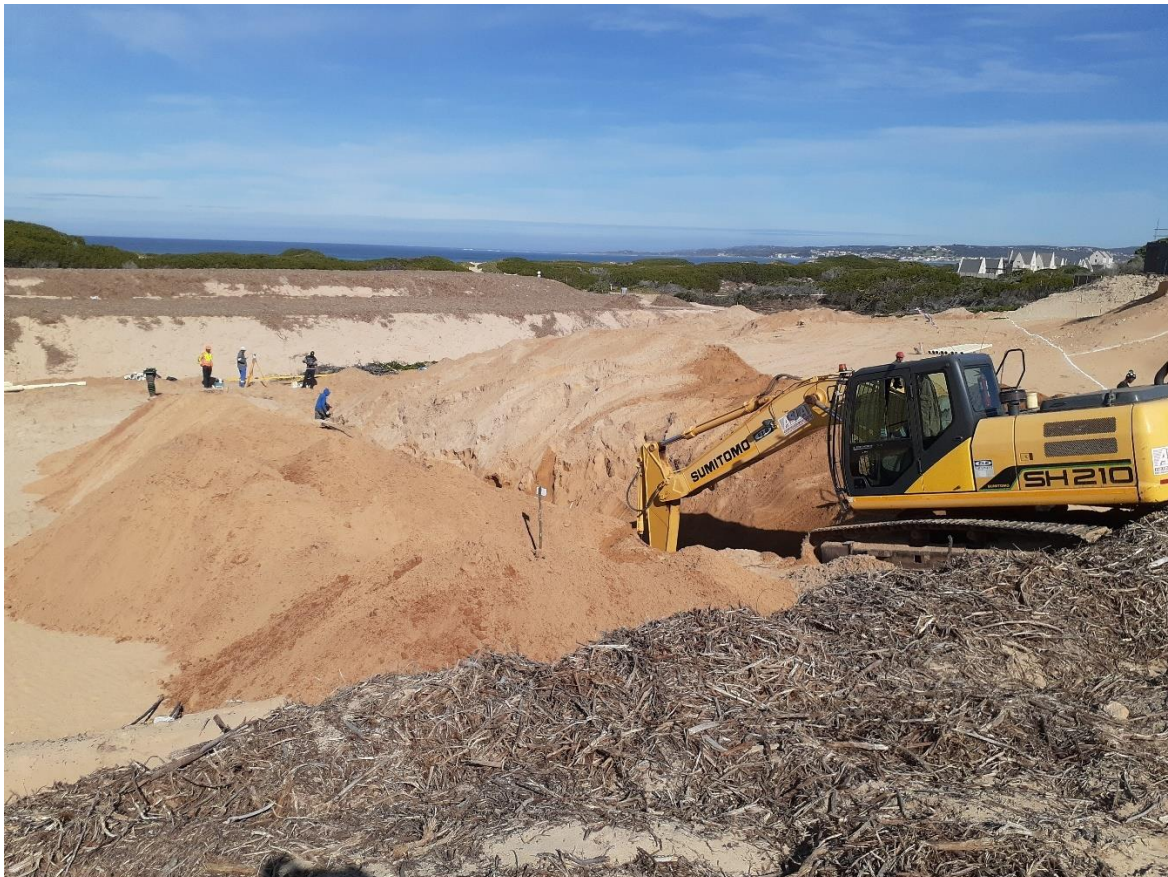
Photo 2: The installation of sewer lines for the Preekstoel Beach Lifestyle Estate. Note the stabilized building platforms covered in wood chips.

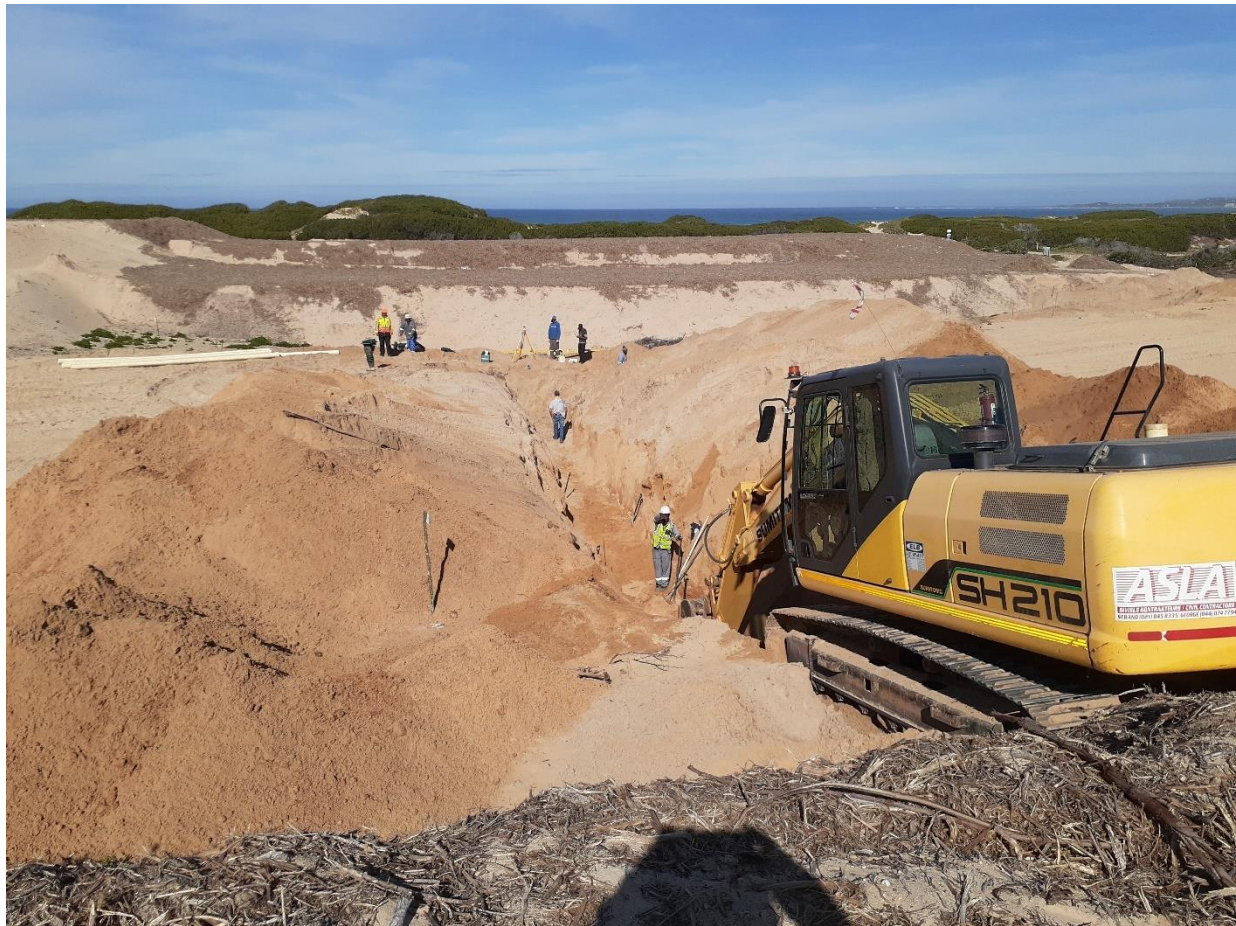
Photo 3: The installation of sewer pipes in the center of an internal road.

ENVIRONMENTAL ASPECTS (PROJECT ACTIVITY)	REQUIRED ACTIONS	TARGET AND RESPONSIBILITY	COMPLIANCE	ECO COMMENTS
	with at all times			
Institute measures for stormwater management to prevent erosion , damage to property and pollution of the environment.	1. Stormwater measures are not required during the installation of services phase of construction. Should a heavy downpour of rain occur the Site Agent must ensure that stormwater is contained on the property.	RE/Site Agent to monitor adequate storage of stormwater after moderate rainstorms and during the wet winter period (Construction Phase).	C	Deep ponding of stormwater on site must be prevented and measures to keep the stormwater on the site must be undertaken by the Site Agent. No heavy rainstorms have occurred on site during the winter period so far.
F.2.3 Soil				
Prevent soil erosion	1. The whole site has been de-grubbed of alien vegetation. Once the various building platforms have been completed it will be necessary to spread the wood chips over the stabilized platforms on site to prevent wind erosion.	ECO to monitor site clearing and site preparation and check for any erosion that may take place.	C	The whole site has been cleared of all alien vegetation and de-grubbed. The phase 1 building platforms have been prepared and the wood chips spread over them. Municipal services are currently being installed within and along the roads (Photo 3). No major wind erosion has been currently noticed on site.

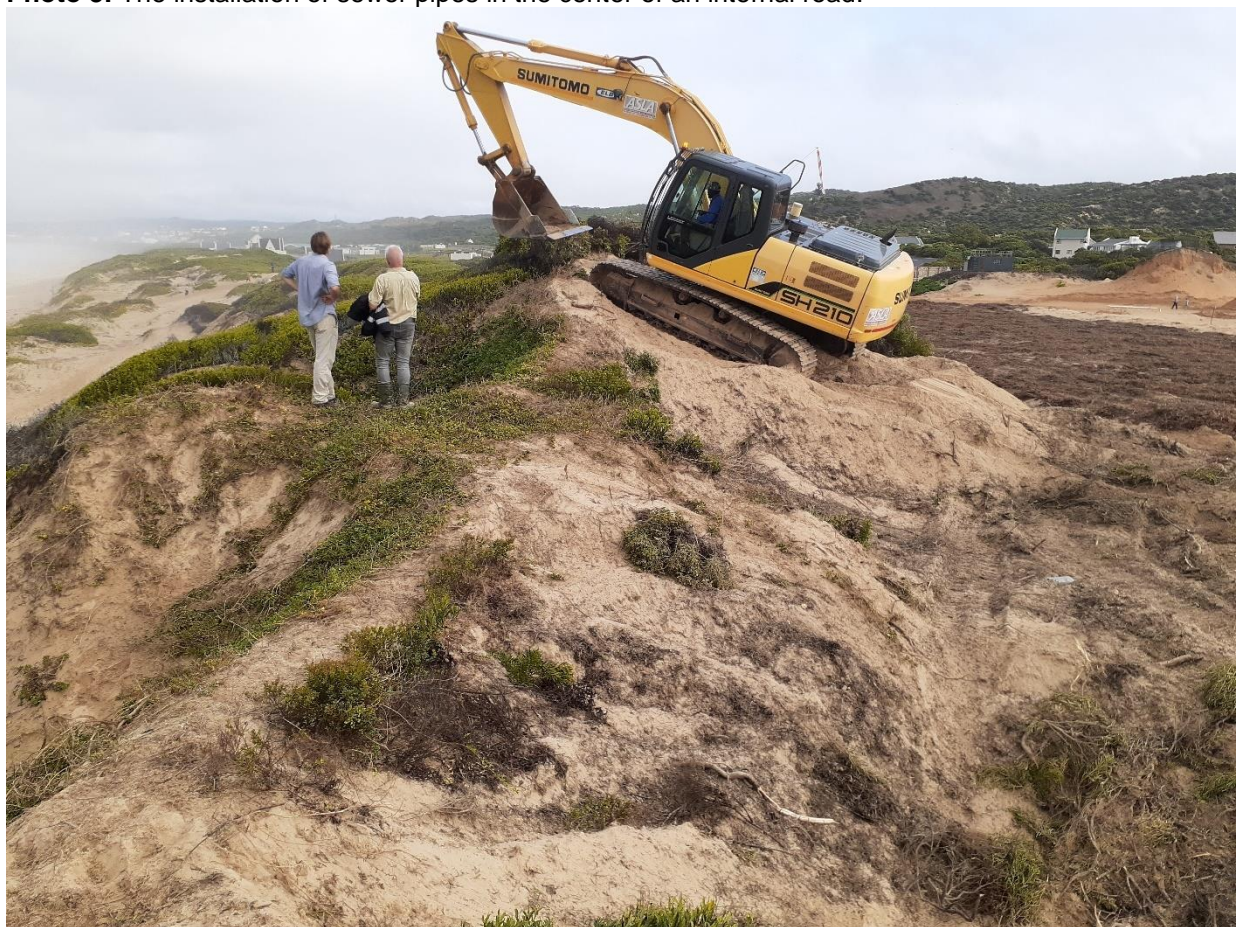
Photo 4: The back dune of the frontal dune system has been raised by at least 2m by windblow sand causing blowouts within the dune system. The sand from these unstable dunes was moved towards the sea

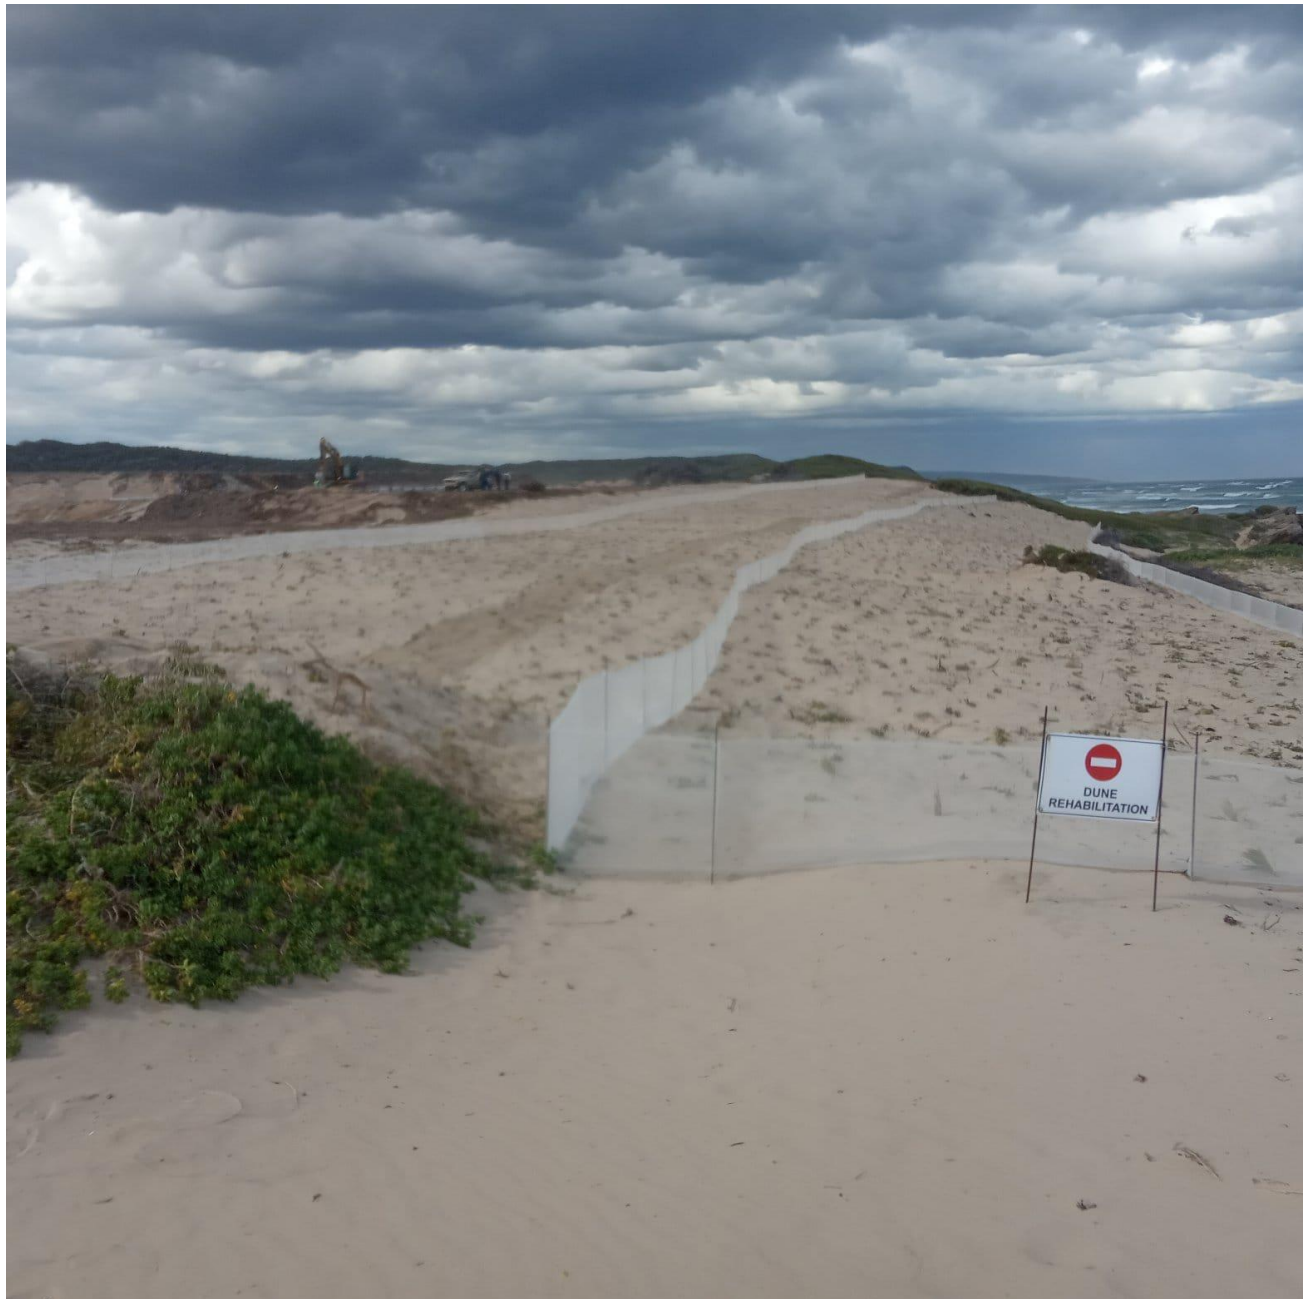
Photo 5: The sand from the unstable back dunes was moved towards the seashore at an angle of repose of dry sand (about 26°). Note the netting to reduce wind erosion and the soil saver hessian to the left of the middle net. The whole area was planted with indigenous strand plants about 1m apart.

ENVIRONMENTAL ASPECTS (PROJECT ACTIVITY)	REQUIRED ACTIONS	TARGET AND RESPONSIBILITY	COMPLIANCE	ECO COMMENTS
Rehabilitate all areas where soil erosion has taken place	1. The badly eroded frontal dune system must be rehabilitated by trapping windblown sand using brushwood fences placed at strategic points	If the brushwood fences take too long in trapping sand moved off the beach by wind, sand harvested from the interior of the property can be used to fill in blowouts and reshape dunes. The ECO and the specialist dune rehabilitation company, VULA, will be responsible for such rehabilitation.	C	The back-dune area of the frontal dune system has grown in size (by at least 2m vertically over a period of about 20 years) by rooikrans trapping windblown sand off the beach and from prolonged blow-outs (Photo 4). It is envisaged to mechanically drag such sand back towards the beach to get a stable, low angle dune front, which will be rehabilitated with locally indigenous strandveld plants. Shade netting rows will be used for long term trapping of sand off the beach and prevent erosion of the newly formed back-dune (Photo 5).
